**GEOTECHNICAL INVESTIGATION REPORT BY JEFFREY AND KATAUSKAS (J&K)  
IN APRIL 2010 REF: 23922ZNRPT**

**GEOTECHNICAL INVESTIGATION**

**PROPOSED REDEVELOPMENT OF  
BALMAIN LEAGUES CLUB**

**VICTORIA ROAD, ROZELLE, NSW**

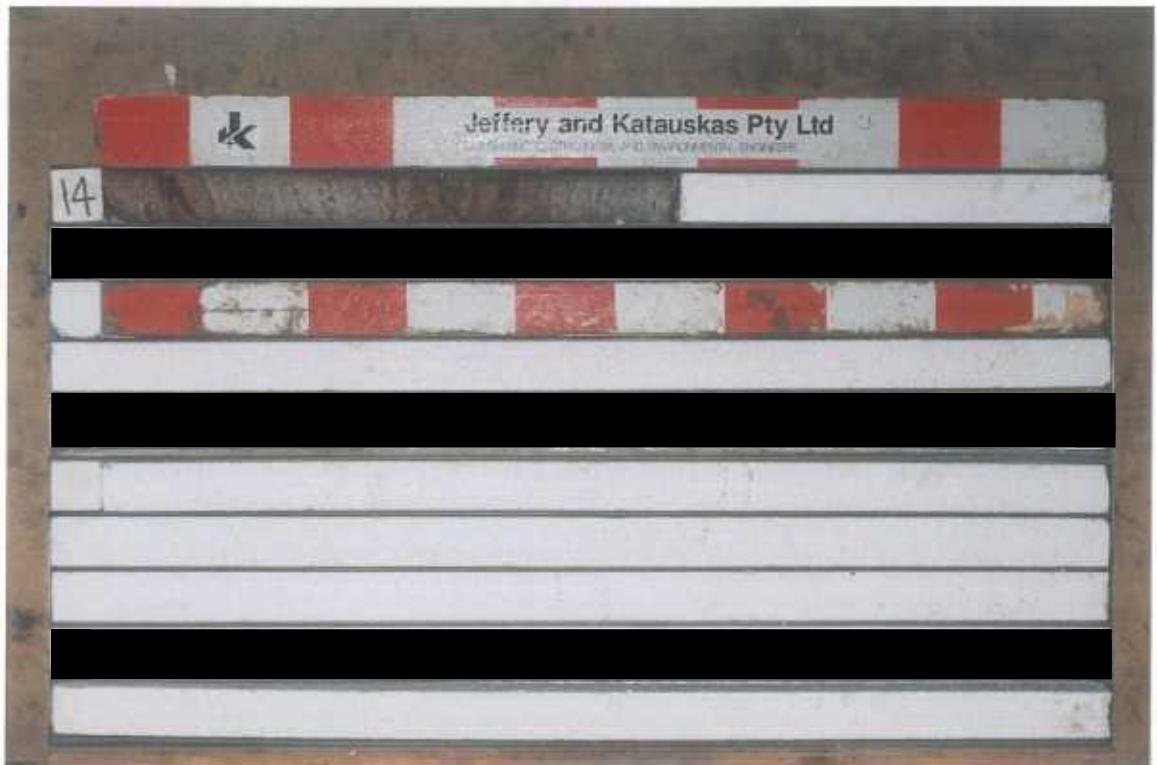
Water Loss/Level	Barrel Lift	Depth (m)	Graphic Log	CORE DESCRIPTION Rock Type, grain characteristics, colour, structure, minor components.	Weathering	Strength	POINT LOAD STRENGTH INDEX I <sub>s</sub> (50)	DEFECT DETAILS											
								DEFECT SPACING (mm)										DESCRIPTION Type, inclination, thickness, planarity, roughness, coating.	
								EL	VL	L	M	H	VH	EH	500	300	100	50	20
		5		START CORING AT 5.77m															
		6		SANDSTONE: fine to medum grained, light grey, bedded at 10°.	DW	L-M	X												
		7			XW	EL-VL	X												
		8		DW	L-M	X													
		9		XW	EL-VL	X													
		10		DW	L-M	X													
		11		XW	EL-VL	X

75% RETURN

BOREHOLE LOG 101 WITH CORE PHOTOGRAPH
