Northparkes Mines  
A century of mining together

# 2022 Annual Review

| Document Details | |
|---|---|
| Name of Operation | CMOC-Northparkes Mines |

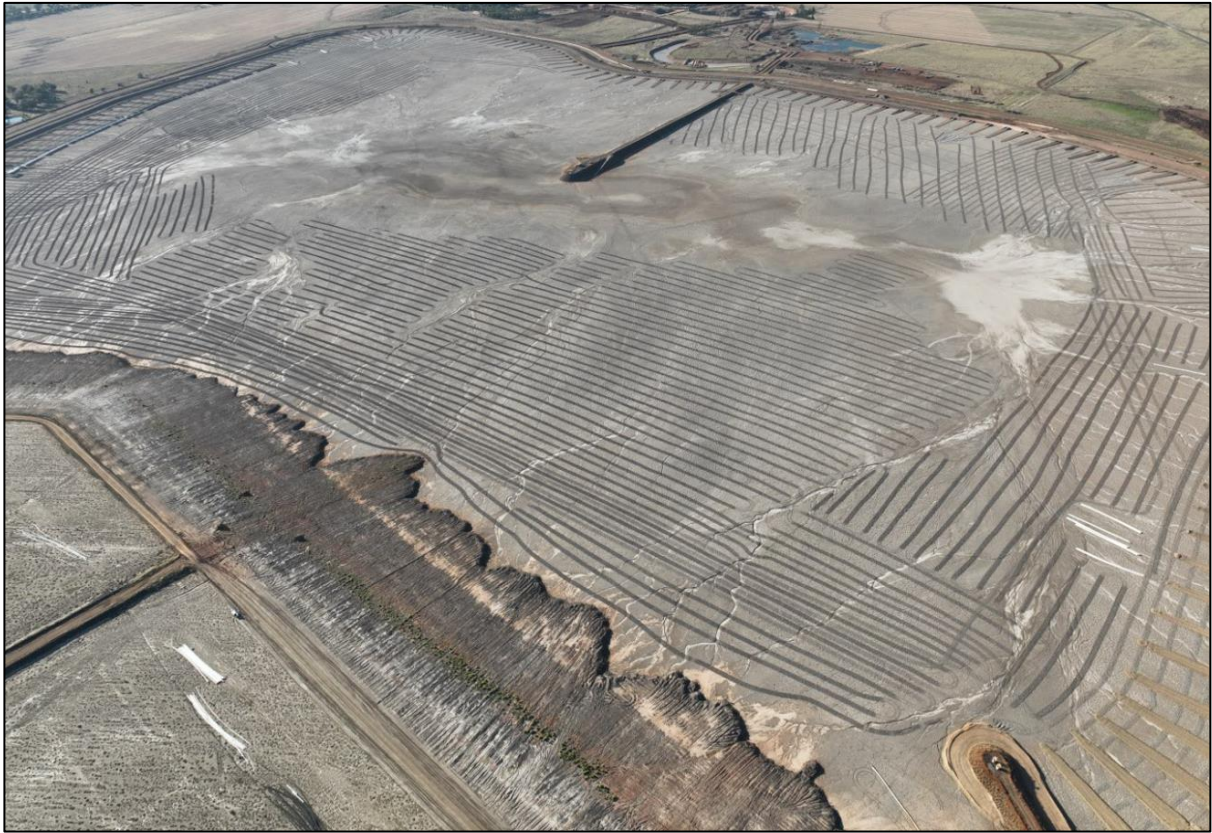
**Figure 9 Ripping undertaken on Rosedale TSF for dust control**

During the month of November, airborne particulates were noted to be generated from Rosedale TSF and TSF1 during high wind events. Ripping of the tailings surface was instigated and provided immediate mitigation that effectively managed dust generation. Ripping is scheduled on a regular basis to ensure that facilities have minimal surface area that is likely to incur dust lift off. Figure 9 below shows ripping undertaken on the Rosedale TSF.

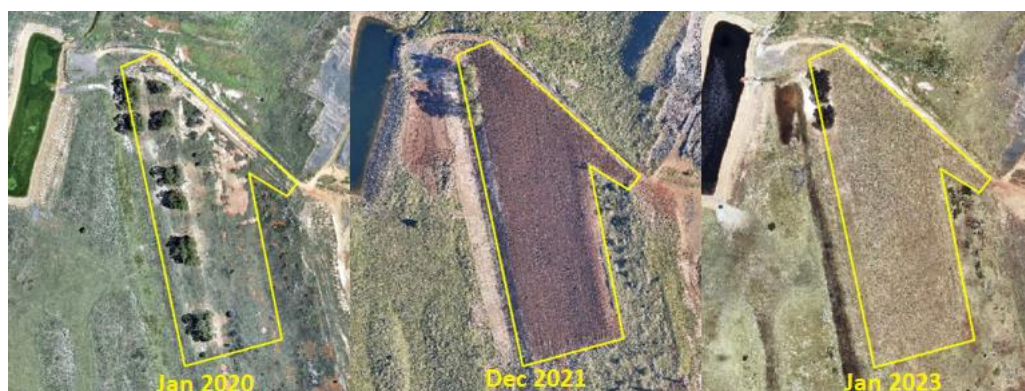
**Figure 25 E22 waste rock batter rehabilitation repairs from 2020 to 2023**

A small area on the western batter of the rehabilitated E22 waste rock emplacement had erosion repairs carried out in 2021. The area was reshaped, with erosion gutters and benches removed to create a consistent gradient (Figure 25). Growth medium was sourced immediately below the area from a rehabilitation stockpile that was against the Sediment Pond 3 embankment.

During 2022 a range of vegetation species established creating the early succession of the ecosystem. As expected, the percentage of common introduced vegetation species were higher than the adjacent undisturbed areas. The species composition will continue to be monitored by Northparkes staff.

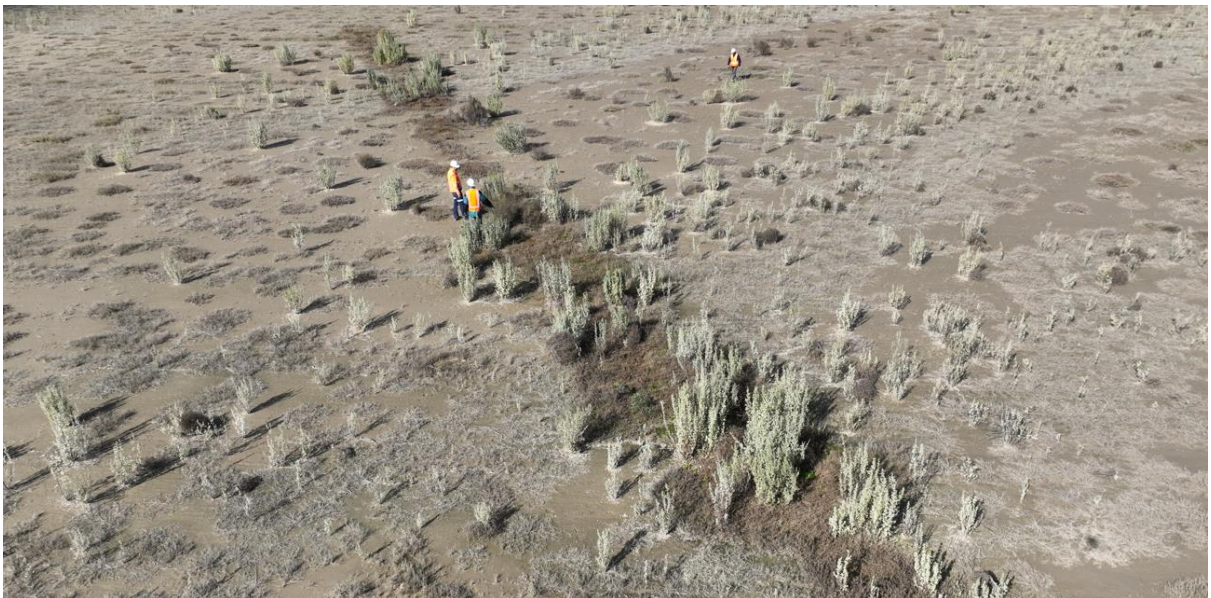
**Figure 28 Visible influence on vegetation due to a strip of chicken manure**

- There were distinct bare and vegetated areas
- Fibrous roots had established as fan like structures between the deposited tailings layers
- Visible roots were present even in the bare patches
- Established salt or blue bush species had significant visible roots below 700mm into the tailings profile
- Application of nitro humus or chicken manure increased surface biomass significantly.
