Northparkes Mines
A century of mining together

2020 Annual Review

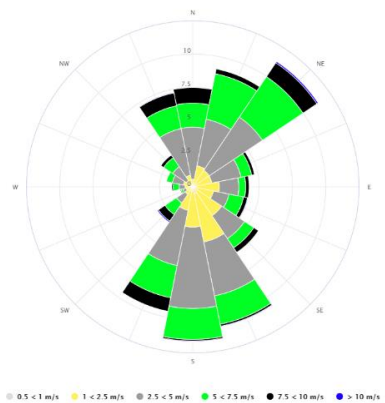
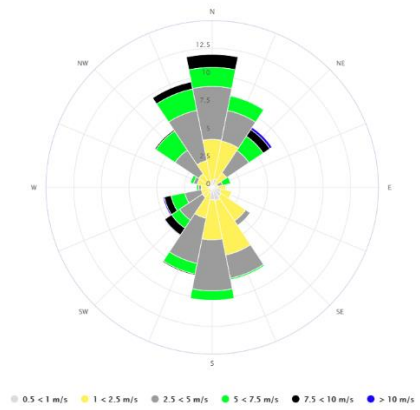
Figure 9 Monthly wind rose summary for 2020

Analysis of data reveals that prevailing winds during the 2020 reporting period were predominantly from the North and South. Stronger winds during summer and spring periods were typically experienced from the North whilst Autumn and Winter were typically from the South. The prevailing wind conditions during this reporting period were consistent with the historical data as presented in the Step Change Environmental Assessment (EA), Umwelt 2013. Average wind speeds were generally consistent through the year recording 3.45m/s in H1 and 3.19m/s in H2.

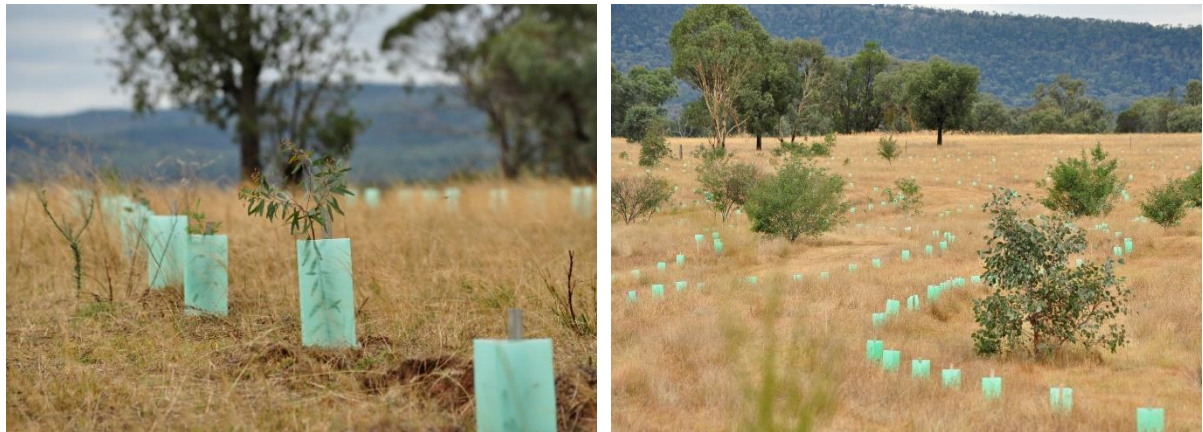
Figure 24 Plant installed in April trial planting and Spring planting lines

The planting area was deep ripped approximately 500mm along the contour, six months prior to the Spring planting. Each individual was planted with a combination of mycorrhiza, water crystals, tree tonic and native fertiliser. To prevent grazing and vegetation competition, 400mm coreflute guards and weed matting was placed around the installed plants. During the summer period, plants were followed up with ongoing maintenance to ensure adequate moisture and grazing pressures were alleviated.

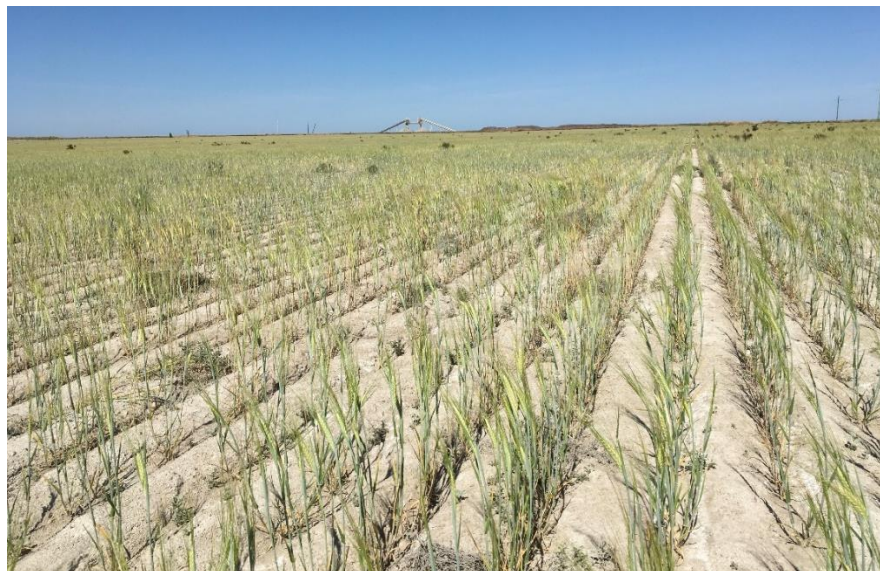
Figure 34 2020 barley planting on TSF2

During May 2020, the majority of the TSF2 tailings beach was sown to barley. With a wetter than average year the germination rates and plant establishment were successful in reducing dust. The cover provided by the barley stubble will ensure effective dust control for the 2021 reporting period.

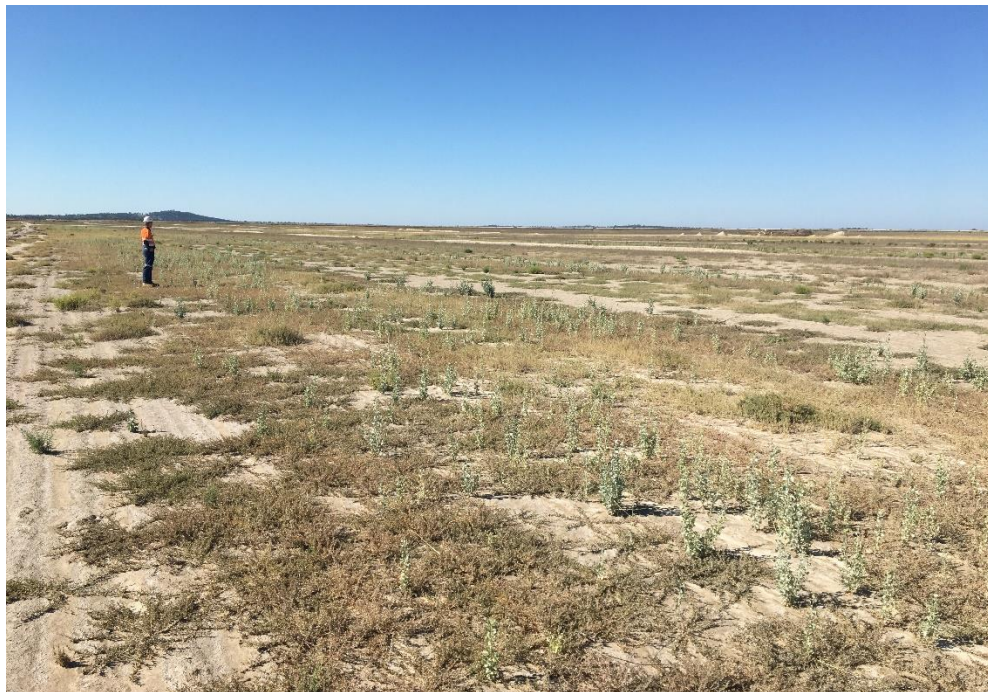
Figure 35 Bluebush and saltbush established directly within the TSF2 tailings (February 2021)

During 2020, a mix of native salt bush and blue bush species were sown in strips across TSF2 (Figure 35), which has accelerated the native vegetation cover across the tailings. The species mix consisted of Oldman Saltbush, Creeping Saltbush, Climbing Saltbush, Ruby Saltbush, Yanga Bush, Small-leaf Bluebush. The groundcover percentage within the strips of native species increased significantly during the reporting period.

During the reporting period an ecologist recorded the range of species that have established within TSF2. The report stated that of the 15 different species identified, the Creeping Saltbush, *Sclerolaena* spp. and Yanga Bush were all observed growing well.

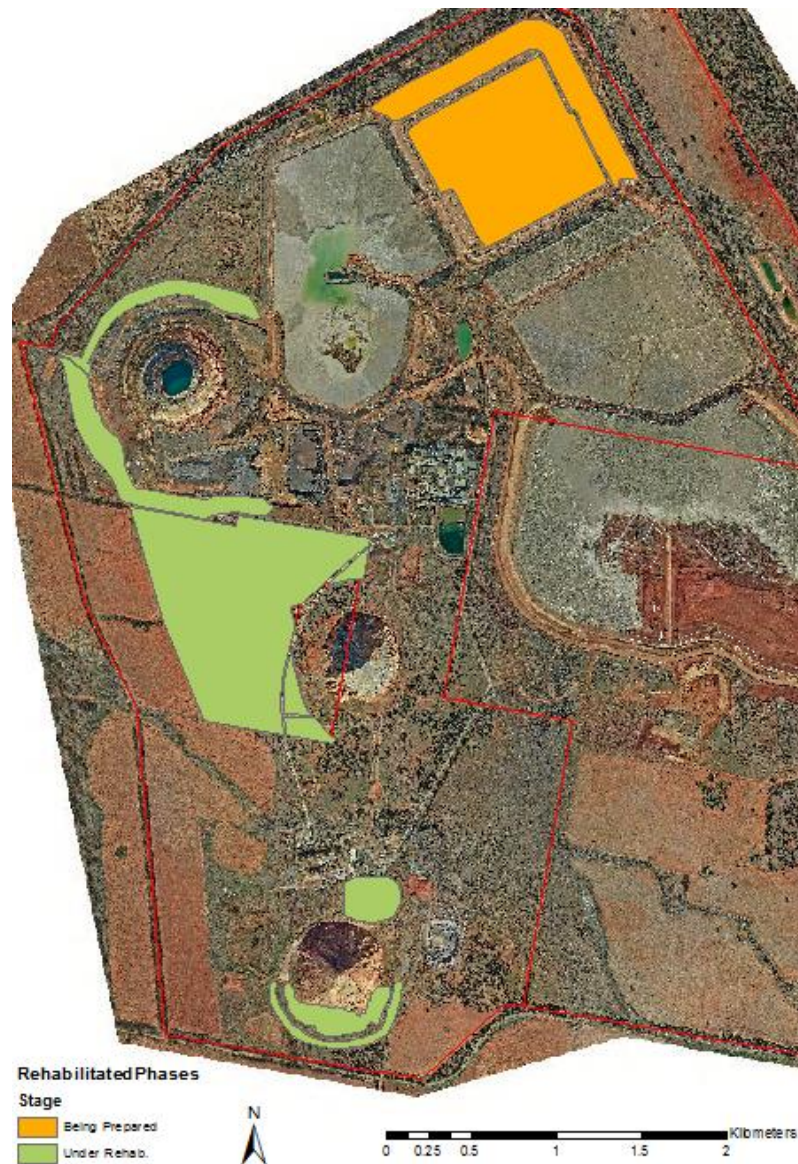
Figure 36 Current status of mining and rehabilitation at the end of the reporting period

Mine Area Type	2019 Reporting Period (actual)	2020 Reporting Period (Actual)	2021 Reporting Period (forecast)
Total Mine Footprint	1,145	1,145	1,160
Total active disturbance	876	876	865
Land being prepared for rehabilitation	102	102	144
Land under active rehabilitation	163	163	151
Completed Rehabilitation	0	0	0

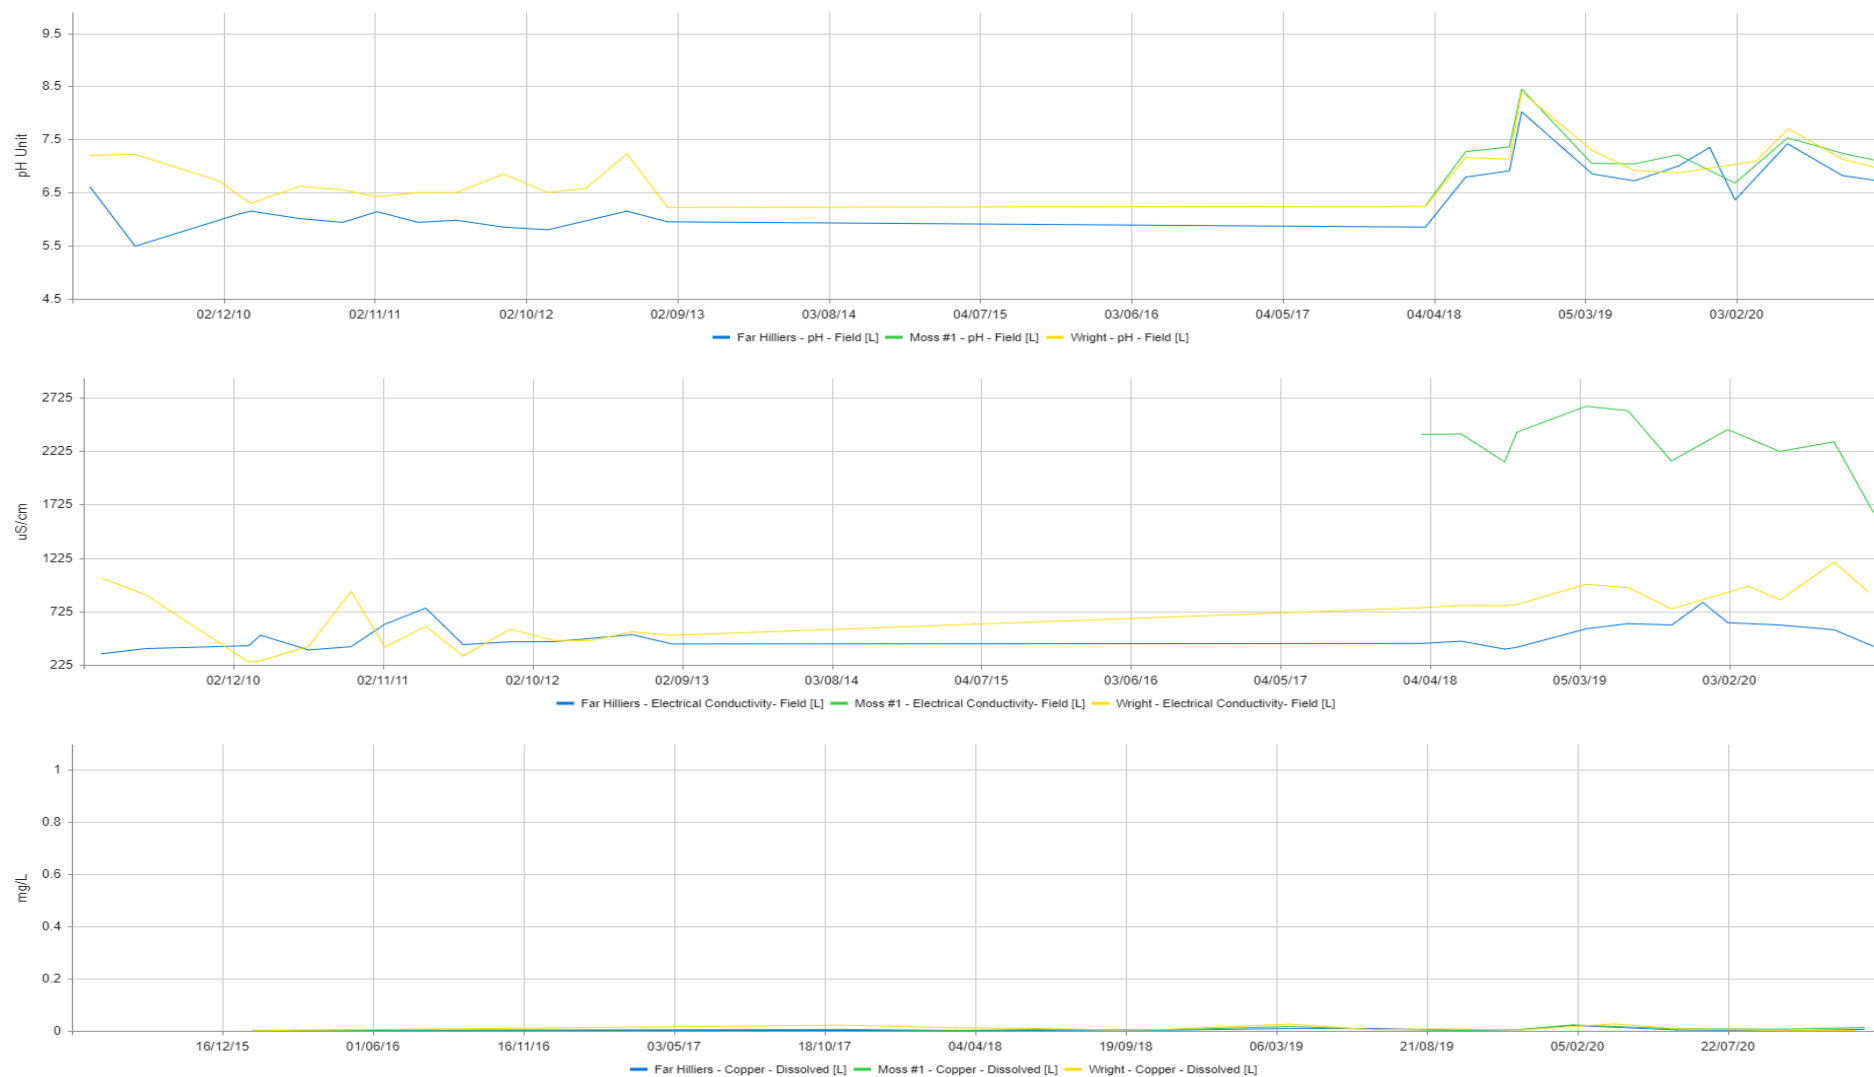
Ground water monitoring results – Regional bores pH, electrical conductivity and copper
