Northparkes Mines  
*A century of mining together*

# 2019 Annual Review

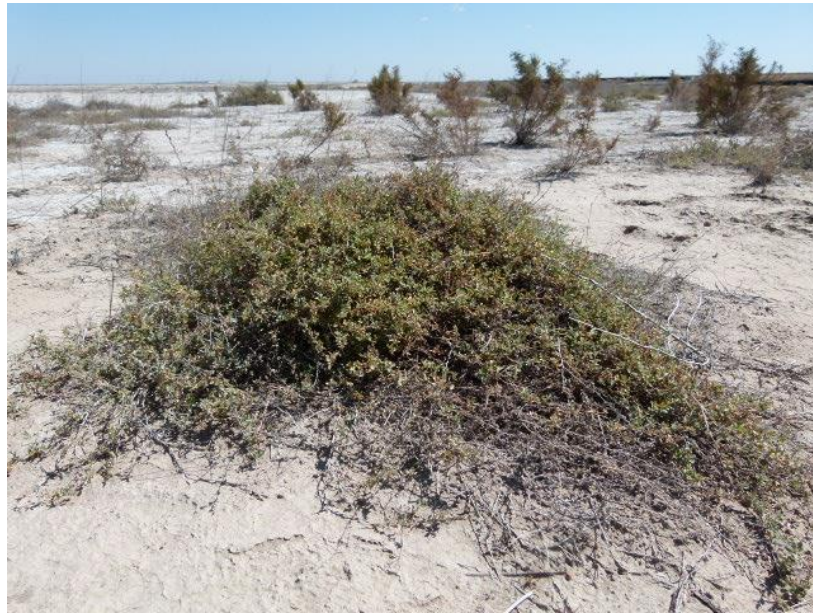
The ongoing success of these vegetation species directly in the TSF2 tailings has initiated a study into the potential long-term rehabilitation outcomes. The study will be initiated in 2020 and is planned to be carried out over several years to ensure vegetation performance is also measured in non-drought periods. The study will assess the benefits and risks of direct revegetation into tailings profiles at Northparkes.

**Figure 30 Bluebush and saltbush established directly within the TSF2 tailings (Oct 2019)**

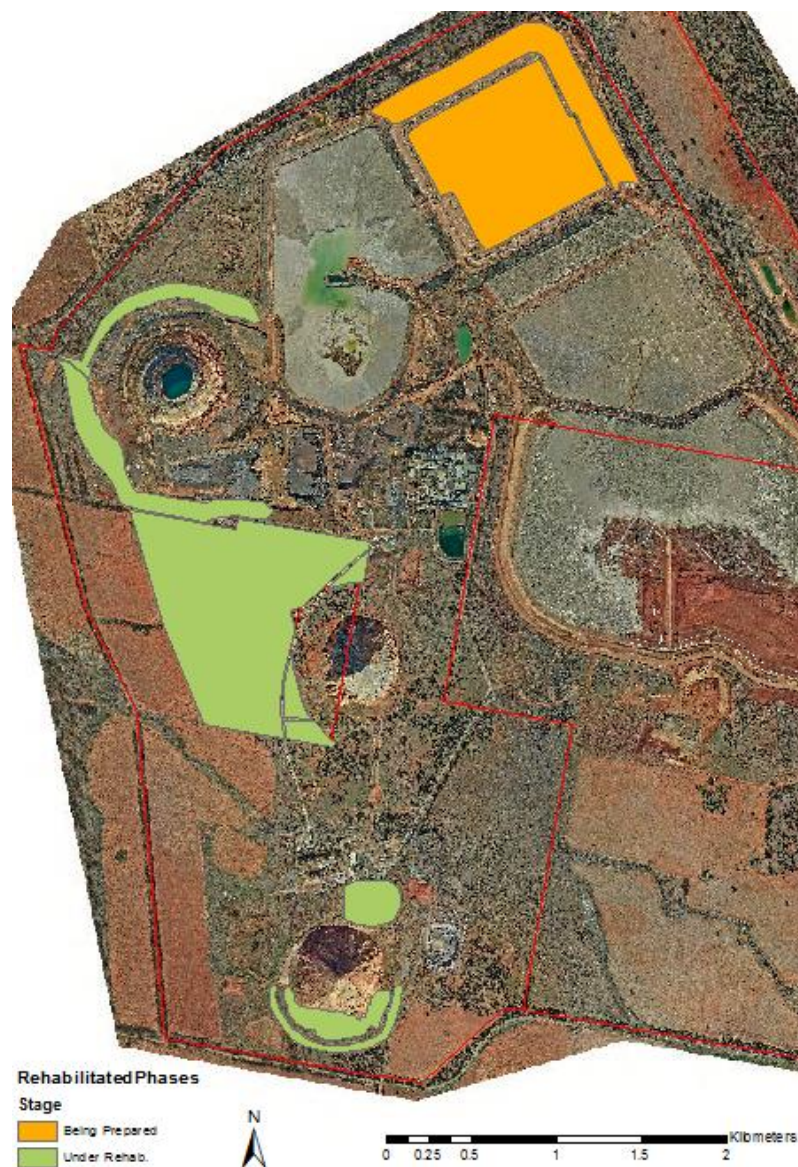
**Figure 31 Current status of mining and rehabilitation at the end of the reporting period.**

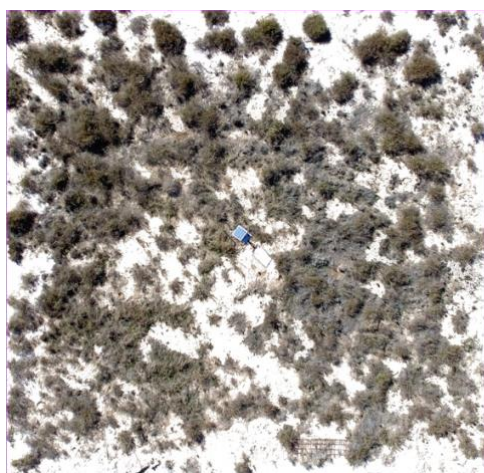
*Plate 4: Enhanced image (left) and result from image analysis (right)*

Plate 4 shows exemplarily a colour enhanced original image of the aerial photo and the cover analysis. The percentage of plant cover (vegetative and litter) has been calculated for all four plots (Table 3; 'plus litter')-

Plot	image analysis	visual	plus litter
A	25%	31%	68%
B	18%	18%	58%
C	9%	12%	43%
D	15%	12%	69%

The assessment of the cover trials in regard to success of development of an ideally stable and dense plant cover has demonstrated that access to water determines the extent of the vegetation cover. The proportion of revegetative plant cover is highest in the direct revegetation plot (Plot A), which provides the highest amount of soil moisture in the root zone, and varies in the other plots. Including plant litter in the quantification of plant cover, which represents growth and cover conditions at times with higher water availability for plant growth, the cover reaches values > 40% for all plots and is highest for Plot A and D.

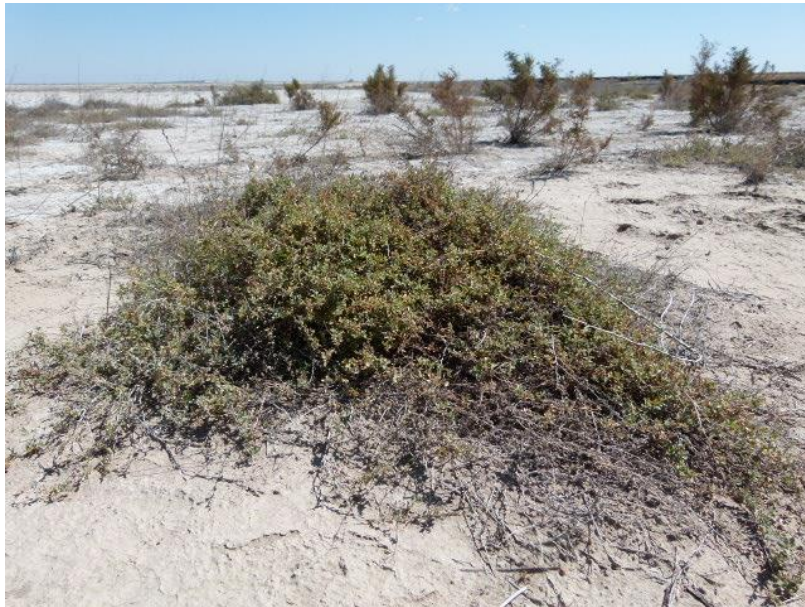
A2-P1: Natural colonisation on tailings; established plant grows above tailings surface due to wind-blown tailings, which is captured by the plant. The elevated position presumably allows salts to be leached from the higher position and produces favourable conditions for plant growth

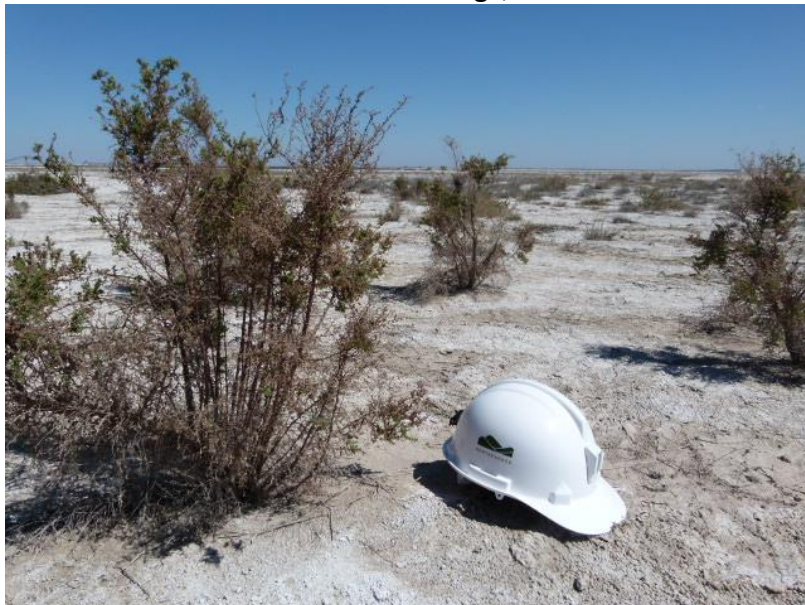
A2-P2: Natural colonisation on tailings; view towards centre of TSF

Photos provided by NPM; photos were taken on 30 September 2019
