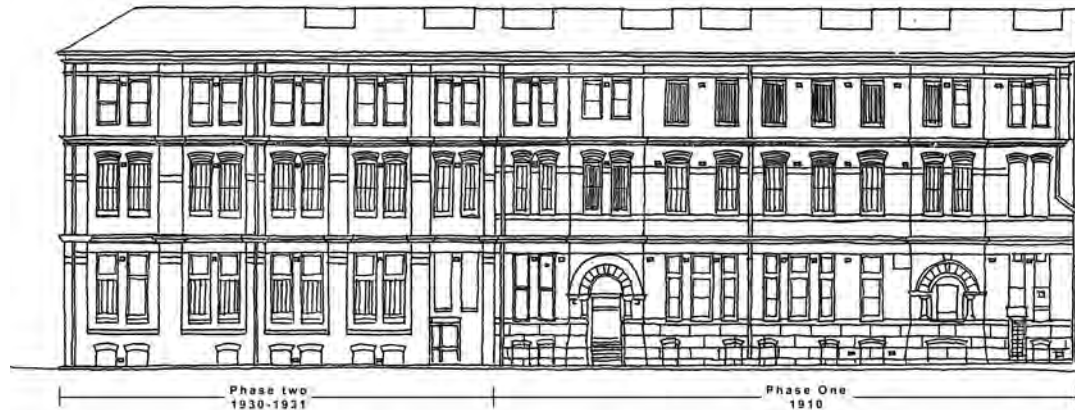
Figure 4: The main facade of the Administration Building faces what was originally the main brewery driveway and is now to be known as Carlton Street. The main phases of the development of the building are shown.

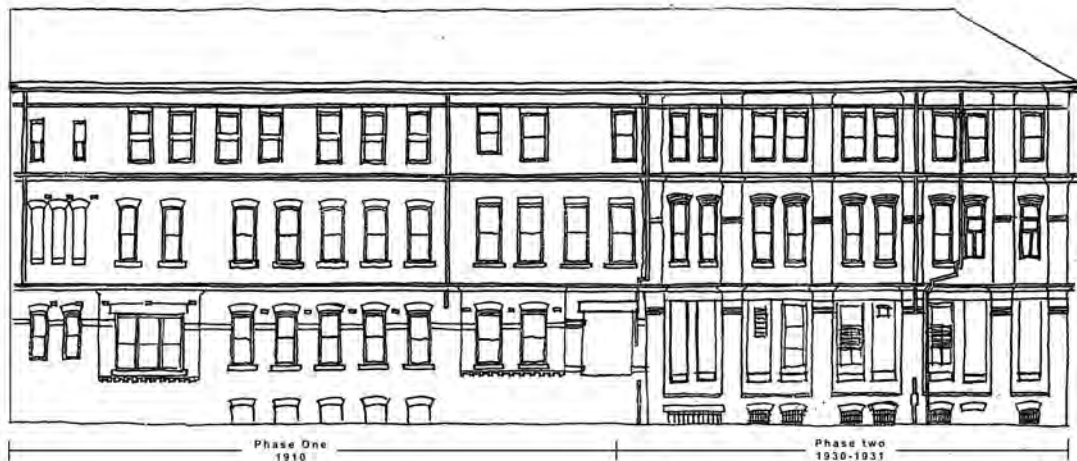
Figure 5: Eastern elevation of the Administration Building showing the major phases in its development. The upper level was added at the same time as the northern extension but noticeably less care was given to ensuring that the fenestration patterns are consistent with those on the lower levels on this side of the building, although the overall rhythms and disciplined character of the facade are retained.

The uppermost level of the building is superficially consistent with the lower, but on close inspection the eastern, Kensington Street elevation in particular breaks from the strong discipline found on the lower levels, with windows placed irregularly along the façade.
