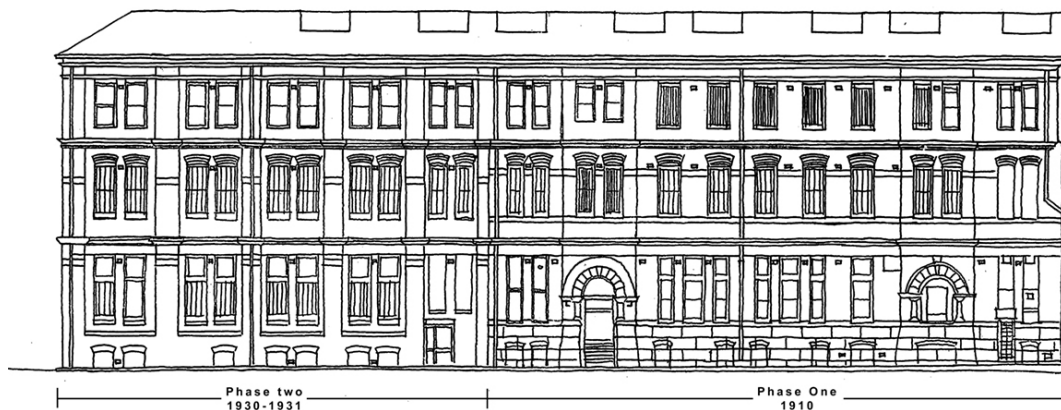
Figure 25. The main facade of the Administration Building faces what was originally the main brewery driveway and is now to be known as Carlton Street. The main phases of the development of the building are shown.

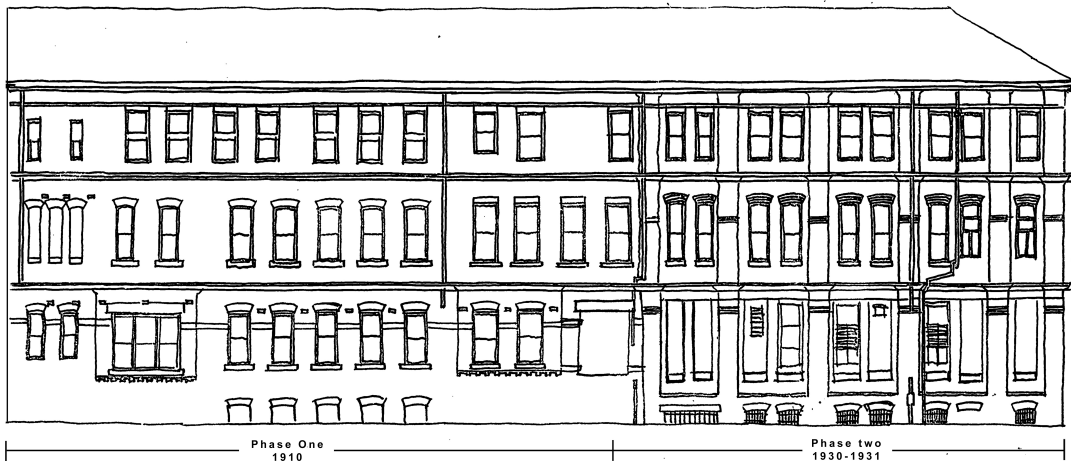
Figure 26. Eastern elevation of the Administration Building showing the major phases in its development. The upper level was added at the same time as the northern extension but noticeably less care was given to ensuring that the fenestration patterns are consistent with those on the lower levels on this side of the building, although the overall rhythms and disciplined character of the facade are retained.

*with eaves boxed with Vee jointed timber linings. On the Kensington Street elevation the windows of the second floor addition are not aligned with those of the floors beneath as strictly as on the main facade. The double hung window assemblies along the eastern elevation at the boardroom are detailed with leadlight glazing.*
