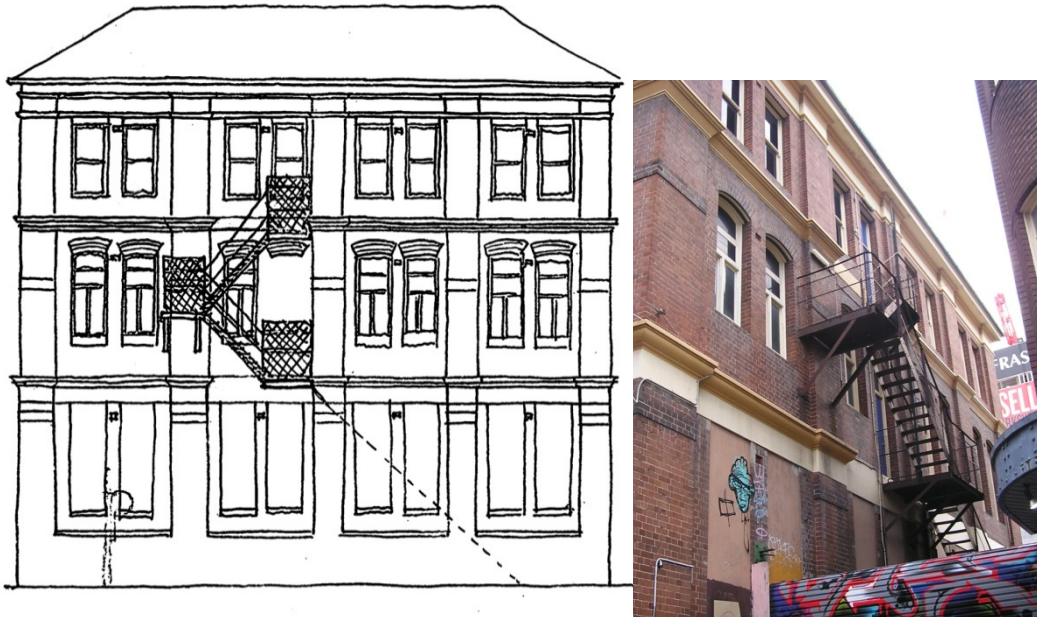
Figure 27 and 28. The northern elevation of the Administration Building is largely hidden in views from Broadway by the adjacent County Clare Hotel due to the narrow driveway and the bulk of the County Clare Hotel. The facade is dominated by the external fire escape.

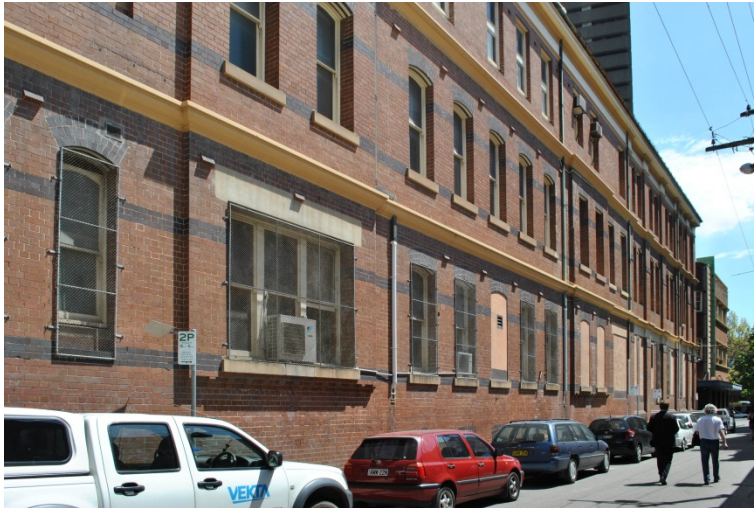
Figure 30. The Administration Building forms an important edge to the northern end of Kensington Street due to its imposing scale and strong patterning created by the rhythms of the fenestration and projecting moulding which direct the eye along the street. The building is also notable for its lack of access from the public domain, reinforcing the prominence in the streetscape. Although the building reads as intact on casual inspection, closer interrogation reveals a wealth of layering and adaptation over the years.

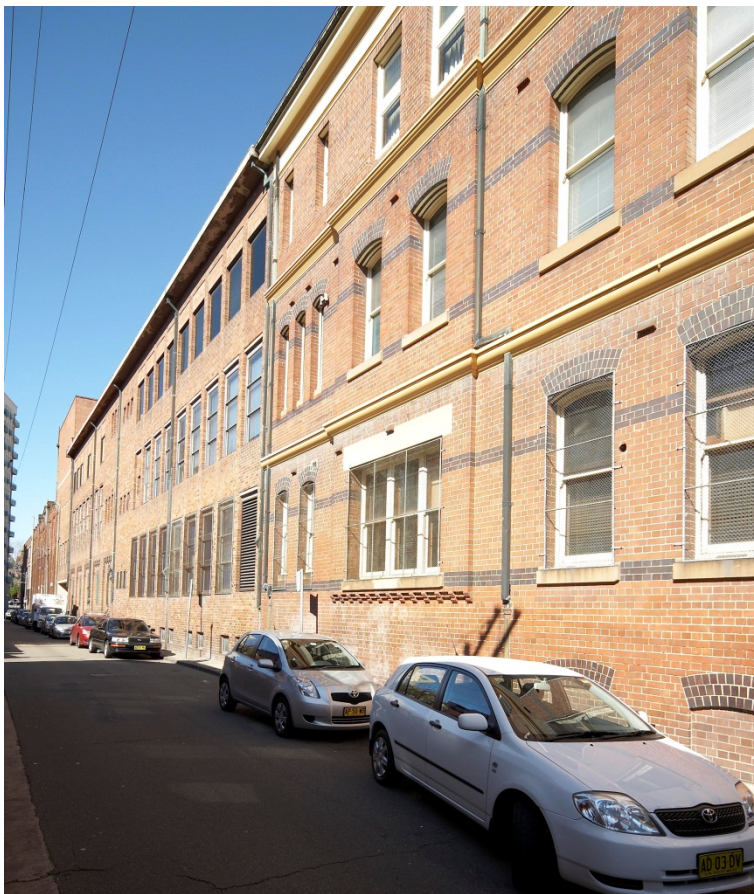
Figure 31. The western side of Kensington Street was dominated by the 3-4 storey scale of the brewery buildings that lined it and dwarfed the adjacent terraces on the eastern side. This photograph was taken prior to the demolition of most of the structures on the site. The building in the middle distance is the later extension to the Administration Building which has now been demolished.

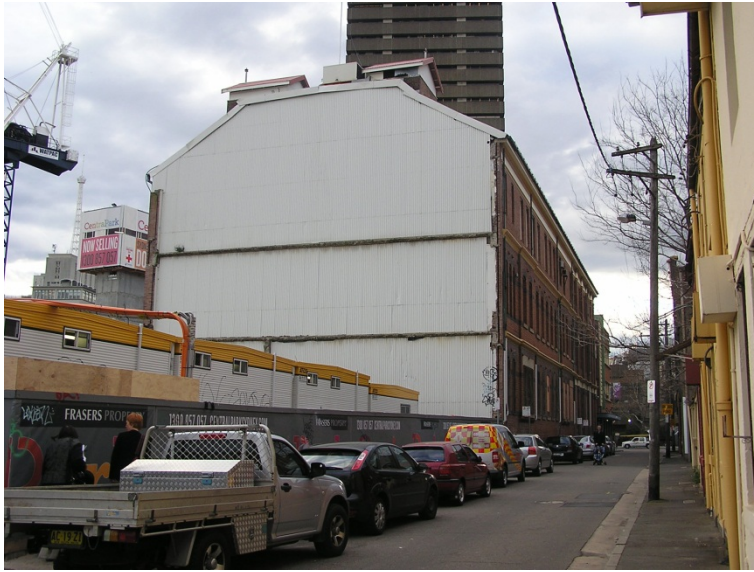
Figure 32. Southern elevation of the Administration Building showing the temporary wall erected to protect the Administration Building following the demolition of the earlier extension.

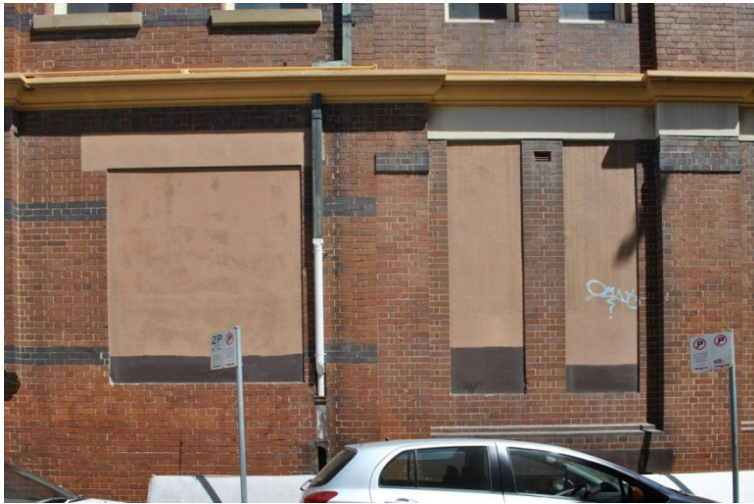
Figure 33. The 1930 addition was designed to sit comfortably with the earlier part of the building, and this has been so successfully achieved that the two parts are only readily discerned on close inspection. Indicators include the clearly defined joint (no attempt was made to key the brickwork) and the subtle differences in the modelling and fenestration of the two sections.

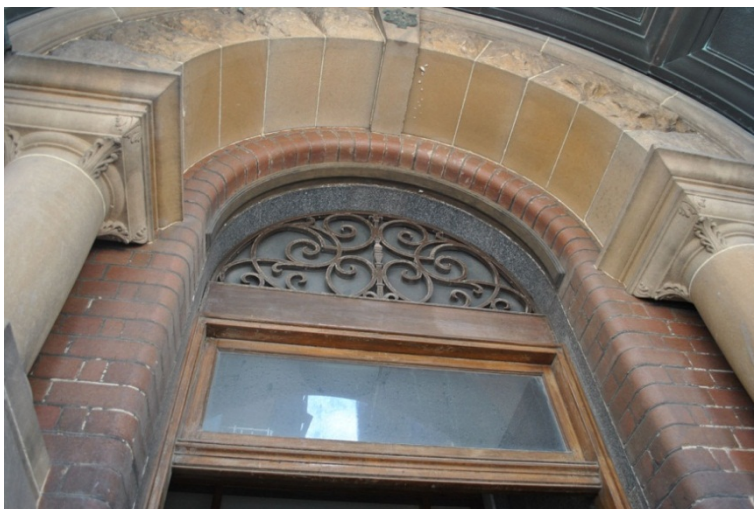
Figure 34. The formal entrance to the building is positioned at the centre of the western facade of the building and opens into the internal road. Protected by a simple Romanesque style arch and a copper hood, its restrained design and quality construction allow it to play an important part in the composition of the building.

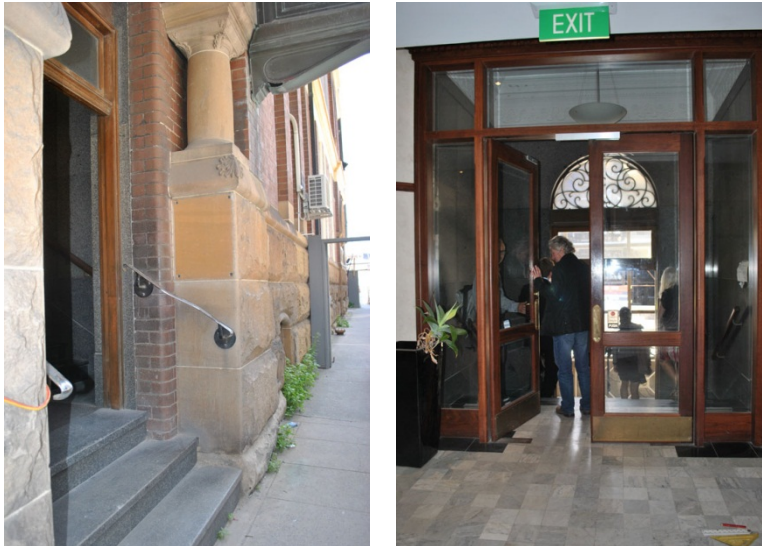
Figure 35 and 36.

(left) The entrance to Carlton Street, and (right) main door to the building. The joinery to the main door is simple, with a pair of glazed leaves framed in varnished timber. A decorative ironwork grill has been added to protect the glazed arch above the front door. Its relatively light weight and nondescript detailing suggests that this screen was installed in the mid-late 20th century, possibly as part of the 1950s works; other evidence suggests that it was contemporary with the Inter-War alterations.

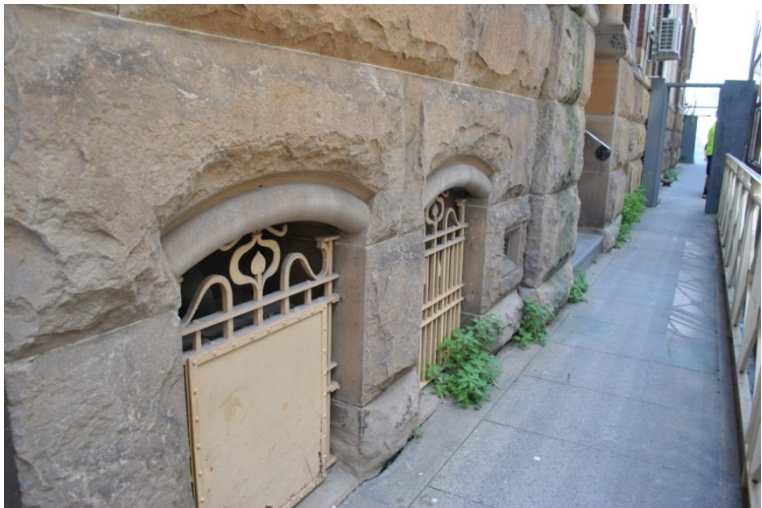
Figure 37. The Carlton Street elevation is set on a rusticated stone base into which the basement windows are set, the openings finished neatly with a dressed roll. The basement windows are protected by worked iron grilles in the Art Nouveau style.

The sandstone base to the building on the western elevation appears to be in good condition and free of damage which is notable given the industrial environment within which it was located.

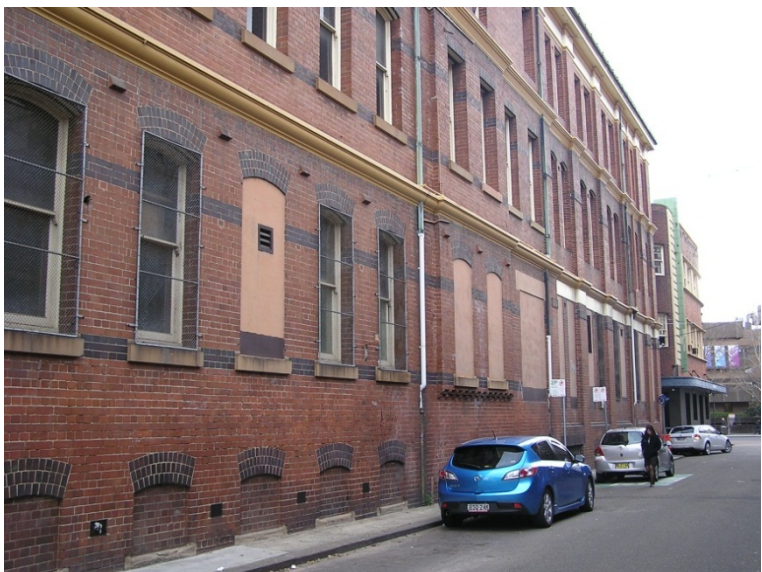
Figure 38. The building turns its back on the adjacent Kensington Street, with no door openings and groups of windows set high above the footpath level to allow light. The windows to the basement have been infilled with brickwork at the southern (1910) section and protected by utilitarian heavy grilles to the northern (below).

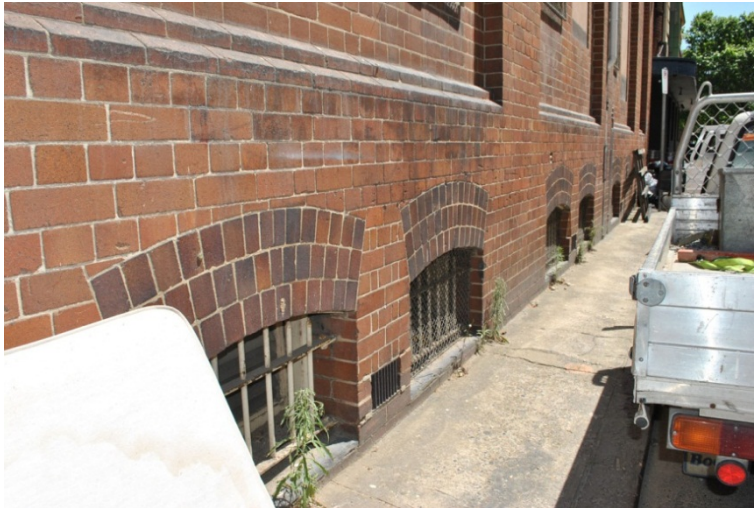
Figure 39. The 1930s extension provided gridded windows to the basement on Kensington Street.

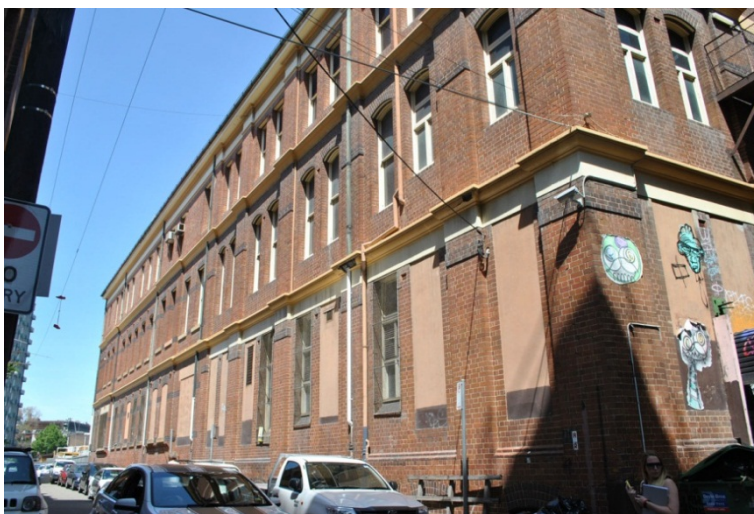
Figure 40. The condition of the external fabric appears to be generally sound, with the main areas of damage noted being limited to the PVC downpipes used to the lower levels of the building, and which have now cracked and broken allowing water penetration and some deterioration of brick jointing.

The building has remained relatively free of vandalism such as graffiti or malicious damage. The 'graffiti' seen here was applied on a film base as part of a community art project.

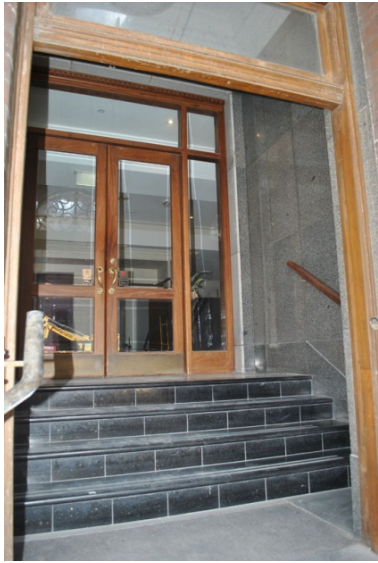
The Main entrance was refurbished, with grey granite paving and wall facings and new metal entrance gates. The granite facings of the walls and the lower steps remain, as does the decorative metal fanlight.

Figure 41. The main entrance was lined in granite to walls and treads, and the door and its frame replaced as part of the 1930s works.

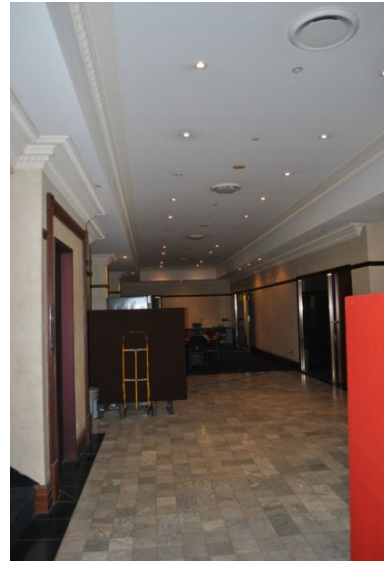
The Entrance Vestibule, Ground Floor was refurbished with the original floor replaced by a reinforced concrete floor paved with marble, and maple frames, side-lights and swing doors at the main entrance. A photograph taken in 1950 of the entrance vestibule shows these 1930 modifications including light fittings, the high coffered ceiling between the structural grid, timber paneling around the base of columns, and office partitions including glazed transom lights. The Carrara marble floor of the entrance vestibule is retained in part today, but the area has been reduced and a polished granite border introduced. The maple joinery with its leadlight glazing has been removed.

Figure 42. The floor of the vestibule area was replaced by a concrete slab and Carrara marble tiles were laid in the 1930s.

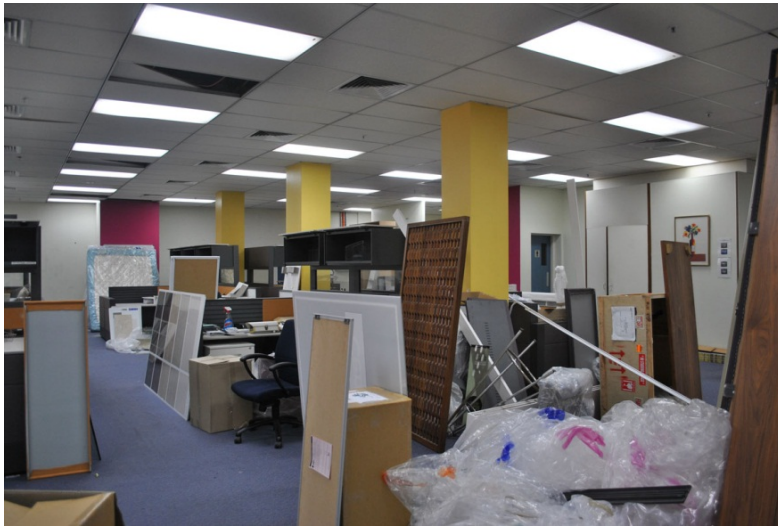
Figure 43. The ground floor has been converted into an open plan office space. Little evidence of the original fabric can be seen.

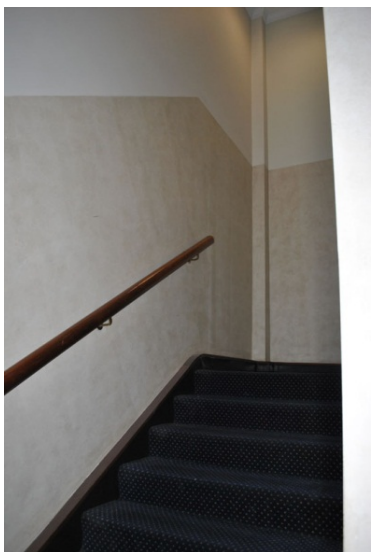
Figure 44. The stair to Level 1 is simple and not lined. It is likely, given its prominent position next to the access to the main lift that led to the Boardroom, that it was originally panelled.

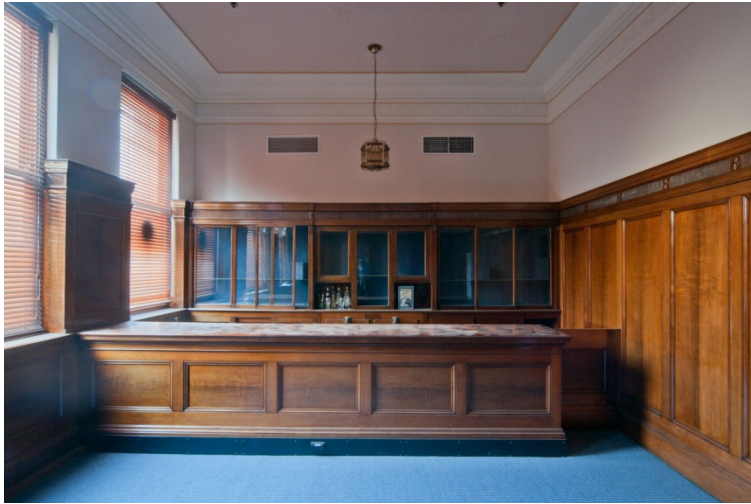
The first floor lavatory, 'Traveller's Cash Room' and light well shown on the Spain and Cosh drawings were adapted to form the Show Room Bar. Much of the 1930/31 fit out of the Show Bar including the Maple paneling survives today, but the flooring has been removed or is covered by carpet. A photograph taken in 1935 shows the new Maple wall and bar joinery and a black and white marble chequered floor. The original light fitting is still in existence today.

Figure 46. The Show Bar is an impressively presented room built in 1931 for the tasting and promotion of the company's products. The room is lined in Queensland Maple and features a large parquetry bar in front of a display cabinet and built-in refrigerator facilities.

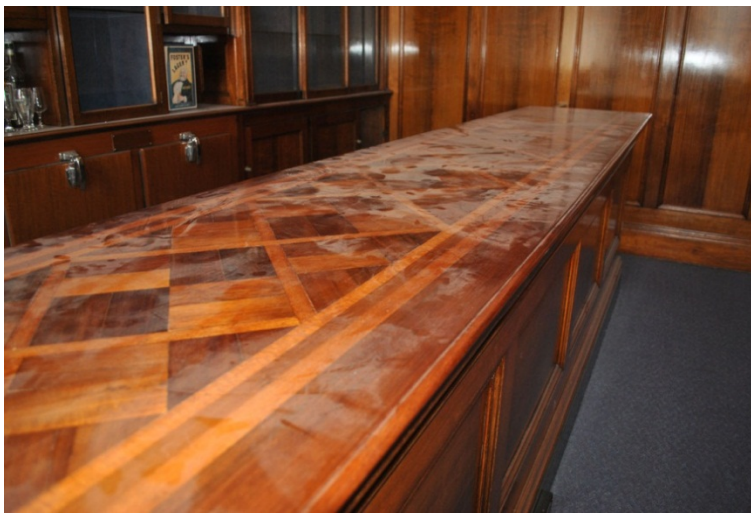
Figure 47. Parquetry bar in the Show Bar – early photographs reveal that the floor was also parquetry laid in the same pattern. It is not known if it survives under the carpet.

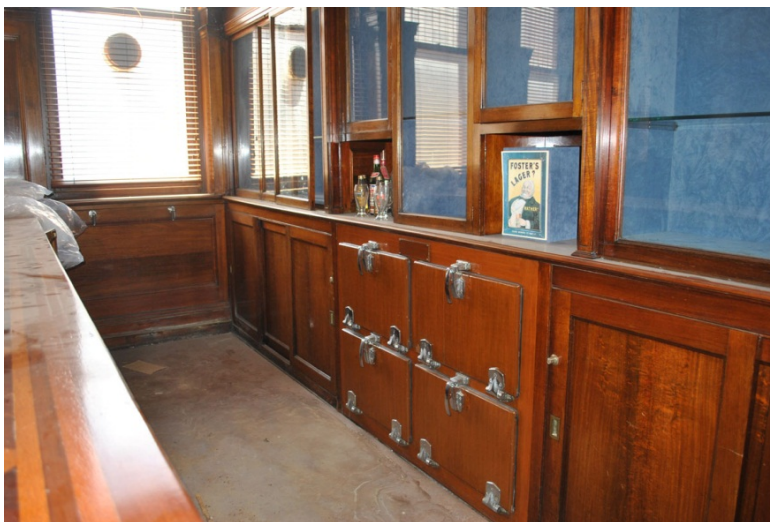
Figure 48. Fitted fridges and display cabinet in the Show Bar.

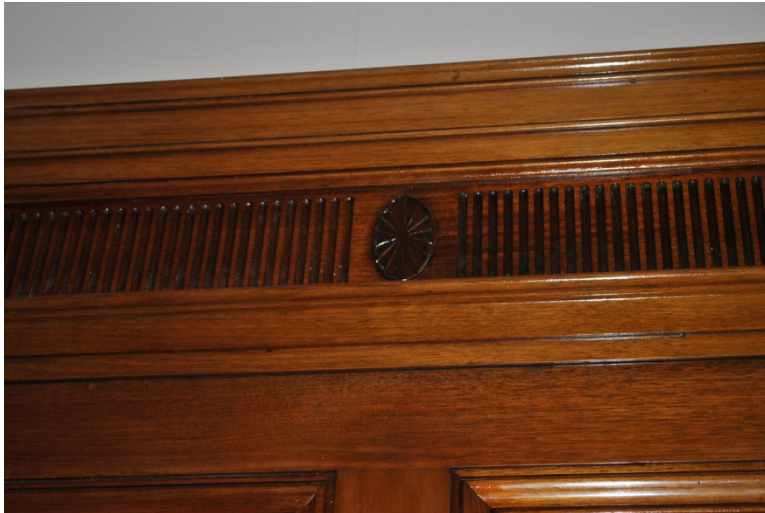
Figure 49. Detail of carved panel frieze.

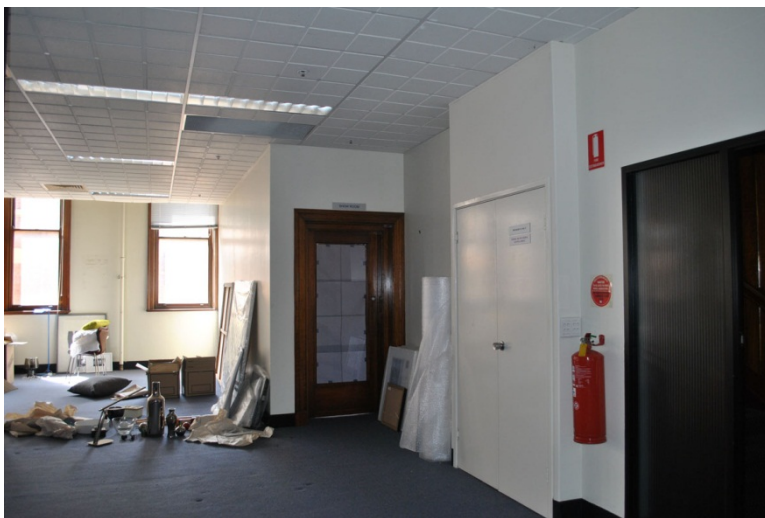
Figure 50. The contemporary entrance to the Show Bar is through the general office space.

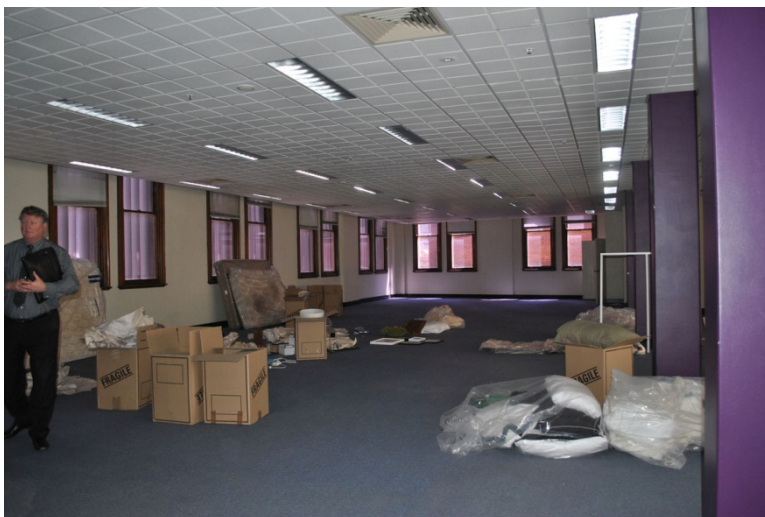
Figure 51. The main area of Level 1 has also been gutted and open plan office style fitout. Note the low ceilings created by the suspension of services under the timber ceilings which limit natural illumination and give the space a claustrophobic air.

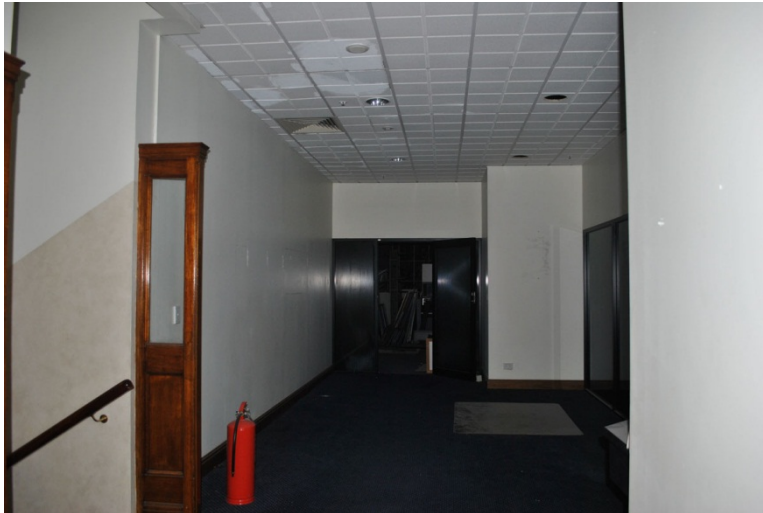
Figure 52. Looking to the south from the Level 1 vestibule. This area also reads as a late 20th Century office space.

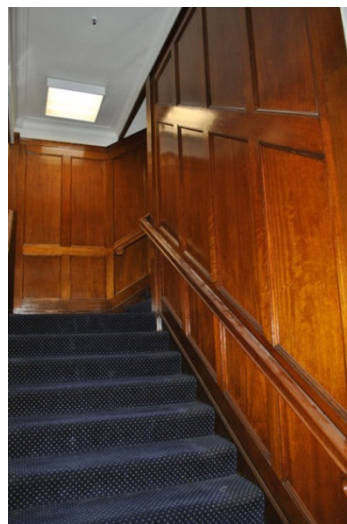
Adjustment of the lift would have been required to service the second floor addition. The original drawings show an open style lift shaft where the present lift is fully enclosed. The Queensland Maple wall linings of the lift car and stair date from these 1930 modifications. The direction of the stair and its enclosure were also possibly altered at this stage, with further modifications occurring in the 1970's.

Figure 54 and 55. The richly lined stair between Levels 1 and 2 is a part of the heritage significance of the Administration Building and forms part of the visual differentiation of the 'Executive Route' to the Boardroom.
