## REVIEW OF THE HERITAGE SIGNIFICANCE OF 2-10 KENSINGTON STREET

## MAJOR BUILDING MAINTENANCE AND REPAIR REQUIREMENTS FOR 2-10 KENSINGTON STREET

## 4.5 WAREHOUSE AT 12 KENSINGTON STREET

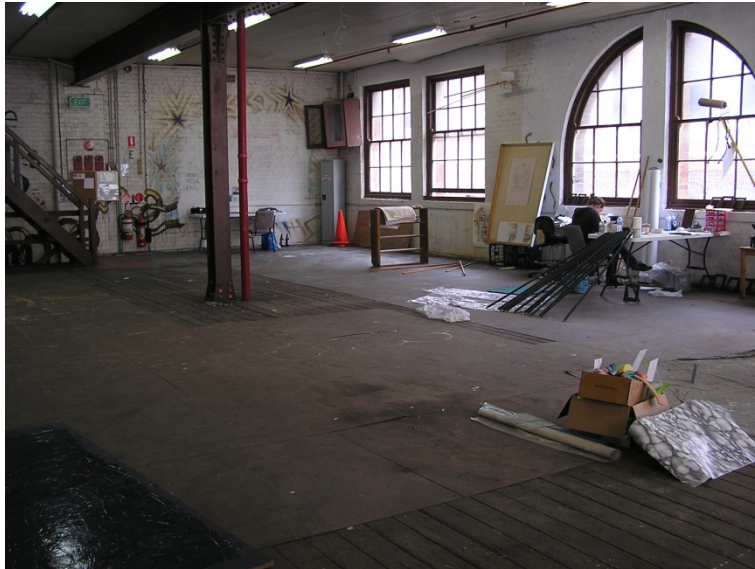
Figure 36. Interior: Level 2 has the same structural configuration as the ground floor with the riveted beams and columns aligned with those below. Arched bays sit along the eastern wall with fittings for gas lanterns built into two of the bays. The lift bay is lined to c1200mm above floor level with heavy steel mesh above. A small sign is attached to the lift doors warning of load capacities in hogsheads. Floors are timber: they are mainly sound, although the scratched surface provides evidence of heavy loads being dragged. Floorboards have been replaced in places. The stair to this level is not meshed or gated.

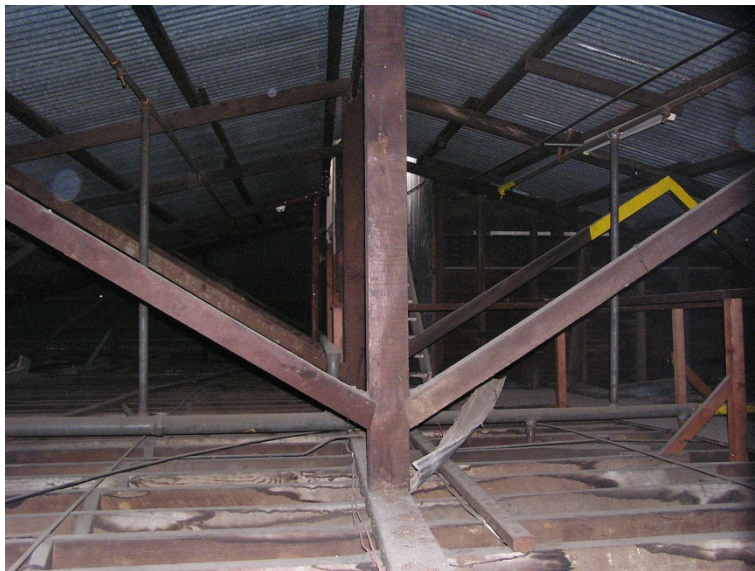
Figure 37. Within the roof space. A simple king post truss timber construction with corrugated iron sheeting. A timber walkway provides access to the roof exterior and the lift motor room.

| Element | Comment |
|---|---|
| Roofs | Form is intact although sheeting has been replaced. Periodic replacement of roof sheeting will be required in the future. |

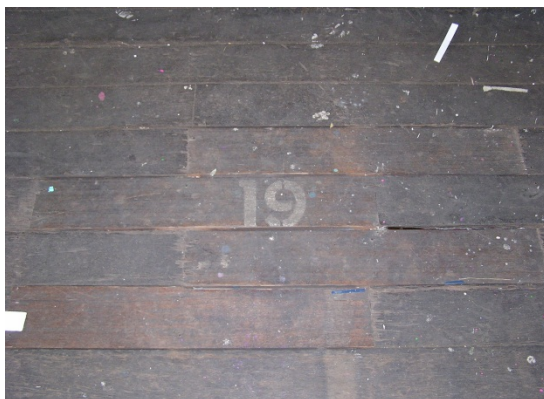
Figure 38. The floor to the ground level is a poured concrete slab with a separate poured slab where a turntable was previously located (note that this was offset to the door openings). There is also small area of patching near Dwyer street. The floors to the upper levels are timber tongue and groove boards — mostly intact, but patched in places. Neatly painted numbers survive to the storage areas on the upper floors. The boards throughout are worn, providing evidence of the use of the space; but appear to be sound.

| Element | Comment |
|---|---|
| Floors | Ground floor is poured concrete slab: includes evidence of vehicular turntable Floors are original timber. |

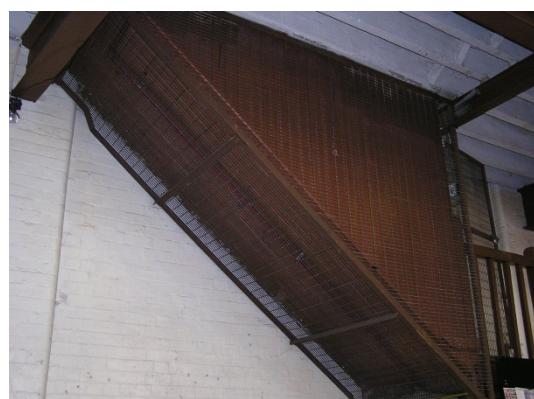
Figure 39. Staircases are banked on the southern wall, although the configuration varies between floors. All are open timber tread, but evidence such as grille doors and caging provides evidence of use as secure (bonded) storage area. The stair between ground and first floors is open tread and rail to a mid-way landing, and fully enclosed (with timber boarding and welded mesh overlay) to the upper part. Evidence of heavy grille (likely to be fixed or possibly a gate) to the stair (a lighter gate with welded mesh is extant).

| Element | Comment |
|---|---|
| Staircases | Open tread industrial/functional form and materials. |

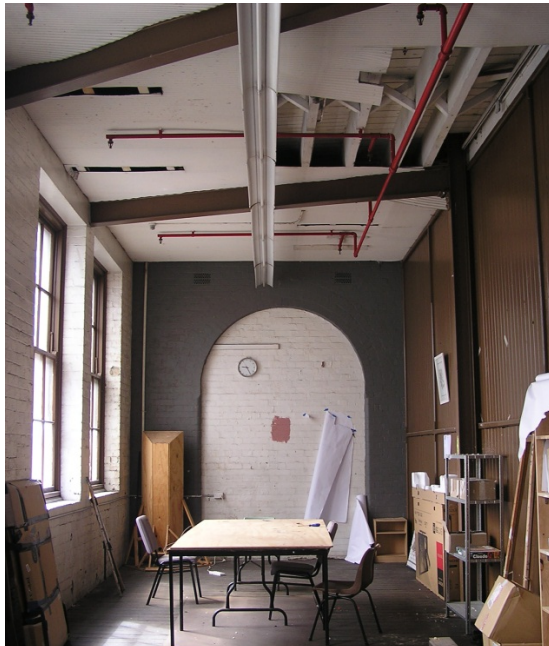
Figure 40. A small office area has been formed on each level between the lift and windows overlooking Dwyer Street. This area is not reinforced and has a ripple iron ceiling lining, and tongue and groove timber lining has been fixed to the wall of the adjacent lift cage.

| Element | Comment |
|---|---|
| Ceilings | Intact. Mostly unlined ceilings – painted underside of joists for floor above reflect industrial purpose. The use of the area beside the lift as an administrative area is evident in part by its ripple iron ceiling. Upper level ceiling is lined – sheets of ripple iron and some timber lining boards (near lightwell). Some later plain sheeting also evident. All have been painted white. |

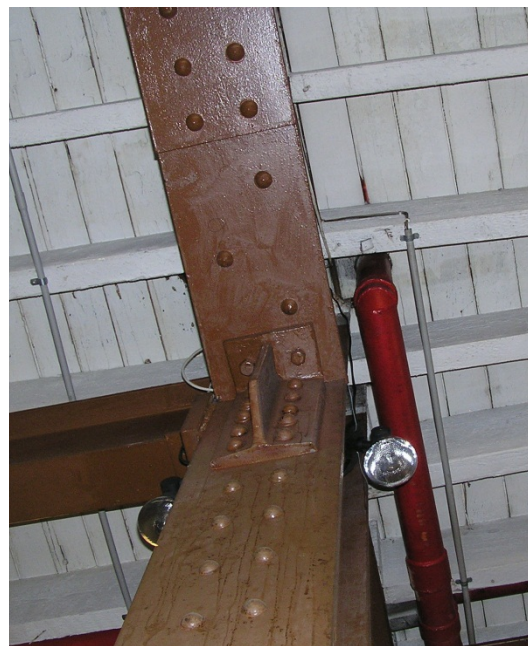
Figure 41. Looking up to the underside of the floor above showing riveted steel girder construction.

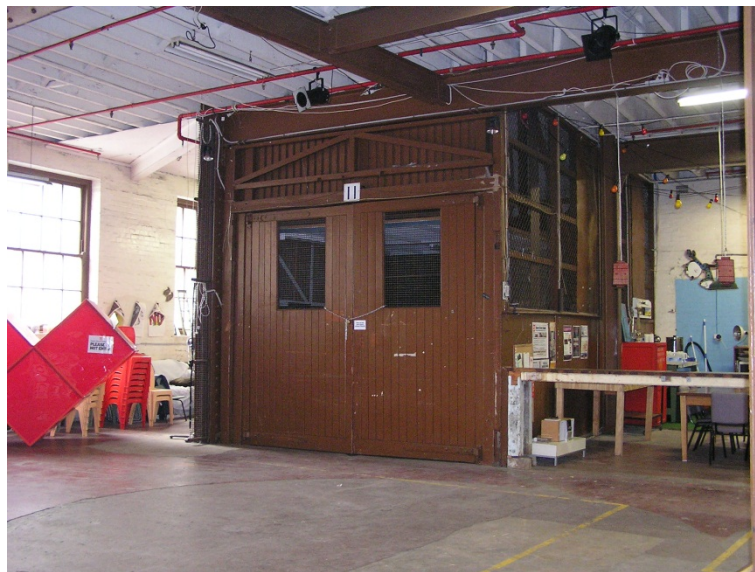
Figure 42. The large goods lift at the eastern end of building is a distinctive feature of the building. Its size is sufficient to carry an early 20th century motor vehicle.

Garage-style doors have been fitted to the lift cage at ground floor, with timber lining boards to the northern (administrative) area. The southern side of the structure is lined to c1500mm, and is caged above with heavy wire.

| Element | Comment |
|---|---|
| Evidence of earlier use - Industrial archaeology | <p>Vehicular/goods lift enclosure with garage-style doors. Do not use until inspected for operational potential and safety.</p> <p>Substantially intact motor/winch/cable system. Do not use until inspected for operational potential and safety.</p> <p>Evidence of turntable (infilled) on ground floor.</p> <p>Safety light fittings on eastern wall.</p> <p>Bundy clock near lightwell on ground floor.</p> |

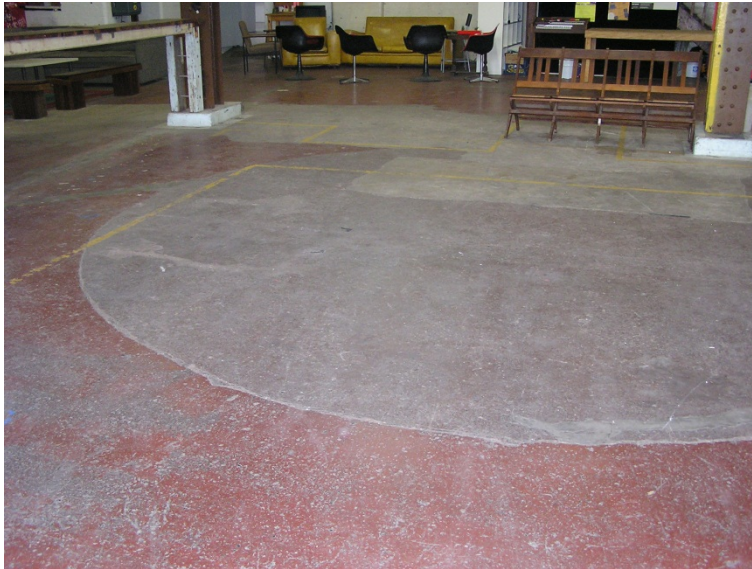
Figure 43. Marking on floor at ground level providing evidence of an earlier vehicular-scaled turntable set into floor (the mechanism has been removed and the area infilled with concrete slab). The position of the turntable does not align with either the door opening or the lift.

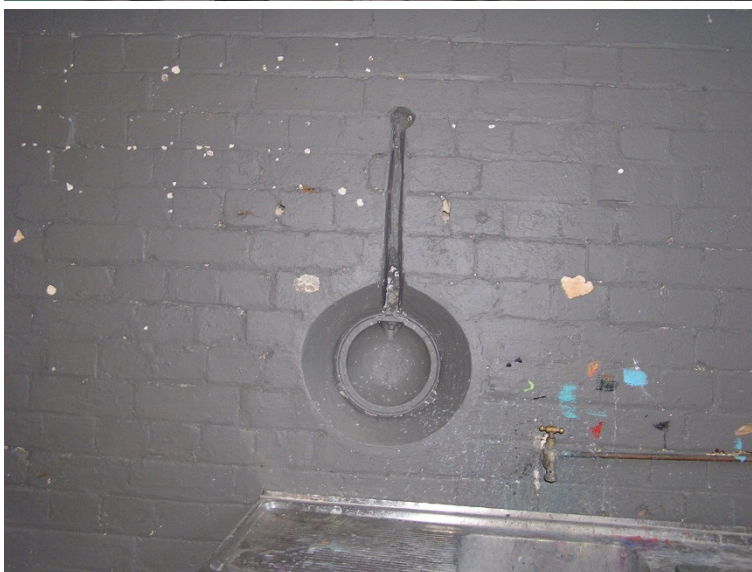
Figure 45. Fittings for safety lights have survived throughout the building with raw wiring to the ground floor in administrative area.

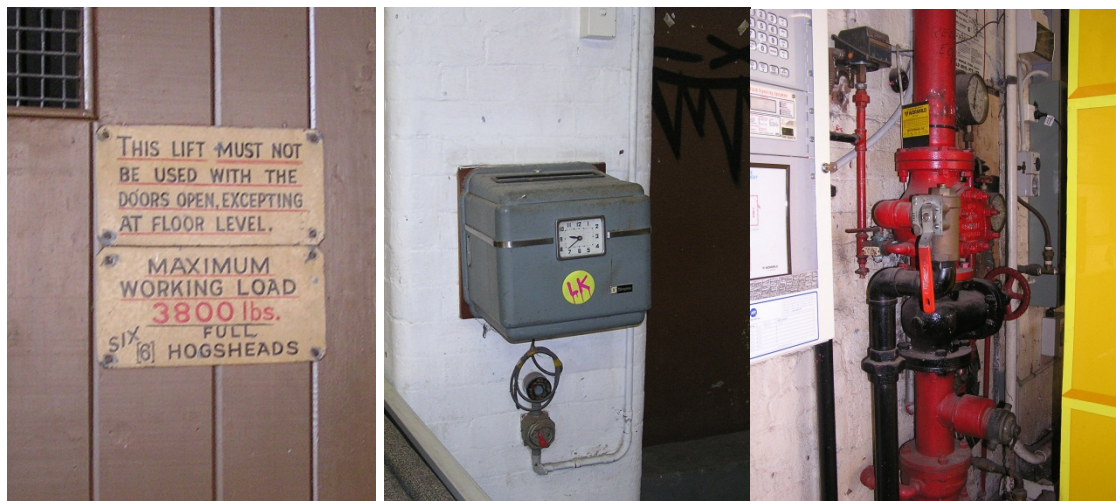
Figure 46. (left) original sign on the door to the lift identifies its six hogshead cask capacity – evocative of the former use of the building.

Figure 47. (centre) the timekeeping, or bundy, clock was a characteristic element of mid-late 20thC businesses but is now increasingly rare.

Figure 48. (right) The storage of spirits in the building necessitated effective protection against fire. A sprinkler system control board is set on the southern wall near the entrance to the property along with an electrical distribution box.

| Element | Comment |
|---|---|
| Services | Early (and maintained until industrial use ceased) fire protection system. Maintain fire protection systems in working order while current use remains. |

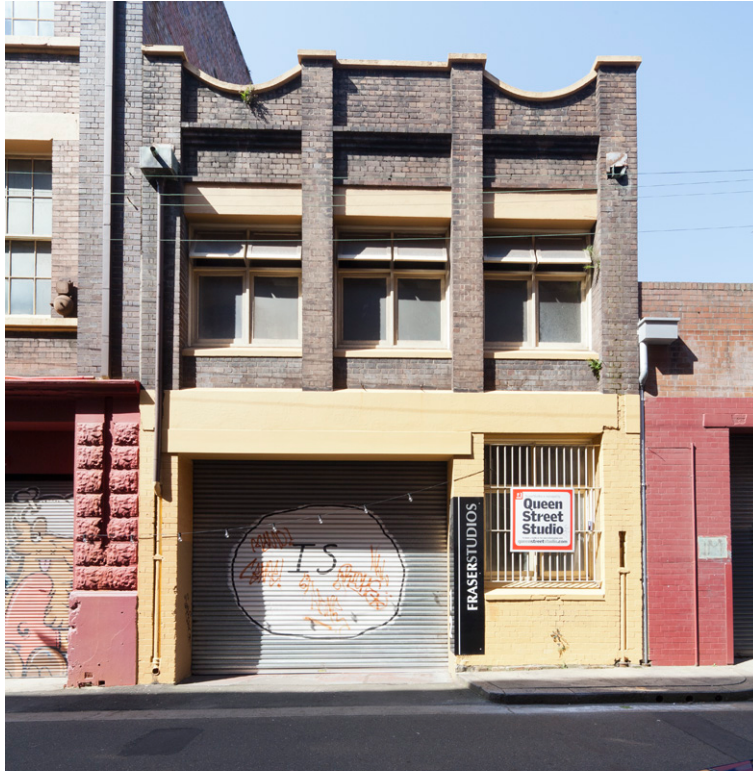
Figure 49. The façade of 12 Kensington Street is similar to that of the adjoining Motor Garage/rum cask store at 2-10 Kensington Street. Minor differences in scale reflect the narrower lot and lower height of the building. Detailing is consistent with 2-10 Kensington Street. The form of the parapet is similar to that of the adjacent building at 2-10 Kensington Street but is smaller in scale and simpler in detailing.

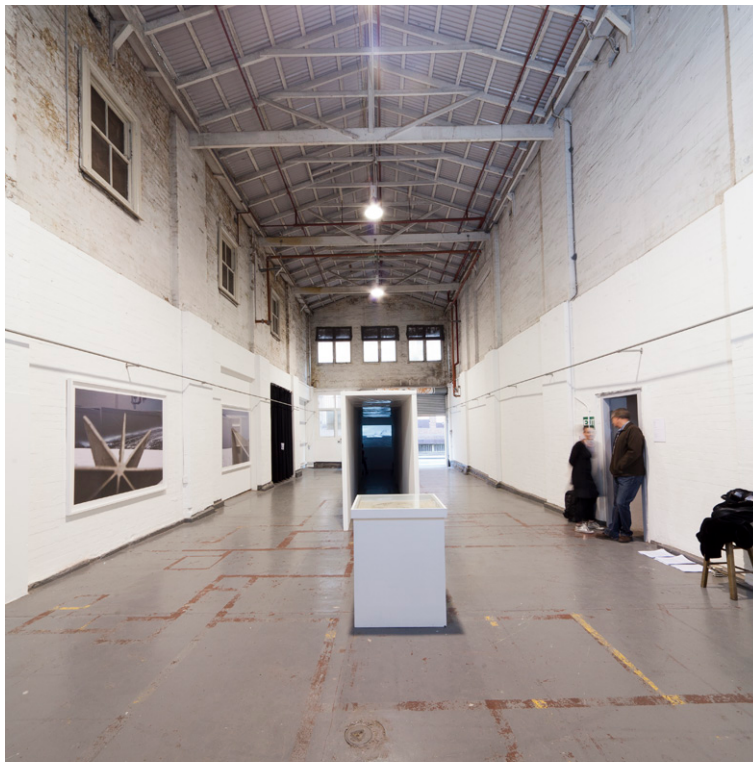
Figure 50. The interior of the building has been gutted, including the removal of the upper level, to create a single large space. Door openings have been cut in the walls to the north and south to provide direct access between the three buildings by the Brewery. (Photo: Nat Hughes)
