#### 4.6 WAREHOUSE AT 14 KENSINGTON STREET (1962)

## 4.7 TERRACE AT 16-16A KENSINGTON STREET (C1906)

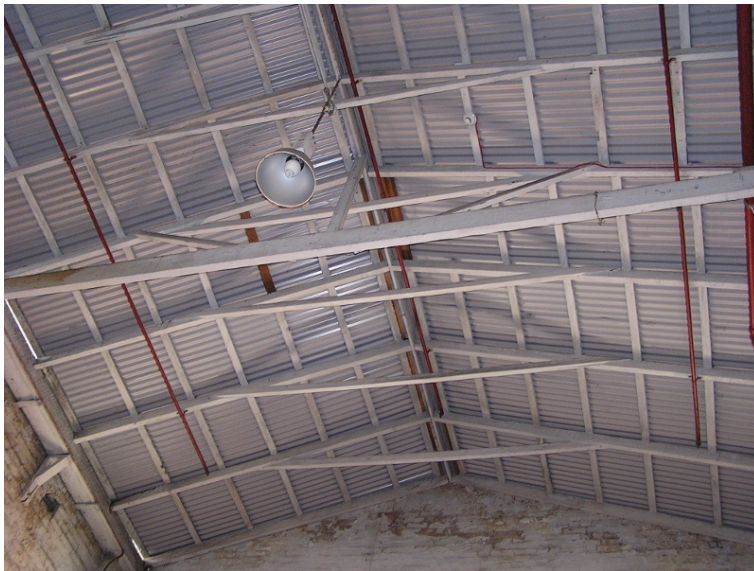
Figure 52. Roof and ceiling  
The roof of the building is a simple structure with corrugated steel sheeting (non-original) laid on simple timber trusses sitting on wall plate. No ceiling is present.

| Element | Comment |
|---|---|
| Roofs | Form is intact although sheeting has been replaced. Periodic replacement of roof sheeting will be required in the future. |

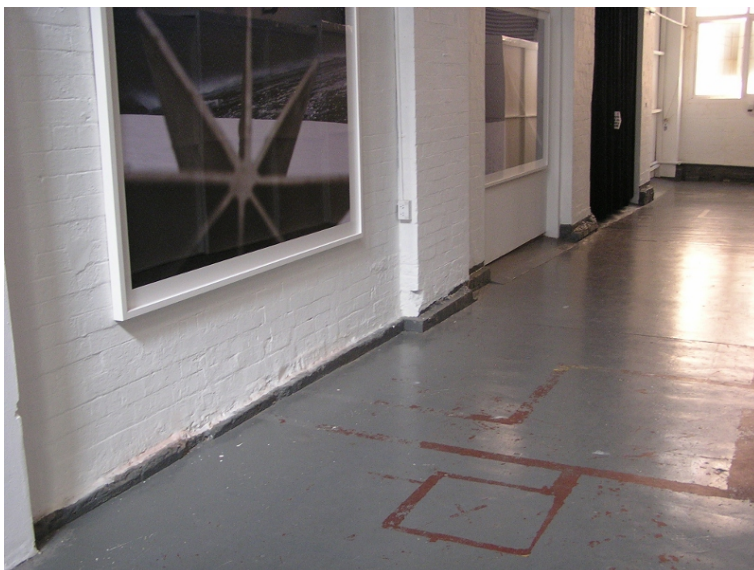
Figure 53. Floor:  
Floors are simple, formed from a polished/painted concrete slab. Markings indicate former warehouse use. The slab slopes down toward the roller door opening to allow vehicular access to the interior.

| Element | Comment |
|---|---|
| Floors | Ground floor is poured concrete slab. Retain only as required to ensure structural stability of the shell. |

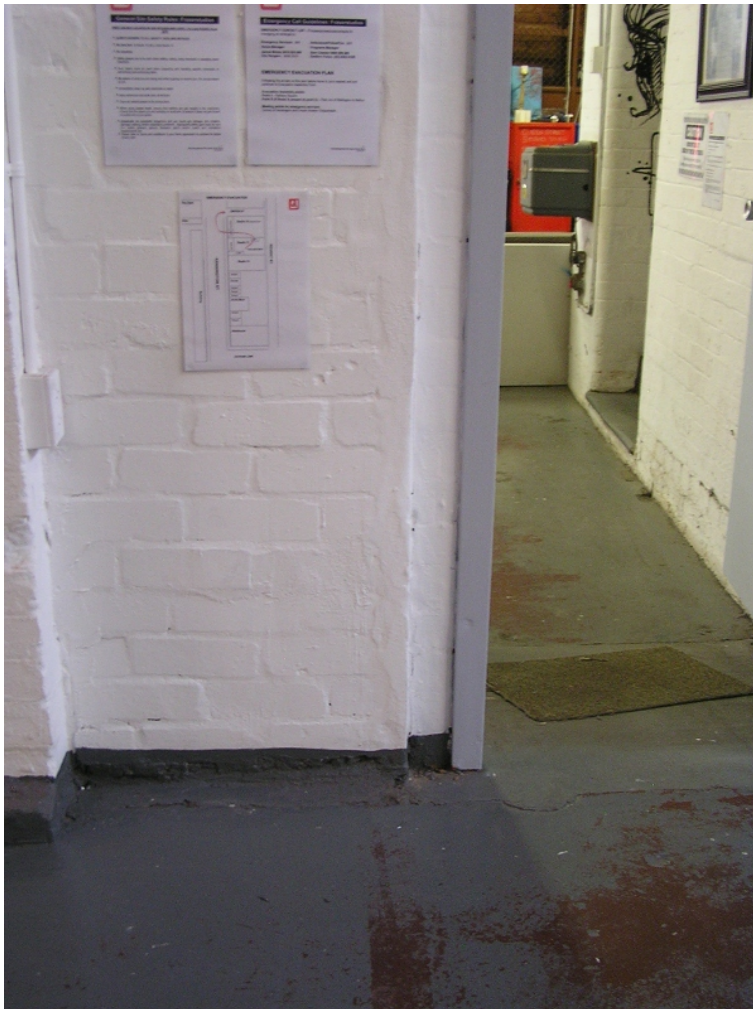
Figure 54. Doors:

The main access to the building is via a wide roller door to Kensington Street, with a narrower access opening for pedestrians.

An internal door (pictured) has been cut in the northern wall to provide access to the main warehouse at 2-10 Kensington Street, with the difference in floor levels separated by a ramp.

A section of brickwork has been removed on the southern wall to provide access to the adjoining building on that side (14 Kensington Street), with the spaces being divided by a heavy double curtain.

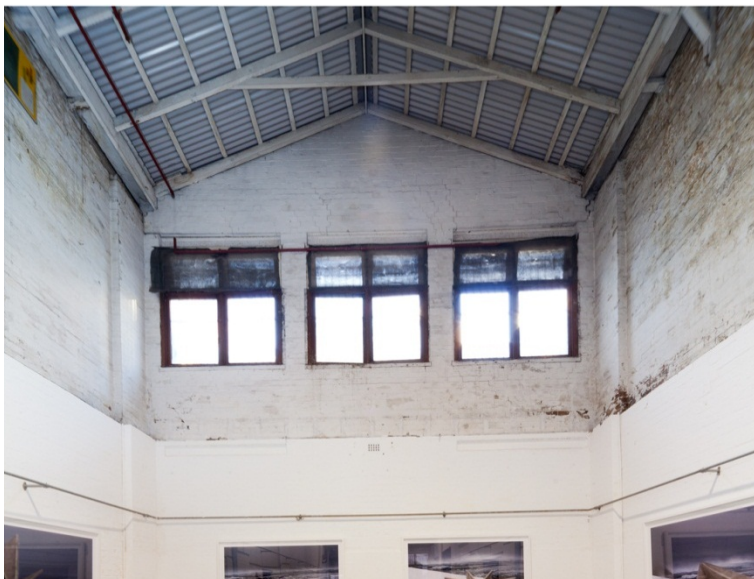
Figure 55. Windows

A pair of large timber-framed casements to the Kensington Street elevation at ground level – the extent of their opening is limited by security bars. Three windows are also found on each of the eastern and western (Kensington Street) elevations at the upper (former first floor) level. These are simple, fixed pane windows with the hopper-opening highlight windows covered on the western elevation by cloth/blinds on the interior. (photo: Nat Hughes)

| Element | Comment |
|---|---|
| Joinery | Exterior windows to Kensington Street are large and timber-framed. Their form and position in the façade is significant, but the fabric could be replaced with like if repairs area required. |

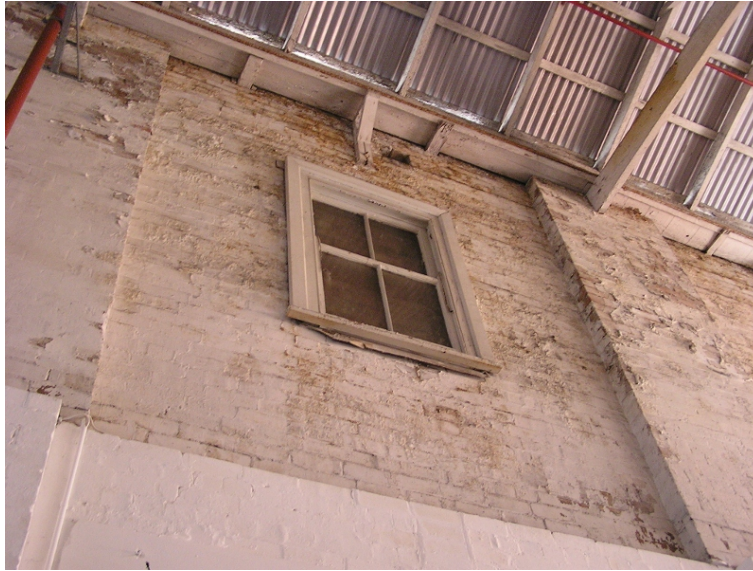
Figure 56. Windows

More elaborate timber framed sash windows survive on the long southern wall of this former upper level but they now look onto the brickwork of the wall of the adjoining property (14 Kensington Street).

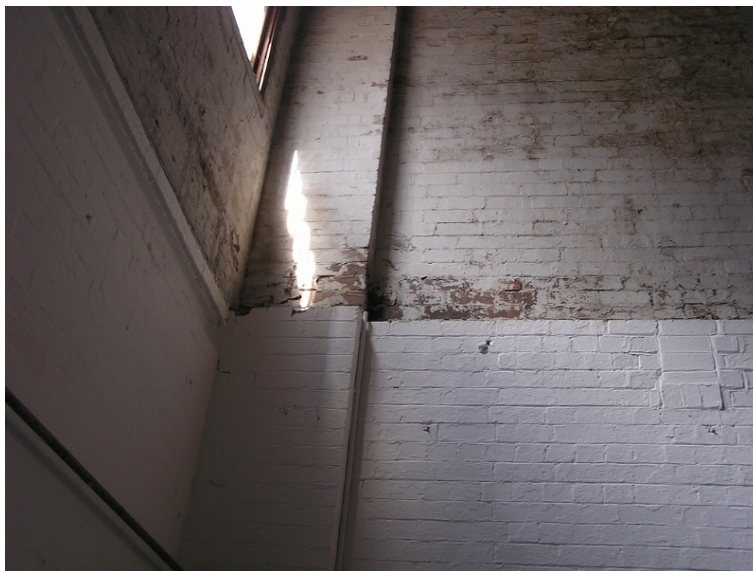
Figure 57. Interior finishes:

Interior detailing is minimal. Both the brickwork and the floor have been painted.

A roughly built single skin brick wall has been constructed around the perimeter of the interior to the level of the original upper floor. Evidence of the beams that supported the floor to the upper level can still be seen in the patching to the expressed columns around the walls. A rail capable of hanging heavy curtains has been fitted around the perimeter. Electricity, smoke detectors and fire sprinkler system. Lights are simple hanging industrial fittings.

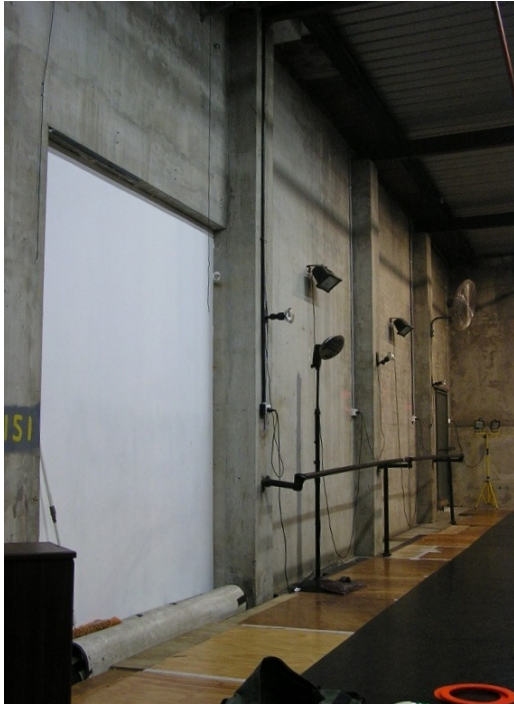
Figure 60. The current use of the building is as a rehearsal space, with timber floor over concrete base with tarquette surface. Barres have been fixed to the northern wall with fans set high on the wall. The opening to 12 Kensington Street has been infilled with lightweight materials and the smaller door covered by a curtain. A door at the eastern end of this wall provides access to the small area behind 12 Kensington Street.

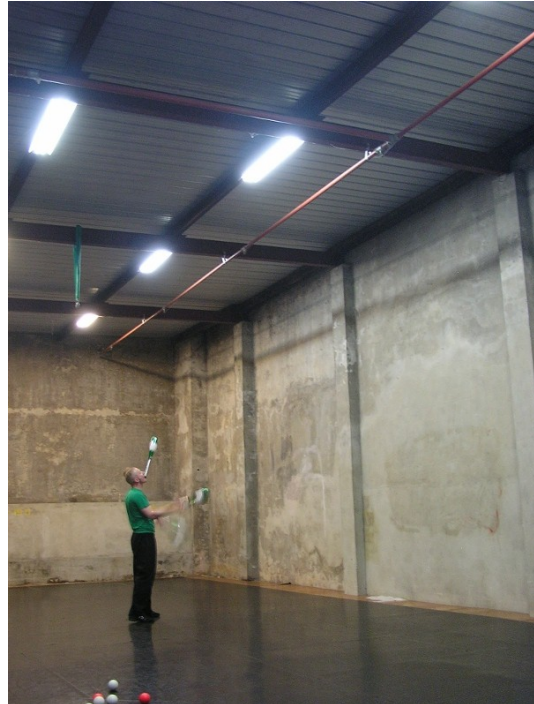
Figure 61. The roof is a simple structure with corrugated steel sheeting (non-original) laid on light timber trusses at a very low pitch. The space has negligible detailing. Walls are rendered in cement – no paint finish. Vehicular licence plate numbers have been painted around the walls – associated with earlier use as garage.

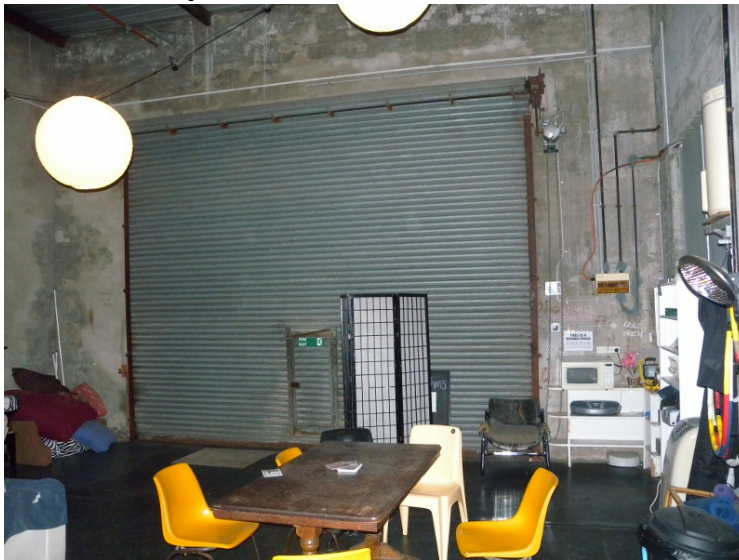
Figure 62. The interior of 14 Kensington Street is utilitarian in character with the metal roller door occupying most of its width.

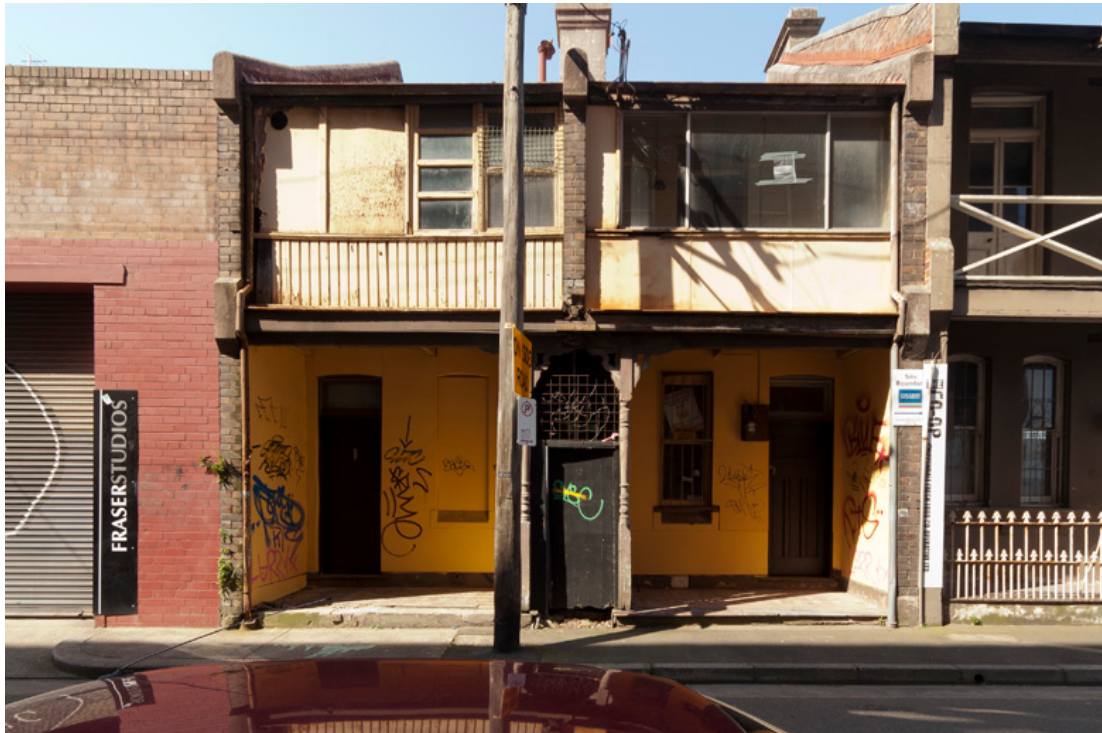
Figure 63. The pair of terraces at 16 and 16A Kensington Street. The face brickwork has been covered by fibre-cement panels but is extant beneath. The upper level verandahs have been enclosed by lightweight materials but the original external elevation to the terrace has survived.
