Remediation Action Plan

Proposed School  
Lot 100, DP1261496 Maitland Street, Muswellbrook,  
NSW

Prepared for  
Pacific Brook Christian School Ltd

Project 91601.02  
August 2020

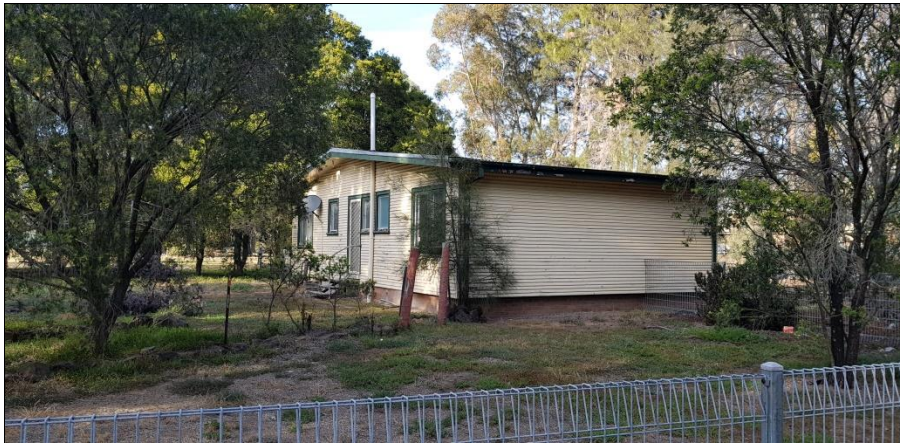
**Figure 1: Residential building in the central portion of the site, looking south east**

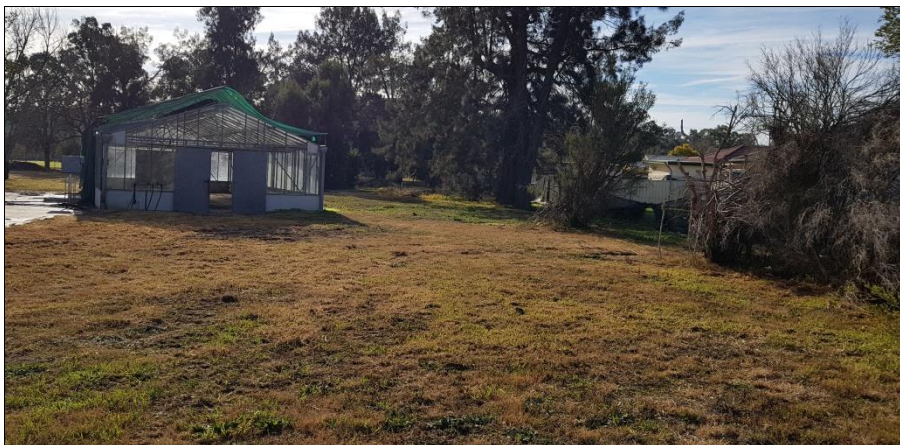
**Figure 2: Glasshouse in the south eastern portion of the site, looking north**

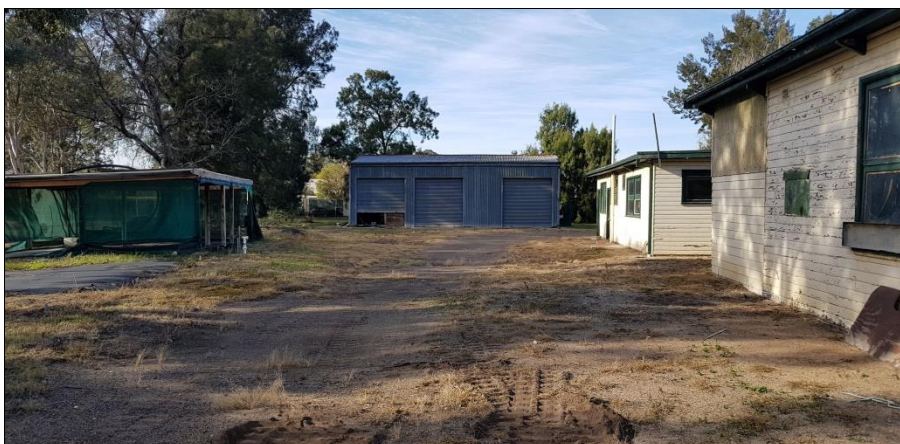
**Figure 3: Hazchem buildings in the background and on the right and awning / shed on the left, looking south east**

The concrete flooring and concrete surrounds within the Hazchem buildings did not comprised gross staining or evidence of chemicals leaking from the buildings.

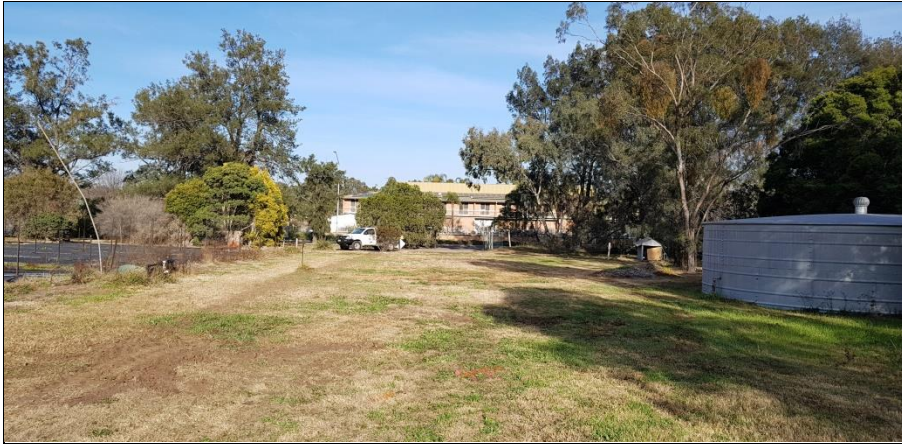
**Figure 4: Large water tank on the right and gravel beds lined with weed matting on left, looking south west**

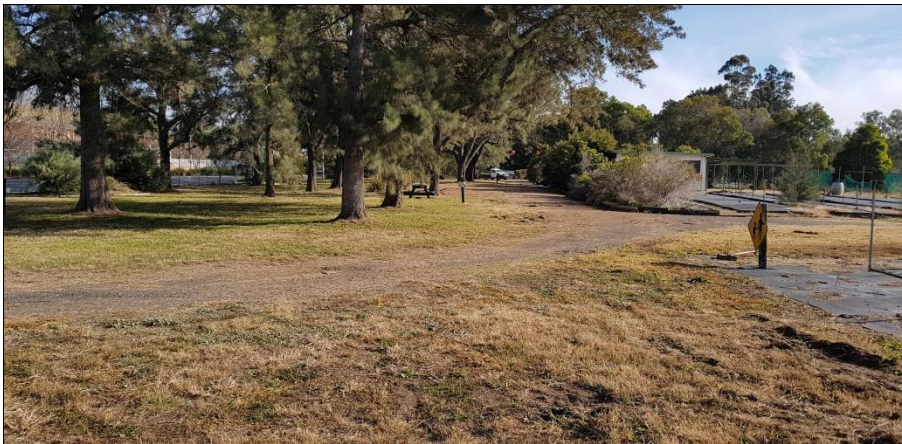
**Figure 5: Grassed covered areas, internal gravel paths and gravel / weed matting areas, looking north west**

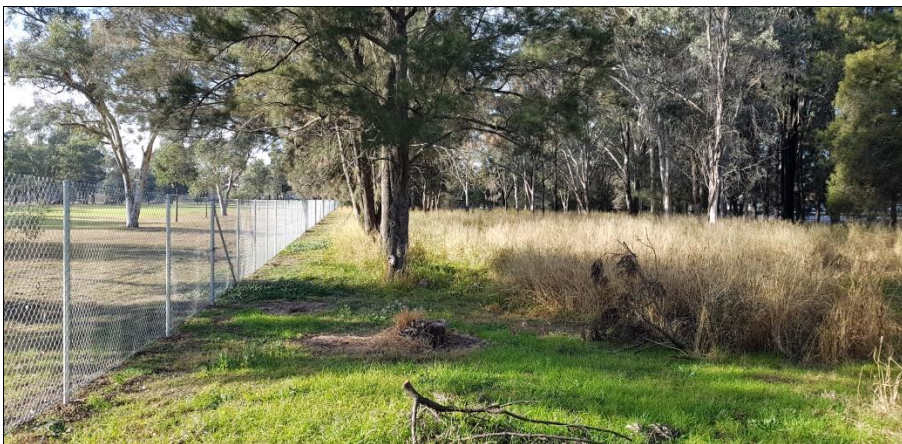
**Figure 6: Dense grass covered area with abundant mature trees in the undeveloped north western portion of the site, looking south**

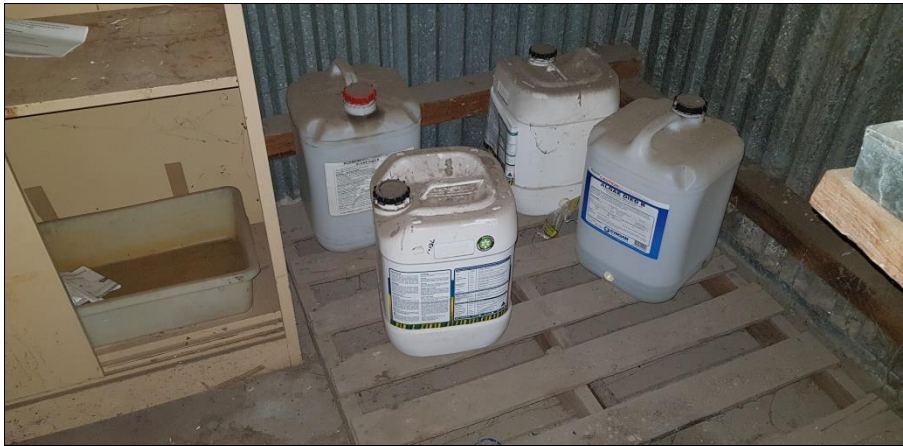
**Figure 7: Stored chemical containers within the Hazchem building**

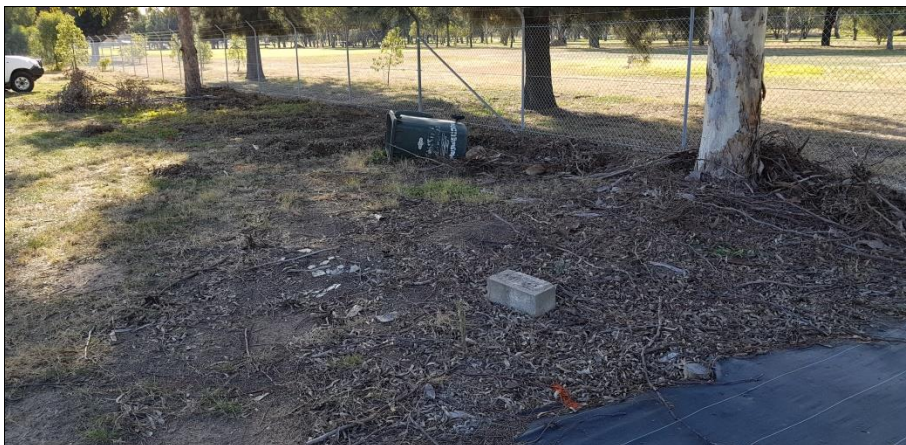
**Figure 8: Fibrous cement fragments encountered adjacent to the northern boundary in the south eastern portion of the site, looking north**

Fibrous cement fragments were also encountered in south eastern portion of the site adjacent to the northern boundary (Figure 8).

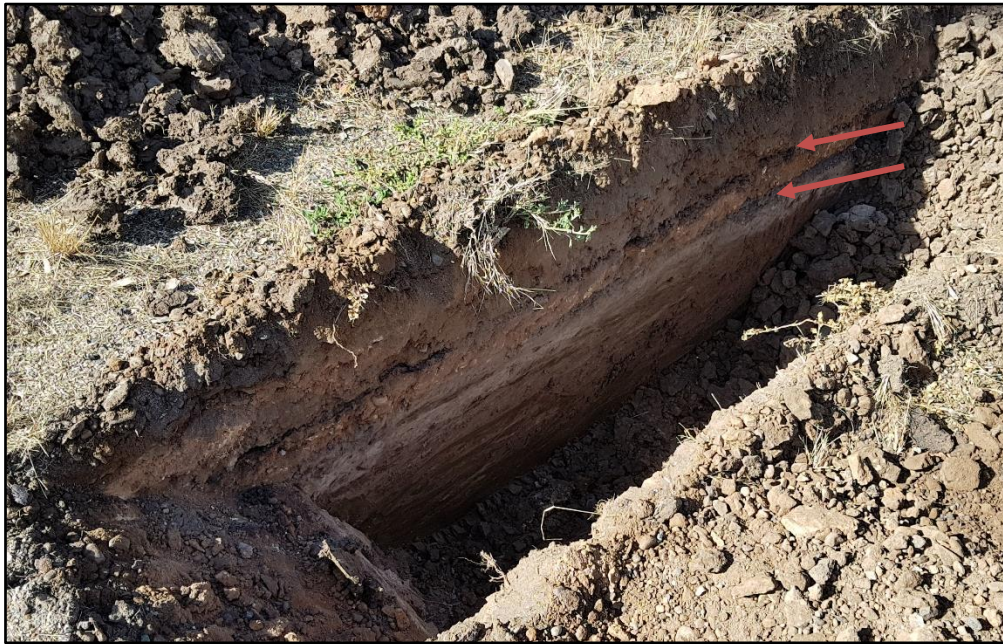
**Figure 9: Pit 106 excavation with asphalt layers identified**

Based on the results of the previous investigation, the extent of remediation is generally limited to localised lenses of asphalt, identified in Pit 106 between 0.25 m to 0.28 m and from 0.35 m to 0.37 m depth (ie two asphalt lenses 0.2 to 0.3 m thick). The asphalt lenses observed in Pit 106 are indicated in Figure 9. The test pit log for Pit 106 is contained in Appendix A.

It is noted that the asphalt materials were not encountered by DP in Pit 107 excavated within the gravel path. The underlying asphalt lenses, therefore, may not be present or continuous throughout the entire gravel path area. For the purposes of preparing this RAP, and in the absence of additional investigations, it is assumed the lateral extent of the asphalt lenses are confined to the gravel pathway, and the depths are as observed in Pit 106. Based on the conditions encountered in Pit 106, the estimated dimensions of the gravel path (ie approximately 307 m long and 4 m wide), discussions with a Remediation Contractor (RC) and consideration of practical excavation / segregation depths, an approximate volume of 250 m<sup>3</sup> has been estimated for the removal of impacted soils.

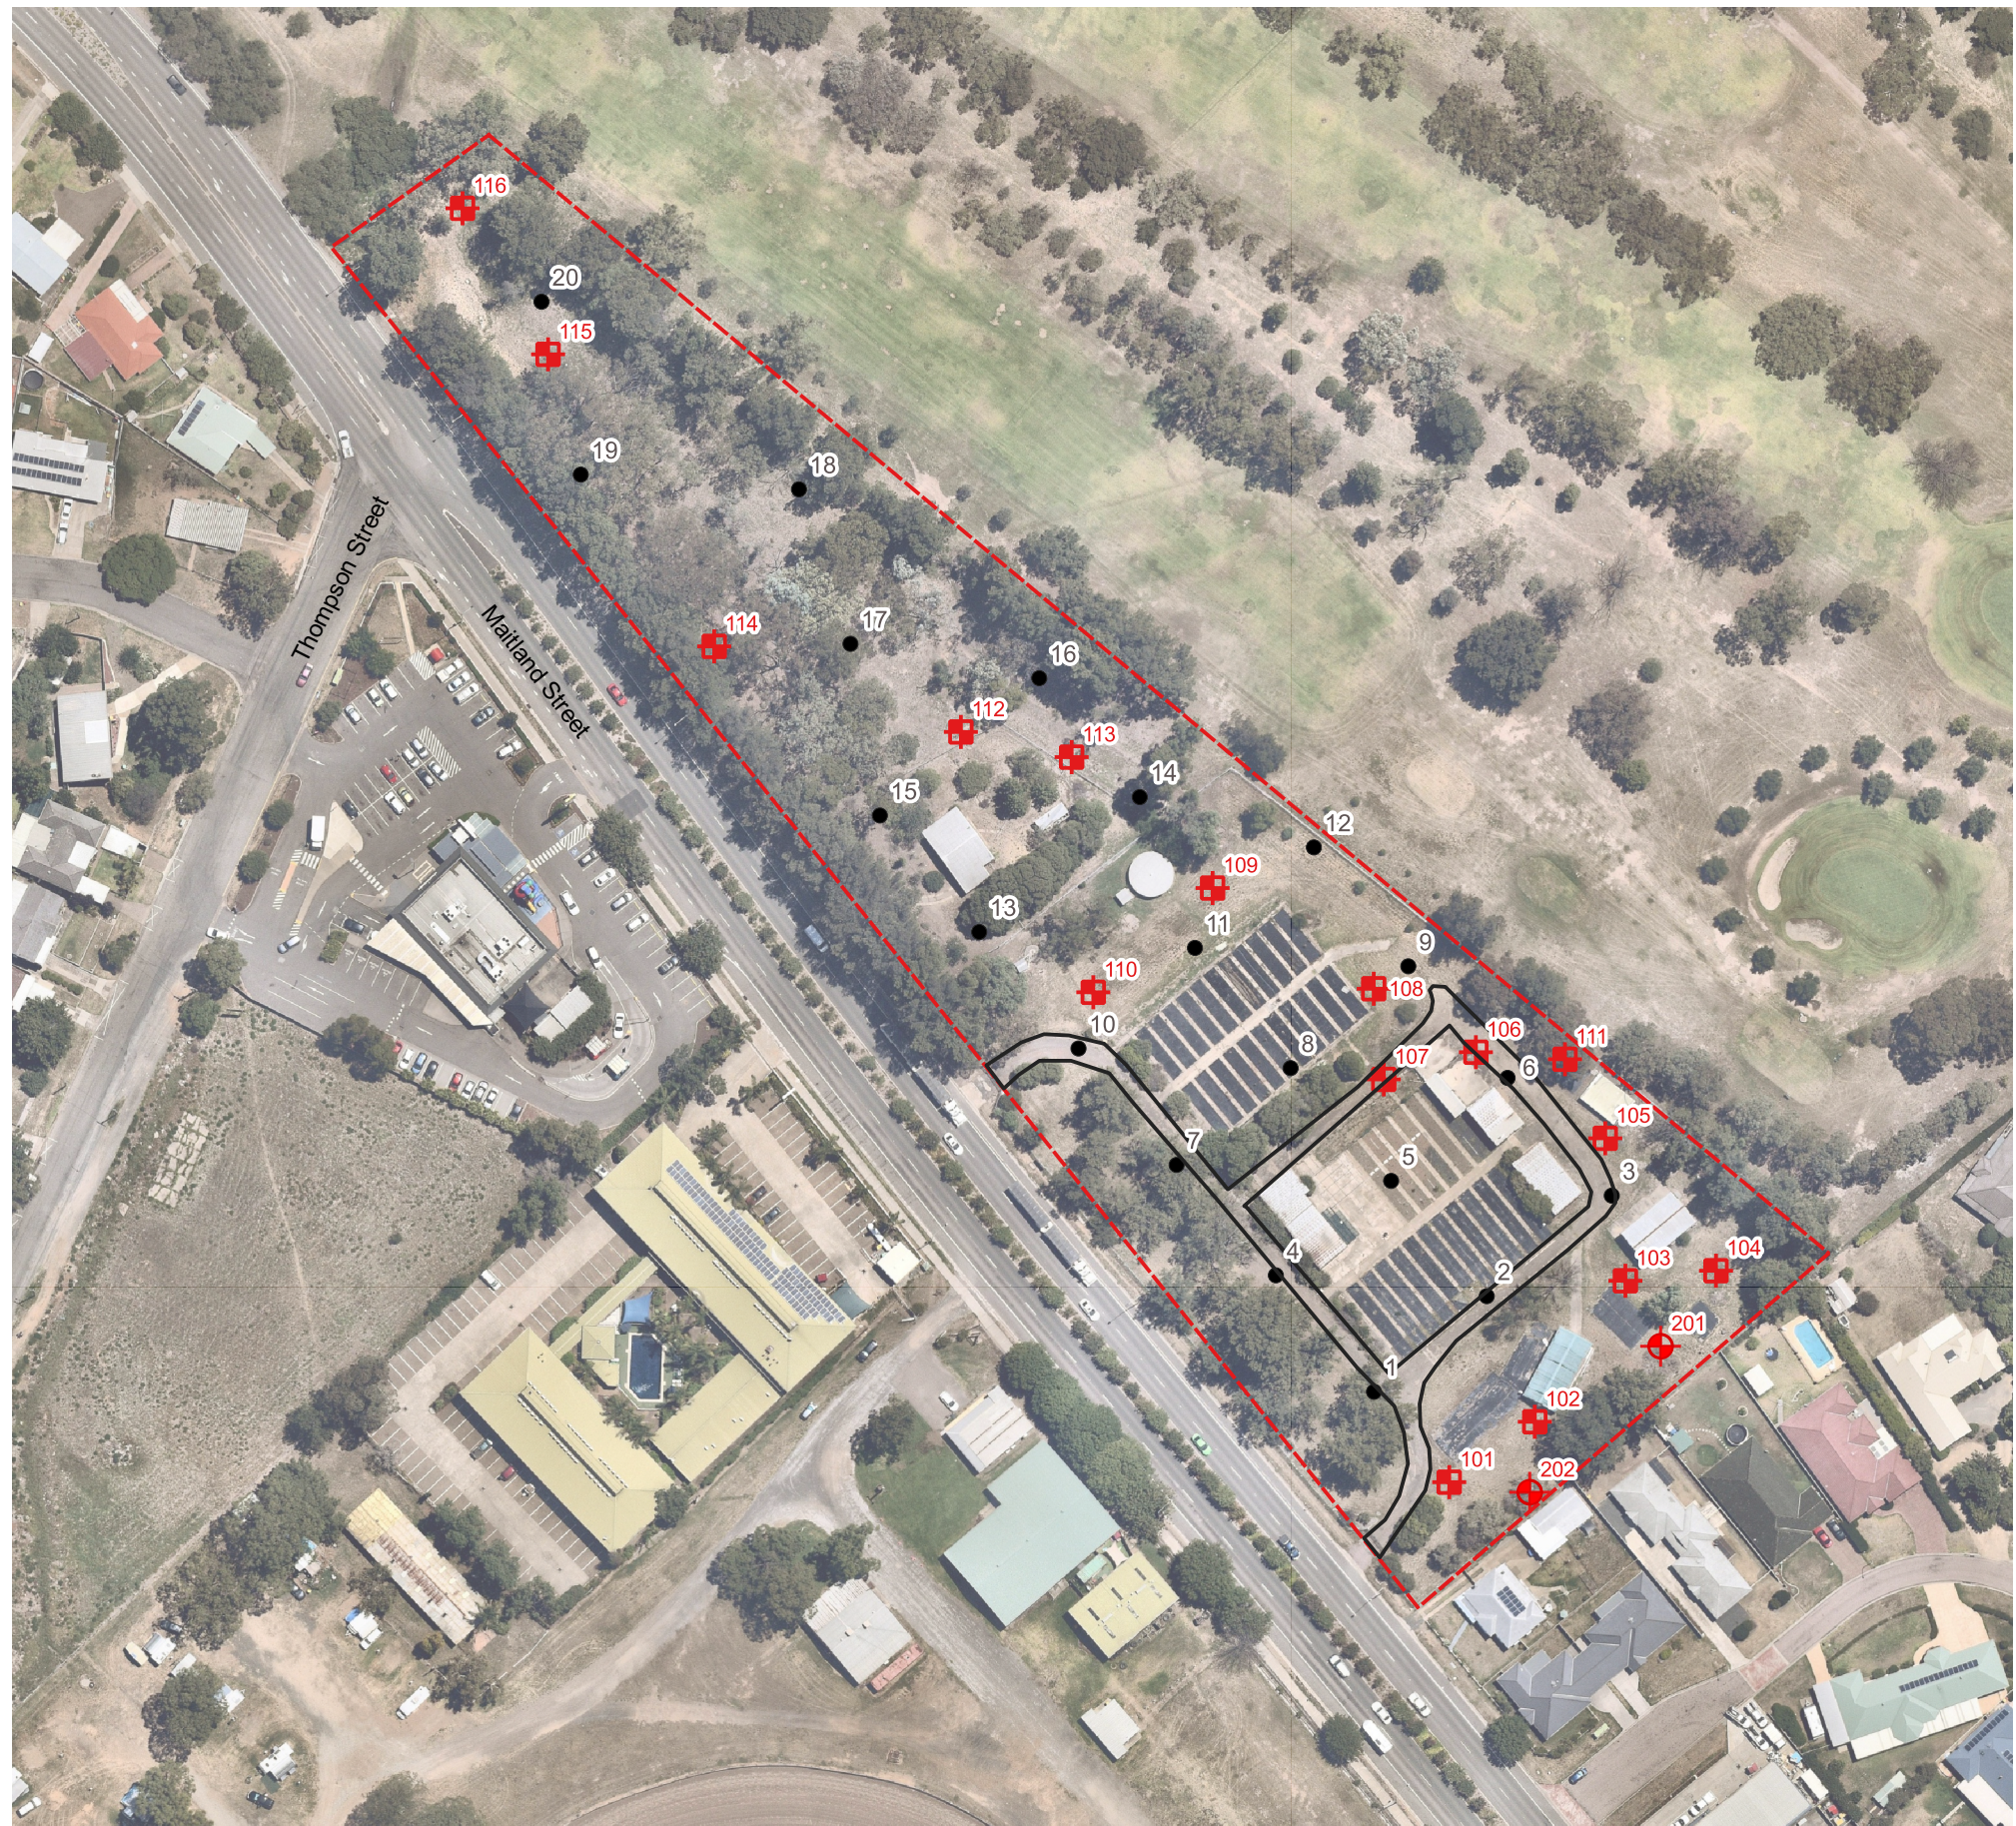
| | Drawing 1 – Test Location Plan |

The site is identified as Lot 100 DP 1261496, Maitland Street, Muswellbrook, New South Wales, as shown in Drawing 1.

The extent of the asphalt is unknown, however the lateral extent is expected to be associated with the construction of the gravel paths, indicated on Drawing 1.

This RAP specifically addresses the localised PAH soil contamination identified in asphalt fill materials in the Detailed Site Investigation (DSI) (DP Report 91601.00.R.001.Rev0 dated 23 July 2019). The PAH contamination exceeded the relevant NEPM 2018 guidelines for the proposed landuse. Remediation was therefore recommended to render the site suitable for the intended use. The asphalt was observed in discrete lenses in Pit 106 located within the gravel path, as shown on Drawing 1.

Refer to Drawing 1, Appendix A, for site features.
