Luddenham Resource Recover Centre

Scoping Report

Prepared for Coombes Property Group and KLF Holdings Pty Ltd
March 2020

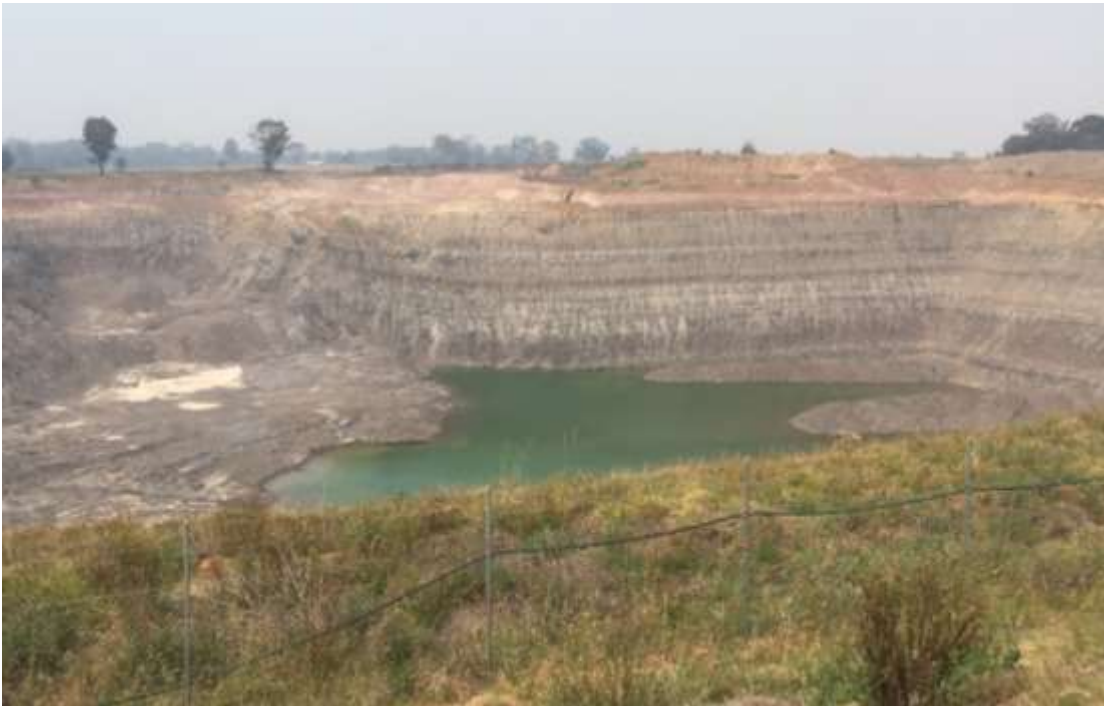
Photograph 1.1 Existing quarry – view to the south towards Western Sydney Airport development site

Other notable subject property features include 3-m-high earthen noise bunds to the west and north of the quarry void. The noise bund to the north of the quarry intersects the southern portion of the RRC site.

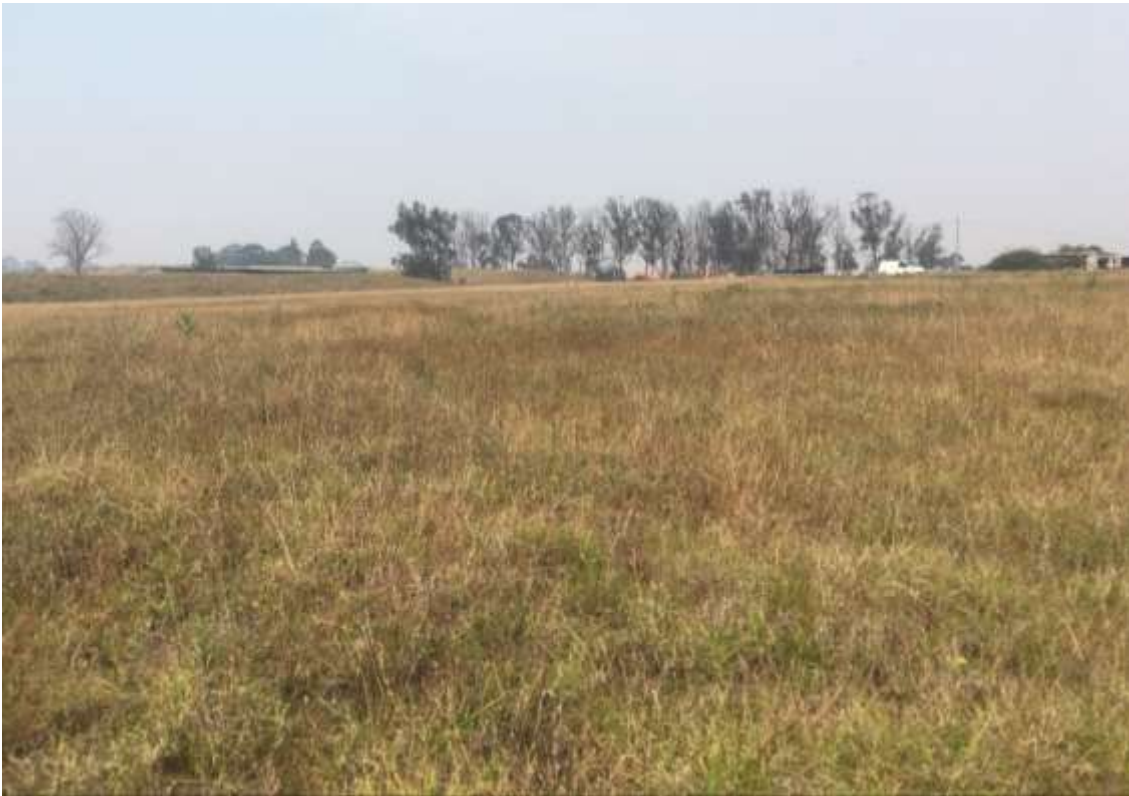
Photograph 1.2 Undeveloped land within the northern part of the site (ie the proposed site of the RRC)

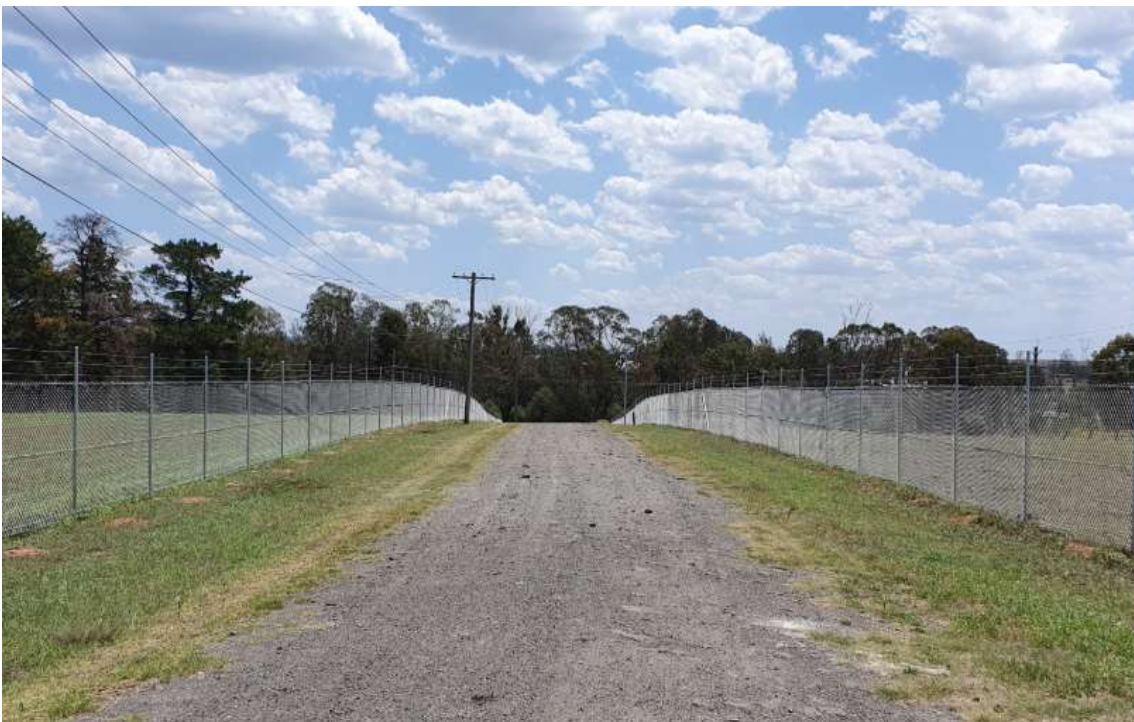
Photograph 1.3 Internal access road to Adams Road

The RRC will utilise the same proposed internal access road as the quarry. This RRC application seeks approval to develop the access road and the intersection to Adams Road required for the operation of the RRC. A more detailed description of the project is provided in Chapter 2.

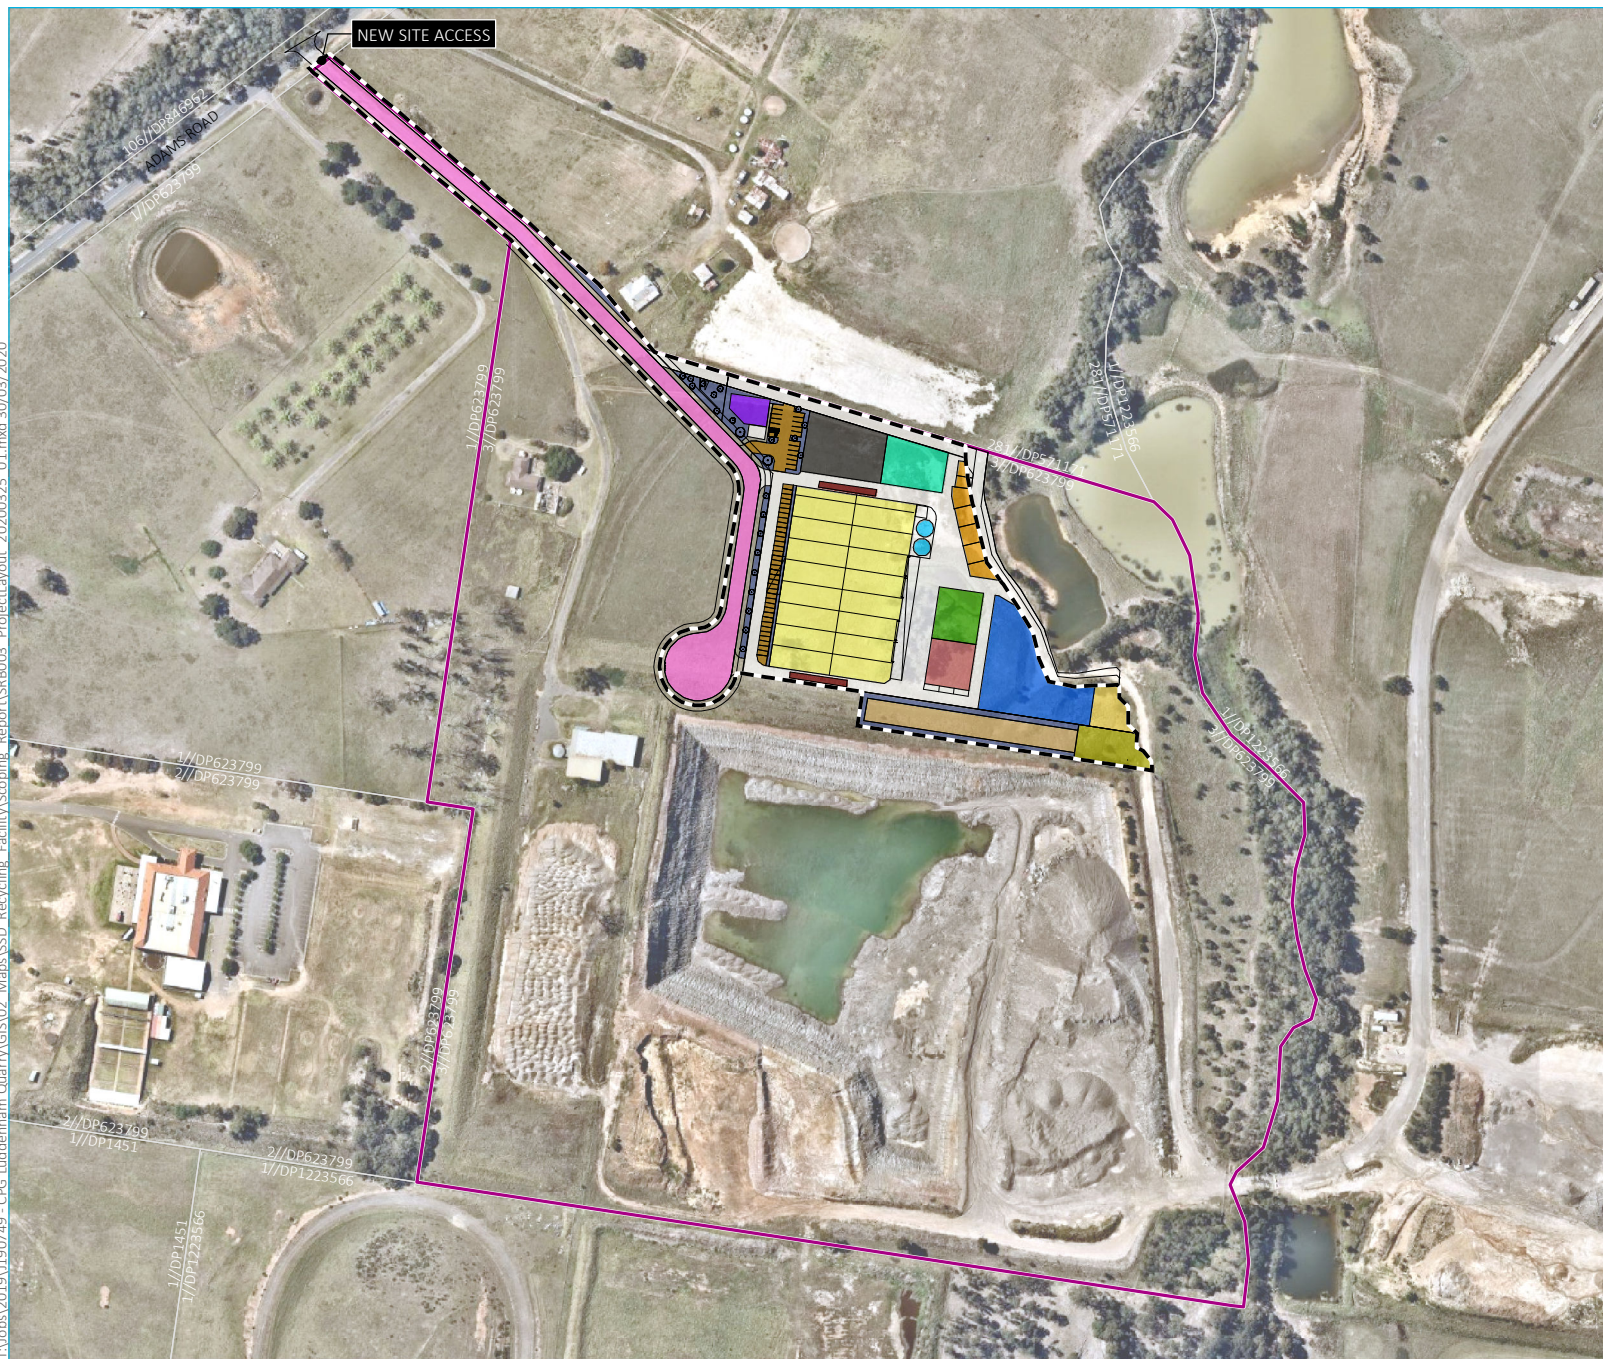
Luddenham resource recovery centre
Scoping report
Figure 2.1

- Subject property
- RRC site
- Cadastral boundary
- Indicative detailed layout
- Proposed layout
- Bin storage
- Car parking
- Clean timber
- Concrete rubble/masonry
- Fine sediment (screened)
- Future washing/tyre shedding
- Hardstand
- Internal 13 m road
- Landscaping
- Leachate/stormwater detention
- Onsite detention
- Product bay
- Site office
- Warehouse
- Rainwater tank
- Water treatment plant
- Weighbridge

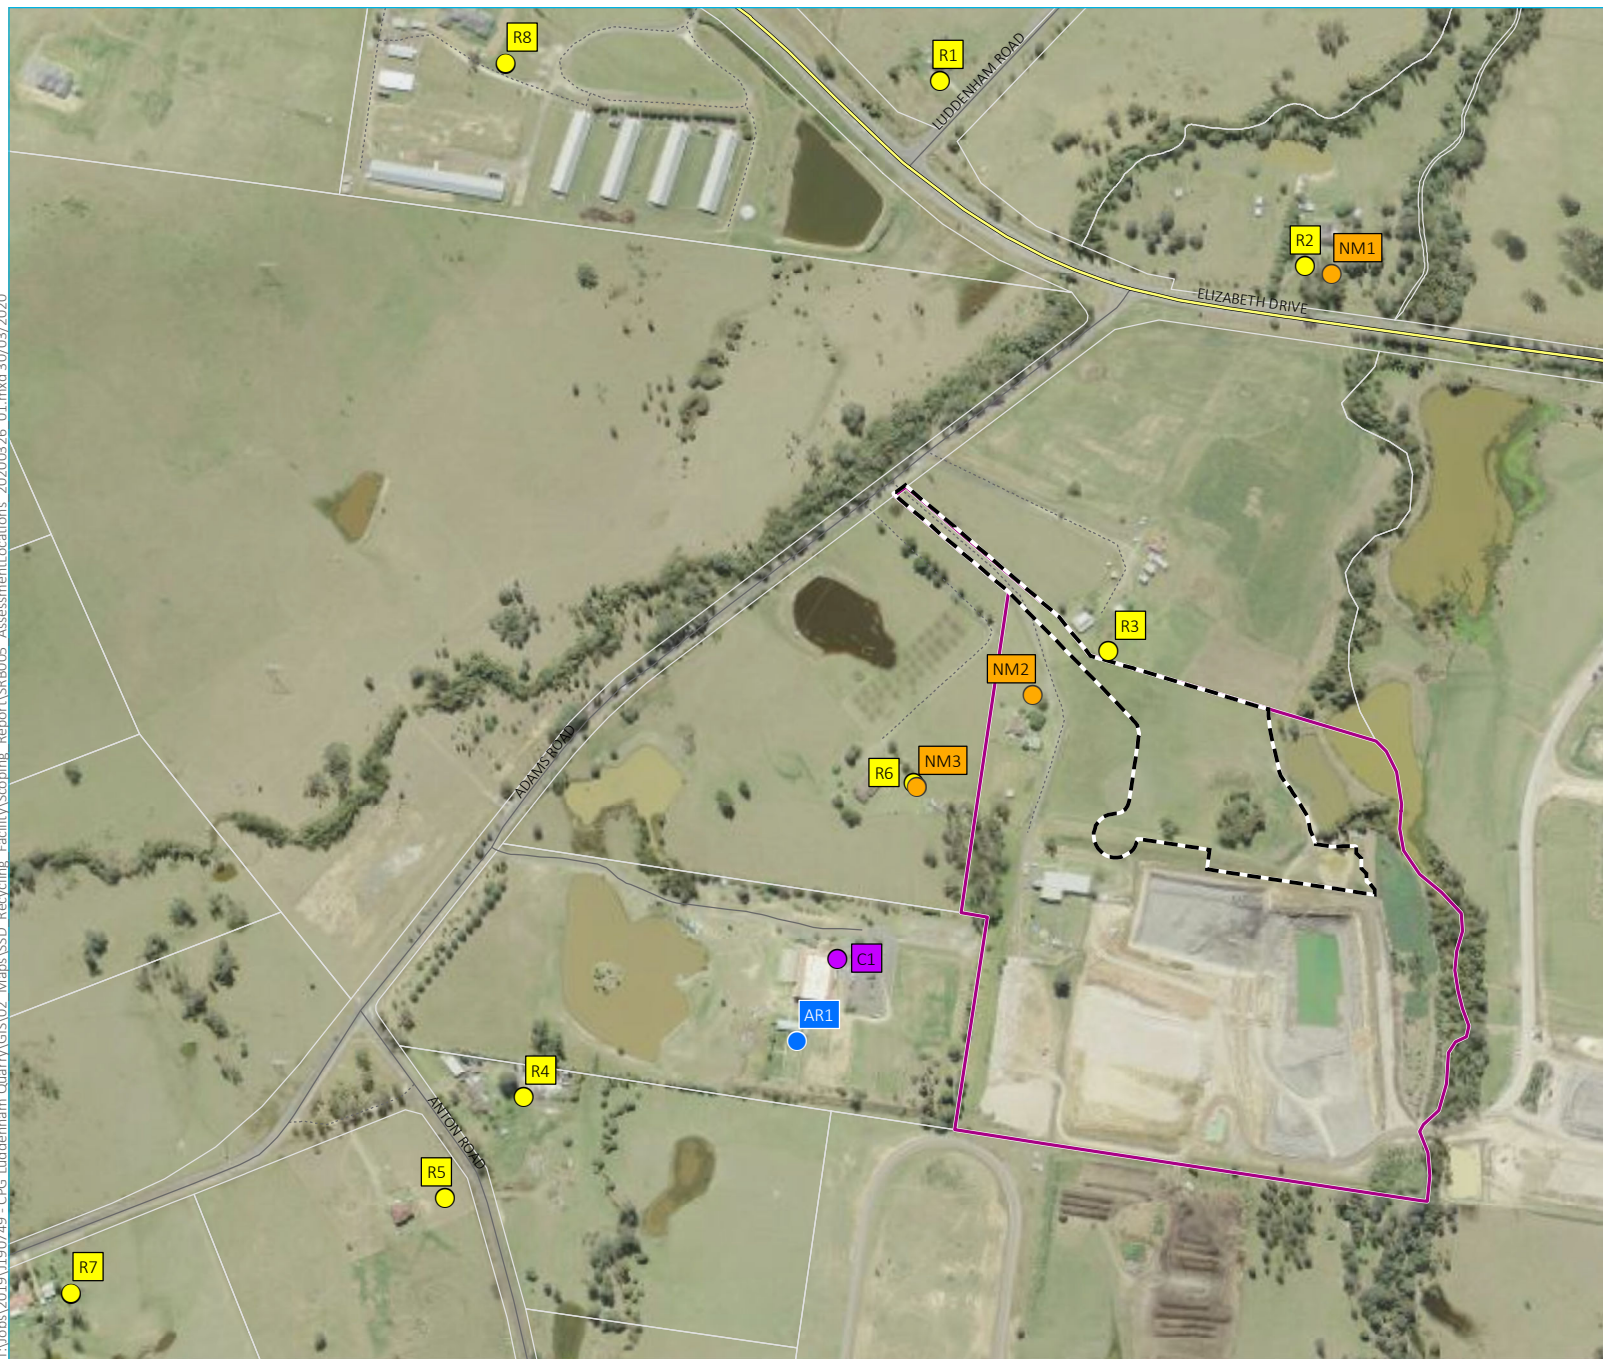
Noise sensitive receptors

- KEY**
- Subject property
 - RRC site
 - Cadastral boundary
 - Major road
 - Minor road
 - Vehicular track
 - Noise monitoring location
- Assessment location type**
- Active recreation
 - Commercial
 - Residential

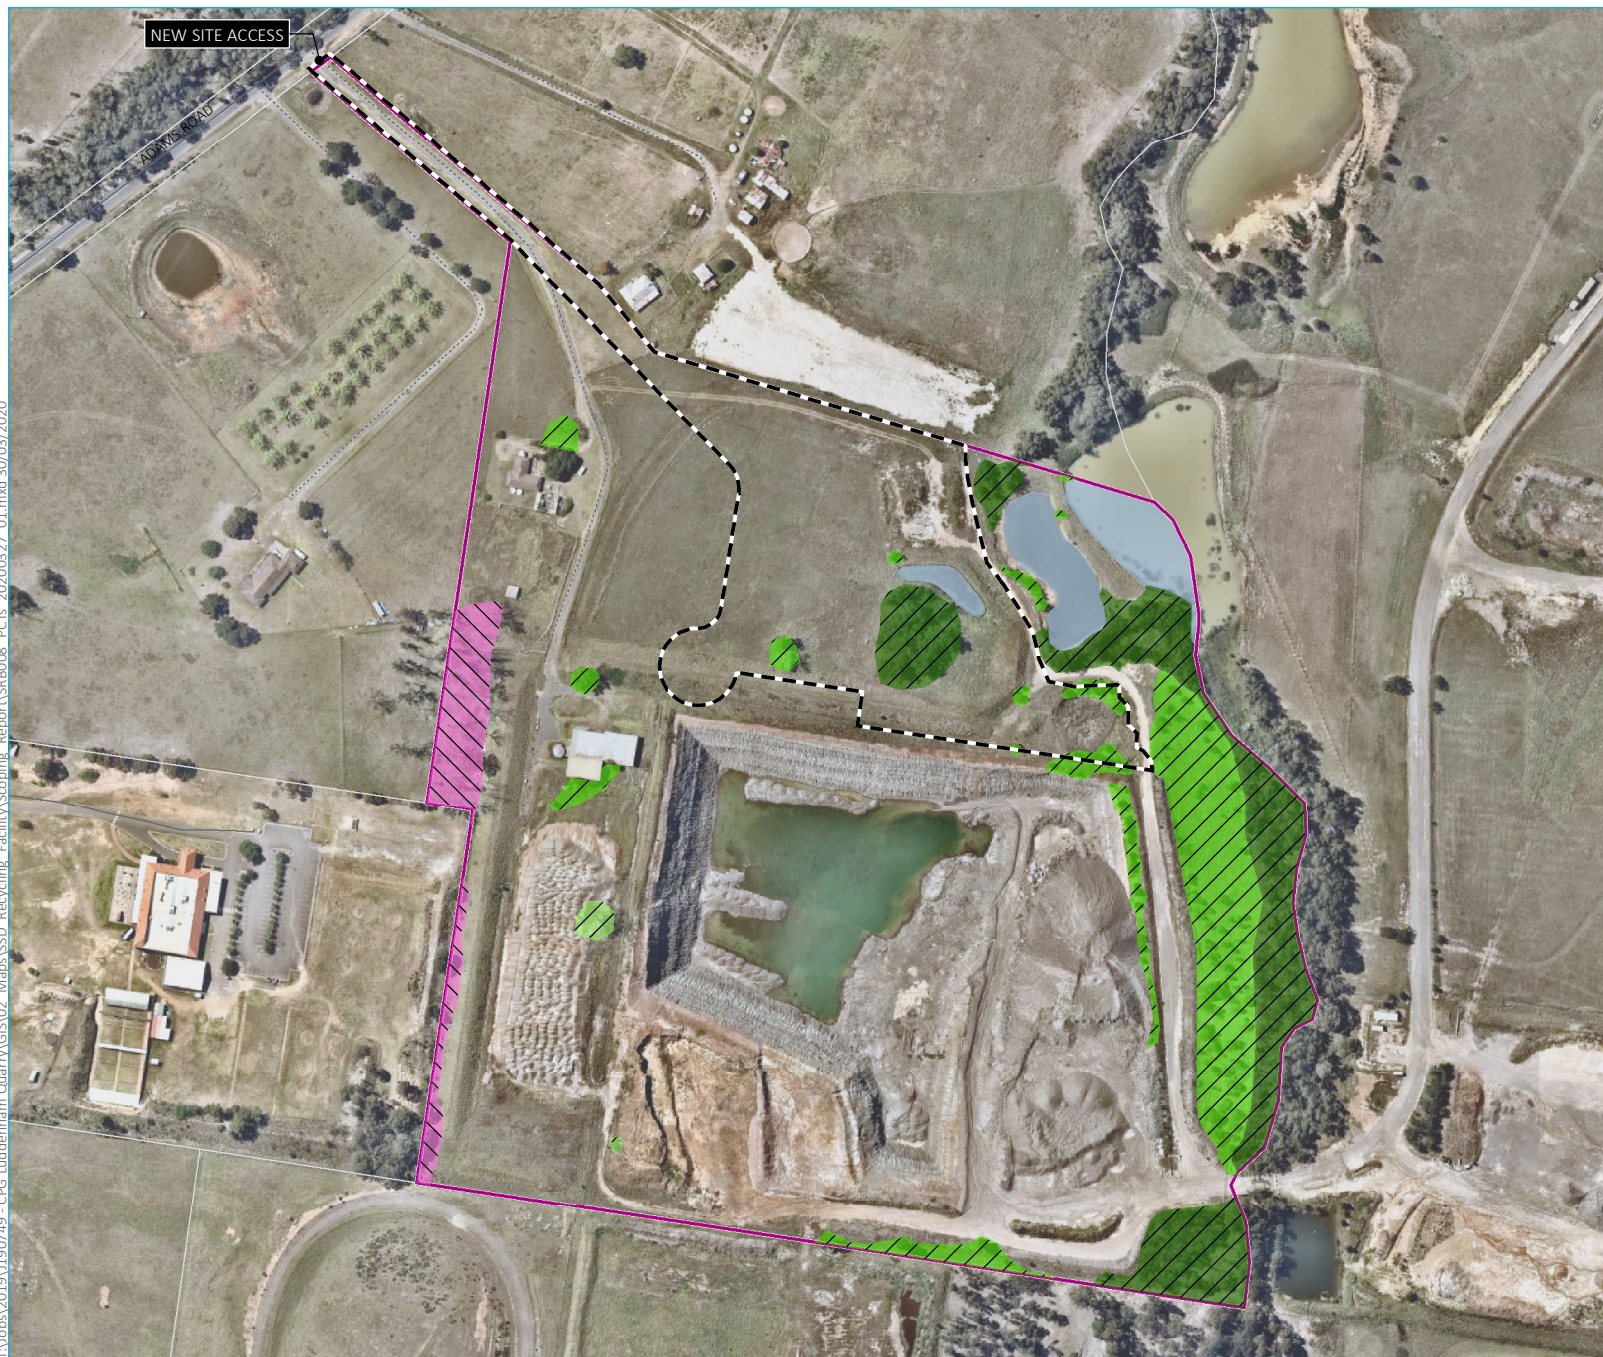
Plant community types in the project area

- KEY**
- Subject property
 - RRC site
 - Waterbody
 - Cadastral boundary
- Plant community type (PCT)**
- 1800 - Swamp Oak open forest on riverflats of the Cumberland Plain and Hunter Valley
- Poor (disturbed)
 - Poor
 - Medium
- 849 - Grey Box Forest Red Gum grassy woodland on flats of the Cumberland Plain, Sydney Basin Bioregion
- Poor
- Threatened ecological community (TEC)**
- Swamp Oak Floodplain Forest of the NSW North Coast, Sydney Basin, South East Corner bioregions
 - Cumberland Plain Woodland in the Sydney Basin Bioregion

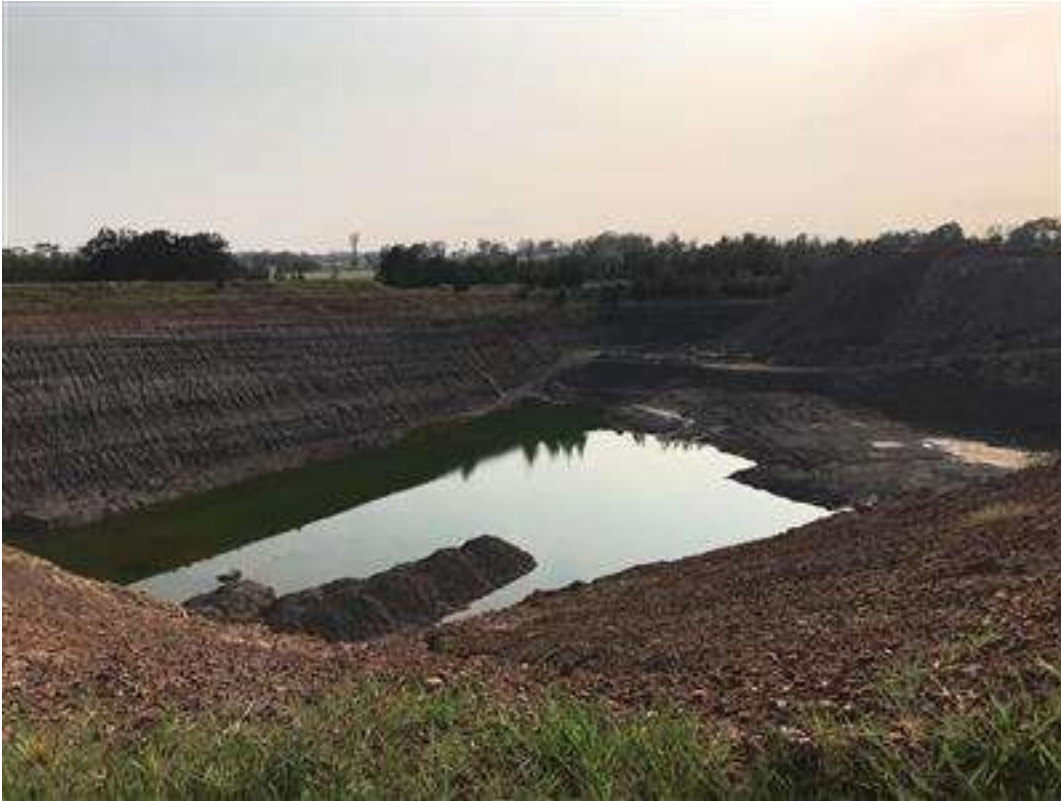
Plate 2.2 Existing quarry. View north-east.

More recent disturbance has been most intensive in the southern half of the study area with the establishment of a clay/shale quarry which was approved in 2003 (Plate 2.2). The quarry extraction footprint is bordered by a

stockpiling area and earth noise bund to the west, an earth noise bund to the north and internal access roads to the south and east.

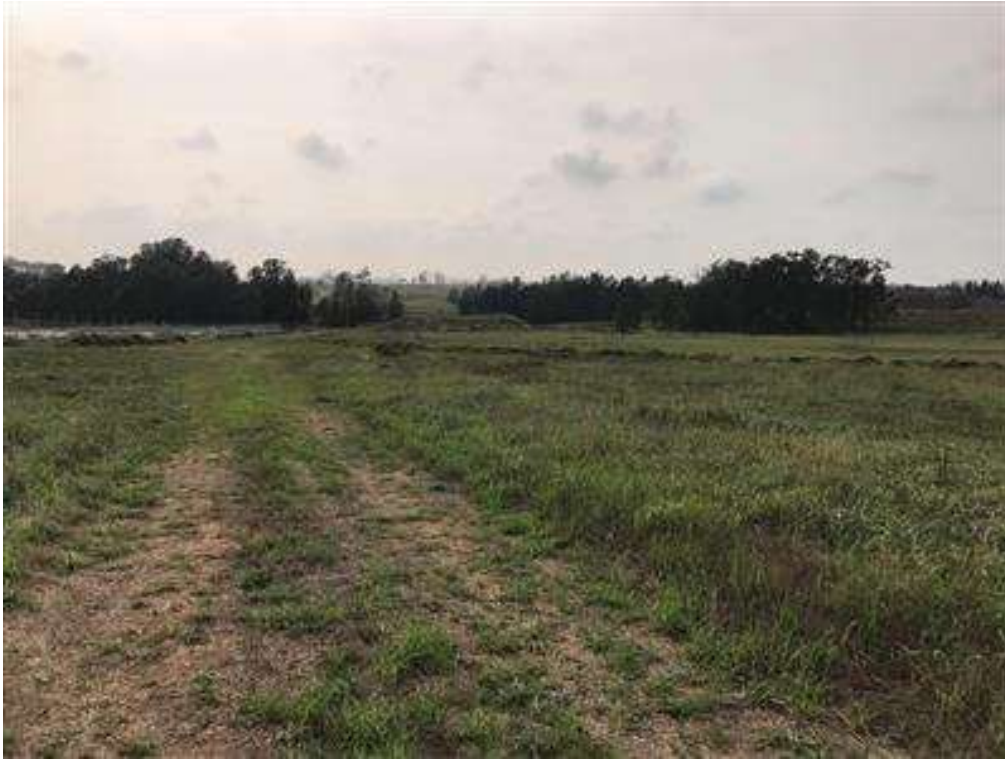
Plate 4.1 Track exposure, cleared area with dense pasture grasses and low surface visibility in northern study area, where the proposed RRC will be located. View east.

The location of the proposed RRC is a grassy paddock in the northern part of the study area that has been heavily impacted by pastoral activities, particularly grazing. Evidence of the pre-1990s turf farm were not visible on the surface. The paddock has a dense cover of exotic grass and surface visibility was limited (Plate 4.10). This riverflat area slopes gently to the east and towards Oaky Creek. A small grove of predominantly young casuarina trees is located to the east of the paddock between a small dam and the bund of the mine. The area to the north of this dam has been highly modified with introduced fill for the road and a mound of soil and gravel in the north east.

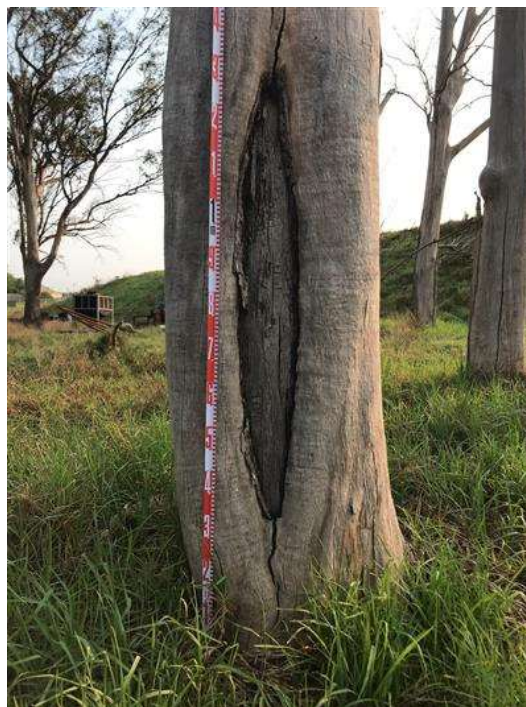
Plate 4.2 Tree with scar to the west of stockpile area. Existing stockpile/bund in background. View north-east.

The study area gently slopes from the west to east. It is bounded to the east by Oaky Creek and, within the study area, this section has been the least disturbed from previous mining and agricultural activities. The northern part of the study area, and a narrow corridor on the western boundary, have been cleared for agricultural use. Assessment of this area was impeded by extremely low visibility at the time of survey. Grass covered most of the study area, limiting ground surface exposure (Plate 4.1). Where trees were present they were inspected for scars. One eucalypt tree, within a grove of Grey Box Forest Red Gum grassy woodland near the western boundary, bore an even, oval shaped scar. Trees in this area had been affected by dieback; although the tree with the scar is alive, and the scar, which is 1 m in length, retains a dry face. However, the tree is not considered to be culturally modified and cannot be classified as a scar tree. Not only is the survival of scar trees extremely rare in the local area (Table 3.1) because of the historically high level of vegetation clearance, but the tree itself is quite young. It is likely that the scar has been caused by termite activity or incidental damage (Plate 4.2; Plate 4.3). Furthermore, it is outside the proposed activity and will not be impacted by it.

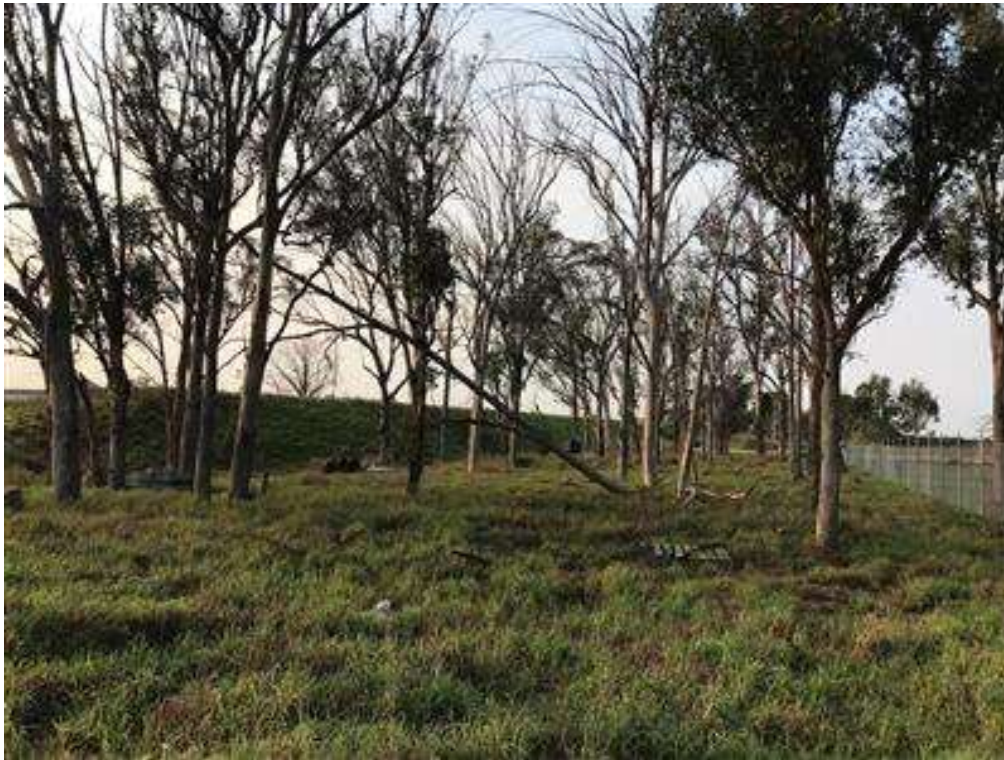
Plate 4.3 **Woodland area of young trees affected by dieback, western study area. Tree with scar is in the background. View south.**

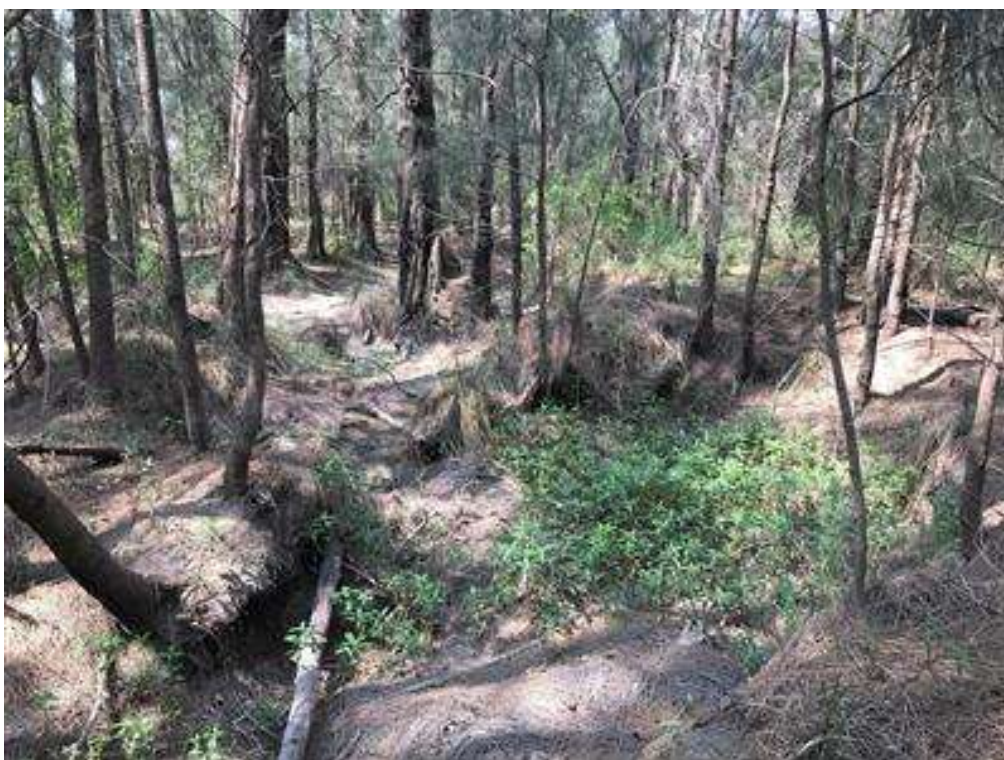
Plate 4.4 **Oaky Creek. View south.**

However, the eastern corridor of the study area, encompassing the riparian zone on the west side of Oaky Creek, has been less disturbed (Plate 4.4; Plate 4.5). Site inspection confirmed the assessment of previous reports (Navin Officer 2016) that this area has higher potential for Aboriginal cultural material to be present. However, it should be noted that a series of dams and earthworks, in the north-east corner of the study area, has impacted the flow of Oaky Creek and disturbed the ground surface. At the time of the site inspection, Oaky Creek was dry. Ground surface visibility was limited by a dense coverage of casuarina needles. An access track that runs north to south between the quarry and Oaky Creek has been raised and levelled with introduced fill (Plate 4.6).

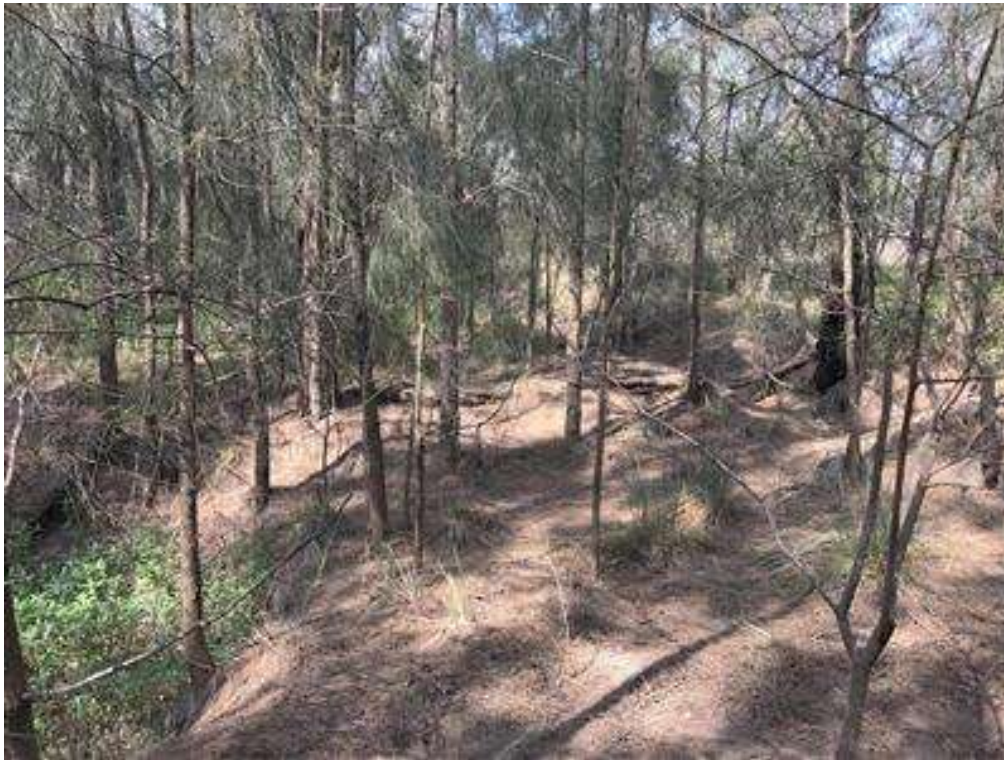
Plate 4.5 **Elevated terrace flat beside Oaky Creek. Potential for Aboriginal objects in this woodland area on the west side of Oaky Creek. Negligible surface exposure. View south.**

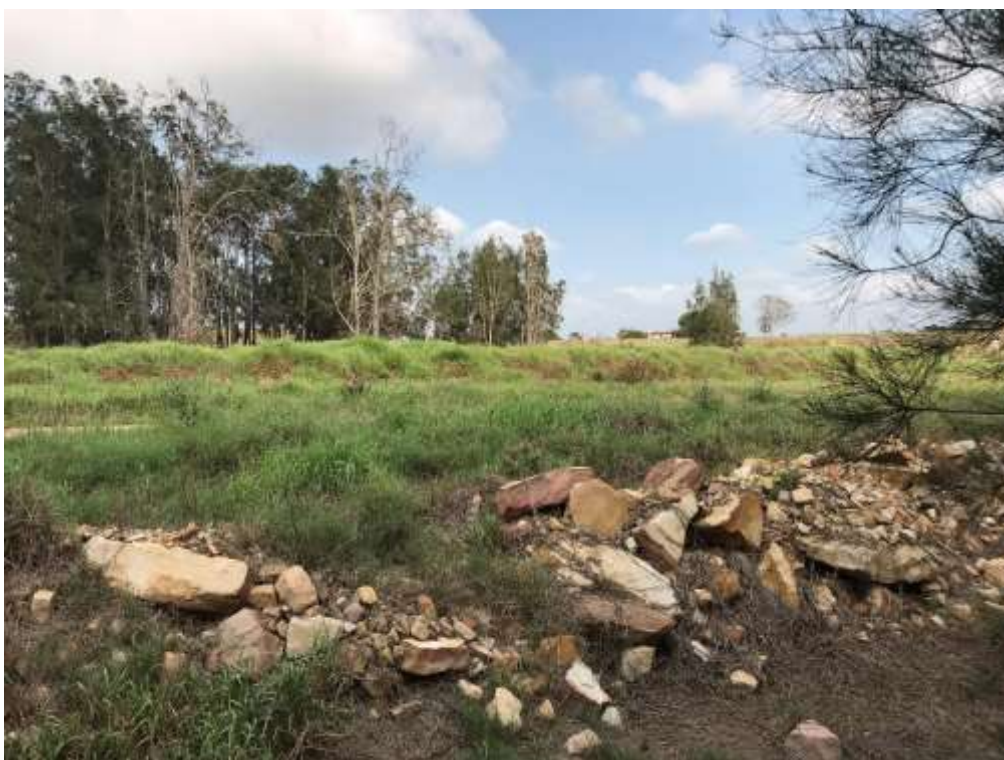
Plate 4.6 **Fill used to create a level surface for the road. Bund beside dam behind. View north-west.**

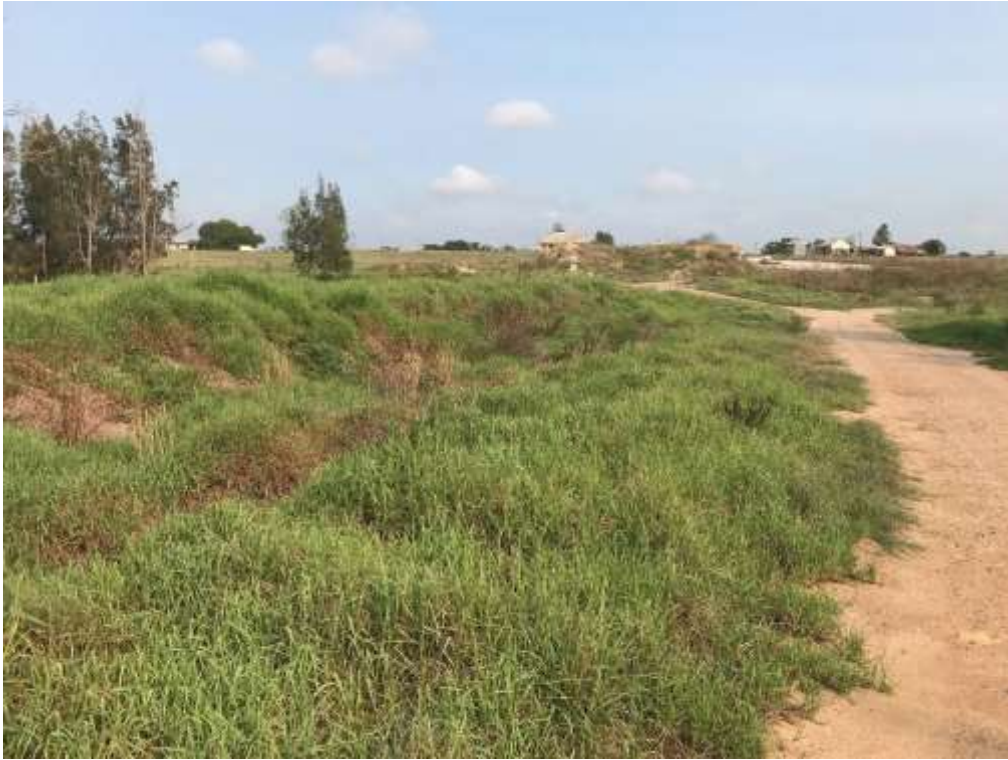
Plate 4.7 **Location of AHIMS site #52-5-2280 as recorded on the AHIMS database. View north.**

The one recorded AHIMS site in the study area (#45-5-2280) was inspected. However, the site inspection found that the spatial coordinates on the AHIMS database do not match its physical location in the study area (Plate 4.7). The recorded AHIMS location was inspected and found to have a high level of disturbance from creation of the road, the dam walls and a nearby noise bund. High grass limited the ground surface visibility. No artefacts were identified. Approximately 50 m to the east of the recorded AHIMS location is a fenced area that marks the true location of the AHIMS site. The corrected location of #45-5-2280 is shown on Figure 4.1. The securely fenced area is located beside Oaky Creek and contains an area approximately 2.5m x 6m (Plate 4.8). At the time of the site visit, the ground was covered in a deep layer Casuarina needles and no artefacts were identified (Plate 4.9).

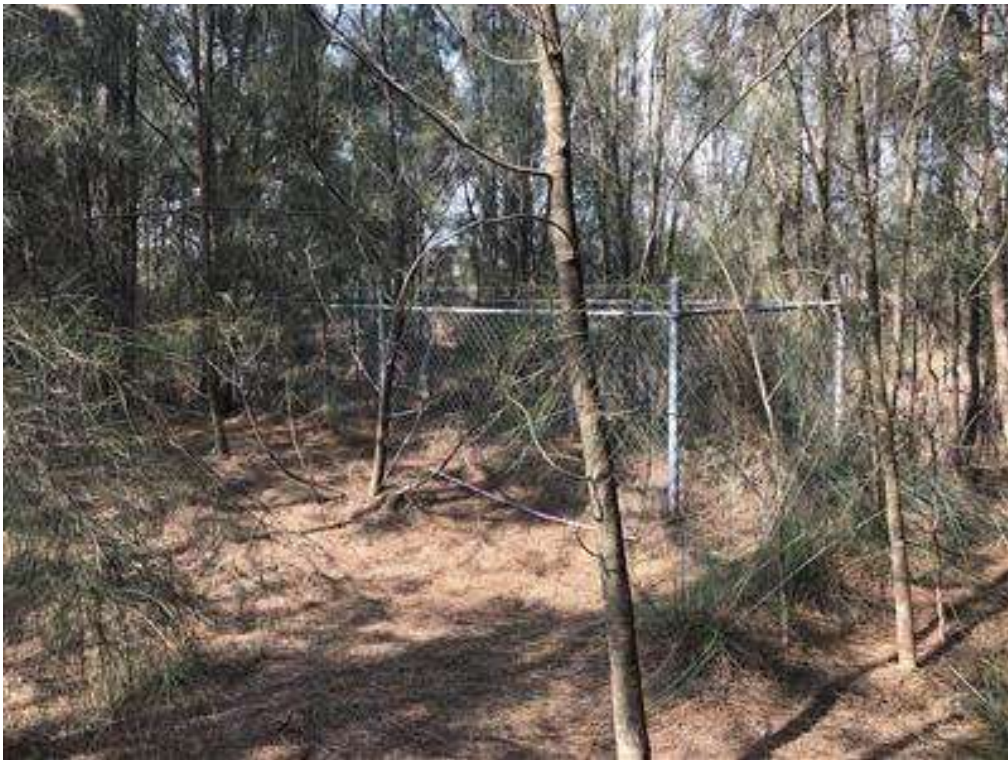
Plate 4.8 **Fenced area around AHIMS site #45-5-2280. View north.**

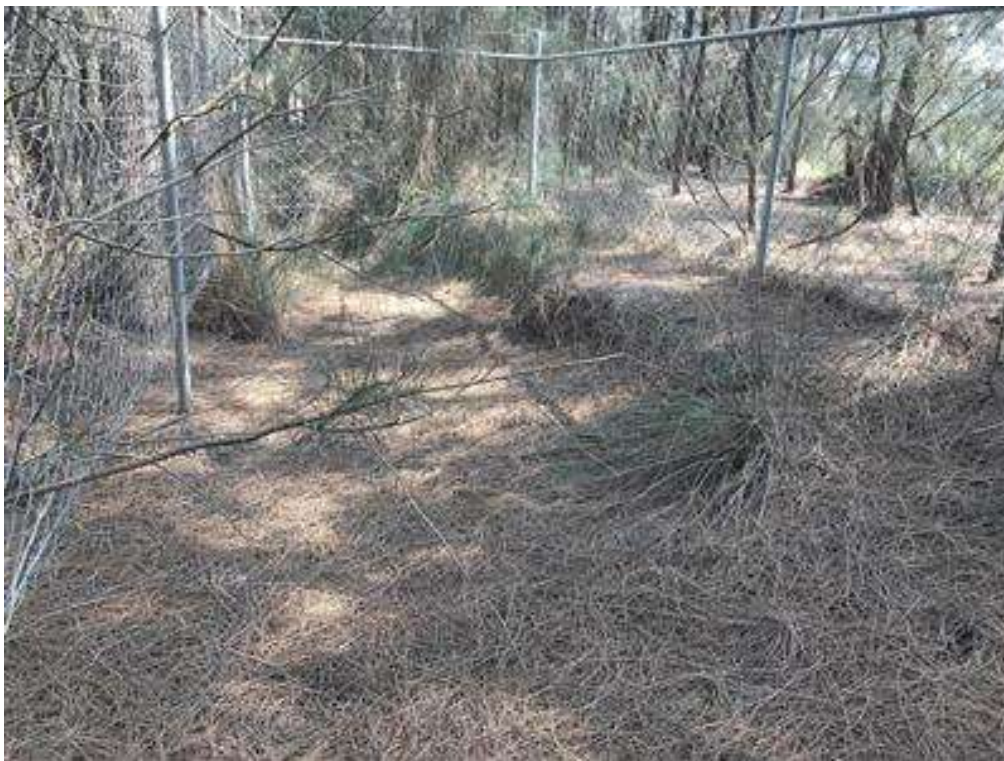
Plate 4.9 AHIMS site #45-5-2280. Eroded bank within the enclosure where artefacts were identified. Area is now covered in a deep layer of Casuarina needles View north.

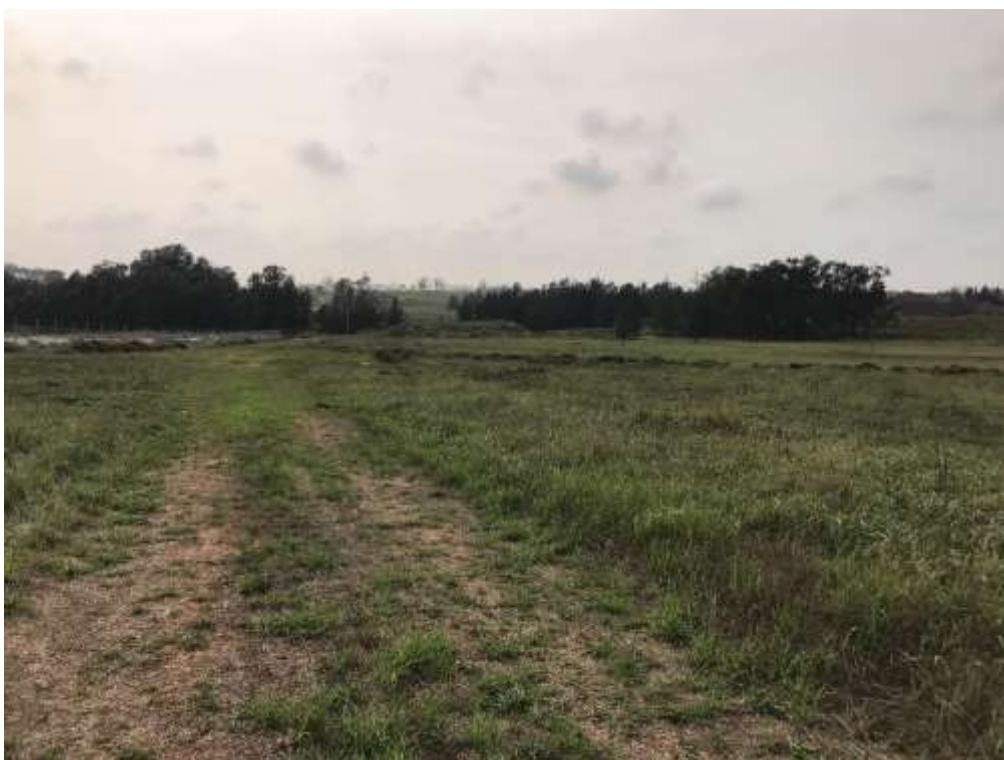
Plate 4.10 Grassed paddock in northern part of the study area. View west.
