# **AGL Macquarie Pty Limited**

## Liddell Power Station - Proposed Borrow Area Preliminary Geotechnical and Contamination Report

July 2021

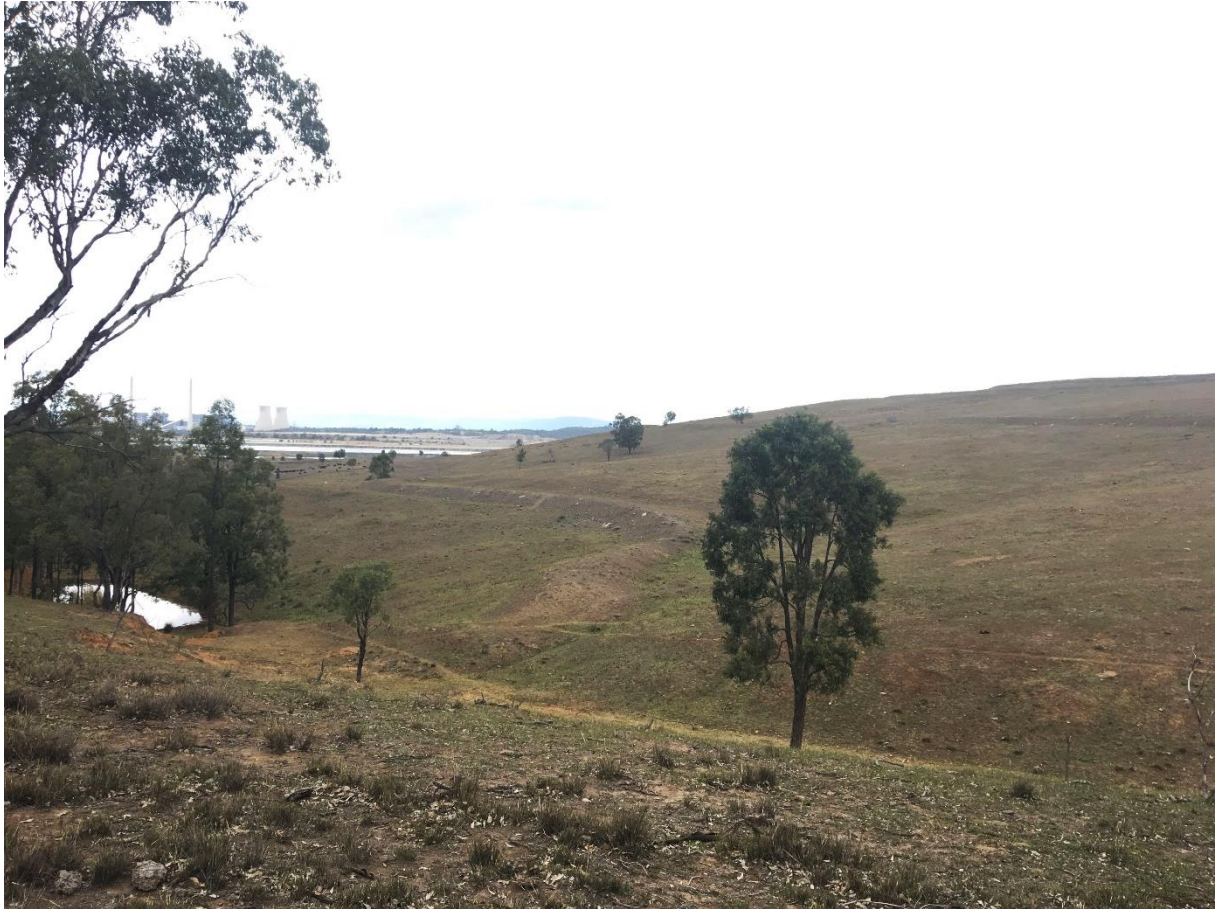
**Photograph 1 View looking south towards borrow area**

The borrow area covers an area of approximately 0.65 **km<sup>2</sup>** and comprises a grass mound with multiple terraced levels, ranging from Reduced Level (**RL**)190 to RL 255. The western portion of the proposed borrow area lies within the former Drayton Coal Mine, and was not included as part of this investigation.
