Preliminary Aboriginal Cultural Heritage Assessment

Hunter Transmission Project

Prepared for Energy Corporation of NSW

May 2024

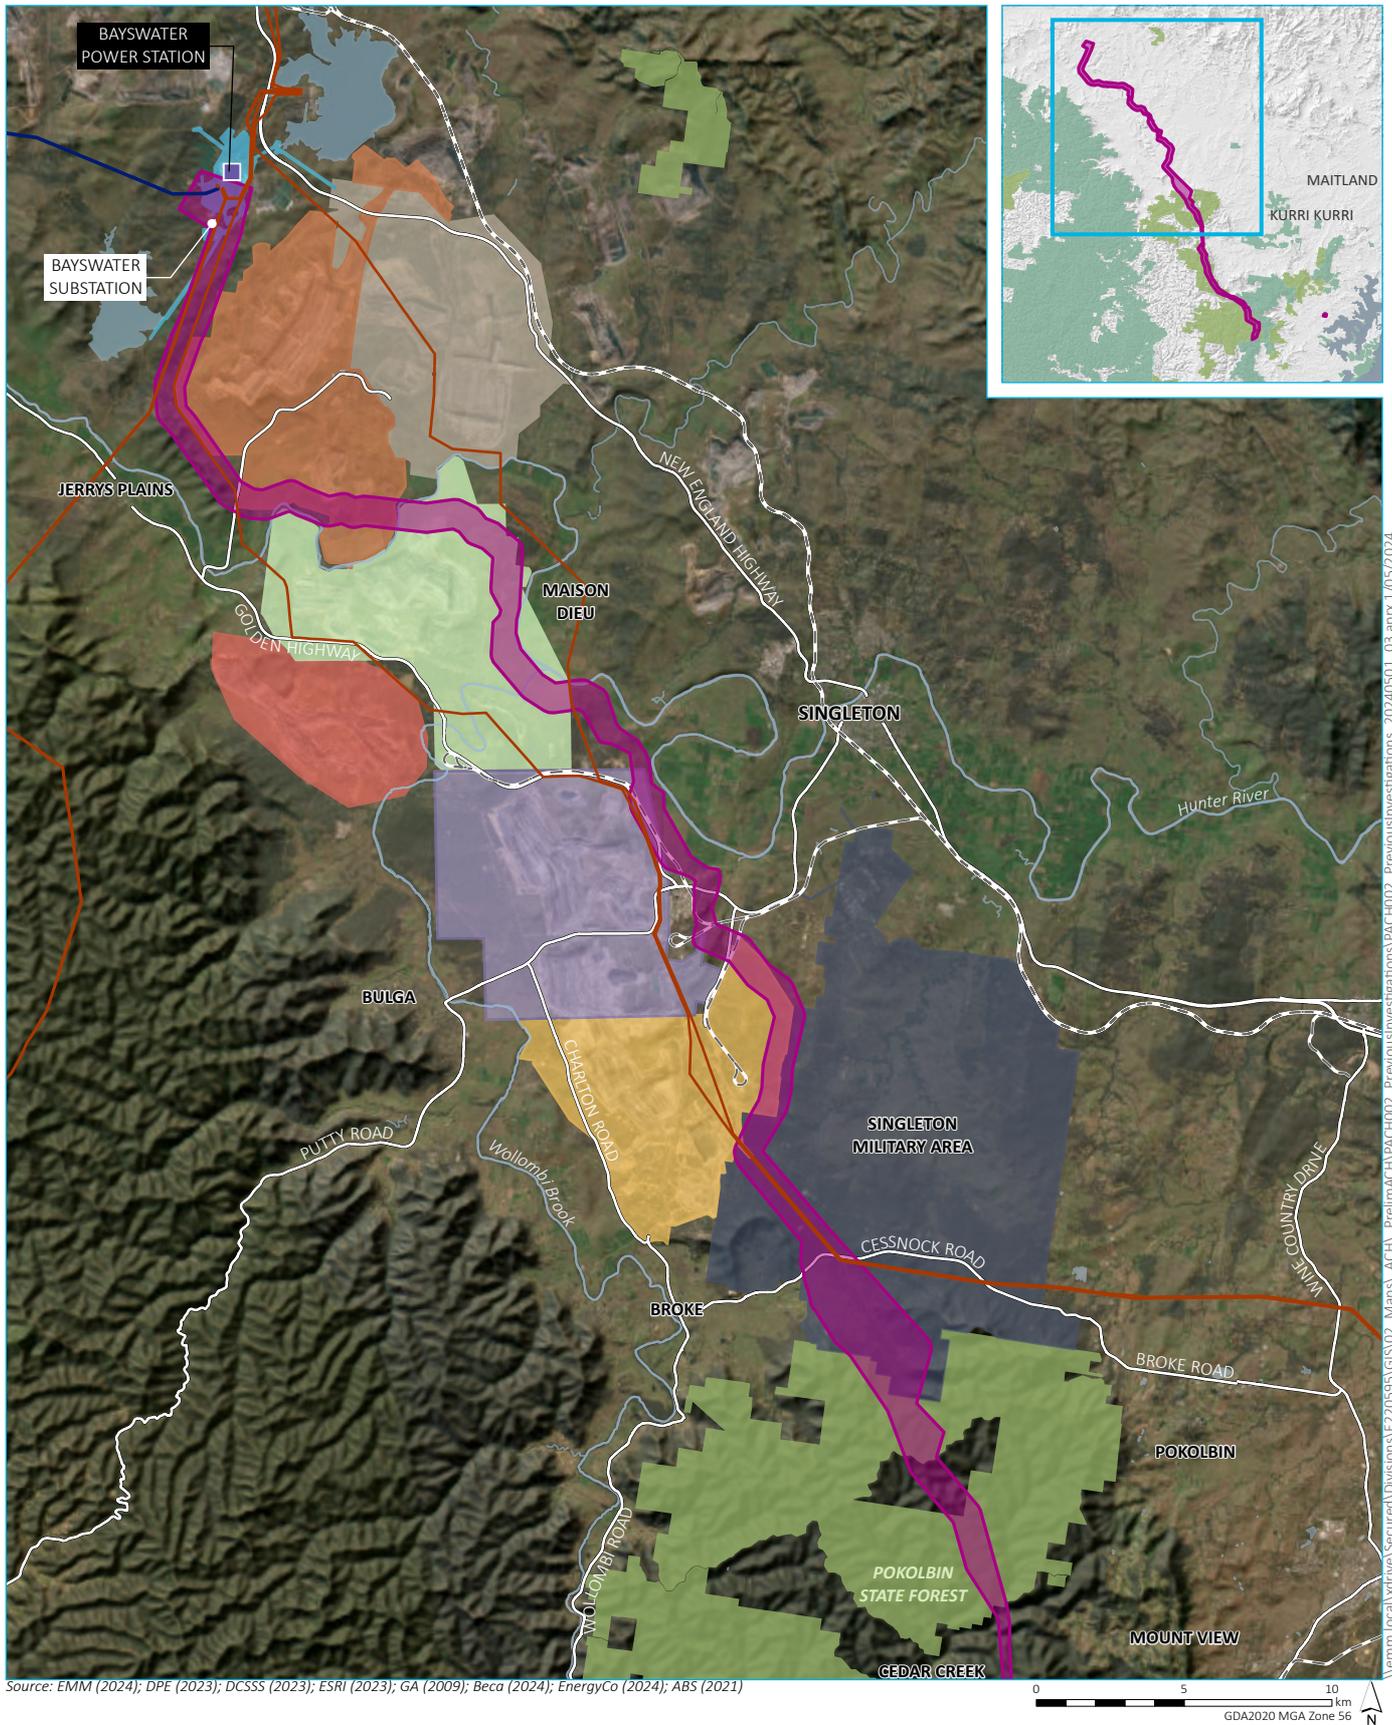
Hunter Transmission Project
Preliminary Aboriginal Cultural Assessment
Figure 1.2

Previous investigations within the proposed HTP corridor

There have been a number of previous studies that have encompassed parts of HTP North within the last decade. These locations, therefore, have up to date and readily available information on cultural materials that will be used to supplement additional assessment for the project. These include (Figure 1.2):

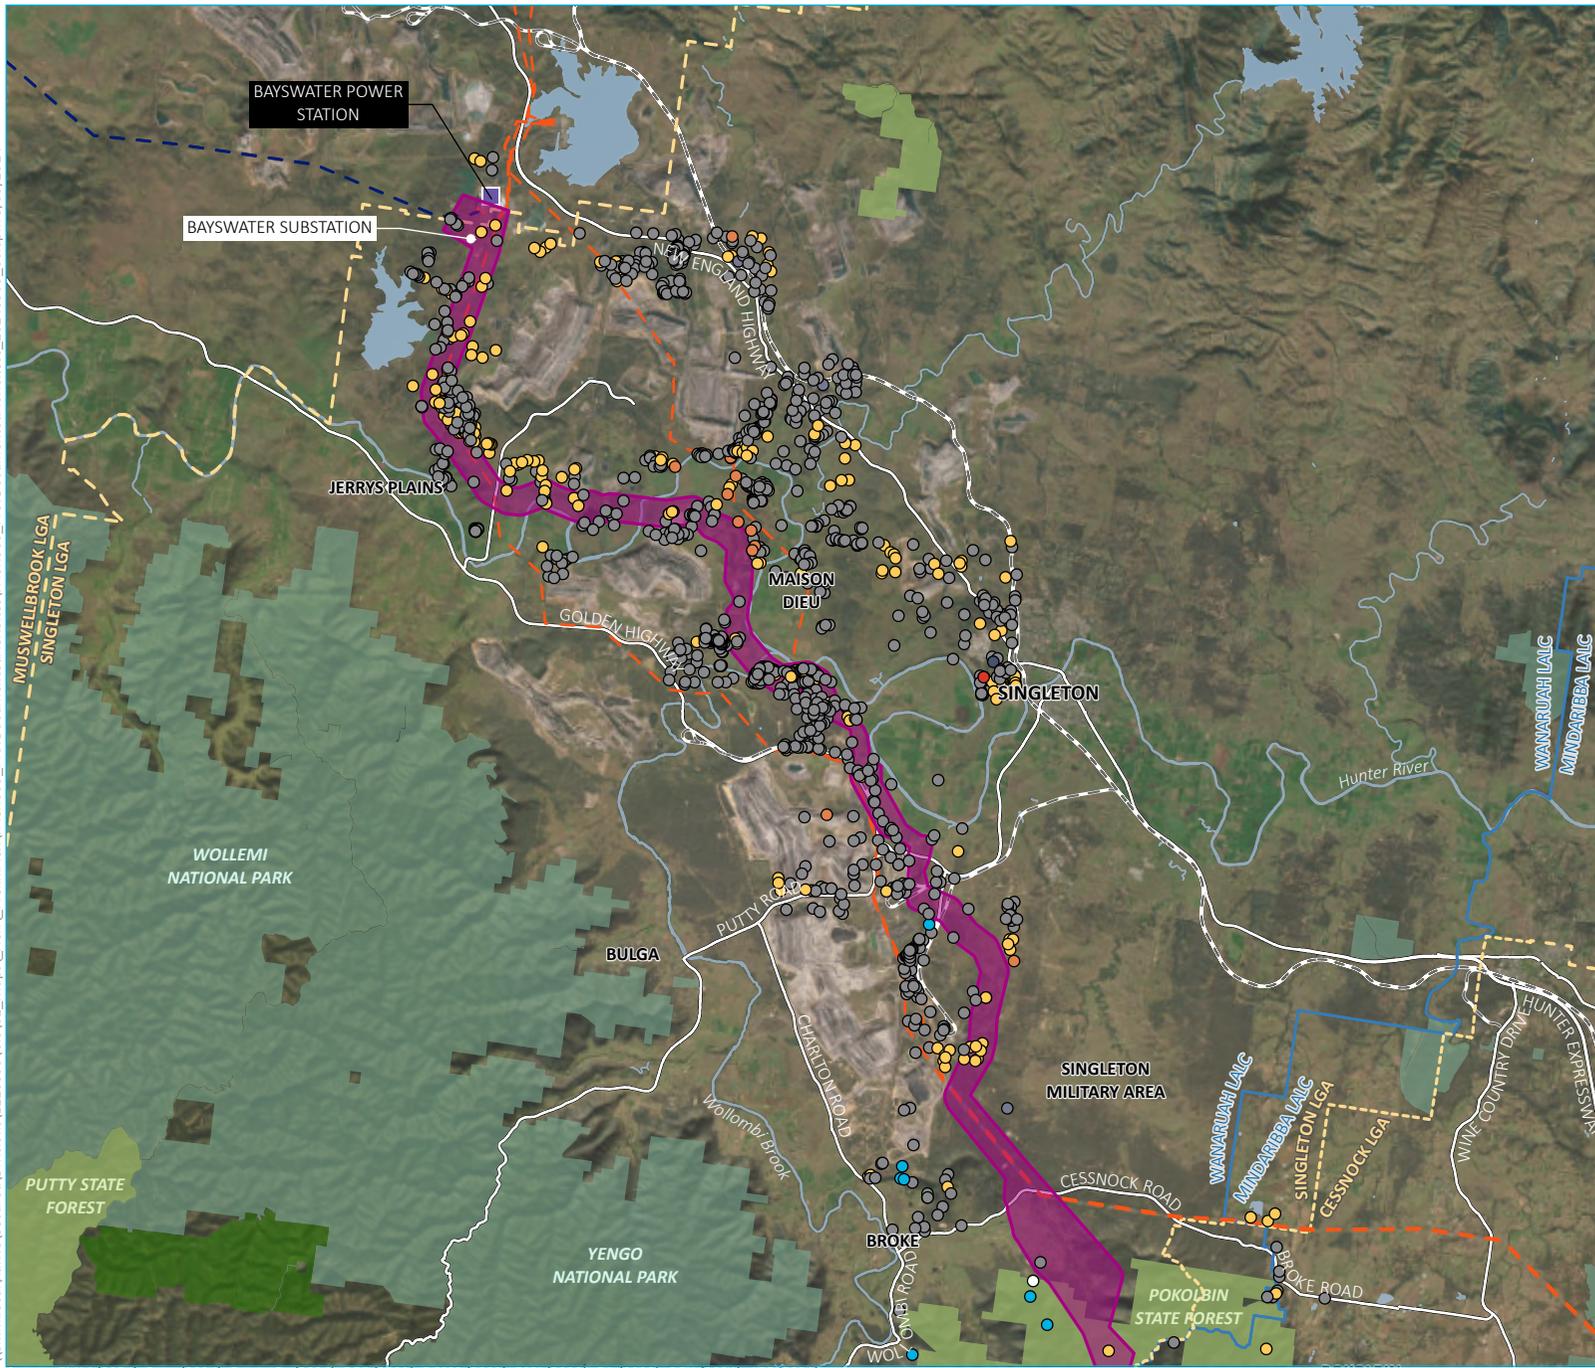
Hunter Transmission Project
 Preliminary Aboriginal Cultural Assessment
 Figure 1.3

Previously documented Aboriginal objects and sites- HTP North

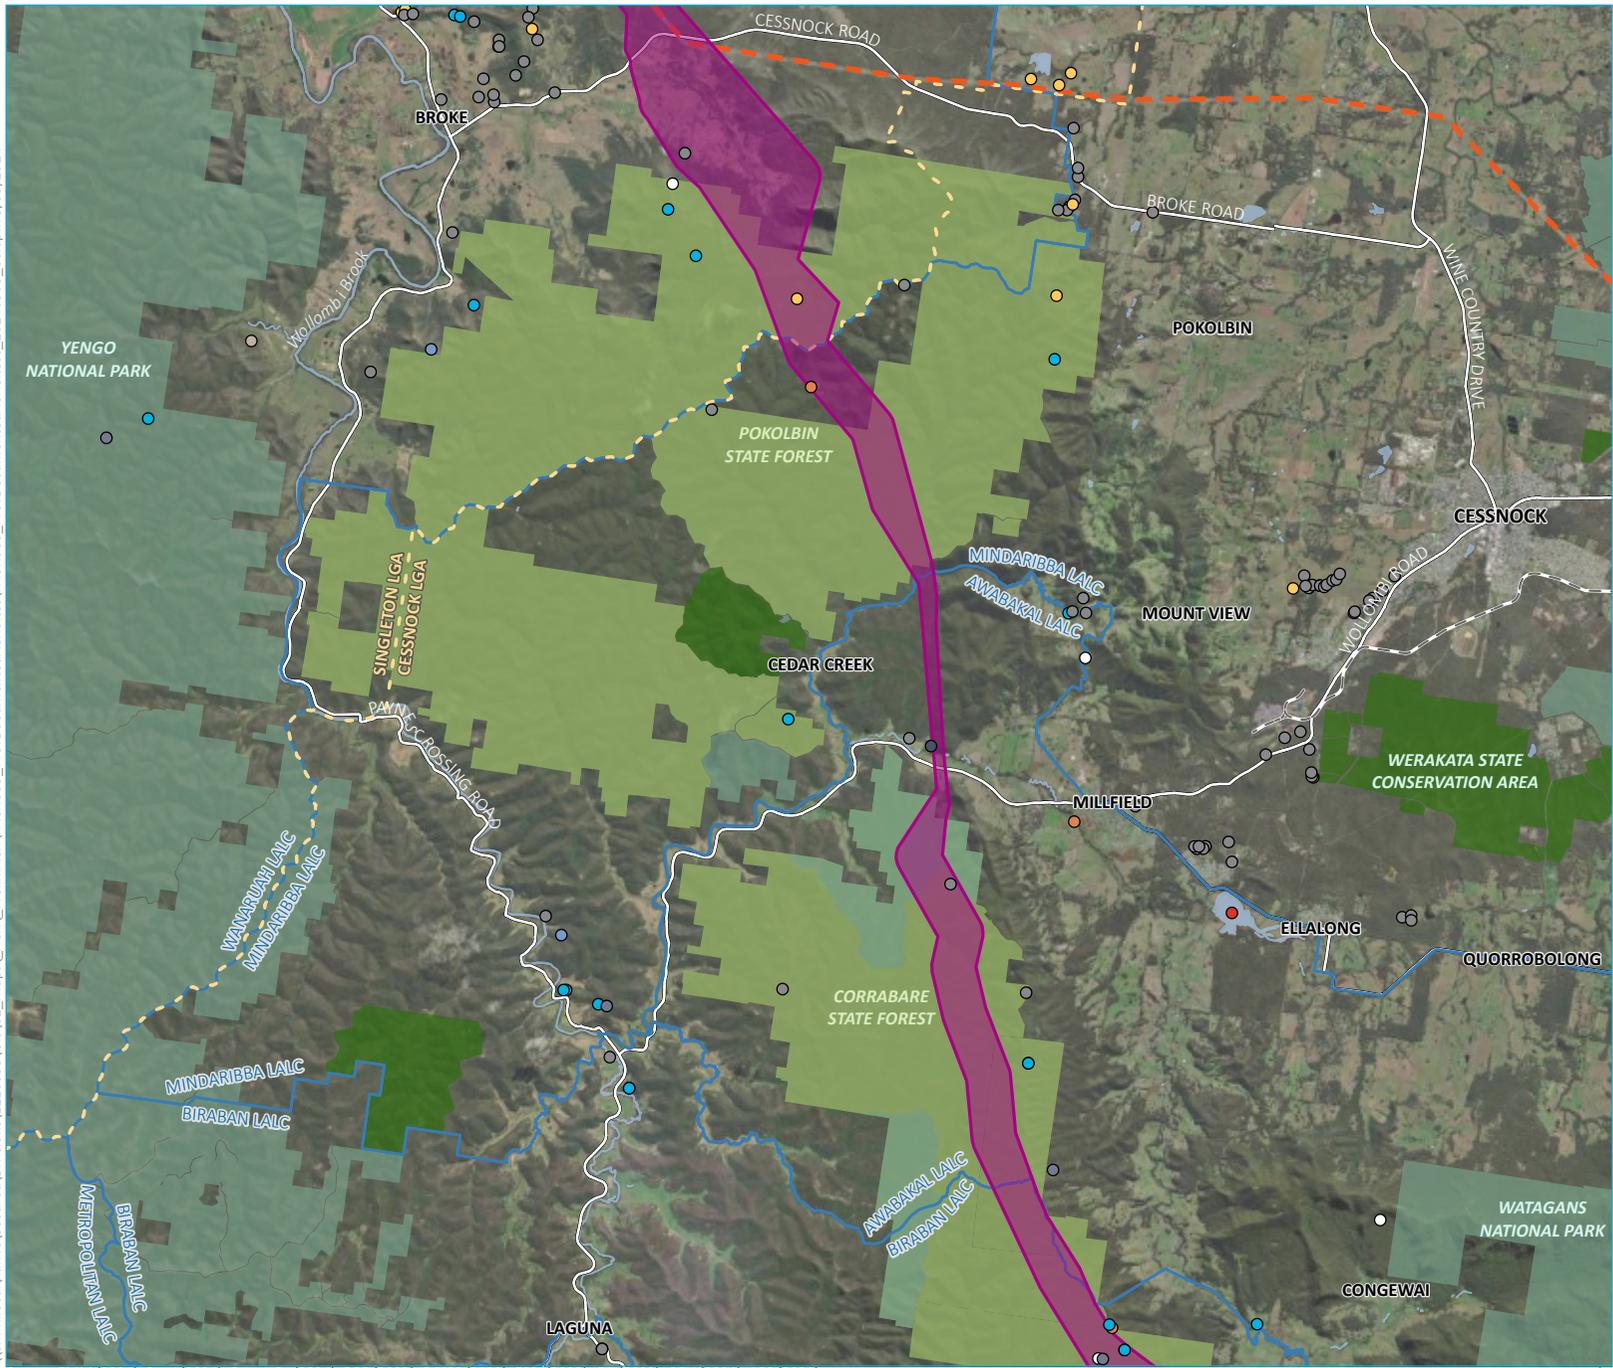
Hunter Transmission Project
Preliminary Aboriginal Cultural Assessment
Figure 1.4

Previously documented Aboriginal objects and sites- HTP Central

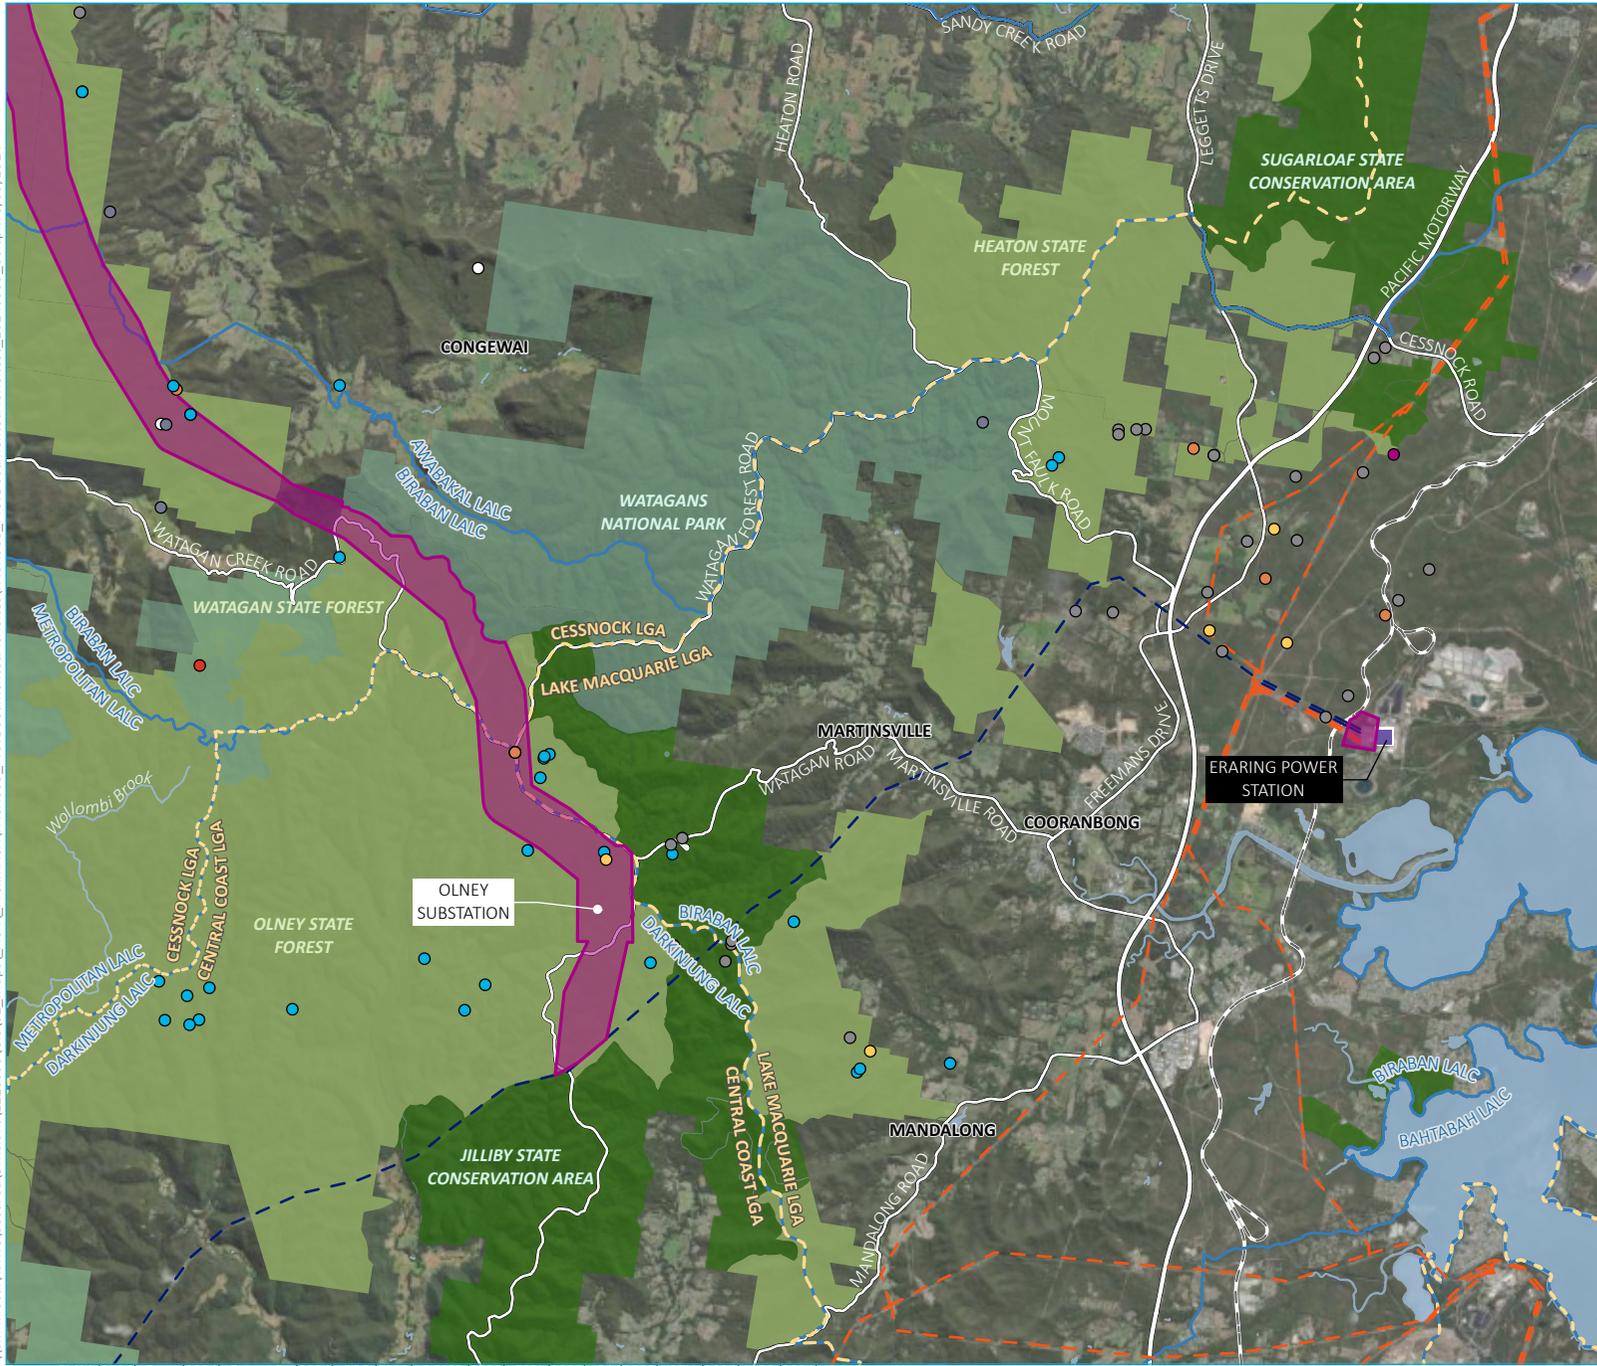
Hunter Transmission Project
Preliminary Aboriginal Cultural Assessment
Figure 1.5

Previously documented Aboriginal objects and sites- HTP South

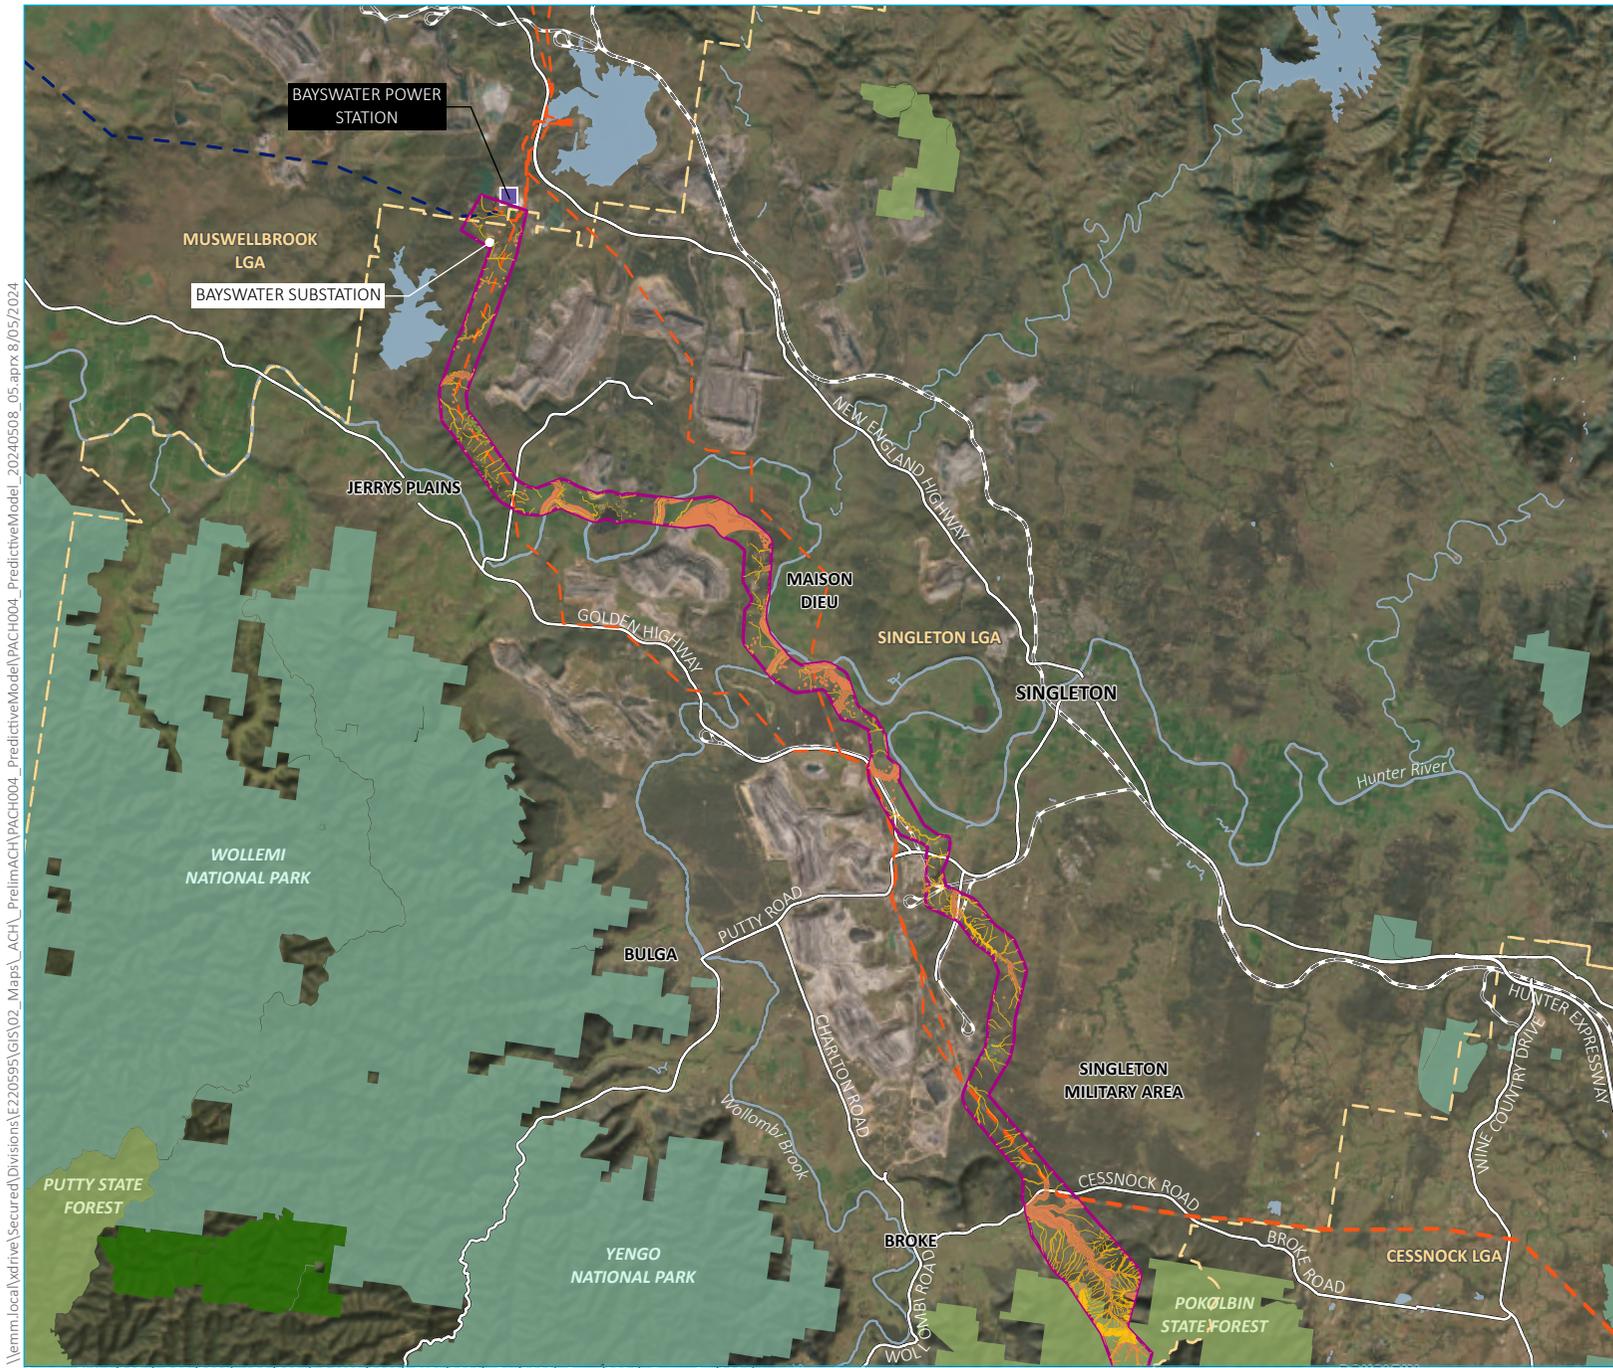
Hunter Transmission Project
Preliminary Aboriginal Cultural Assessment
Figure 2.1

Predictive model for the proposed HTP corridor- HTP North

The information outlined in Section 1.3 has been used to develop a predictive model for the HTP corridor to both inform design and subsequent assessment activity. The predictive model is provided in Figure 2.1 to Figure 2.3 and highlights areas of high and moderate potential where cultural materials are either known or expected to occur. Overall, some 1,602 ha of the project area is considered of high potential, and 1,177 ha of moderate value.

The model has used the following criteria in its formation to identify areas where cultural materials would be expected:

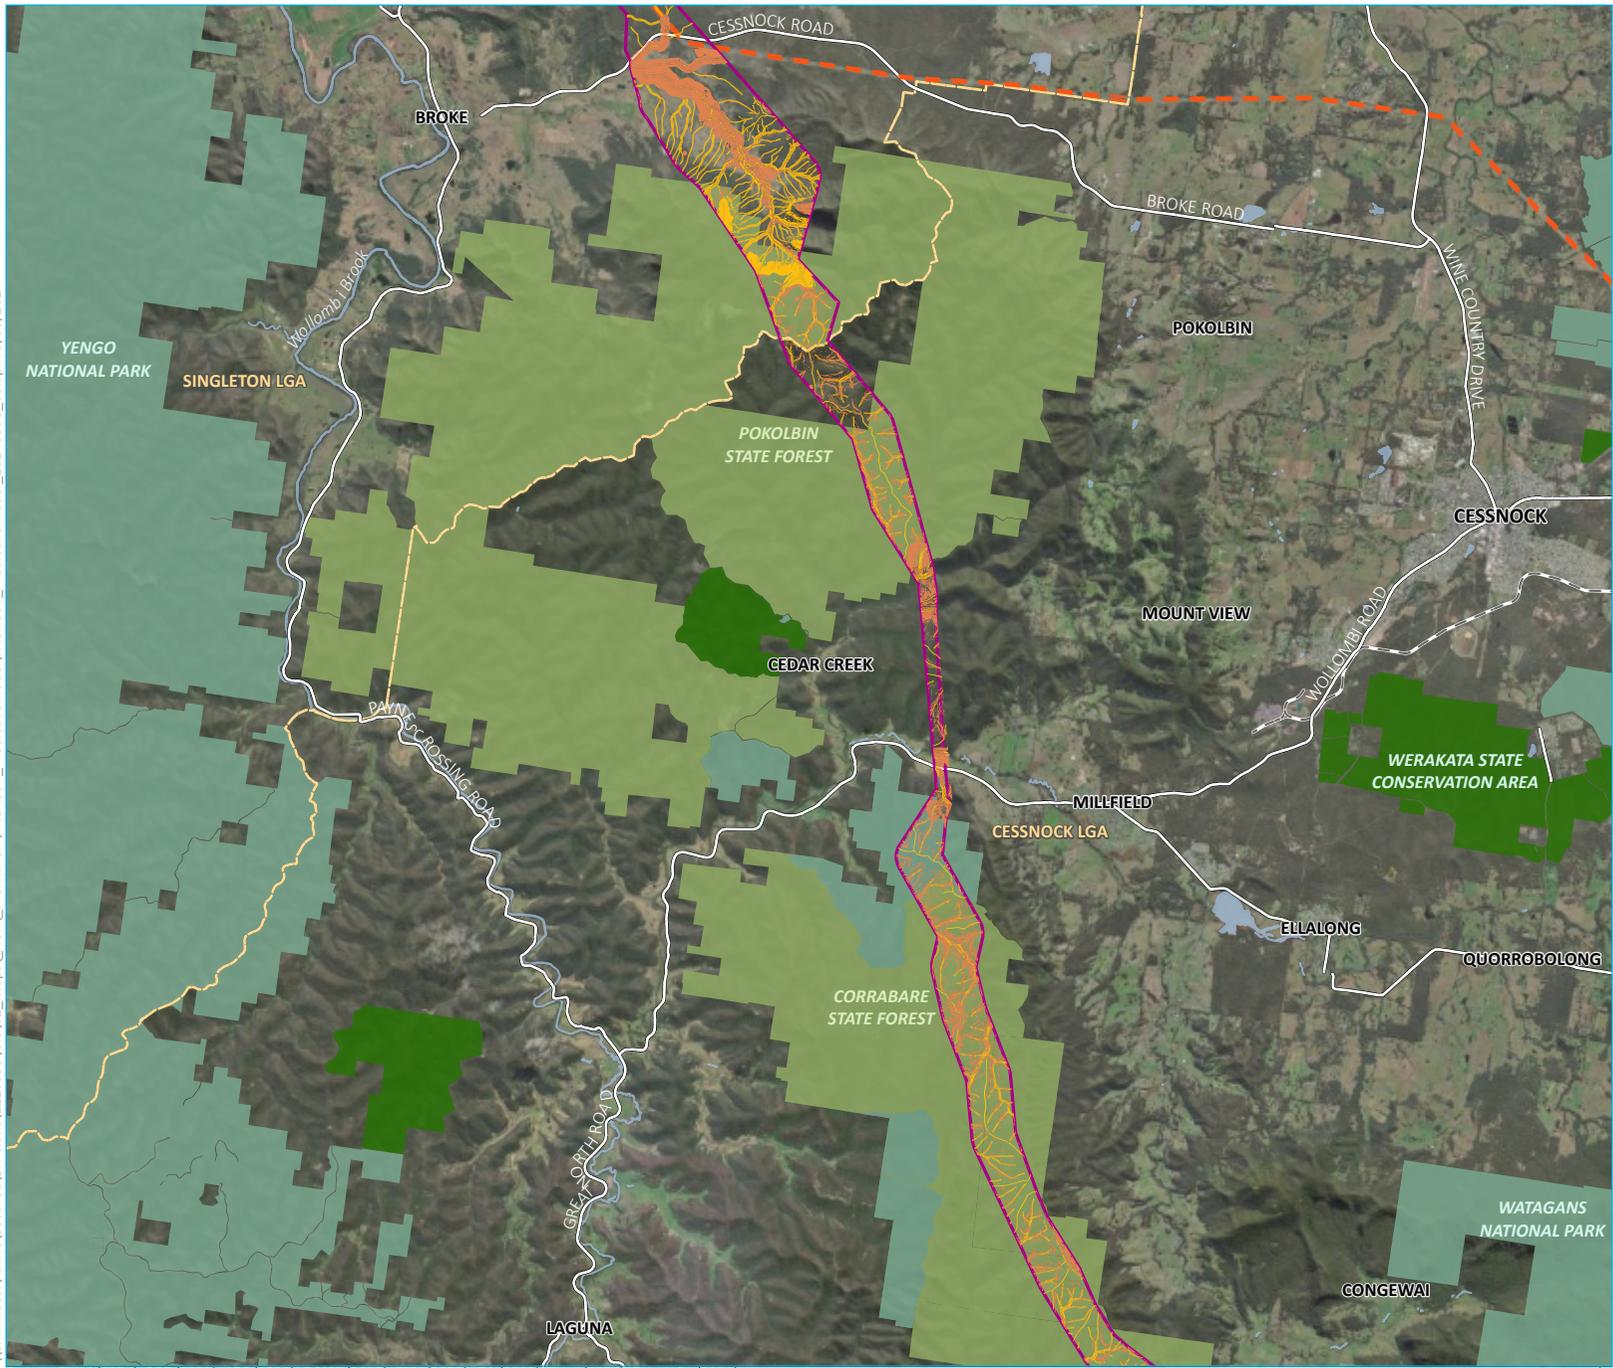
Hunter Transmission Project
Preliminary Aboriginal Cultural Assessment
Figure 2.2

Predictive model for the proposed HTP corridor- HTP Central

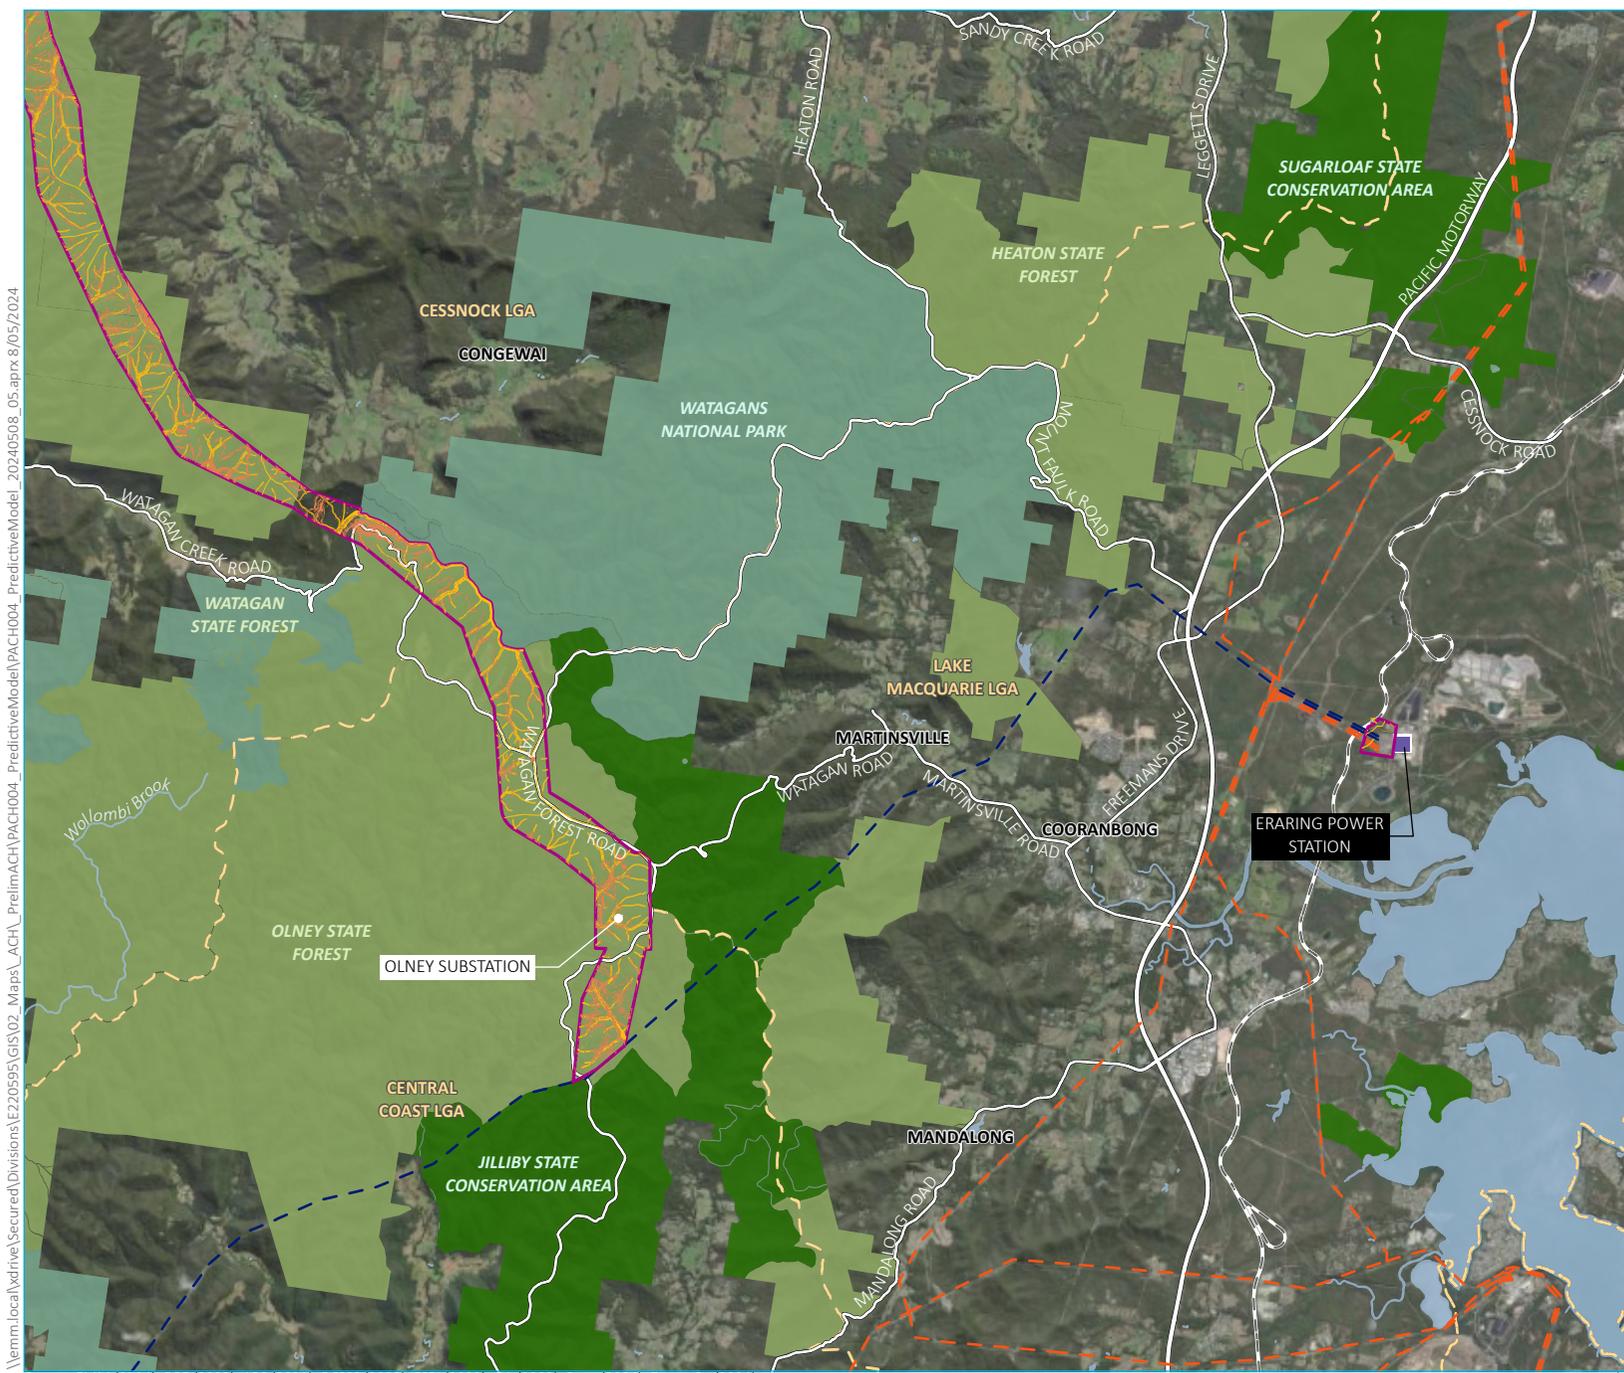
Hunter Transmission Project
Preliminary Aboriginal Cultural Assessment
Figure 2.3

Predictive model for the proposed HTP corridor- HTP South

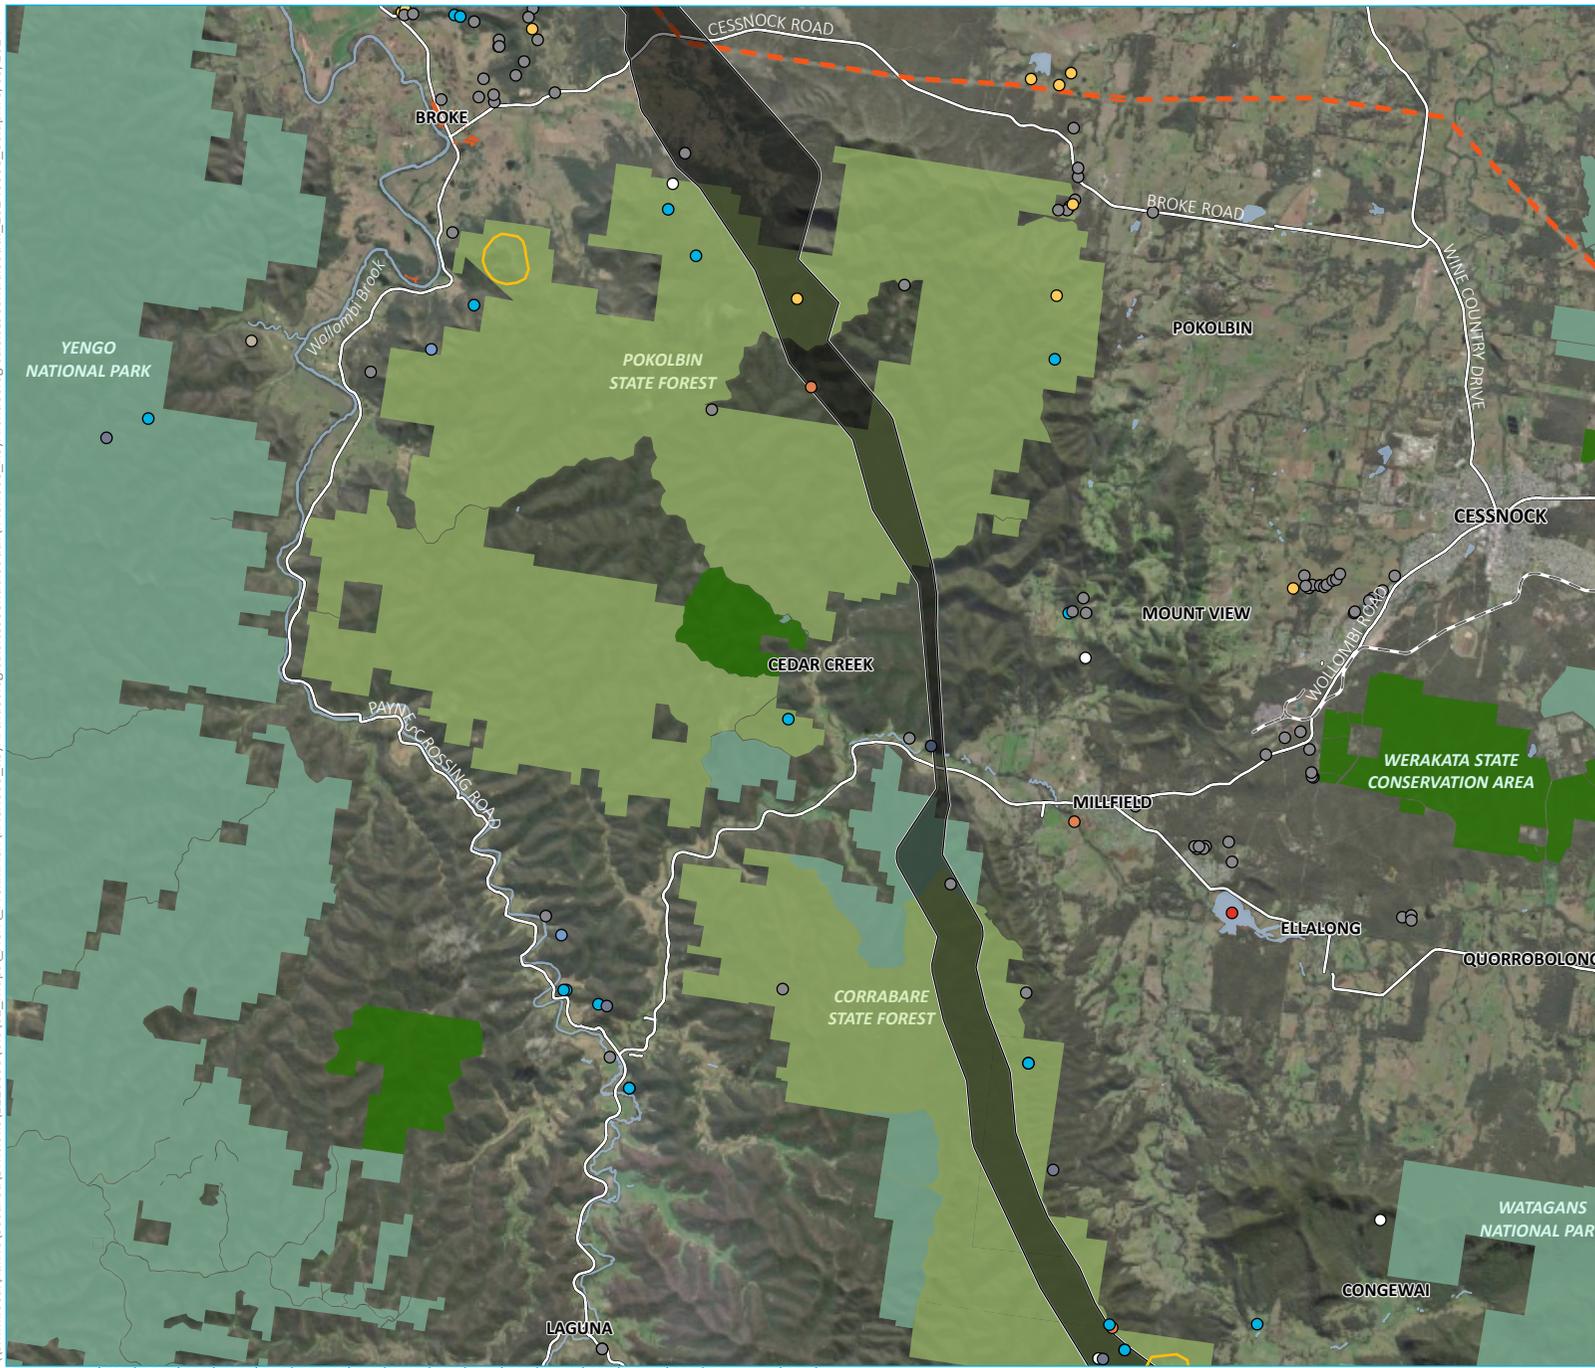
Summary of key archaeological and cultural sites and places within the proposed HTP corridor
 HTP Central
 Hunter Transmission Project
 Preliminary Aboriginal Cultural Assessment
 Figure 2.6

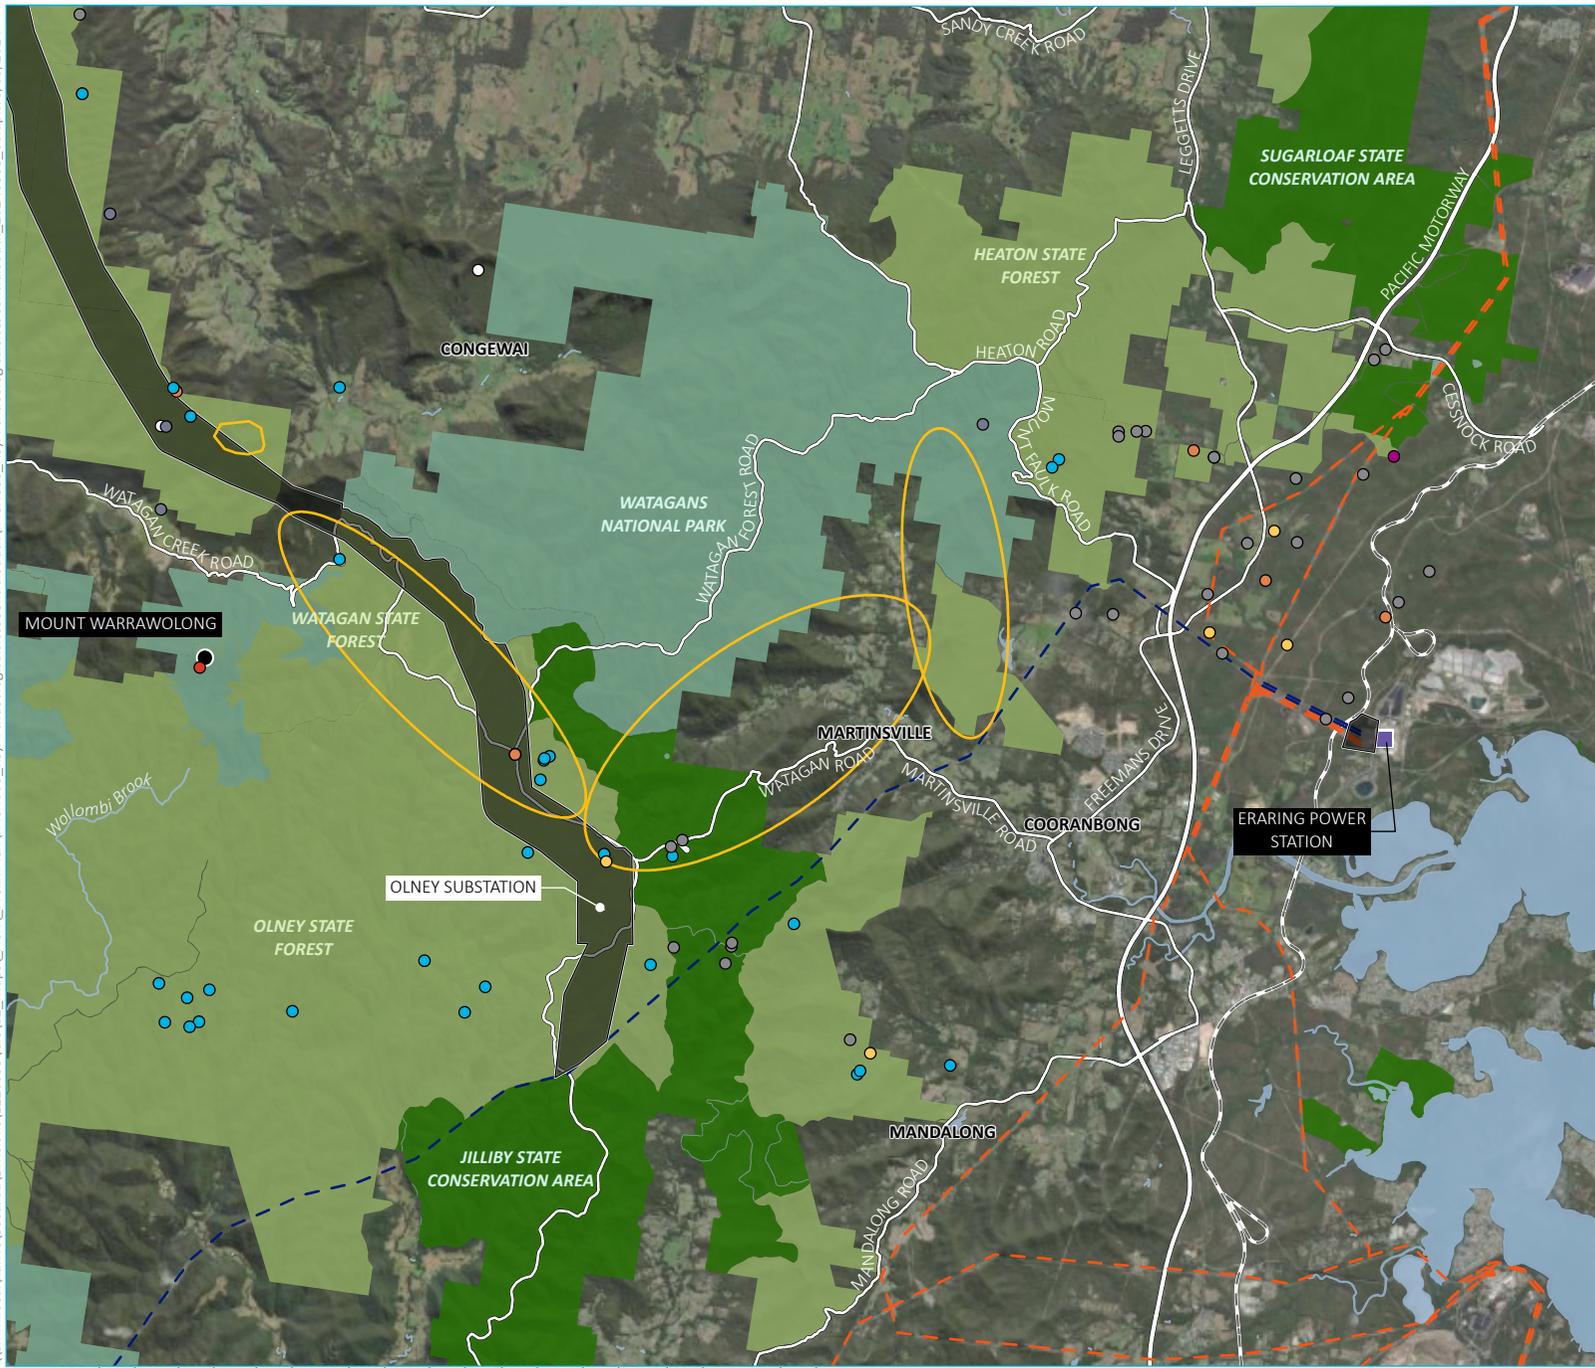
Summary of key archaeological and cultural sites and places within the proposed HTP corridor
 HTP South
 Hunter Transmission Project
 Preliminary Aboriginal Cultural Assessment
 Figure 2.7
