## Geotechnical Assessment

# Proposed Retention System

# 286-310 Gregory Street, South West Rocks

Report Ref: G0730-GI-001-Rev1

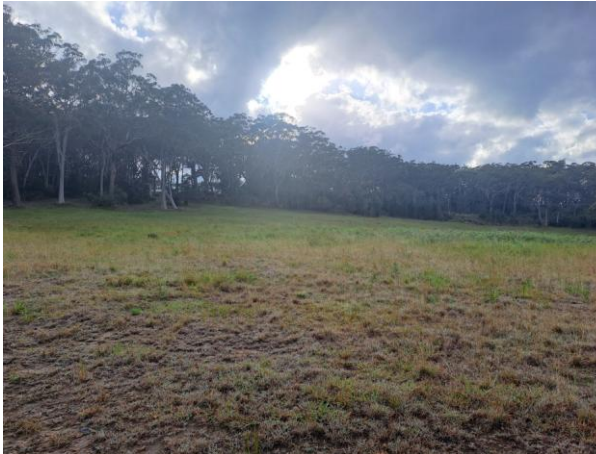
**Figure 2:** Looking west across the site from Gregory Street. Proposed excavations in areas of rounded upper slopes that coincide with boulder floaters that increase in incidence as the slope trends south

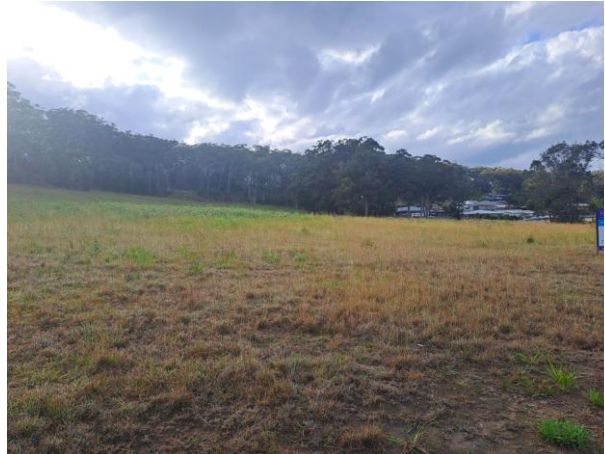
**Figure 3:** Looking southeast across the gently undulating lower slopes comprising residual clays and sandy saprolite

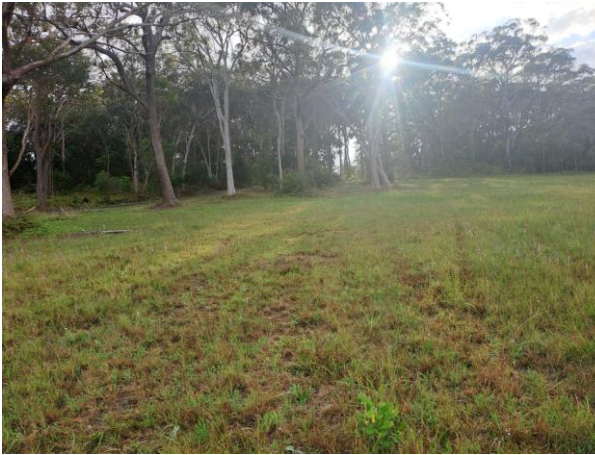
**Figure 4:** Looking east from the northeast boundary of the site. Excavation extents are populated with mature native trees.

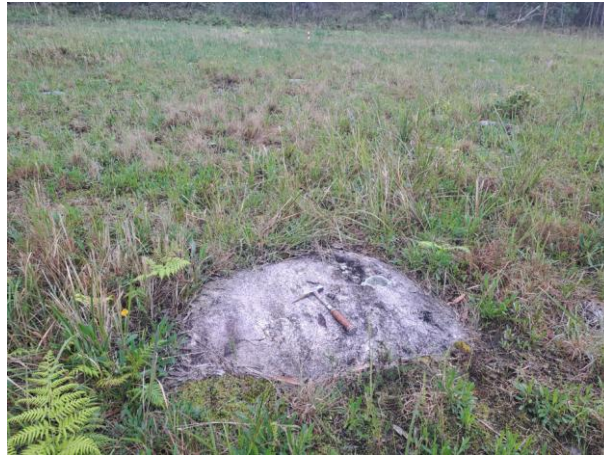
**Figure 5:** High strength granite boulders increasing in frequency in a southeast direction

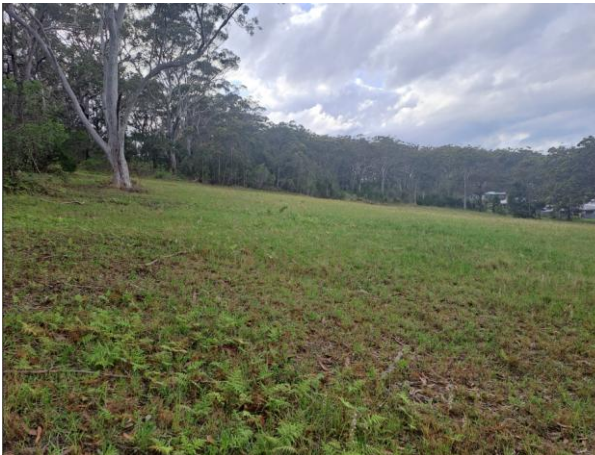
**Figure 6:** Looking south across the site, showing an increase in slope to 6° to colluvial hills

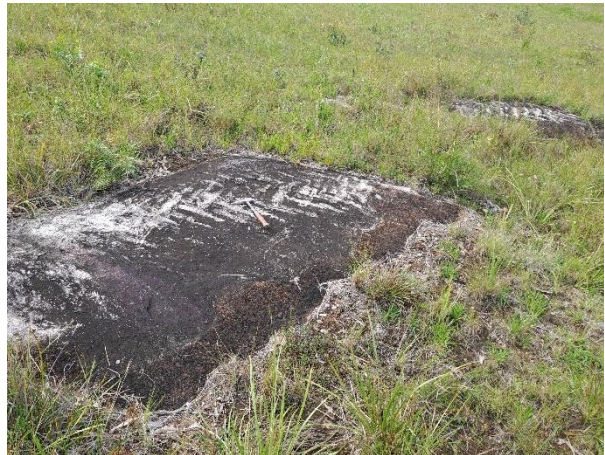
**Figure 7:** Showing Adamellite (granitic) boulders outcropping at the surface near TP4

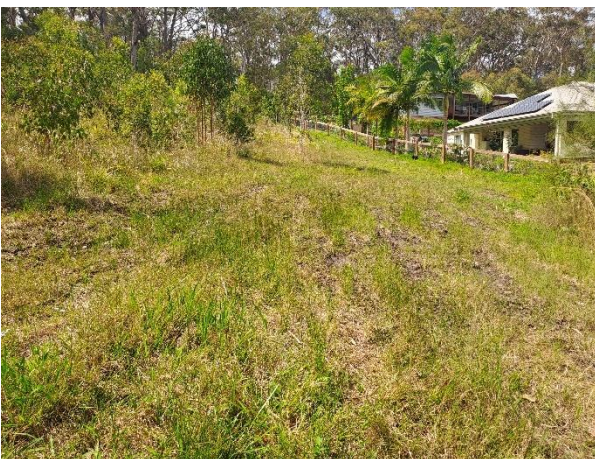
**Figure 8:** looking east across the site at the southern boundary, showing seepage from spring activity with moisture favouring grasses and poor ground conditions located at TP6

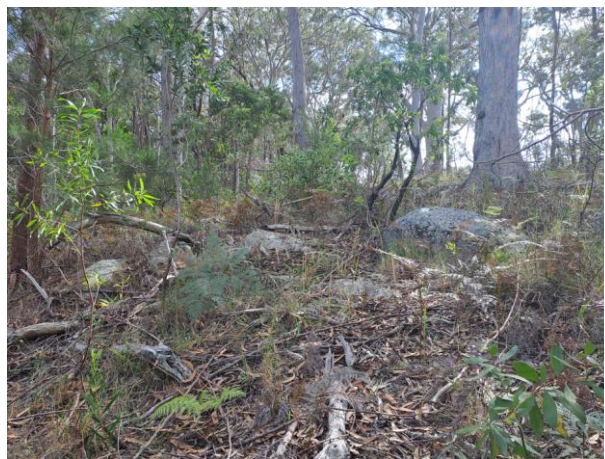
**Figure 9:** Boulders frequent in bushland upslope, it is likely that the paddock has been cleared of surface boulders during previous land uses.

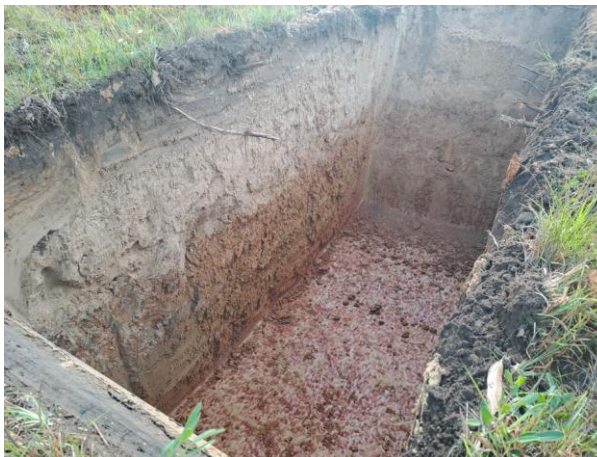
**Figure 12:** TP1 comprising colluvial deposits overlying pale orange residual clays, grading to extremely weathered granite as mottled clay

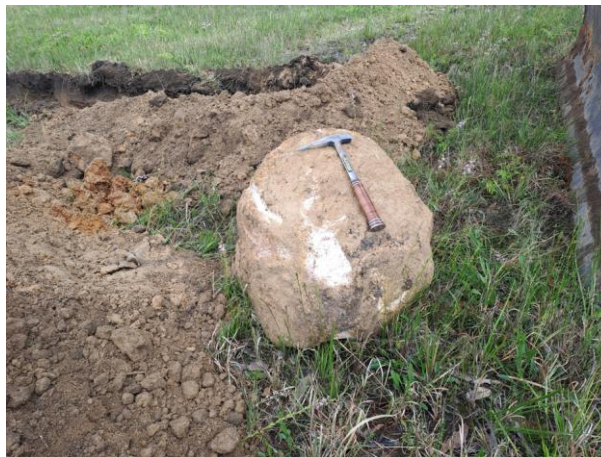
**Figure 13:** Boulders excavated from TP2, approximately 600mm diameter.

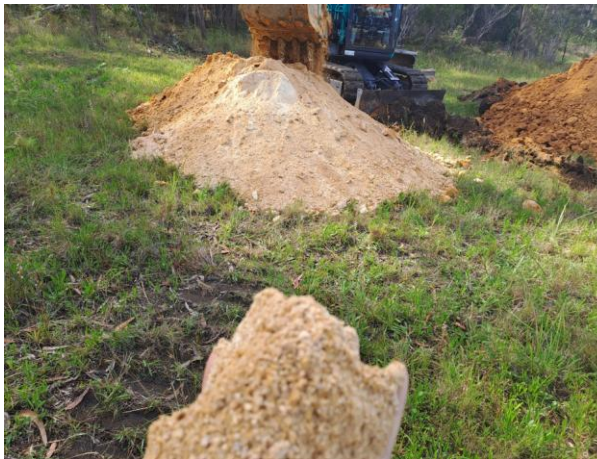
**Figure 14:** HW Granite excavated as gravelly sand from TP3. Excavator refusal was not encountered within limits of reach

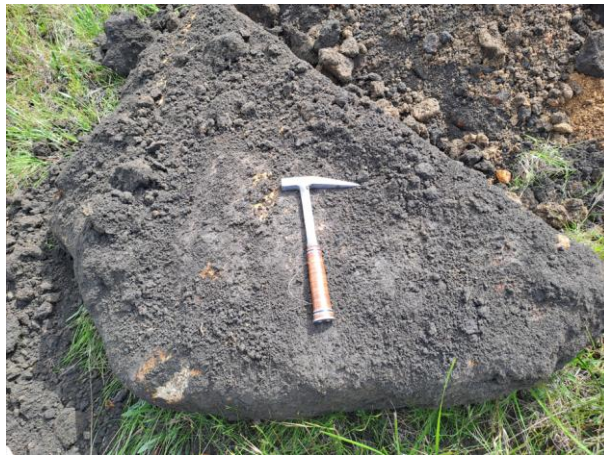
**Figure 15:** 1000mm colluvial boulder recovered from TP4

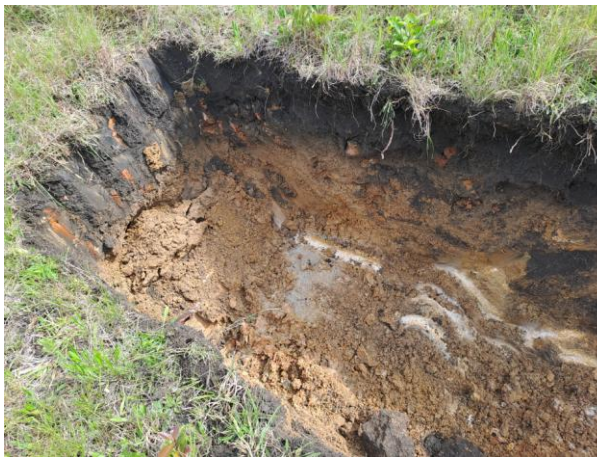
**Figure 16:** TP4 resulting to bucket and ripper tyne refusal on large colluvial boulders

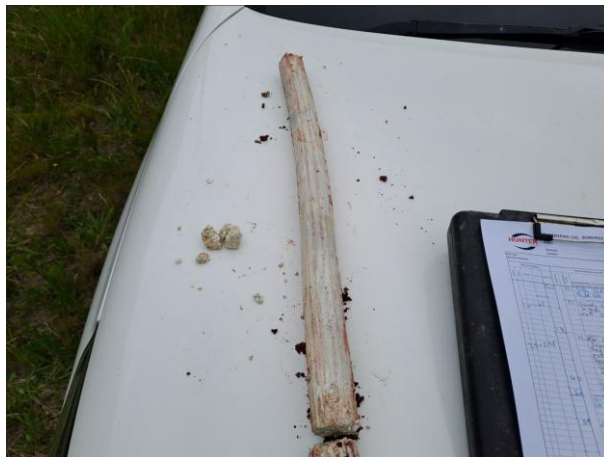
**Figure 17:** High plasticity, firm kaolinite clay from 7.5m below ground level in BH5

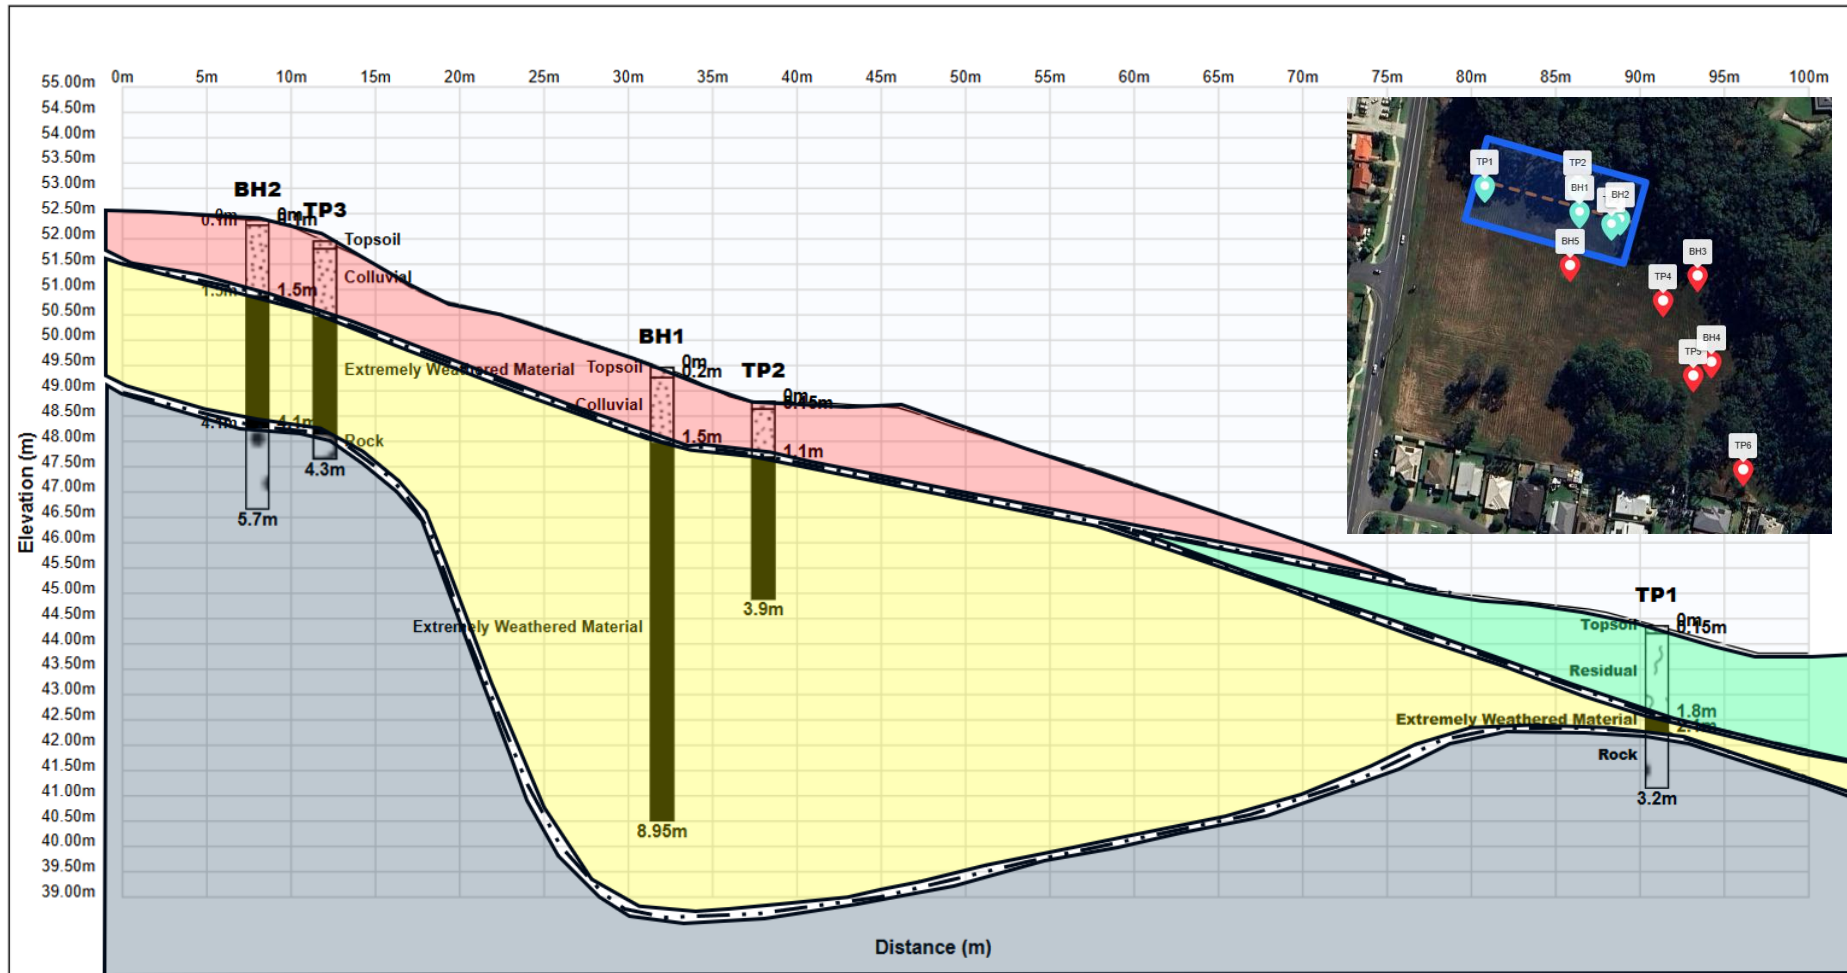
Figure 18: Geotechnical Long Section Ground Model Interpretation
