12-16 Florence St, Tweed Heads

## Construction Environmental Management Plan

| Project # | : 242060_1 |
| Date | : February 2026 |

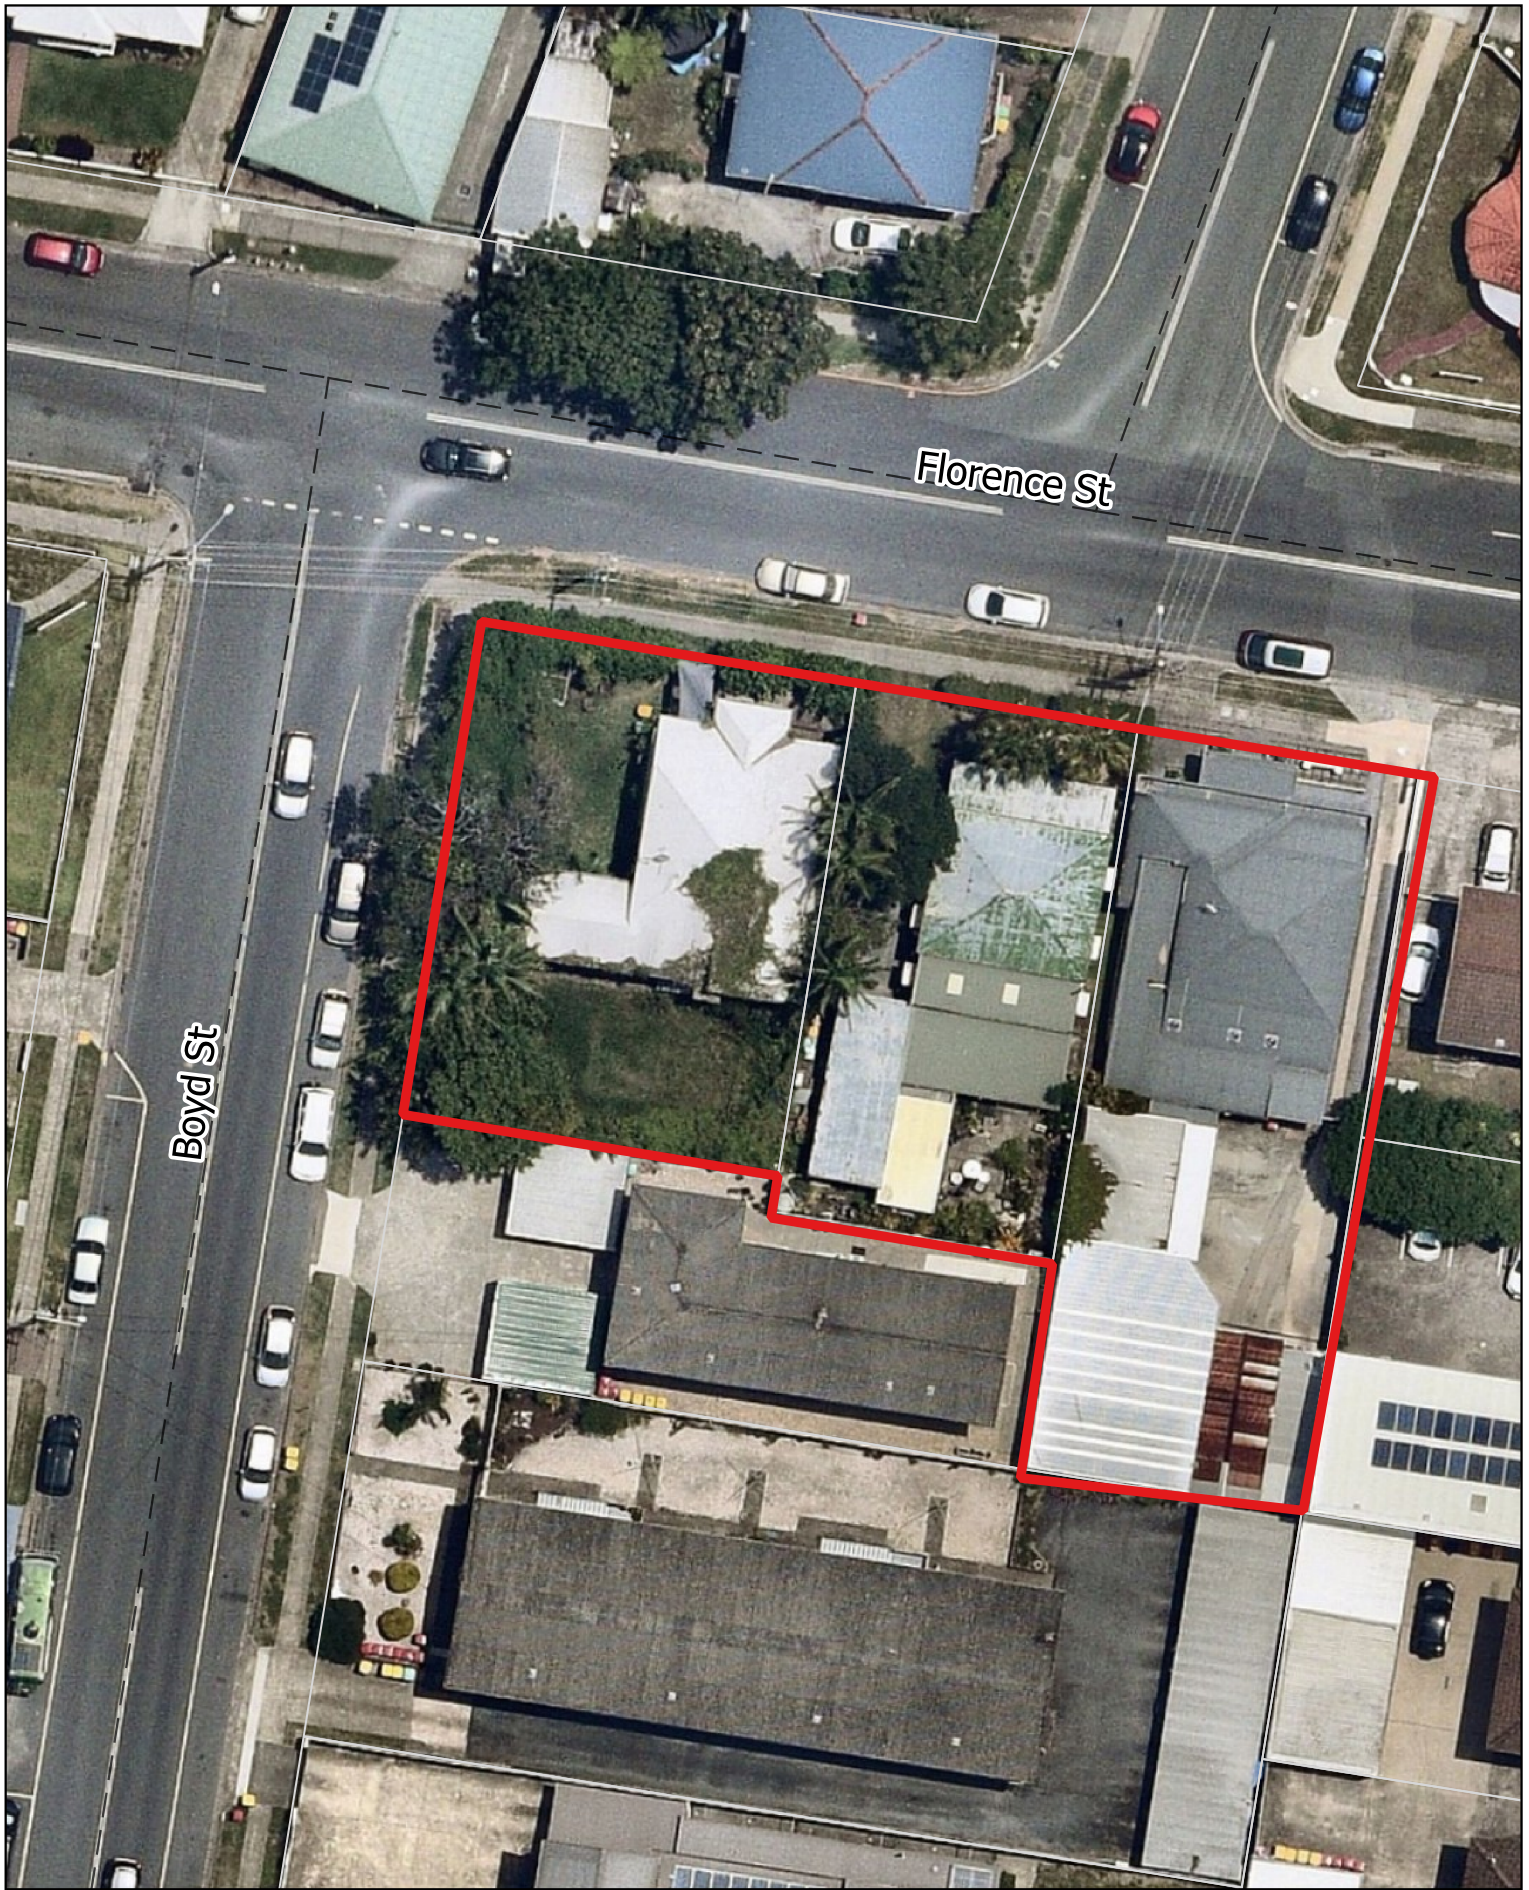
**Figure:**  
 1.1 Subject Site

The subject site is 12-16 Florence St, Tweed Heads (hereafter referred to as the 'site'). The site currently has three residential buildings, with associated out-buildings, hardstand, gardens and landscaping. Vegetation on the site includes 32 trees and is typical of urban garden landscaping and does not conform to any Plant Community Type (PCT). The site is presented in terms of its general area in Figure 1.1. Planning details for the site as determined by NSW Planning Portal Spatial Viewer (DCS 2020) are detailed in Table 1.1.

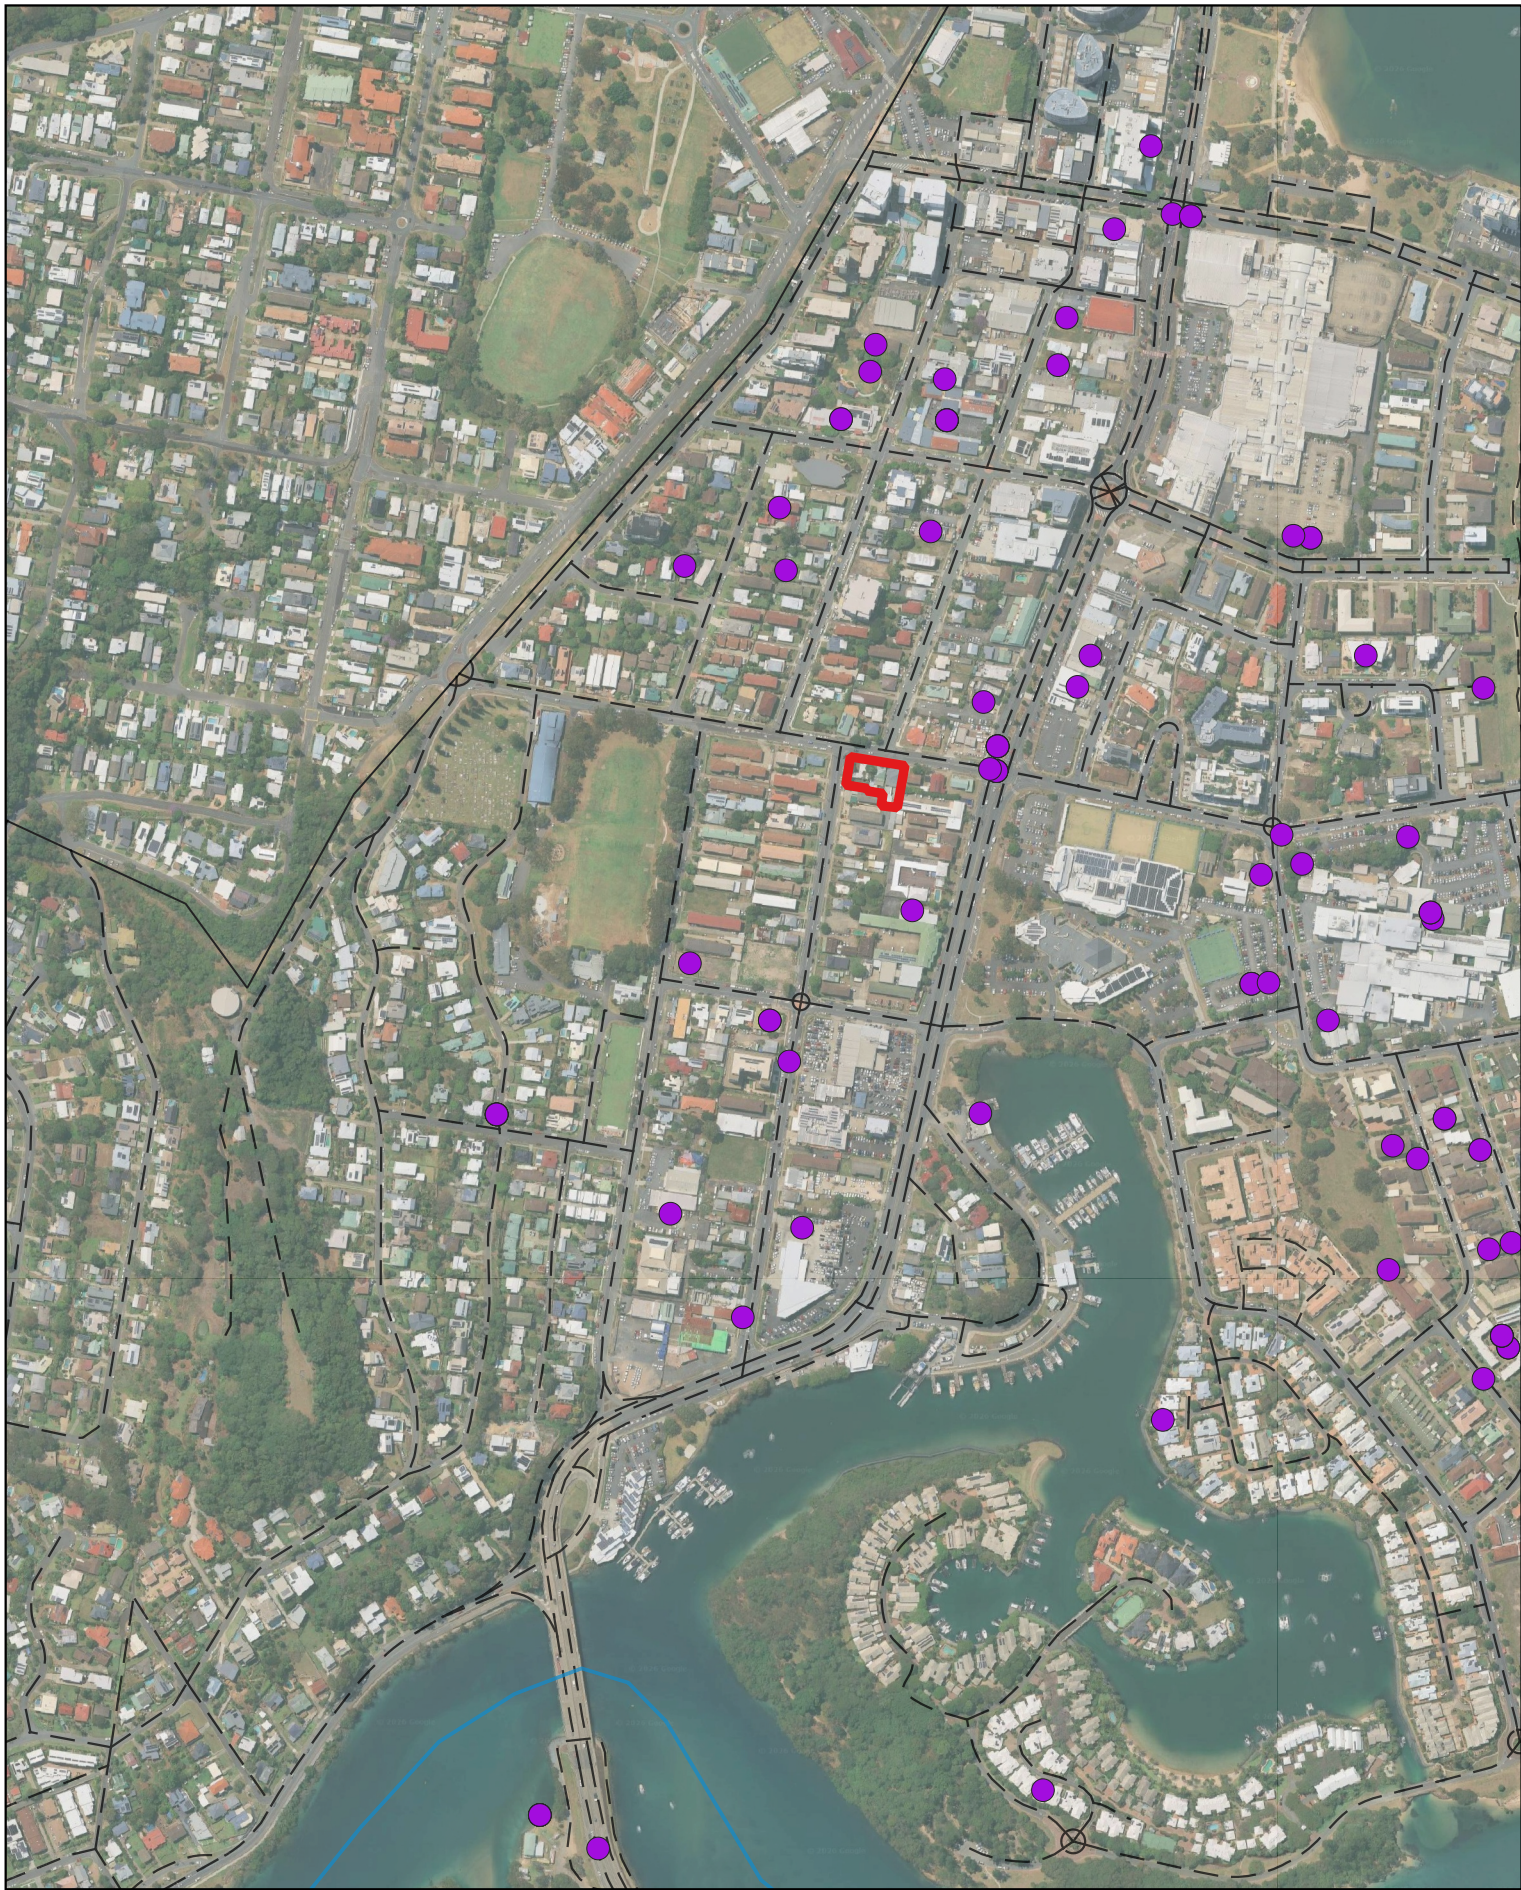
1.3 Bush Stone-curlew  
Distribution - Tweed Shire

Once common, this species has experienced a significant decline, to where they are now endangered in NSW. Tweed’s Bush Stone-curlews are the only population in NSW to record an increase in numbers since conservation efforts commenced in 2010 (TSC 2026). The Tweed Shire now supports over 40 pairs of breeding birds (TSC 2026), and there is over 800 records of Bush Stone-curlews’ in the LGA since 2010 (BioNet 2026) (Figure 1.3)

The site does not have, and the proposal does not require the removal of, any significant native vegetation, or other vegetation or habitat that would support the Bush Stone-curlew. Distribution of Bush Stone-curlew in the locality indicates that they have been observed in locations that do not have suitable native vegetation or habitat. As such, there is a risk that Bush Stone-curlew will be present, despite the lack of native vegetation and poor-quality habitat available on the site.
