# **Port Botany Quayline Equalisation Project: Maritime Archaeological Assessment**

Report prepared for Port Botany Operations Pty Ltd as Trustee for  
Port Botany Unit Trust (NSW Ports)  
March 2026

**Project Name:** Port Botany Quayline Equalisation Project  
**Document Title:** Port Botany Quayline Equalisation Project – Desktop Maritime Archaeological Assessment  
**Revision:** 2 – Final  
**Date:** 24 March 2026  
**Client Name:** Port Botany Operations Pty Ltd as Trustee for Port Botany Unit Trust (NSW Ports)  
**Authors:** Chris Lewczak

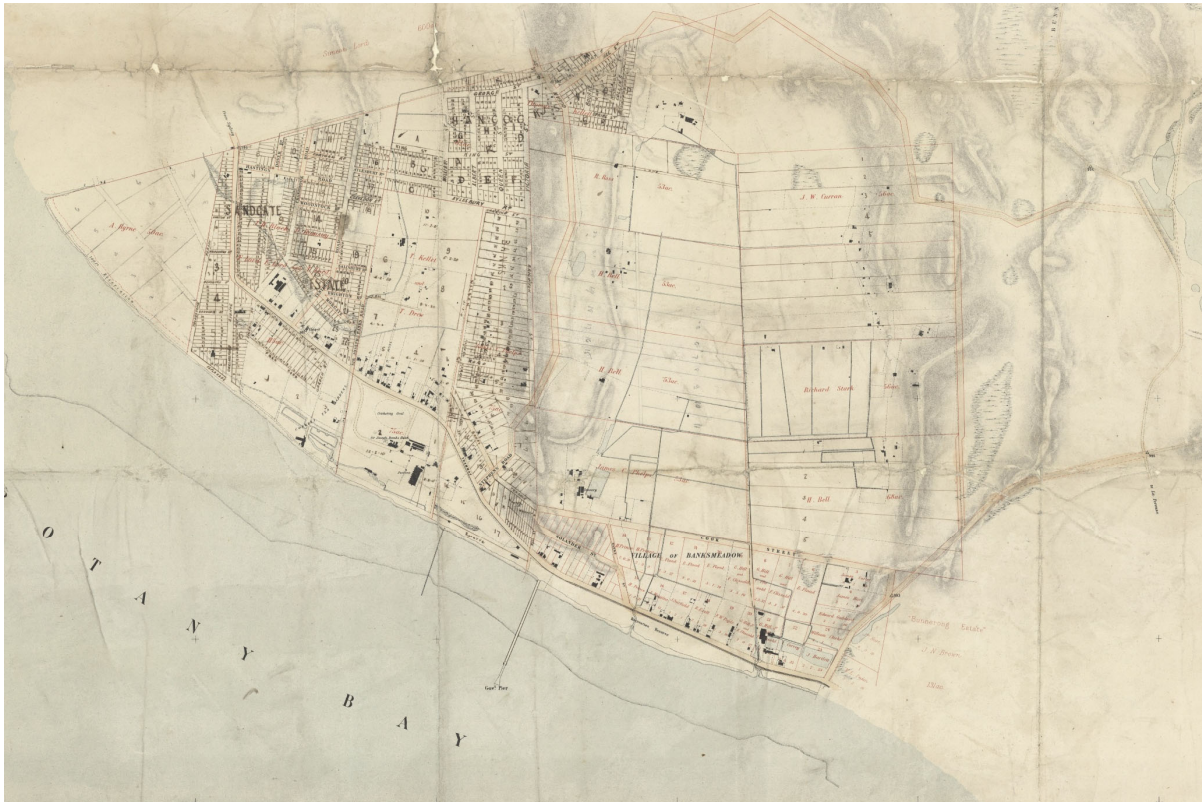
**Figure 3.4: 1885 survey of Botany parish showing slow development of Banksmeadow. The subject site is located overwater south of ‘Bunnerong Estate’ in the lower right corner. Note reserve east of Govt. Pier (Source: SLNSW, Z/M4 811.186/1885/1).**

As the local population of mostly market gardeners and noxious industry workers in Botany rose, so did the demand for local government services. The three Botany municipalities of Botany, North Botany and West Botany came into existence after the *Municipalities Act* of 1867 (Butler, 2011). The opening of Sydney's first tramline connecting Botany to the CBD at 54 minutes travel time encouraged residential development. In 1888, the municipalities of Botany and North Botany were incorporated (Butler, 2011). Botany Council placed considerable priority on residential development and beautification of the local area, and undertook many public amenity construction schemes. One such scheme was the reclamation of the foreshore for the reserve. Between 1869 and 1905 the government dedicated 24 acres of foreshore in Banksmeadow as a public reserve (Jervis, 1938: 220). This reserve can be seen in Figure 3.4.

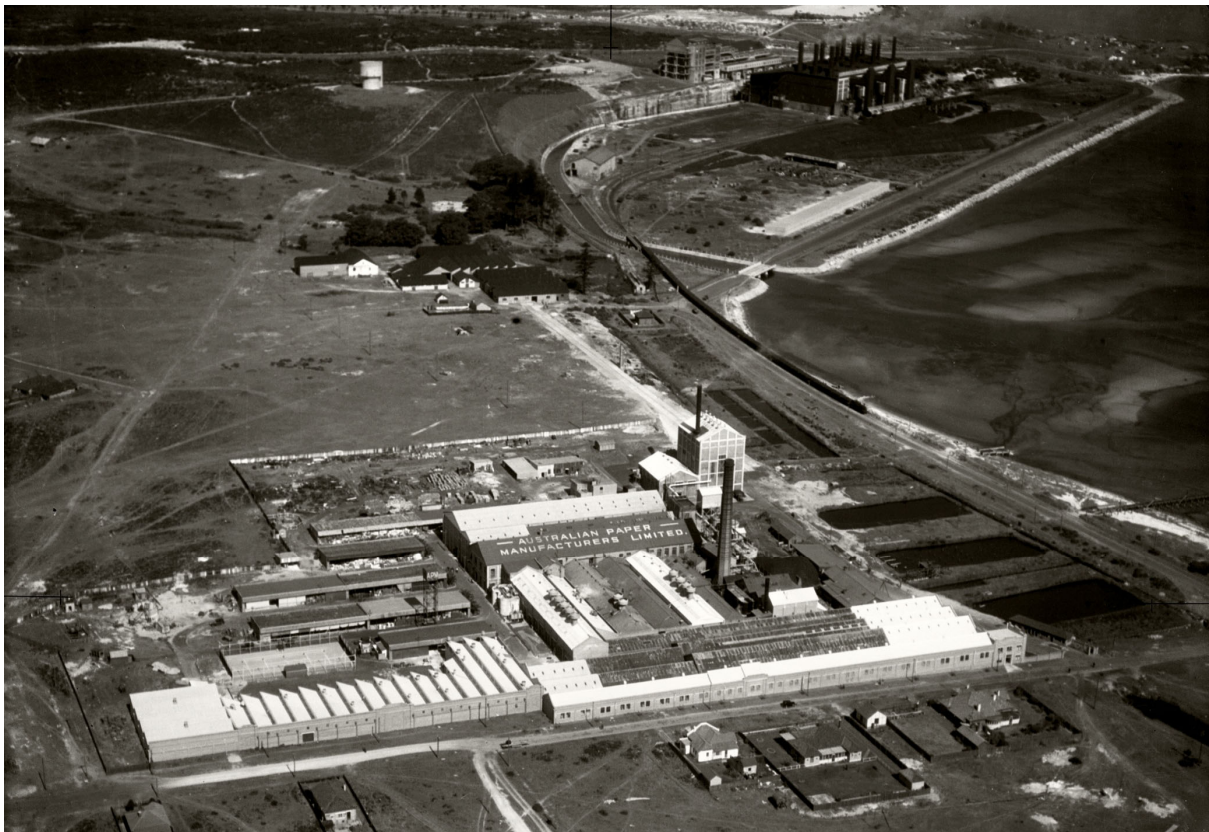
*Plate 3.2: 1935 aerial photo of Australian Paper Manufacturers Ltd, pier visible at far right, with Bunnerong Power Station in the distance. (Source: RAHS, 2014).*

The Australian Paper Manufacturer's Plant included a long pier measuring approximately 460 metres long which reached south over the shallow mudflats at the Botany Bay shoreline out into deep water. This enabled cargo ships carrying softwood pulp from the northern hemisphere to land and disembark cargo. The pier was likely constructed at the same time as the mill in 1901, and certainly present by 1935 (see Plate 3.2).

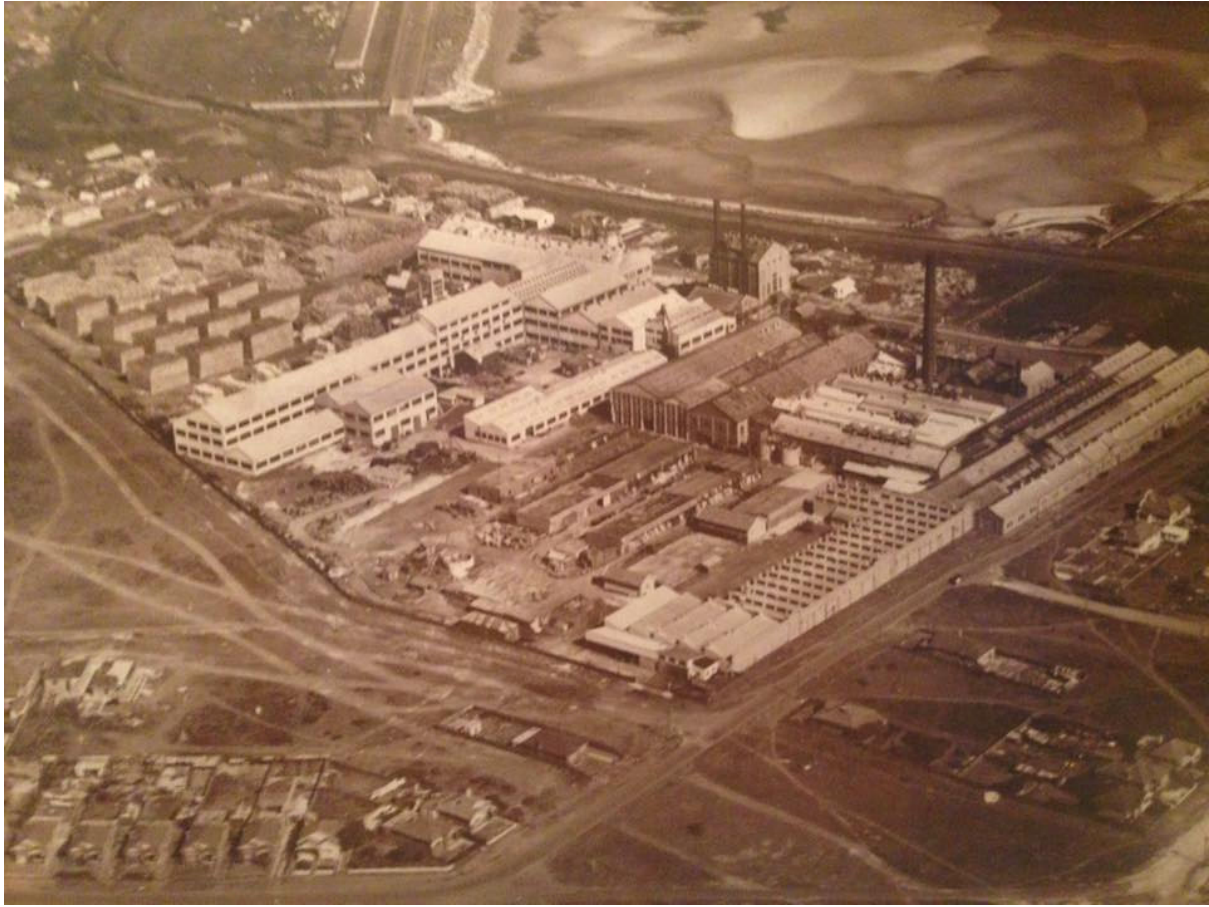
*Plate 3.3: 1940 aerial of Australian Paper Manufacturers, pier visible at far right. (Source: Nerida Walters-Welch Family Album, 2016).*

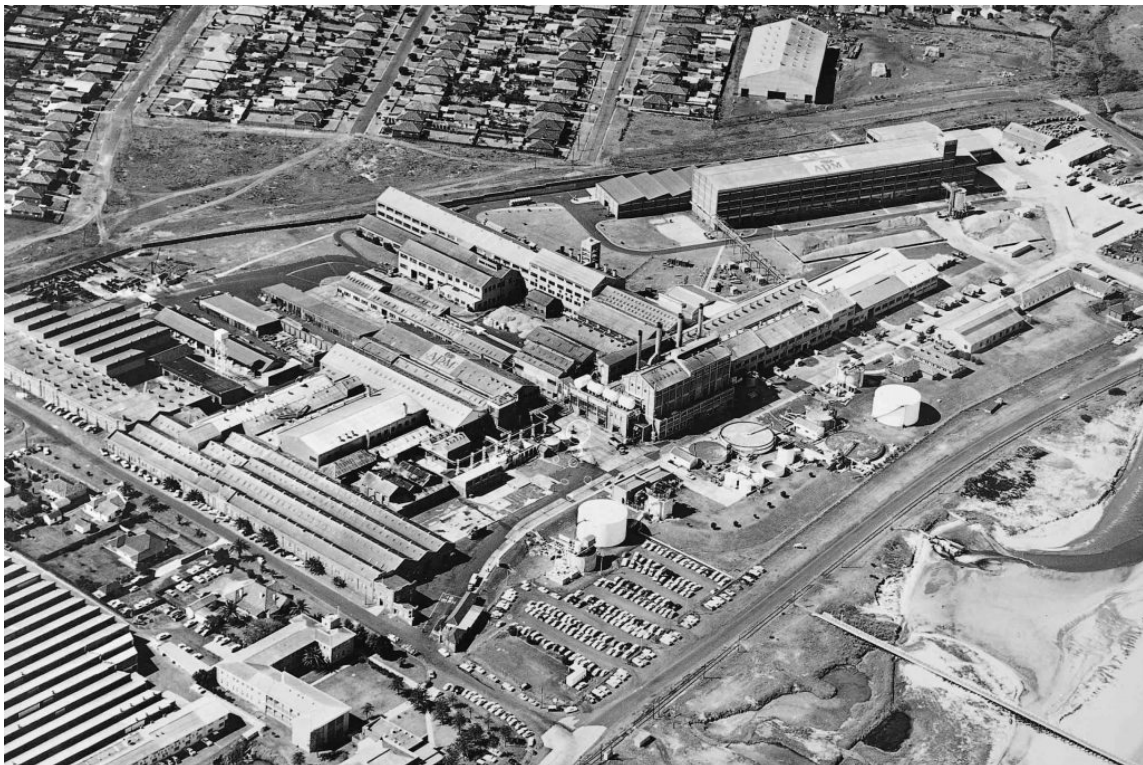
*Plate 3.4: c.1970 aerial of Australian Paper Manufacturers, pier visible at far right. (Source: OPAL ANZ, 2026).*

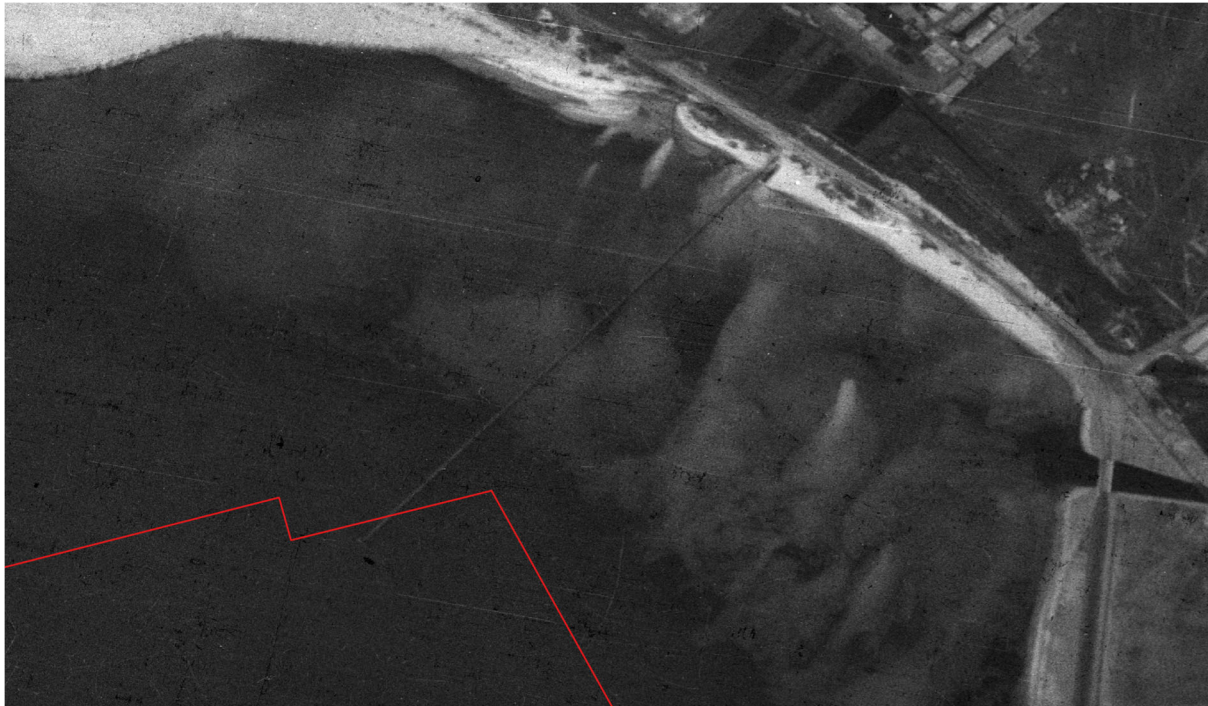
*Plate 3.5: 1930 historic aerial with subject site overlaid in red. The end of the APM pier is contained within the subject site (Source: Geoscience Australia).*

Note that due to the overwater nature of the subject site, historical aerial coverage is patchy. Historical aerial photography shows the approximately 460 metres long APM pier present in 1930 up until 1972 (Plate 3.5 to Plate 3.11). The pier contained a small waiting room or storage room on its

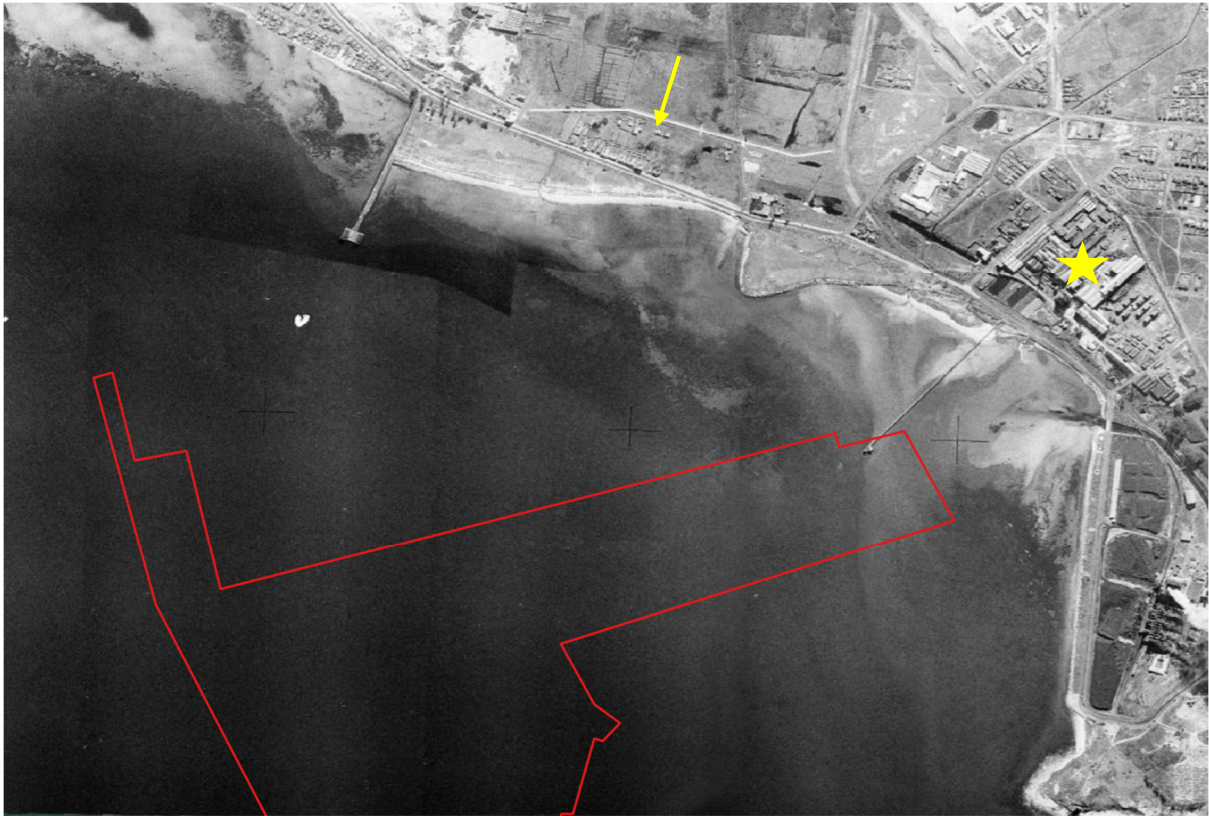
**Plate 3.6: 1943 historic aerial with subject site overlaid in red. Banksmeadow suburb indicated with yellow arrow, APM plant indicated with yellow star (Source: NSW Spatial Services).**

By 1943, only 50 years after its establishment, little evidence of the village of Banksmeadow could be seen (Plate 3.6, Conroy, 2017: 273). The only buildings to have survived were the two hotels, the Botany Bay and the Pier.

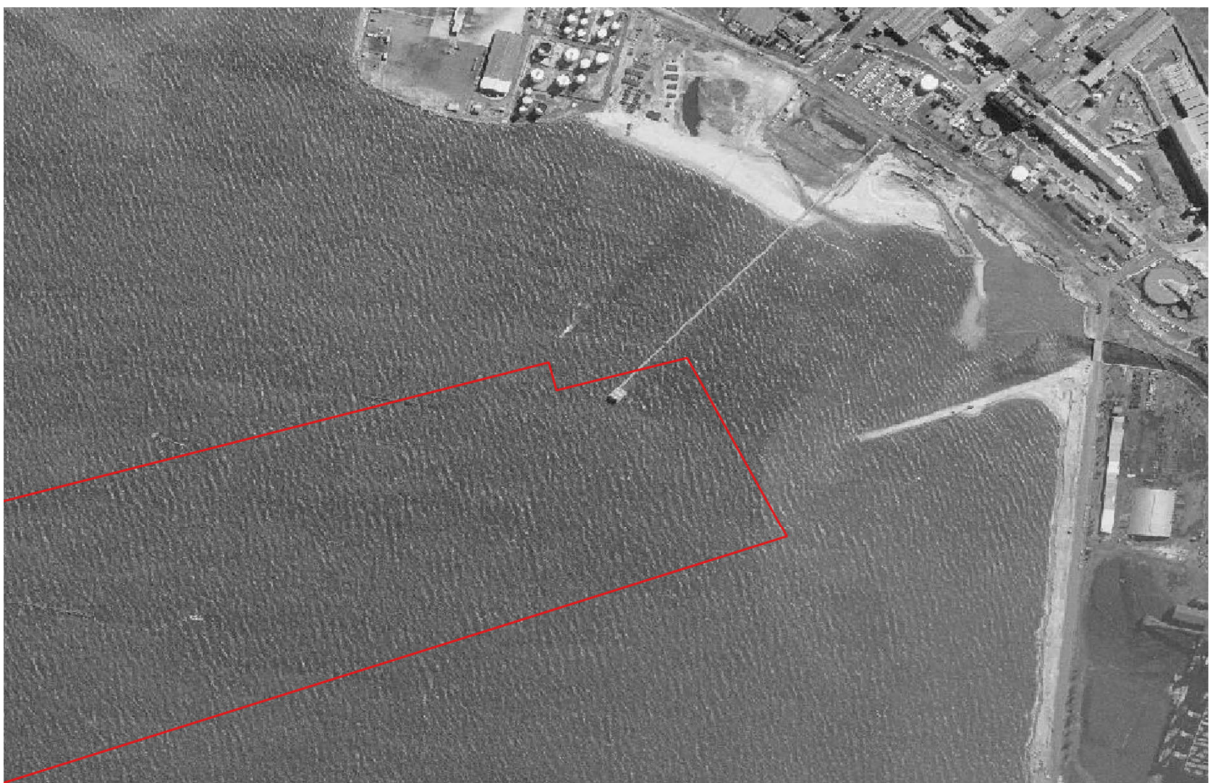
***Plate 3.9: 1971 historic aerial with subject site overlaid in red. Construction of Port Botany beginning (Source: NSW Historic Aerial Photography Viewer).***

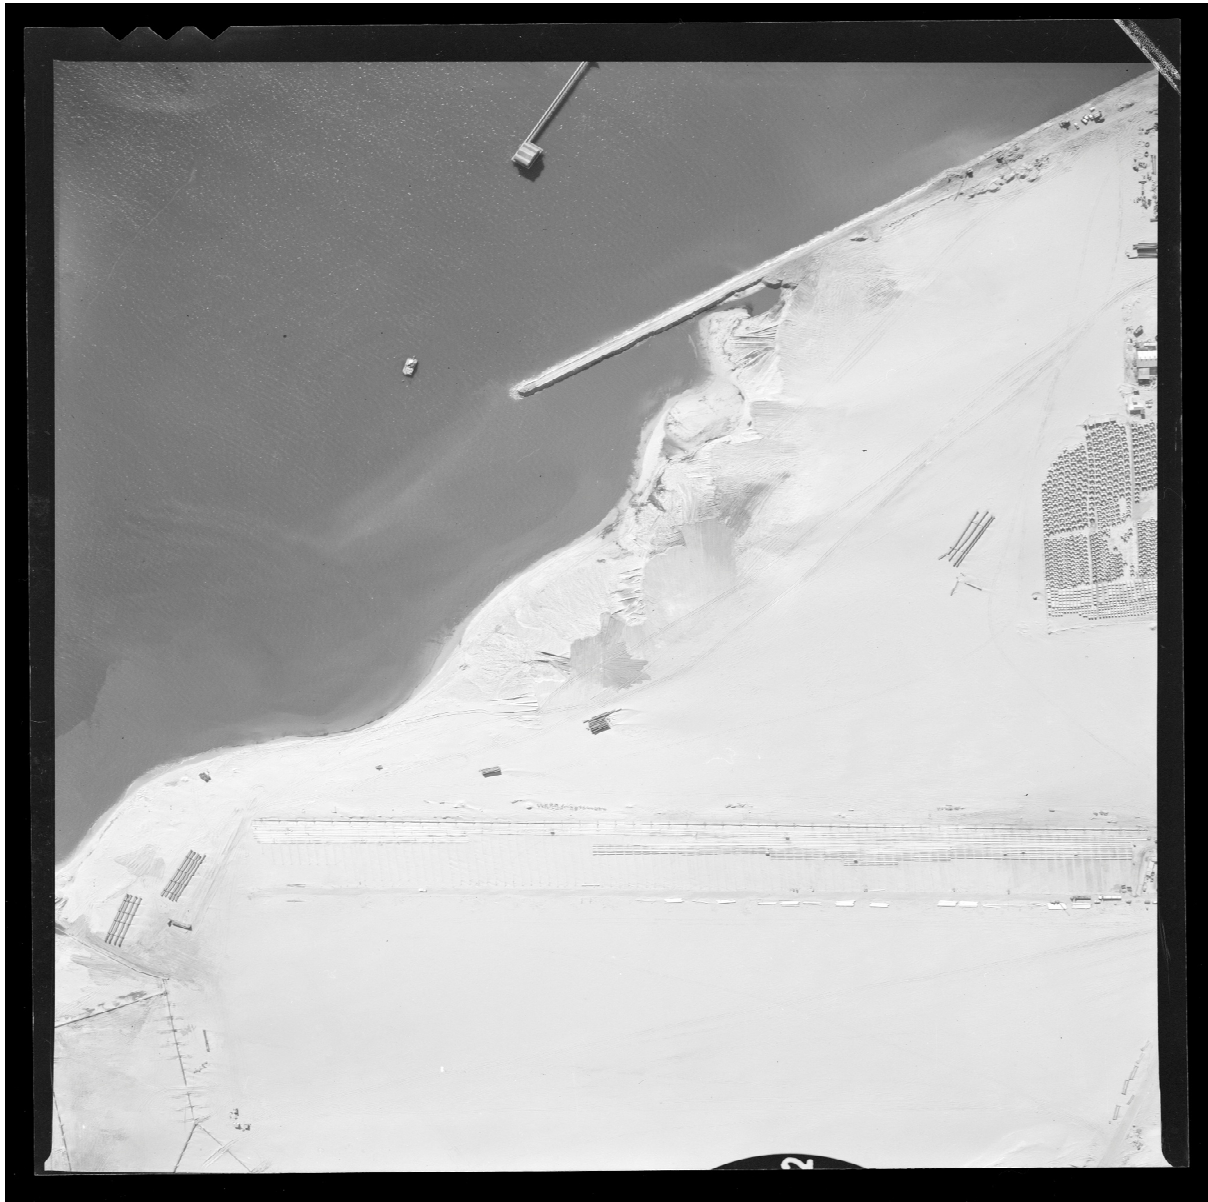
*Plate 3.11: 1972 Milton Kent aerial showing construction of Brotherson Dock Two, north up, with APM pier top middle (Source: SLNSW, ON 447/Box 032).*

seaward end measuring approximately 10 metres wide east – west and 15 metres long north – south. Plate 3.11 could not be overlaid due to a lack of reference points, however, shows that Brotherson Dock Two was constructed while the APM pier was left intact. Plate 3.12, an oblique aerial from 1975, shows that the APM pier had been demolished by this date. The 1978 aerial (Plate 3.13 and Plate 3.14) shows the middle of the Port Botany construction, with no pier present. The 1988 aerial (Plate 3.16) shows the completed port, prior to the 2002 expansion.

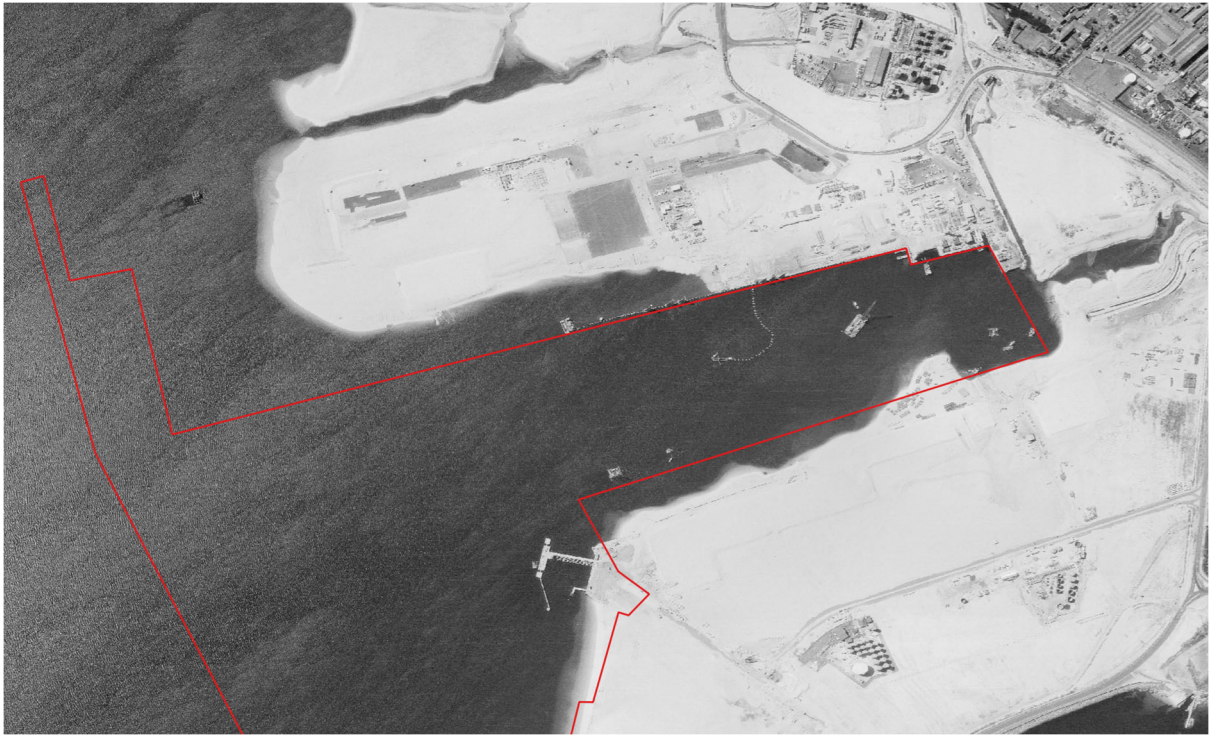
***Plate 3.13: 1978 historic aerial photograph with subject site overlaid, during construction of Port Botany (Source: NSW Historic Aerial Photography Viewer).***

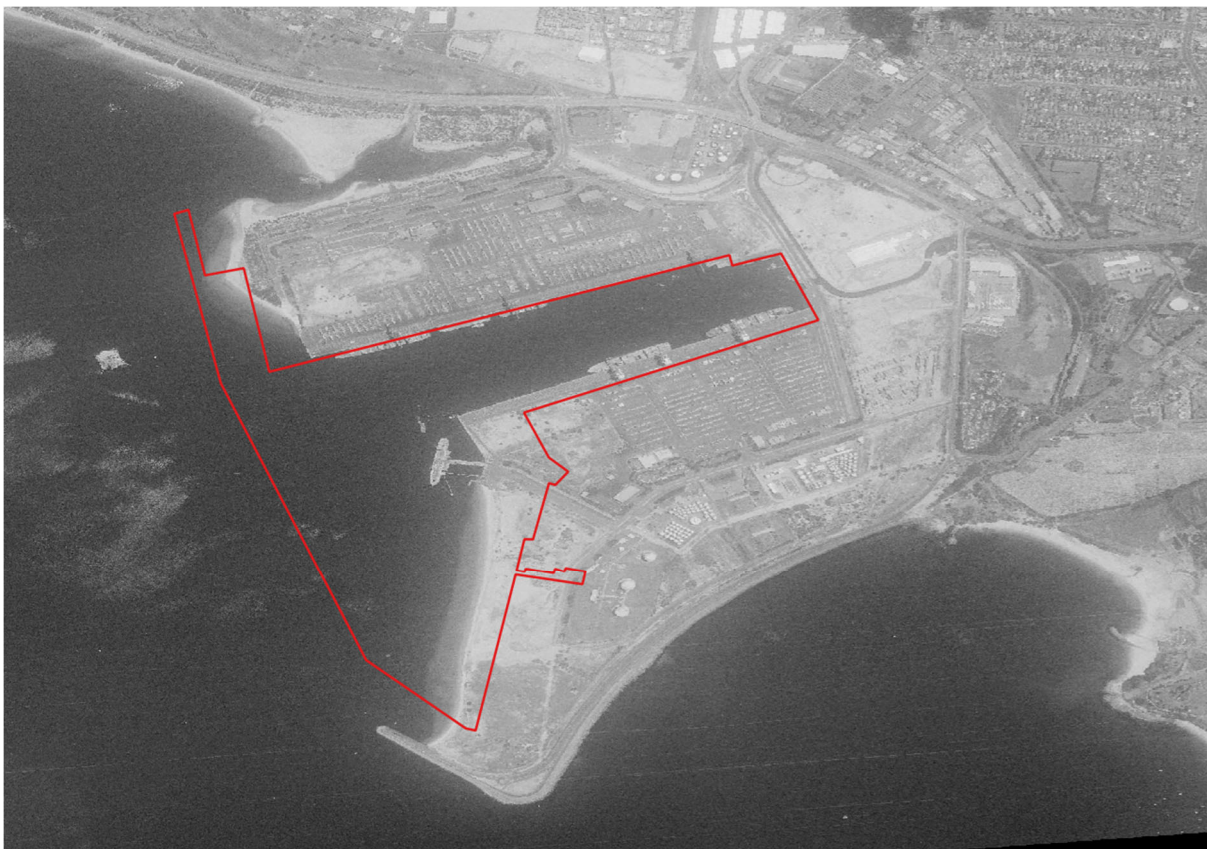
**Plate 3.16: 1988 aerial after completion of Port Botany (Source: NSW Historic Aerial Photography Viewer).**

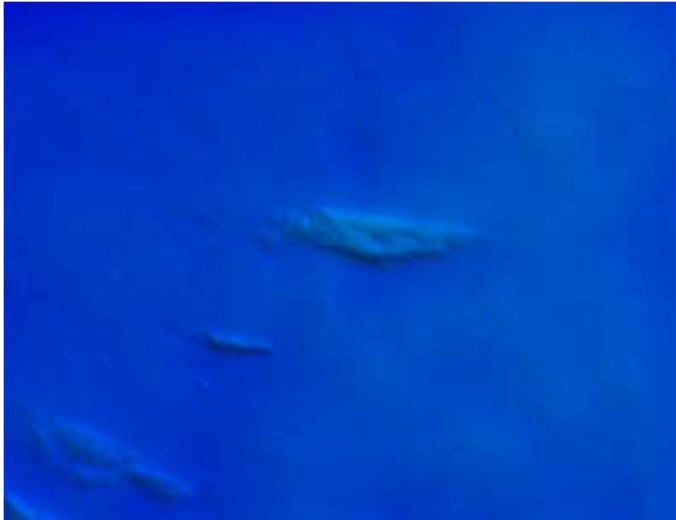
**Figure 4.12:** Contact 0001 as seen in the MBES survey data collected by Port Authority of NSW (Source: Port Authority of NSW).

The anomaly identified in the WSP survey data, Contact 0001, is also clearly visible (Figure 4.12). In the Port Authority survey the anomaly appears to be part of a much larger formation on the seabed within the turning basin in front of Brotherson Dock. The other formations consist of both longer and wider features, all with irregular shapes. Also of note, are the shadows that are cast from these other features, predominately on the southern and southwestern sides of these features. The shadow can denote the height of an item above the seabed. As seen with Contact 0001 in the WSP survey data, the shadow on the southern side of the anomaly is also present on other features present further out from the dock entrance (Figure 4.13).

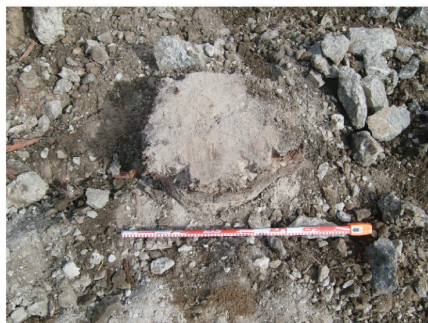
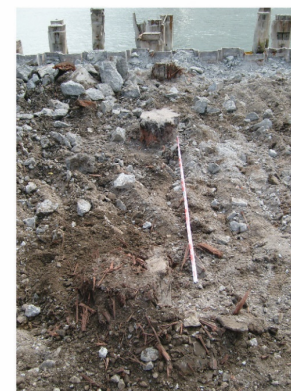
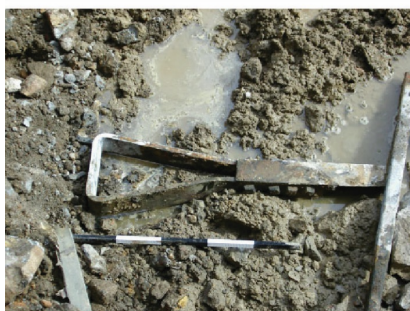
How to photograph piles.

Scale should be placed horizontal to one side.

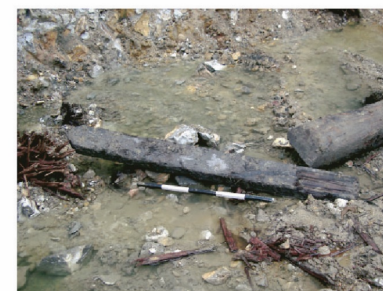
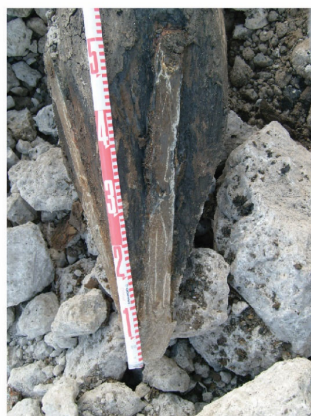
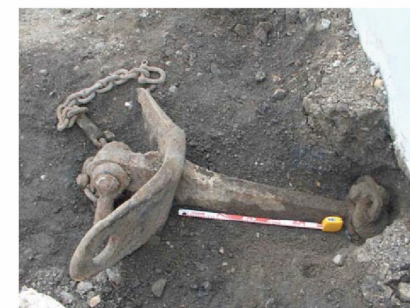
How to photograph misc maritime items within a trench.

If the trench is shallow - scale can be placed outside the trench.

If the trench is deep, the scale should be placed within the trench.
