# SECOND AMENDED SSDA ARBORICULTURAL IMPACT ASSESSMENT

24,26 & 28 MIDDLE HARBOUR ROAD, LINDFIELD

PREPARED BY LEE HANCOCK CONSULTING ARBORIST AQF LEVEL 5

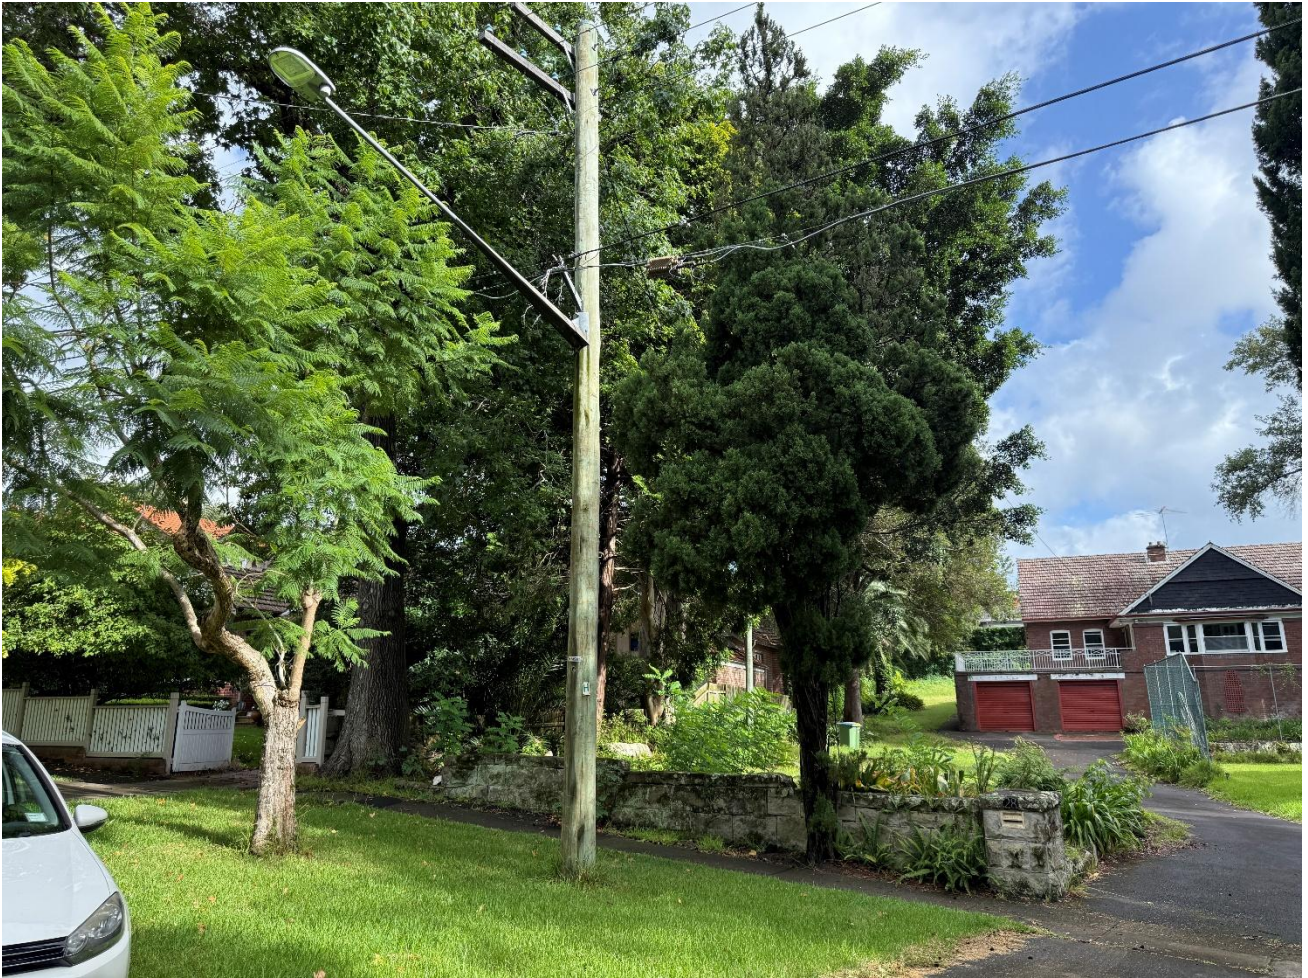
Plate 1. Tree 1. *Liquidambar styraciflua* (Liquidamber) Trees 2. *Cupressus sempervirens* 'Stricta' (Italian Cypress)

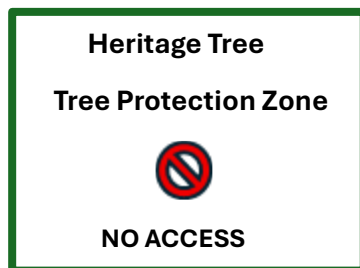
**J ) Tree Protection Signage**

Prior to commencement of any works, tree protection signage is to be attached to the tree protection fencing, displayed in a prominent position. The name and address of Developer and Project Arborist.
