Report on  
Groundwater Investigation and Dewatering  
Management Plan

Proposed Northside Private Hospital  
22 Faunce Street West, West Gosford

Prepared for  
Erilyan Pty Ltd

Project 83574.04  
March 2021

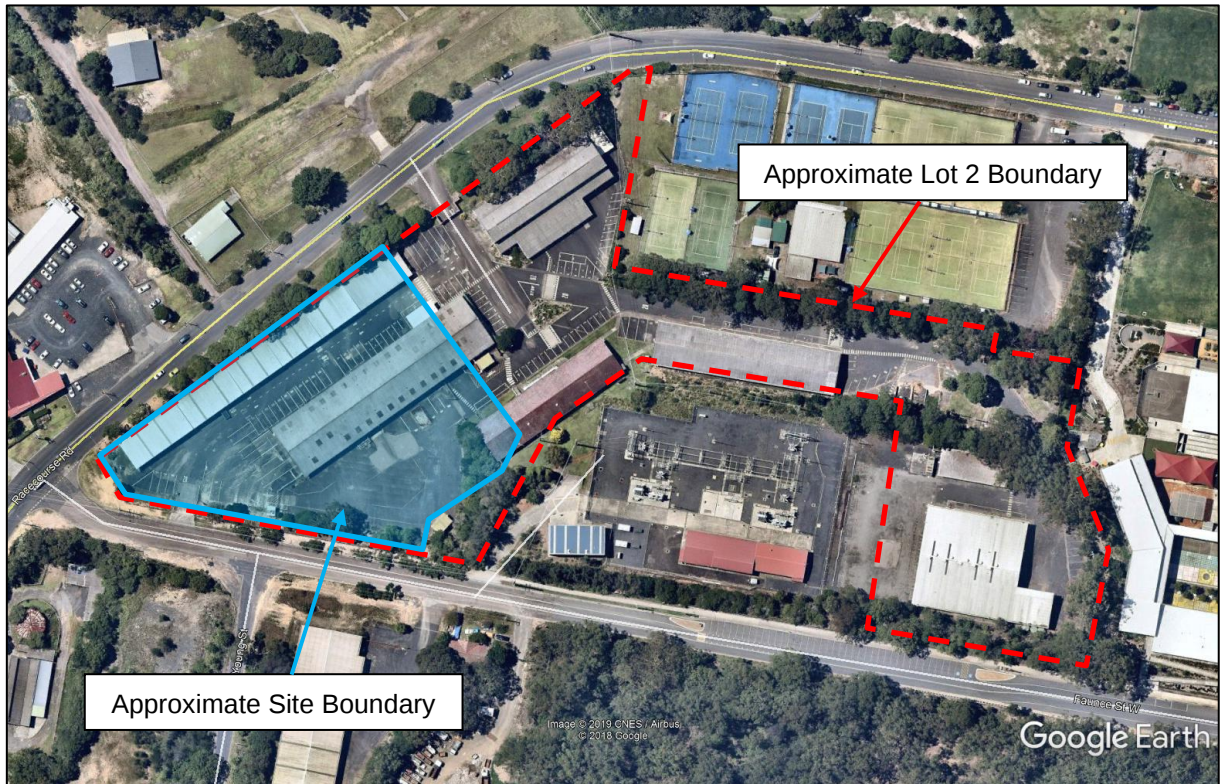
**Figure 1 – Aerial view of site (sourced from Google Earth with Nearmap Overlay dated 27 December 2018)**

Figure 1 below, shows an aerial view of the site.

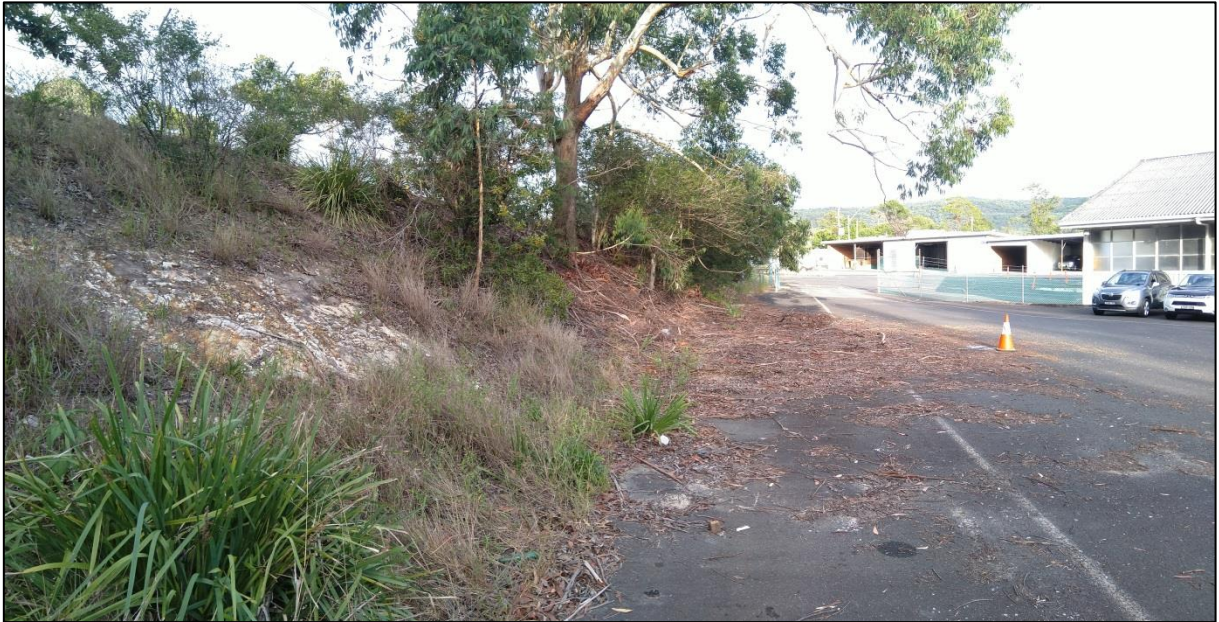
**Figure 5 – View of the cut batter along the southern boundary, looking west**

Along the southern boundary, in the eastern area of the site, a cut batter was also observed, and sandstone bedrock was exposed.
