Southwest Metro Corridor – Construction Heritage Management Plan

SMCSWSSJ-JHL-WEC-EM-PLN-000013

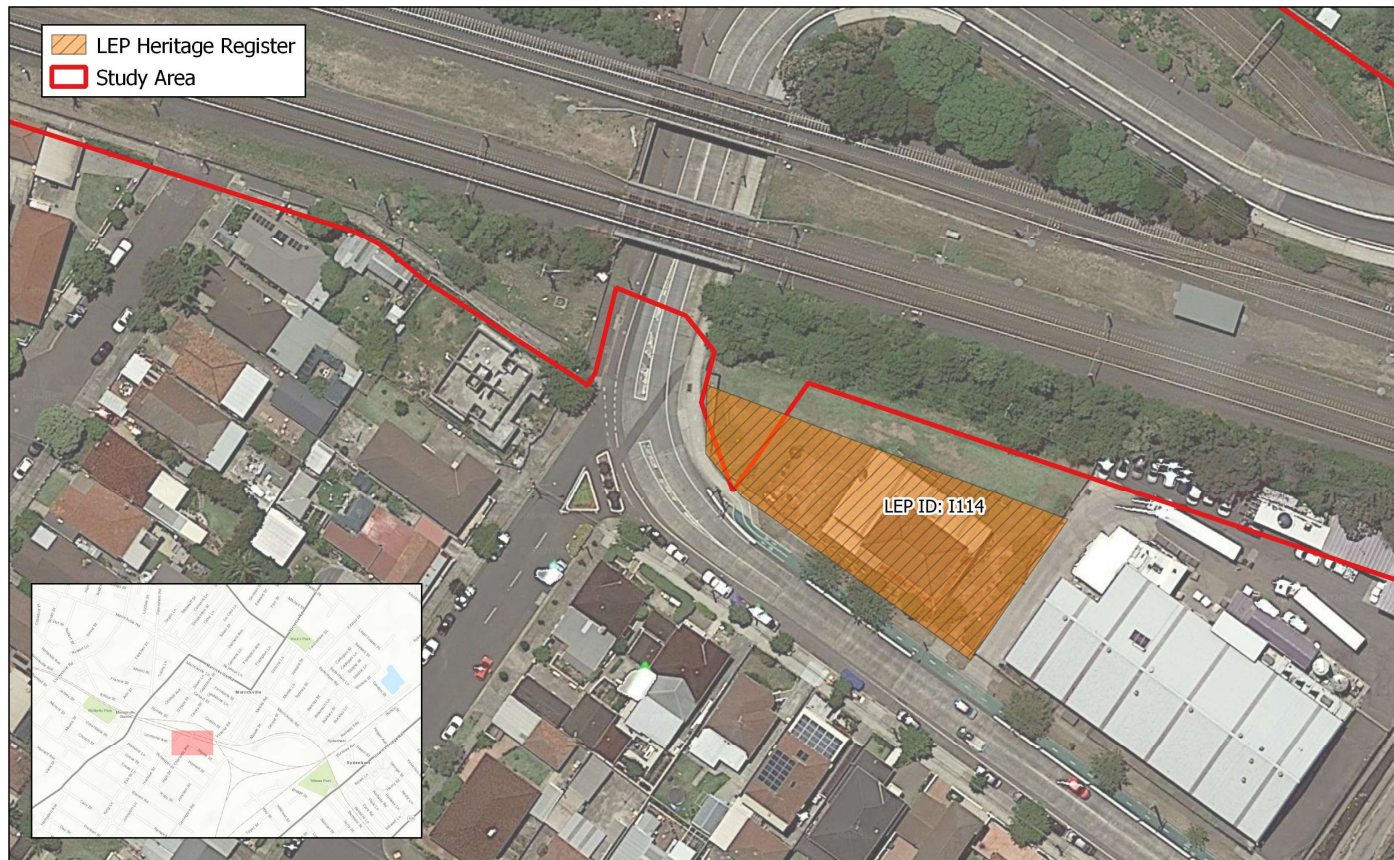
Figure 4-2 Heritage curtilage – stone house including interiors

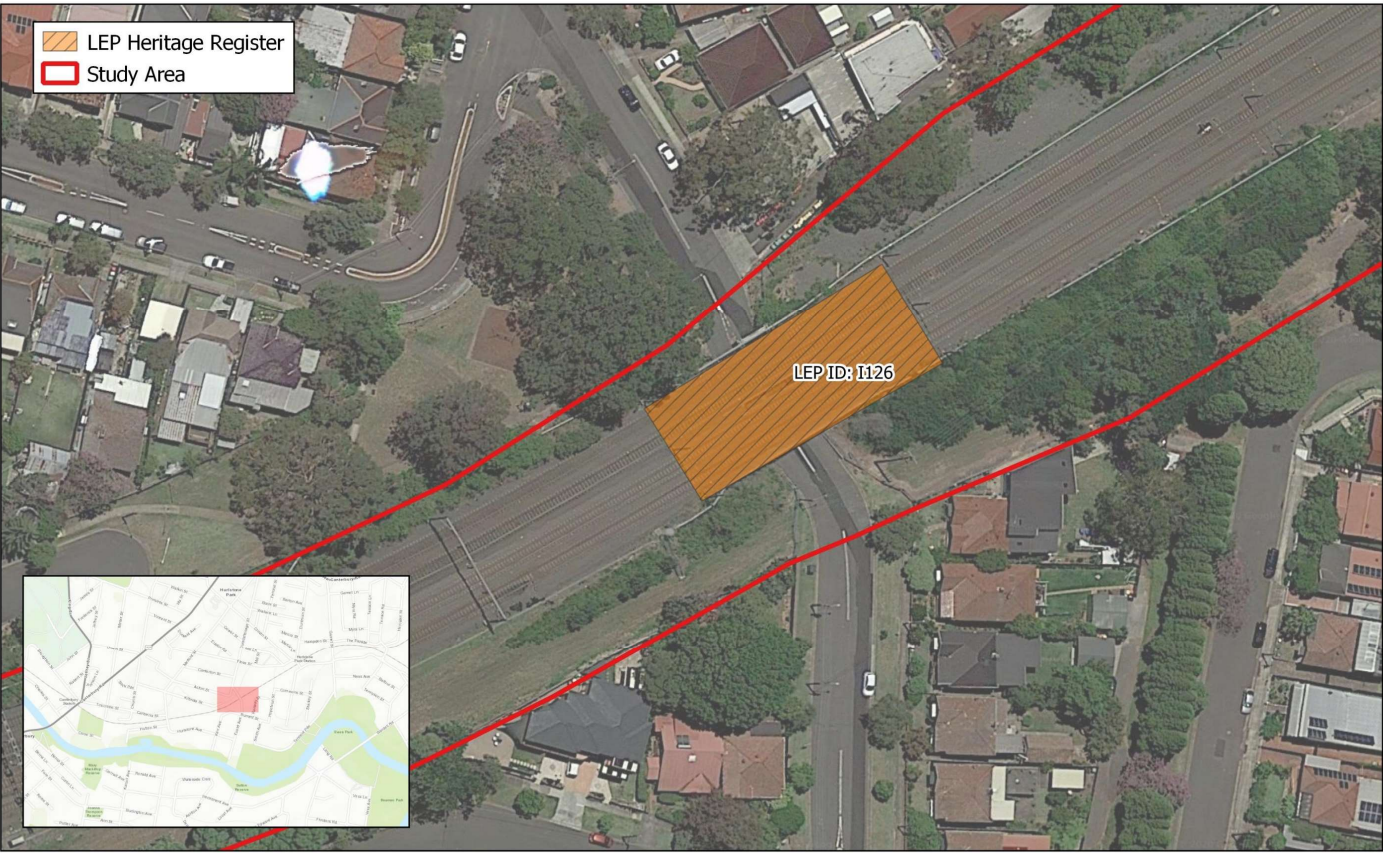
Figure 4-6 Heritage curtilage Hurlstone Park Railway Underbridge

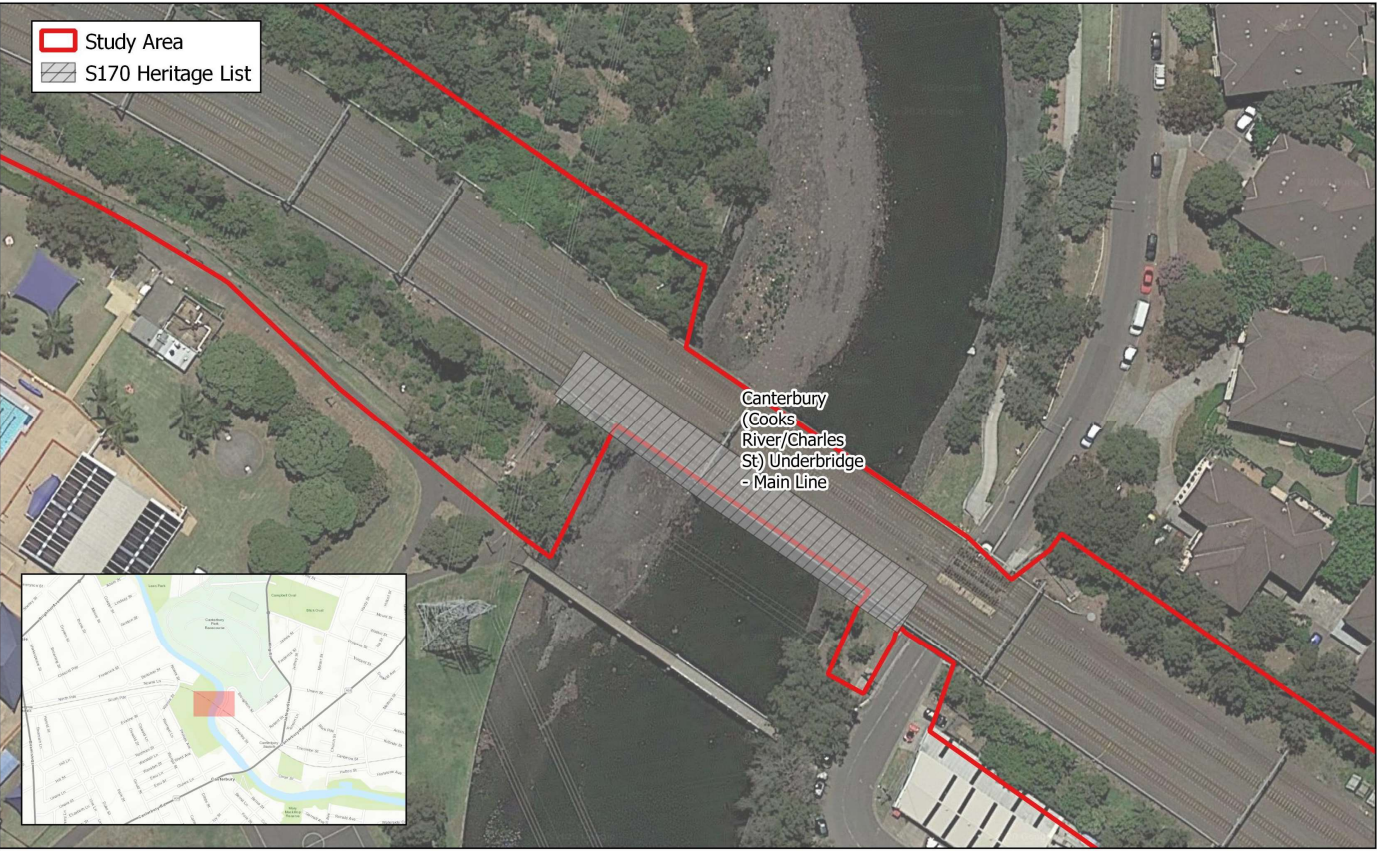
Figure 4-9 Heritage curtilage Canterbury (Cooks River/Charles St) Underbridge – Main Line

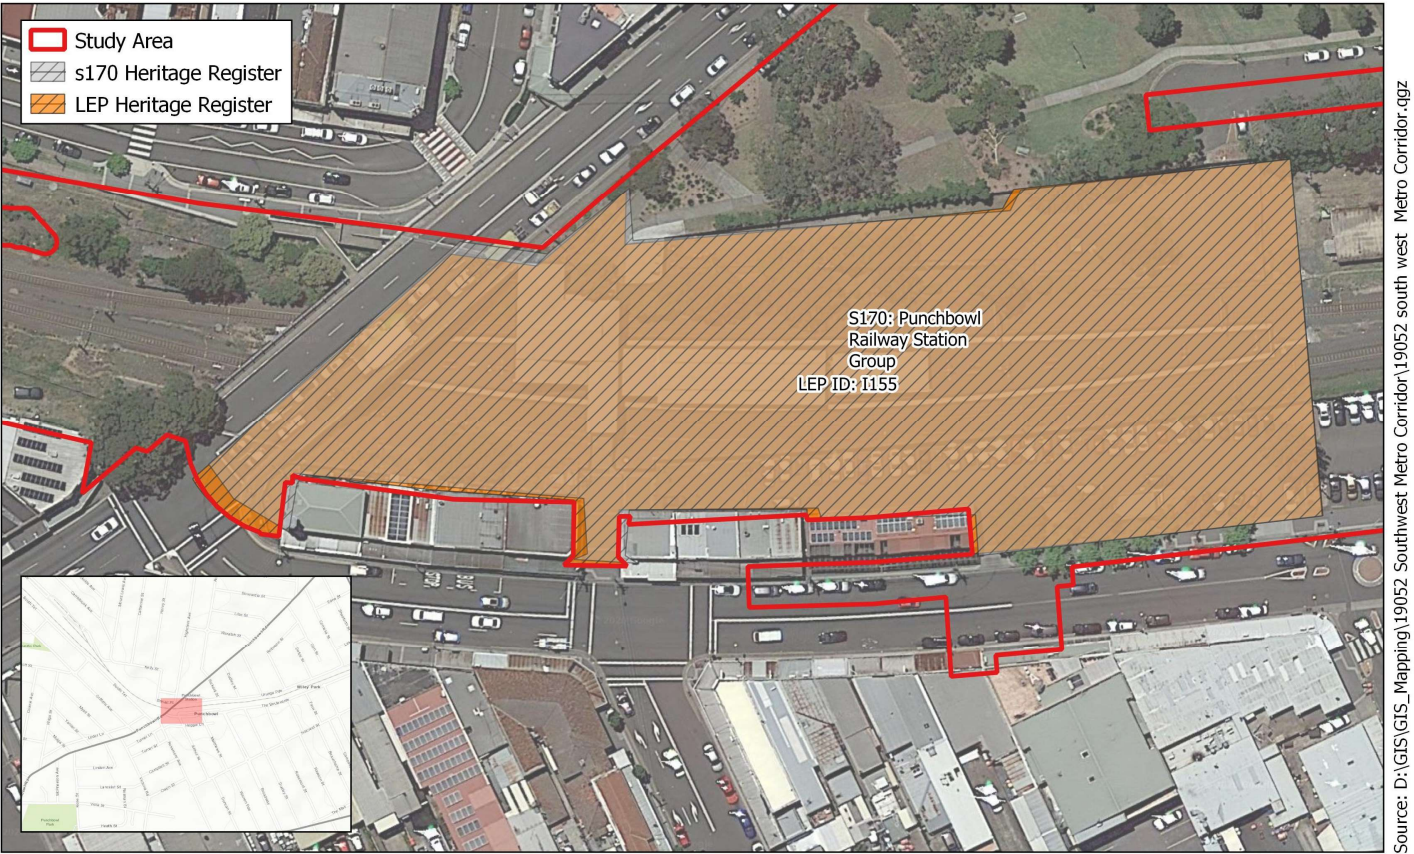
Figure 4-14 Heritage curtilage Punchbowl Railway Station Group

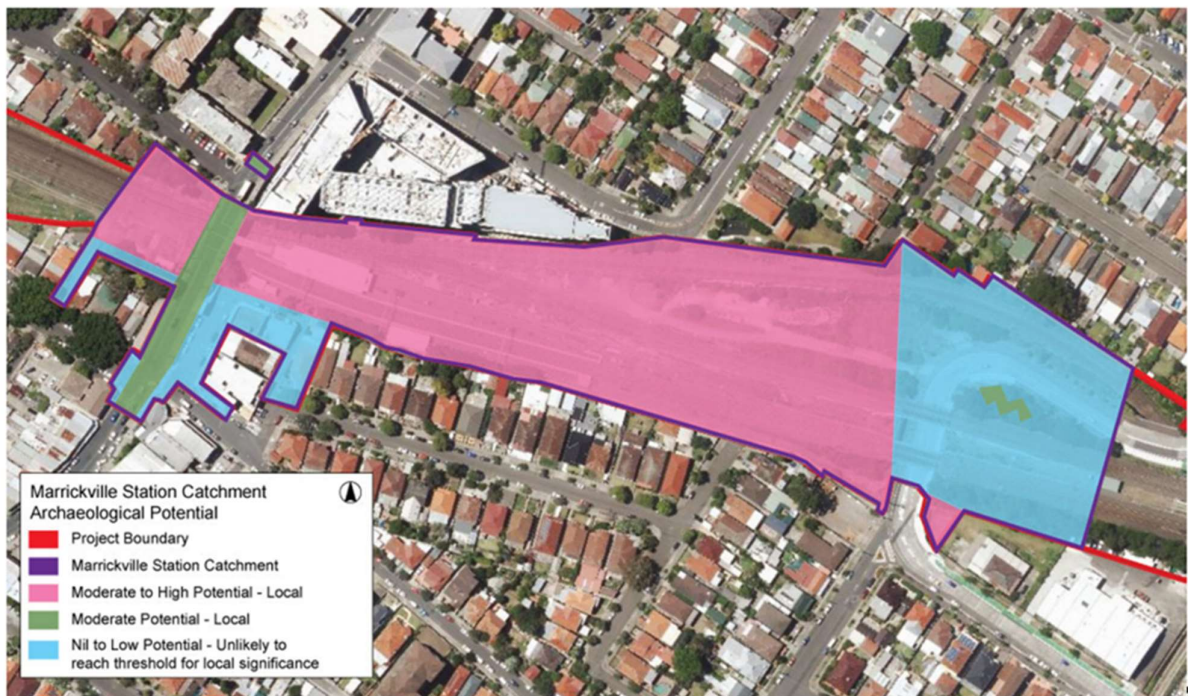
Figure 4-15: Archaeological potential at Marrickville Station

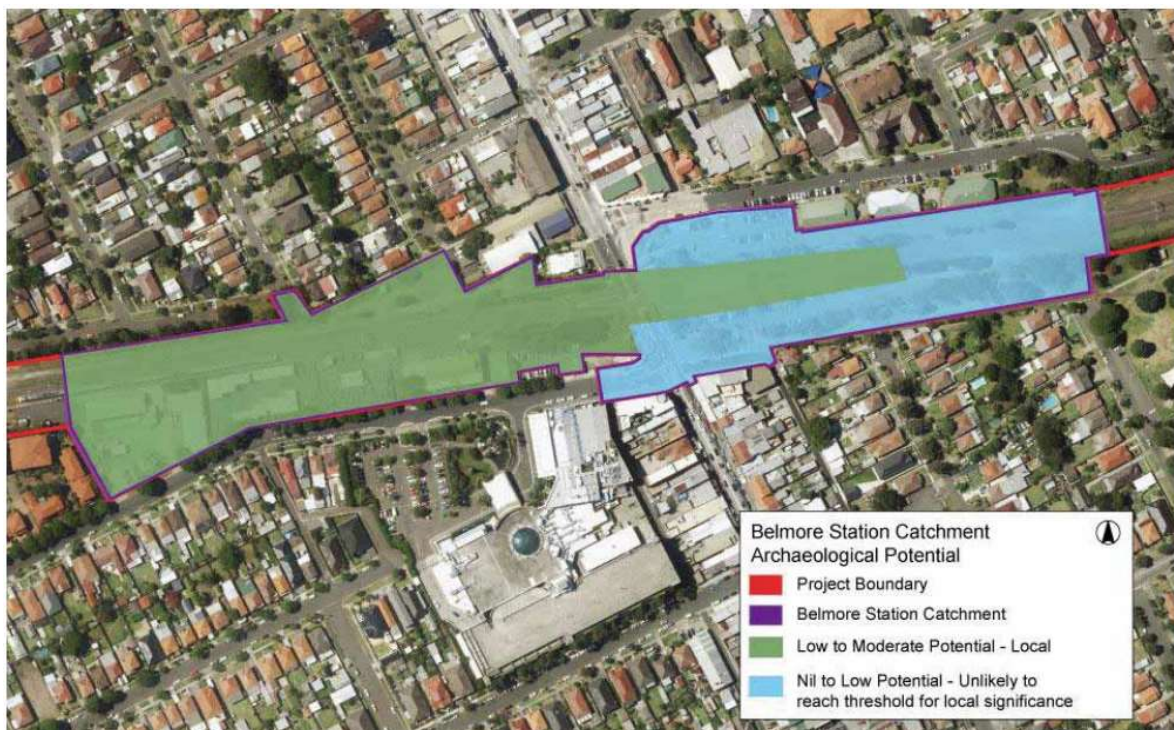
Figure 4-17: Archaeological potential at Belmore Station

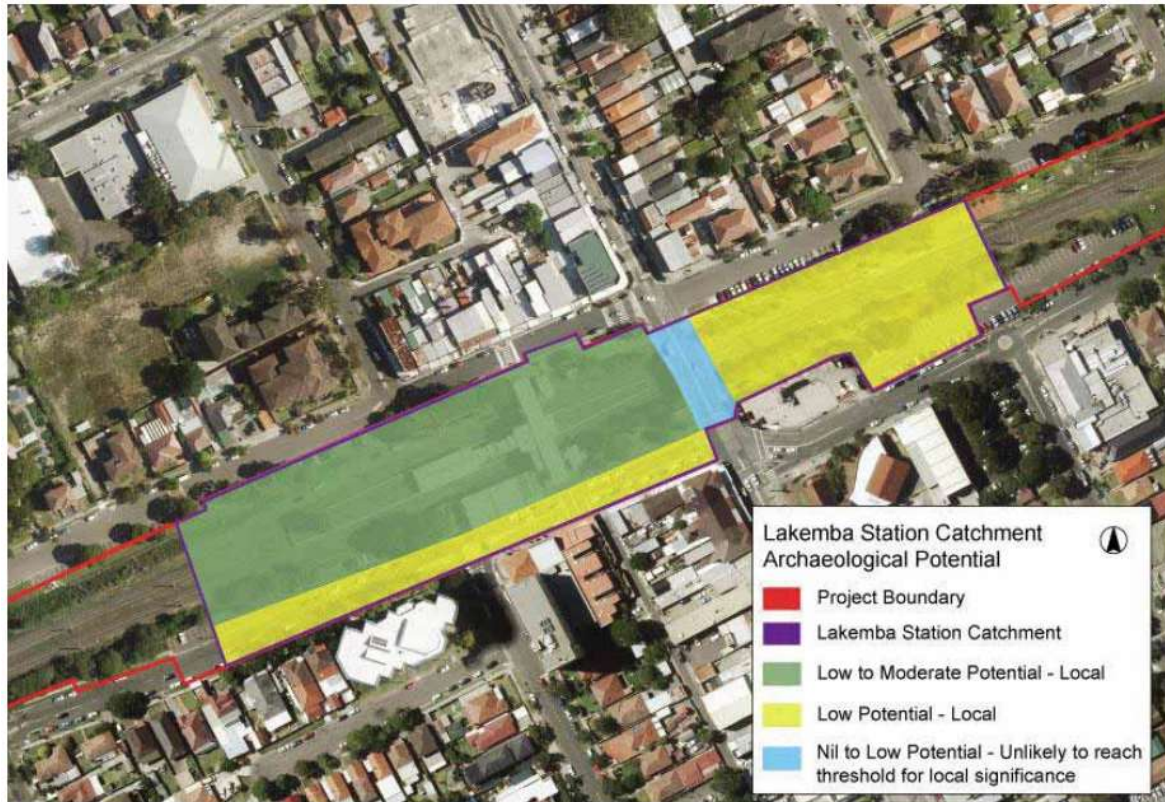
Figure 4-18: Archaeological potential at Lakemba Station

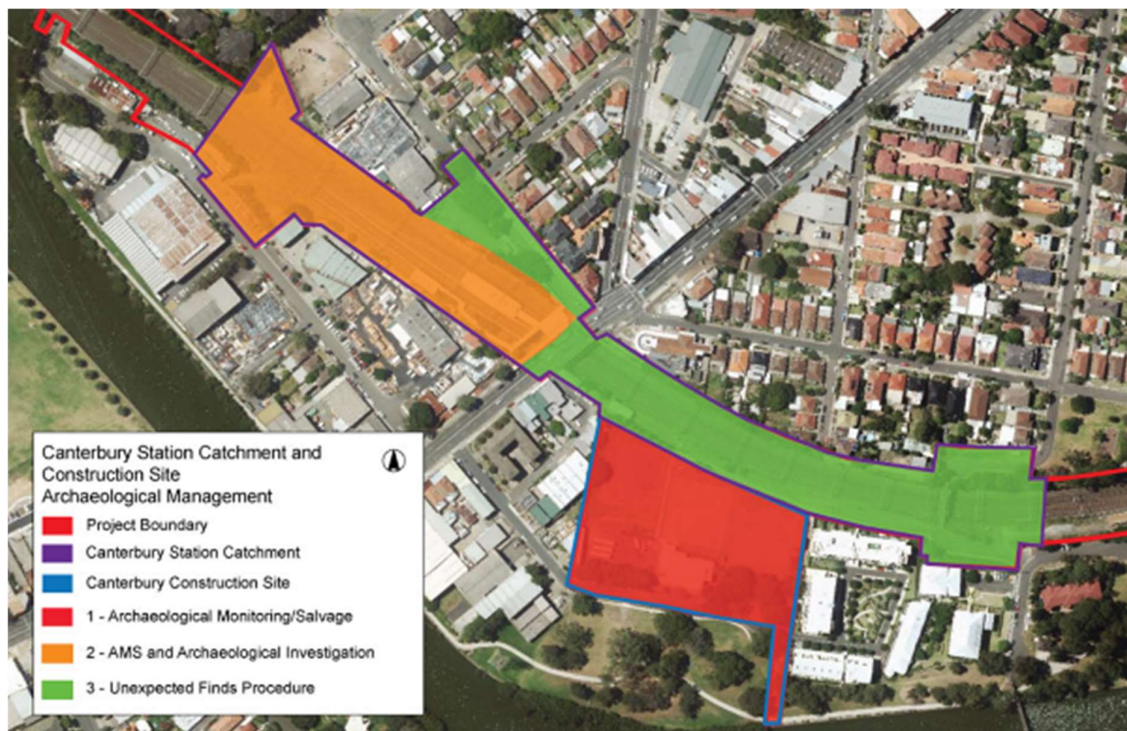
Figure 6-2 Archaeological Management zoning for Canterbury Station (Artefact Heritage 2017c)

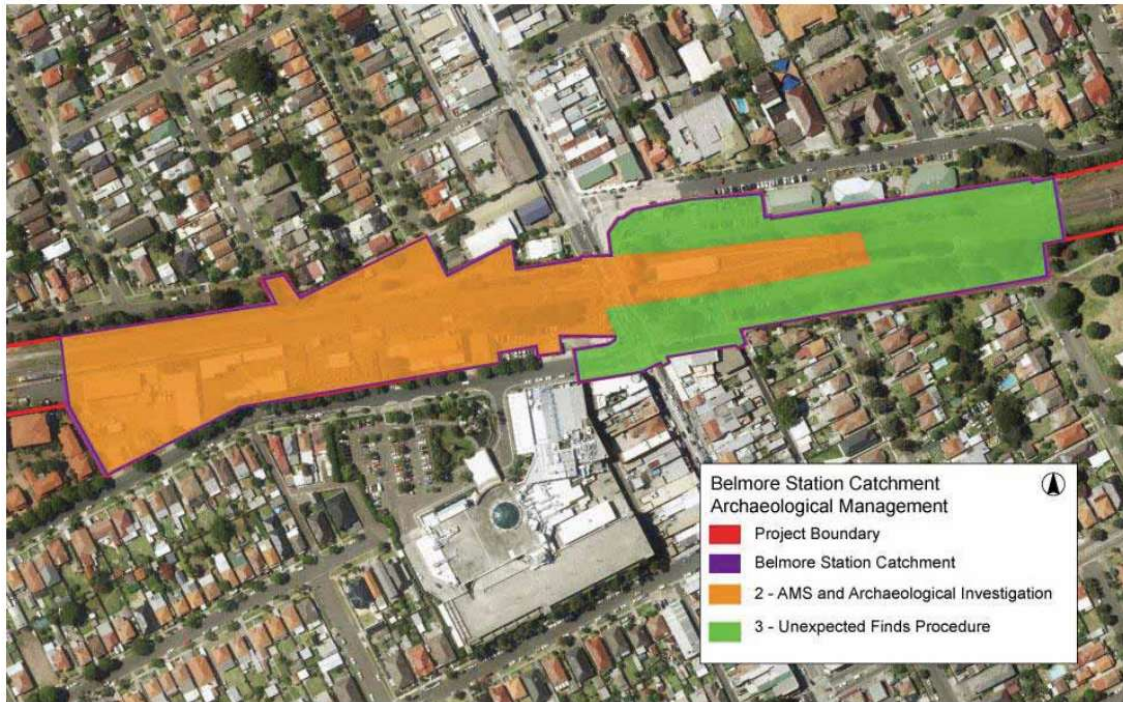
Figure 6-3 Archaeological Management zoning for Belmore Station (Artefact Heritage 2017c)

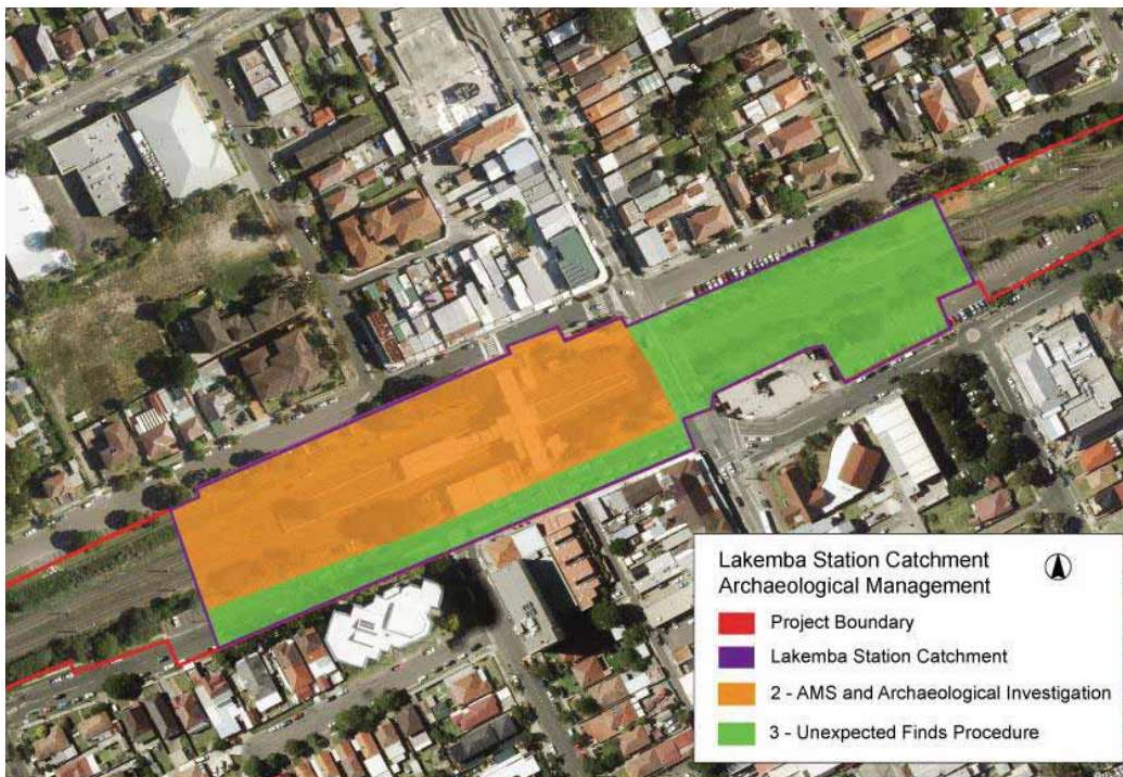
Figure 6-4 Archaeological Management zoning for Lakemba Station (Artefact Heritage 2017c)

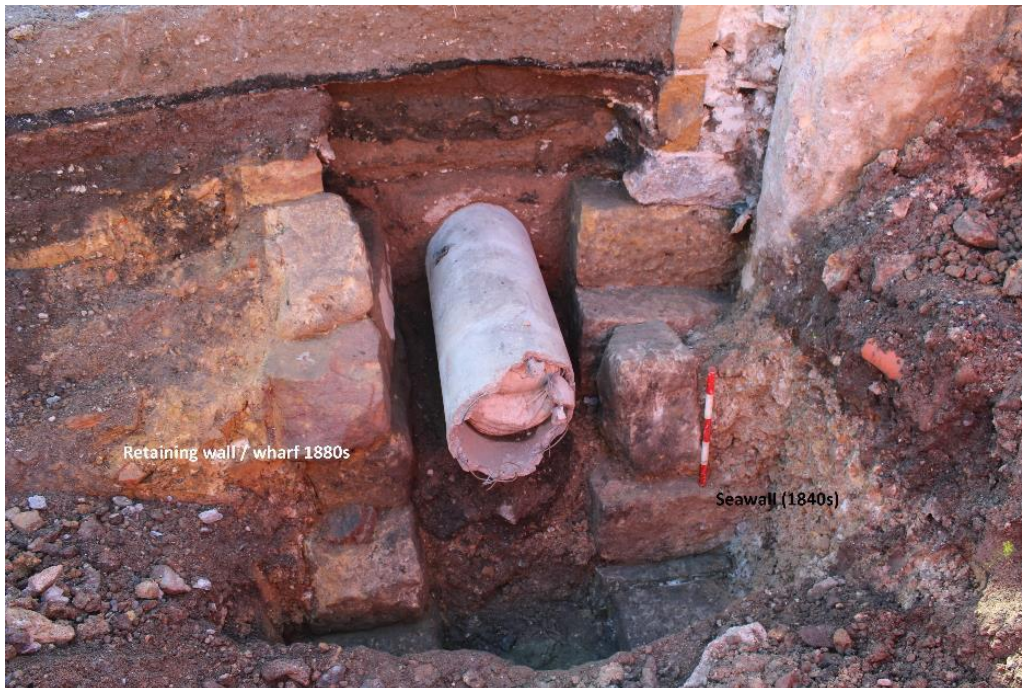
Photo 3 1840s seawall and 1880s retaining wall uncovered at Balmain East, 2016

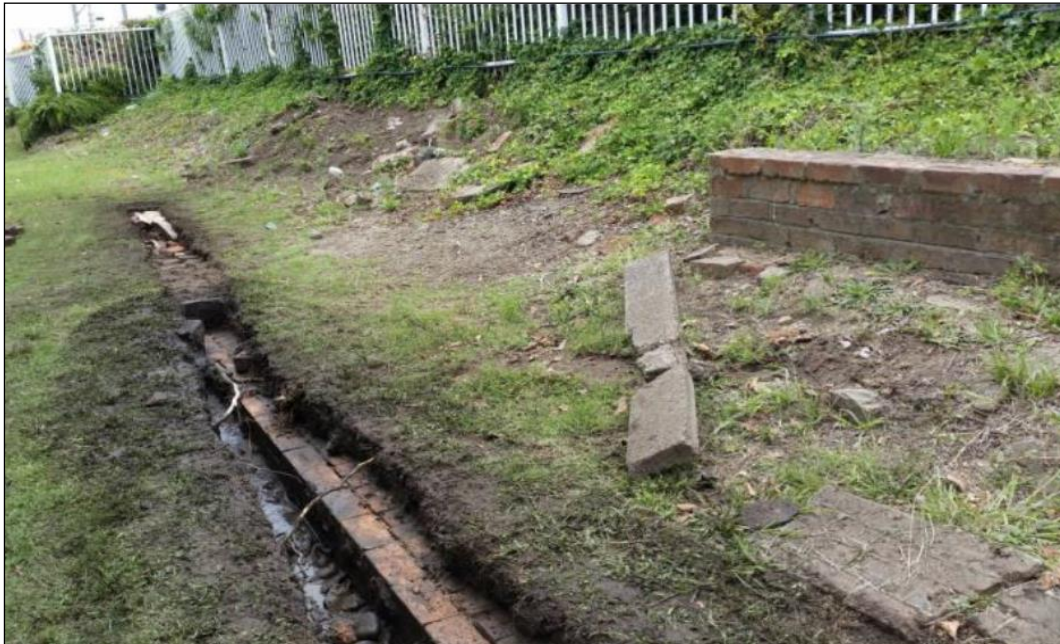
Photo 5 - Platform structure at Hamilton Railway Station classified as a 'work' by the project archaeologist - Wickham Transport Interchange project, 2015

Photo 6 - Platform structure at Hamilton Railway Station classified as a 'work' by the project archaeologist - Wickham Transport Interchange project, 2015

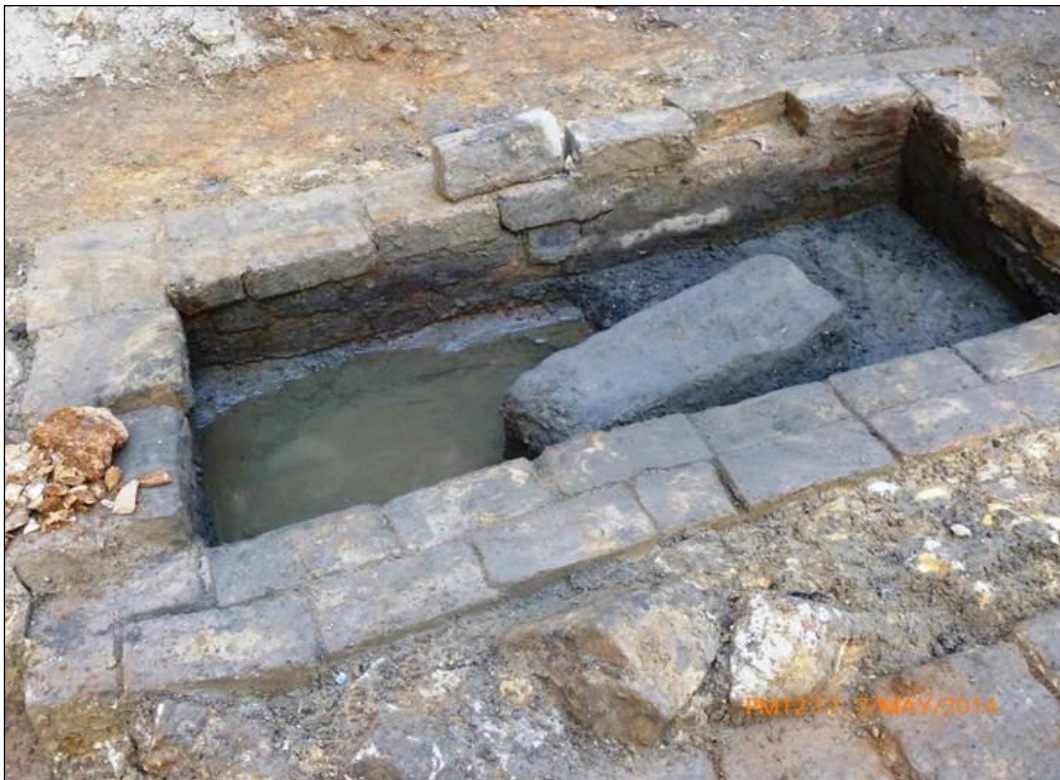
Photo 7 - Sandstone flagging and cesspit - Wynyard Walk project, 2014

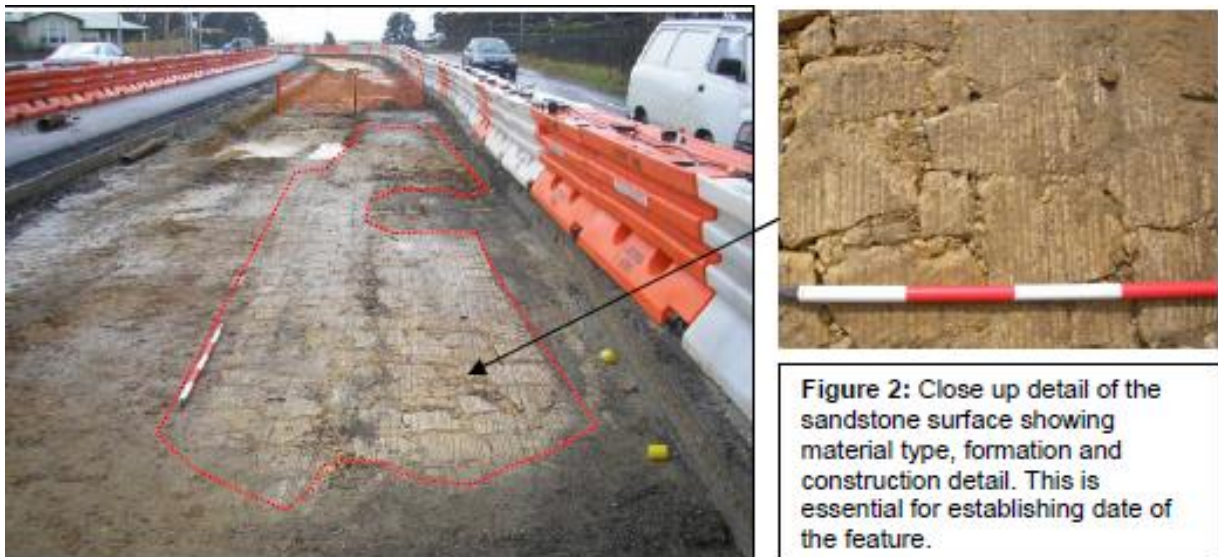
Figure 1: Telford road uncovered on the Great Western Highway (Leura) in 2008 (RMS, 2015).

It is important to take a general photograph (Figure 1) to convey the location and setting of the item. This will add value to the subsequent detailed photographs also required (Figure 2).

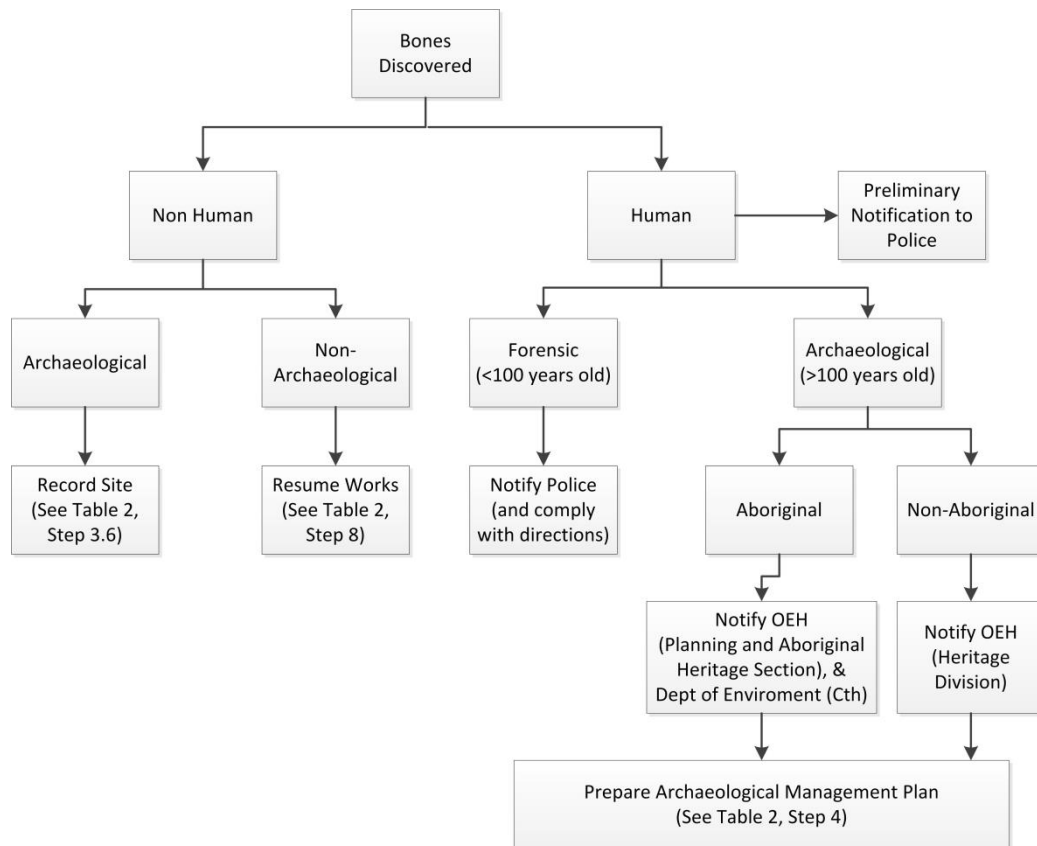
Figure 3 Overview of steps to be undertaken on the discovery of bones

Figure 3 summarises the notification pathways on finding bones.
