**Transport House**

Stage 1 - Outcomes from the  
Preliminary Building Investigation

REP02

Issue 2 | 6 July 2018

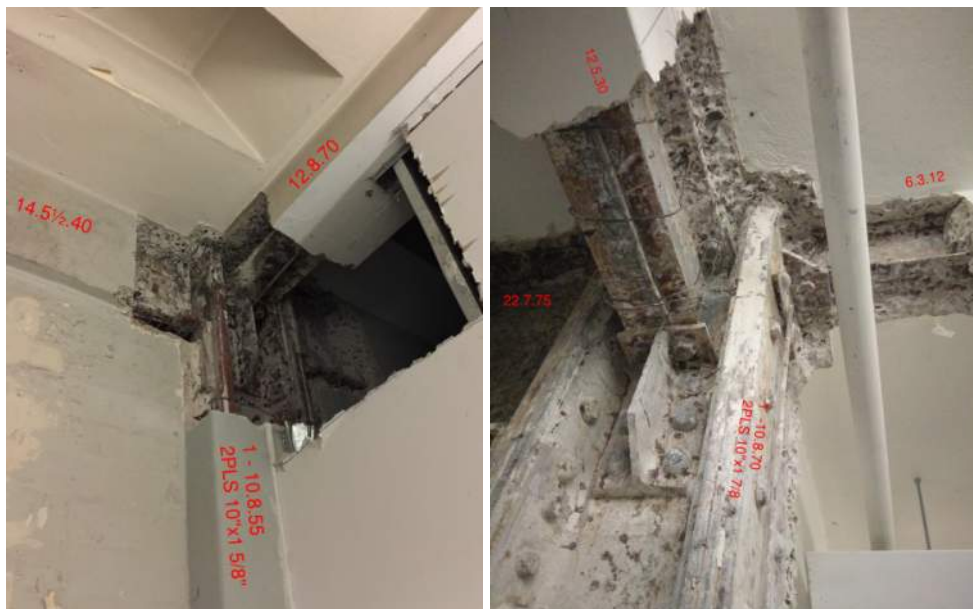
Figure 3 TC4 (left) TC6 (right) column/beam locations after removal of concrete encasement

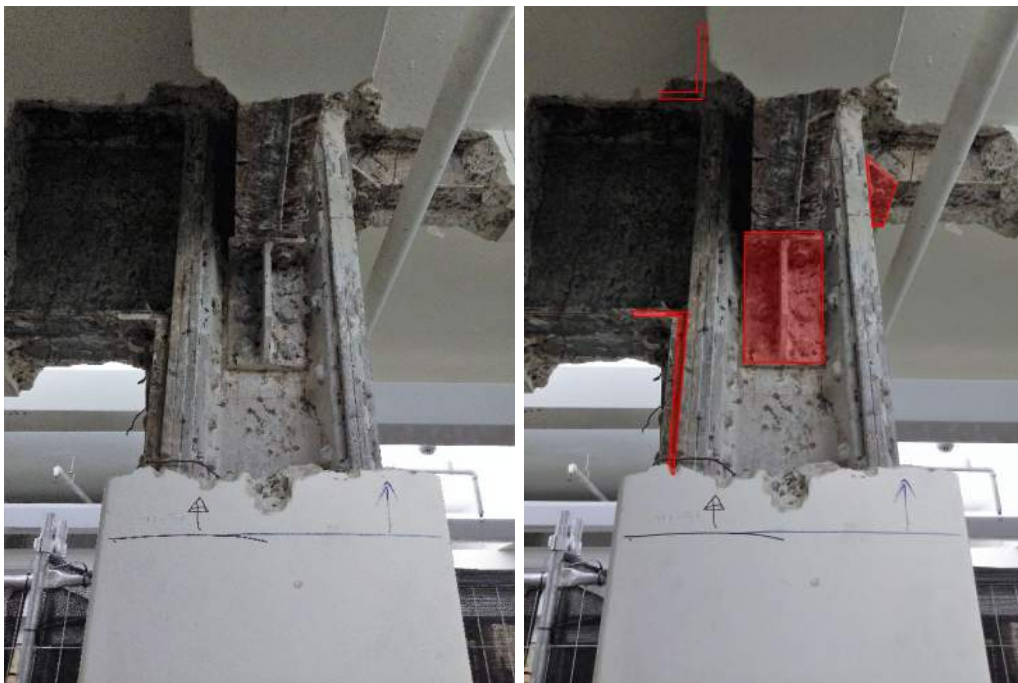
Figure 5 Exposed steel column connection at TC6 (left), with angle support brackets highlighted (right)

This configuration of structural connection observed is commonly described as an angled seat bracket. In these cases, the angle is riveted to the built-up column section and then bolted through the flange of the beam. Bolts can also be seen through the top flange suggesting that the angle bracket connection is mirrored at the top. There is no connection of the web of the beam to the column.

These connections were similar to those at location **TC4**.

It is therefore reasonable to conclude that the steel frame was not be as a moment frame for stability. The additional seismic loads from the proposed modifications to the structure could not be accommodated by the observed connections without extensive strengthening at most column-beam joint locations.
