RESPONSE TO REQUEST FOR ADDITIONAL INFORMATION

Glendell Continued Operations Project

August 2021

Prepared by
Umwelt (Australia) Pty Limited
on behalf of
Department of Planning, Industry and Environment

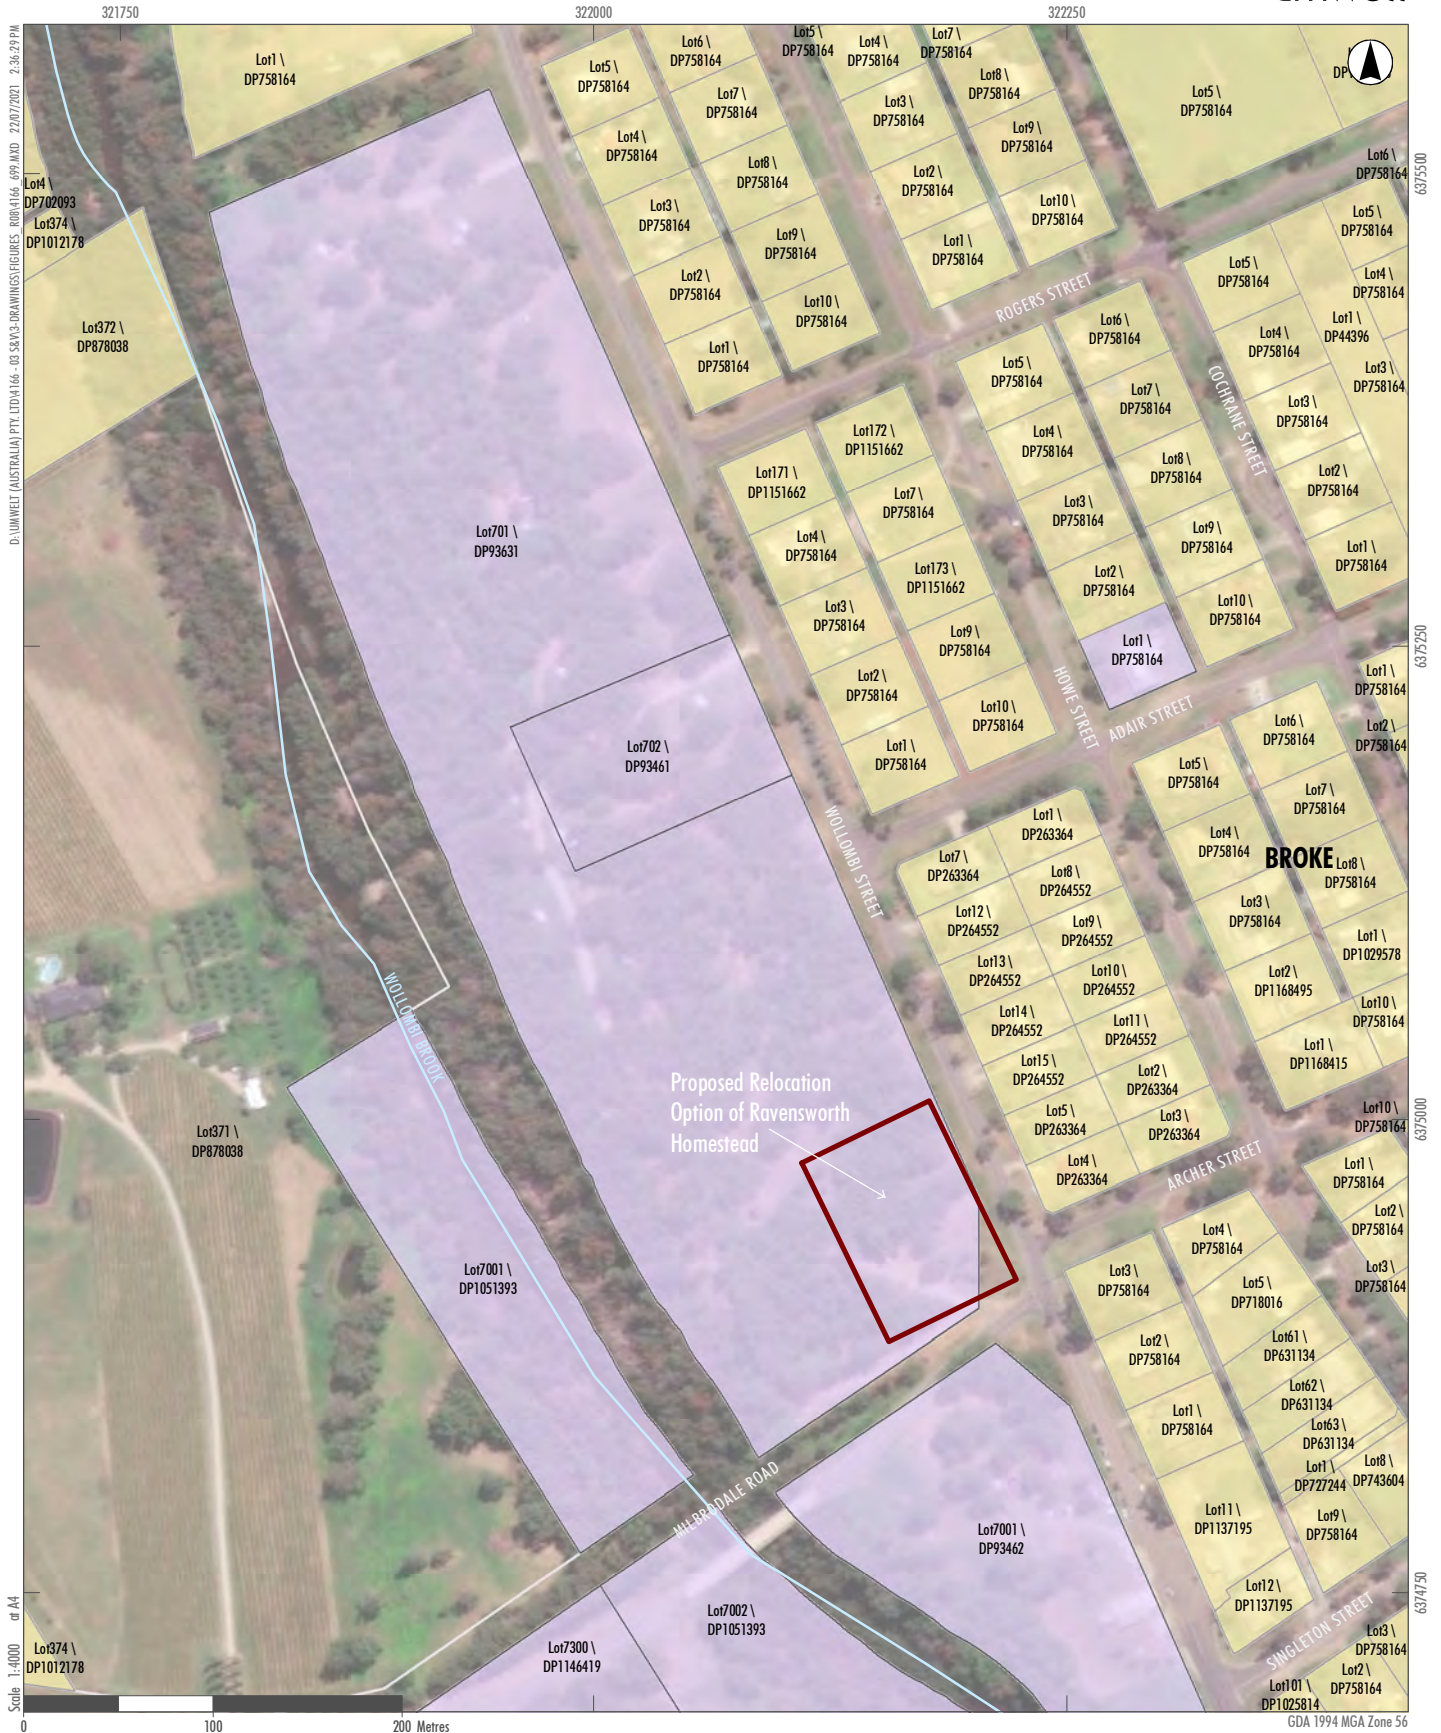
FIGURE 2.3

Broke Recipient Site

The preferred site for the Broke Village Square relocation option is in the southern end of McNamara Park (the Site). The Site is currently owned by the Crown and managed by Singleton Council as land manager pursuant to the *Crown Land Management Act 2016* (NSW) (CLM Act) (refer to **Figure 2.3**).

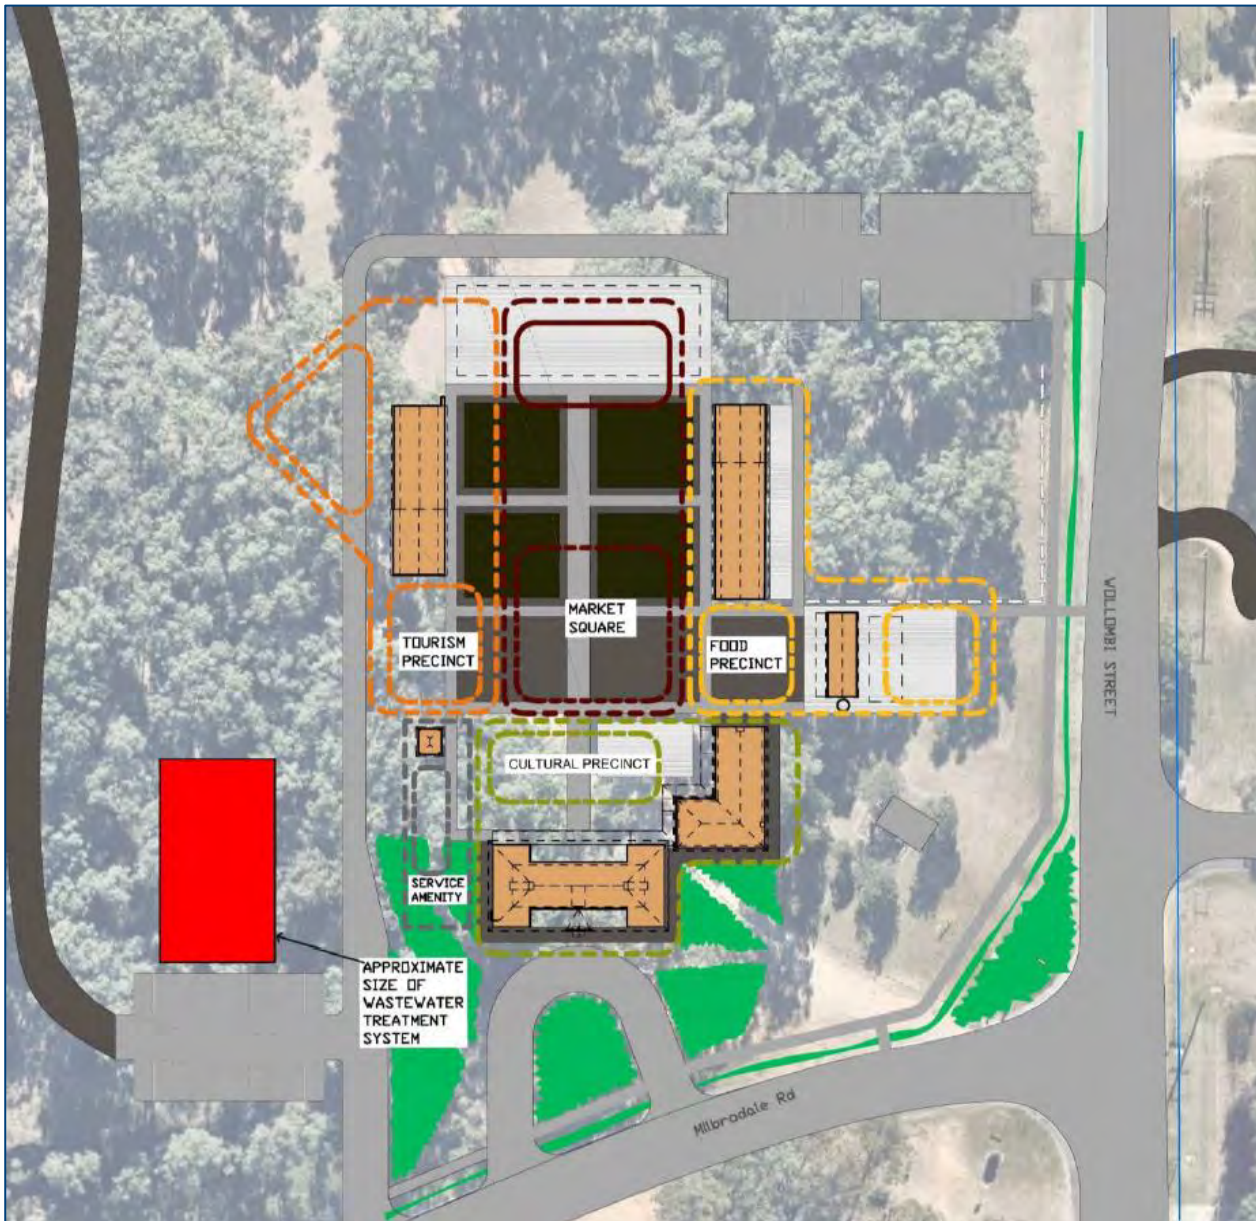
The use of on-site wastewater treatment with disposal through infiltration beds or sand mounds (Option 2) is the preferred option for the management of wastewater generated by the proposed facility. The infiltration area required for the disposal of treated effluent is approximately 720m² (also requires 70kL tank for storage of effluent during maximum flow events), which can be easily accommodated to the west of the facility and is well beyond 40m from Wollombi Brook. **Figure 2.4** shows the approximate footprint size of the treatment system for Option 2 and the area required for the storage and disposal of effluent.

Figure 2.4 Sewage Management - Option 2

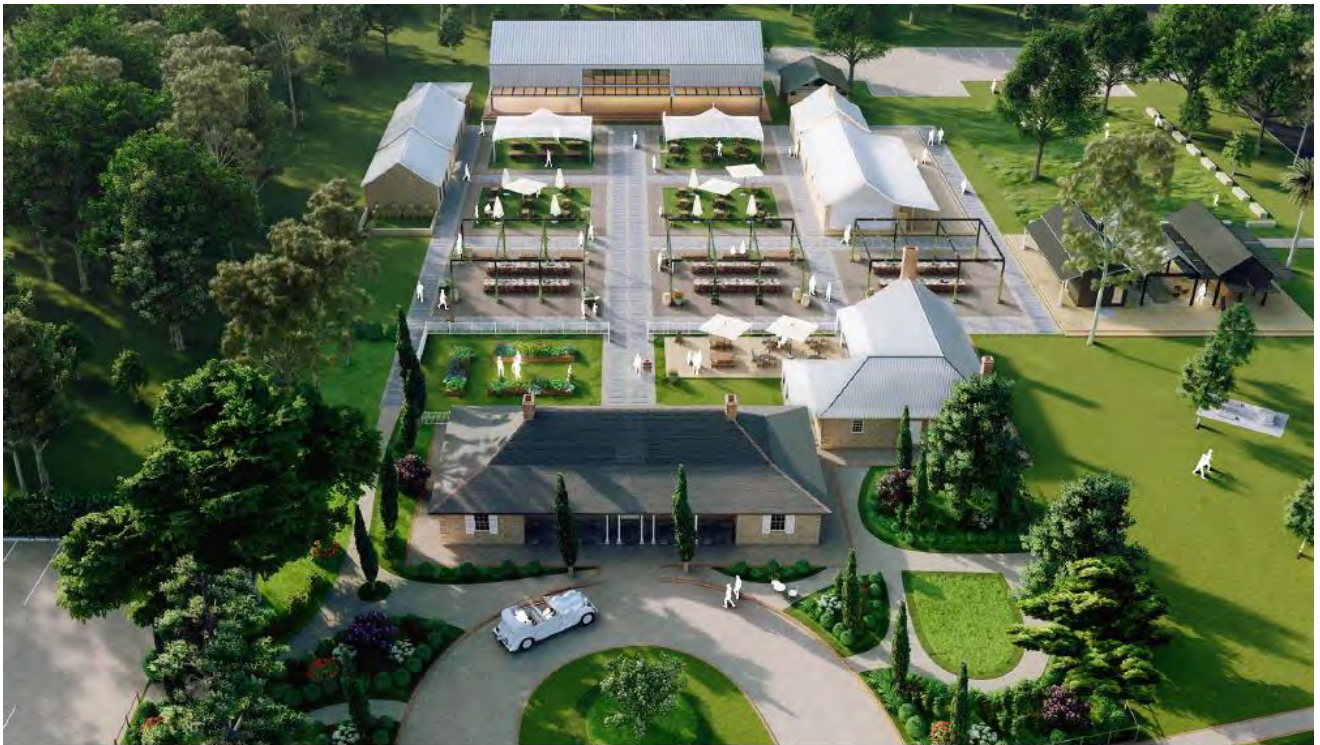
These drawings show the proposed development at Broke is a mixed use facility comprising commercial, tourism and community-based facilities with adaptive re-use of the Ravensworth Homestead central to the site, an extracted perspective from these drawings is shown below in Figure 1.1.

Figure 1.1 *Architectural perspective*

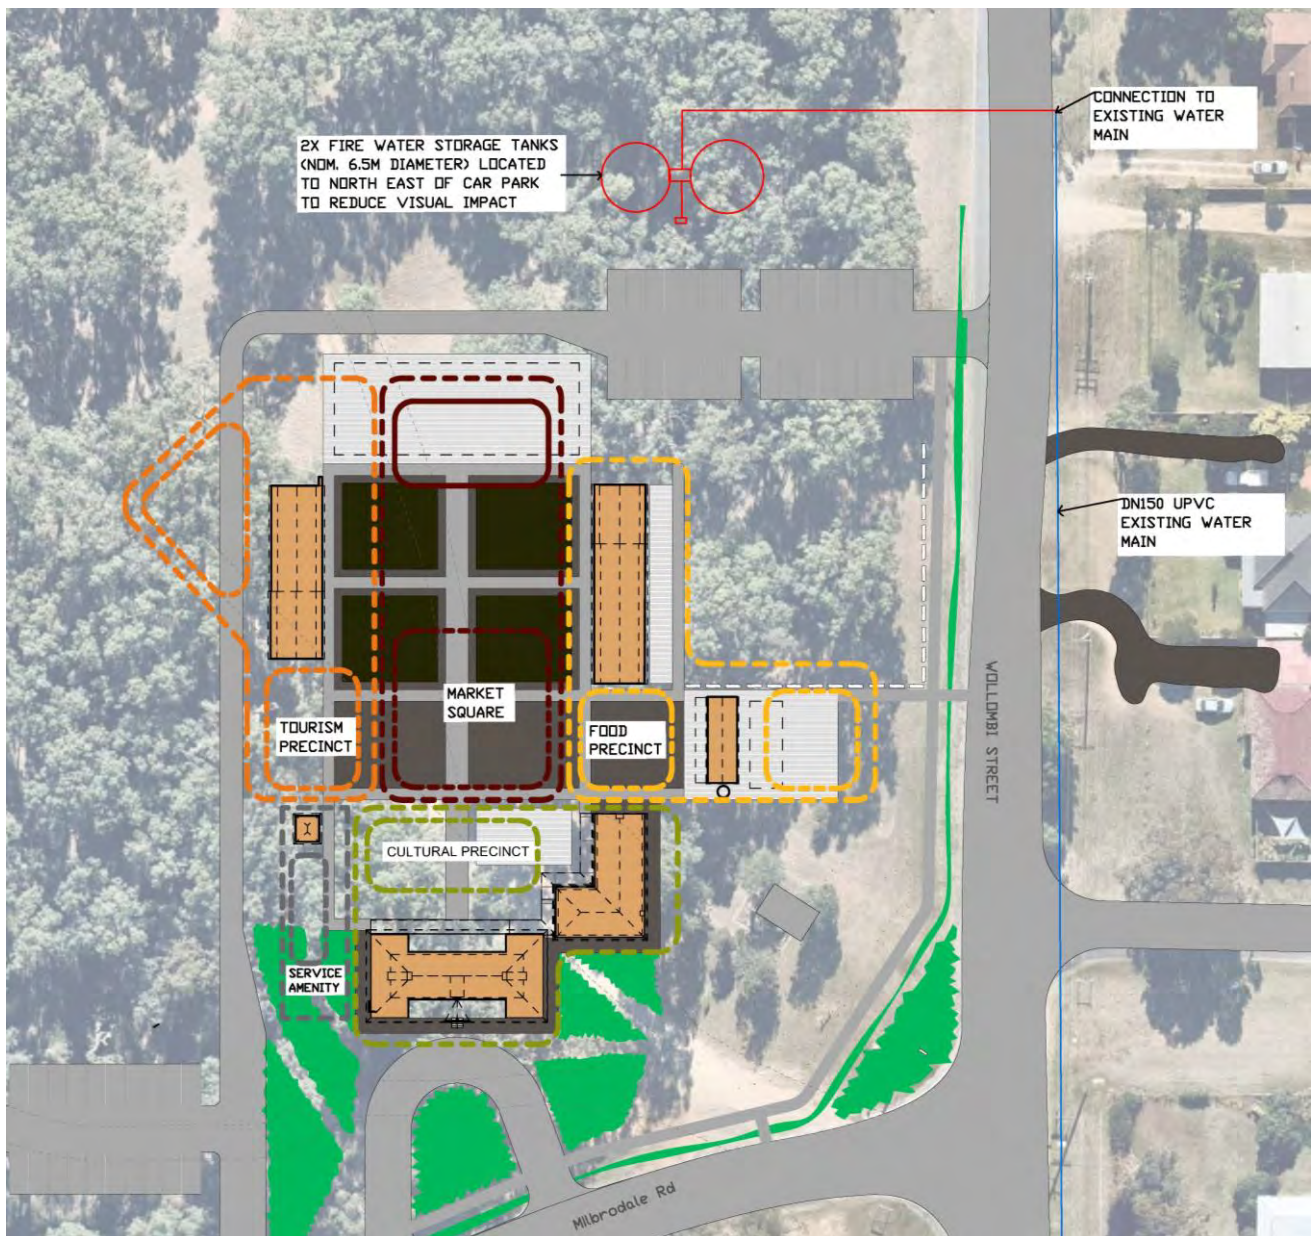
To be confirmed in detail design, but connection would likely be to existing main on eastern side of Wollombi Street, with a road crossing, north of the car park. Based on the SAP results, onsite fire storage will be required; refer to Figure 2.3 for the proposed location of the tanks and connection point. Further design development should consider connection to the Broke irrigation district line for irrigation requirements.

Figure 2.3 Fire water tank and water connection location

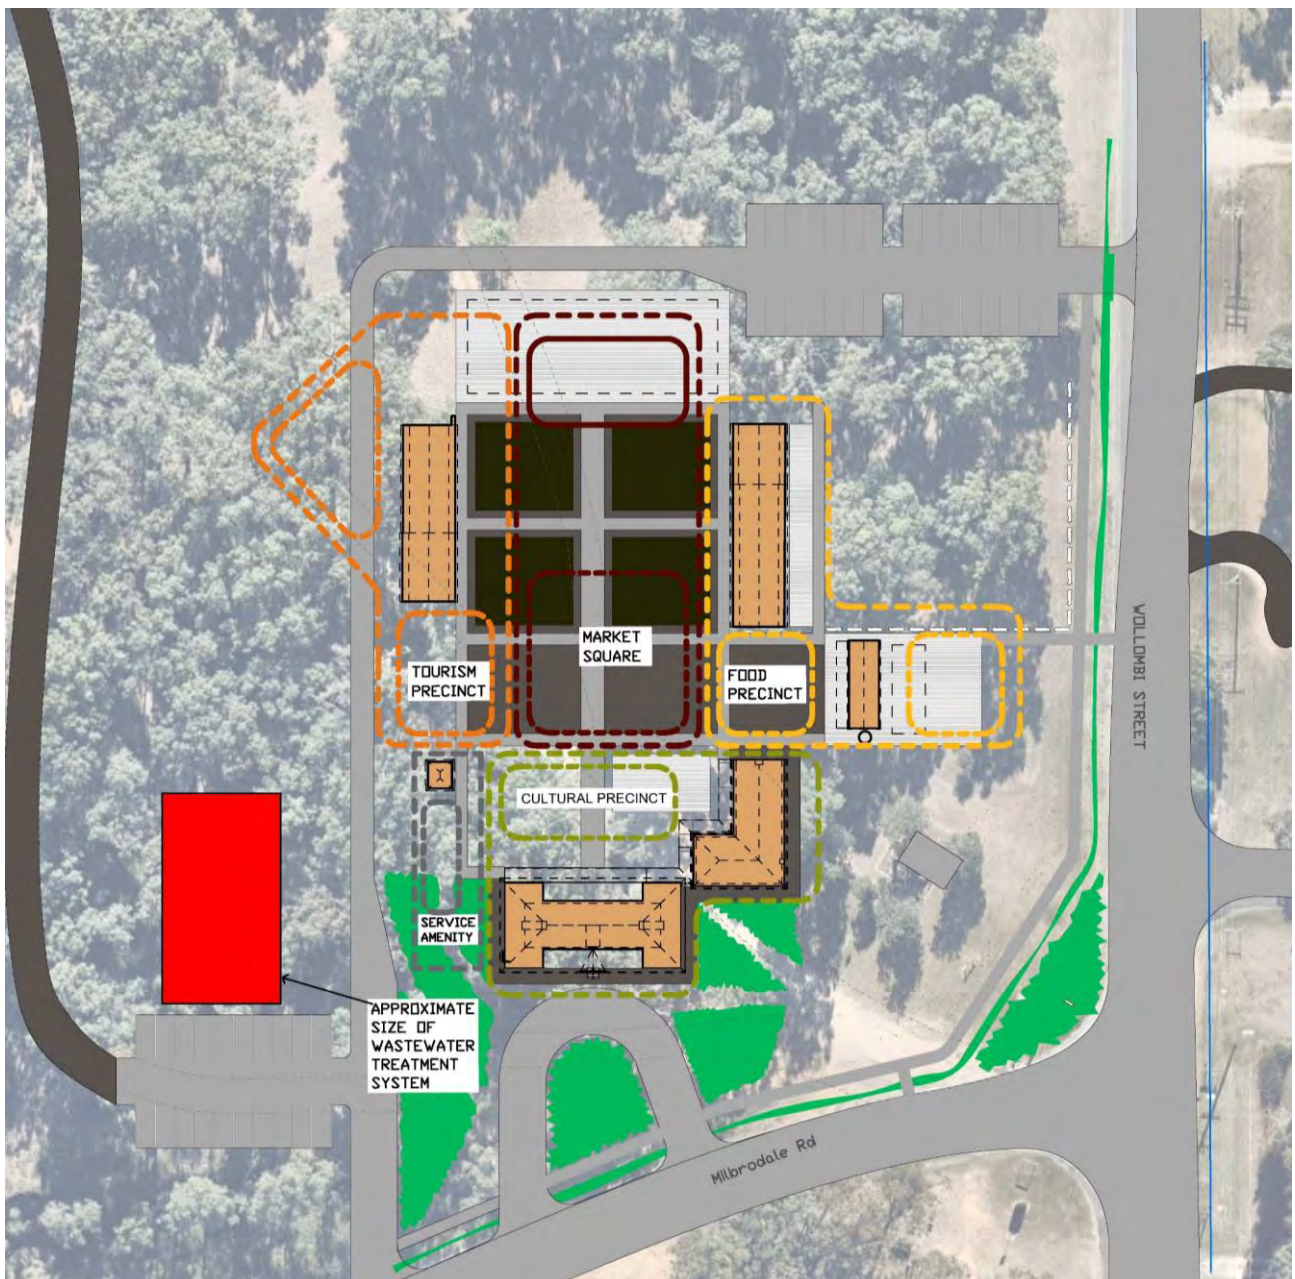
The approximate size of the Option 1 sewage treatment system is shown in Figure 3.1. The area shown corresponds to the greatest expected footprint of the system.

Figure 3.1 Sewage management - Option 1

Option 1 (off-site disposal) of the wastewater is not recommended due to the expected high cost of road tanker transport, particularly during the peak season.

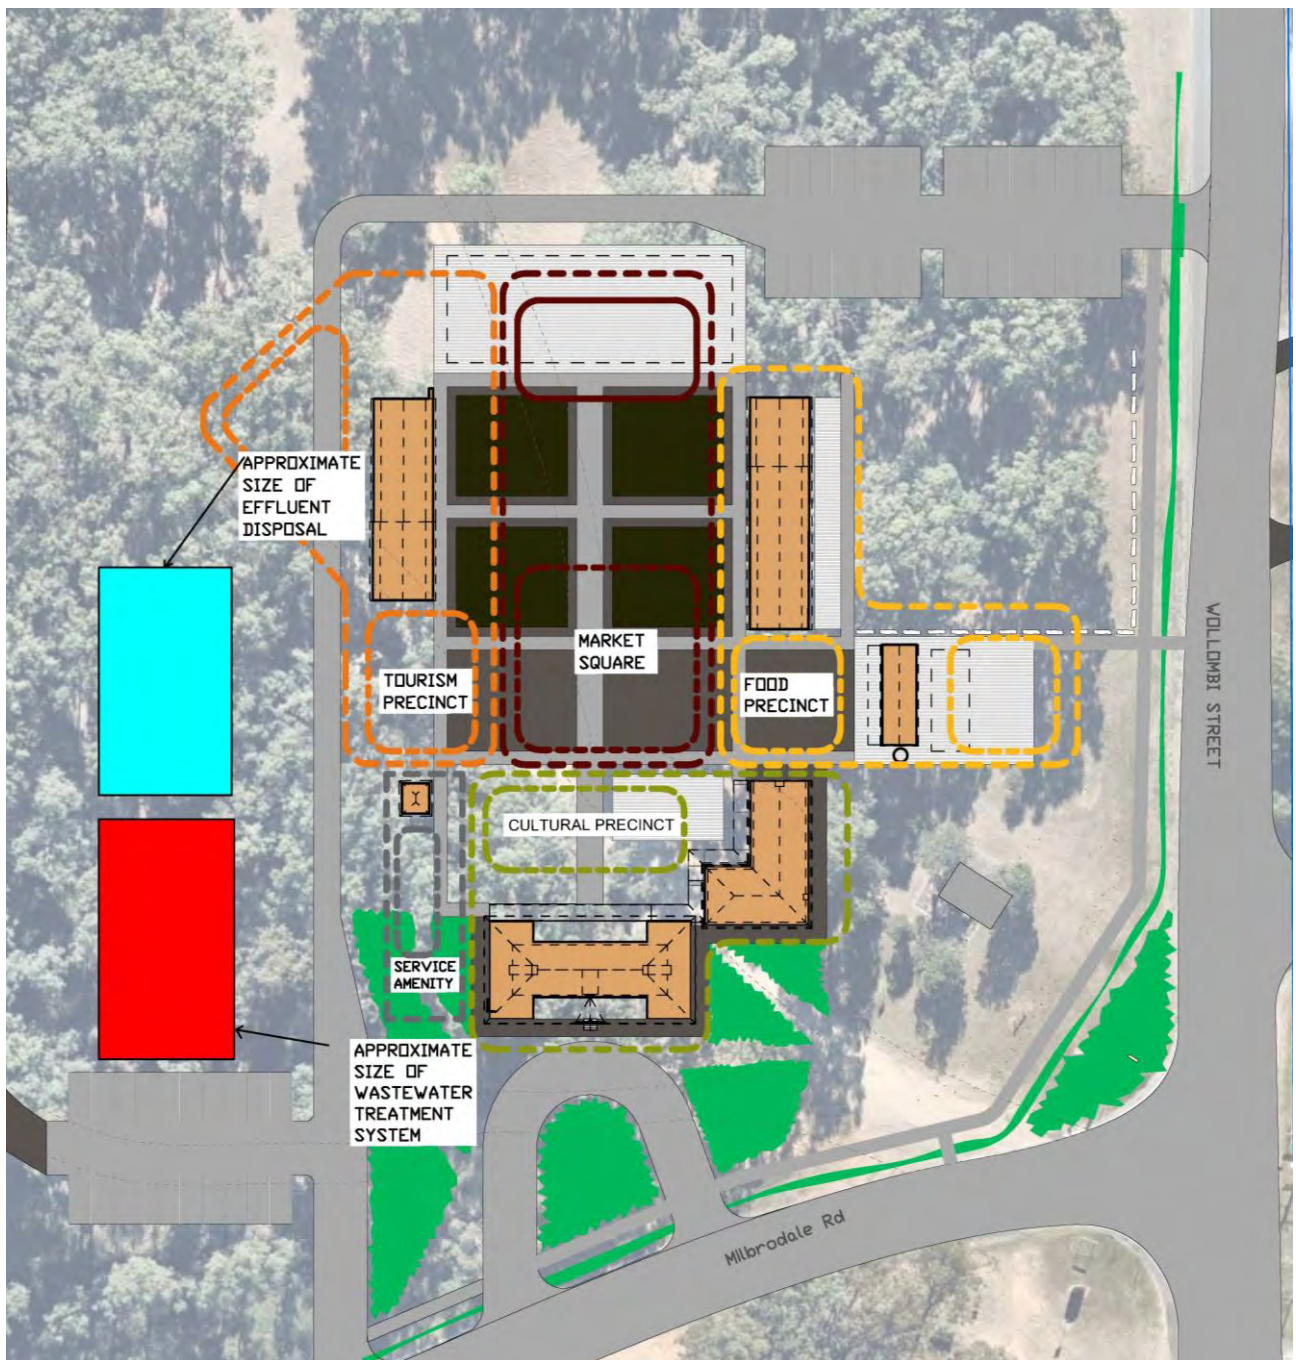
For sand or silty sand soils the infiltration bed design loading rate according to AS/NZS 1547:2012 Table L1 is 50 mm/d. The resulting infiltration bed floor area is 580 m² and the gross area of the infiltration beds is 810 m².

For fractured rock sand mounds may be more suitable than infiltration beds. The adopted sand mound design loading rate according to AS/NZS 1547:2012 Table N1 is 24 mm/d. The resulting infiltration bed floor area is 1200 m² and the gross area of the infiltration beds is 1,700 m².

The use of effluent storage to reduce the infiltration area design flow to the estimated maximum week flow reduces the gross infiltration bed area to 350 or 720 m². An additional 100 m² would be required for the effluent storage tanks (~70 kL), so the net reduction in the area of the sewage management system would be modest for silty sand type soil but substantial for fractured rock type soil.

Figure 3.2 Sewage management - Option 2

GHD recommends that Option 2 (infiltration beds or sand mounds) be pursued as the preferred sewage management option because of its balance of costs, land requirement and absence of discharge to Wollombi Brook. Site investigations to understand the insitu soils and develop a soil profile as described in AS/NZS 1547:2012 should be carried out to inform selection of infiltration beds or sand mounds and to refine the selection of design loading rate and calculations of the land requirement.

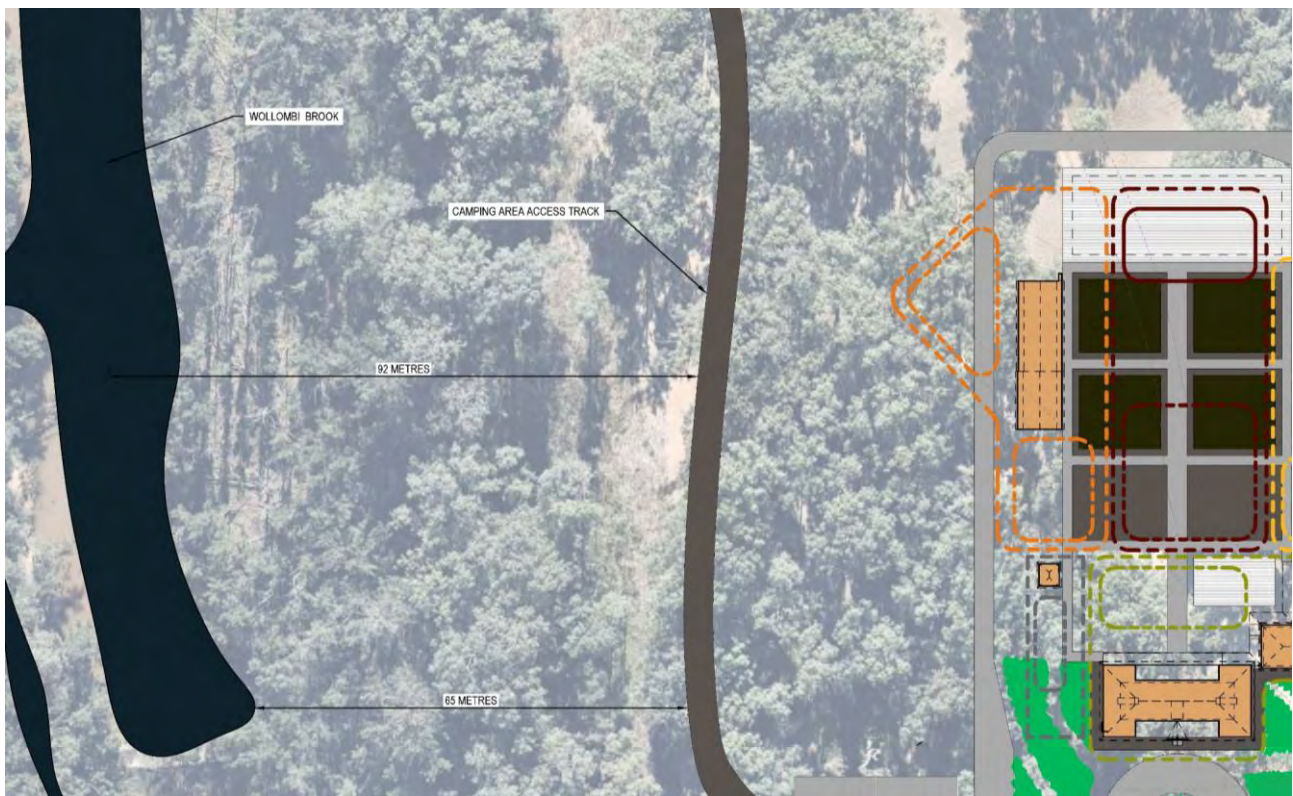
The infiltration beds area needs to be a minimum of 40 m from Wollombi Brook. For this reason, the nominated location is set to the east of the existing track to the camping area, which itself is located over 60 m from the Brook as indicated on Figure 3.3.

Figure 3.3 Locations

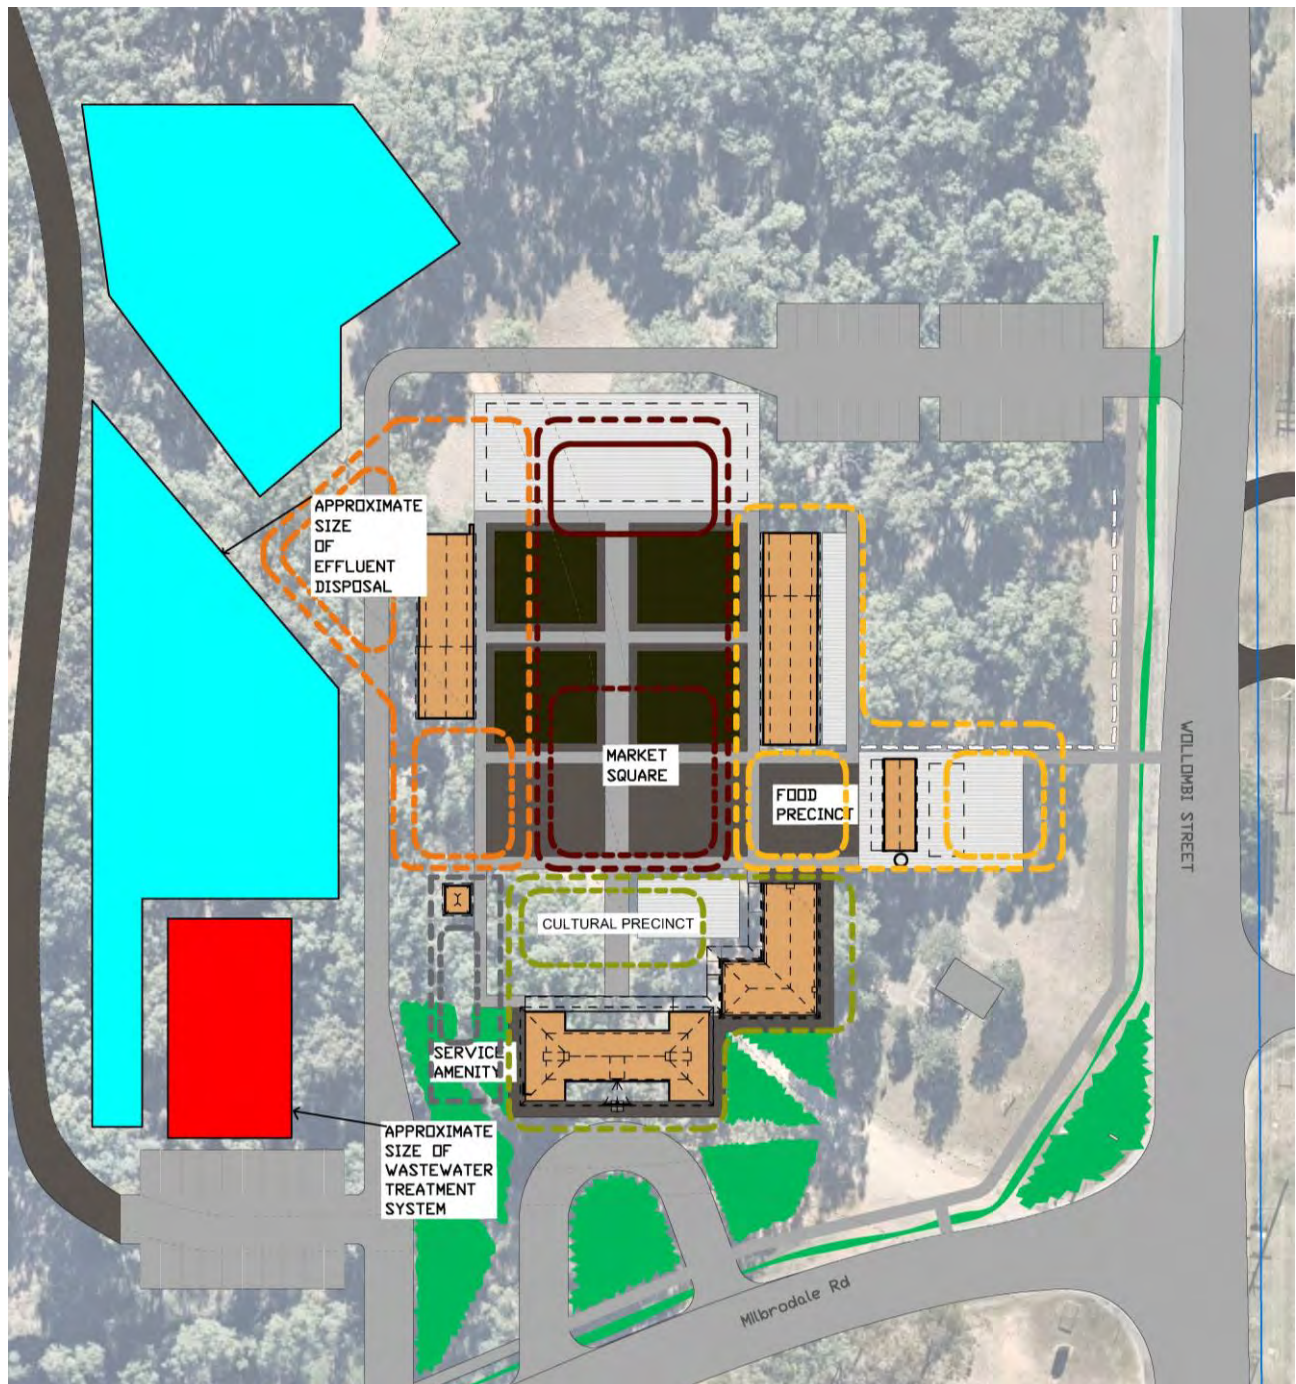
The approximate sizes of the Option 3 sewage treatment system and effluent disposal area are shown in Figure 3.4. The effluent disposal area shown is for irrigation area without public access. A greater area would be required for irrigation of garden beds, grapevines or other non-trafficable landscaping due to the area occupied by paths and non-irrigable landscaping. The irrigation area is located east of the track to the camping ground to provide more than the minimum 40 m offset to Wollombi Brook similar to Option 2, and indicated on Figure 3.3.

Figure 3.4 Sewage management - Option 3

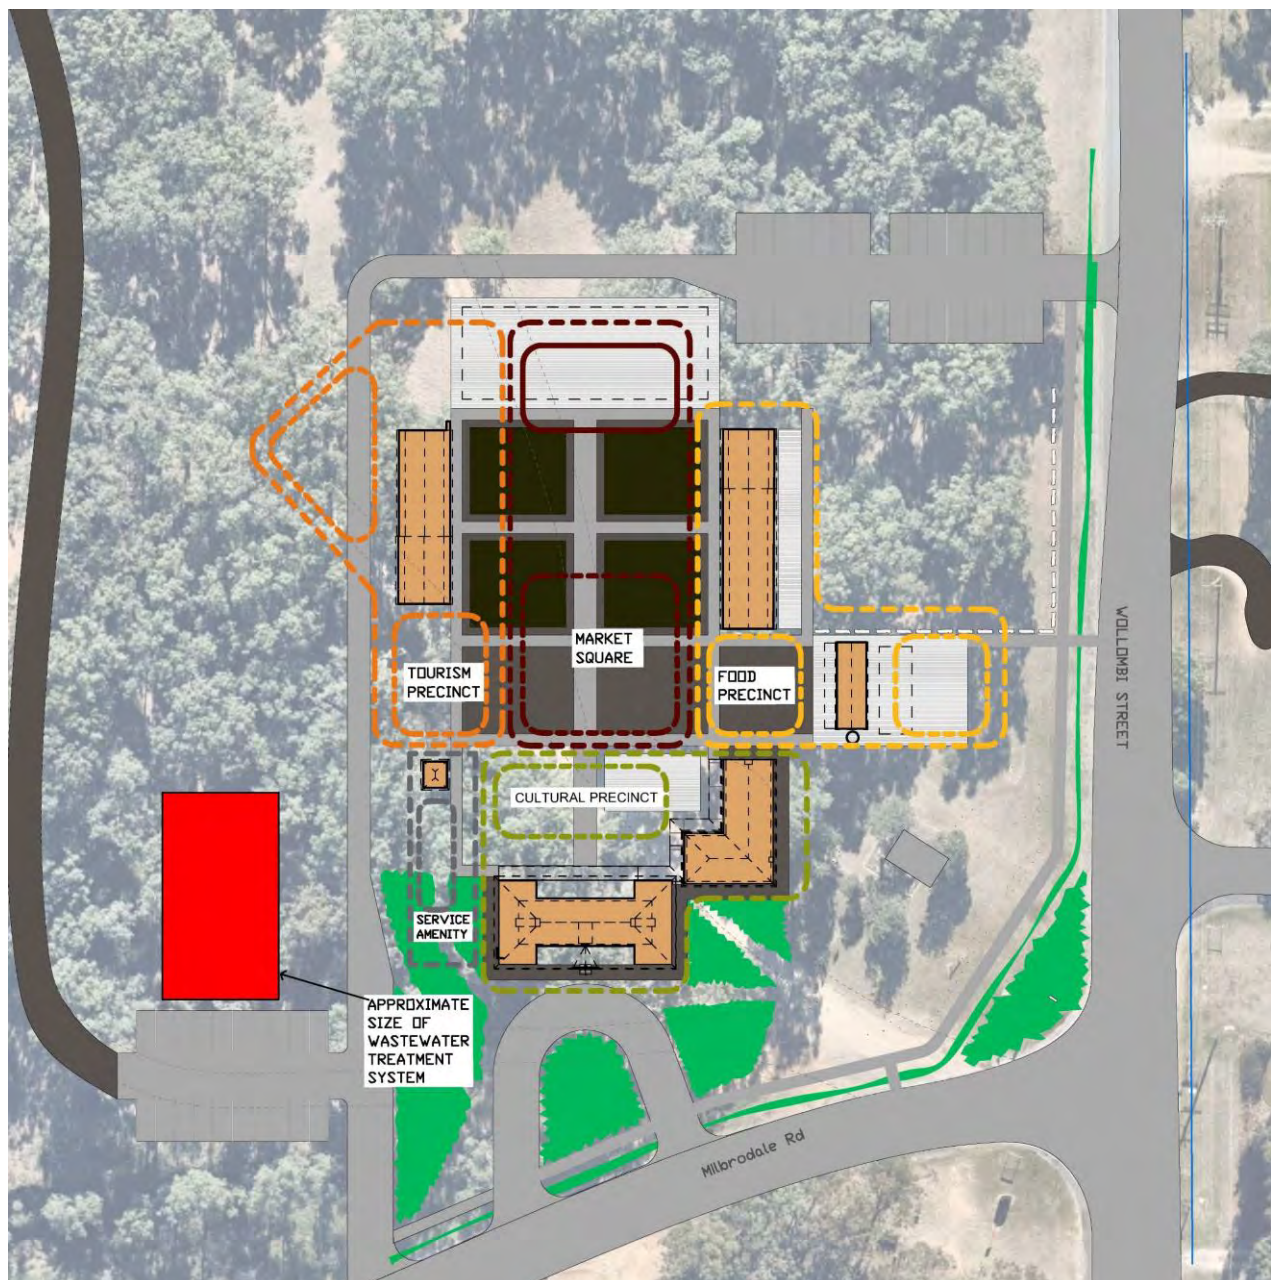
The approximate size of the Option 4 sewage treatment system is shown in Figure 3.5.

Figure 3.5 Sewage management - Option 4

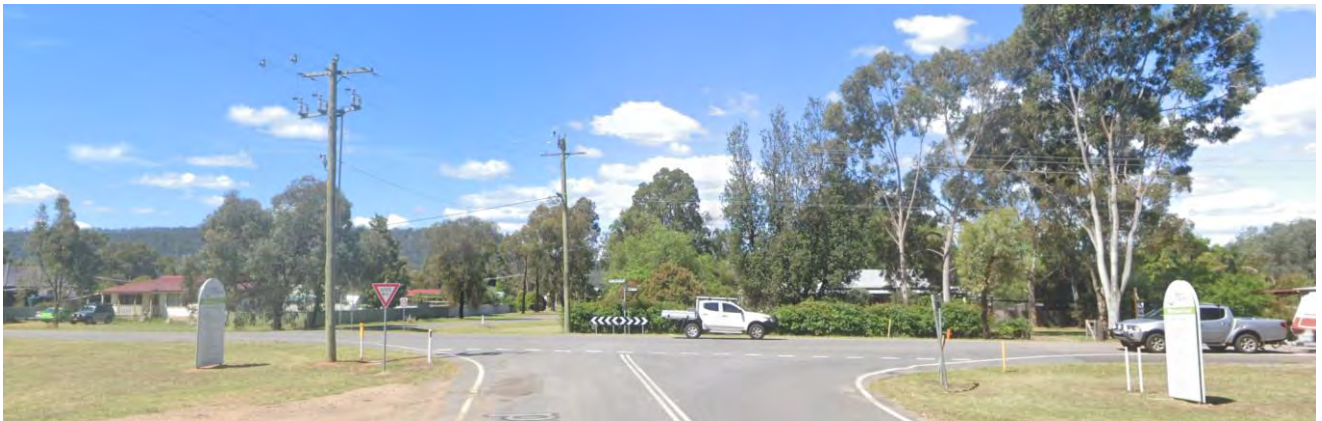
In addition to the 11 kV and low voltage Ausgrid infrastructure discussed above, it should be noted that there is an existing 11 kV feeder pole on Milbrodale Road, in front of the proposed main entrance to the development. This pole is designated DB-40131 and it carries the air break switch (ABL-27354). This air break switch (ABS) is used to isolate the HV branch line supplying properties on the western side of Wollombi Brook. Removal or relocation of this pole mounted ABS to clear the development frontage for aesthetics is feasible; however, this would likely prove to be a complex and costly exercise.

Figure 4.3 Air Break Switch 'ABL-27354' on pole 'DB-40131' at the intersection of Wollombi St and Milbrodale Rd

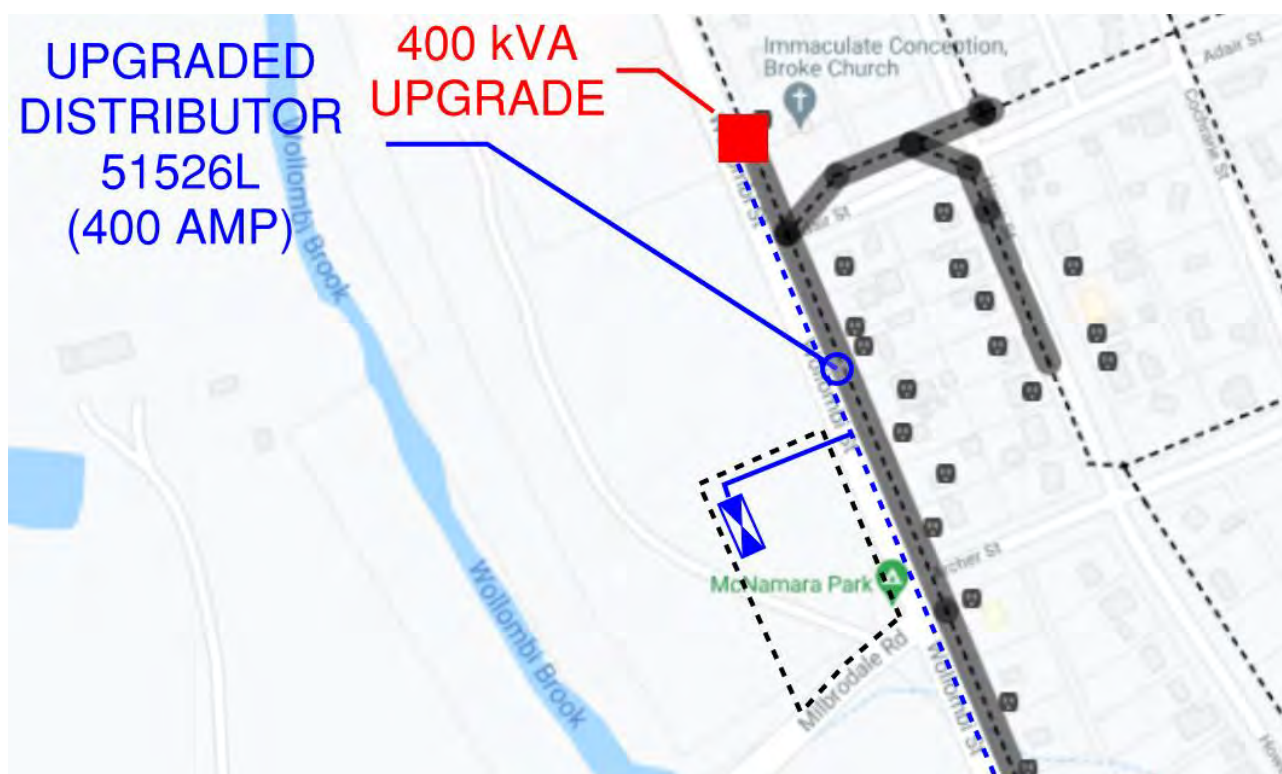
This arrangement would be classified by Ausgrid as contestable because both HV and LV infrastructure would need to be modified for this arrangement. An ASP3 design would need to be prepared then certified by Ausgrid for an ASP1 installation contractor used these to complete the works. The service connection works would still need to be completed by an ASP2 technician, in conjunction with electrical installation works on site by the licensed electrical contractor.

Figure 4.5 200 A 3 phase LV connection

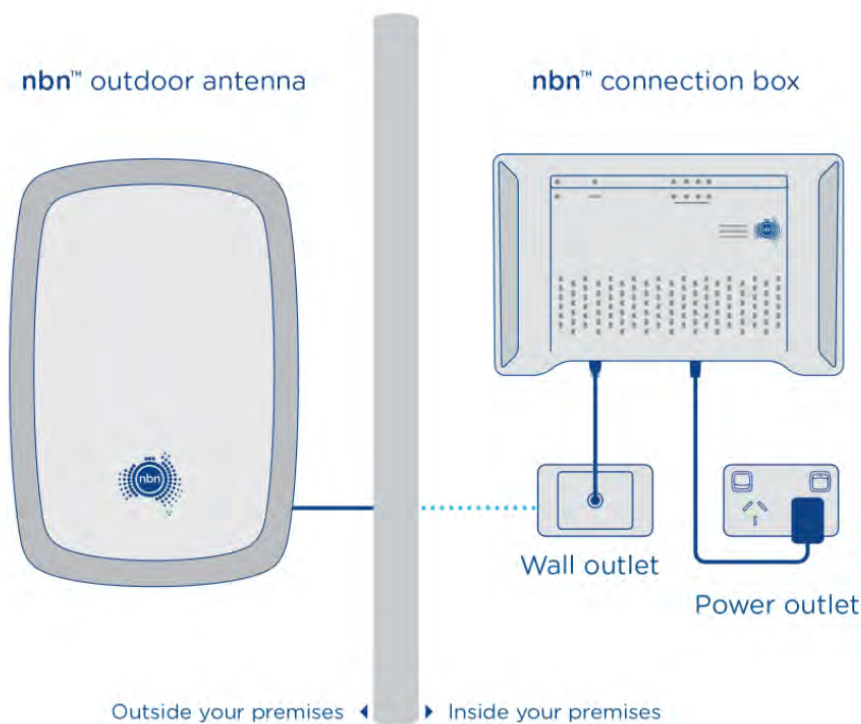
Fixed Wireless connections require an NBN connection box to be installed at the point where the cable from the NBN outdoor antenna enters a building, usually installed at the same building as the main electricity switchboard (i.e., not in a separate detached building or outhouse). This device requires 230 V ac power to operate and connects to a gateway (router/modem) via an Ethernet cable and then onwards using Wi-Fi or Ethernet to connect separate devices and appliances as required throughout the property.

Figure 5.2 NBN Fixed Wireless installation at a typical the development

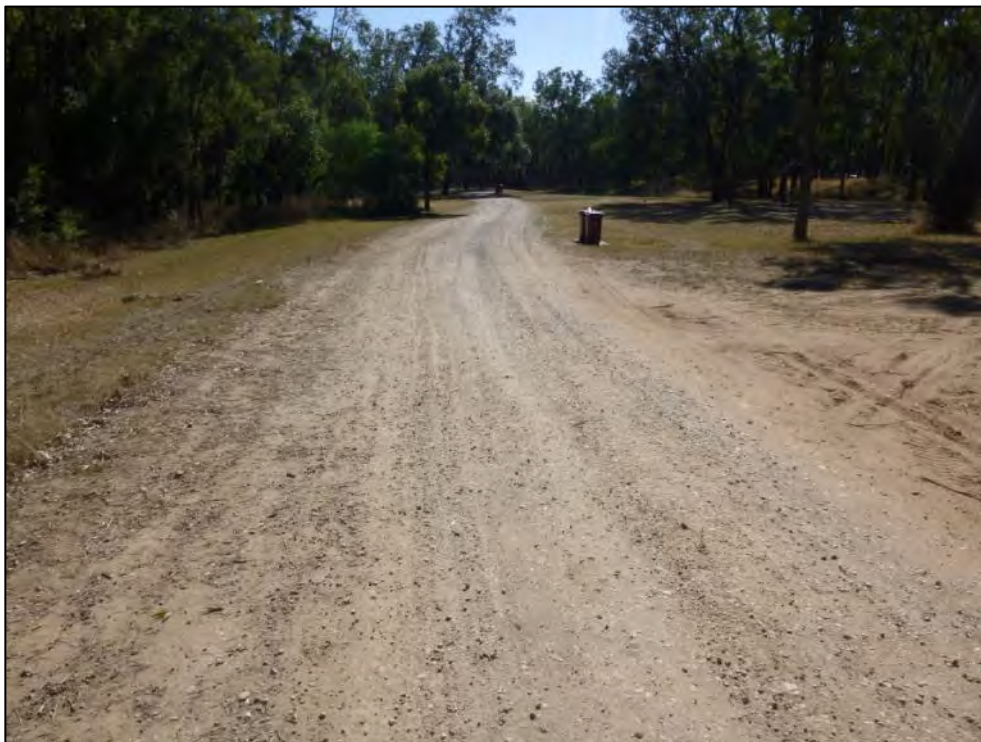
Plate 8: View along the graded access track with imported fill that traverses the secondary terrace.

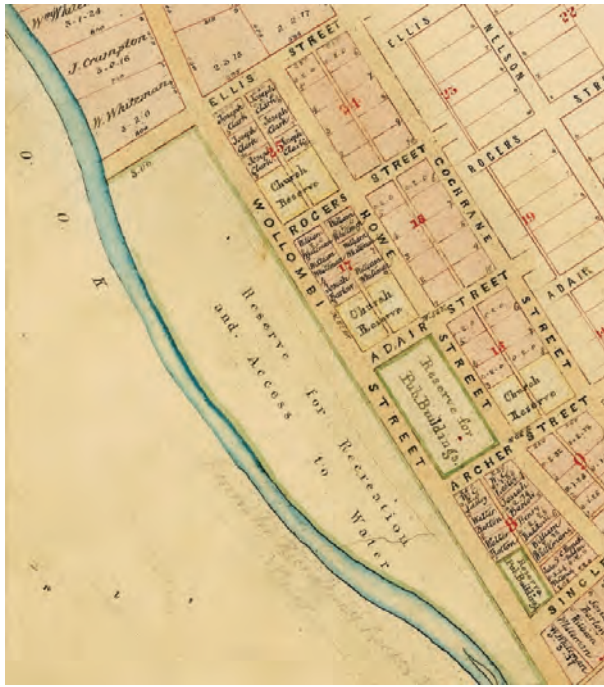
Figure 2. 4: Detail of the 1859 Village Design plan showing the Recreation and Water Reserve. Source: SA Map 1554

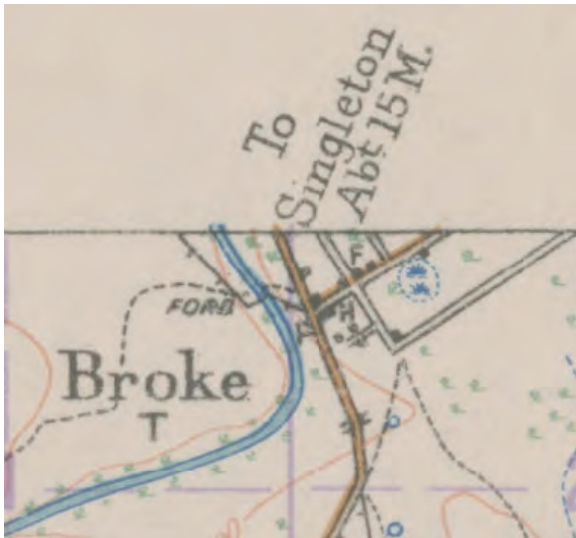
Figure 2. 9: The 1927 Topographical Map showed a ford across Wollombi Brook where a track crossed the Reserve. Source: Australia – Army, Topo Map 1:63360, ML Map M Ser 3 804 3, Cessnock, 1927, Zone 8 Sheet 395

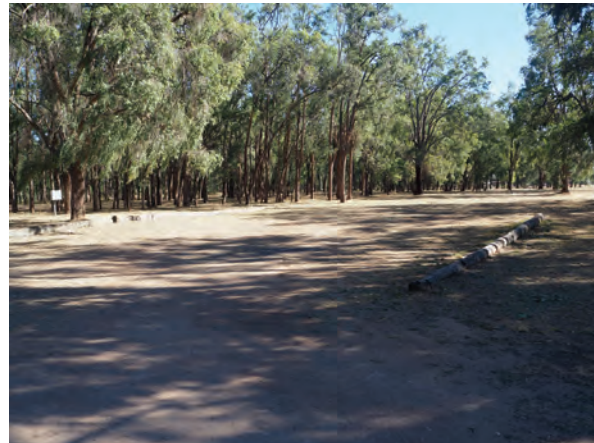
Figure 3. 24: Formal carparking area with log barriers and signage.

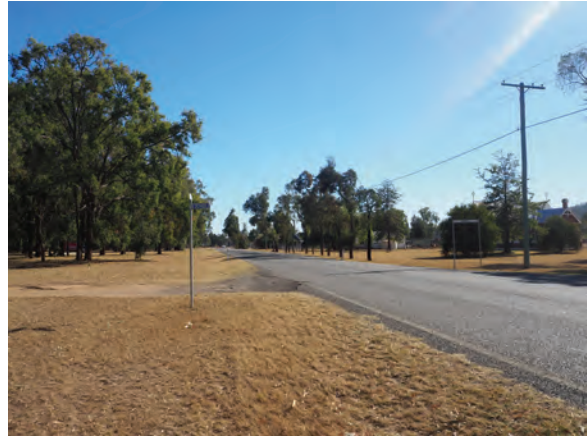
Figure 3.34: **Site Feature 4** - Unformed gravel and dirt road leading into the park from Wollombi Street. This area is designated as a rubbish depot although is not used for this purpose.

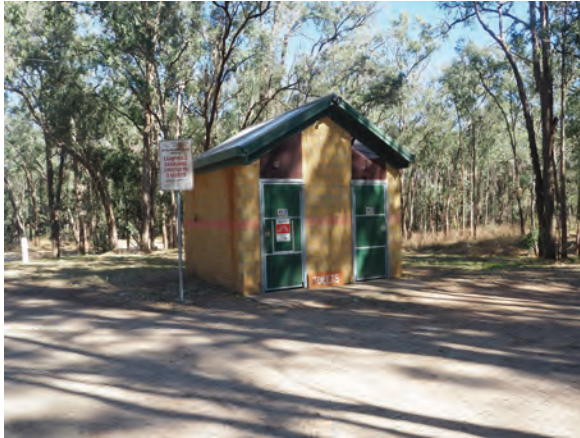
Figure 3.39: **Site Feature 6** - Amenities block

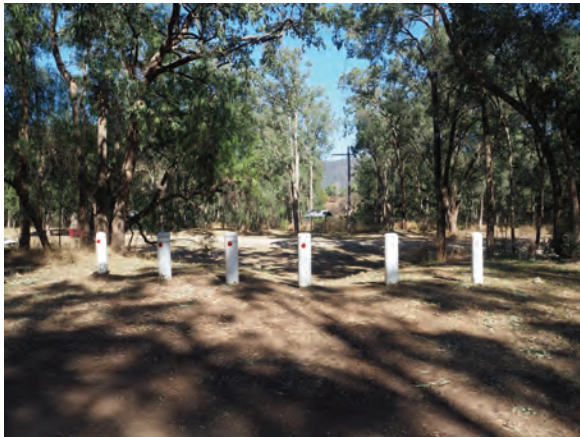
Figure 3.41: Line of painted timber and concrete vehicle barriers on bank leading down to lower camping area and picnic sites.

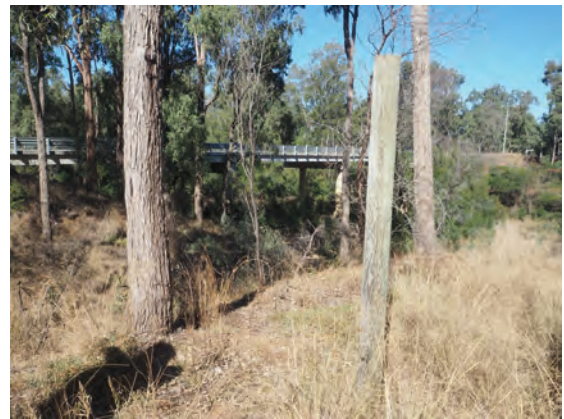
Figure 3.44: **Site Feature 8** - View of Broke Bridge from southern end of park with deep culvert leading down to Wollombi Brook.
