# **Holcim (Australia) Pty Ltd**

## **Dunloe Sand Quarry Landscape Management Plan**

June 2021

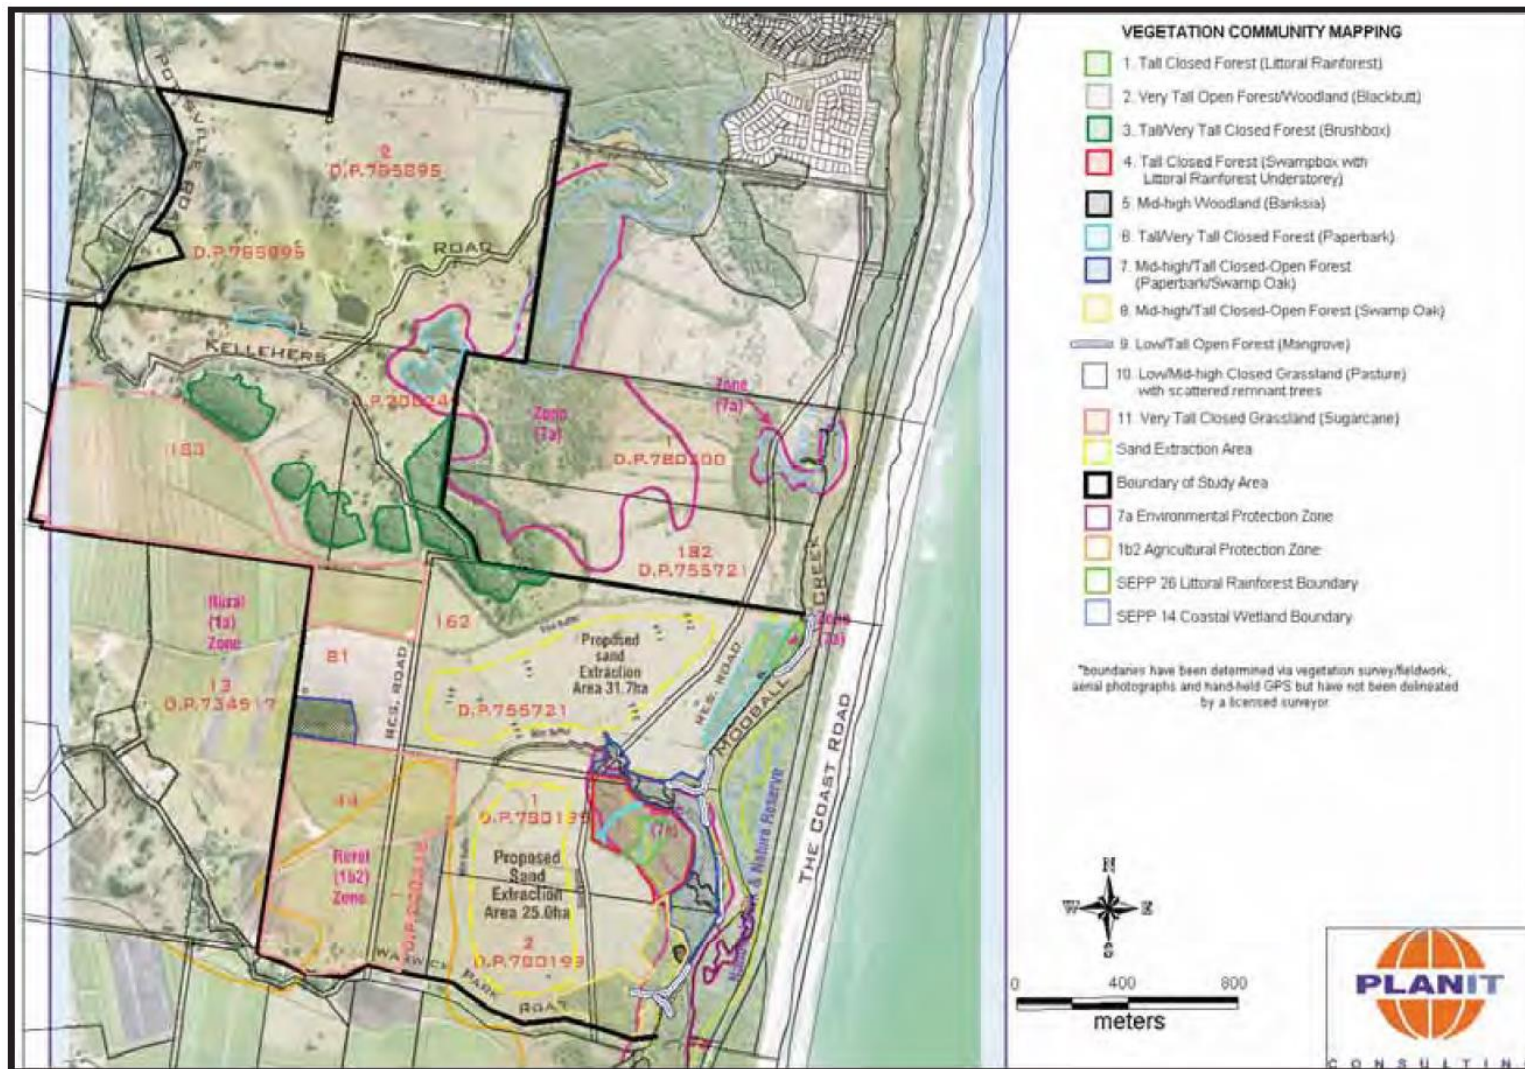
**Figure 3-1 Vegetation communities**

The quarry access road runs parallel with the northern Brushbox Forest (Community 3), which provides koala habitat. Potential impacts to koalas include unauthorised clearing of koala habitat and vehicle strike as a result of trucks and light vehicles accessing the Quarry.

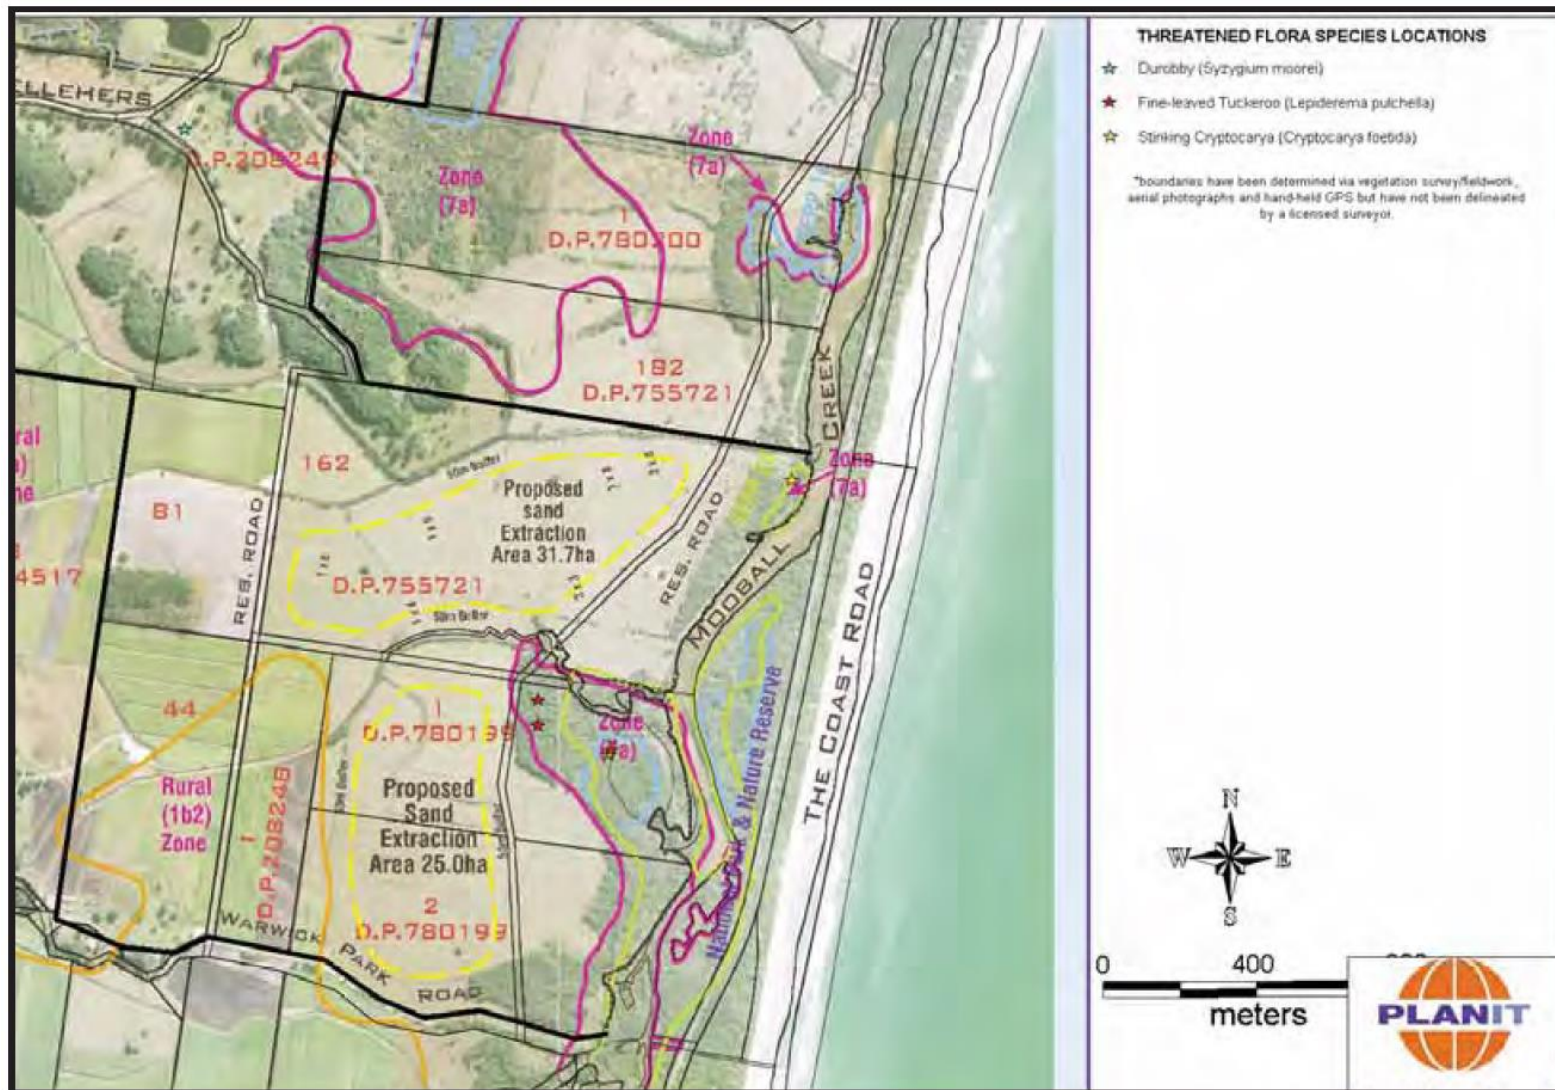
**Figure 3-2 Threatened flora locations**

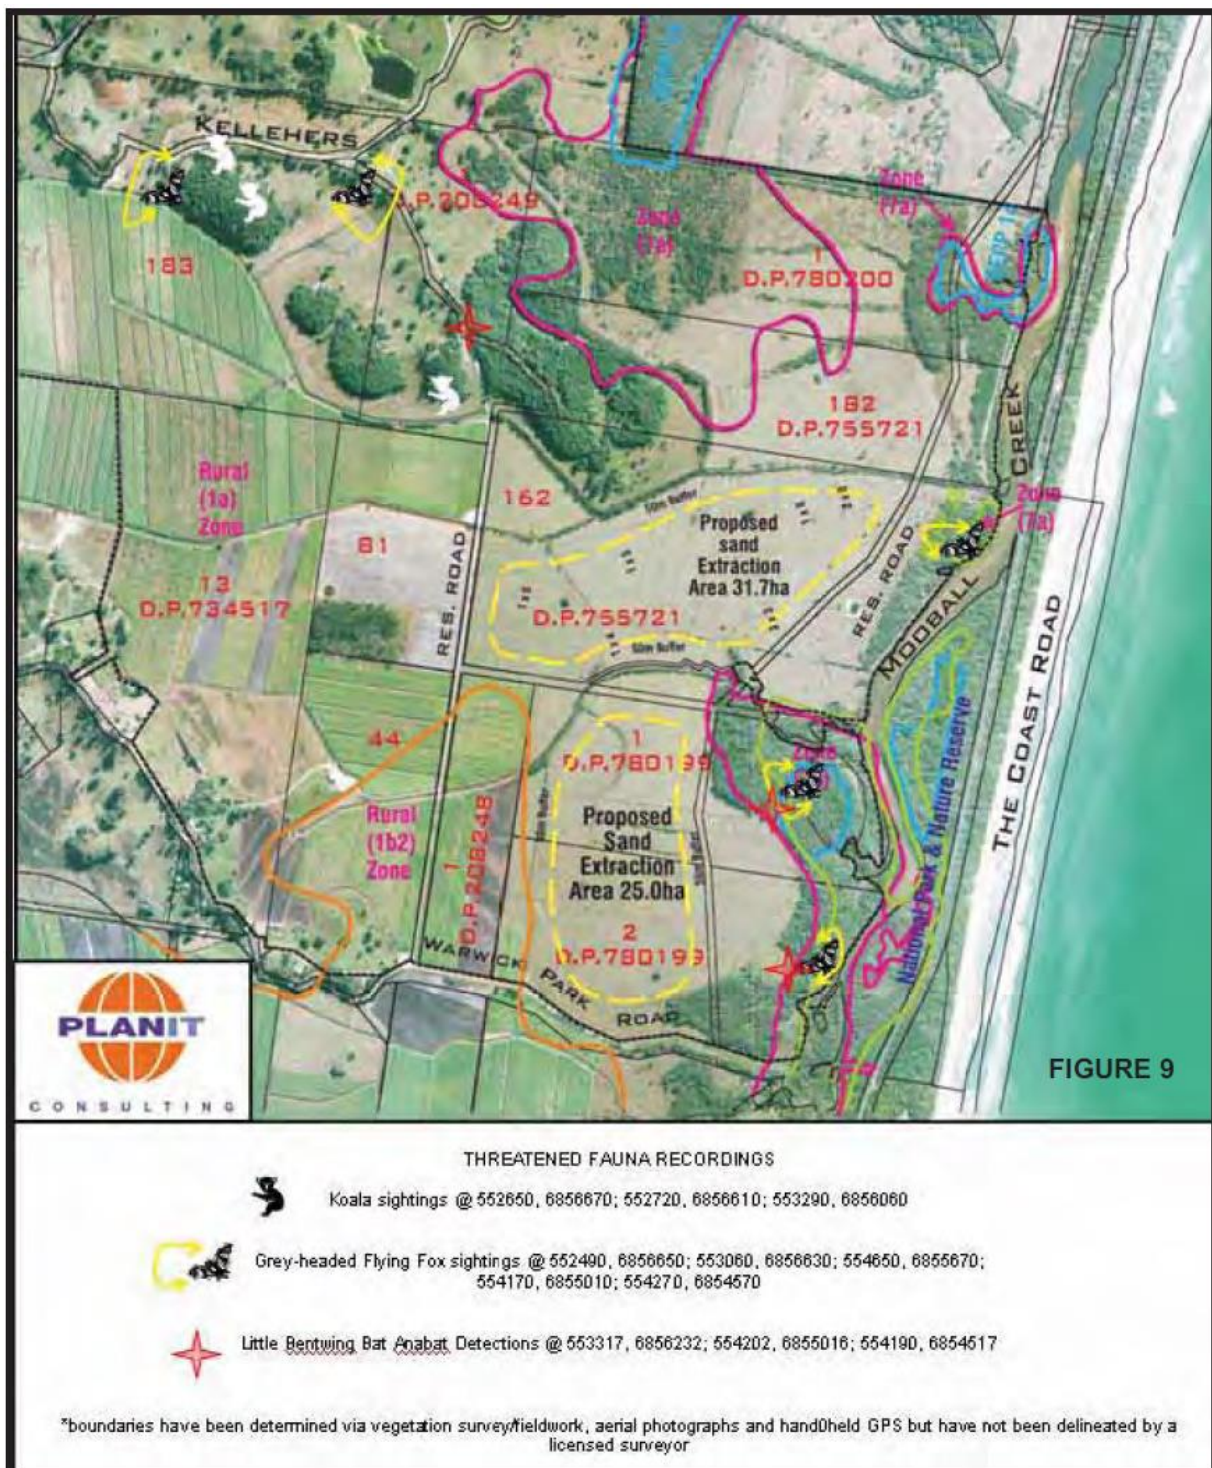
**Figure 3-3 Threatened fauna recordings**

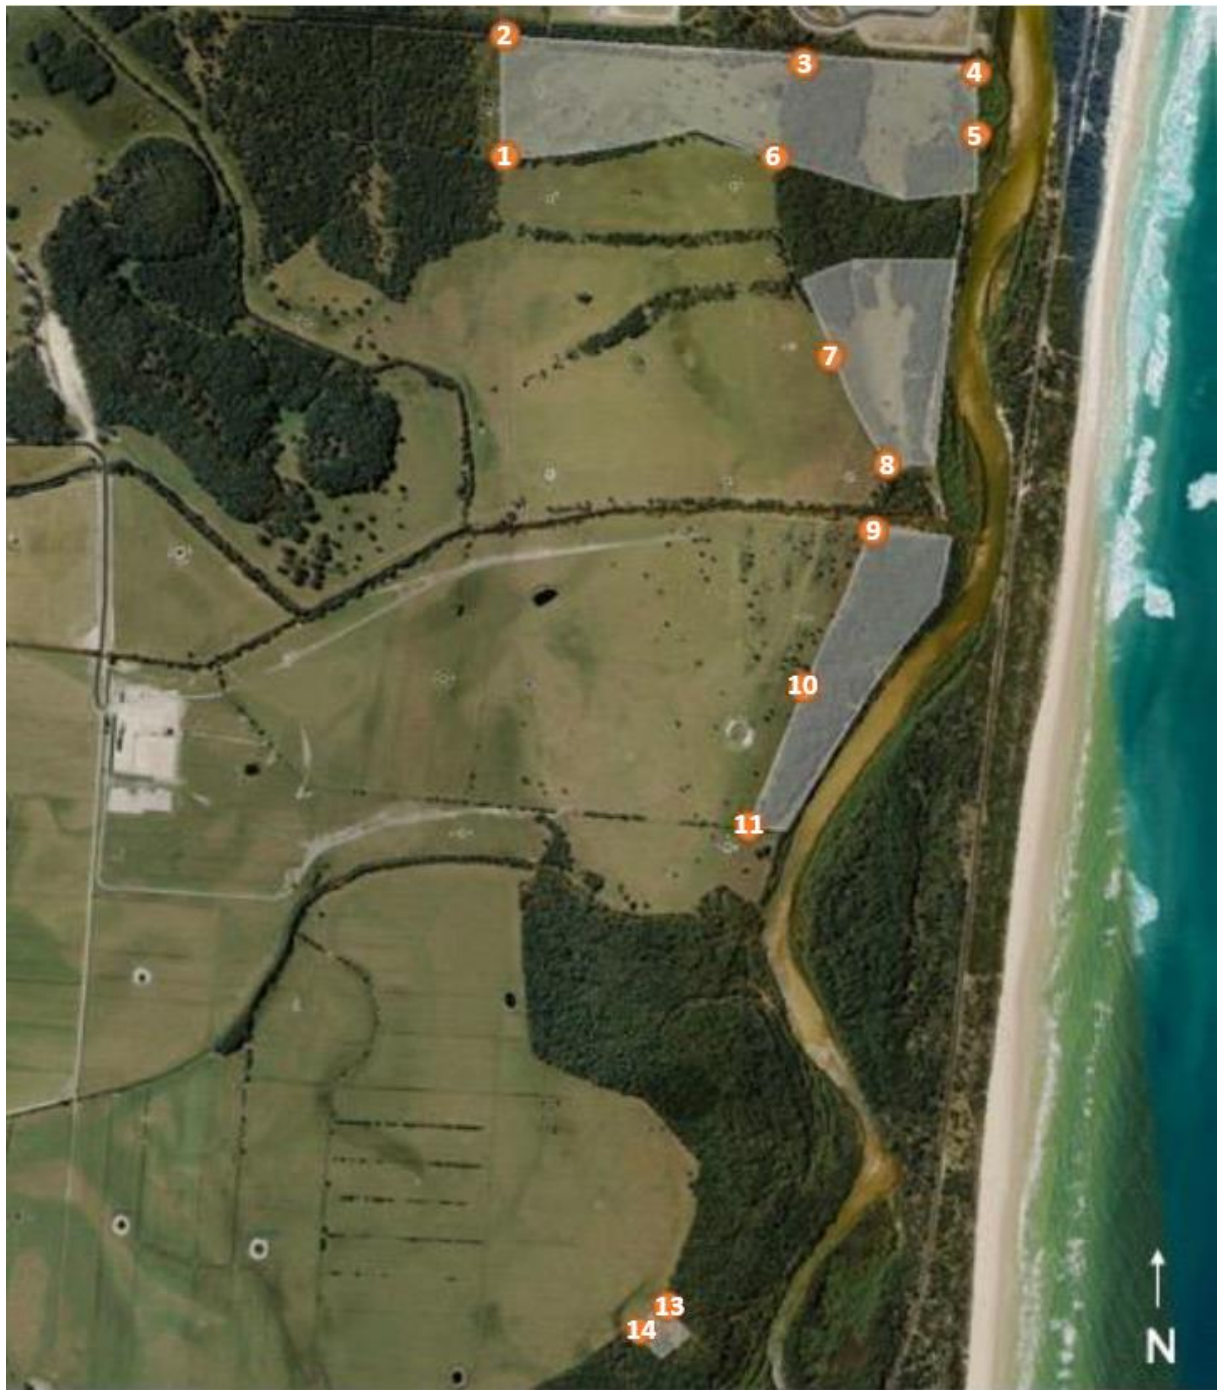
**Figure 5-1 Permanent photo points and monitoring locations**

Thirteen permanent photo points have been established (Figure 5-1) where photographs will be taken at regular intervals to provide a visual indication of plant growth (height and extent) and weed presence. Photographs shall be taken at the SW, SE, NW, NE corners of each monitoring site.

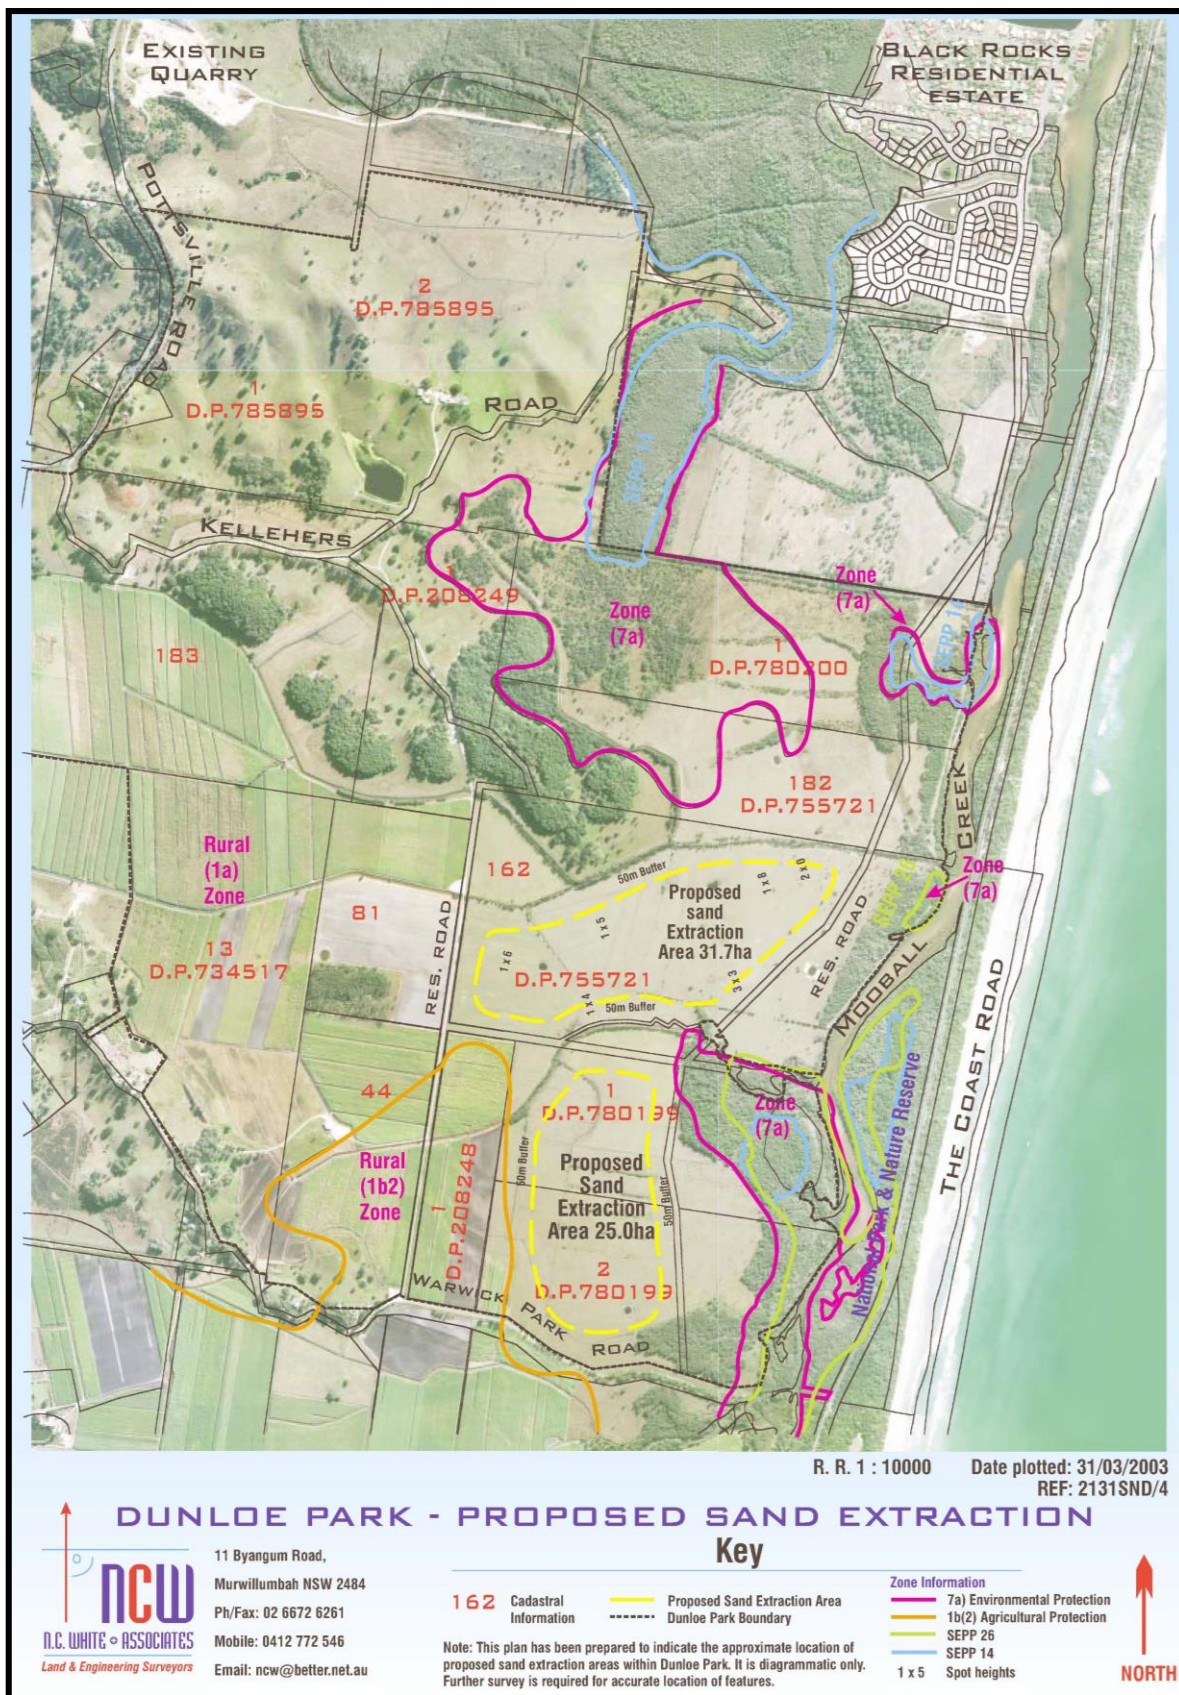
FIGURE 1: AERIAL PHOTOGRAPH

A relatively small works area has been established adjacent to the south western corner of extraction pond stage one (1), which contains the work plant and machinery, stockpiled material and a small building housing workers amenities and an administration area.

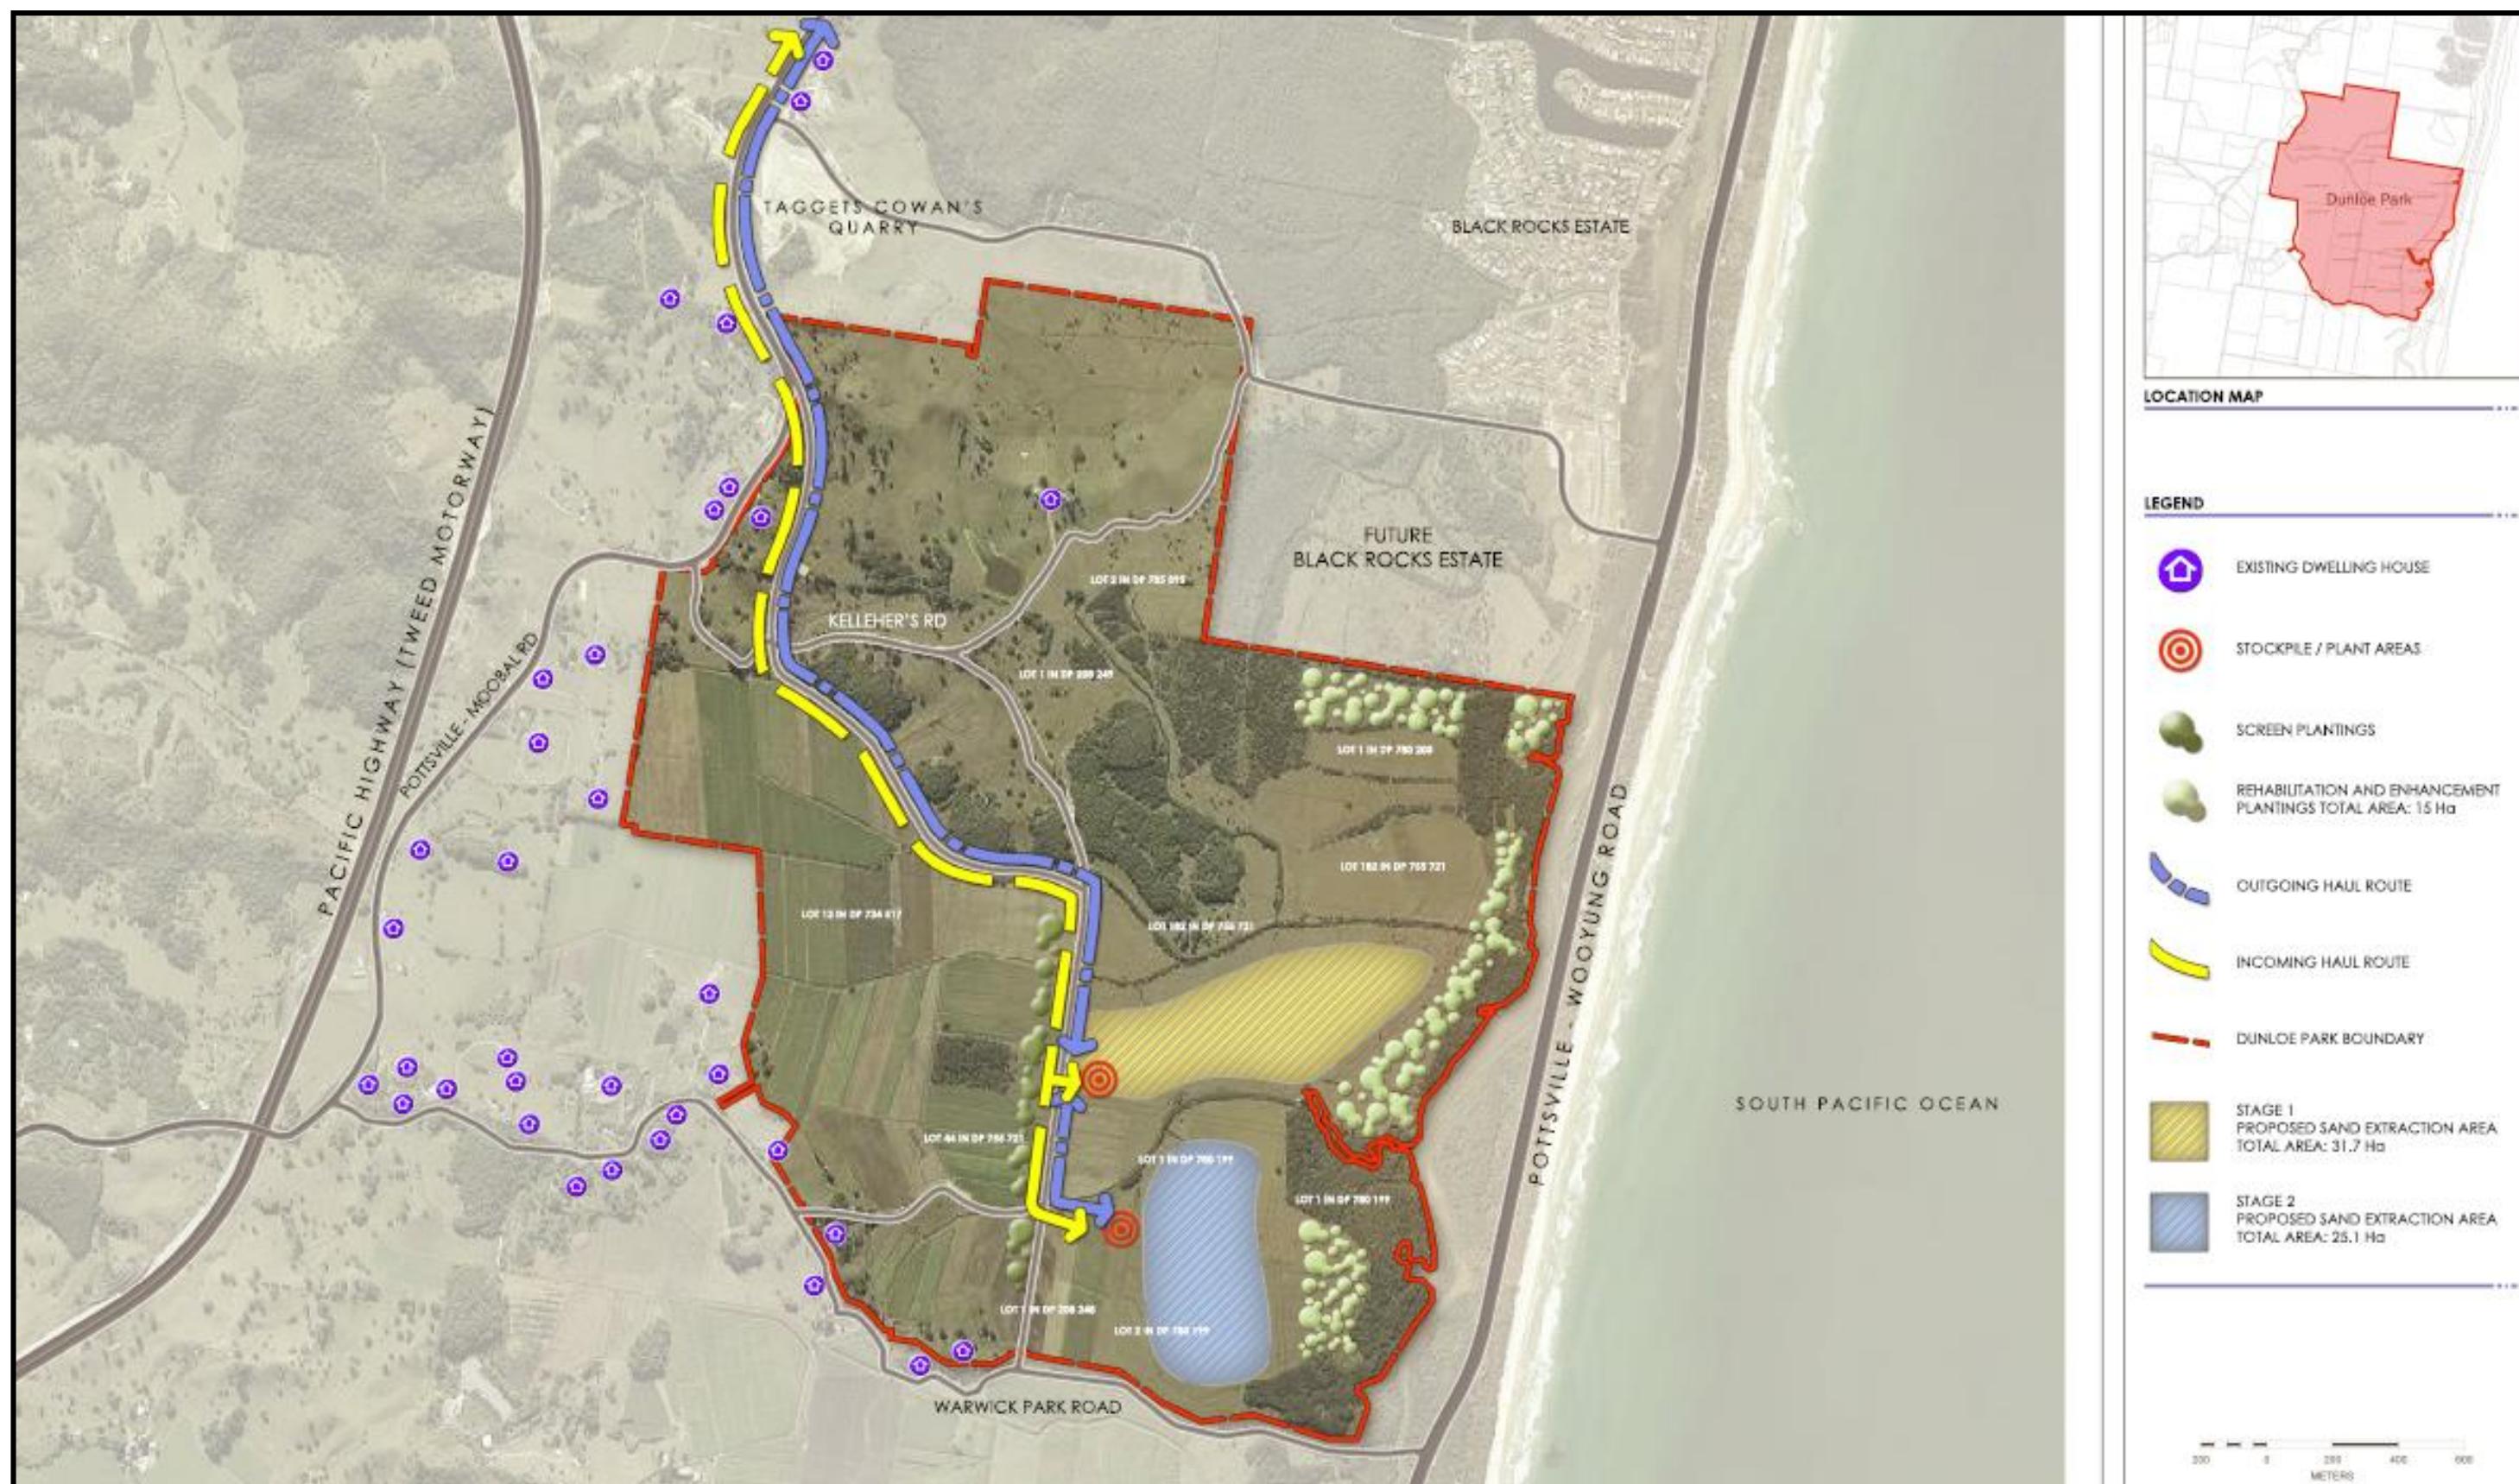
FIGURE 2: PREVIOUSLY APPROVED DEVELOPMENT CONCEPT (Total Rehabilitation Area 15Ha, exact location and extent determined in OPW Rehabilitation Plans)

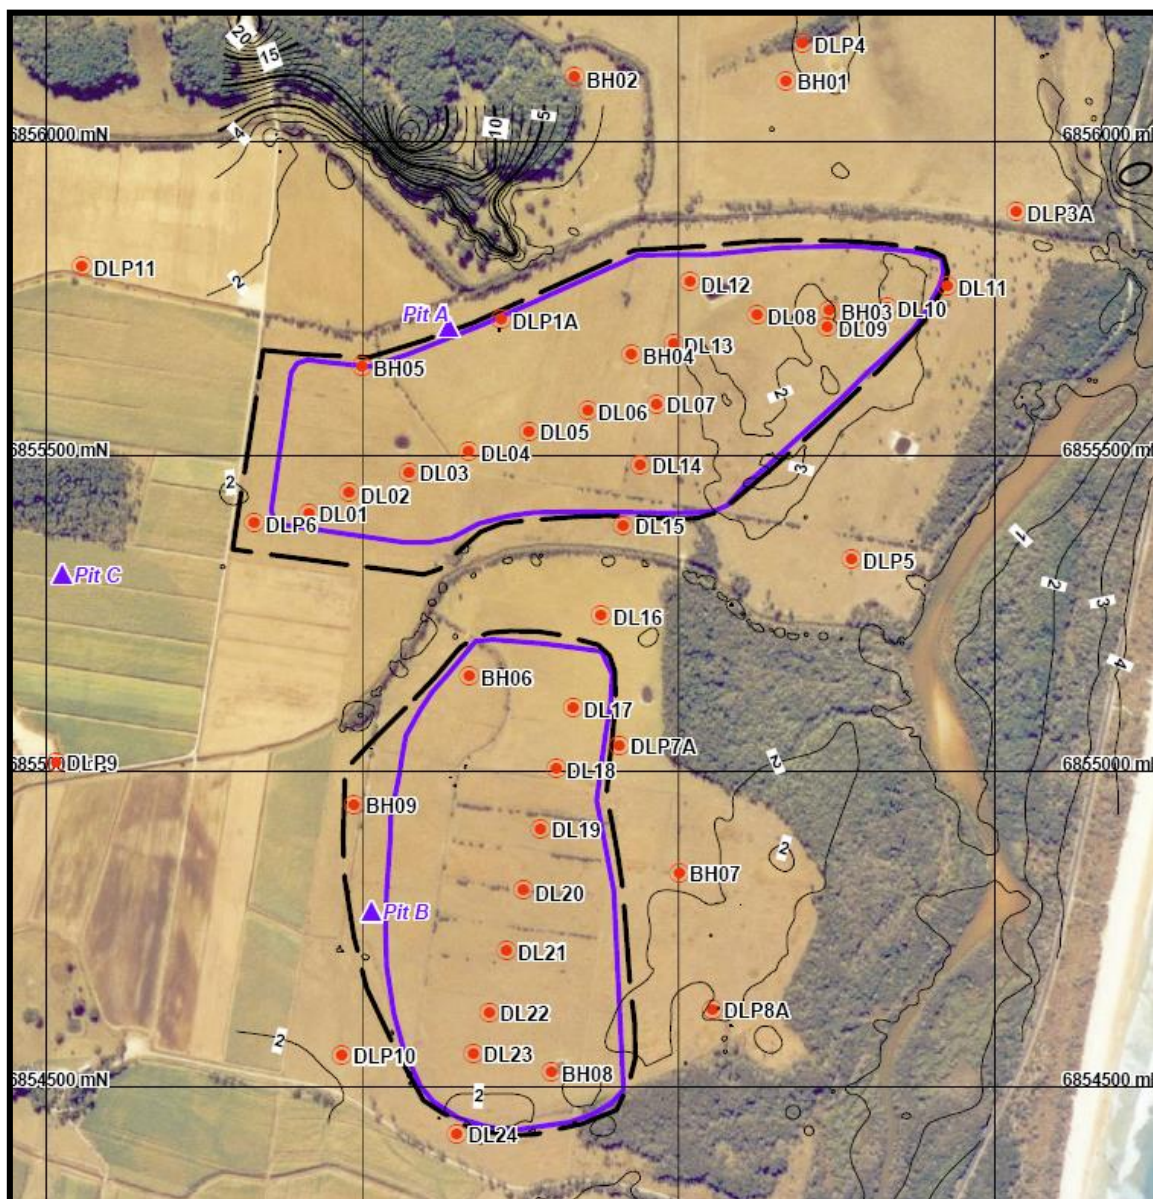
**FIGURE 3: TOPOGRAPHY (SOURCE: GILBERT & SUTHERLAND, 2007)**

The majority of the development site is generally low lying with elevations ranging from <1.3m AHD towards the south western boundary to only a few metres above sea level in the south eastern corner of the proposed Extraction Area No.1. The north western corner of the site has levels in the vicinity of 3.3m AHD

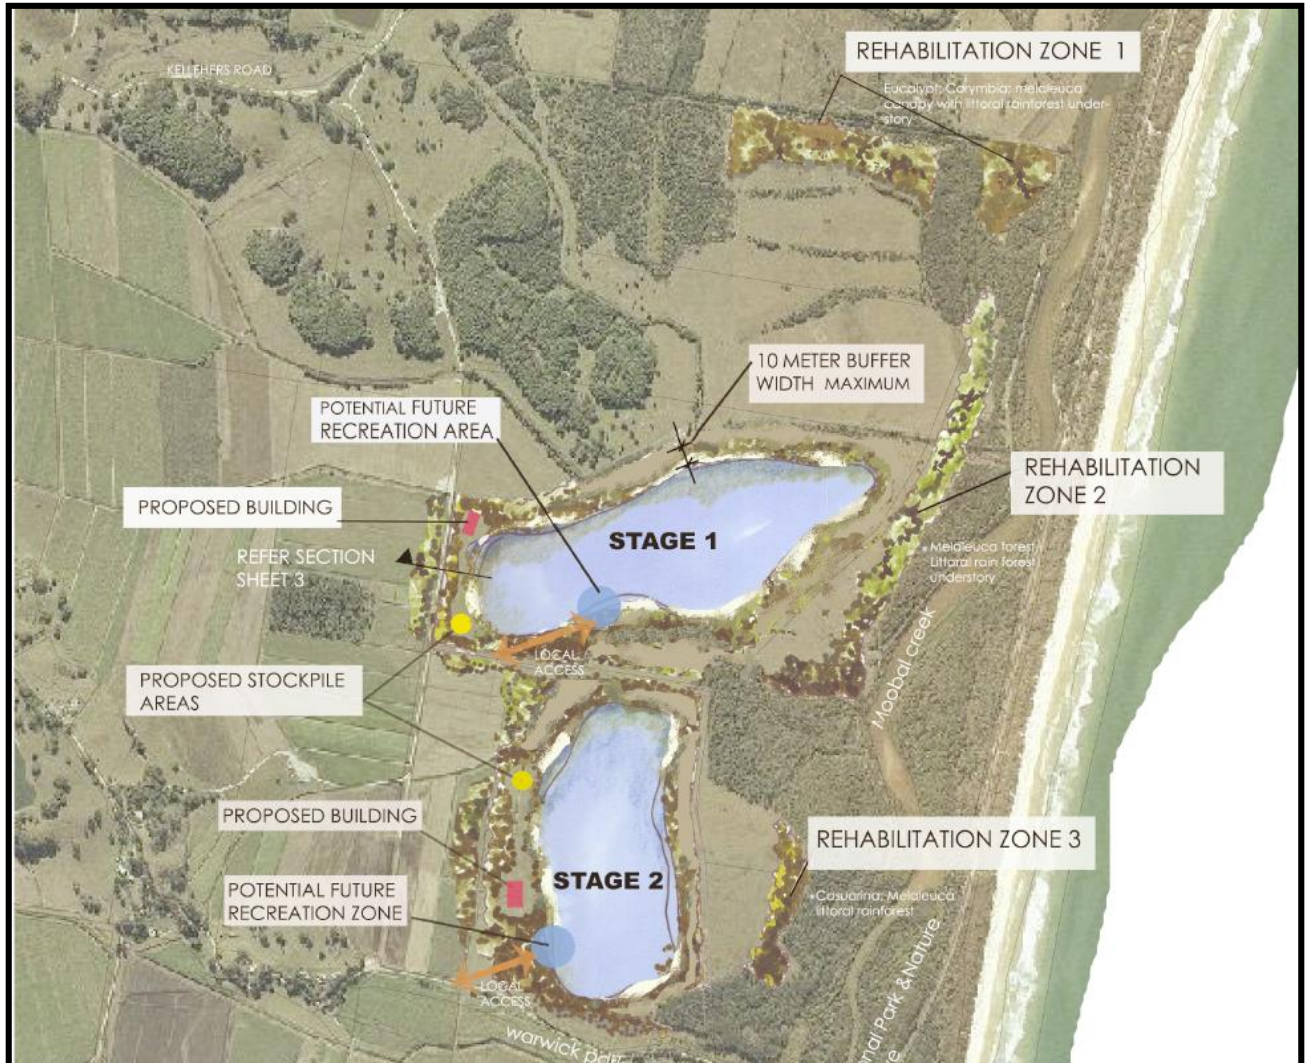
**FIGURE 10: APPROVED REVEGETATION CONCEPT PLAN**  
(Total Rehabilitation Area 15Ha, exact location and extent determined in OPW  
Rehabilitation Plans)

Rehabilitation and Revegetation Management Plan is to incorporate additional revegetation areas proposed (Zone No. 4) and the proposed future agricultural use surrounding the two lakes (i.e. avocado tree plantations).

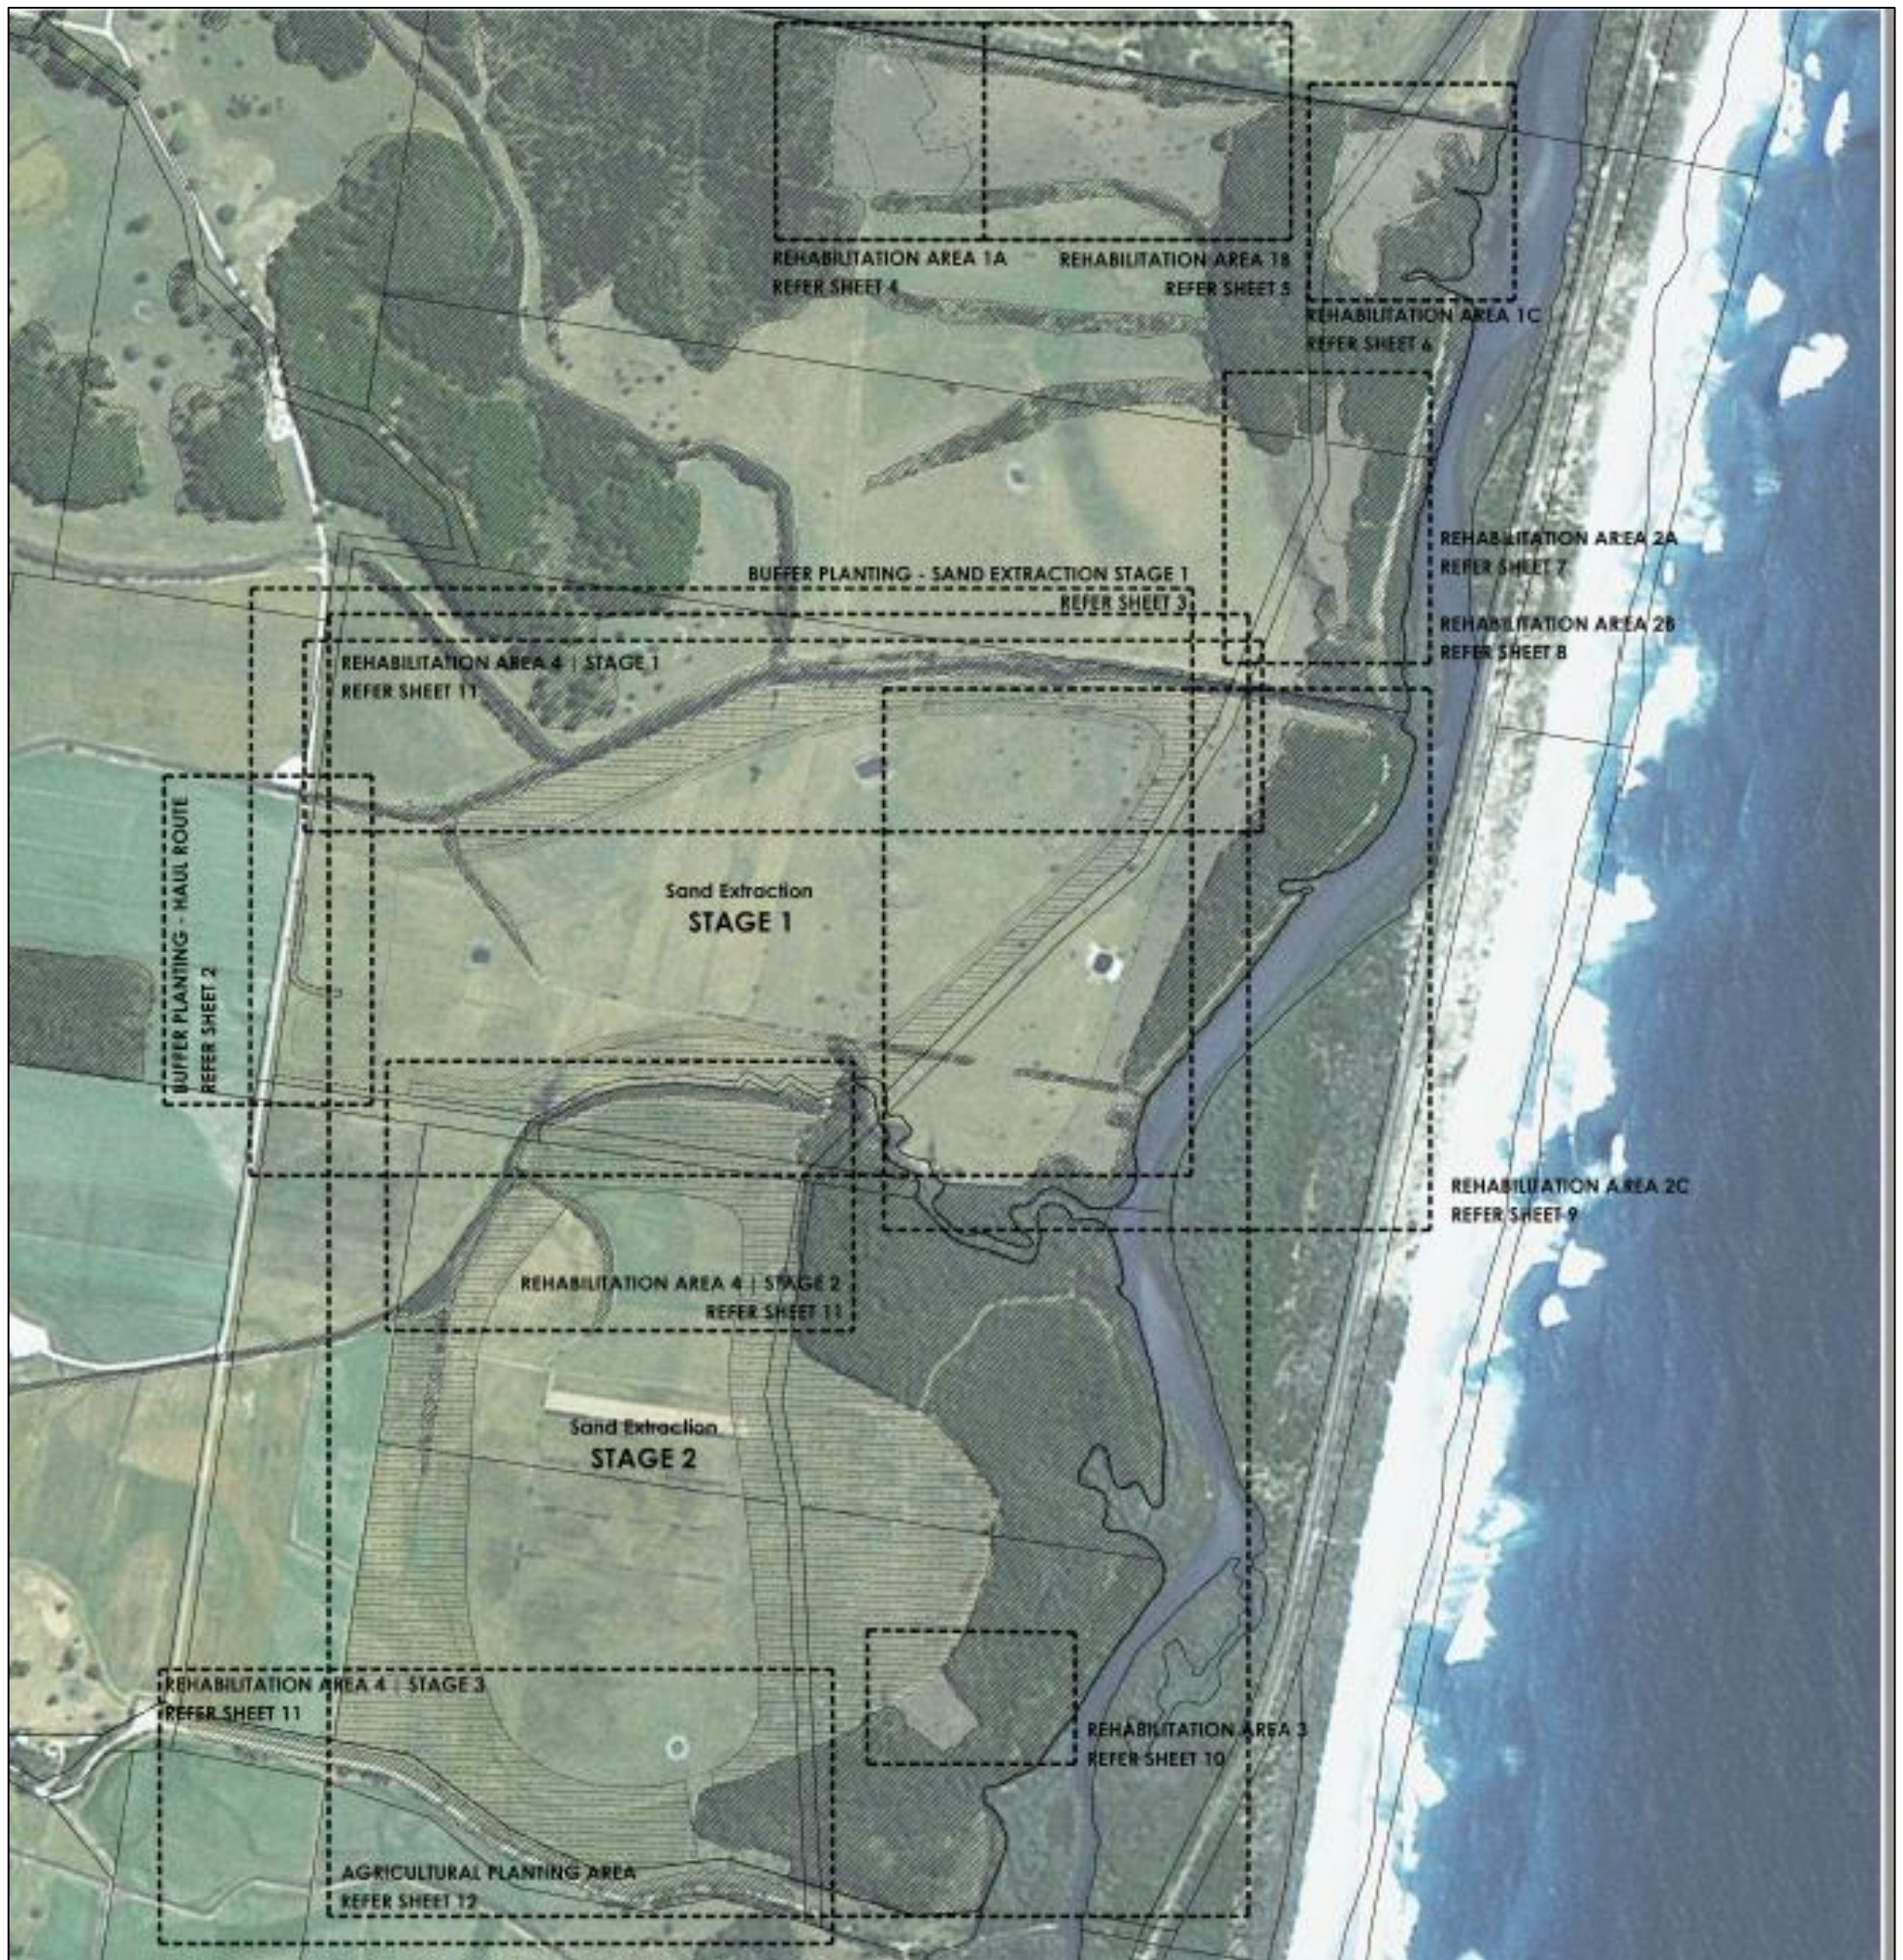
FIGURE 11: DETAILED REVEGETATION/REHABILITATION PLAN (ALSO REFER ATTACHMENT 3)

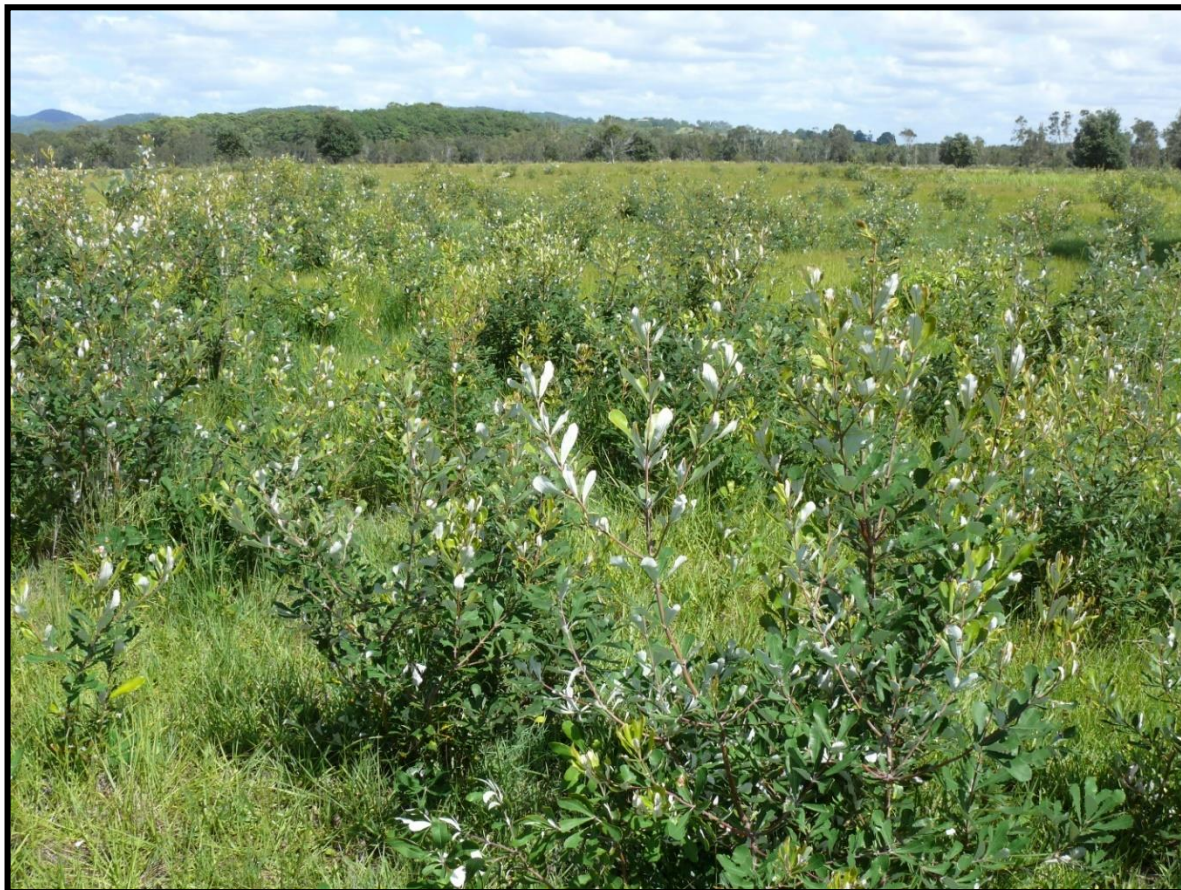
**FIGURE 12: EXAMPLE OF NATURAL REGENERATION DURING TRIALS IN 2008**

Cattle were excluded from portions of the 15ha rehabilitation zone (zones 1-3) in late 2008 to allow test trials of natural regeneration to be monitored with germination of pioneer canopy trees (melaleuca, callistemon, casuarina, lophostemon, banksias etc) noted.

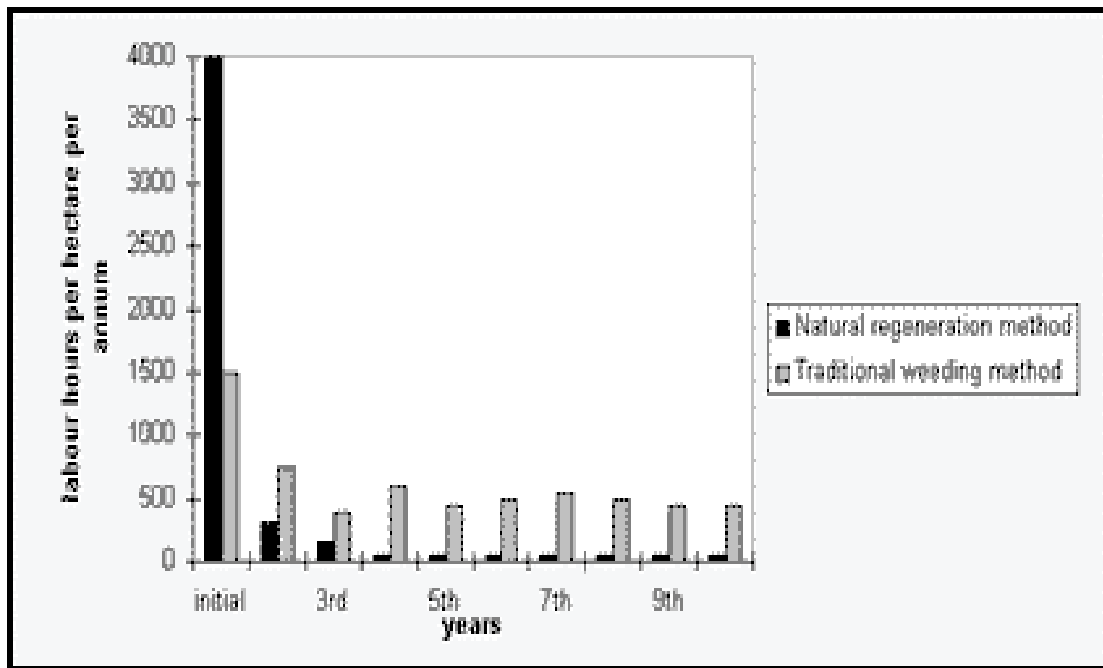
FIGURE 13 : Source - Ku-ring-gai Parks Dept. NSW, cited in Buchanan (1989)  
Comparison of labour hours using traditional weeding and natural regeneration methods.

The regeneration of native species is inversely proportional to increasing weed growth. Therefore, weeding should not automatically move into more degraded areas when less infested areas have been initially weeded. It is often better to simply wait for the less infested areas to regenerate before proceeding slowly into the worse areas. Clearing all infested areas at once causes extensive, additional follow up weeding works (refer Figure 13 below).

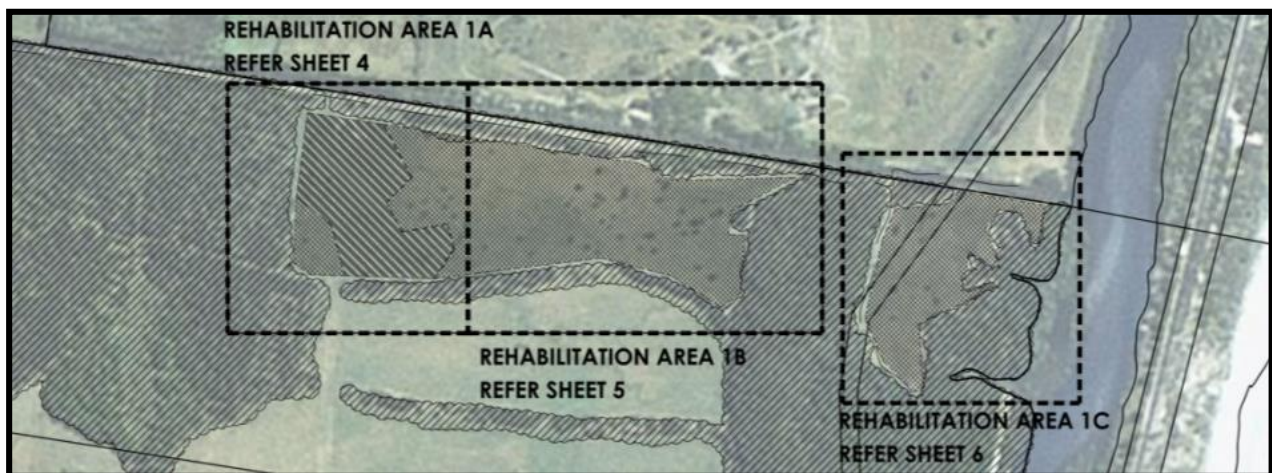
**FIGURE 14: REHABILITATION AREA/ZONE 1**

This rehabilitation zone covers 8.9 hectares and consolidates a fragmented corridor of swamp sclerophyll endangered ecological communities and wetlands located in the northern areas of the site. Cattle have been excluded from this zone to allow rehabilitation. Species noted include Paperbark, Swamp Oak, Swamp Mahogany, Corkwood, Swampbox, Banskia, Hovea, Hatpins, Pennywort, Blady Grass, Bunchy Sedge and Sundew. Wetland plants are also common with a low-lying soak in the west of the zone managed for Freshwater Wetland Endangered Ecological Community (EEC) regeneration.
