# **Holcim (Australia) Pty Ltd**

## **Dunloe Sand Quarry Landscape Management Plan**

June 2021

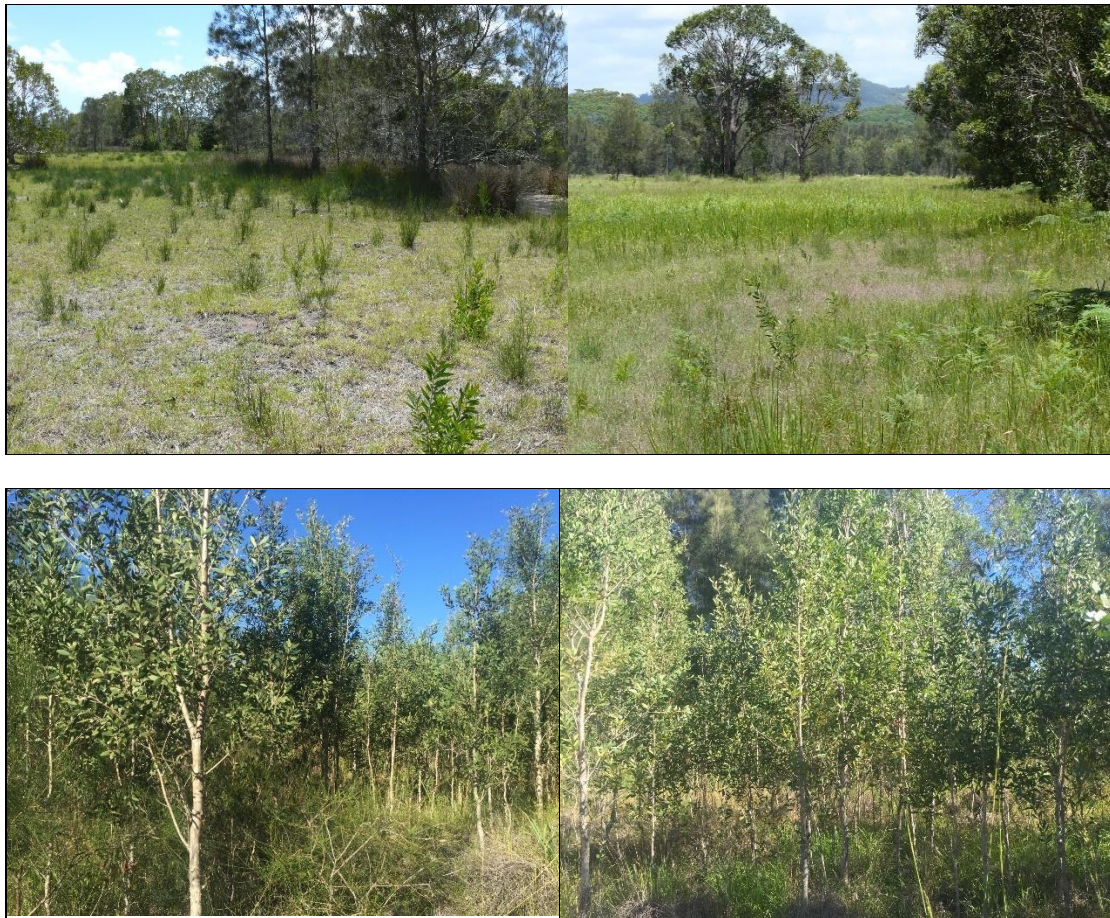
**FIGURE 15: BEFORE AND AFTER REHABILITATION IMAGES OF  
REHABILITATION AREA/ZONE 1**

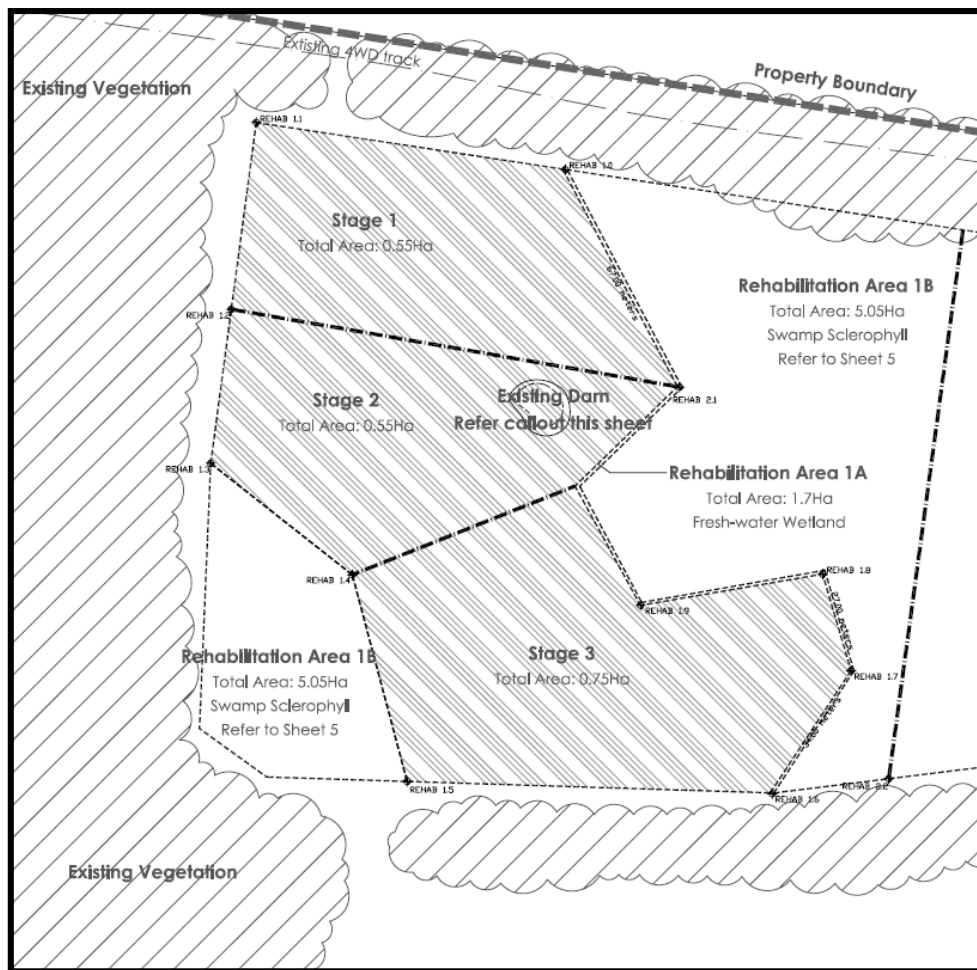
Each zone/area (1A-1C) has been broken down into management stages of approximately 0.5ha to allow staged management as described in Section 4.2.1 above. Zone 1A has been managed to establish a Freshwater Wetland EEC and zones 1B & 1C managed to establish Swamp Sclerophyll EECs. Littoral Rainforest EEC species are utilized in the sub-canopy and shrub layers.

**FIGURE 16: STAGING OF ZONE 1A (ALSO REFER ATTACHMENT 3)**

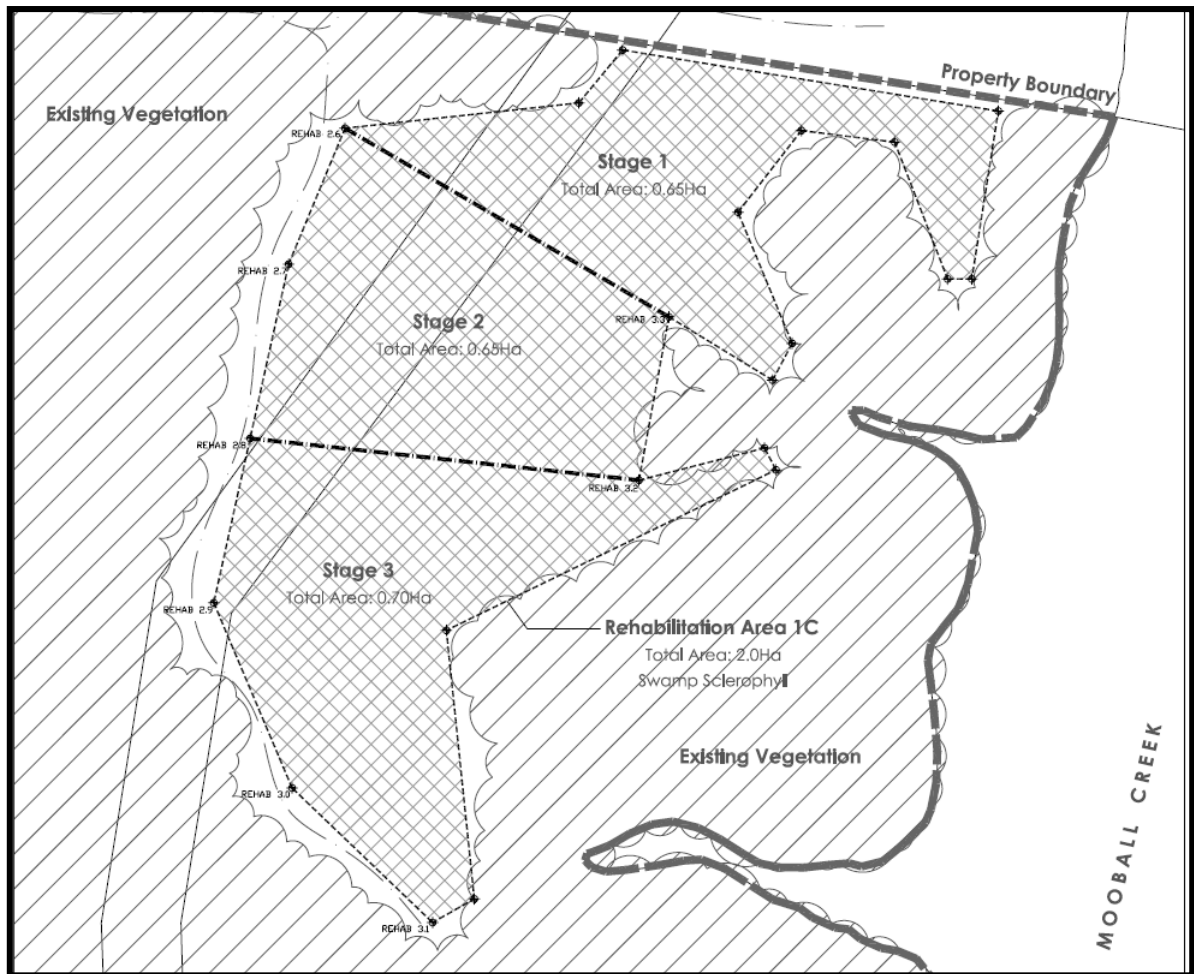
**FIGURE 18: STAGING OF ZONE 1C (ALSO REFER ATTACHMENT 3)**

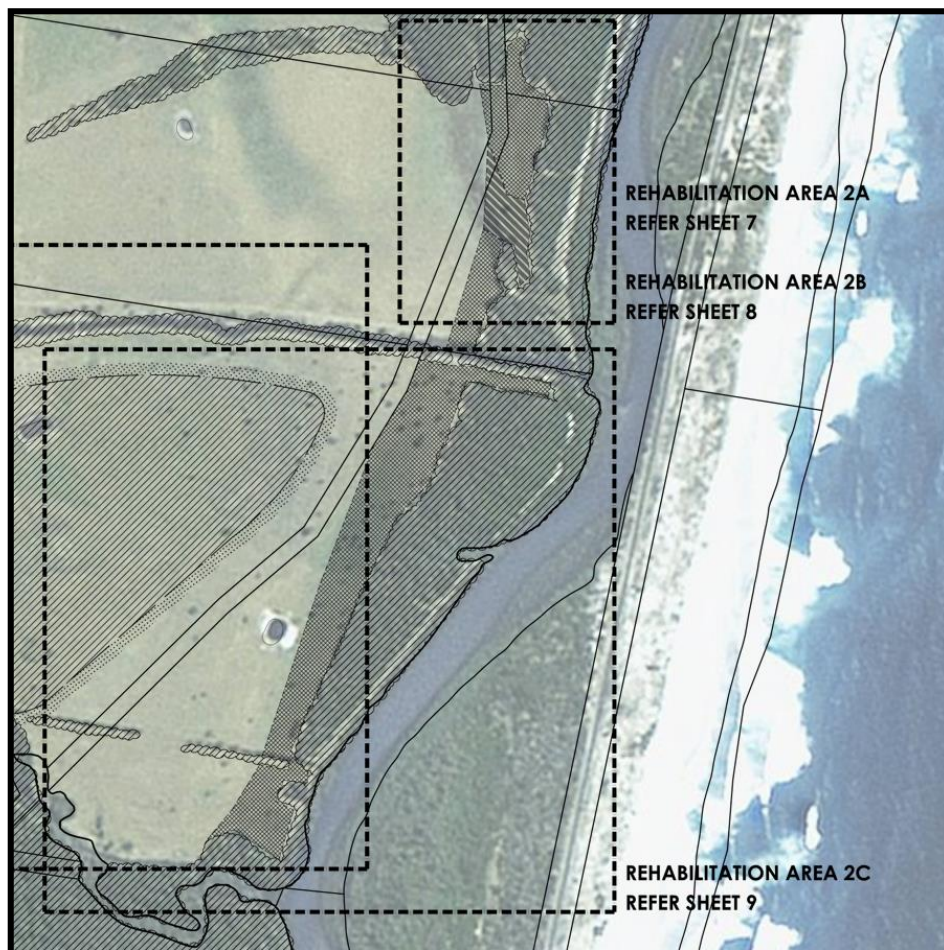
FIGURE 24: REHABILITATION AREA/ZONE 2

This rehabilitation zone covers 5.08 hectares and consolidates a fragmented corridor of swamp sclerophyll endangered ecological communities and wetlands located adjacent to Mooball Creek. Cattle have been excluded from this zone to allow rehabilitation. Species noted prior to regeneration procedures include Banksia, Swamp Oak, Paperbark, Willow Bottlebrush, Corkwood, Swampbox, Geebung, Bracken, Midyim, Blady Grass, Bunchy Sedge and Tuckeroo. Wetland plants are also common with a low-lying soak in the northeast of the zone managed for a combination Freshwater Wetland and Saltmarsh Endangered Ecological Community (EEC) regeneration.

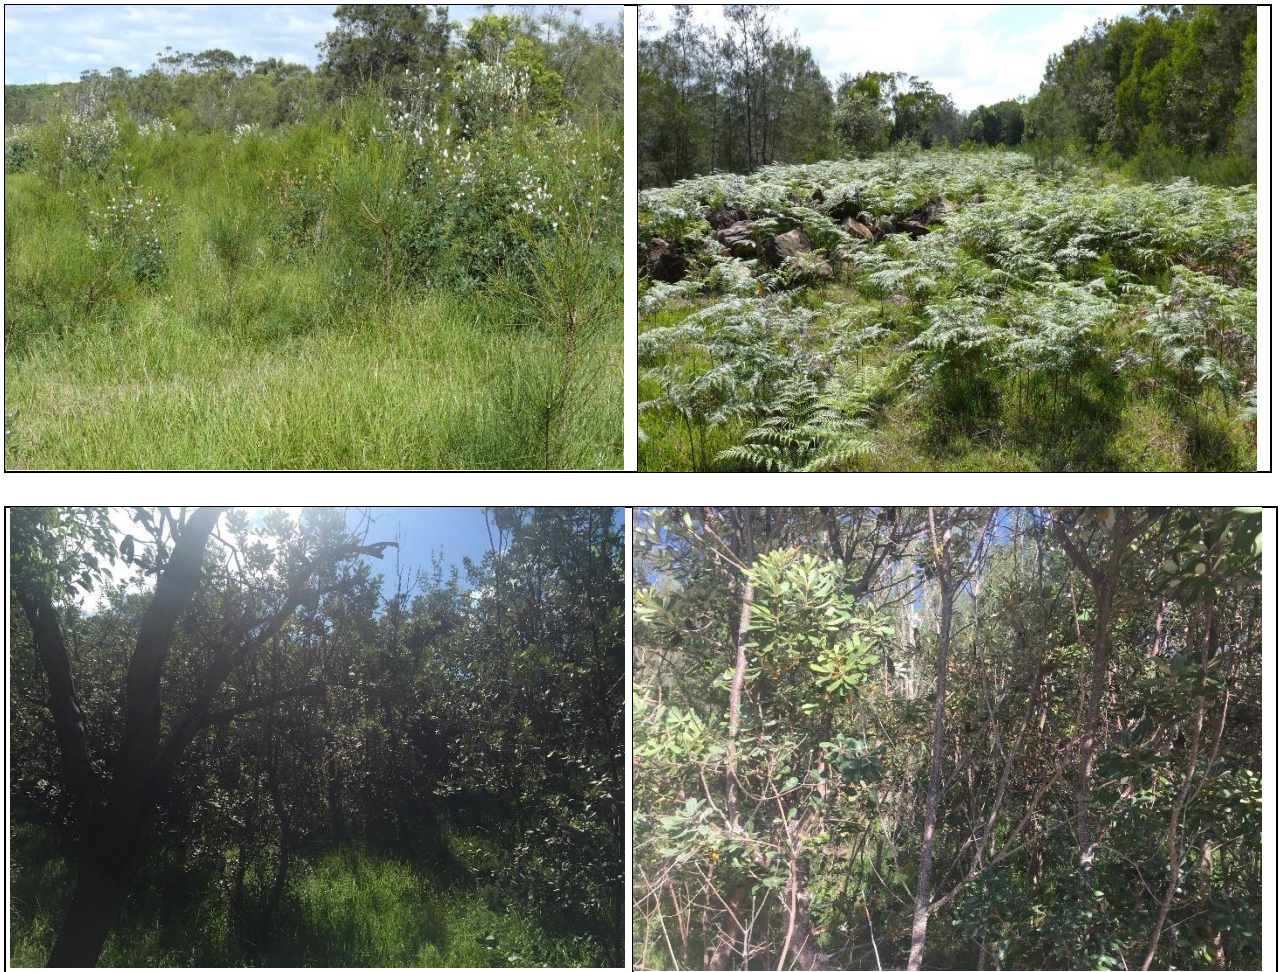
FIGURE 25: BEFORE AND AFTER IMAGES OF REHABILITATION AREA/ZONE 2

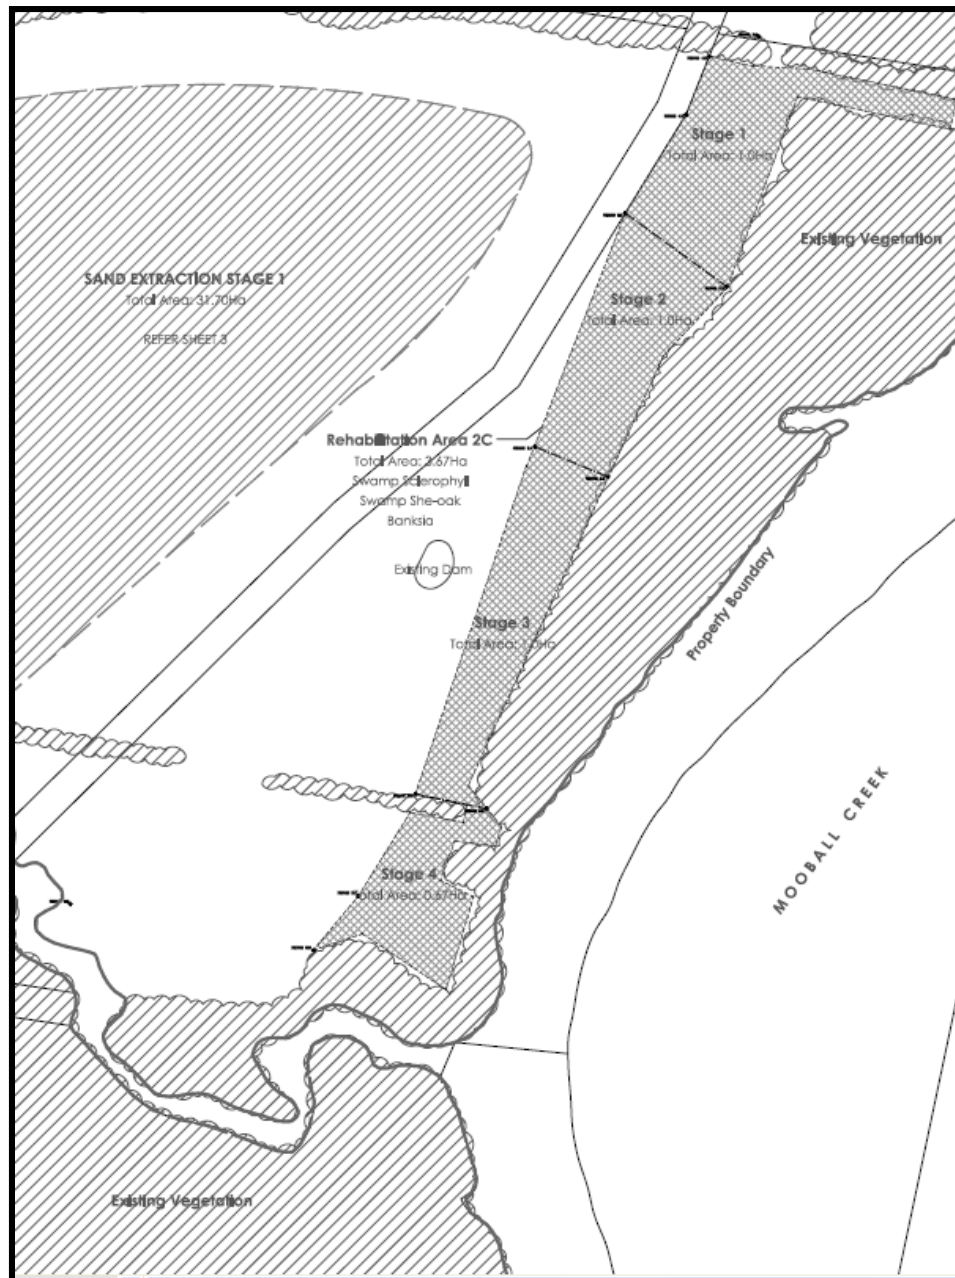
**FIGURE 28: STAGING OF ZONE 2C**

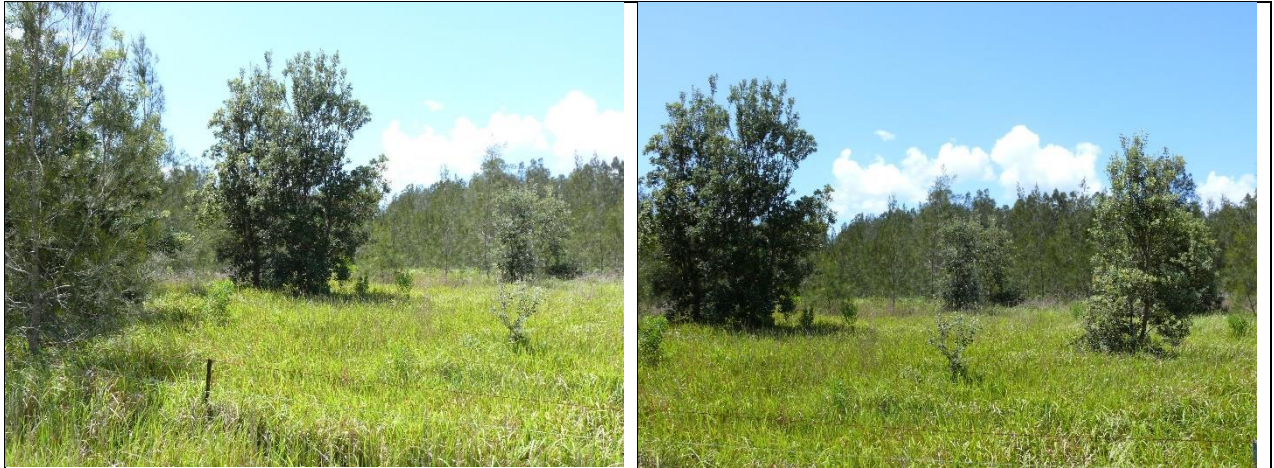
Species noted include Banksia, Swamp Oak, Paperbark, Bracken and Blady Grass. Whisky grass is also common.

**FIGURE 35: IMAGES OF REHABILITATION AREA/ZONE 3 - 2009**

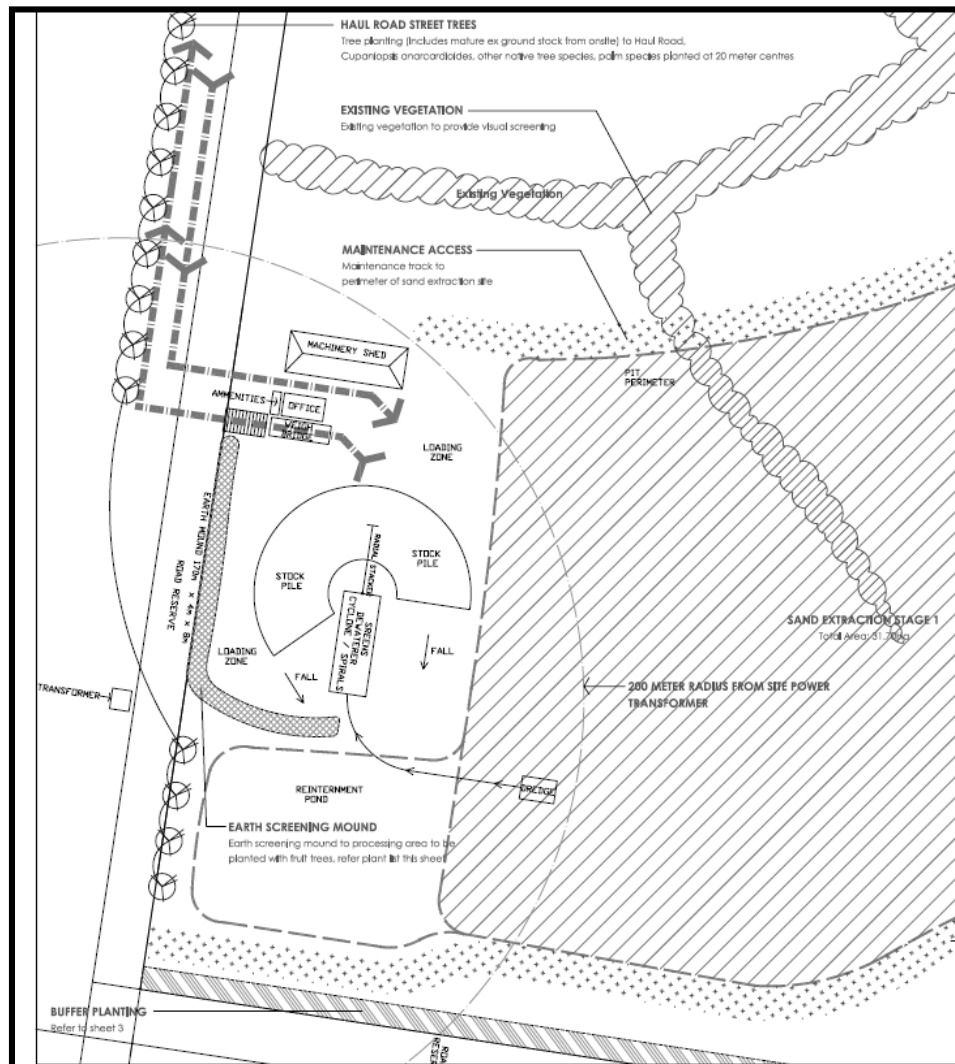
This type of revegetation has occurred within the western visual buffer to the haul route, processing area, site office and wash plant. In accordance with condition 39 of the Development Consent these buffer areas were established within 12 months. Following planting of the buffers (with endemic native species) the areas are monitored and maintained as per the Rehabilitation Zones and in accordance with Section 4.4 below.

FIGURE 44: 10M WESTERN VISUAL BUFFER LOCATION

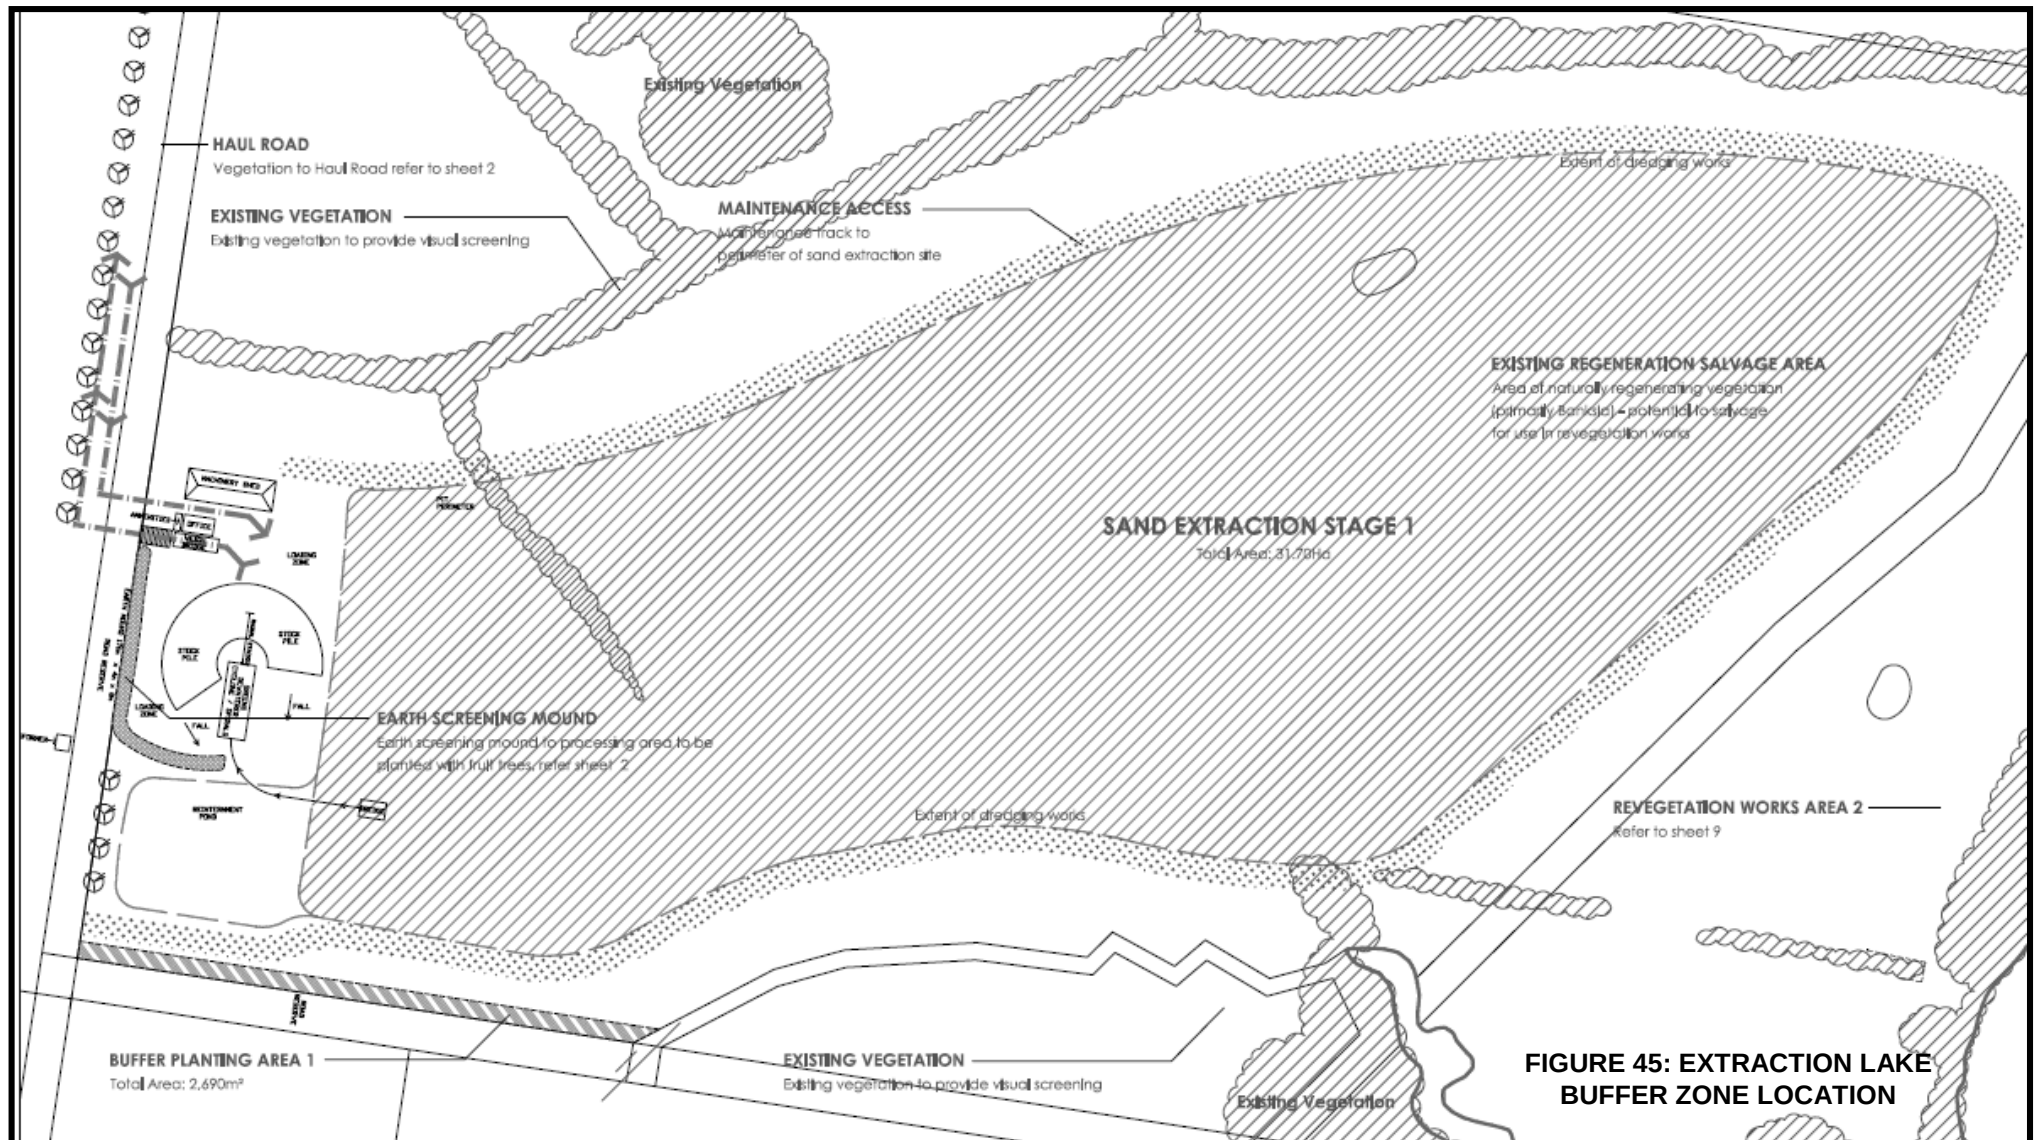
**FIGURE 45: EXTRACTION LAKE  
BUFFER ZONE LOCATION**

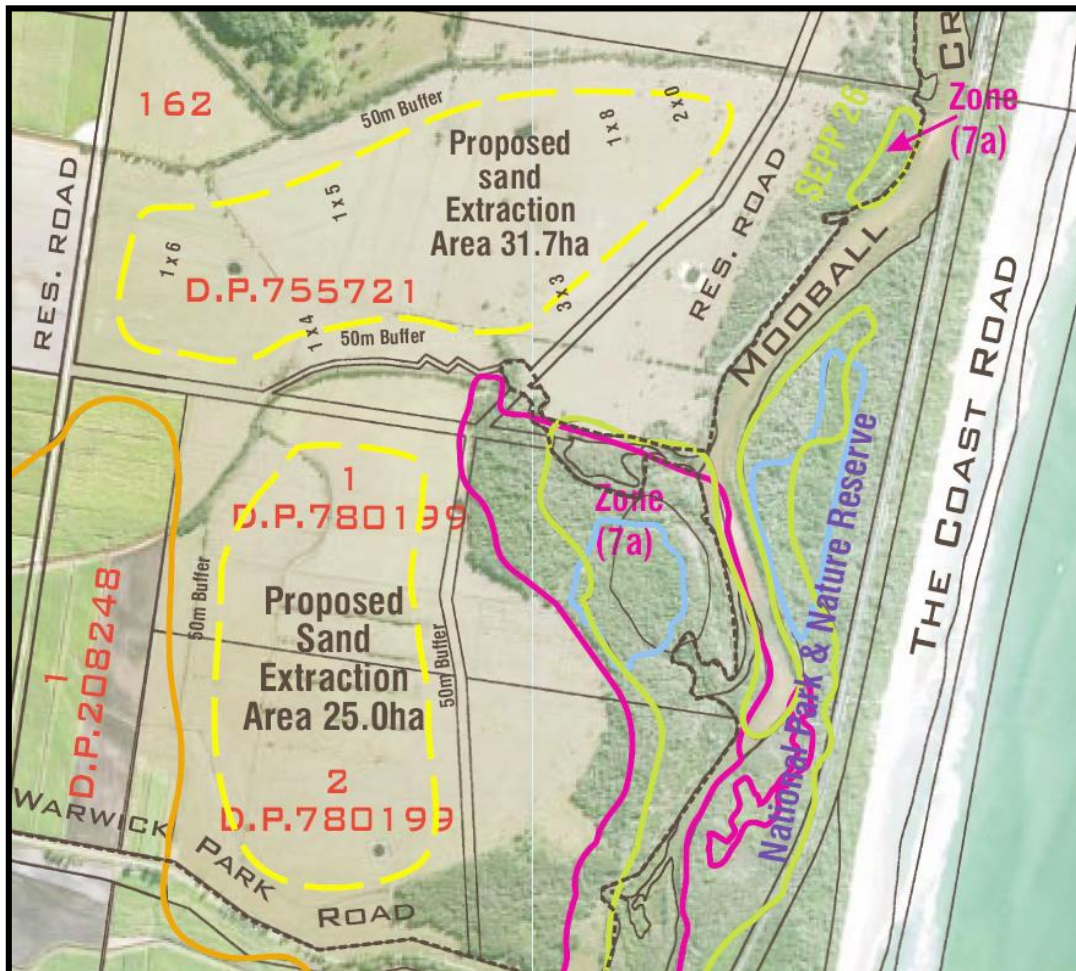
The approved quarry development requires only the minor removal of semi-mature Swamp Oaks and isolated blue gums and areas of pasture grassland in association with preparation and ongoing sand extraction procedures (refer Figure 50 below).

**FIGURE 50: CLEARING ZONES**

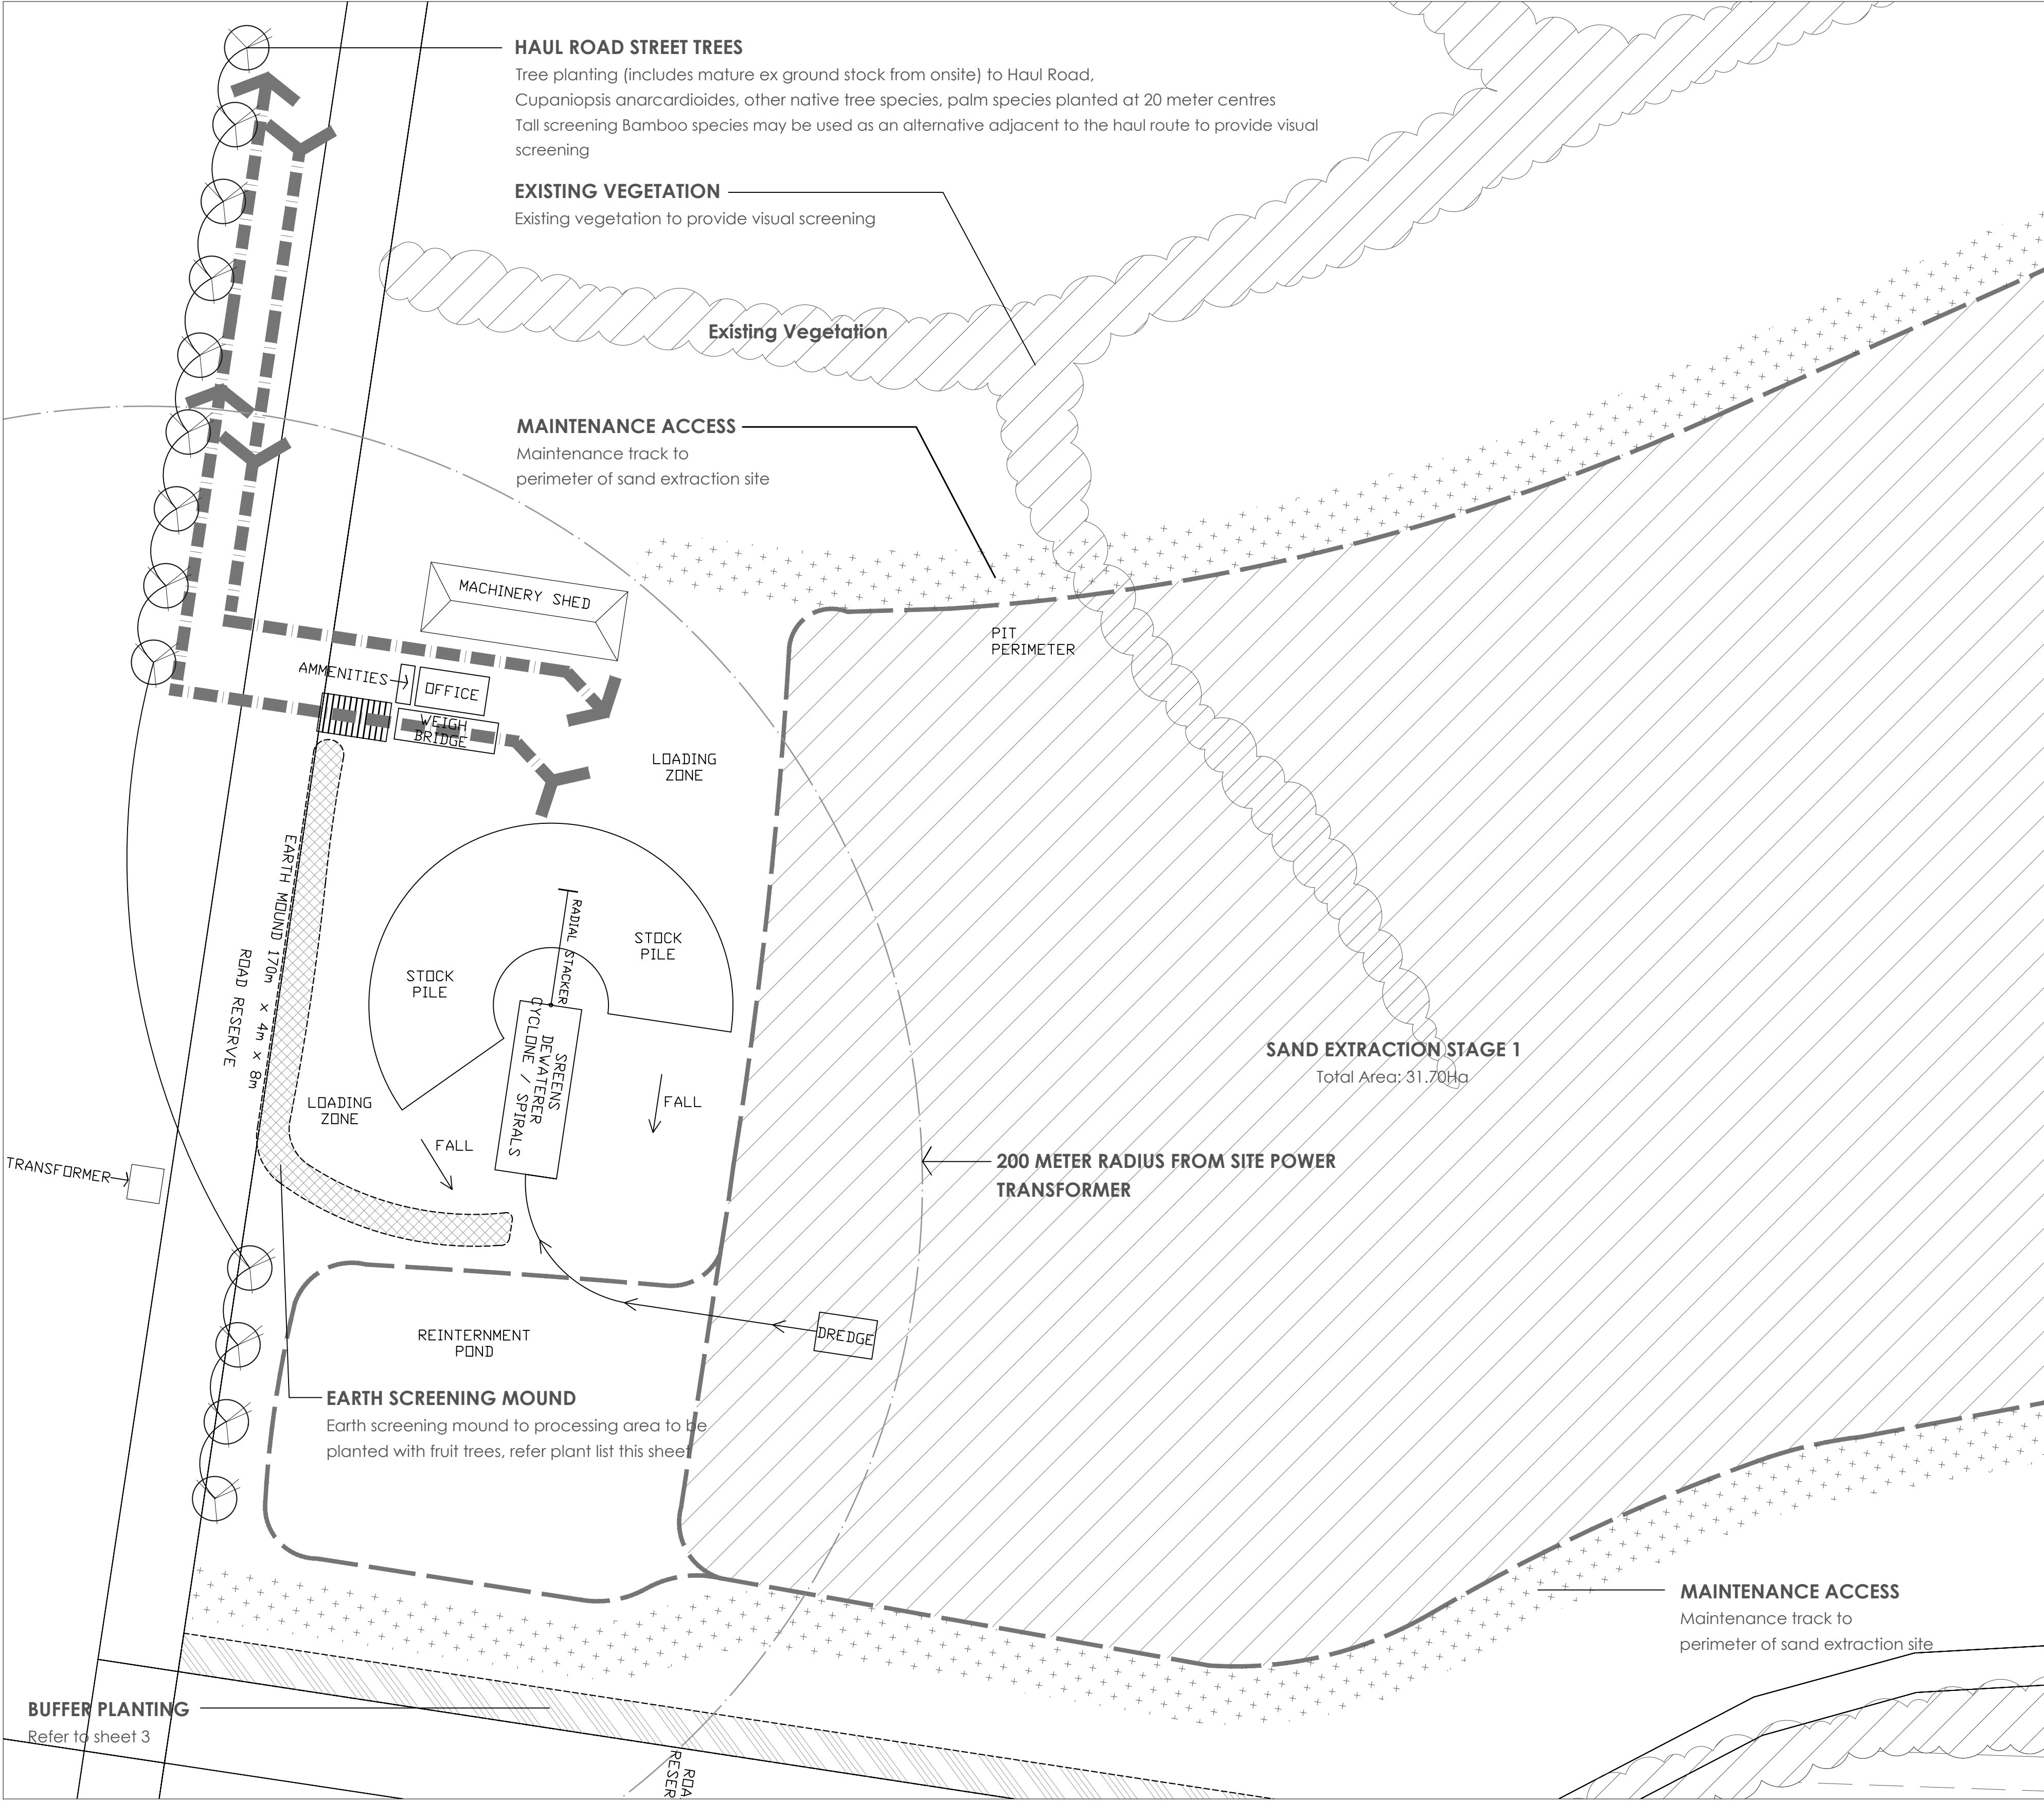
**Buffer Planting Area 1 - Earth Screening Mound**  
Total Area: 0.14Ha

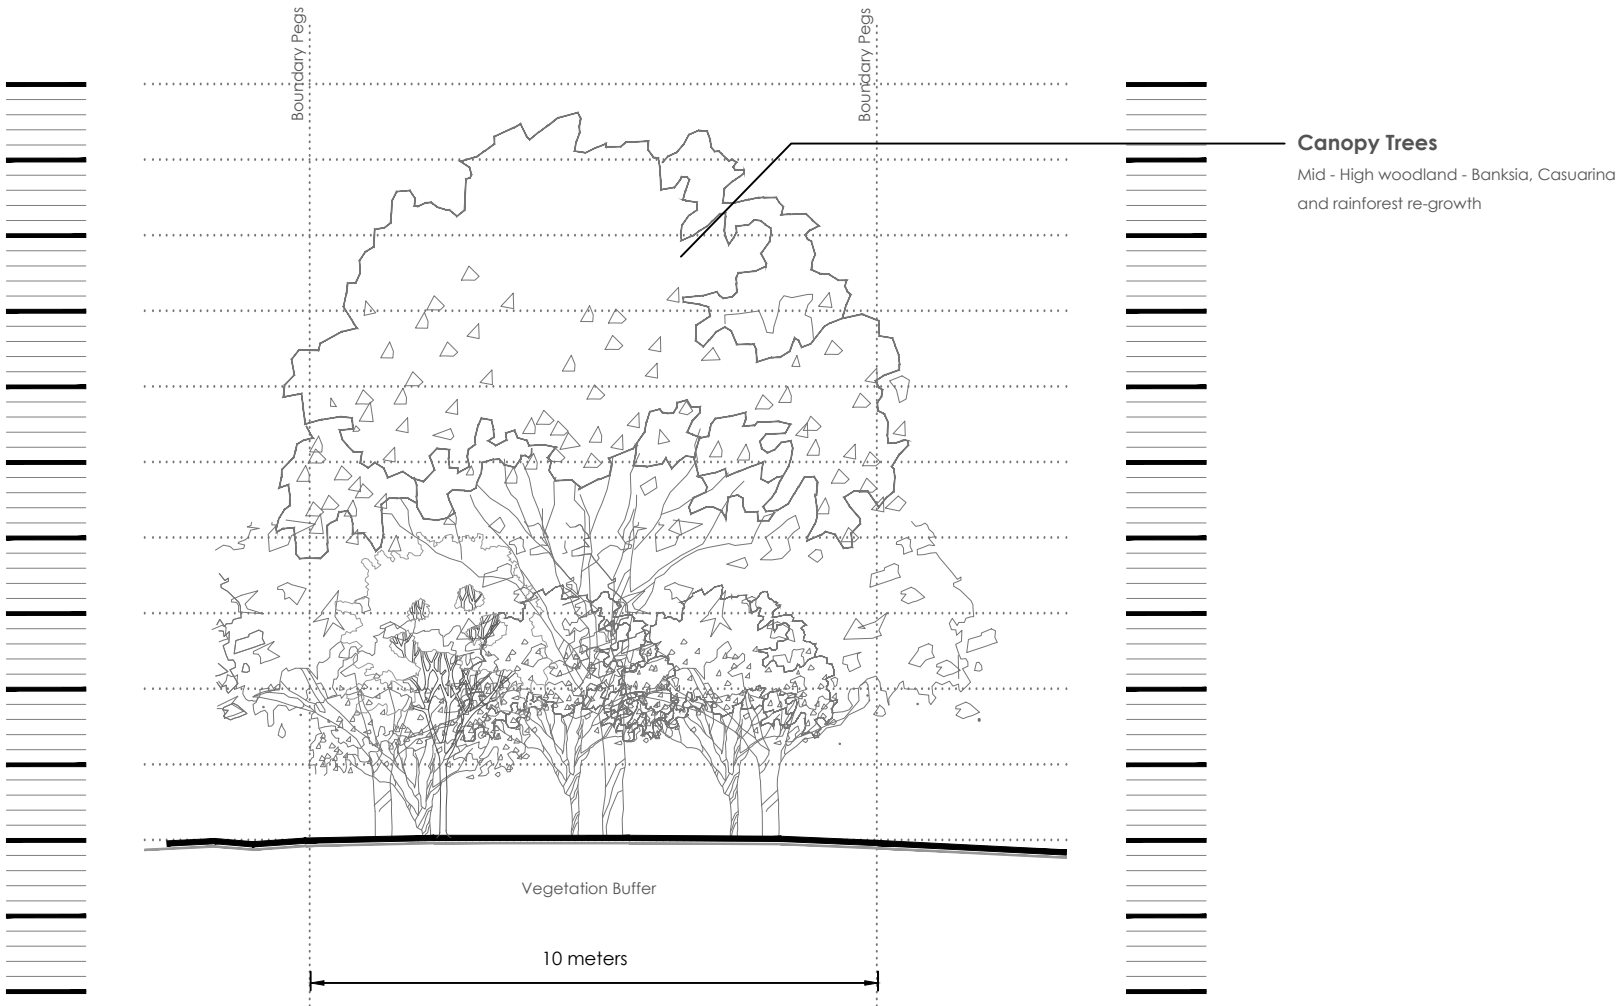
Typical Buffer Profile  
Refer to Plant Modules and Species Listings this sheet for details  
1:100 at full size A1

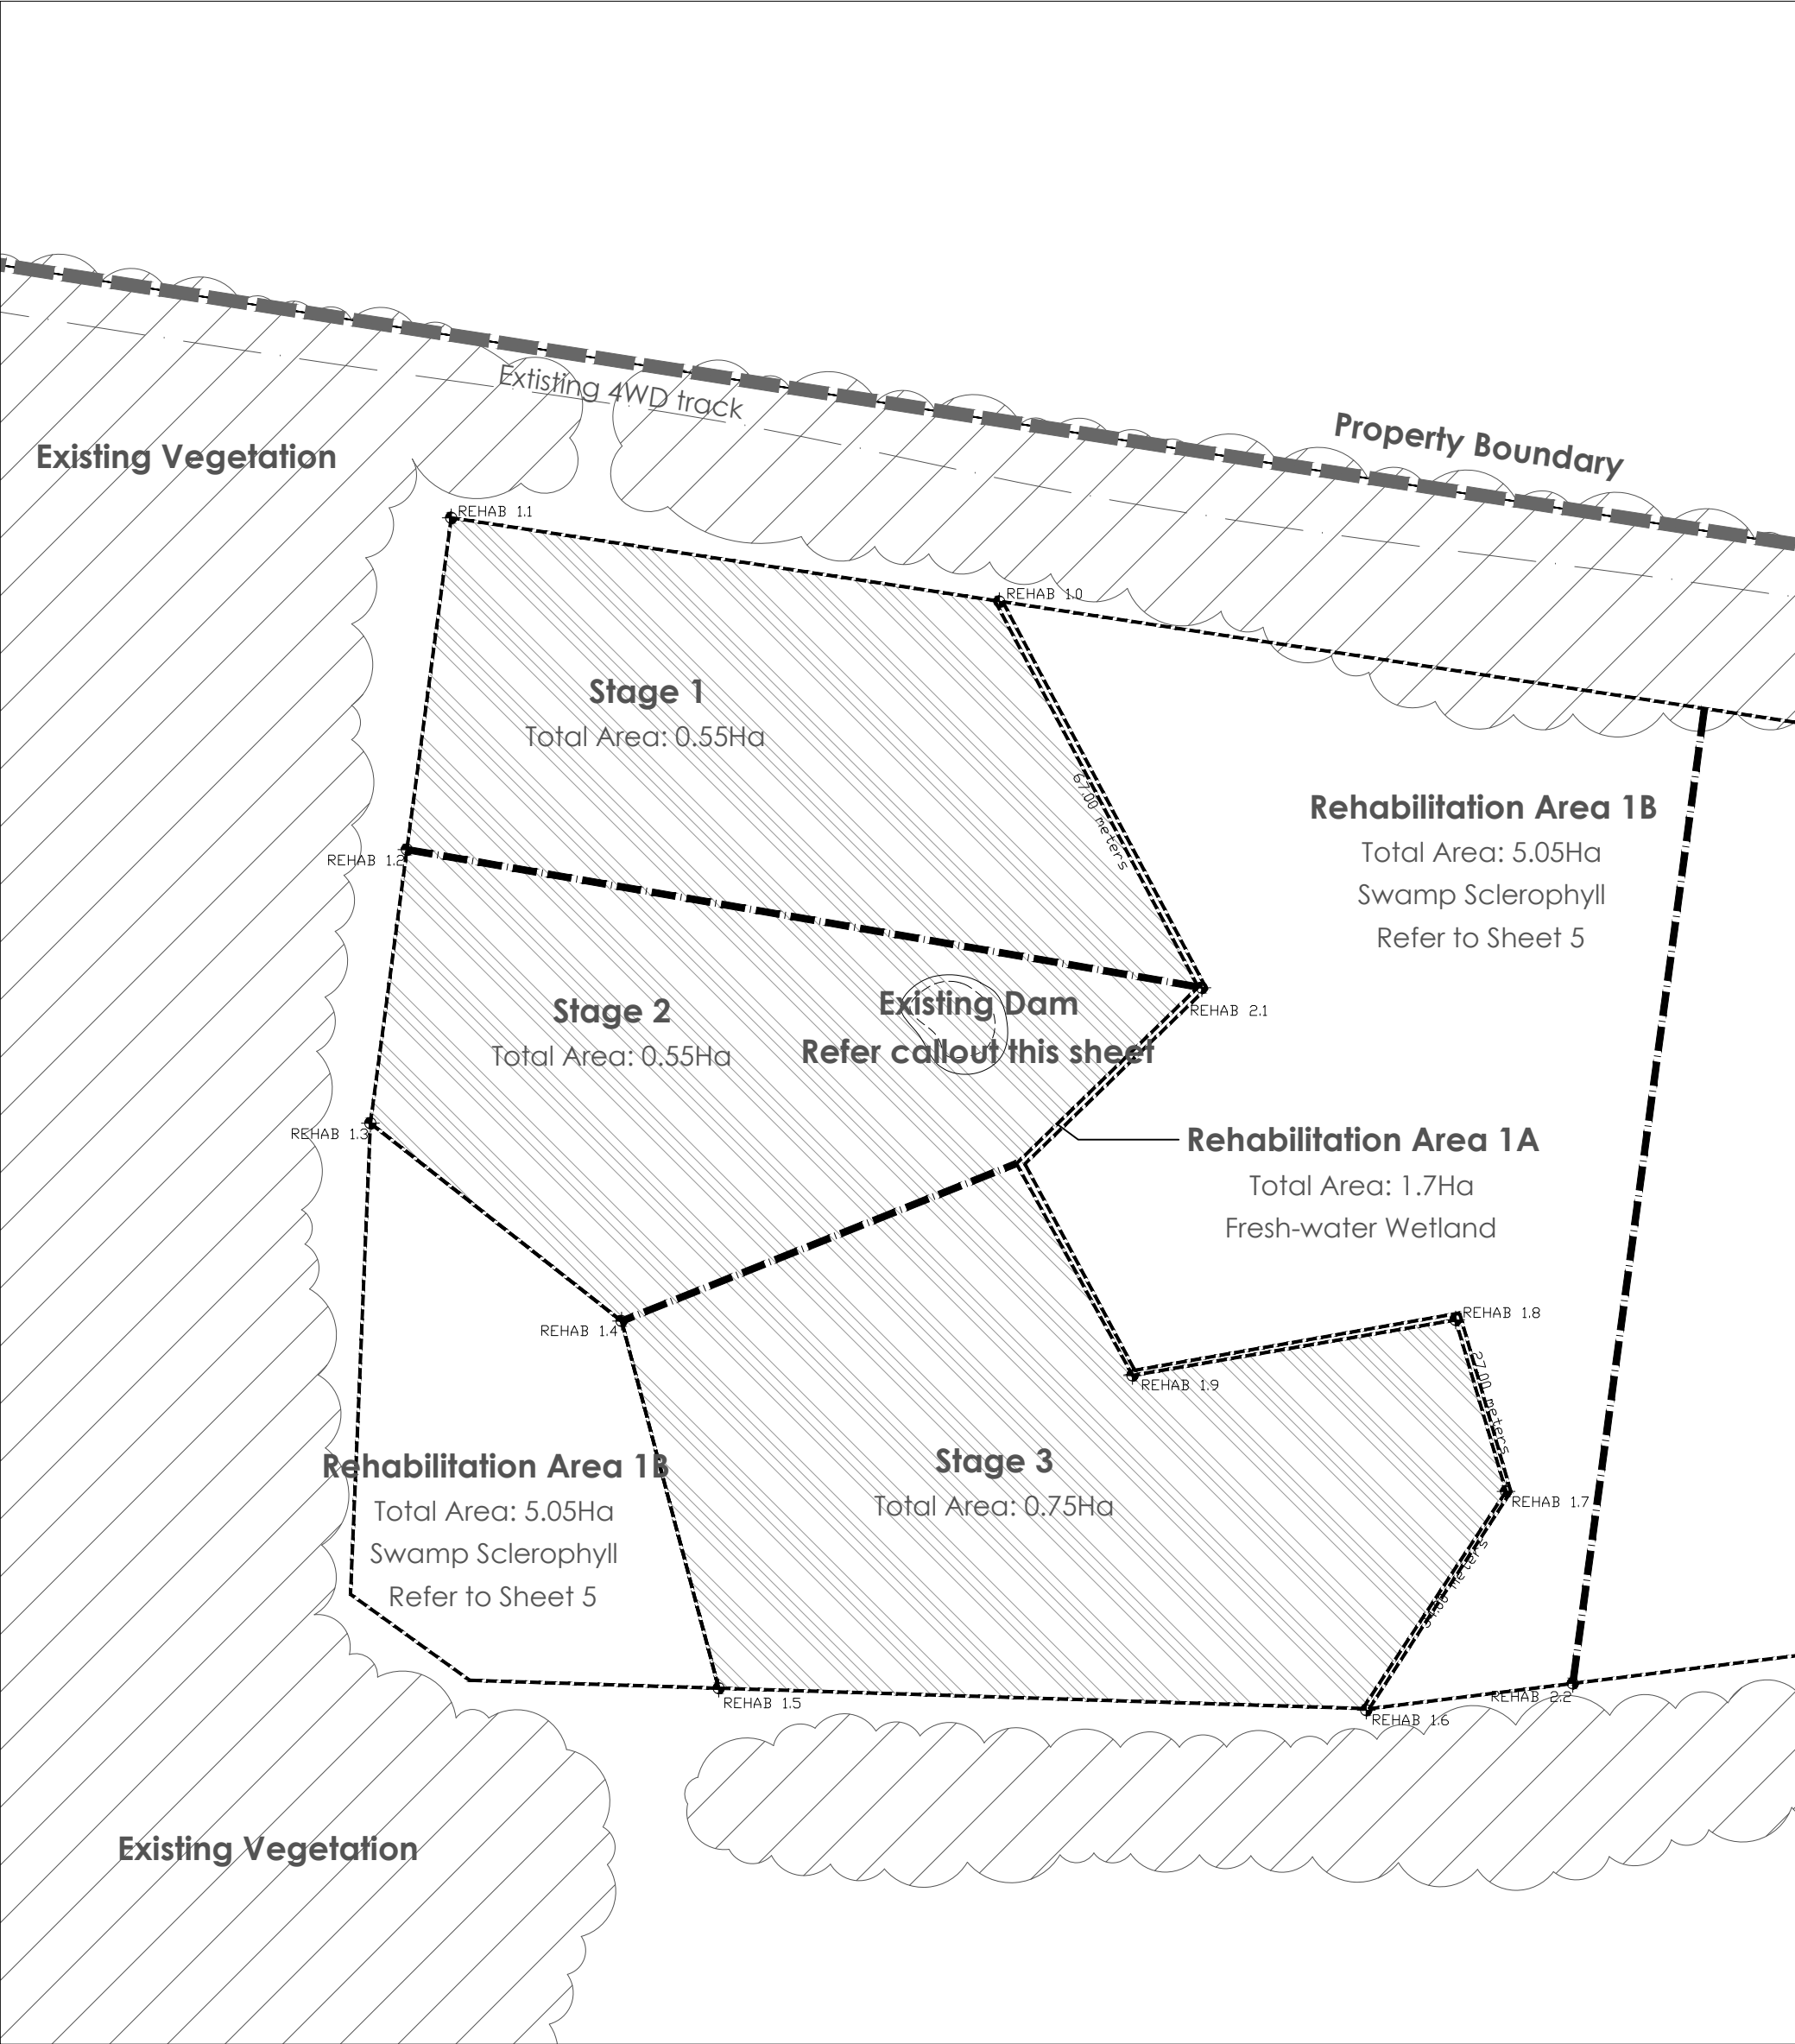
**Rehabilitation Area 1A**  
Total Area: 1.85Ha  
Vegetation Type: Fresh-water Wetland

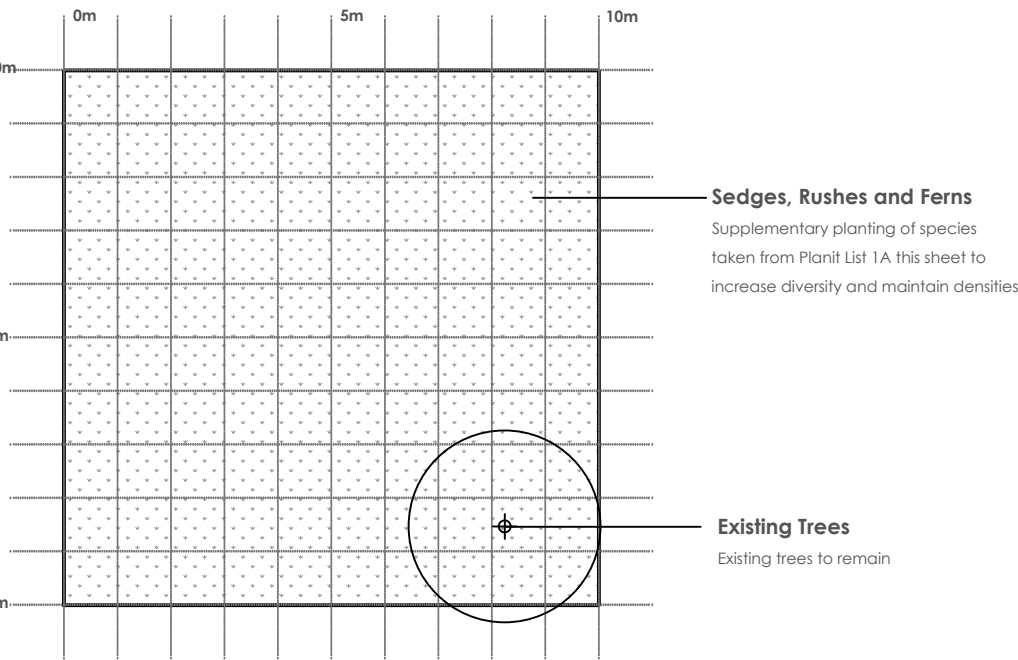
**Planting Module 2 - Freshwater Wetland**  
SUPPLEMENTARY SPECIES PLANTING 10 x 10 meter module
