# **Holcim (Australia) Pty Ltd**

## **Dunloe Sand Quarry Landscape Management Plan**

June 2021

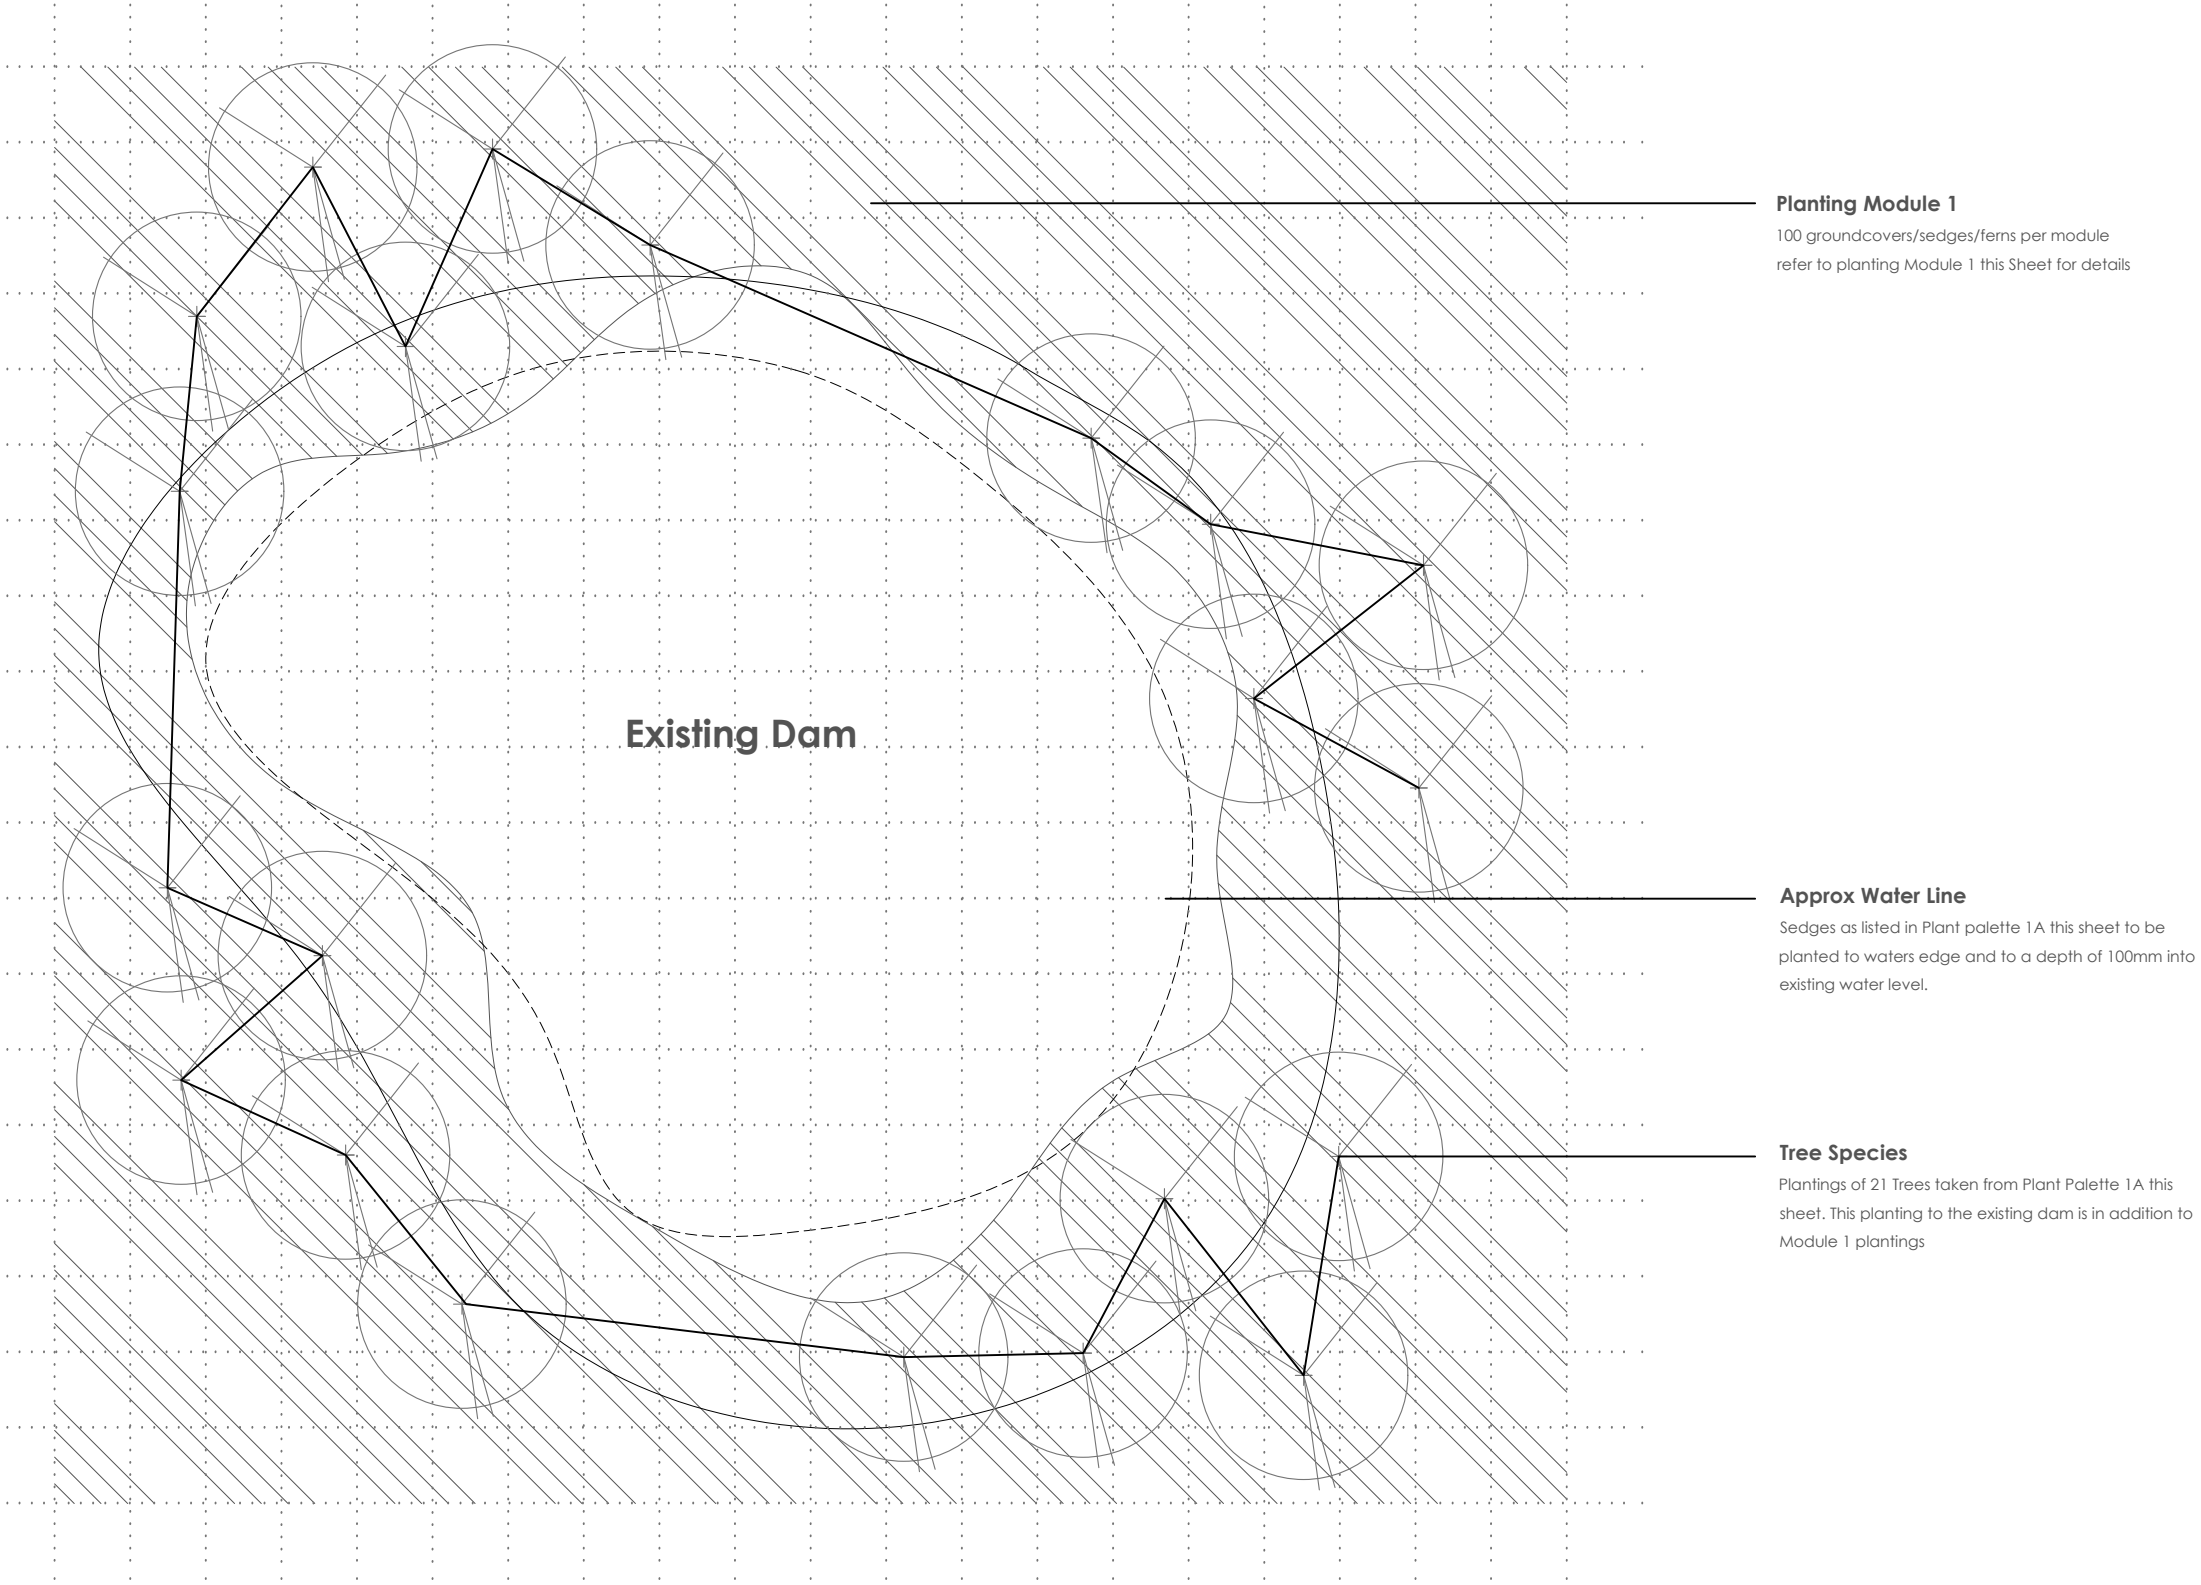
**Callout 1 - Existing Dam**  
To be planted as part of Stage 1 works  
Vegetation Type: Fresh-water Wetland

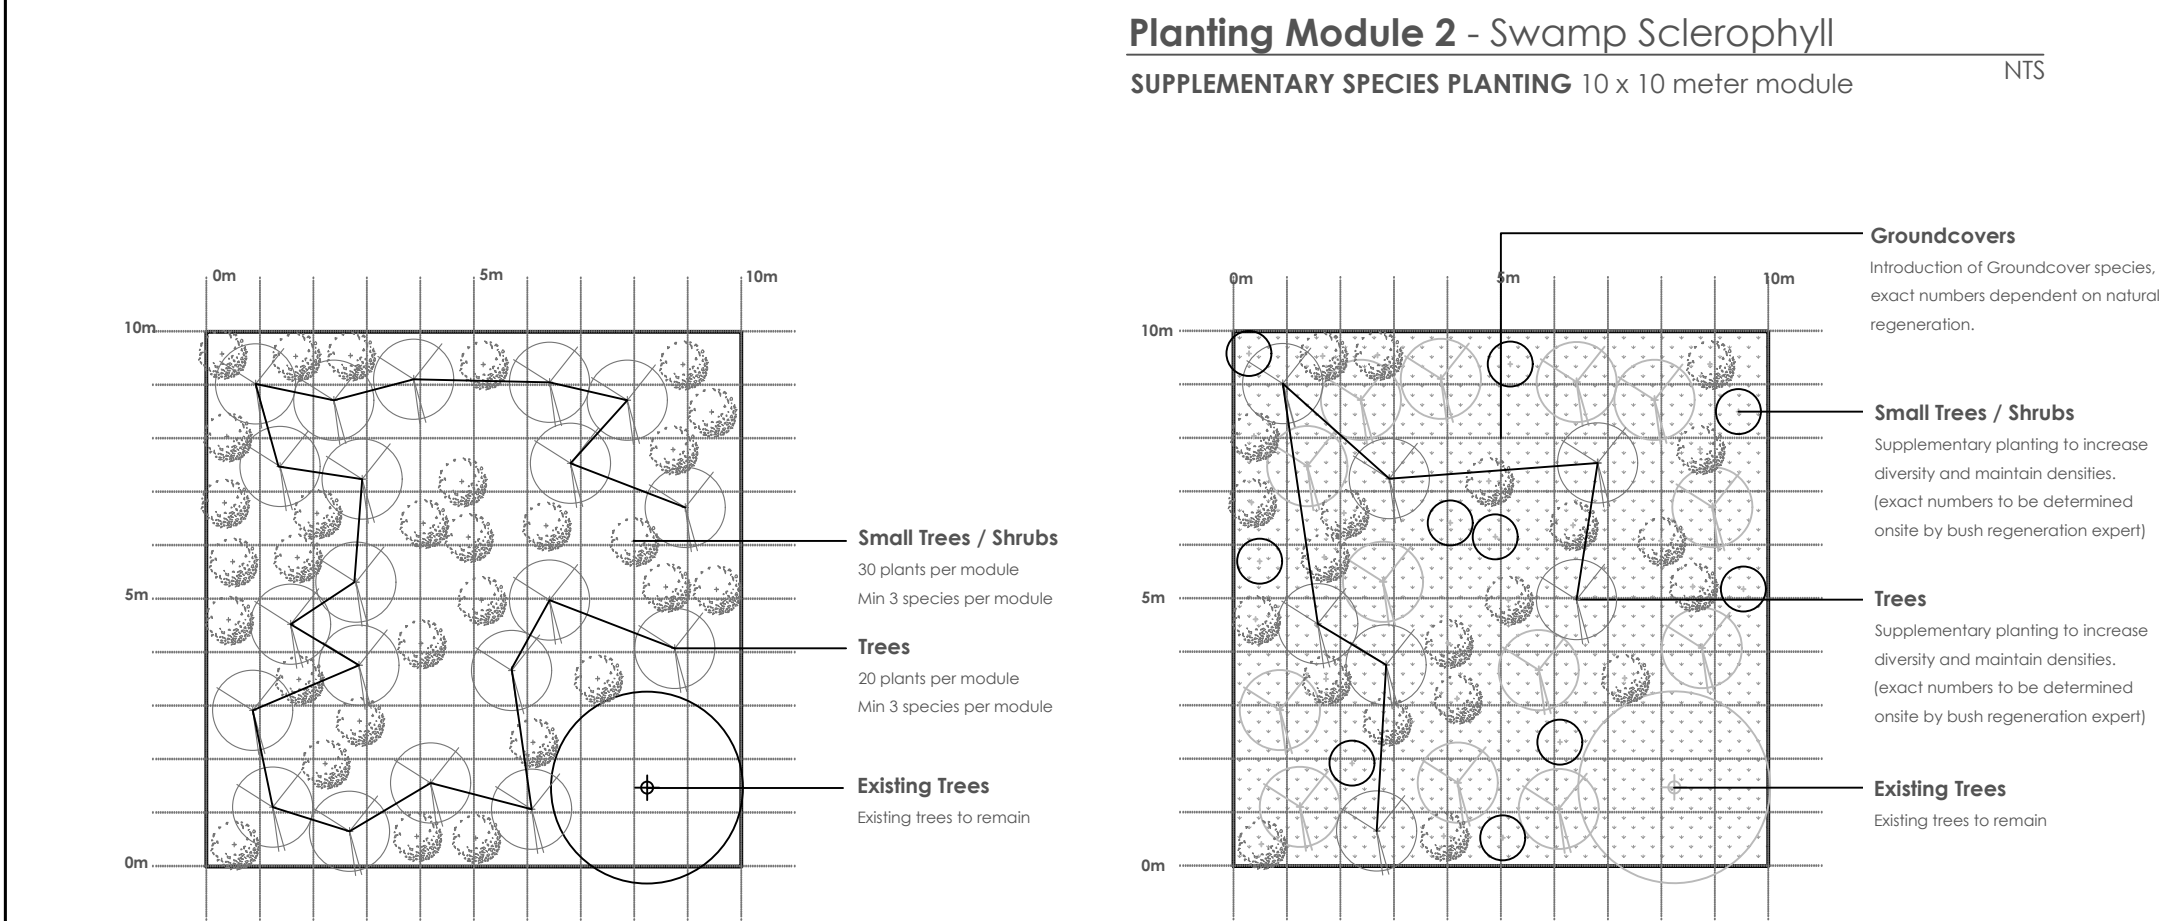
**Planting Module 1 - Swamp Sclerophyll**  
PIONEER SPECIES PLANTING 10 x 10 meter module  
NTS

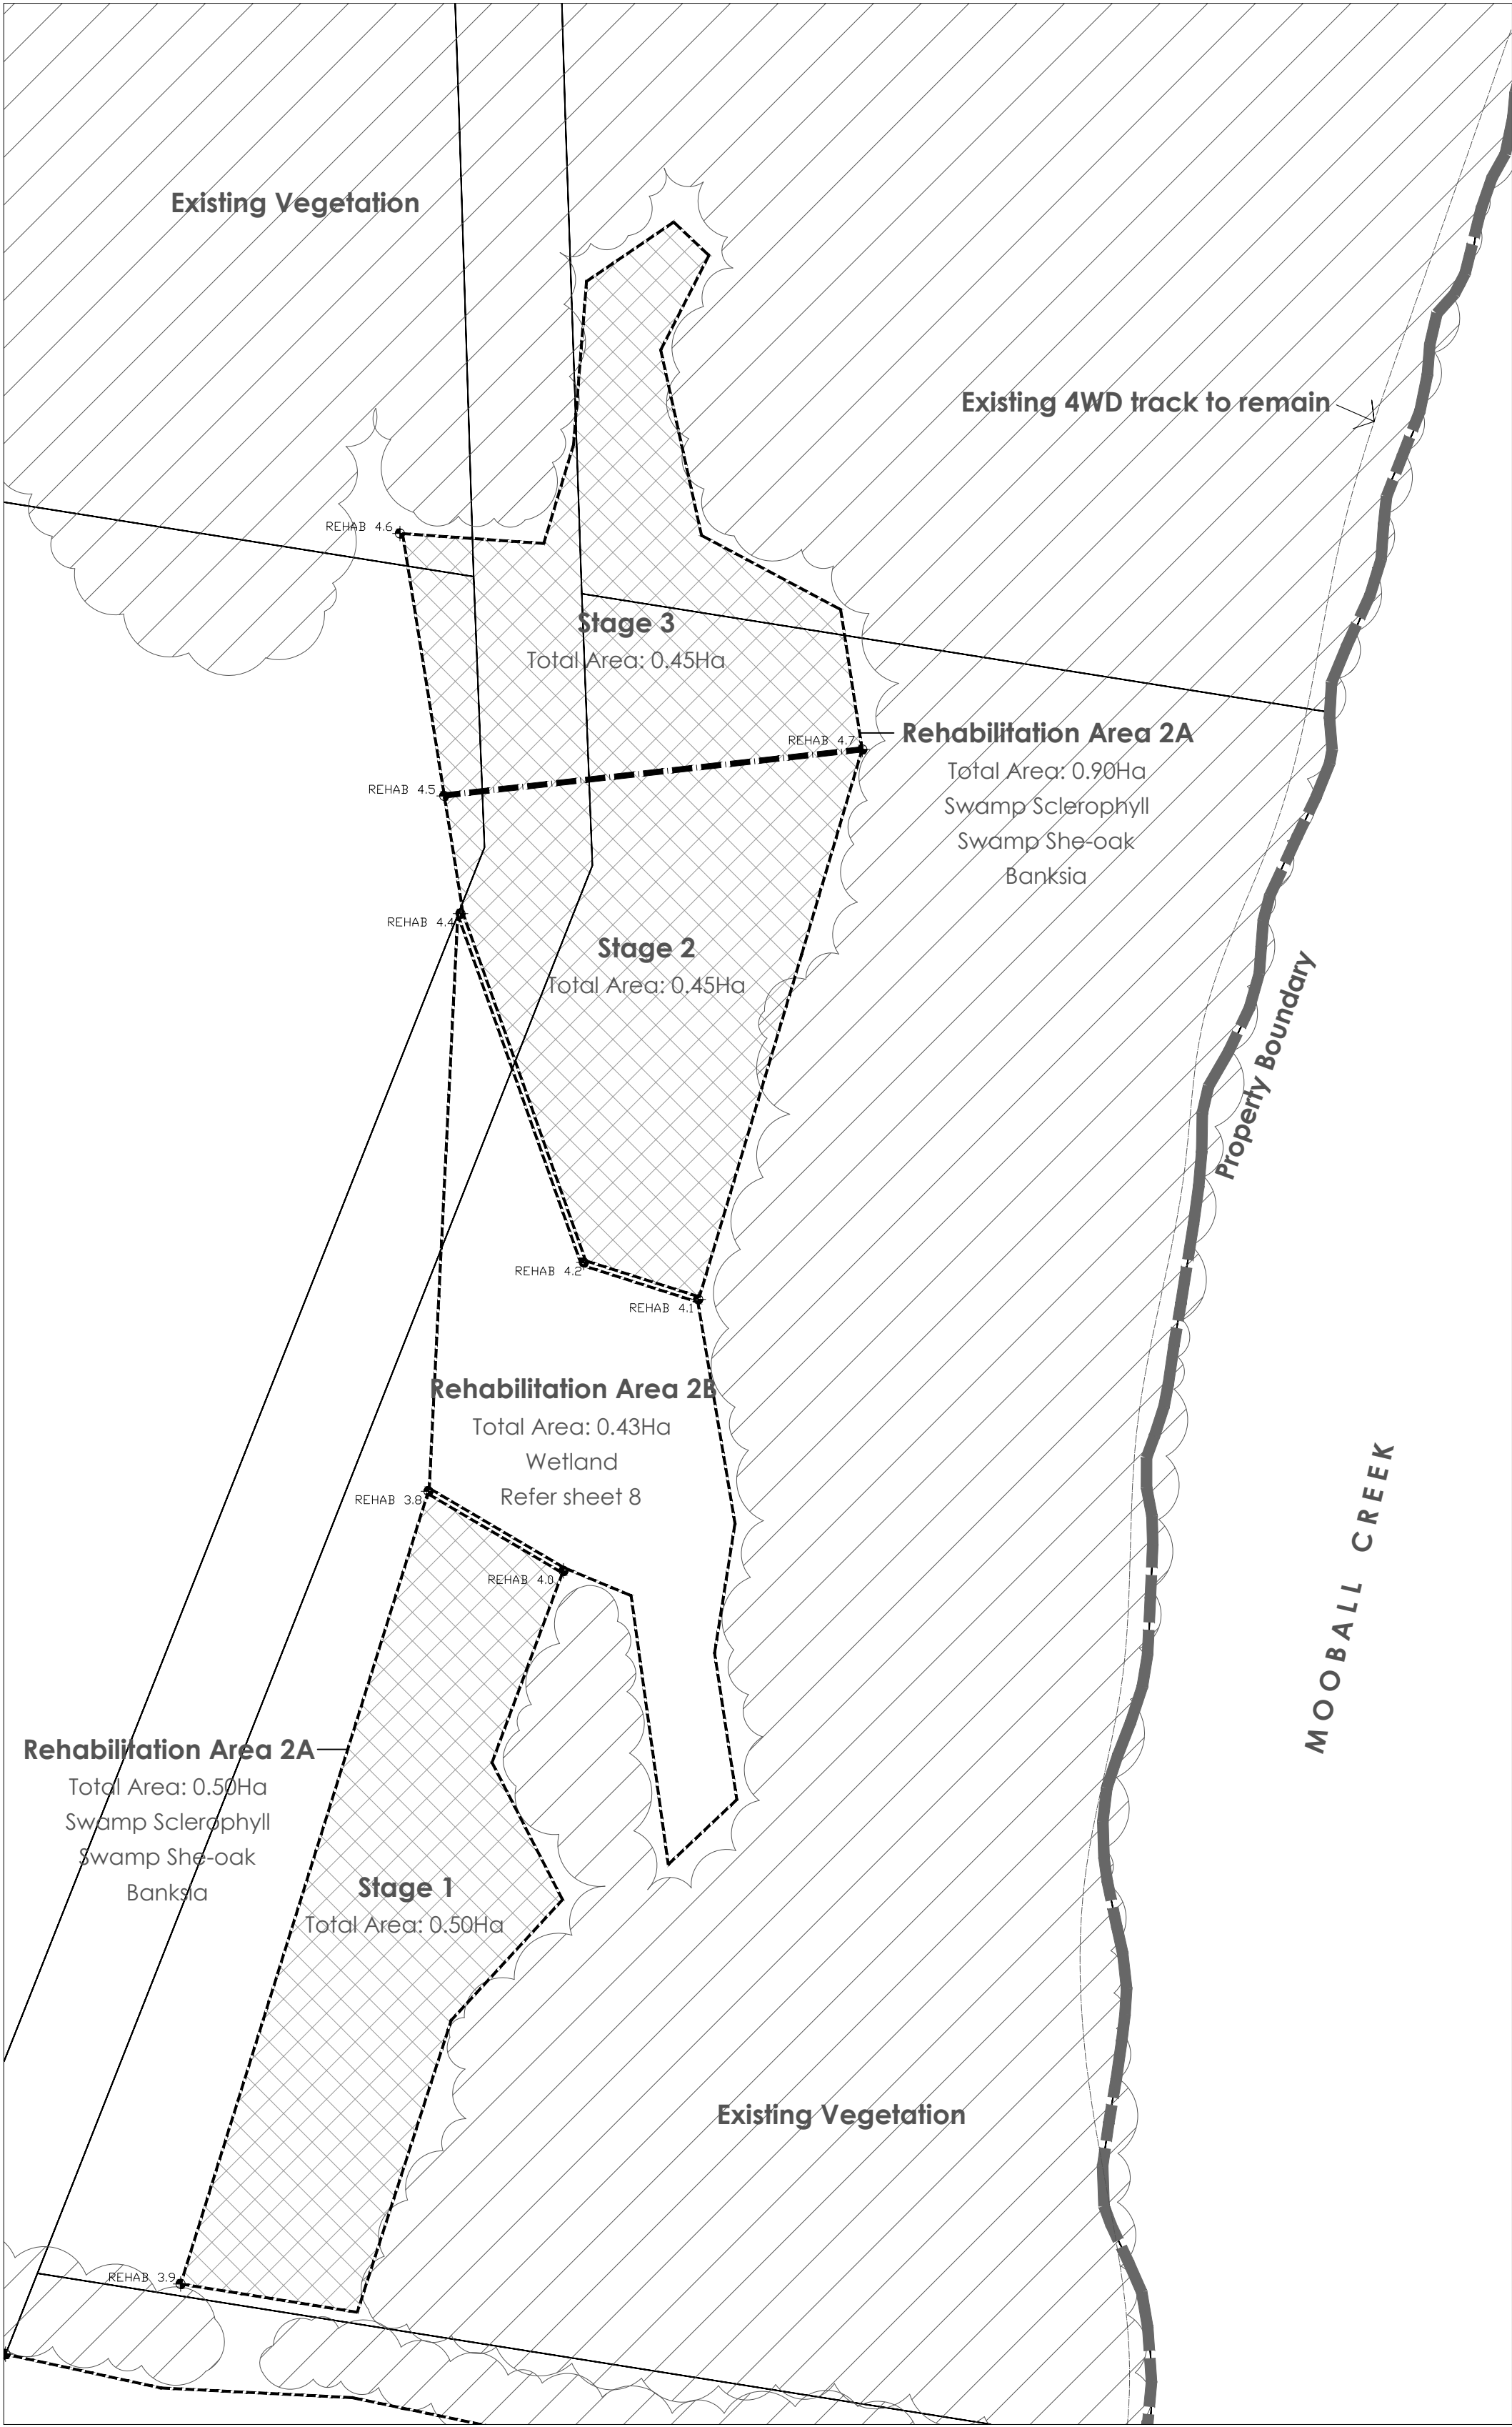
**Rehabilitation Area 2A**  
Total Area: 1.40Ha  
Vegetation Type: Swamp Sclerophyll, She-oak + Banksia with Littoral Rainforest Understorey

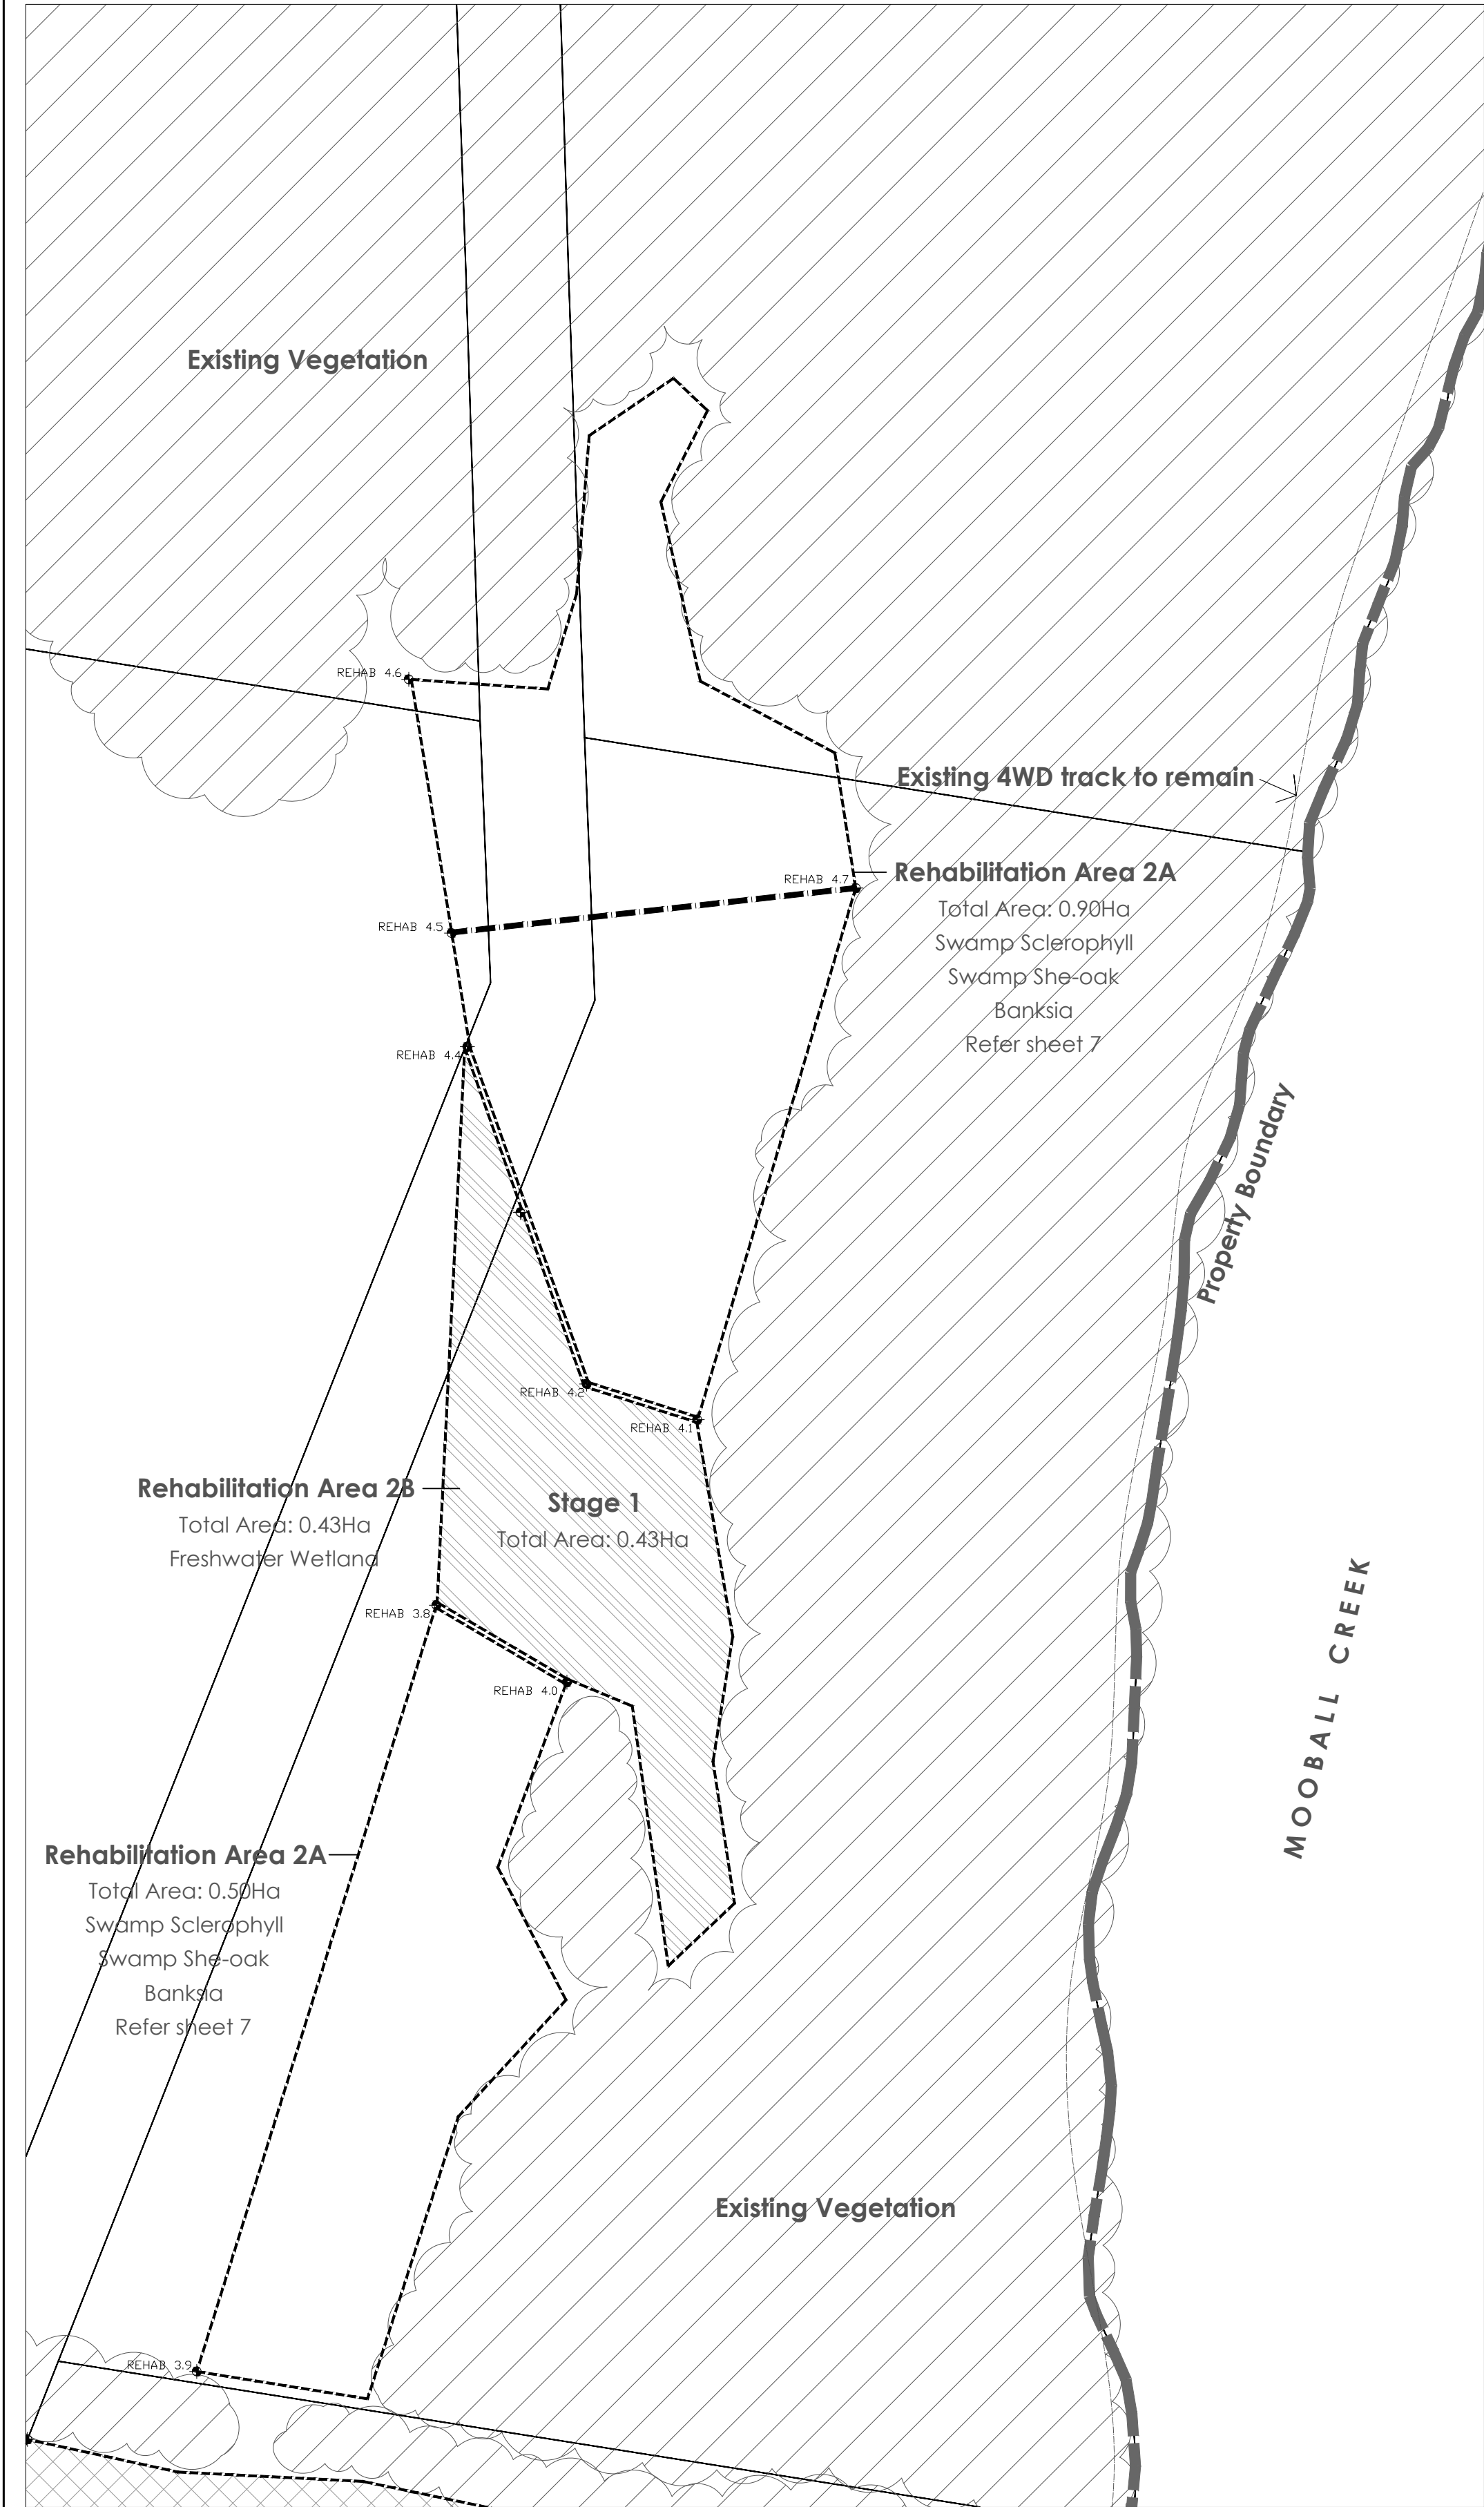
**Rehabilitation Area 2B**  
Total Area: 0.43Ha  
Vegetation Type: Coastal Wetland

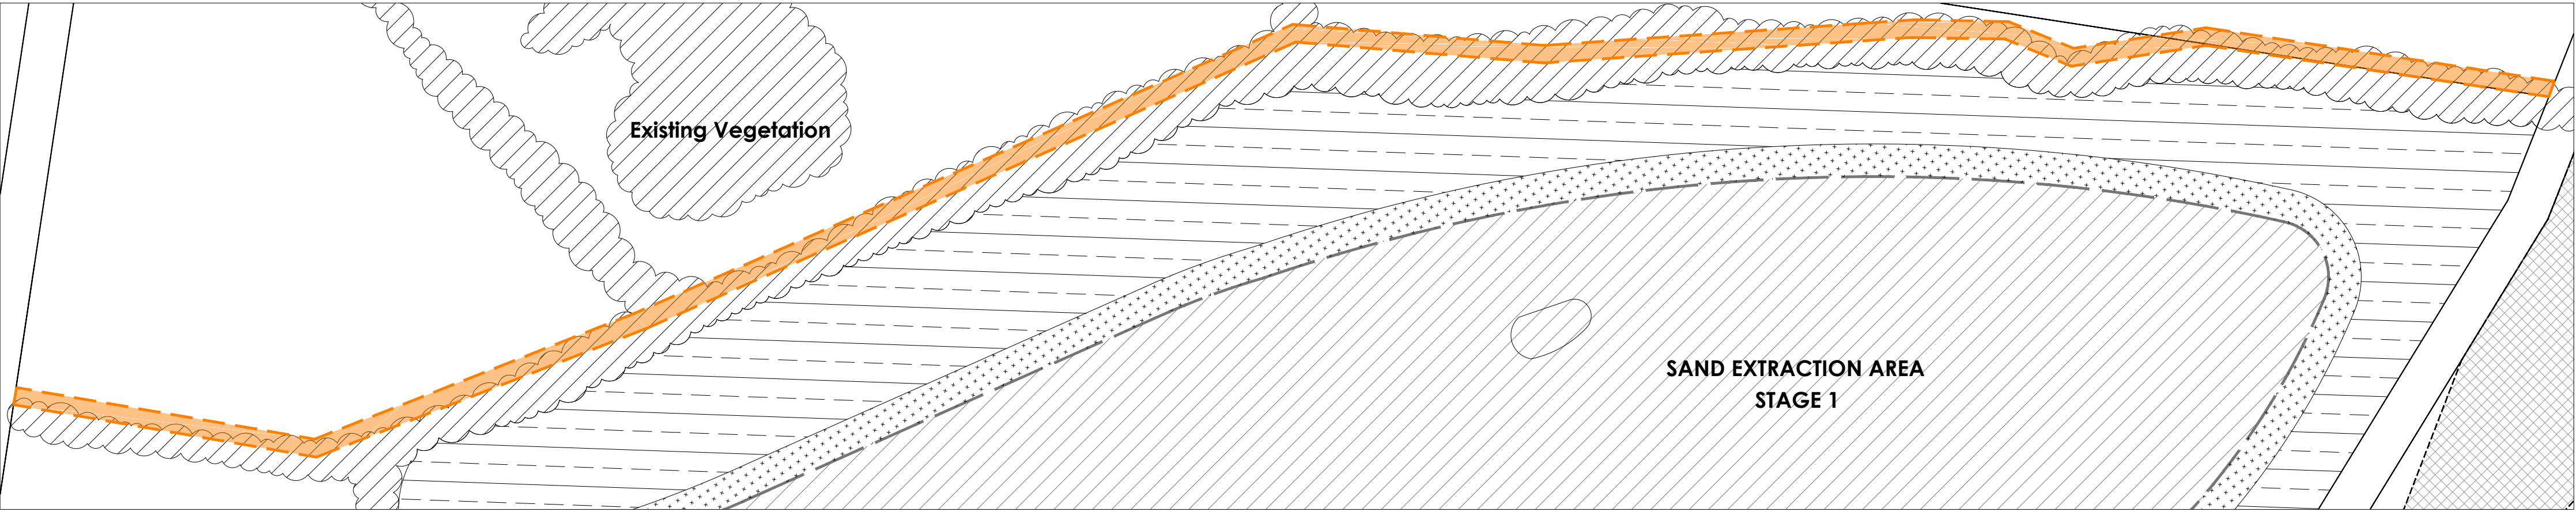
Rehabilitation Planting Area 4 | STAGE 1  
Total Area: 9,688M²

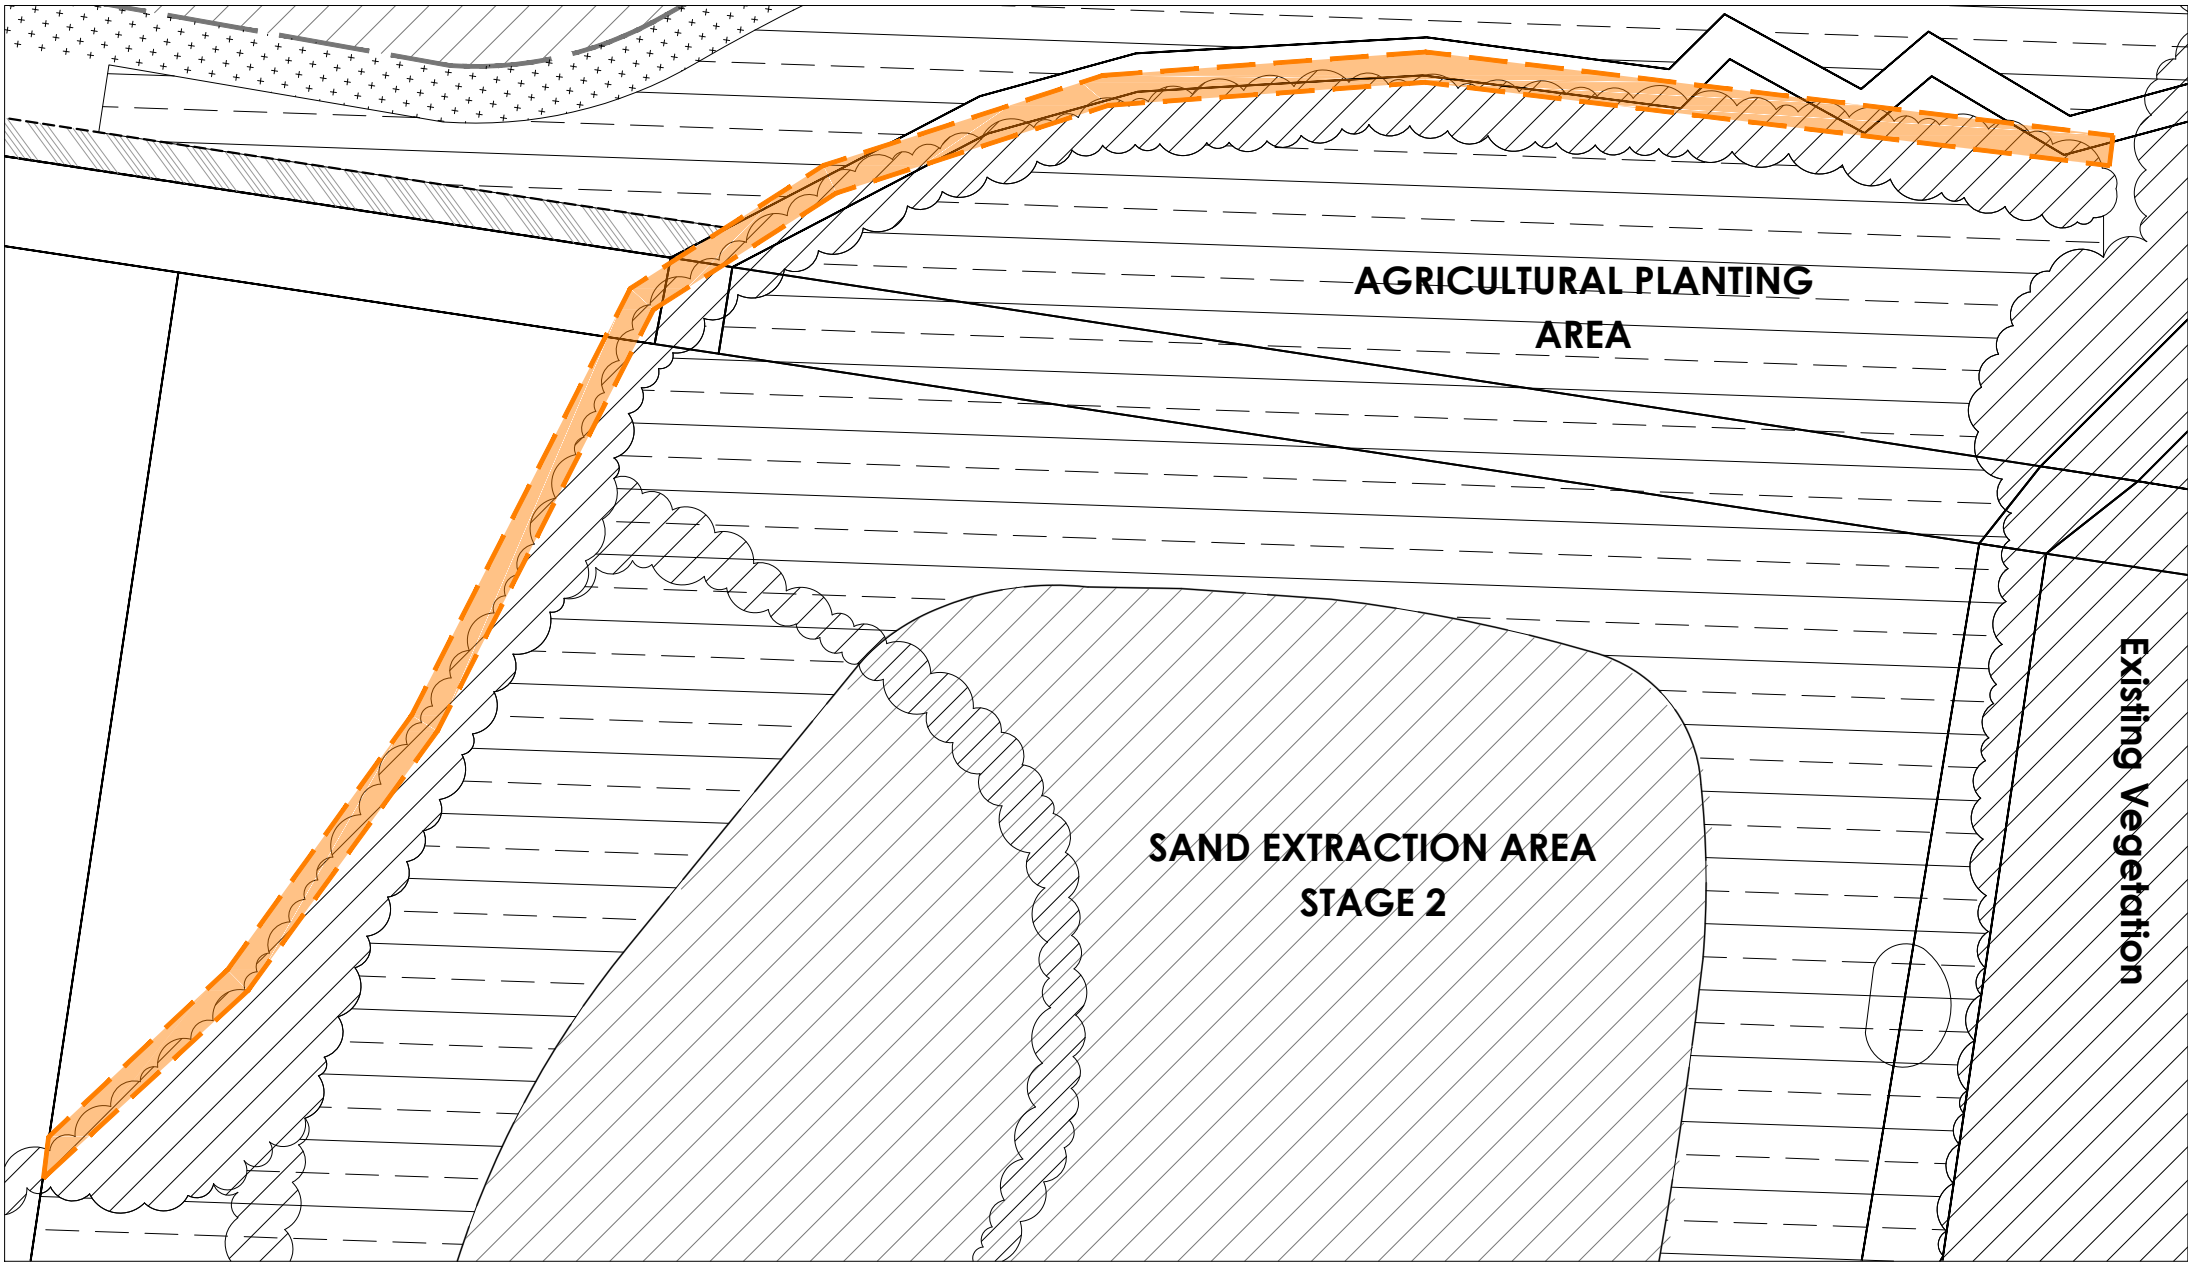
Rehabilitation Planting Area 4 | STAGE 2  
Total Area: 5,432M²

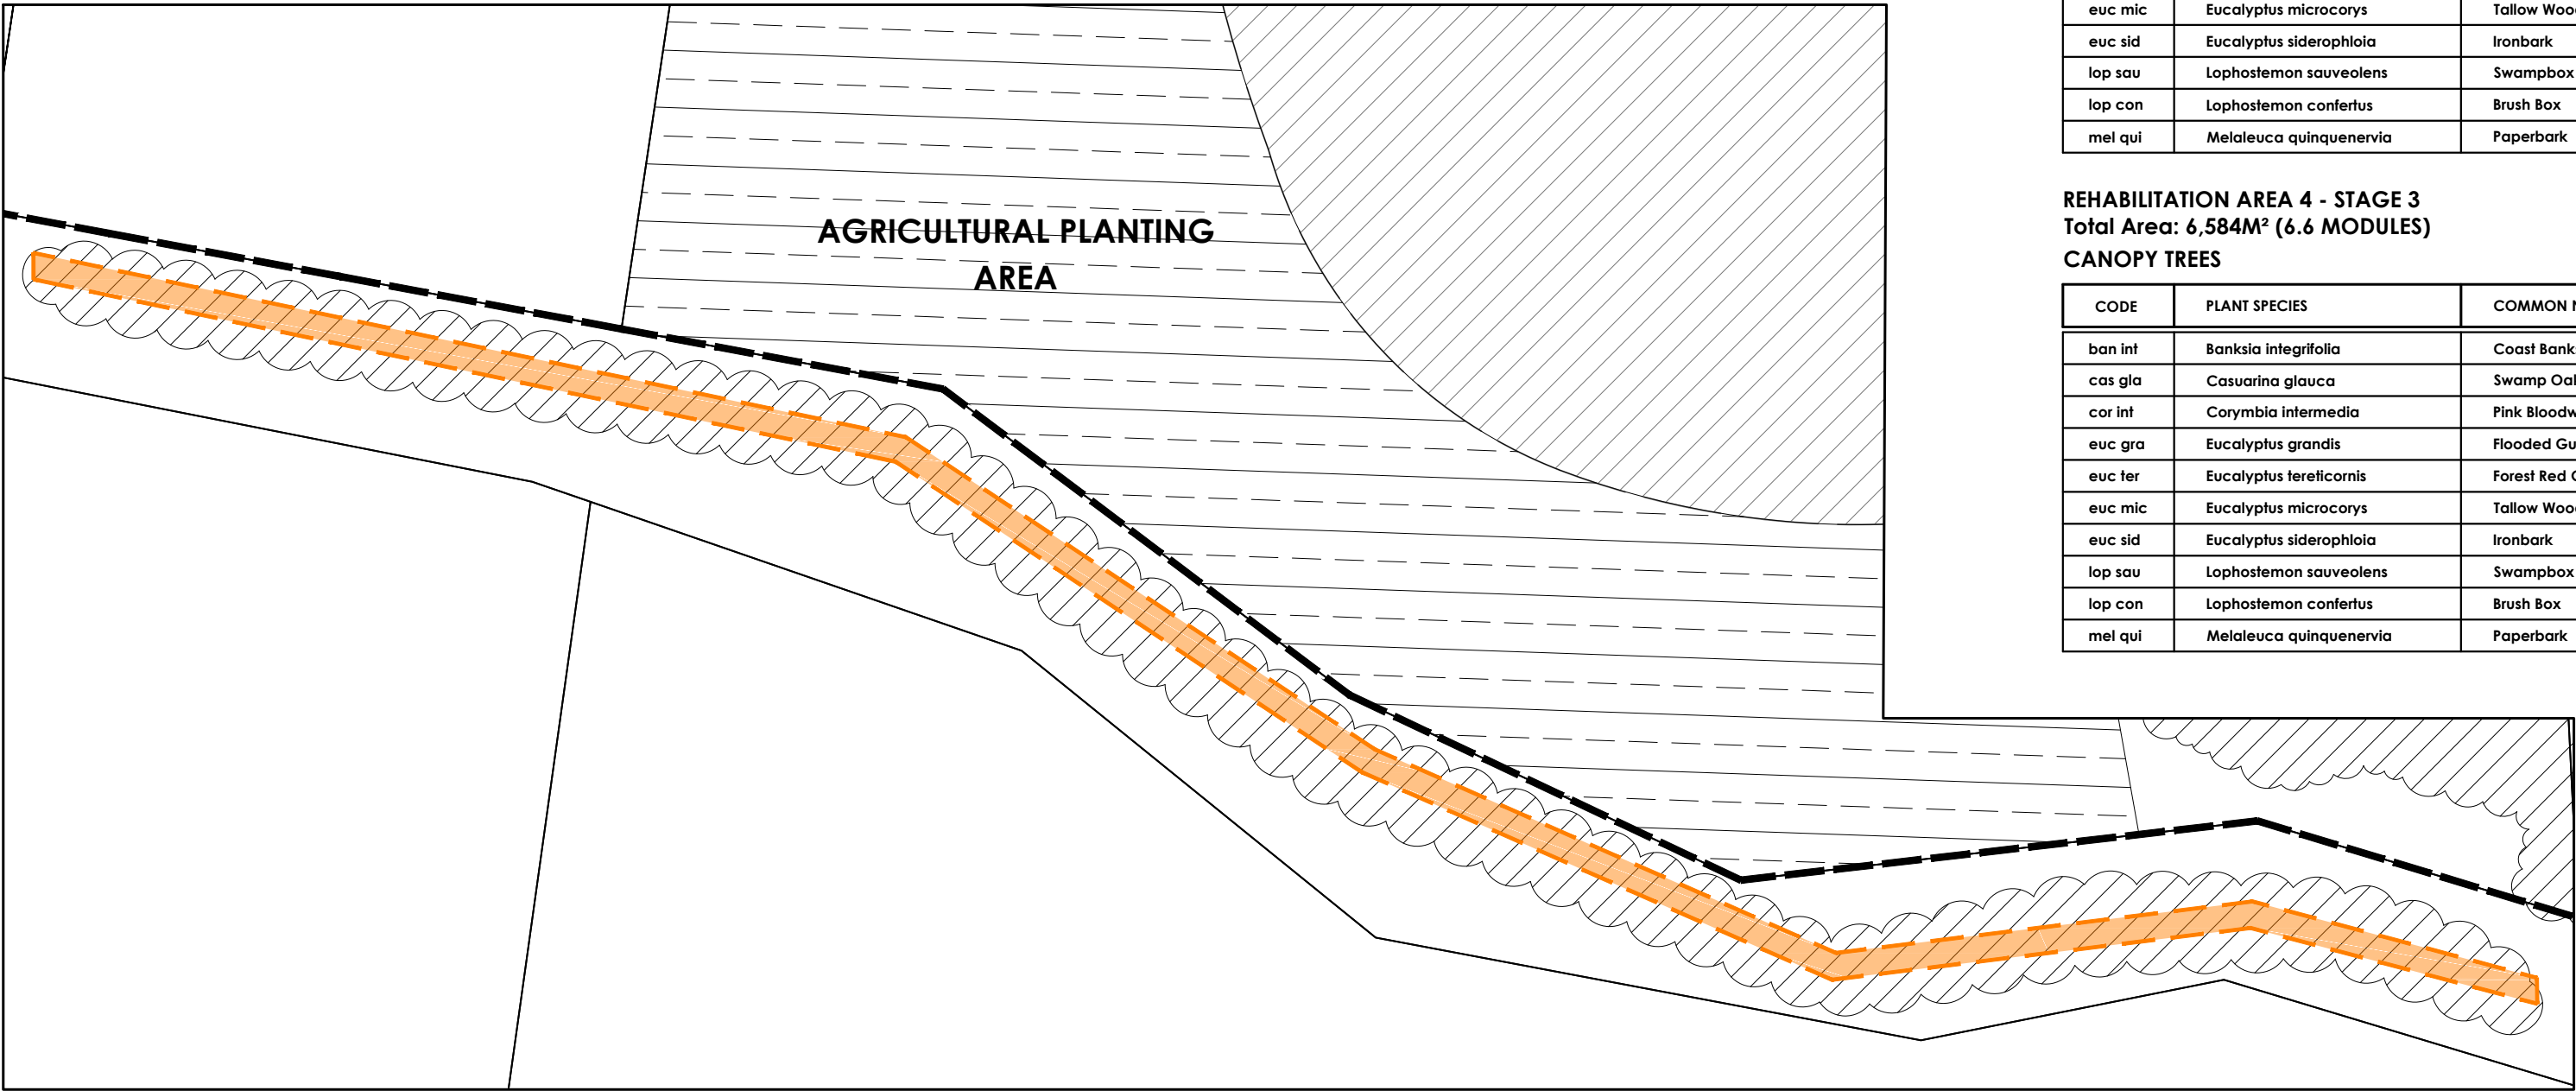
Rehabilitation Planting Area 4 | STAGE 3  
Total Area: 6,585M²

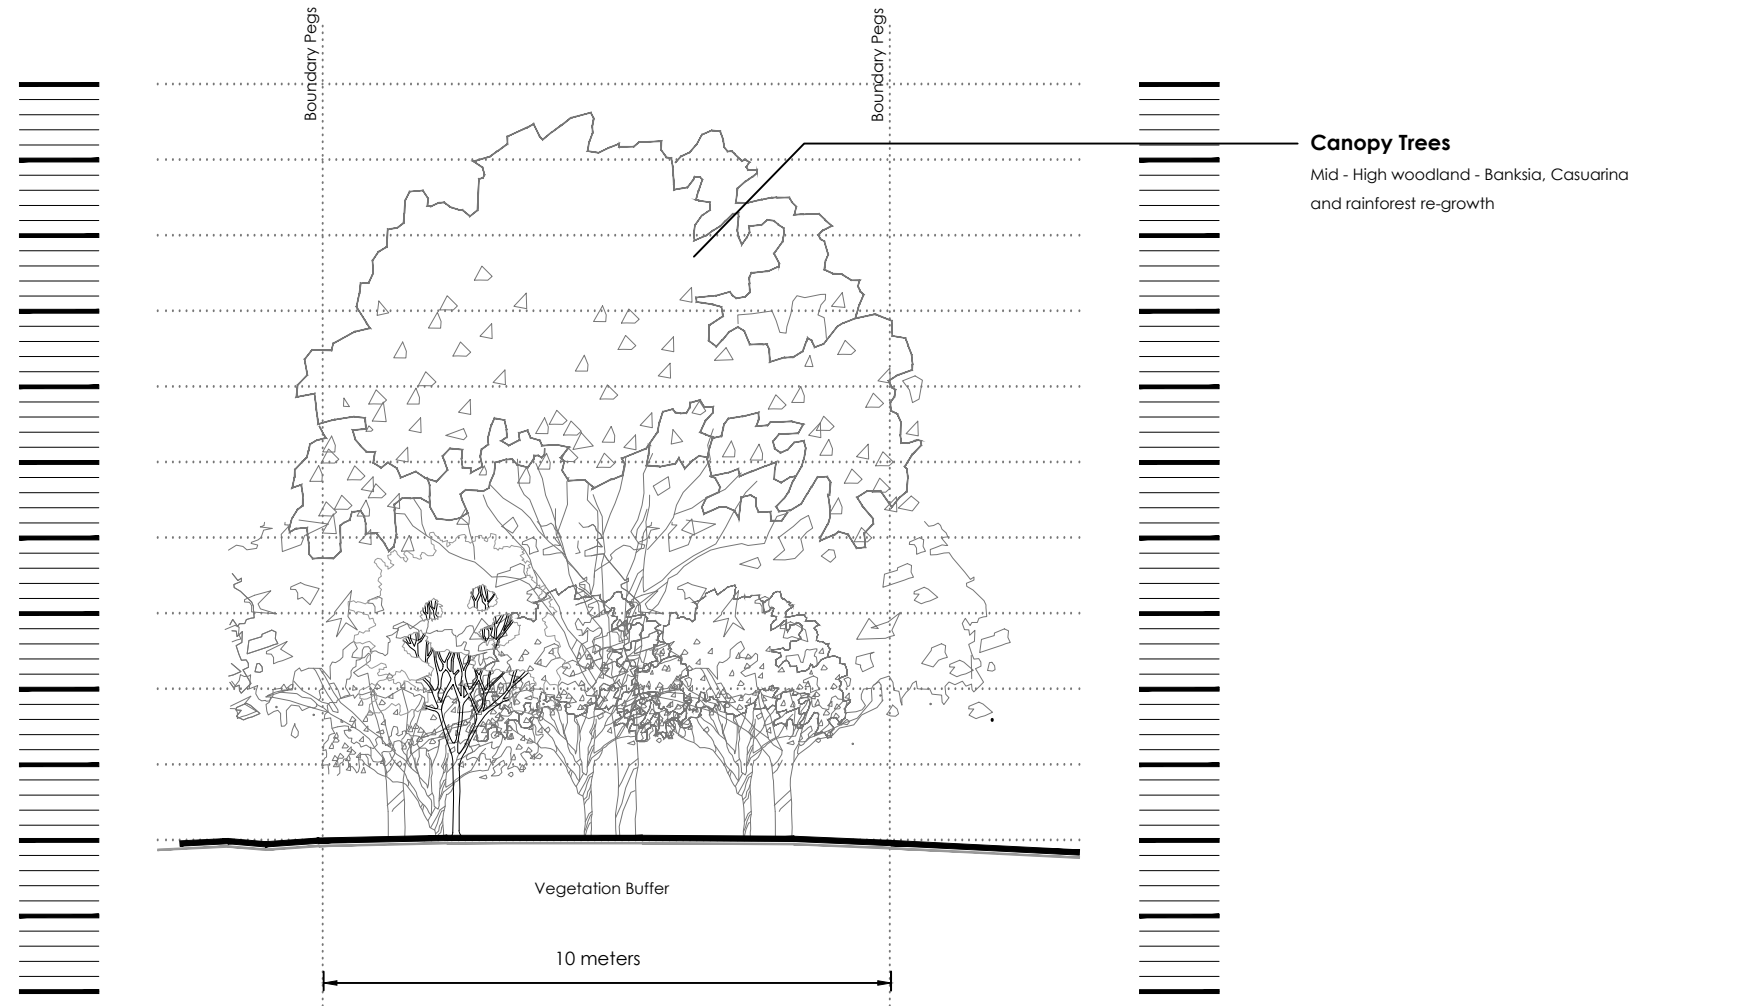
### Typical Buffer Profile
