# **Holcim (Australia) Pty Ltd**

## **Dunloe Sand Quarry Landscape Management Plan**

June 2021

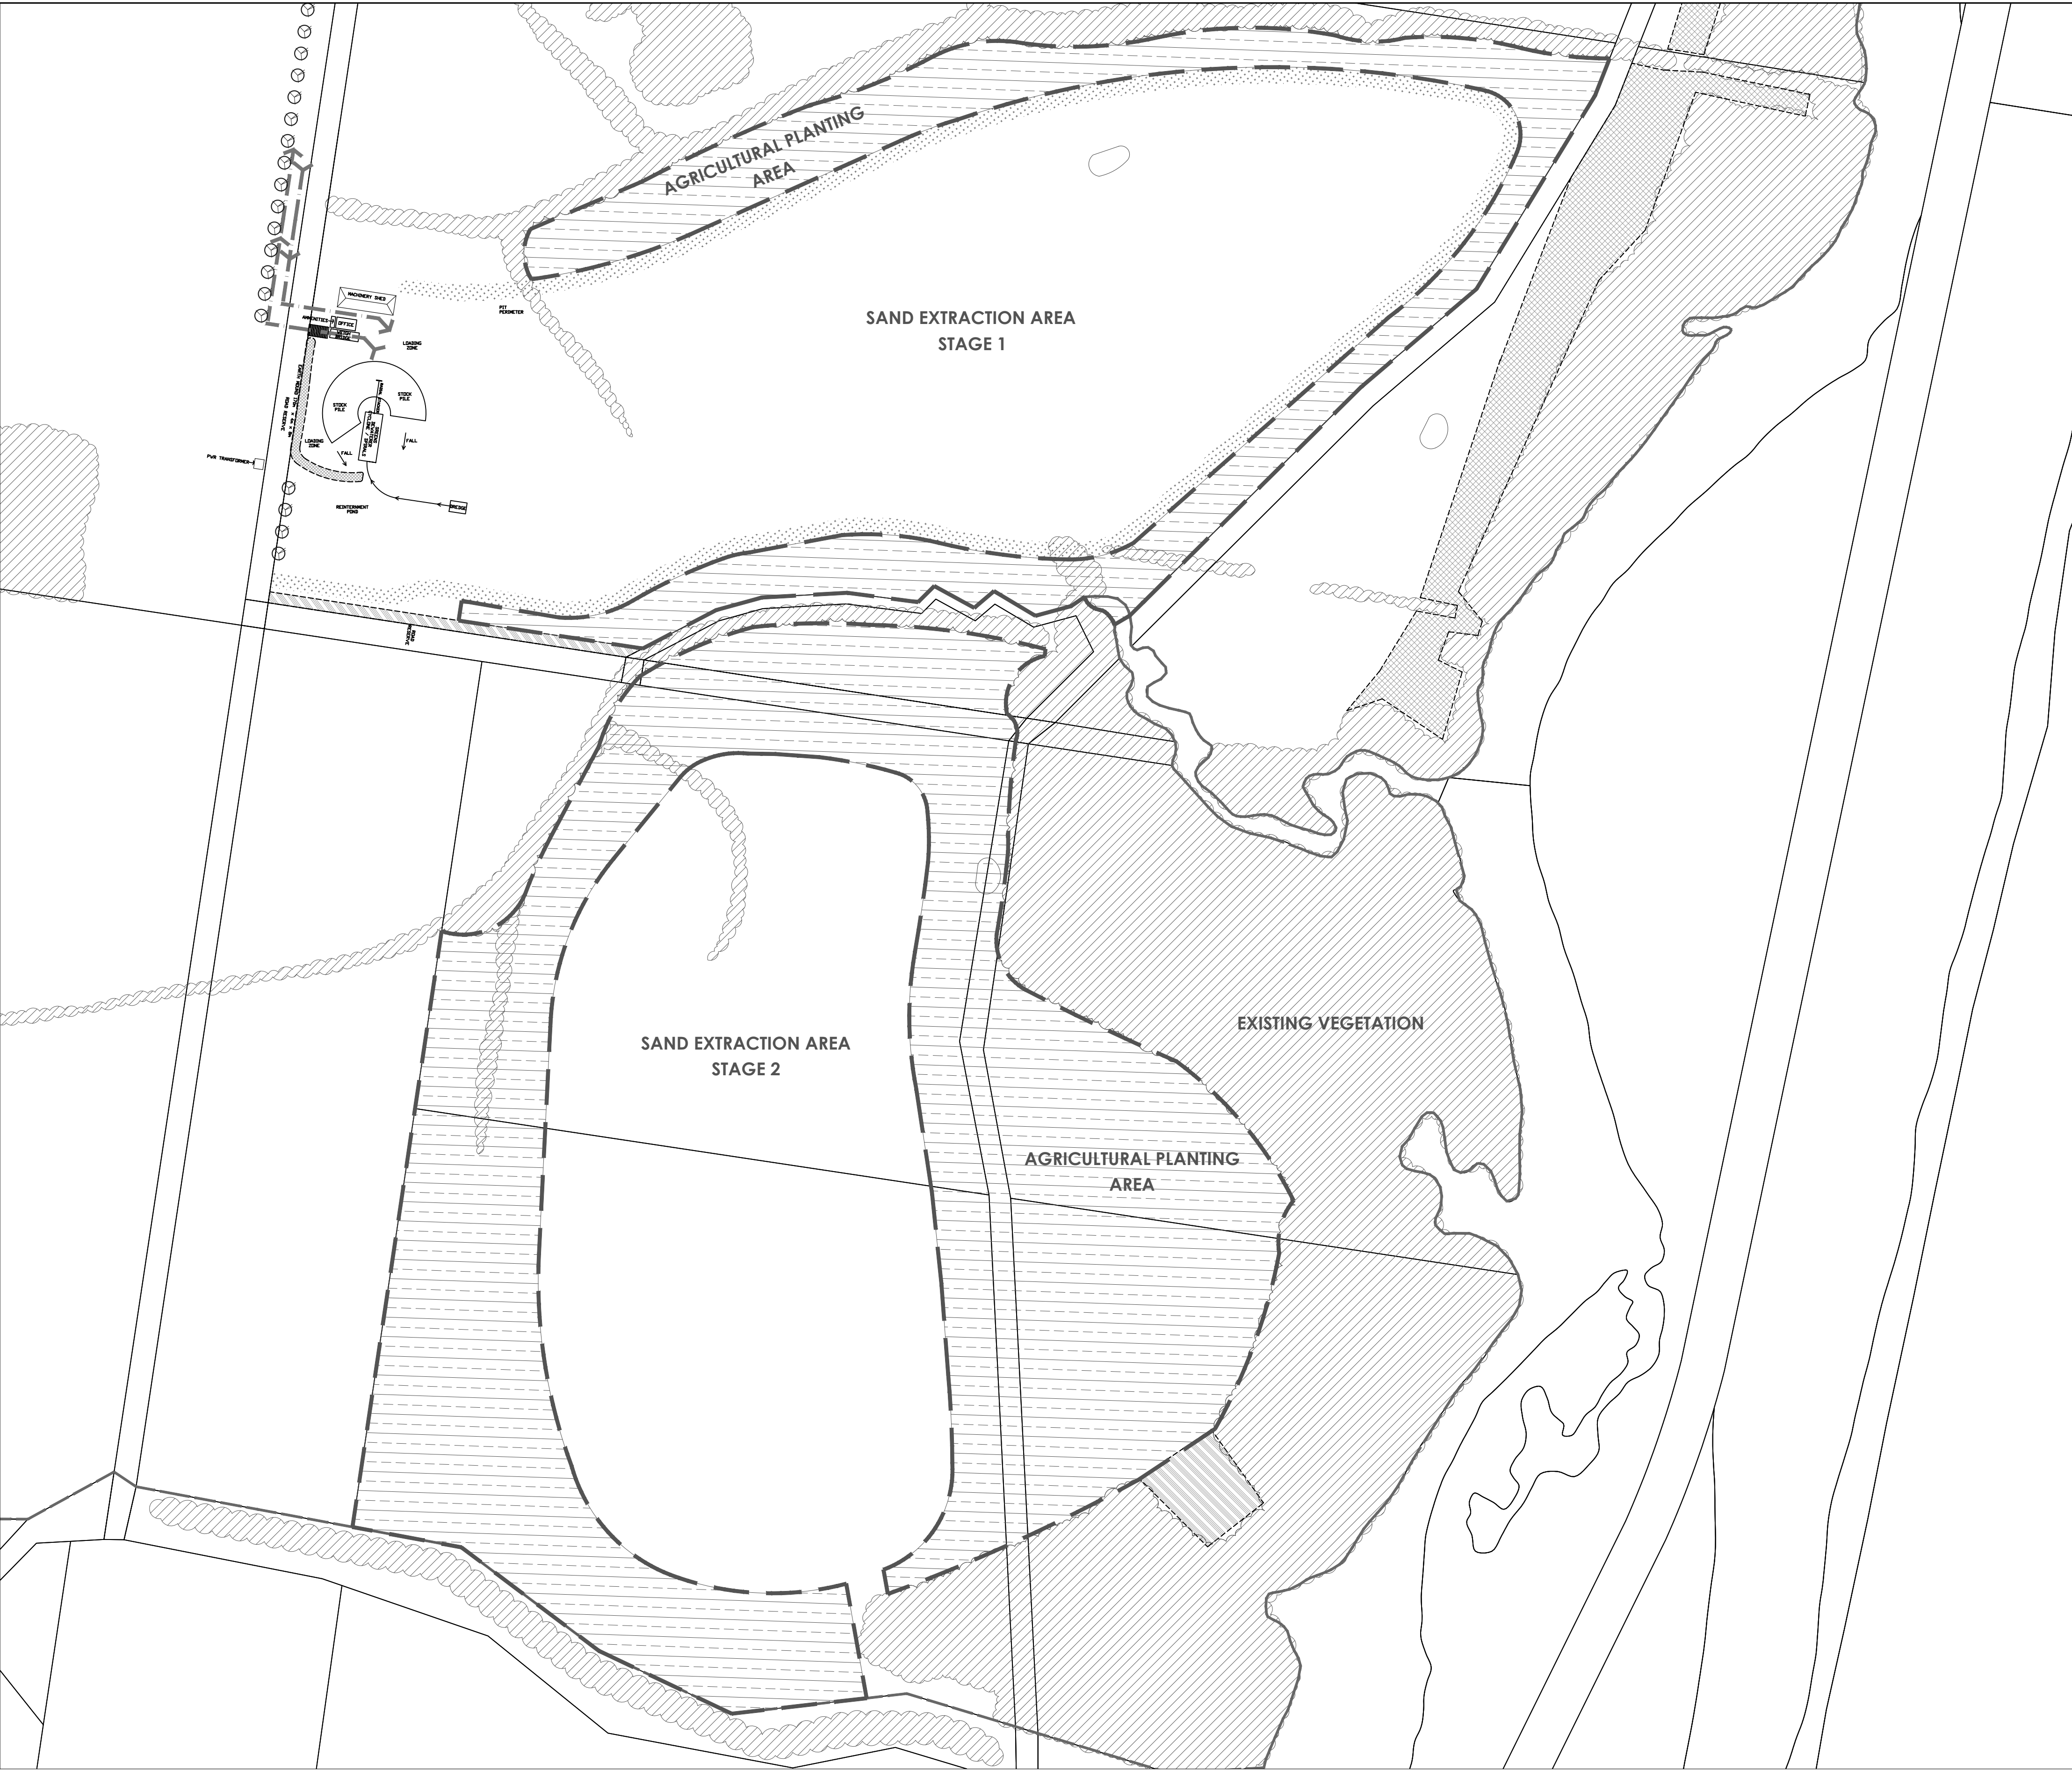
**Agricultural Planting Area**  
Total Area: 396,975M²

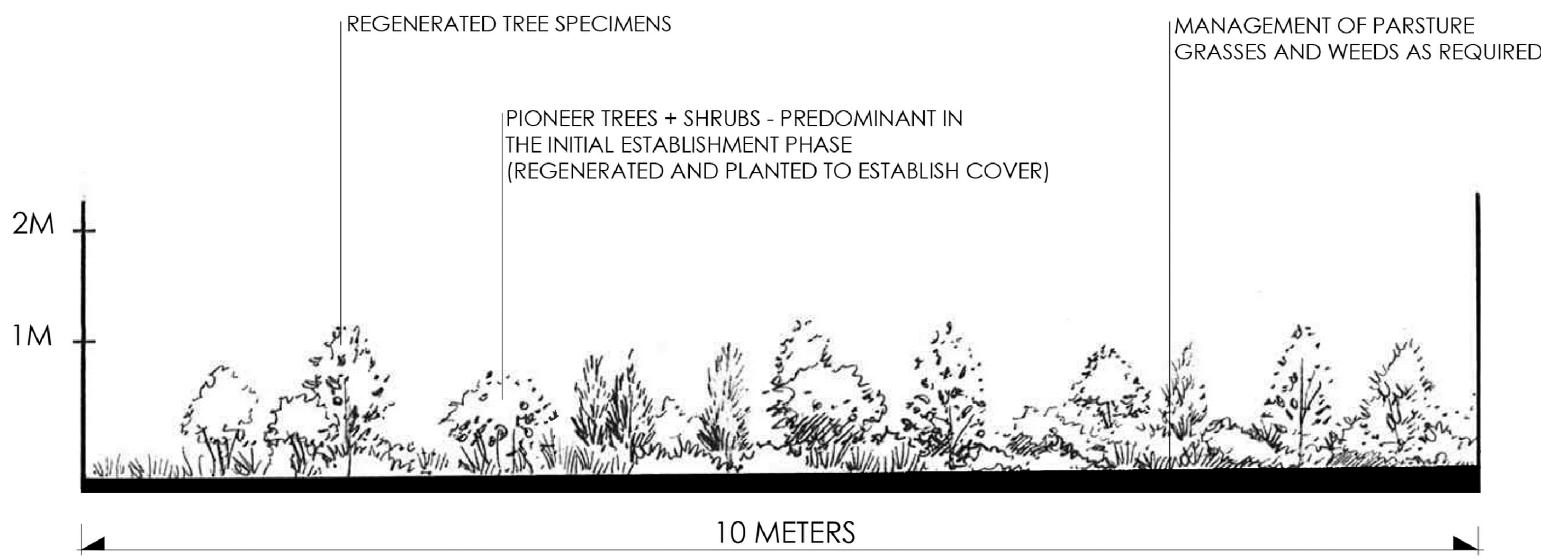
ASSISTED REGENERATION PROFILE: YEAR 1 - 2

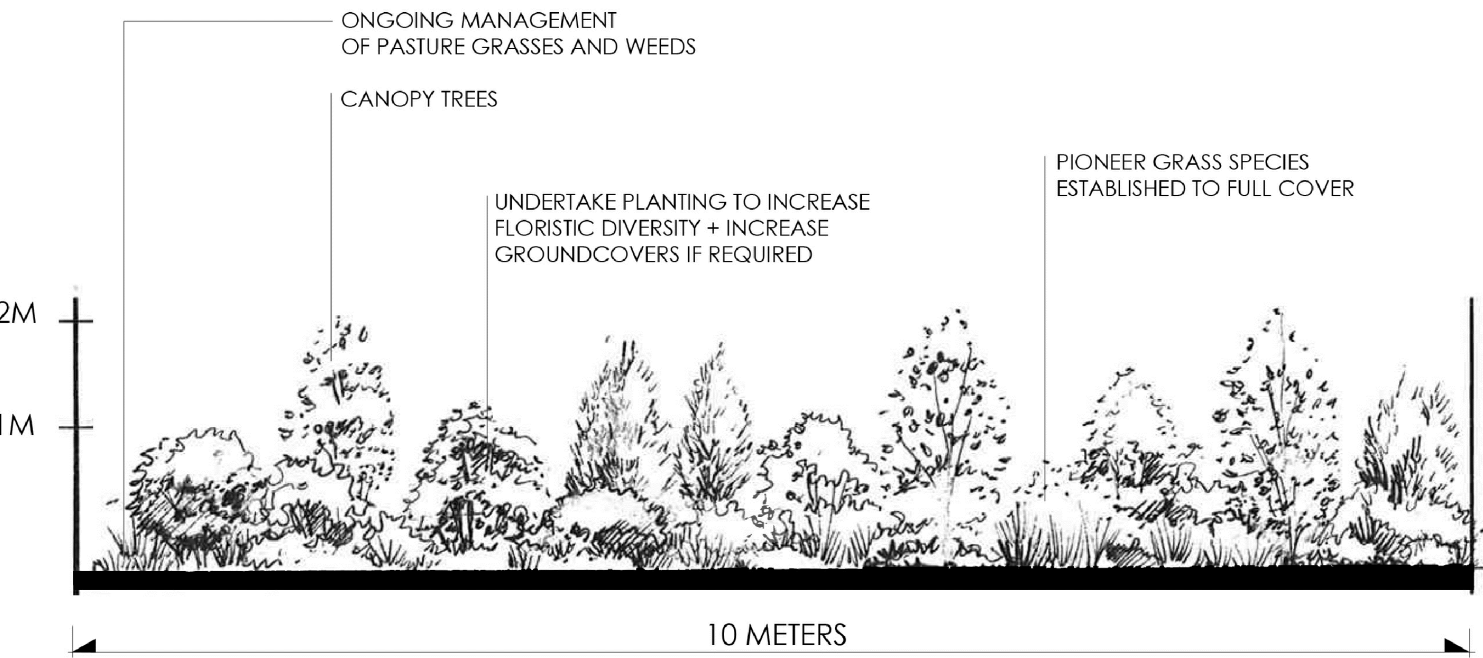
ASSISTED REGENERATION PROFILE: 2 - 4 YEARS
