# St John of God

## Historical Archaeological Assessment

FINAL REPORT V3

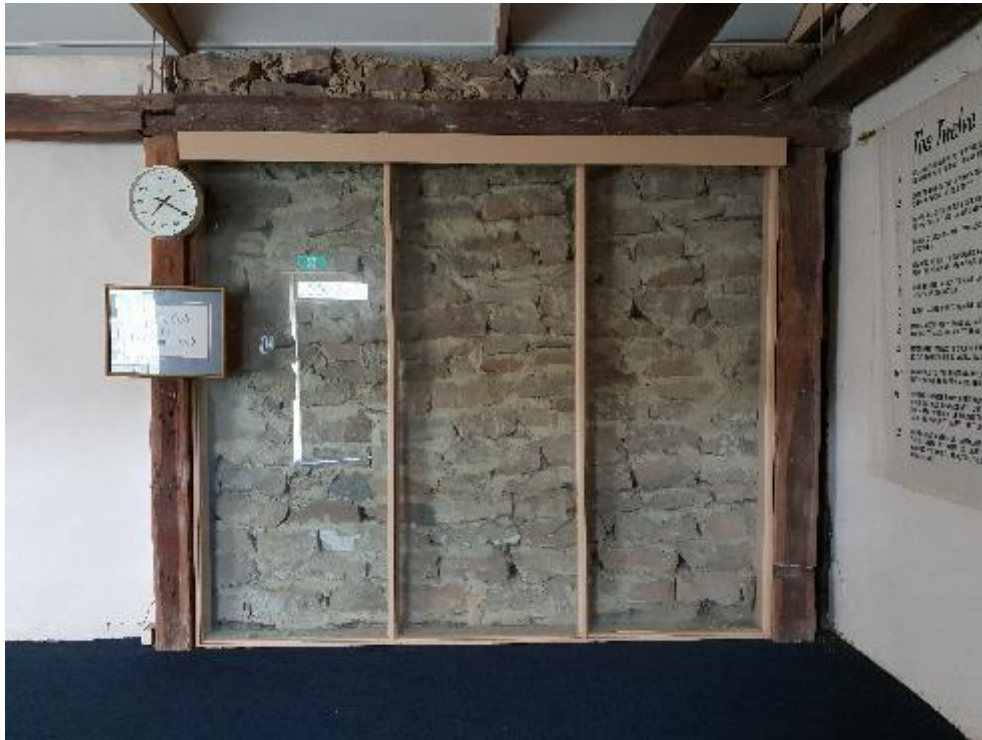
**Photo 5 Portion of the original Bell stable [2] building wall, incorporated into a later sandstone building, possibly the laundry or later stable**

In 1818 Bell acted as barracks master and assisted in founding the Hawkesbury Benevolent Society. He was then appointed chief police magistrate 1820 and became the first magistrate to be paid and occupy Government House. His son, also Archibald Bell, marked a new route across the Blue Mountains in 1823 at age 19, following Aboriginal women into the area from the Belmont property. By 1832 Bell senior was appointed as a member of the Legislative council and held his seat until his death in 1883. Also around this time, the original Bell House [1] was expanded from the timber homestead, with the homestead now comprising a stone dwelling, stables and coach house [2], offices [3] and outbuildings [4], gardens and orchards.<sup>39</sup> Part of the original 1830s stable building wall remains within the study area, incorporated into the later sandstone stables constructed in the 1890s (Photo 5).

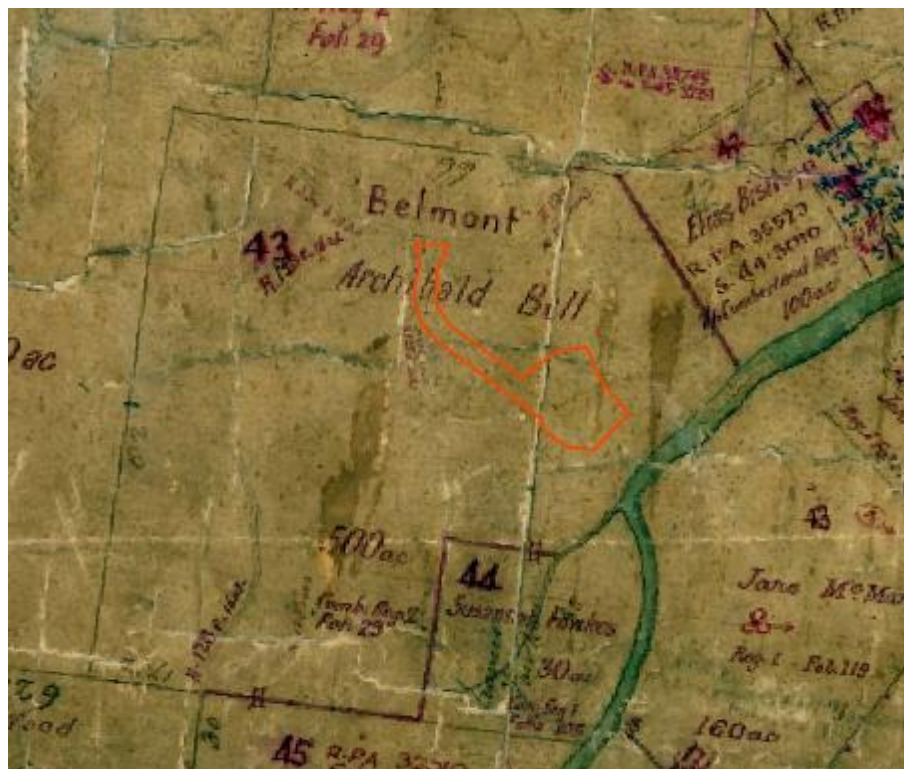
**Photo 11** Extract from undated Crown plan showing land along the Hawkebury River with the study area outlined in orange (Source: NSW Land Registry Services, Crown plan 1-497a)

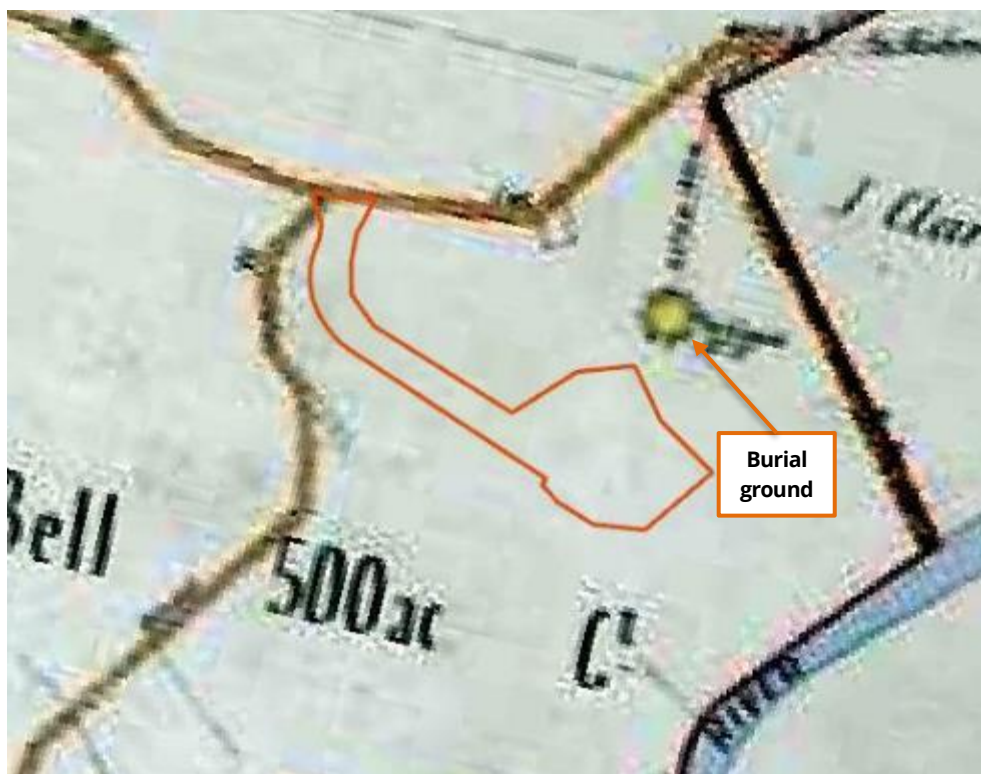
**Photo 15 Plan of the Belmont Estate Land dated to 1890, with the study area outlined in orange (Source: NSW Land Registry Services, Certificate of Title Volume 966 Folio 116)**

The Belmont estate remained in the Newcommen family, with Henry Newcommen's son, William Belmont Newcommen, subdividing part of the estate in 1888.<sup>50</sup> The Belmont property was later transferred to William James Forrester, esquire, George Henry Holmes, esquire and Robert Lismore Moore, grazier in 1890.<sup>51</sup> The Belmont Estate land was promptly sold to Philip Charley the same year.<sup>52</sup> A plan of the Belmont Estate within the Certificate of Title does not show the location of Bell House [1], the stables and coach house [2], offices [3] and outbuildings [4], however a burial ground is recorded to the north of the study area (Photo 15). This is where Archibald Bell and his wife were buried.<sup>53</sup>

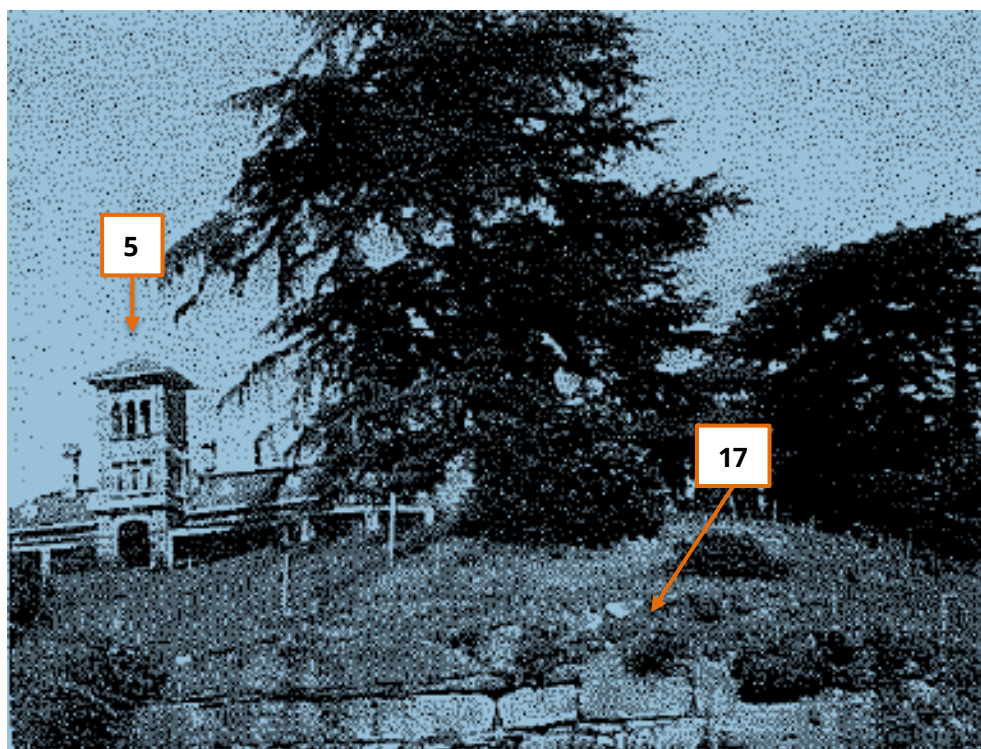
**Photo 28 Photograph of unknown date of the ruins of a sandstone wall [17] purported to be the remains of Bell House, which appear to be incorporated into the terracing in front of Belmont House [5] (Source: (Caritas Date unknown))**

It has been argued that the foundations of the original Bell House remain within the hospital grounds, but it has been difficult to determine their exact location as it has not been possible to locate a plan, sketch or map recording structures within the Belmont estate. Analysis of 19th century artistic depictions (Photo 6, Photo 7, Photo 8, Photo 12, Photo 13, Photo 14, Photo 16, Photo 17) suggest that the Bell homestead was located below the crest of the hill (where the current Belmont House [5] is situated), while the stables [2] was an outlier building on the ridgeline. Photographs from the early-20th century onwards (, Photo 27, Photo 28, Photo 36, Photo 37, Photo 38, ) record ruins of stone walls, either free standing [31] or within the terrace banks [17] [24] [30], and a circular feature [16] below and north of the terrace areas in front of Belmont House [5]. Based on the topography and vegetation in Photo 37 and Photo 38, the free-standing stone wall associated [31] with a timber post is likely to have been located at the base of the terraced slope near the current Maintenance Shed / Engineering building [37]. Similarly, the surrounding features in Photo 28 such as

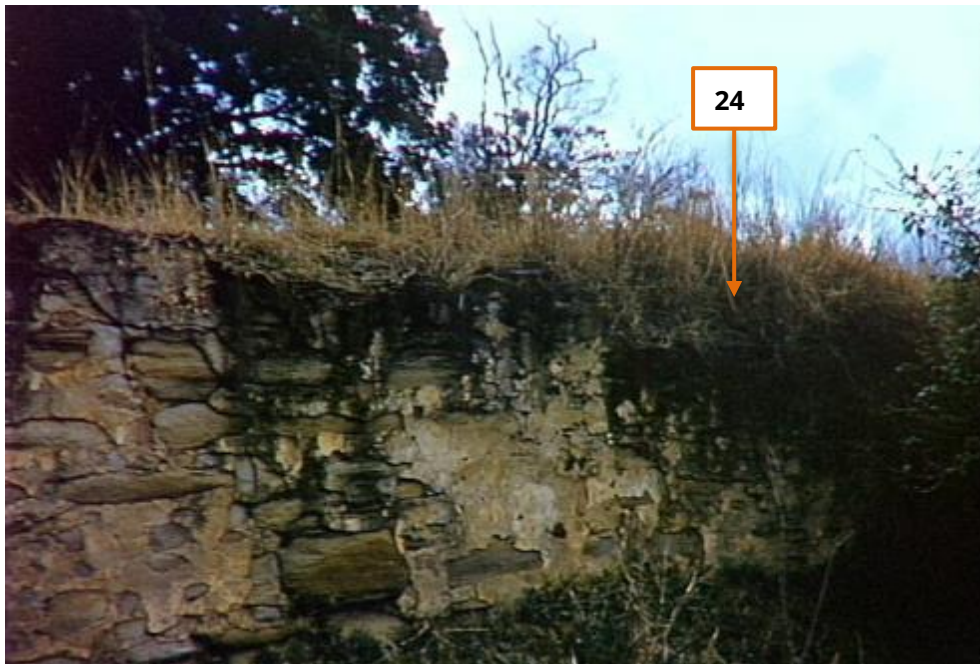
**Photo 33 c.1960s photograph of an overgrown sandstone wall [24], possibly associated with one of the buildings from the Bell homestead (Source: Hawkesbury Library, Image no. 013835)**

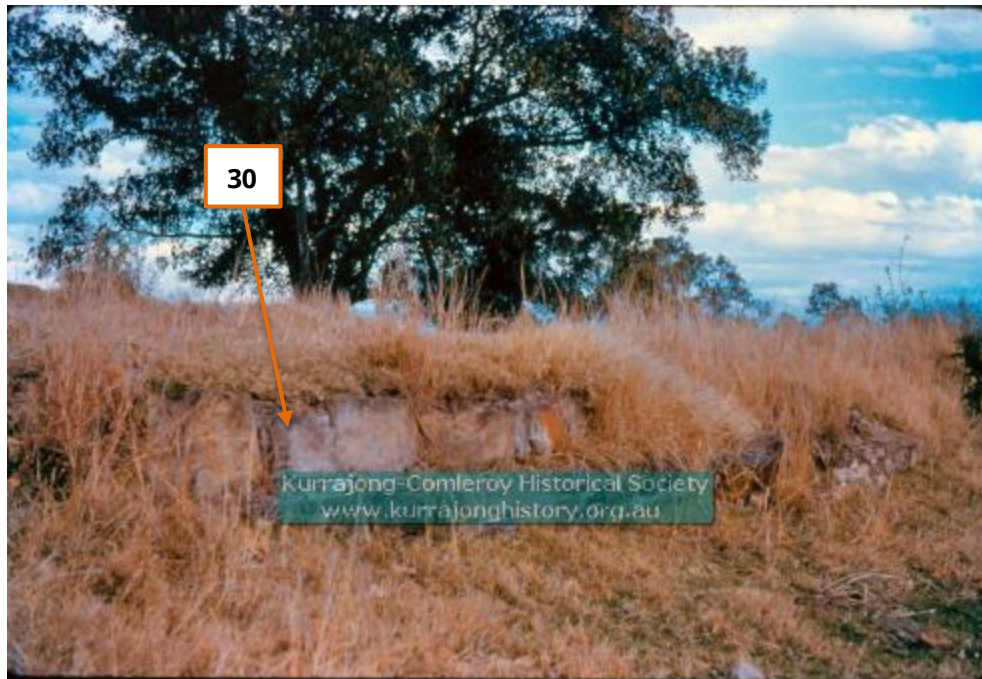
**Photo 36** 1977 photograph of an overgrown sandstone building wall or retaining wall [30] within a terrace bank; no details of the photograph's location are provided in the catalogue entry, but may be the same or associated with a previously identified sandstone wall [24] (Source: (Avern 1977a)

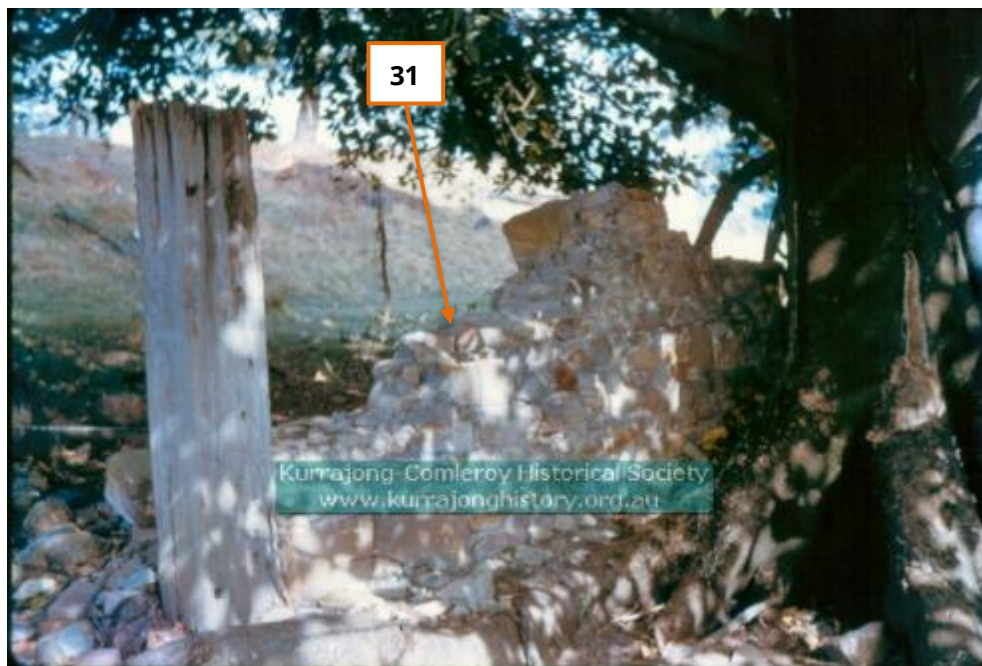
**Photo 37** 1977 photograph of ruins of a stone wall [31] and timber post adjacent to a large fig tree at the base of a slope; no details of the photograph's location are provided in the catalogue entry (Source: (Avern 1977b)

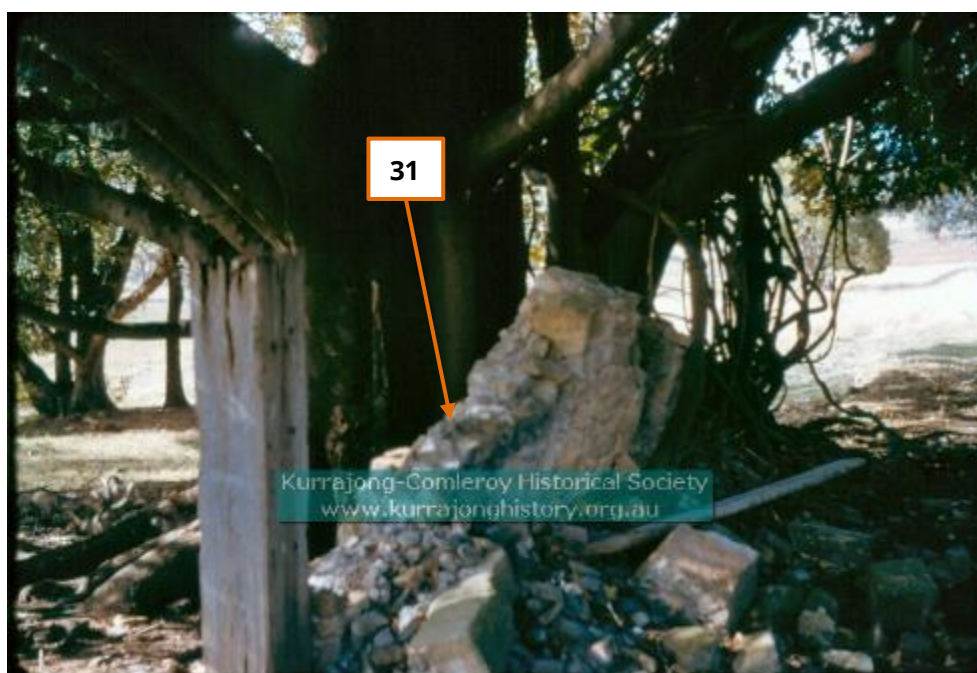
**Photo 38** 1977 photograph of ruins of a stone wall [31] and timber post adjacent to a large fig tree at the base of a slope; no details of the photograph's location are provided in the catalogue entry (Source: (Avern 1977c))

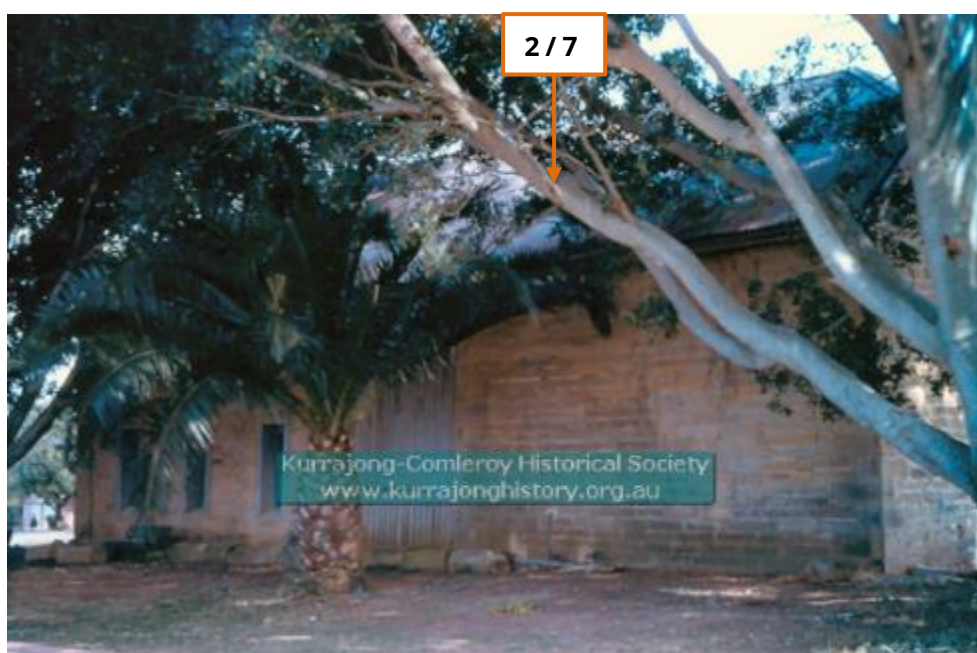
**Photo 39** 1977 photograph of former sandstone stables building [2]/[7], which features part of the original Bell stables [2], facing south-east (Source: (Avern 1977d))

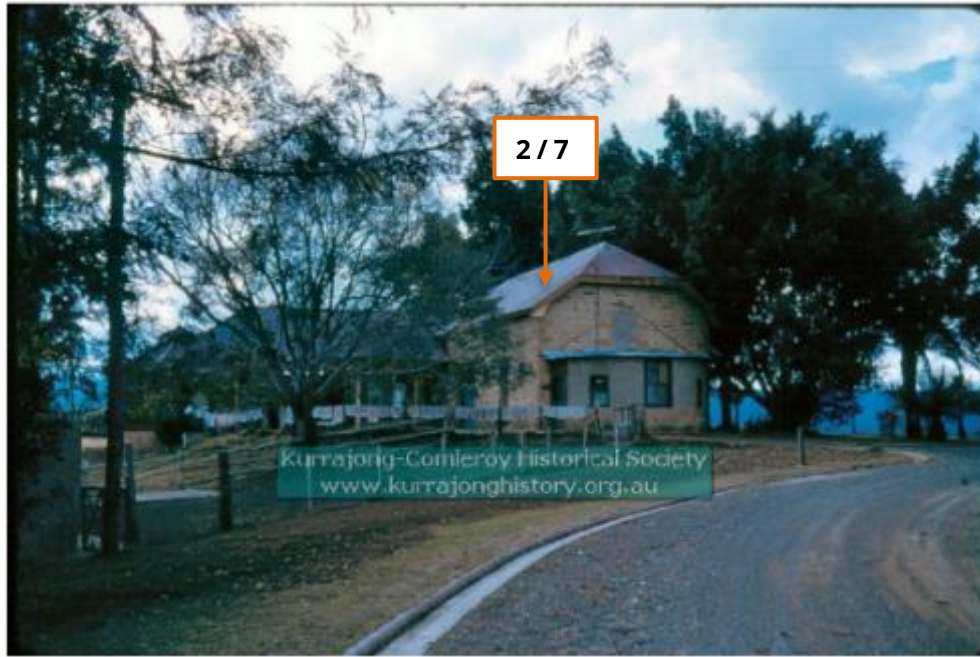
**Photo 40 1977 photograph of former sandstone stables [2] / [7] building, which features part of the original Bell stables [2], facing north-west (Source: (Avern 1977e)**

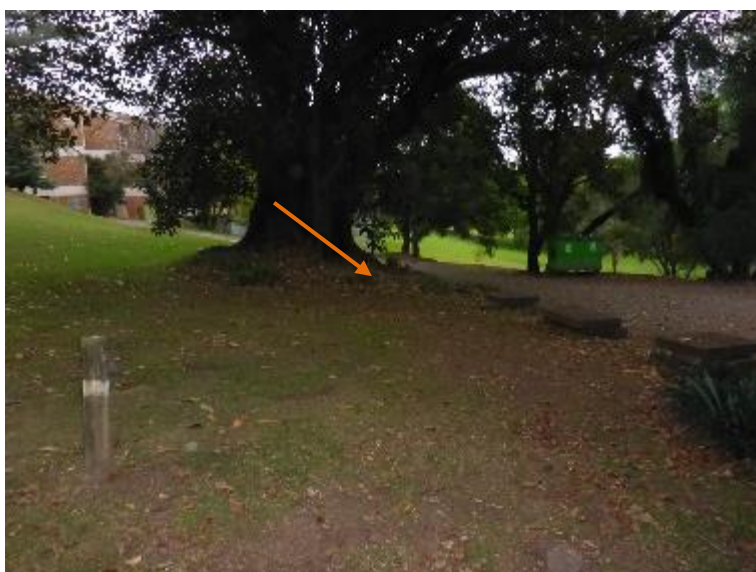
**Photo 59** Area near current maintenance shed / engineering building [37] featuring stone structural features capped with concrete slabs; this may be the likely location for the former sandstone wall ruins [31], facing north

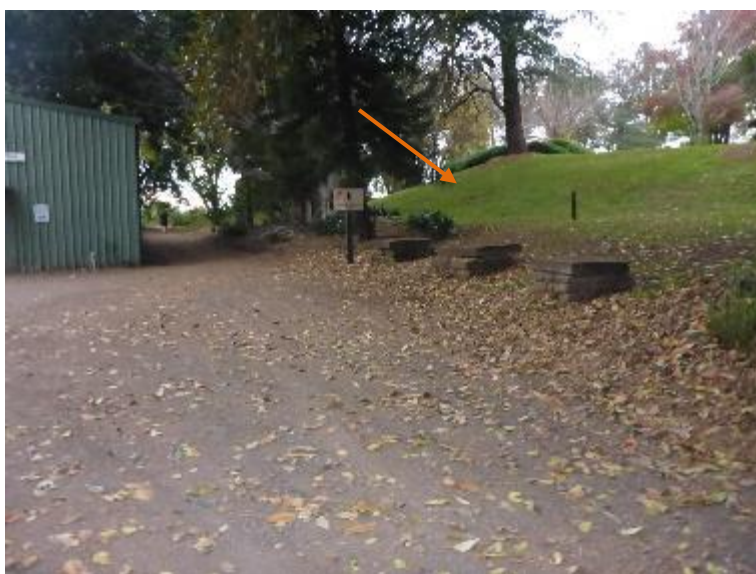
**Photo 60** Area near current maintenance shed / engineering building [37] is the likely location for the sandstone wall in the terrace bank [17] (indicated by the orange arrow), facing east

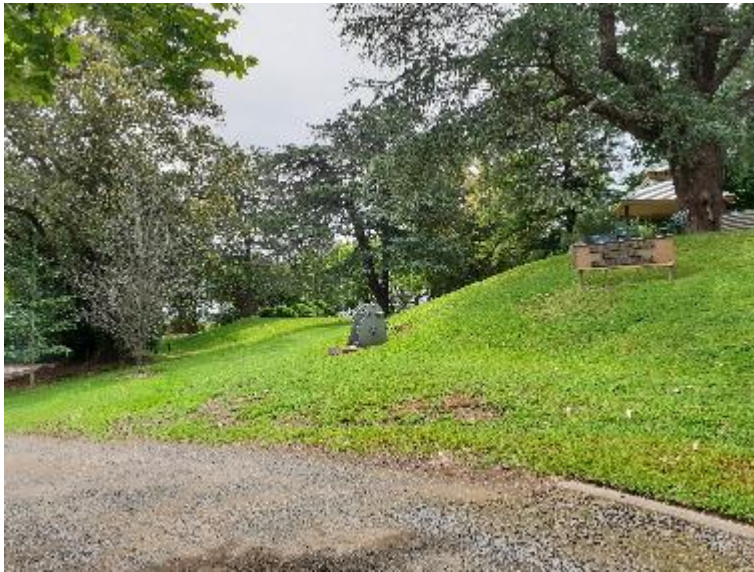
**Photo 61** Area near current maintenance shed / engineering building [32] is the likely location for the circular feature [16], facing south-east

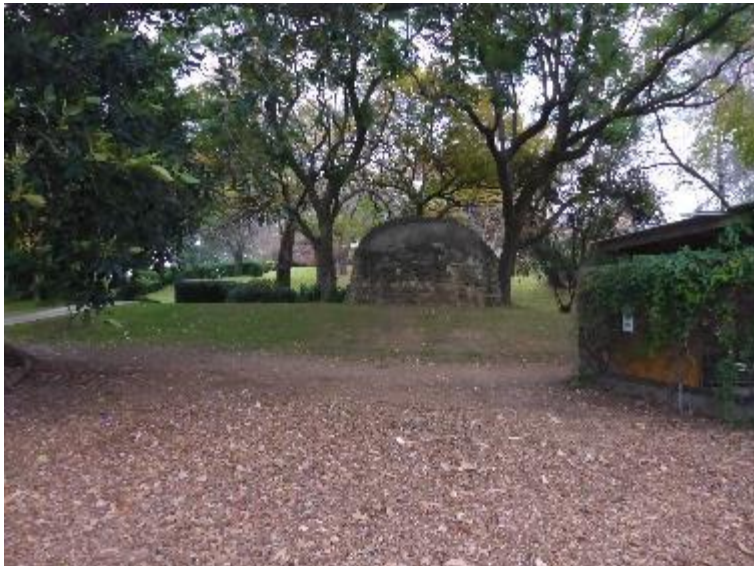
**Photo 62** Grotto of the Lady of Lourdes which may contain reused stone from Bell House [1] or other early buildings [3] [4], facing south-west

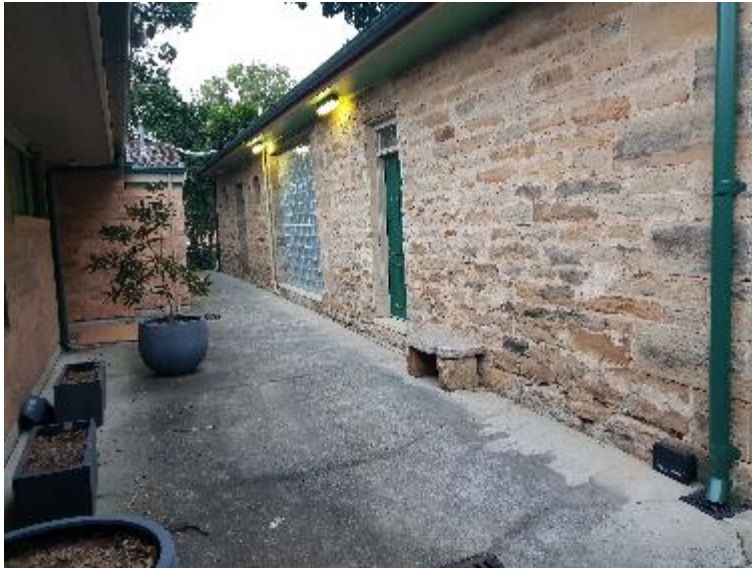
**Photo 64 View of the former stables building [2] / [7], now only featuring one wing facing south**

The stable and coach house [2] was adapted as part of the later stables [7] under the ownership of the Charleys, and is located in the southern portion of the site. The 1890s stables [7] have been modified, with only one wing remaining and new buildings erected on its northern side where the earlier wing would have been located (Photo 64

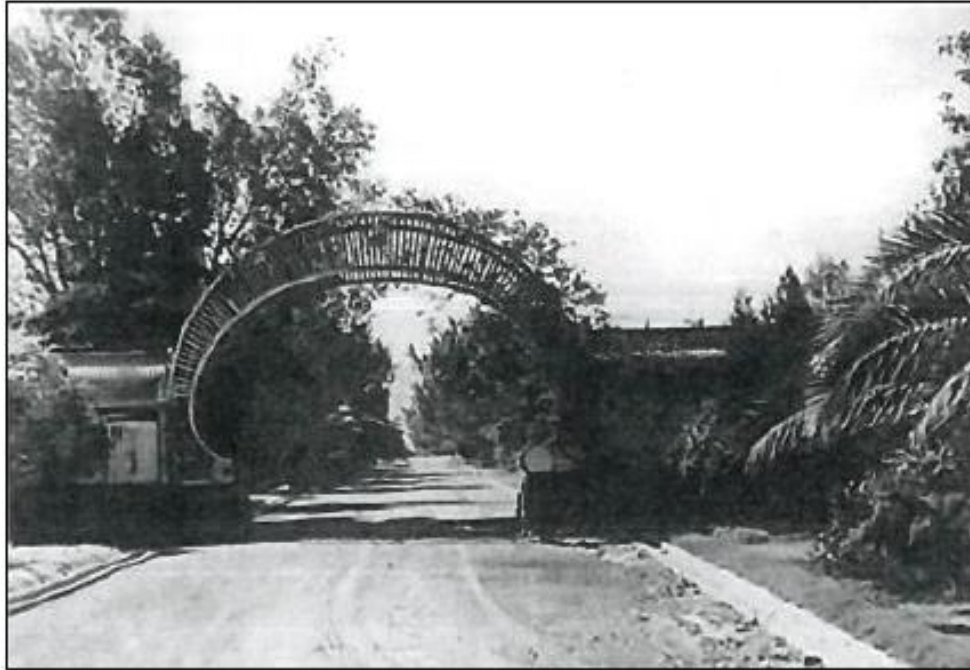
**Photo 65 Undated photograph of what is thought to be the original gate [10] archway to Belmont Park (Source: (Weir Phillips Heritage and Planning 2020, p.20)**

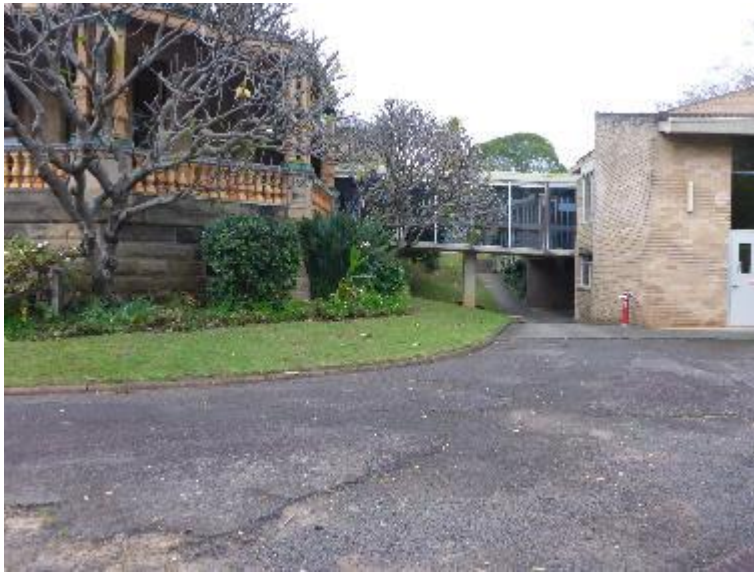
**Photo 66** View of Phase 2 and 3 structures cutting into the slope, also showing infrastructure and utilities, facing south-west

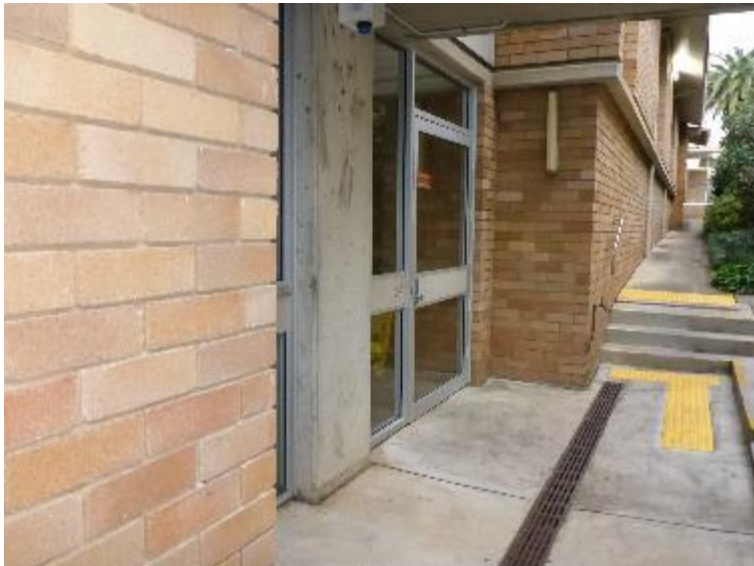
**Photo 67** View of Phase 3 structures cutting into the slope, also showing infrastructure and utilities, facing south-west

The later development of the study area in Phases 2 and 3 has likely had a significant impact on the sub-surface integrity of the archaeological resource associated with Phase 1. There are no extant structures from Phase 1, and the potential locations are also likely to have been impacted through landscaping and terracing, and construction of new buildings. Belmont House [3] and many of the Phase 3 structures situated on the hill cut into the slope, removing or truncating any archaeological resources that may have been present. There has also been significant infrastructure works through the establishment of roads, drainage, electricity and services, which would have involved trenching works across the study area, impacting on any sub-surface archaeological resources from Phase 1 and 2 (Photo 66, Photo 67, Photo 68, Photo 69, Photo 70, Photo 71, Photo 72, Photo 73).

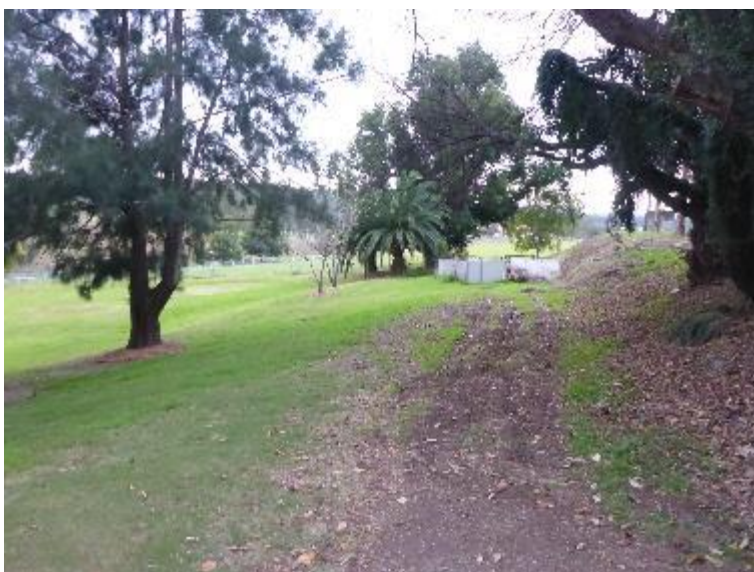
**Photo 68** View of Phase 2 and 3 modifications through terracing and landscaping, facing north-east

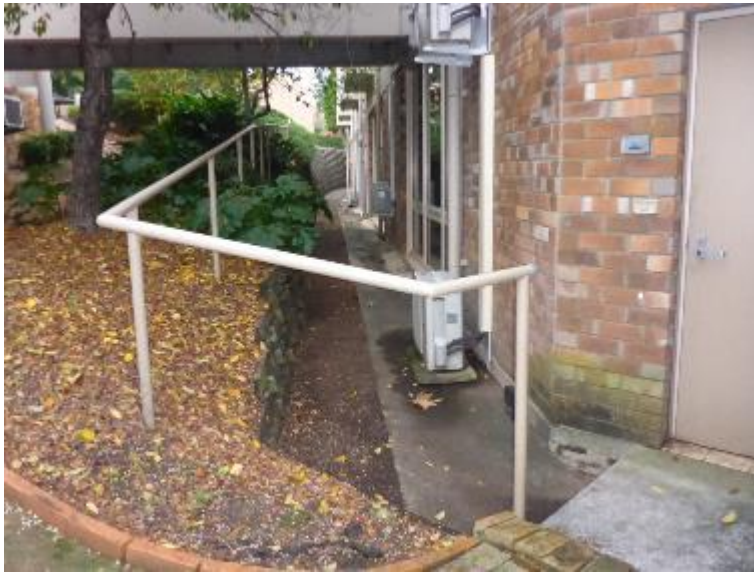
**Photo 69** Example view of Phase 3 structures cutting into the slope, also showing infrastructure and utilities

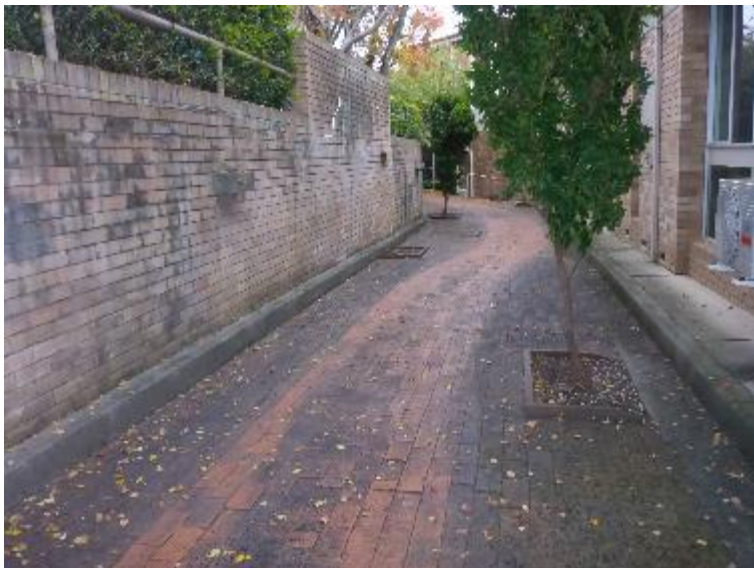
**Photo 70** Example view of Phase 3 structures cutting into the slope, also showing infrastructure and utilities

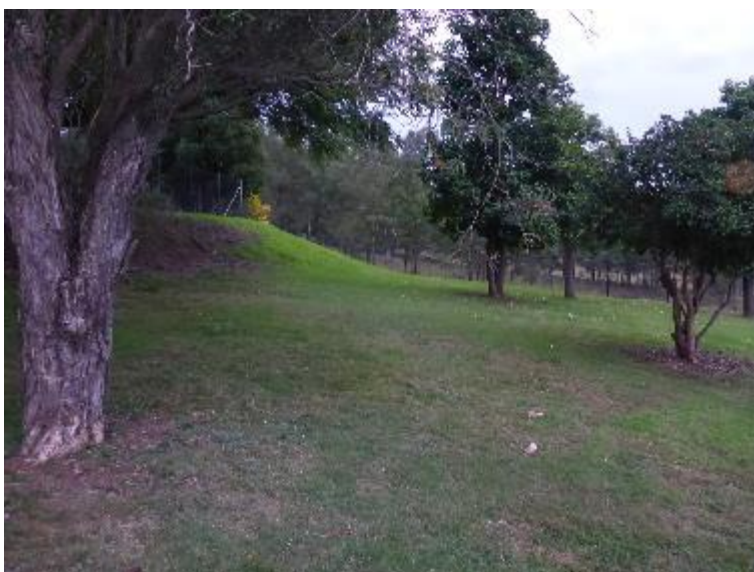
**Photo 71** View of Phase 2 and 3 modification works through terracing and landscaping, facing north-west

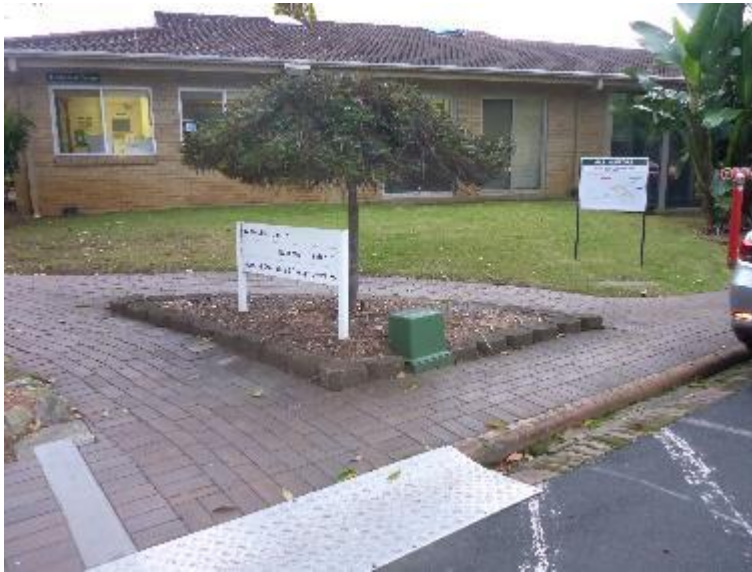
**Photo 72** View of Phase 3 structures, and infrastructure and utilities, facing south

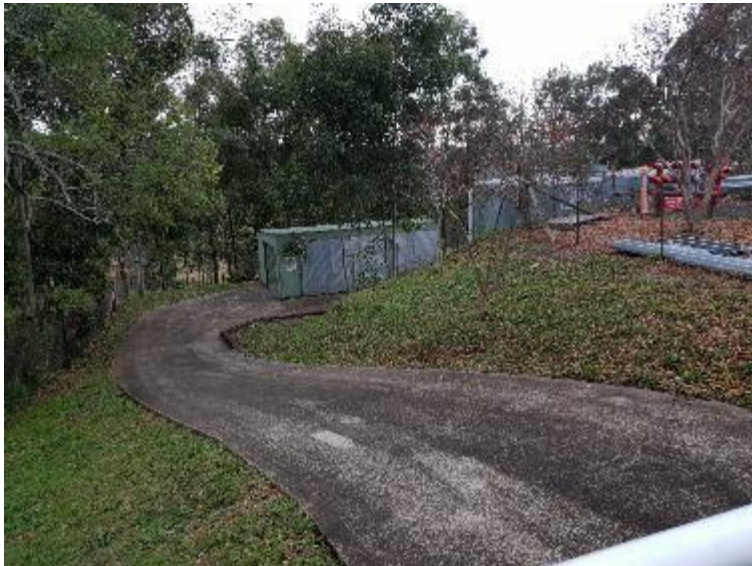
**Photo 73** View of Phase 3 structures and terracing cutting into the slope, also showing infrastructure and utilities, facing east

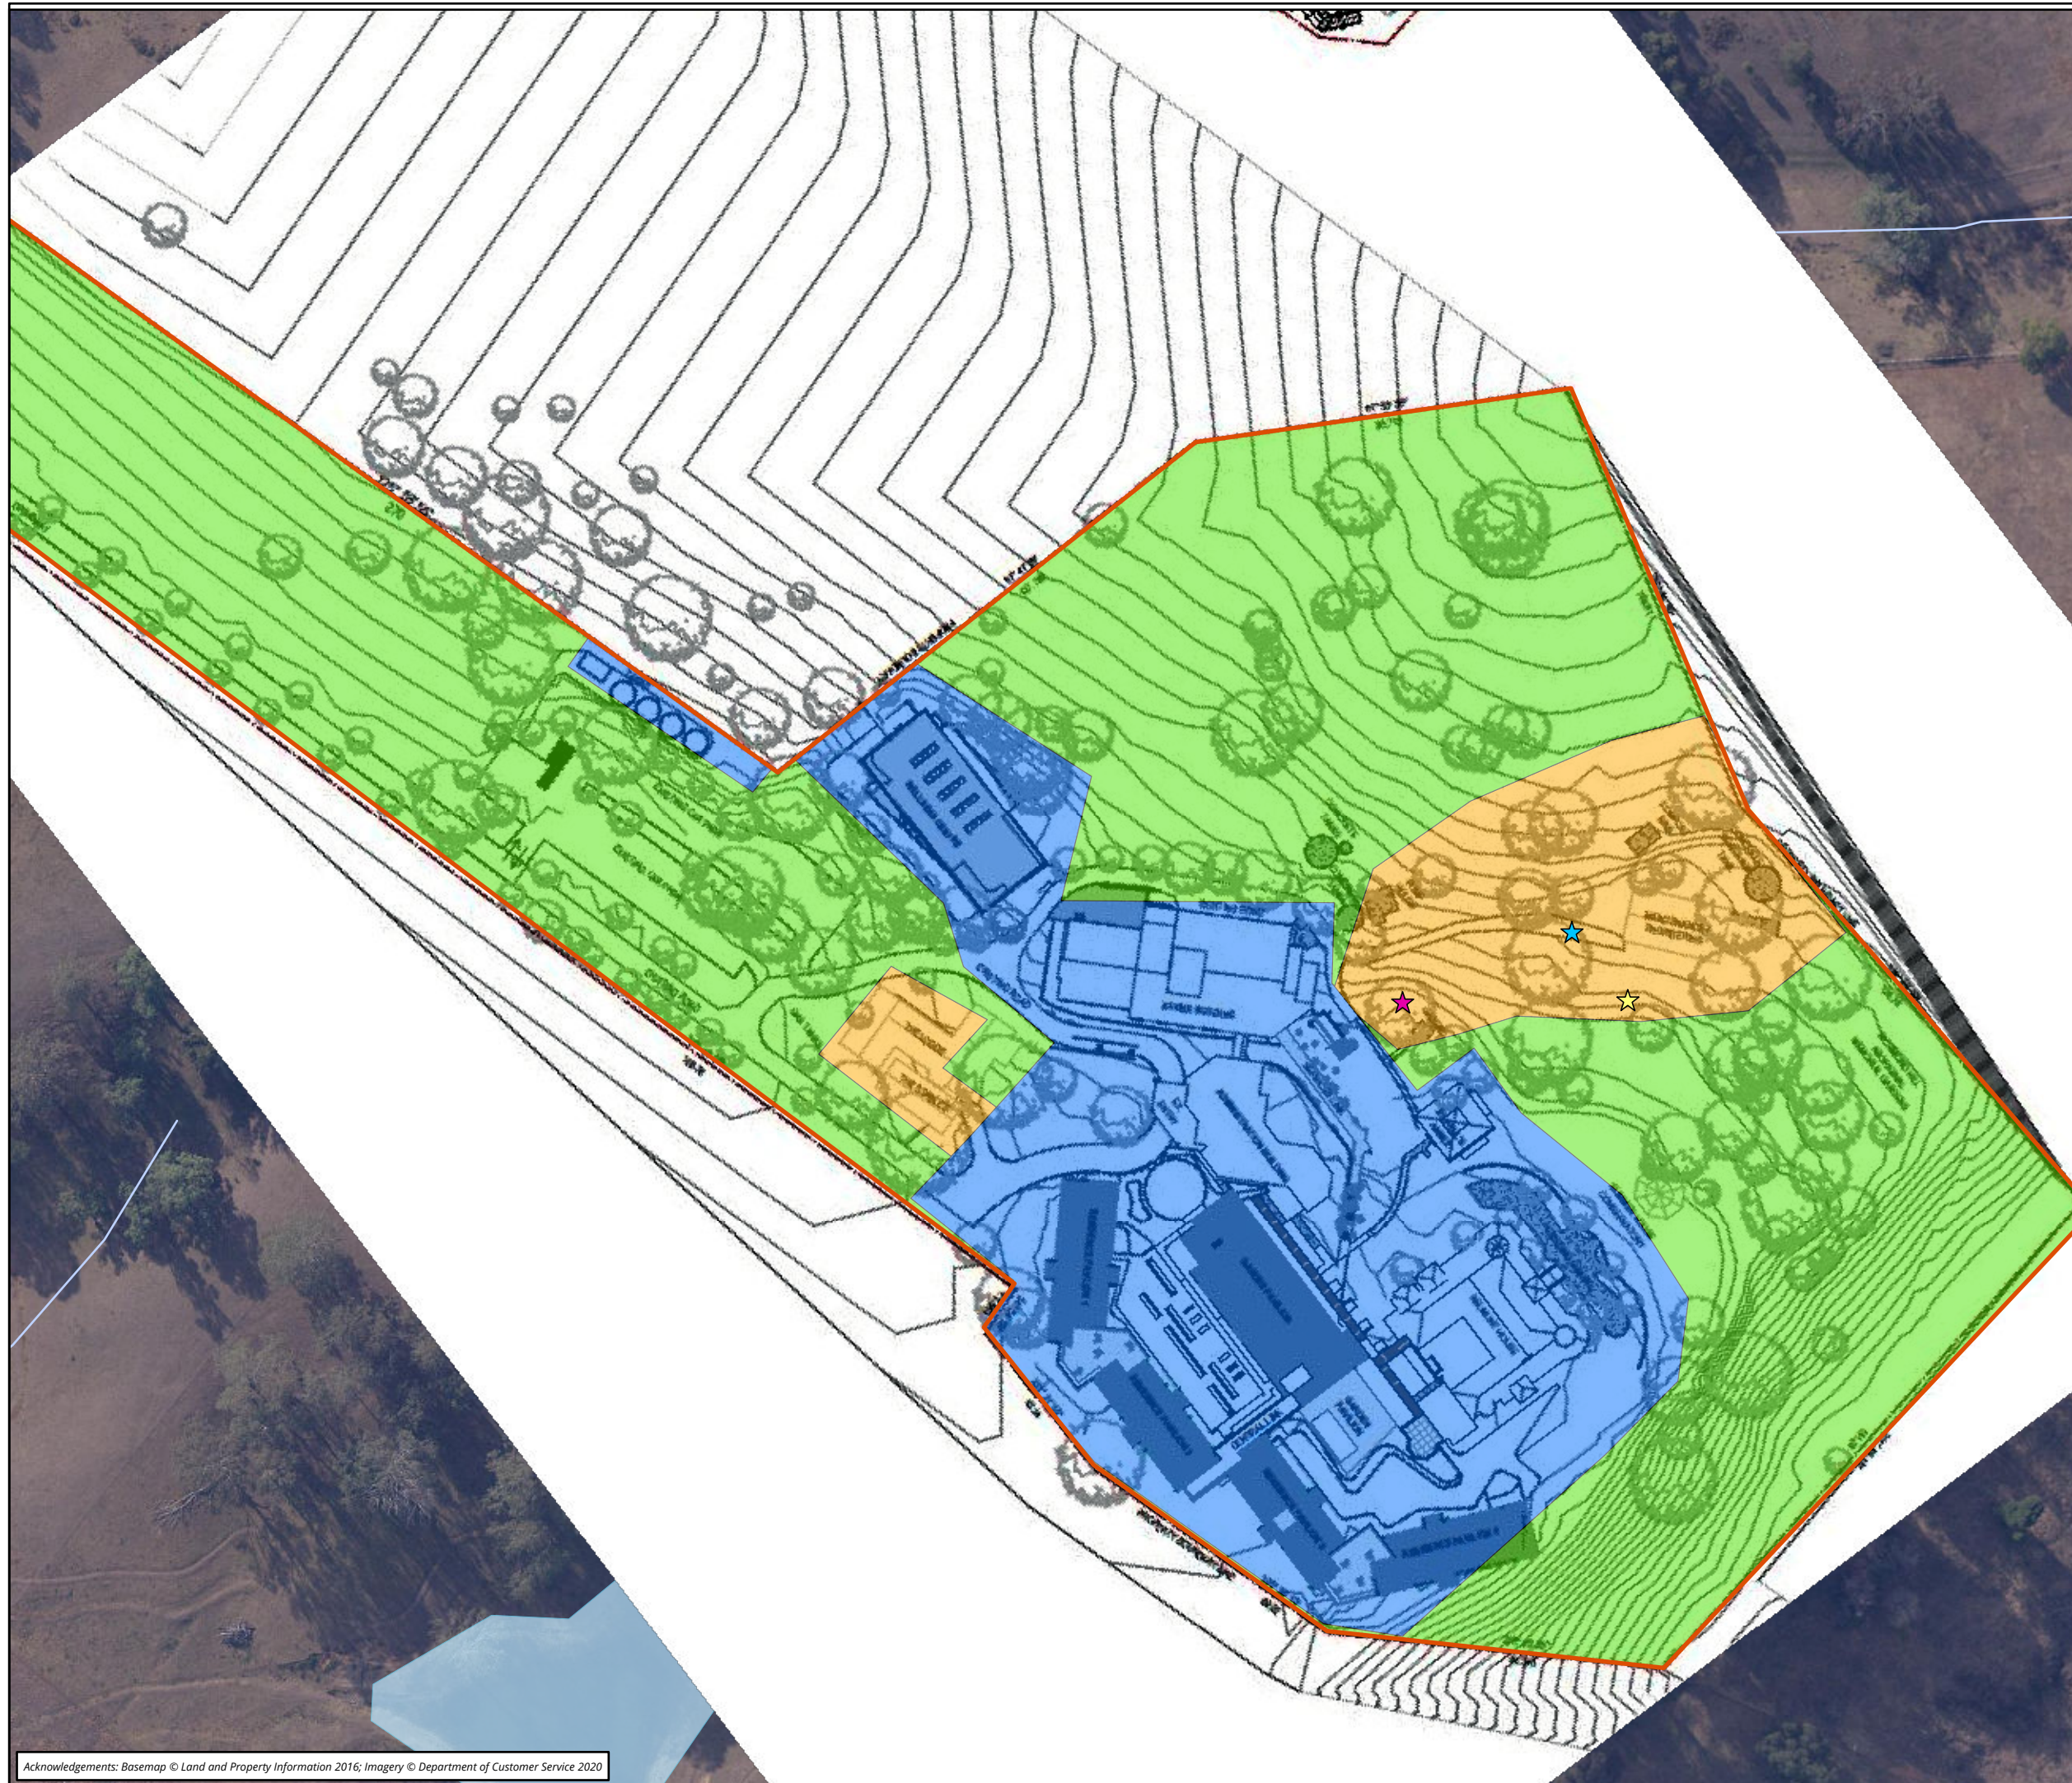
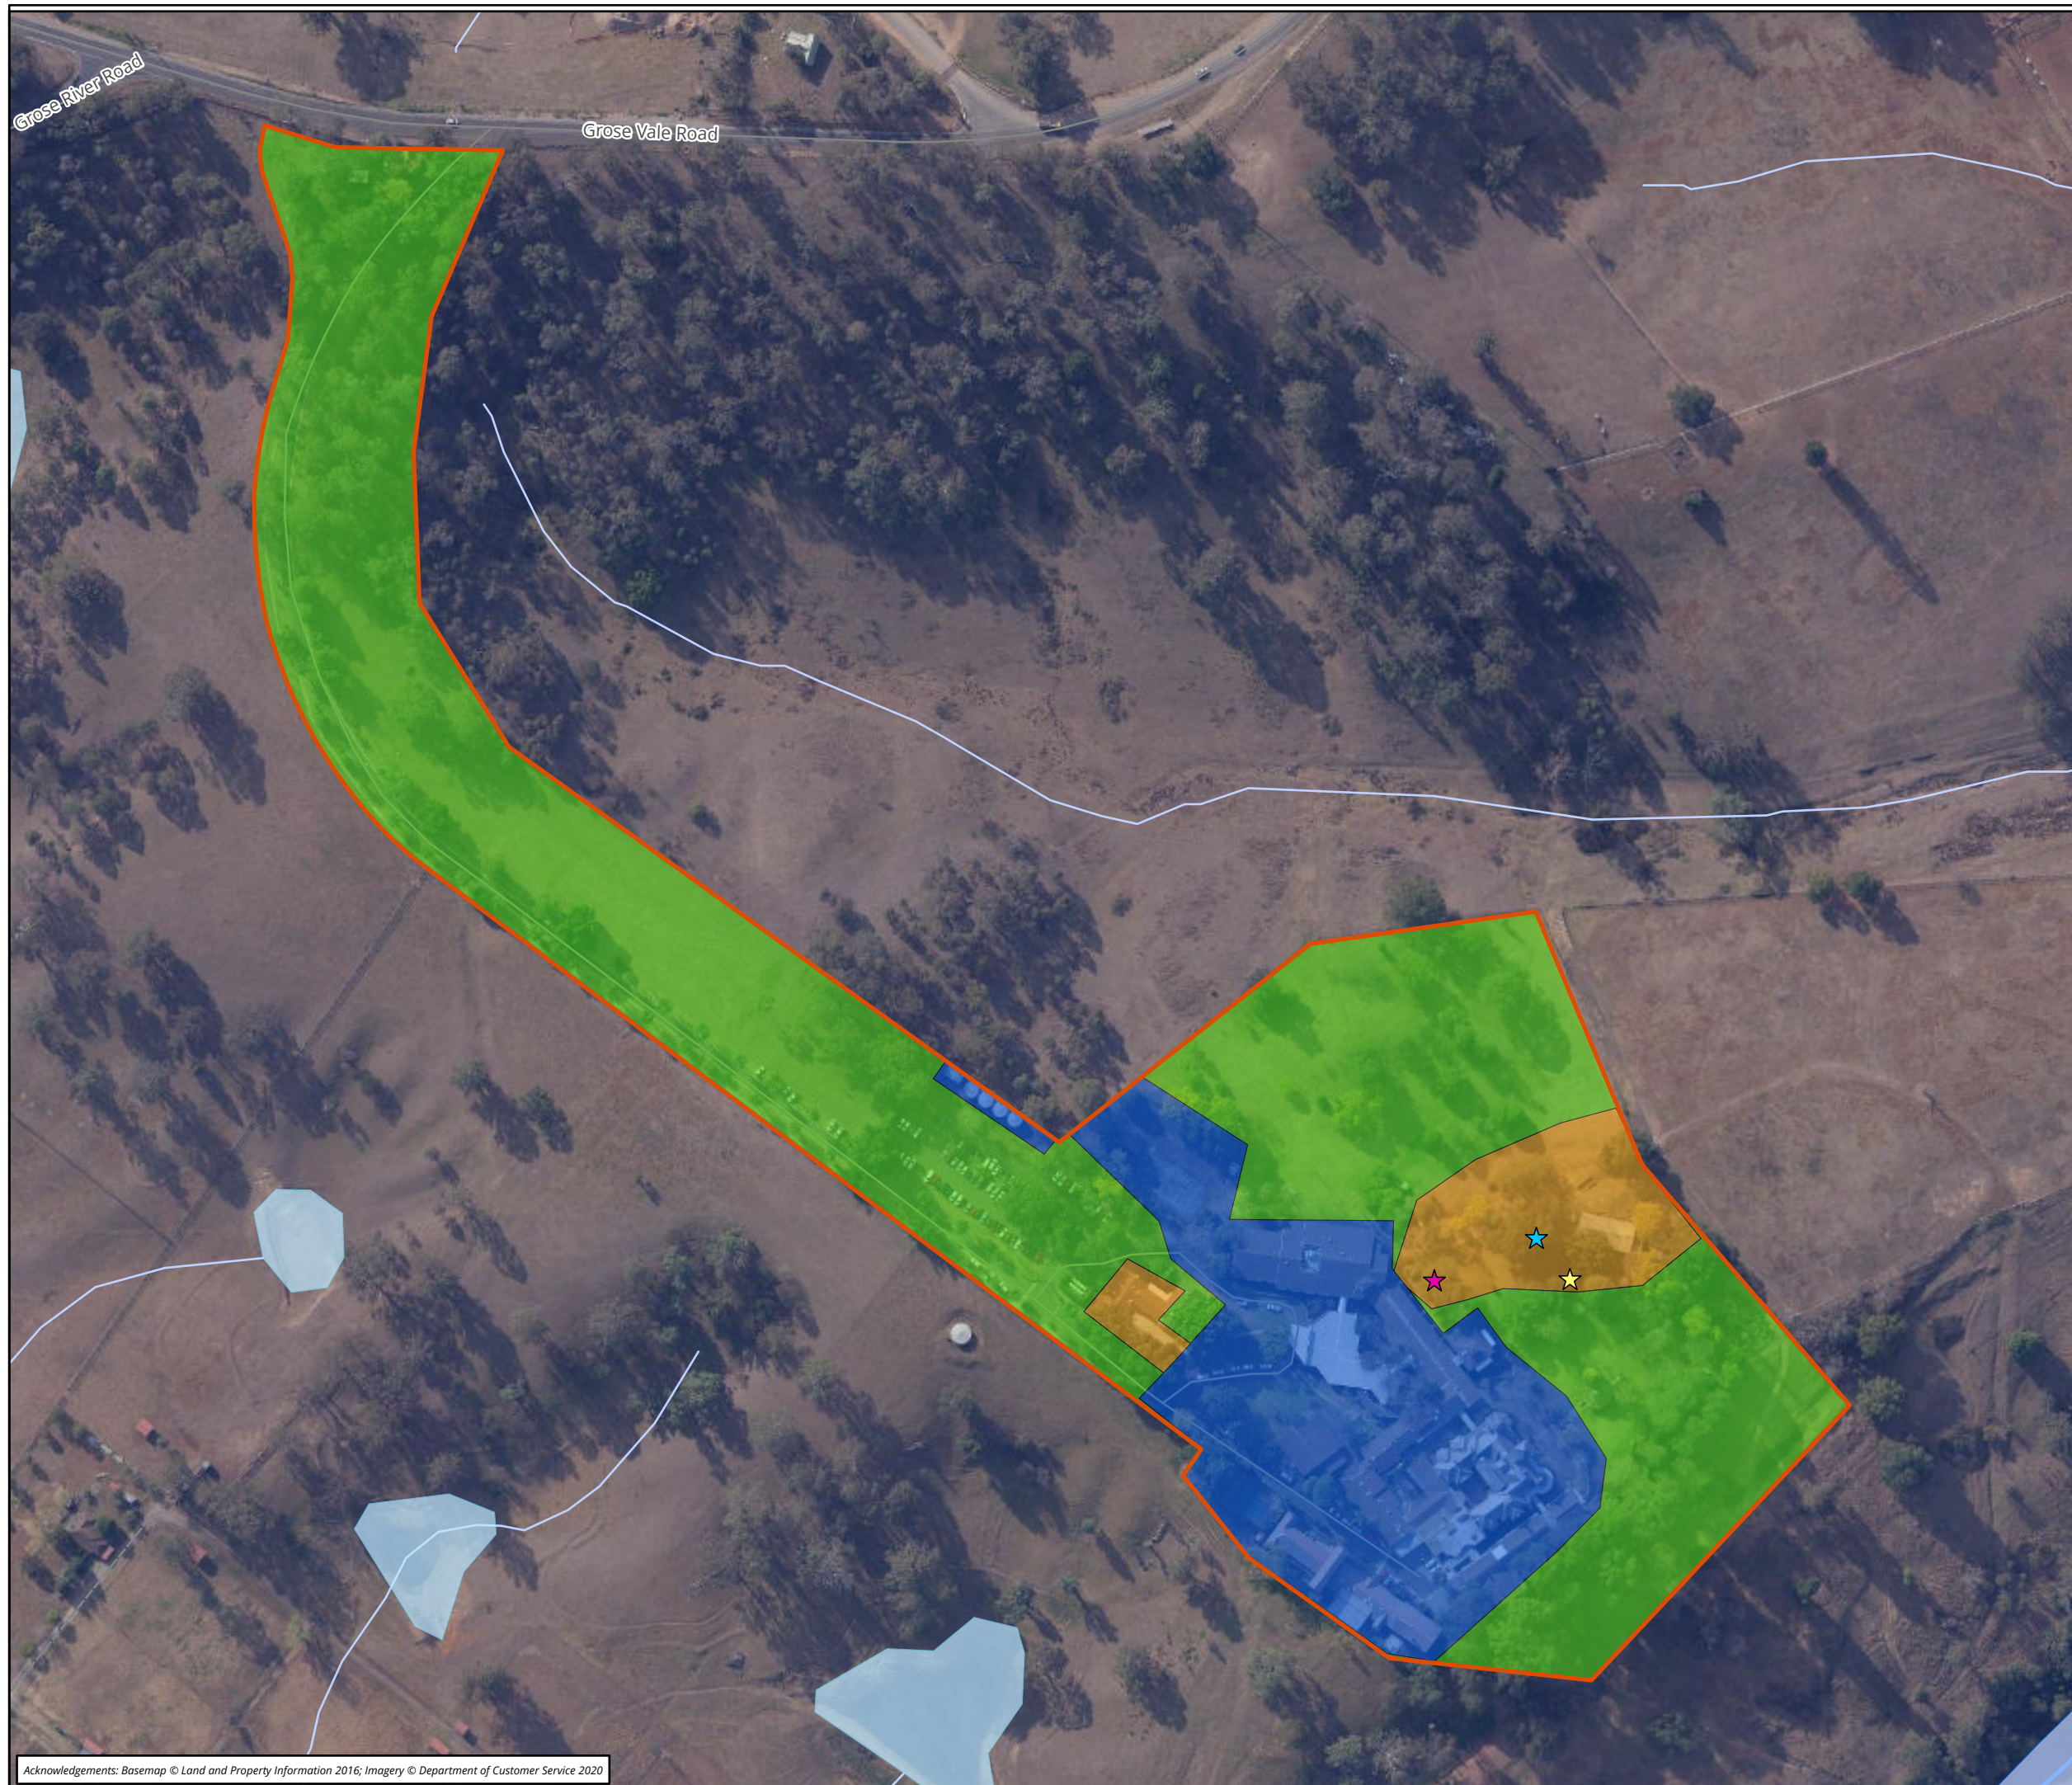
**Figure 6 Assessment of impacts**

- Study area
- ★ Approximate location of circular feature
- ★ Approximate location of sandstone wall
- ★ Approximate location of sandstone wall in terrace
