Report on
Updated Preliminary Site (Contamination)
Investigation

Ignis Project Stage 2
Tambourine Bay Road, Riverview

Prepared for
St Ignatius College

Project 85108.04
January 2020

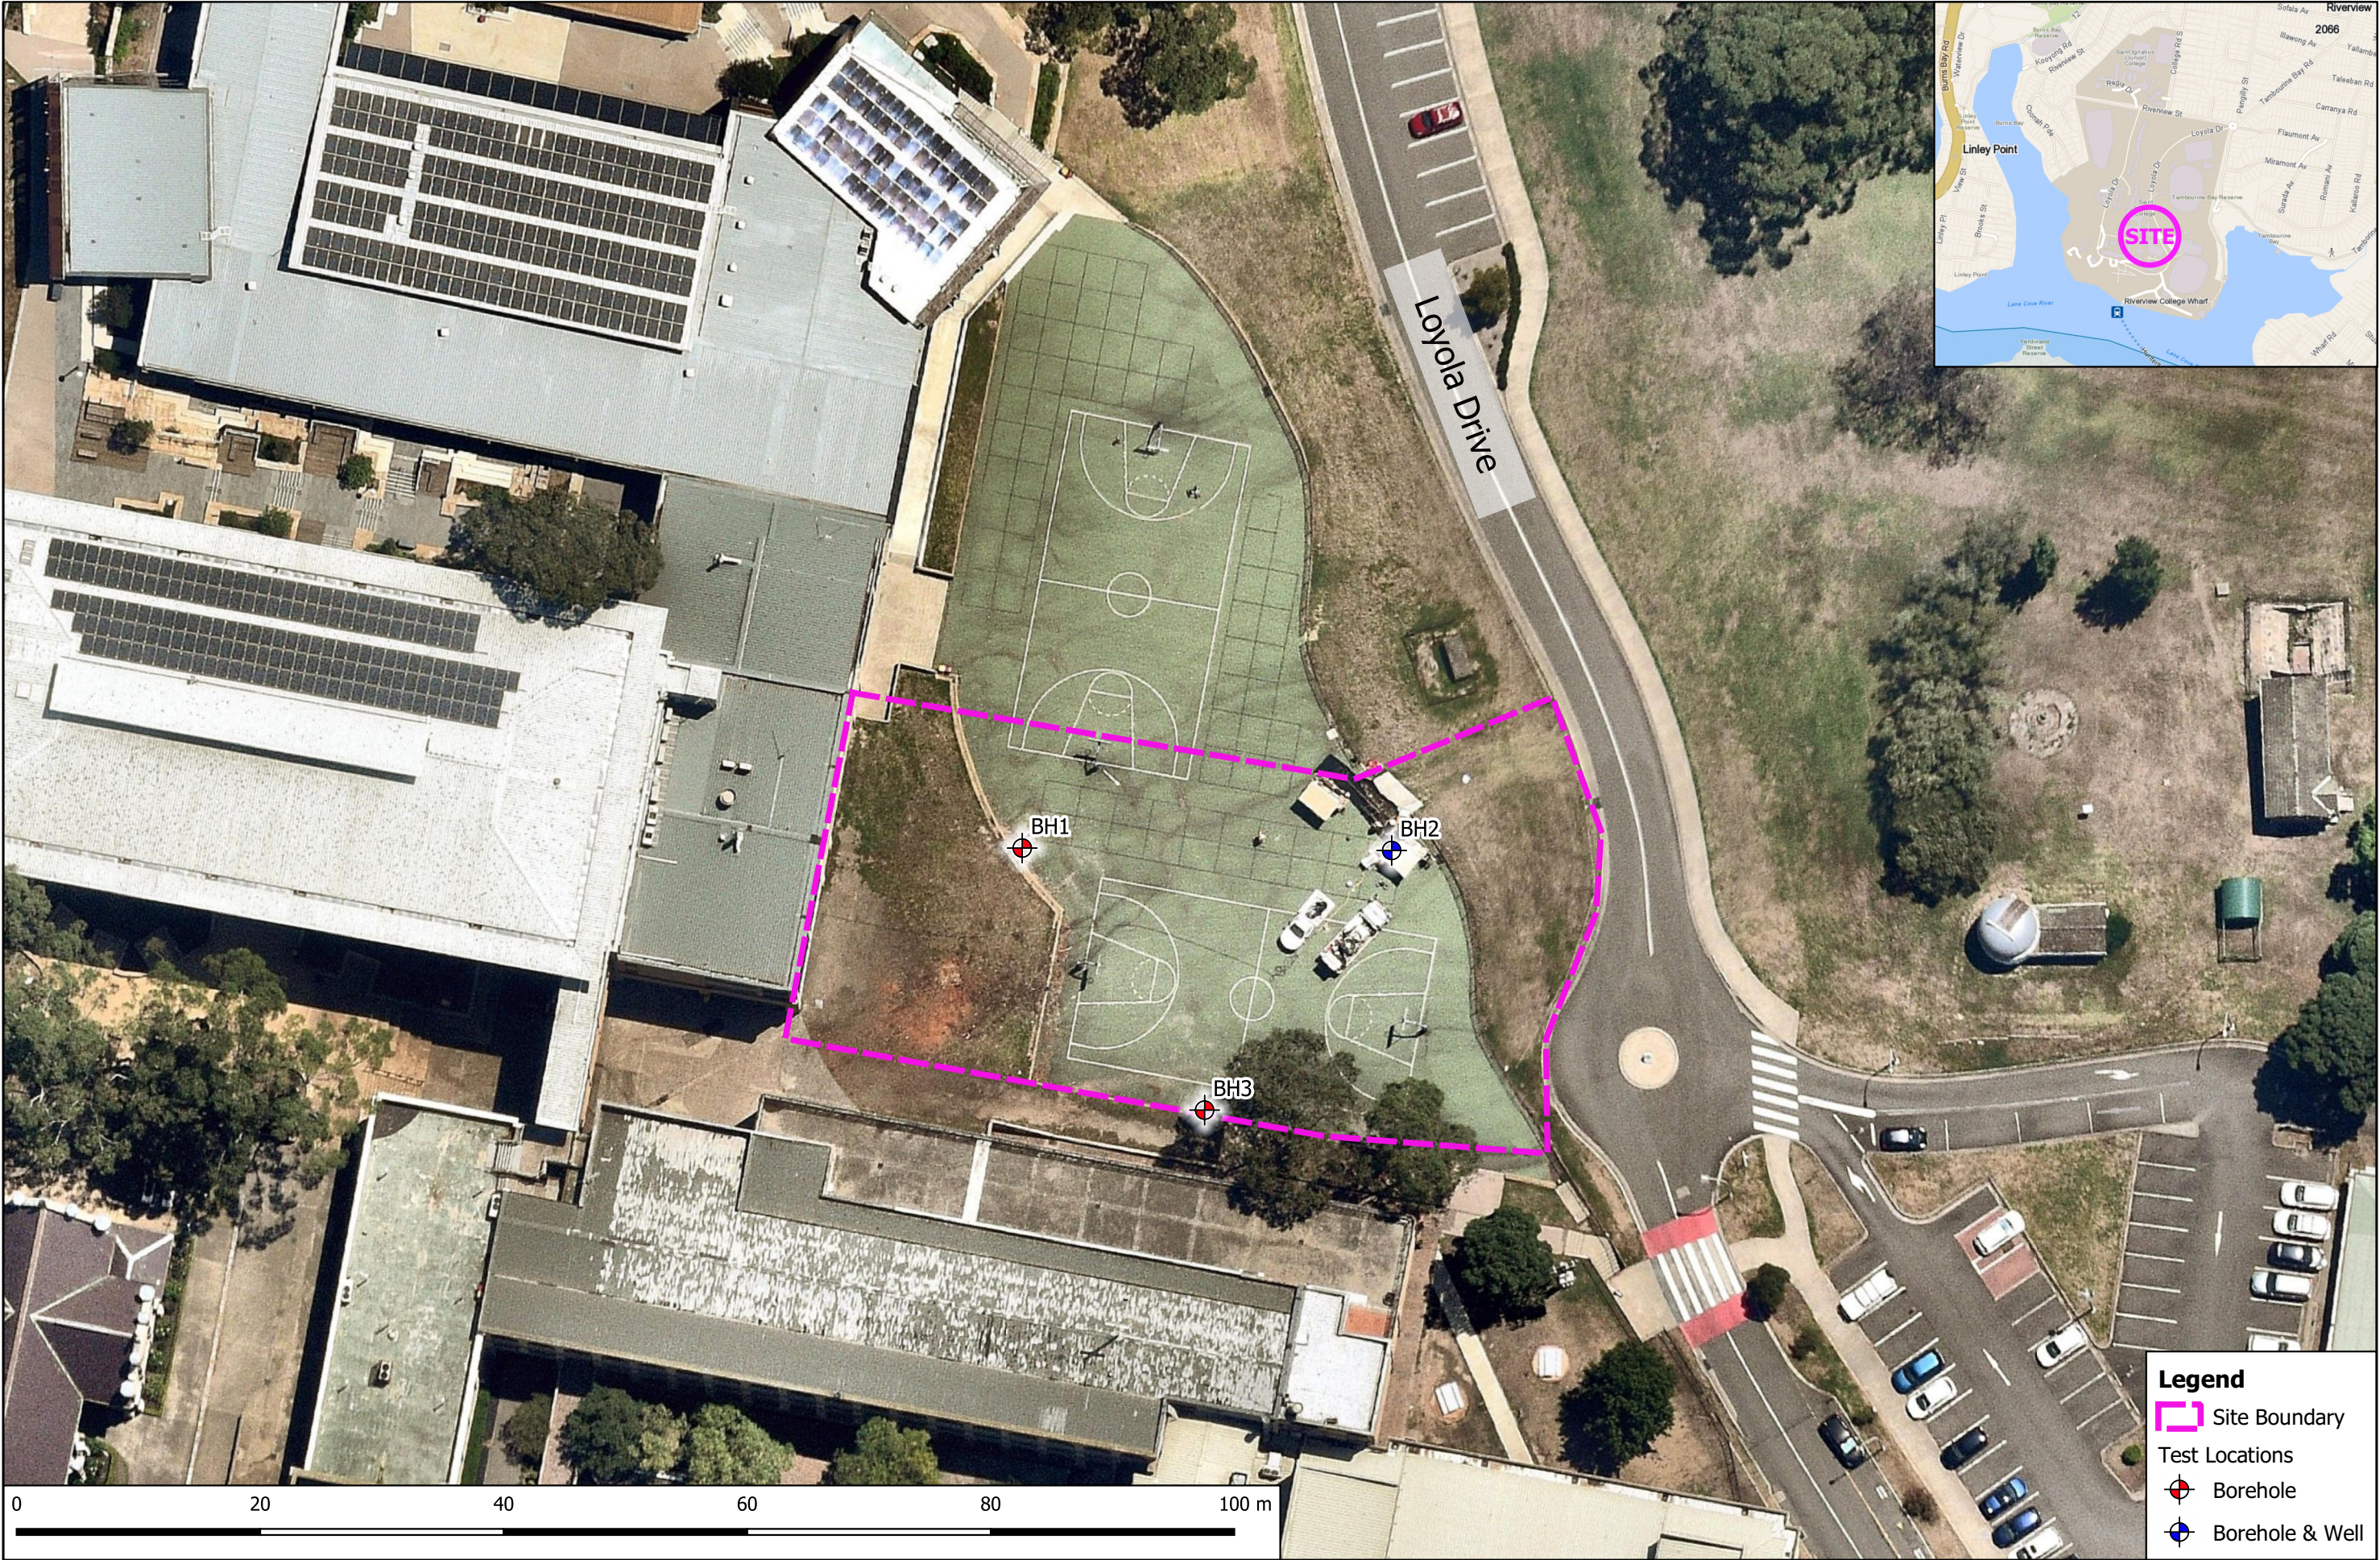
Douglas Partners <i>Geotechnics Environment Groundwater</i>	CLIENT: St Ignatius' College Riverview		TITLE: Test Location Plan Ignis Project Stage 2 St Ignatius' College, Tambourine Bay Road, Riverview	 	PROJECT No: 85108.04
	OFFICE: Sydney	DRAWN BY: MB			DRAWING No: 1
	SCALE: 1:500 @ A3	DATE: 29/01/2020			REVISION: 0
