## DETAILED SITE INVESTIGATION – ASBESTOS

## PROPOSED ST ANTHONY OF PADUA CATHOLIC SCHOOL DEVELOPMENT

**140 ELEVENTH AVENUE, AUSTRAL, NSW**

**31 OCTOBER 2016**

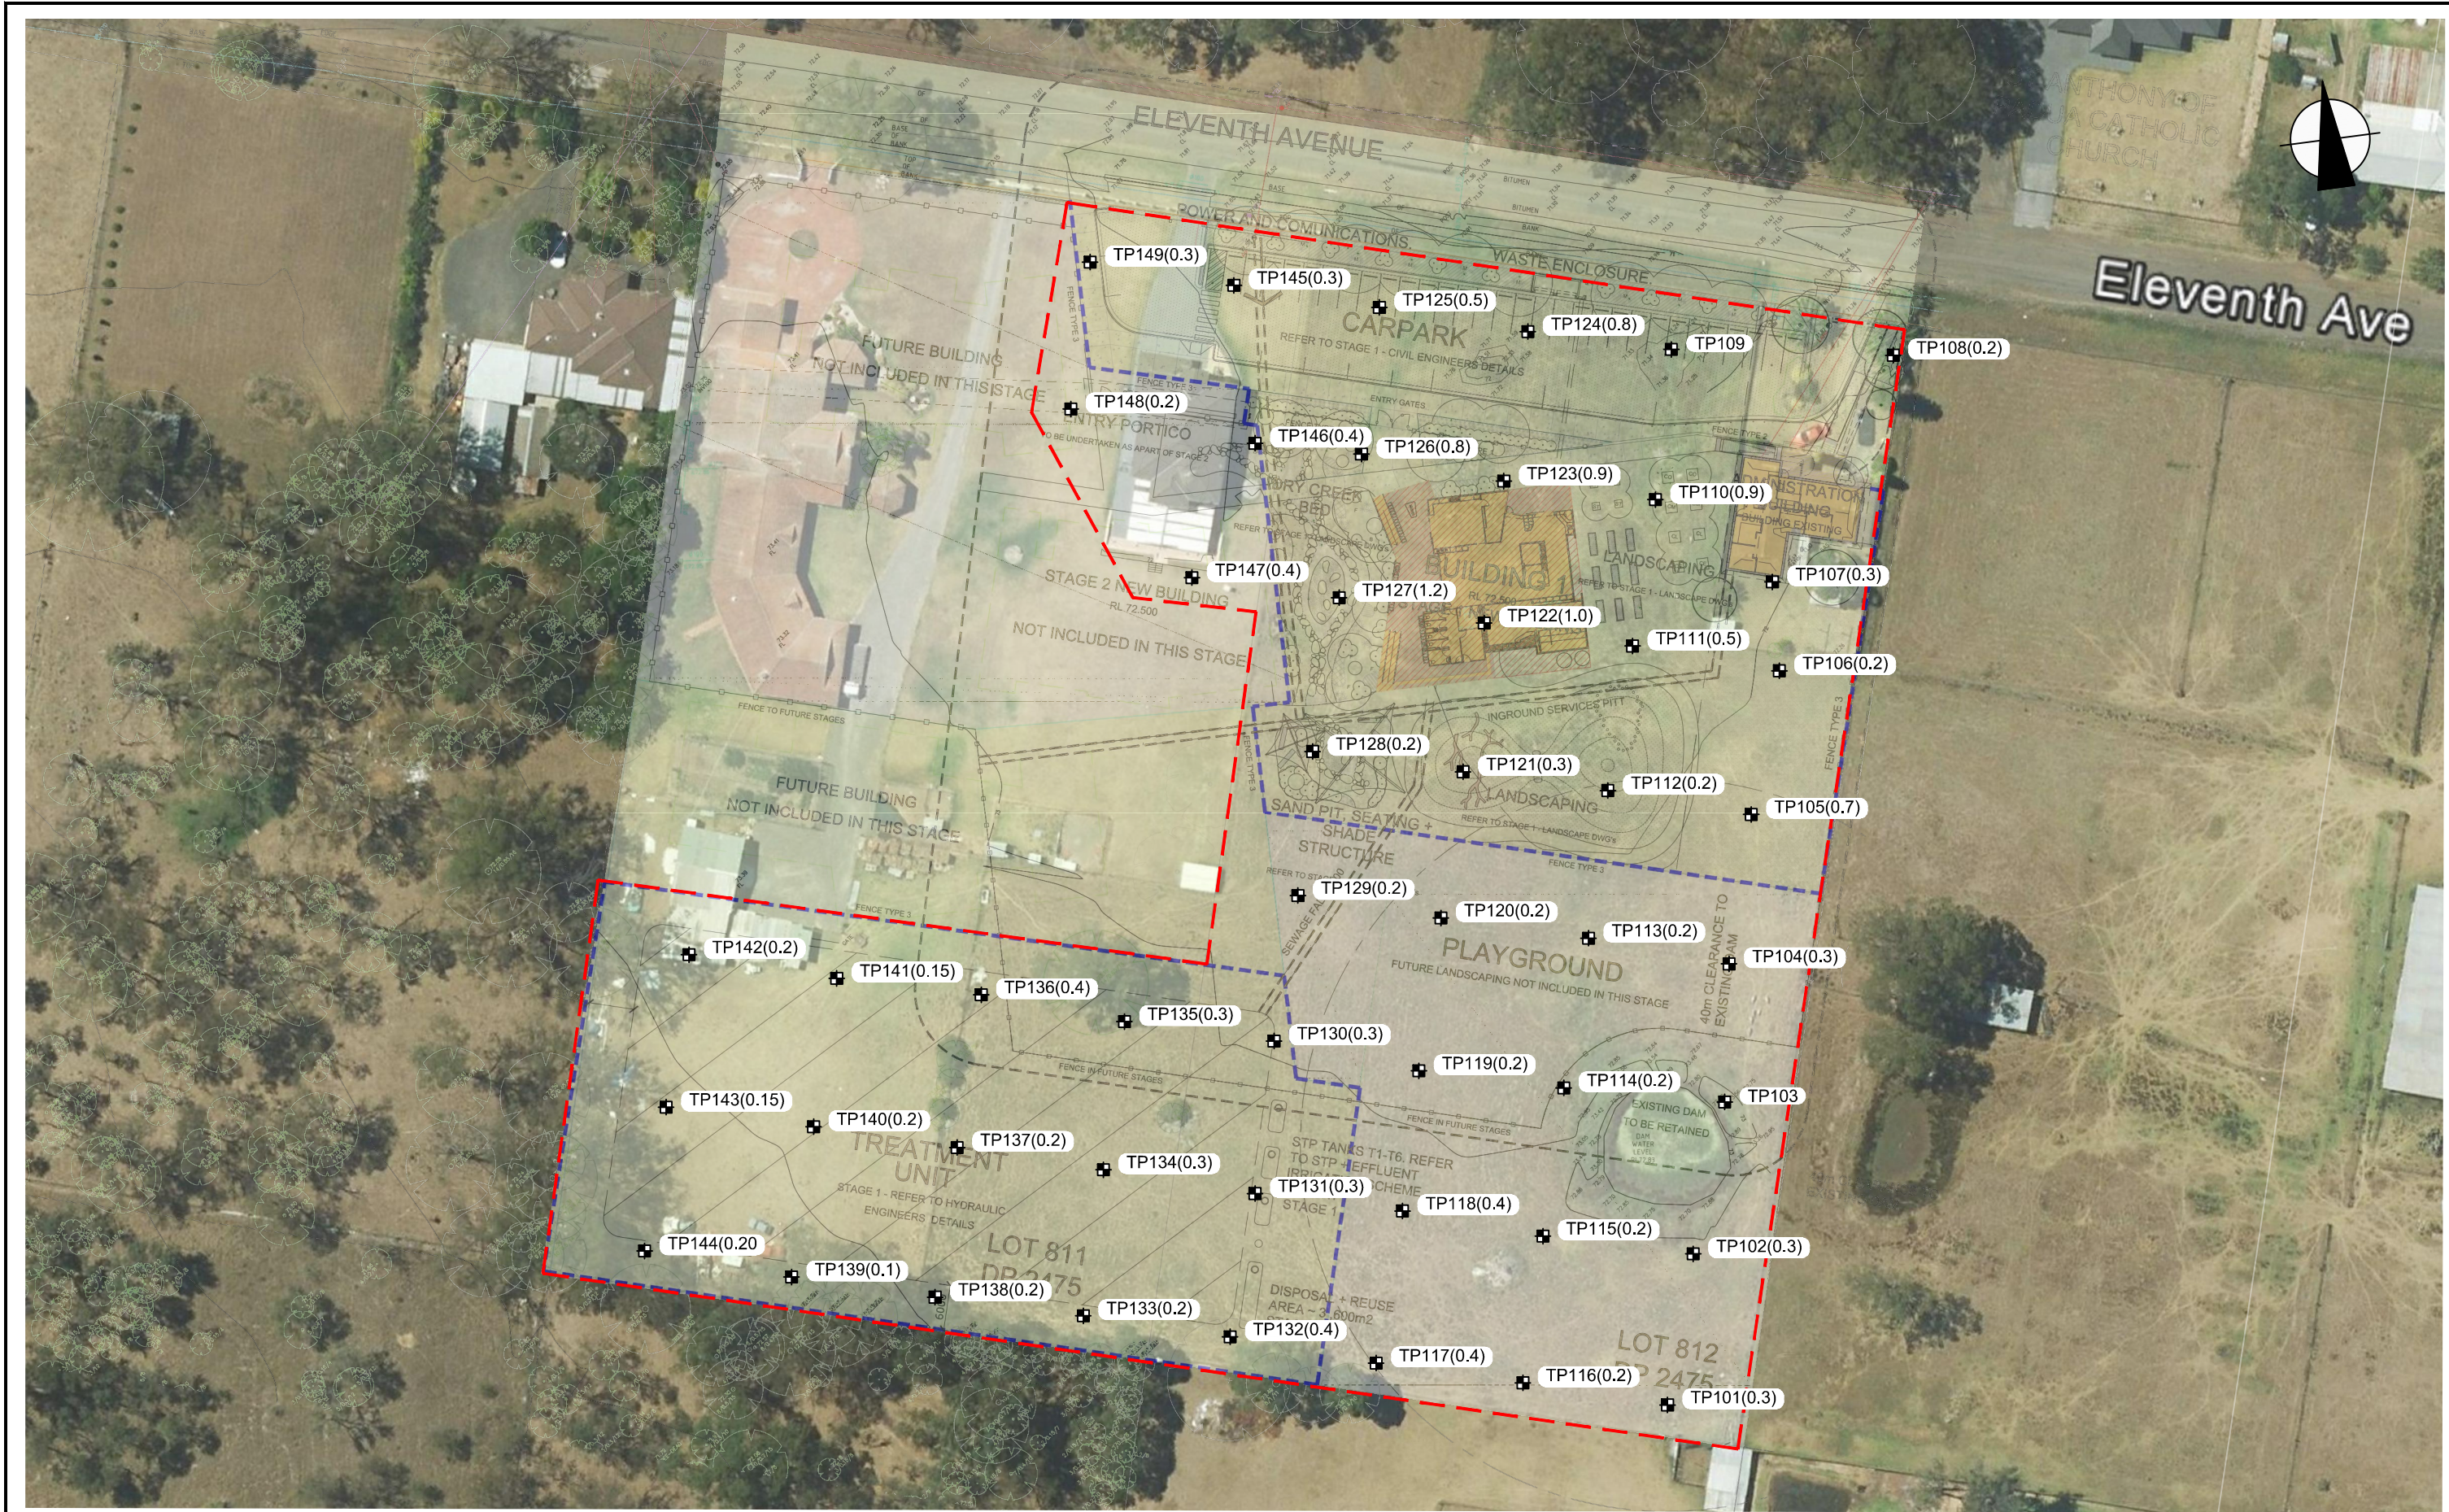
- APPROXIMATE SITE BOUNDARY
- TP(Fill Depth) TEST PIT LOCATION, NUMBER AND DEPTH OF FILL (m)

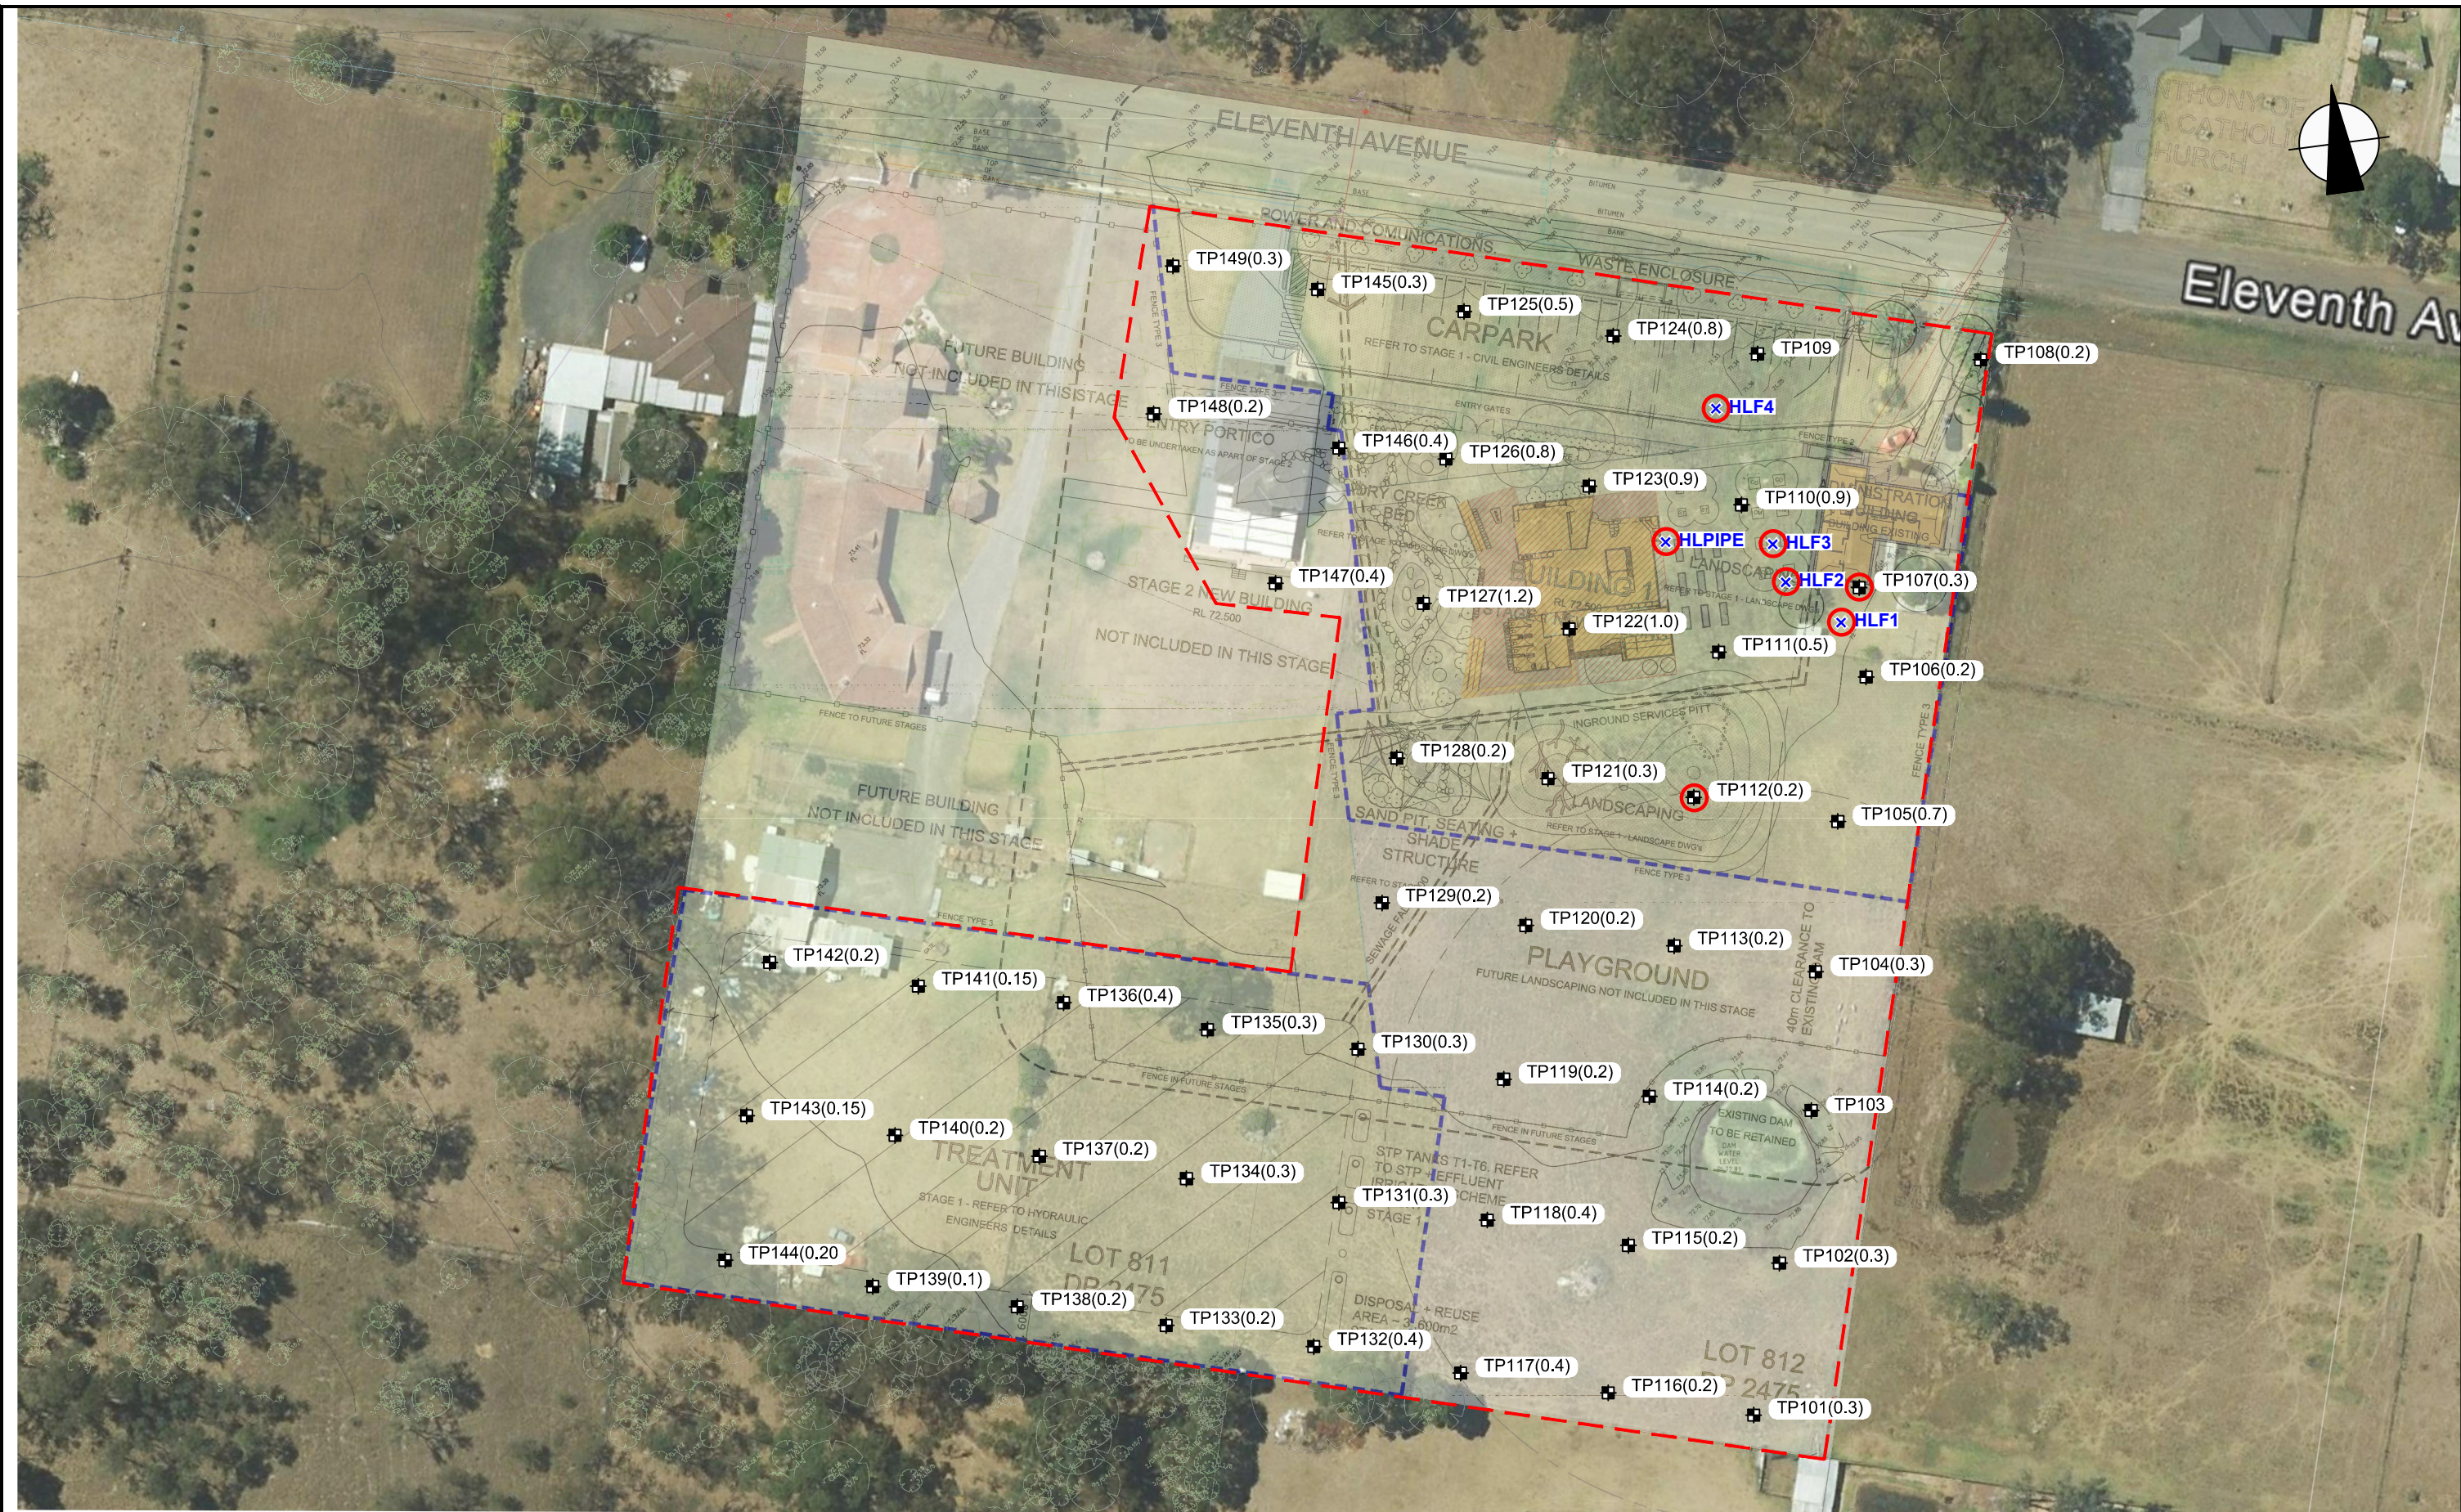
ACM has been identified on the surface and within the fill material at the site. A summary of the detected ACM, suspected ACM and the condition of the materials is presented in the table below:

| Sample ID | Sample Description | Assessment of suspected ACM<br>Condition for Management by EIS<br>Licensed Asbestos Assessor |
|---|---|---|
| HLF1 | Fibre cement fragment on surface. | Degraded condition and considered friable. |
| HLF2 | Fibre cement fragment on surface. | Fair conditions and considered non friable. |
| HLF3 | Fibre cement fragment on surface. | Degraded condition and considered friable. |
| HLF4 | Fibre cement fragment on surface. | Fair conditions and considered non friable. |
| HLpipe | Pipe fibre cement fragment (presumed to contain asbestos). Not sampled or analysed. | Fair conditions and considered non friable. |
| ASF1/ TP107 (0-0.3m) | Fibre cement fragment identified within fill material | Fair conditions and considered non friable. |

- - - APPROXIMATE SITE BOUNDARY
- TP(Fill Depth) TEST PIT LOCATION, NUMBER AND DEPTH OF FILL (m)
- x HLF SURFACE SAMPLE LOCATION

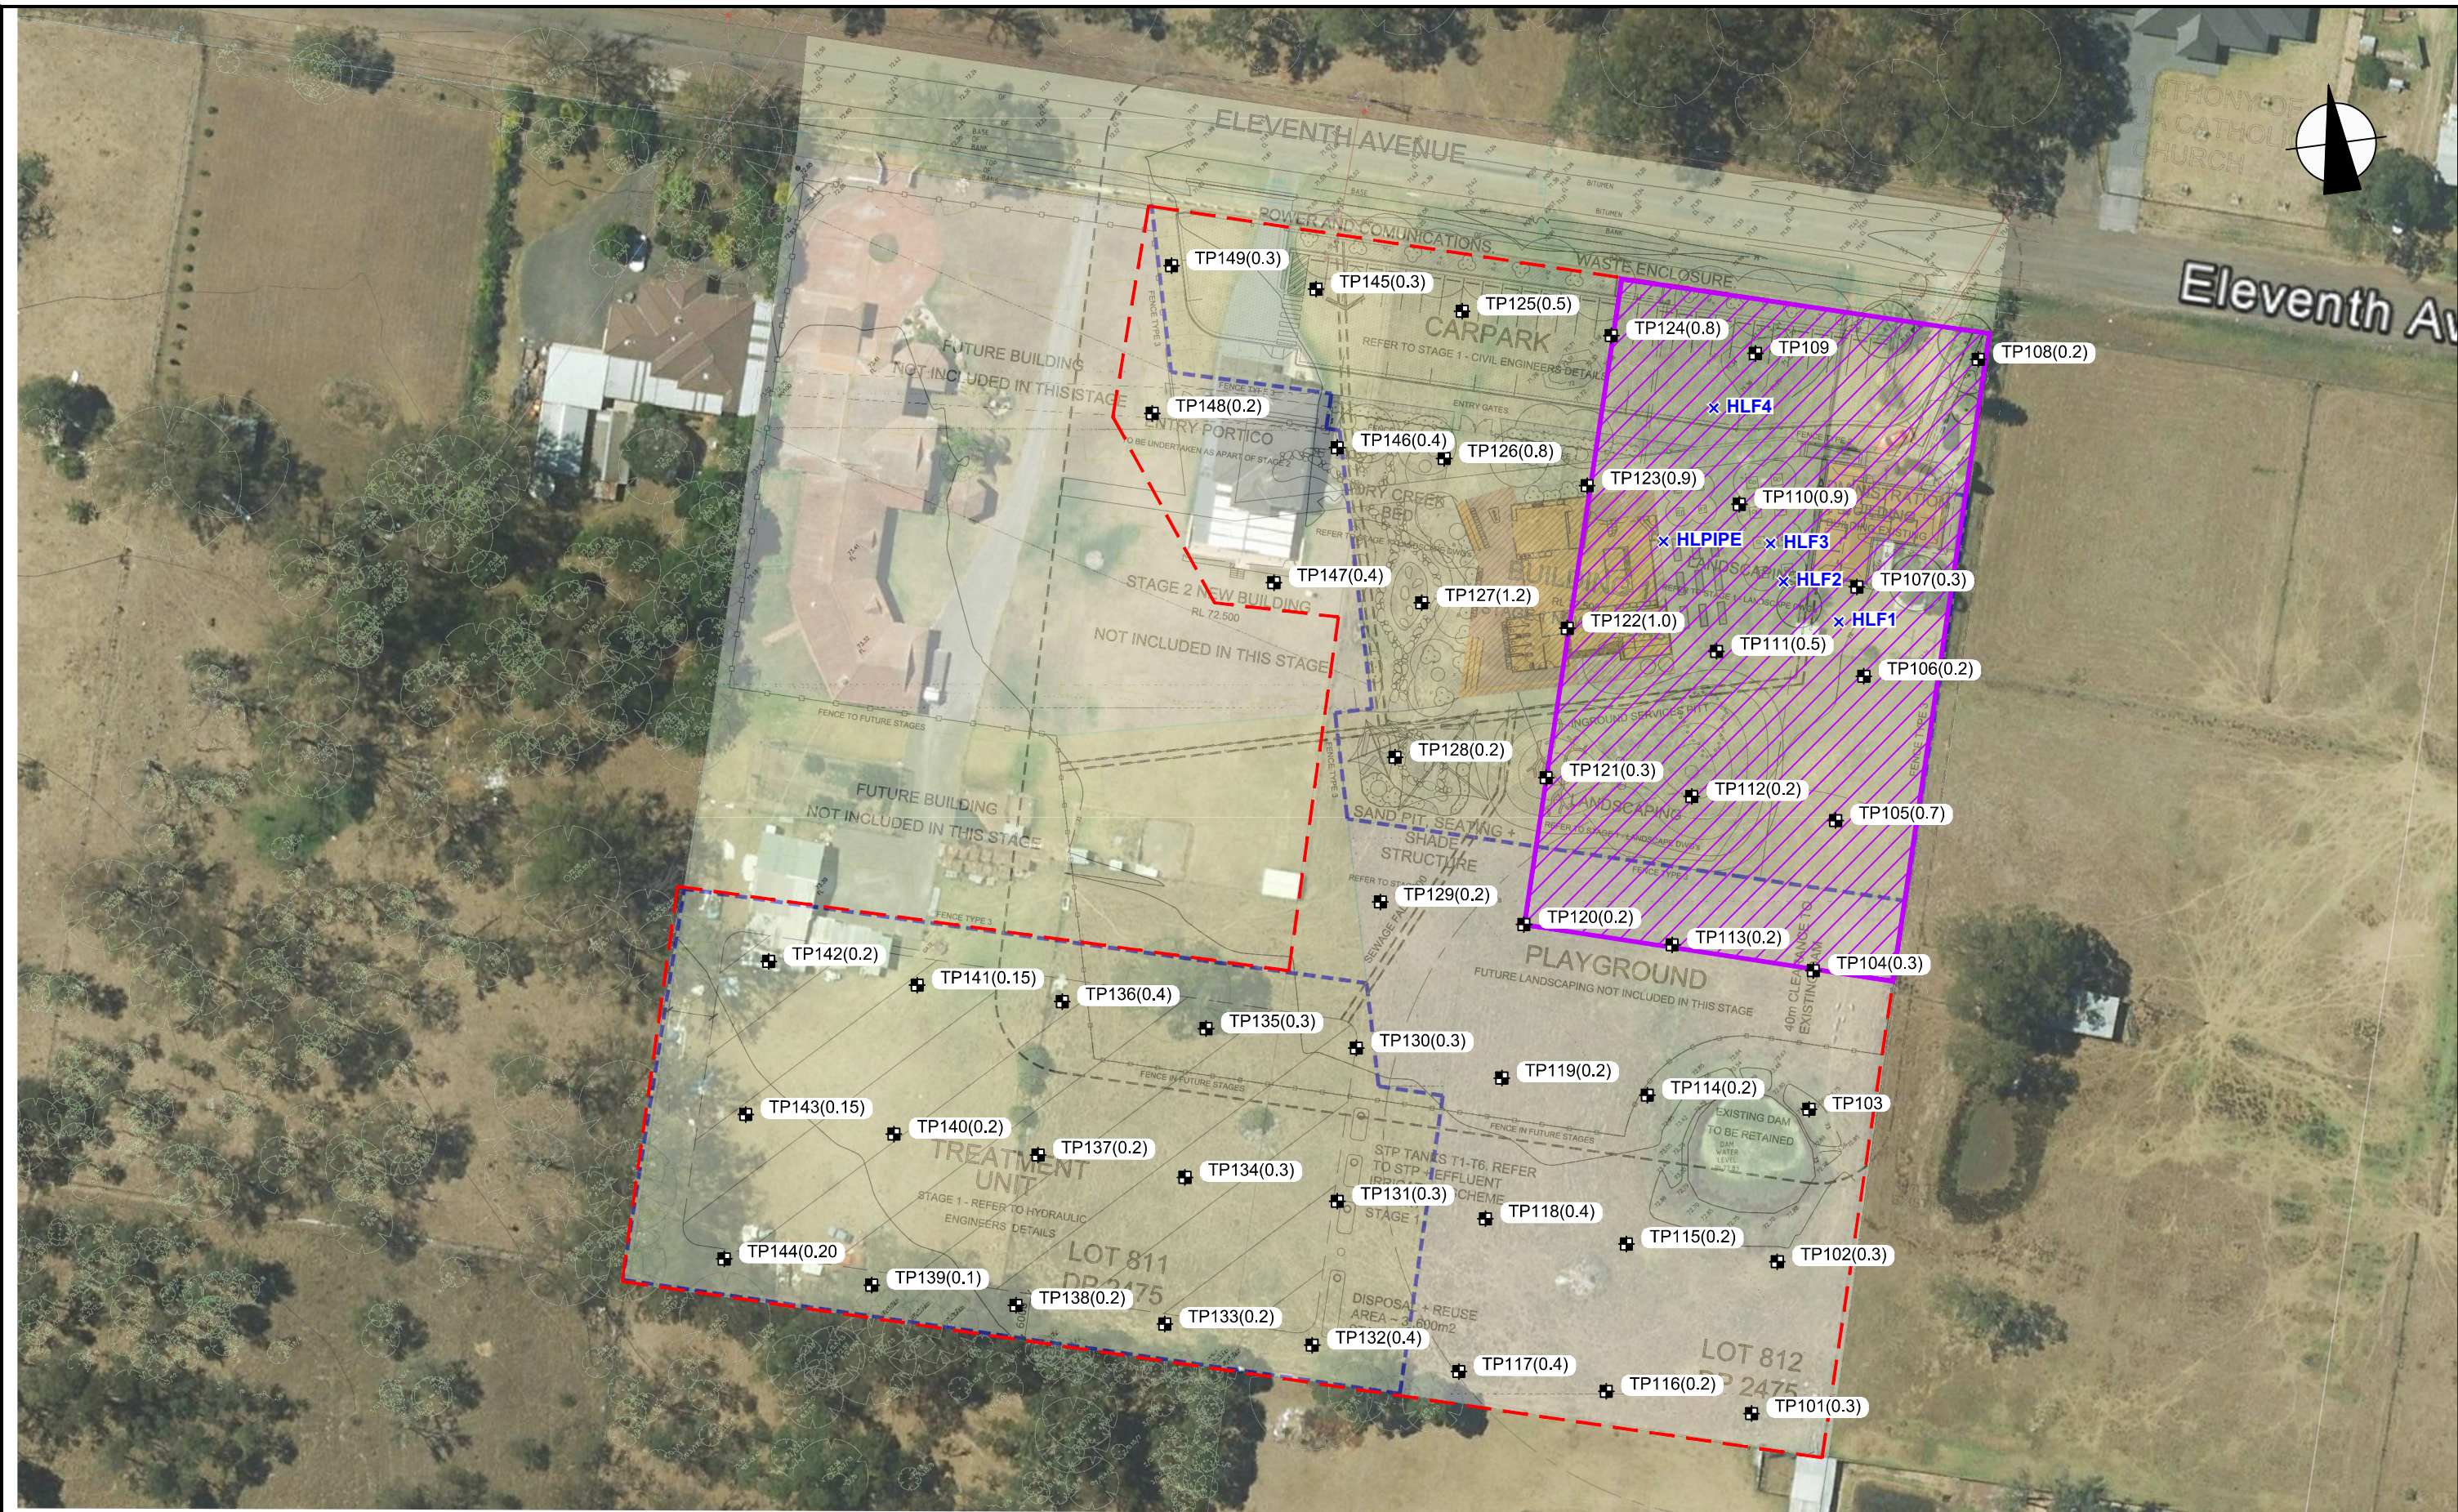
- APPROXIMATE SITE BOUNDARY
- + TP(Fill Depth) TEST PIT LOCATION, NUMBER AND DEPTH OF FILL (m)
- x HLF SURFACE SAMPLE LOCATION
