Reference: **3355B**
9th January 2020

Arborist Response

**Re: Royal Hall of Industries
Lot 3, (D.P.861843) and Lot 52 (D.P.1041134)
No. 1 Driver Avenue, MOORE PARK**

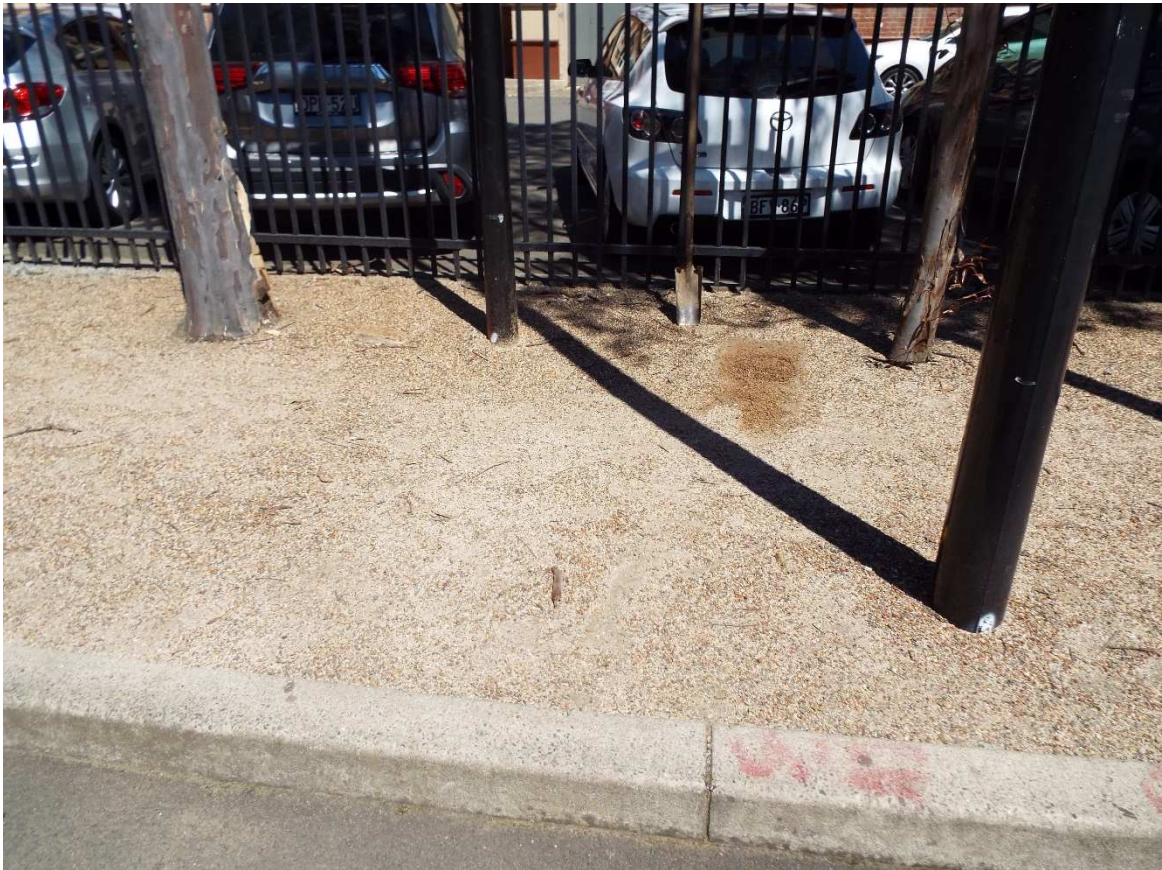
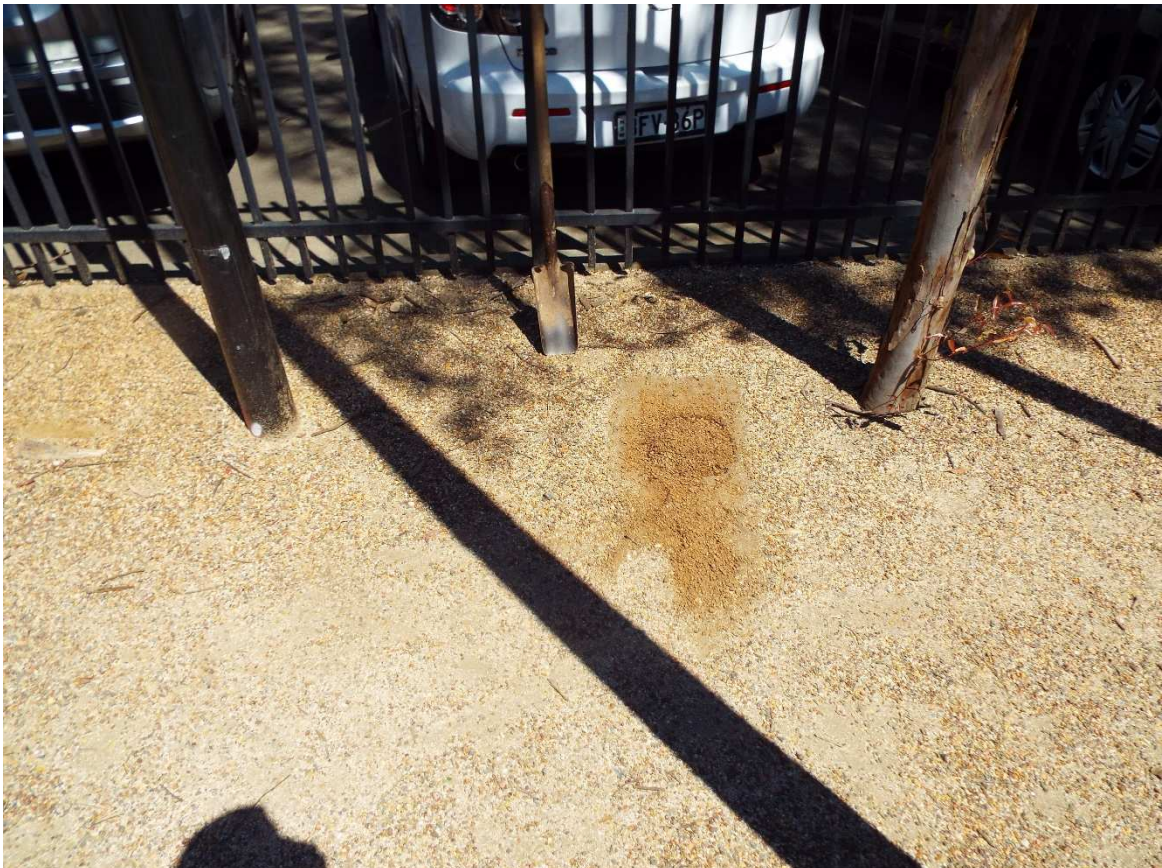
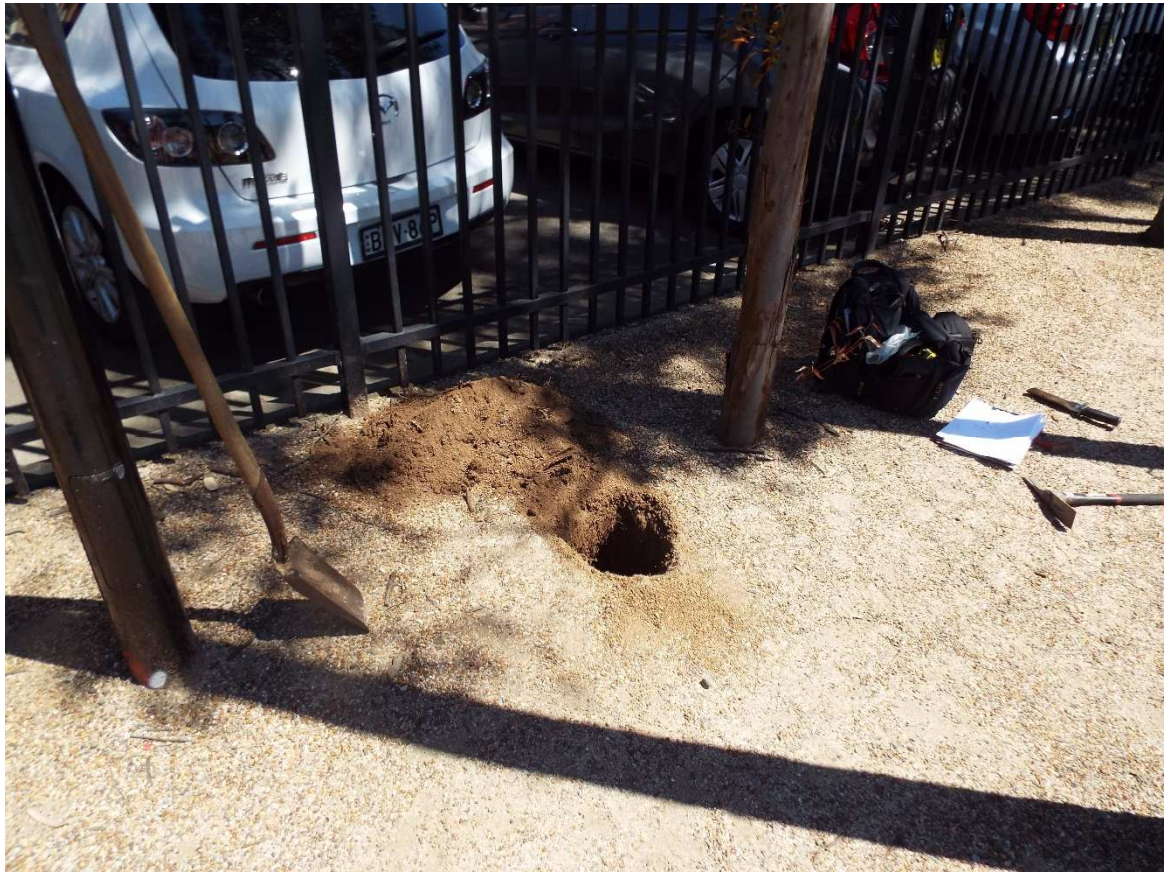
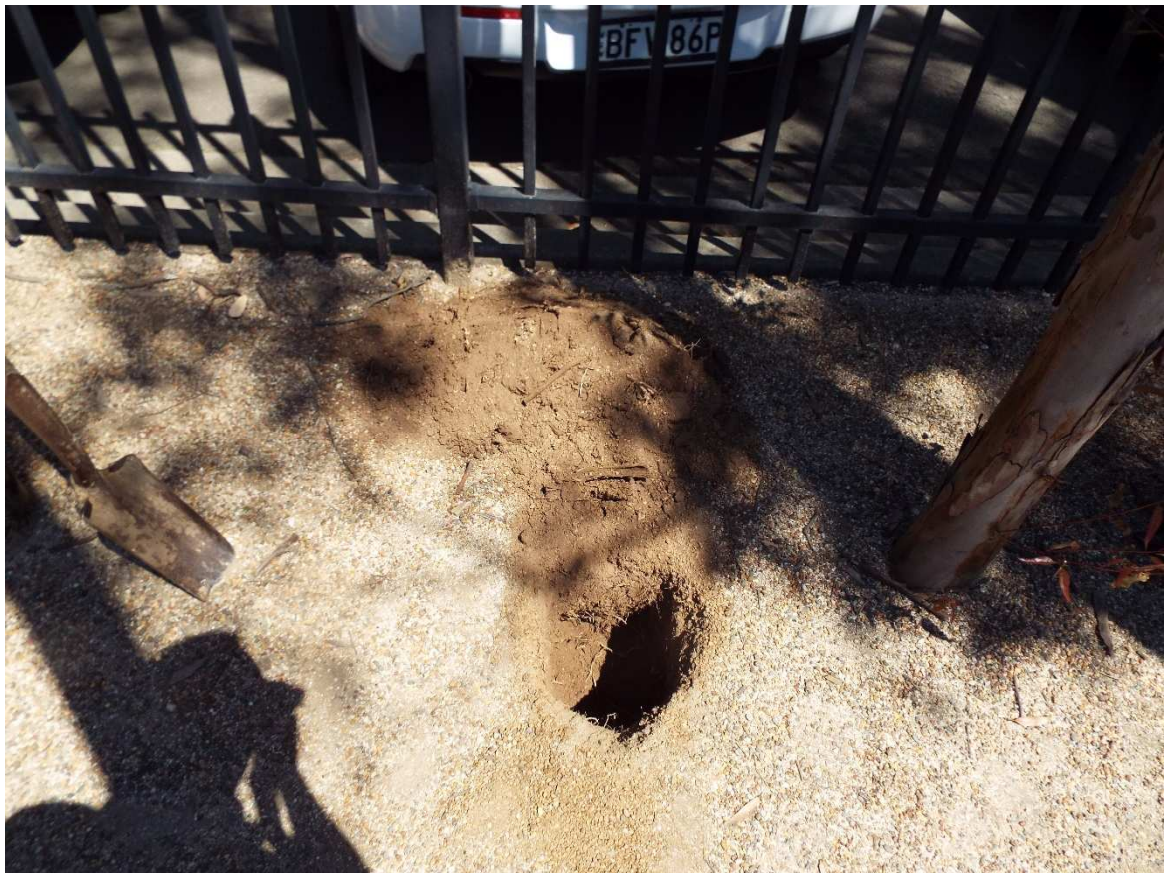
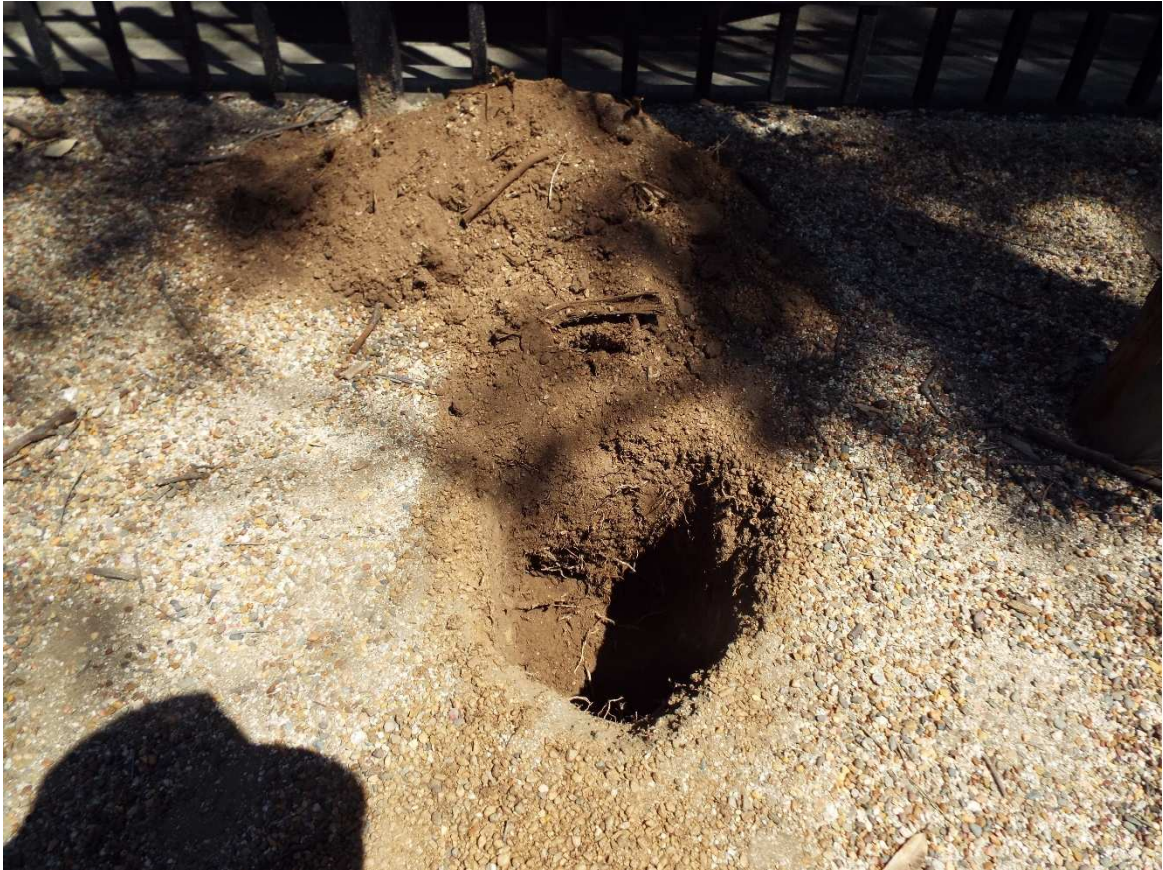
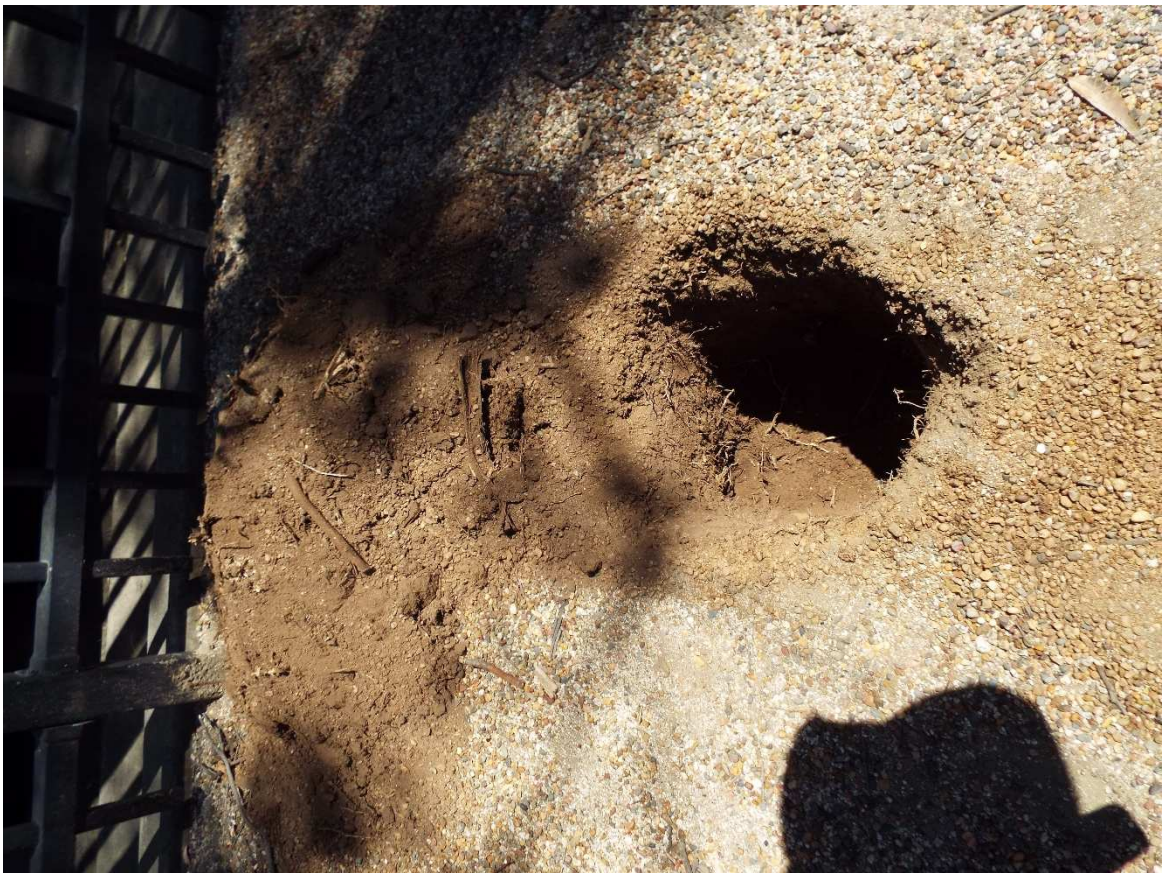
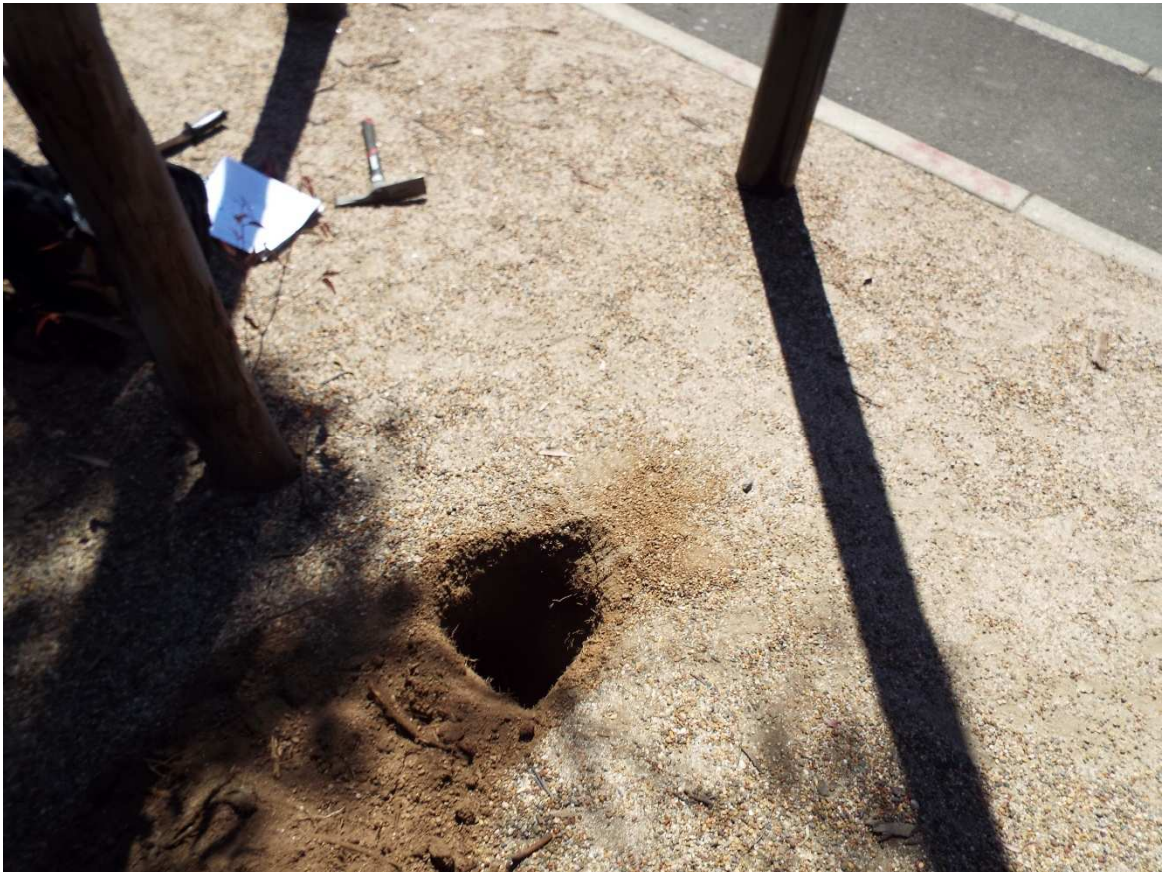
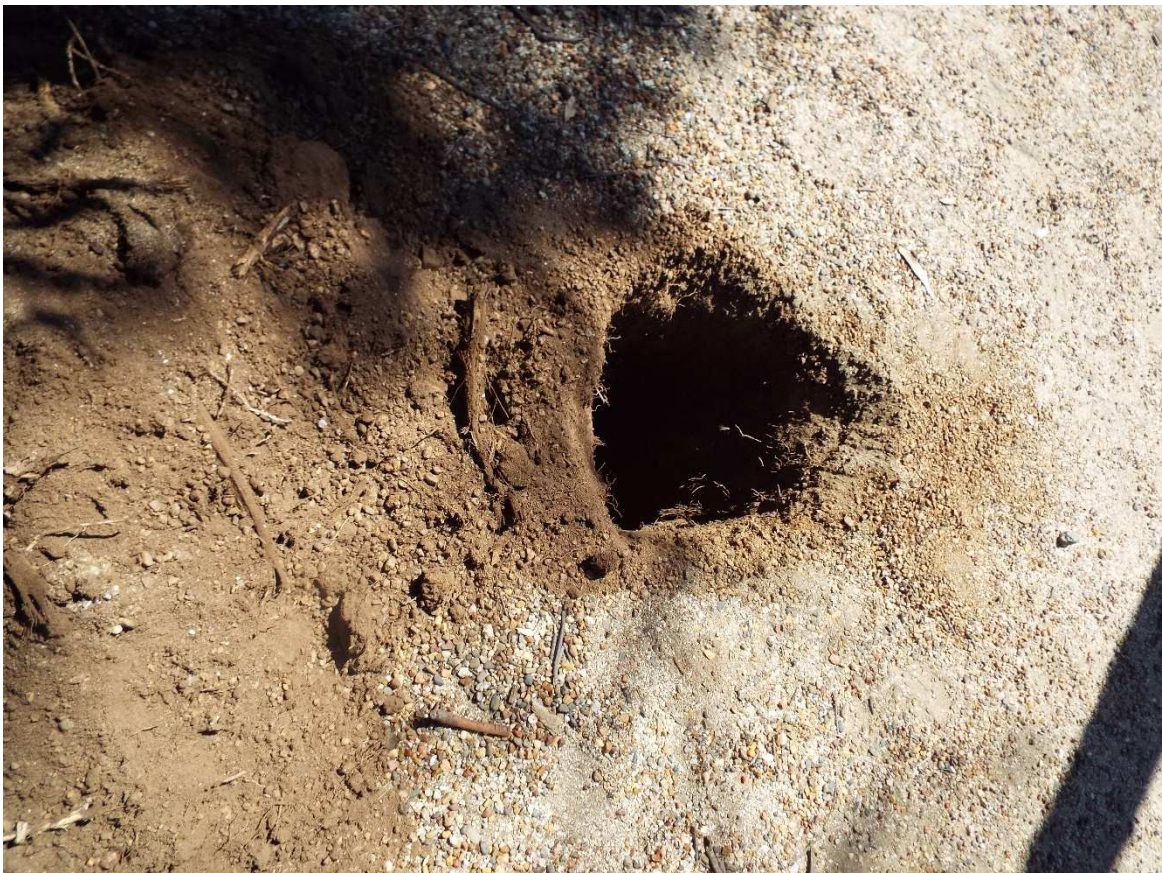
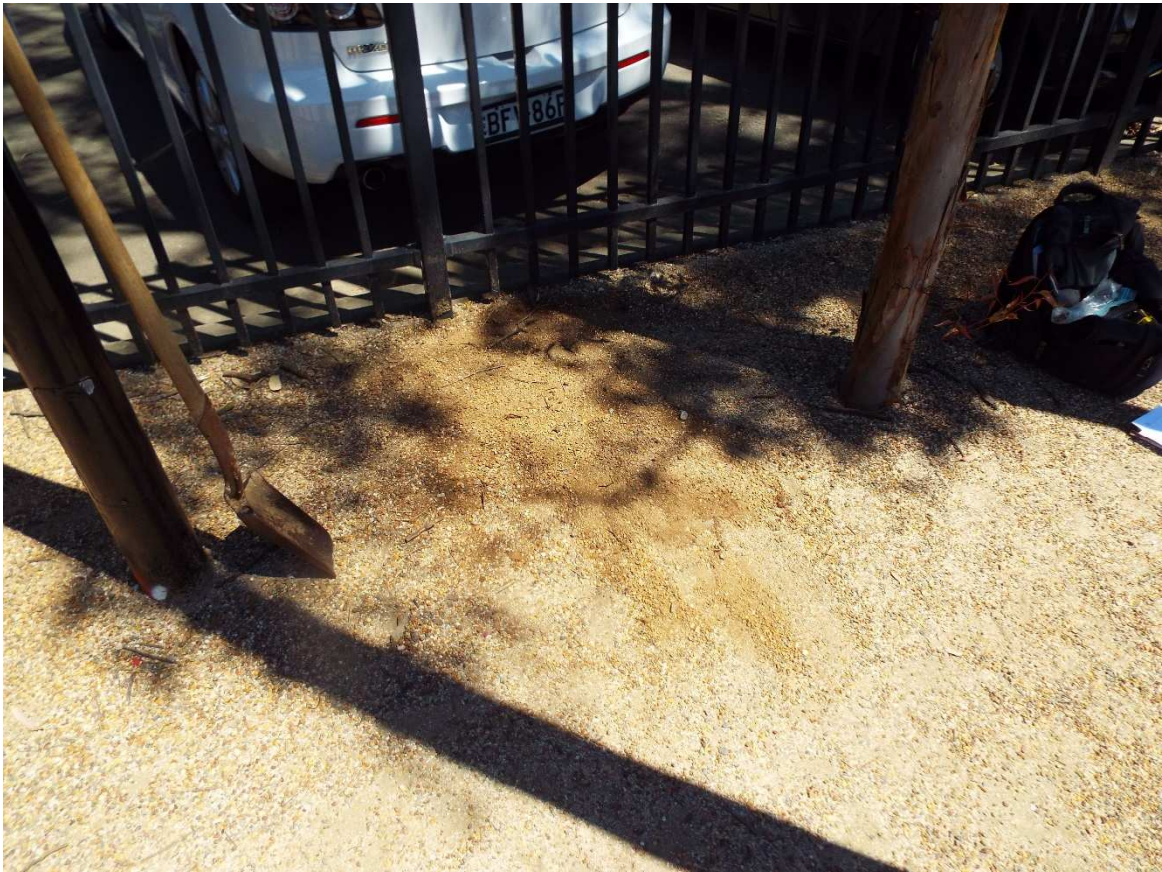
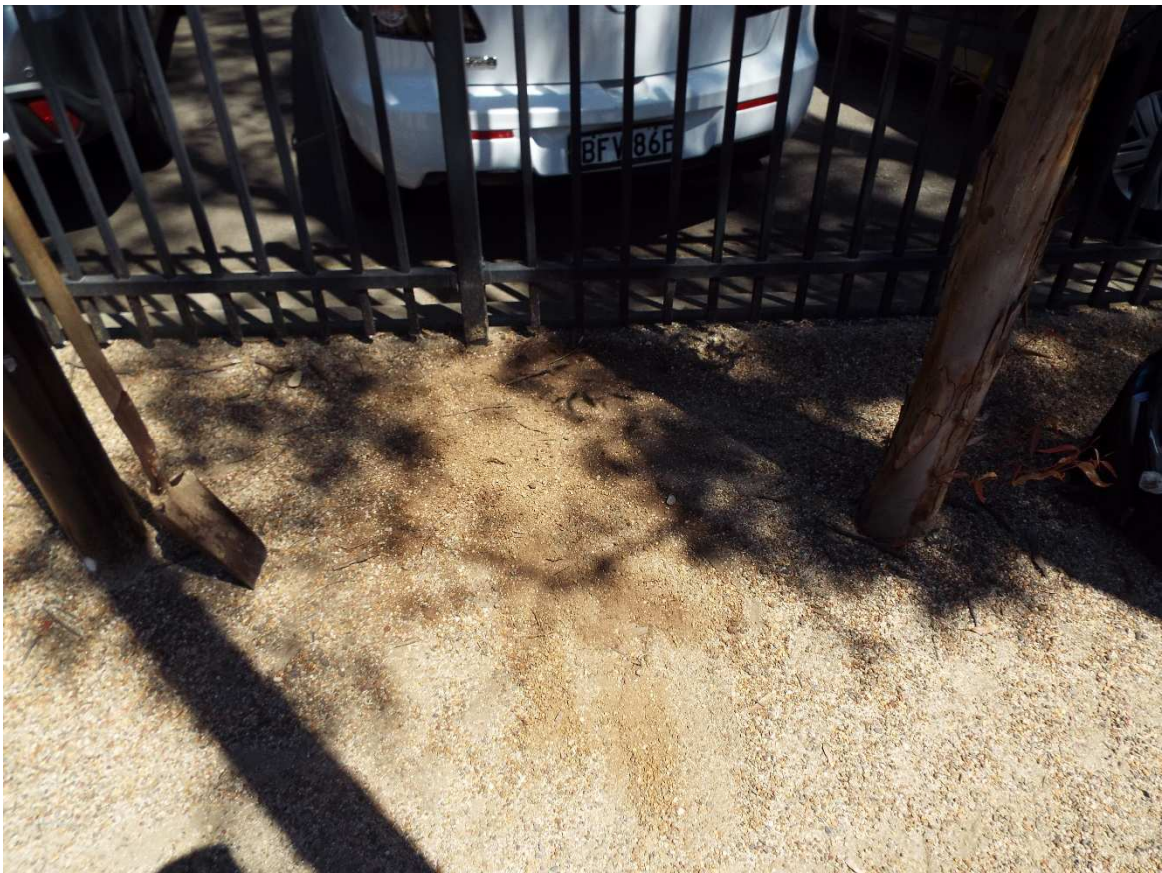
Appendix C; Photos of test pits; Test Pit 1

The lack of root ingress (that is TPZ) has been supported during the last assessment of the area (on the 22nd October 2019, part of data collection for the Addendum), where works adjacent to the trees (No. 8 and 9) on the northern side and flush with the wall had excavation works in progress by external contractors unrelated to the project. The areas of excavation were assessed by the author at this time, and feedback from the contractors performing this excavation stated the wall footing to be approximately 600mm below grade and the excavated pits disclosed no apparent root mass.

It should be noted that the photos of excavation (test pits) within the TPZ of Trees 56-61 have not been provided. Observation 4 of the Arborist Addendum states that the photos are available on request. These photos must be submitted to assess the impacts of excavation.

A file has been issued containing these photos. These photos are contained in Appendix C, Arborist Response.
