# **HERITAGE MANAGEMENT PLAN**

**Tahmoor North - Western Domain  
Longwalls West 3 and West 4**

**August 2021**

**DOCUMENT NUMBER:** TAH-HSEC-331

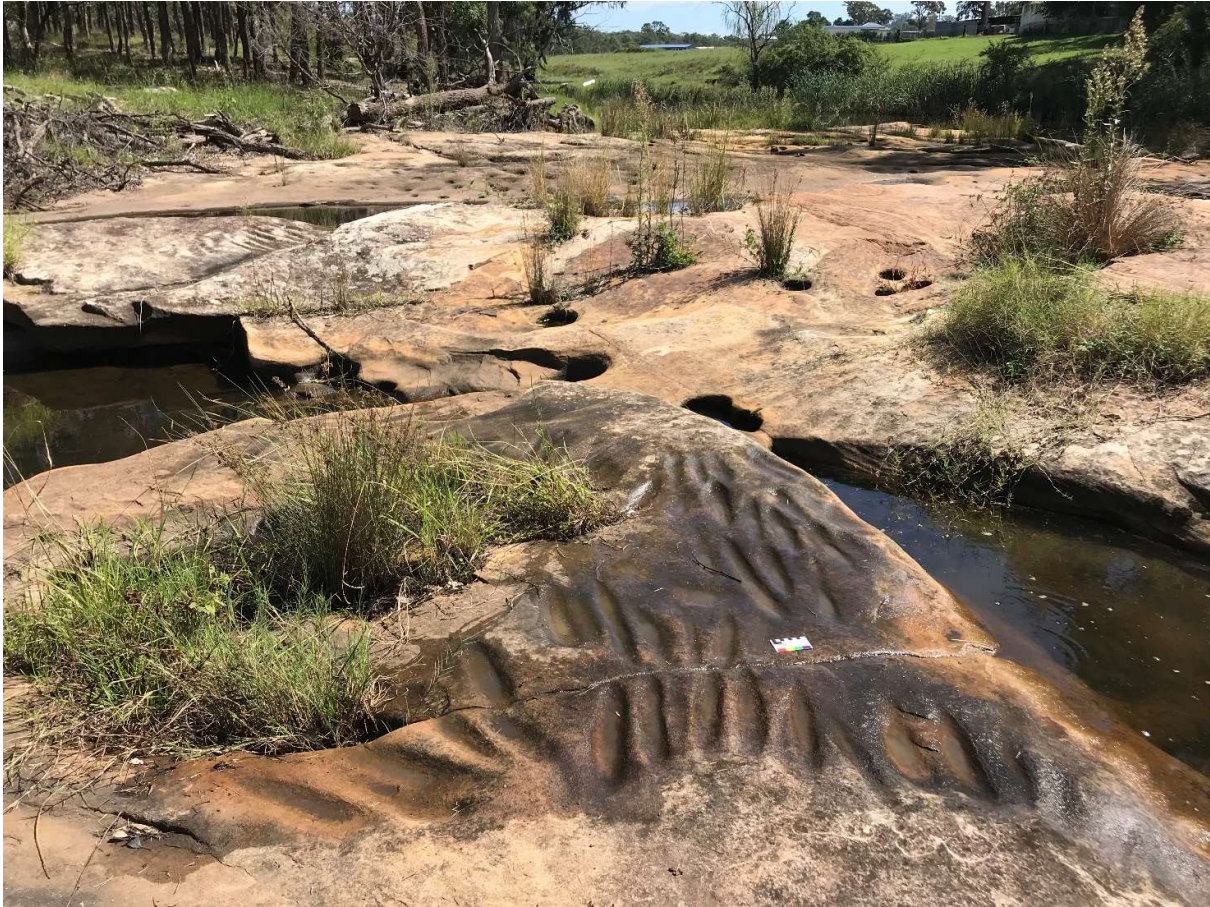
**Plate 4.1** Grinding groove site (AHIMS #52-2-2068) on a rock platform within Stonequarry Creek (view west). Note the pre-existing crack mentioned in the MSEC assessment (2021, p.202).

See Section 5.2.1iii for recommendations around further assessment of potential impacts to this site and Section 6 for recommendations on management of this site.

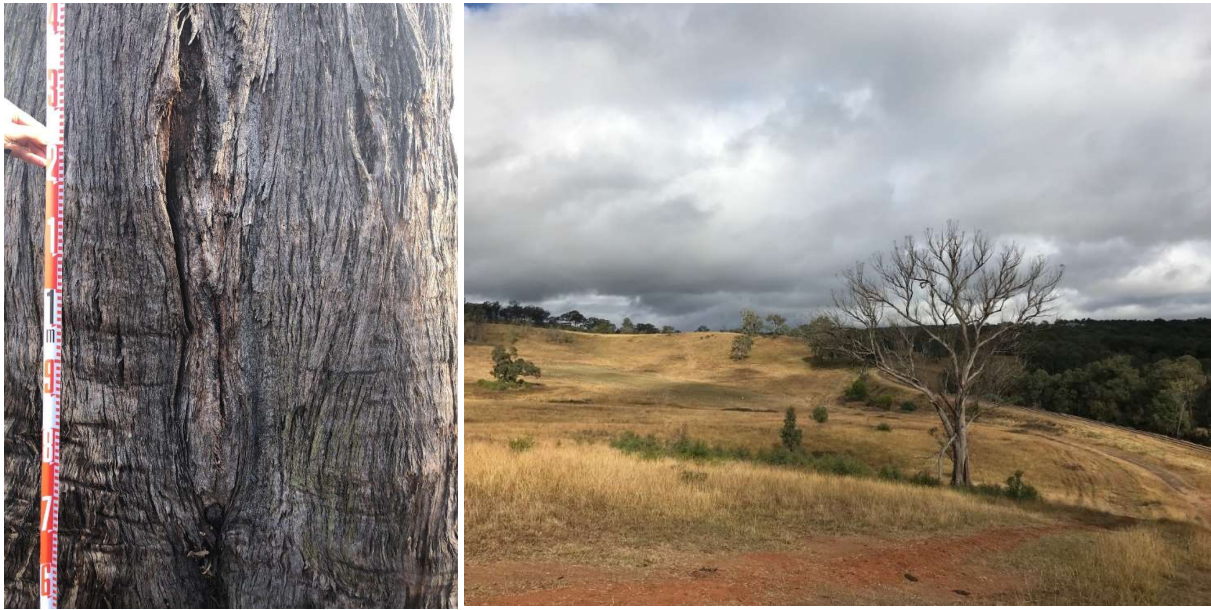
The likelihood of impact is therefore assessed to be *very unlikely* (MSEC 2021).

**Plate 4.2**      **Left: Overgrown scar on the modified tree above LW W2 (#52-2-2100). View north-west.**  
**Right: Modified tree in surrounding landscape. View west.**

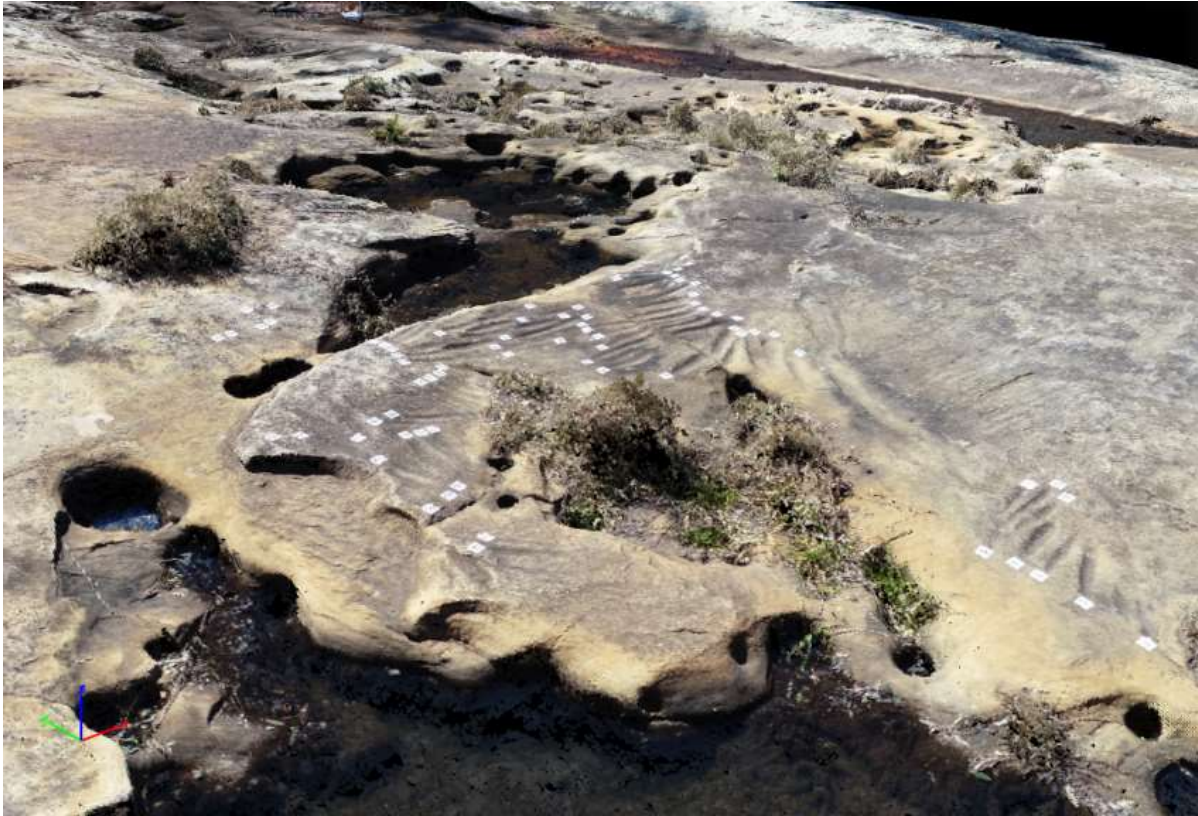
**Plate 5.1**      Example of 3D photogrammetric model perspective of part of the grinding groove site

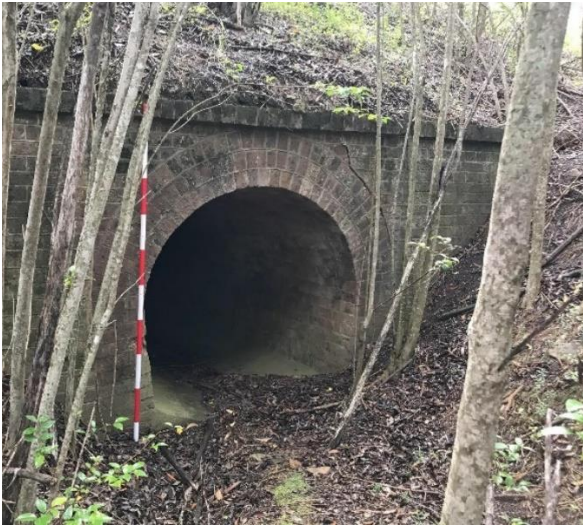
Plate 3.1 Brick culvert (chainage 87.300) beneath disused embankment. View east.

The culverts were found to be generally in fair to good condition. While cracking of the brick culverts along the Loop Line was mostly confined to the mortar, the brick culvert at chainage 87.300 under the disused embankment displayed additional cracking to the bricks themselves around the entrance to the culvert (EMM, 2021b).

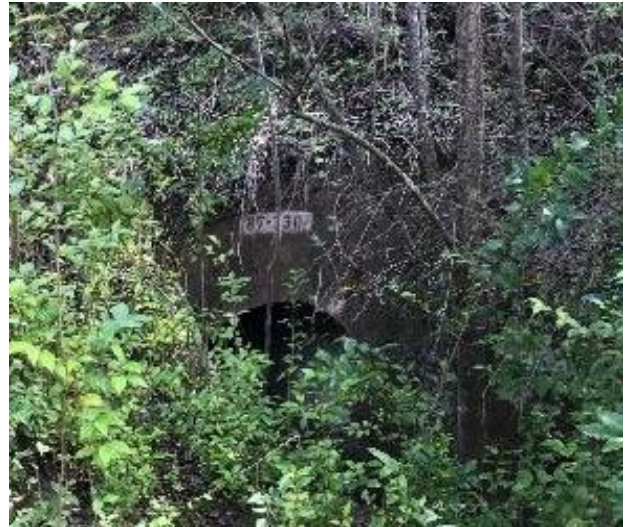
Plate 3.2 Culvert 87.330 km. View north-west.

| Heritage List | Heritage Item | Address | Description of Item | Distance from Longwalls | Significance |
|---|---|---|---|---|---|
| (none) | Loop Line brick culvert 87.330 | Picton-Mittagong Loop Line | Drainage channels of rendered brick have been constructed on either side of the embankments in order to funnel water into the culvert.<br><br>Cracking is along the mortar only and the condition of the bricks is good. | 230 m north-east of LW W3 | Local |

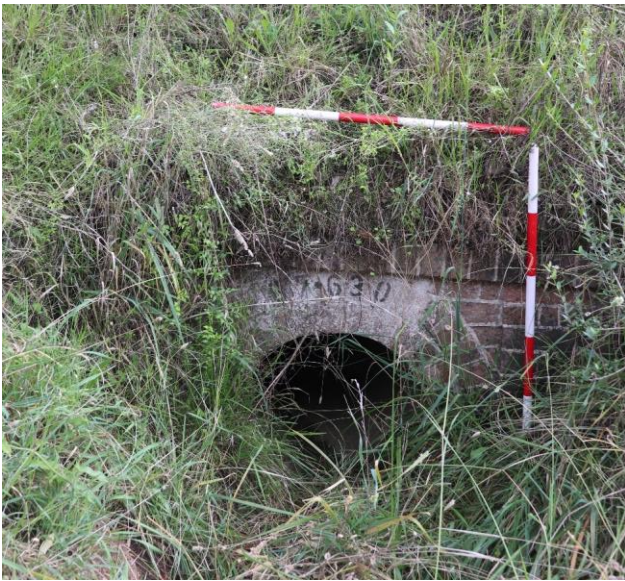
Plate 3.3 Brick culvert (chainage 87.630). View north-west.

| Heritage List | Heritage Item | Address | Description of Item | Distance from Longwalls | Significance |
|---|---|---|---|---|---|
| (none) | Loop Line brick culvert 87.630 | Picton-Mittagong Loop Line | Concrete skin on base and rubble at the mouth. Mortar tuck pointed. Headwall and abutment in good condition. Recent embankment to the south-east means water is largely diverted away from the culvert. | Directly above LW W3 | Local |

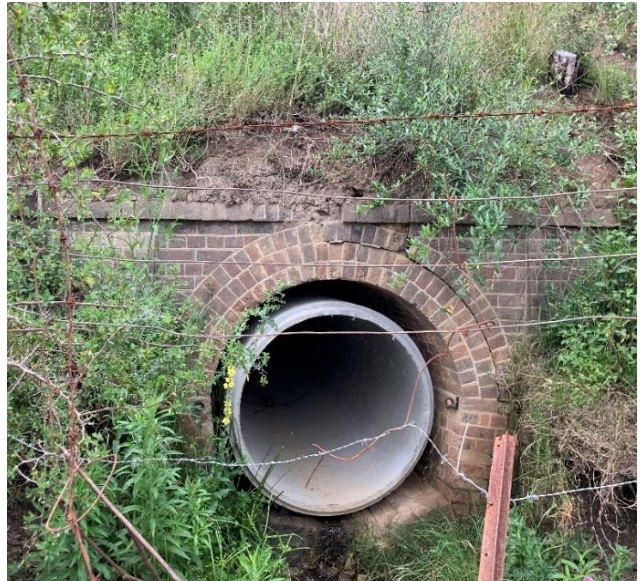
Plate 3.4 Brick culvert (chainage 87.850). View north-west.

| Heritage List | Heritage Item | Address | Description of Item | Distance from Longwalls | Significance |
|---|---|---|---|---|---|
| (none) | Loop Line brick culvert 87.850 | Picton-Mittagong Loop Line | Missing some bricks above the arch. Multiple existing cracks along the mortar. | Directly above LW W3 | Local |

| Item | Measures |
|---|---|
| Loop Line culverts | <p>Management strategies for the culverts were put in place to maintain their integrity during active subsidence during the extraction of LW W1-W2. This involved the installation of a reinforced concrete pipe (RCP) within the culvert opening of culverts 87.850, 88.400 and 88.980 (Plate 3.5, Plate 3.6).</p> <p>The RCPs should all but fill the culvert, with a gap sufficient to allow some movement without cracking either the culvert or the pipe. The purpose of this approach is to minimise harm, should there be any block movement or collapse when a train passes overhead or as a result of subsidence from underground mining, the culvert would be somewhat supported. From a safety point of view, reinforcement is necessary. From a heritage point of view, this method of reinforcement offers a reversible solution that would result in minimal harm to the fabric of the culverts.</p> |

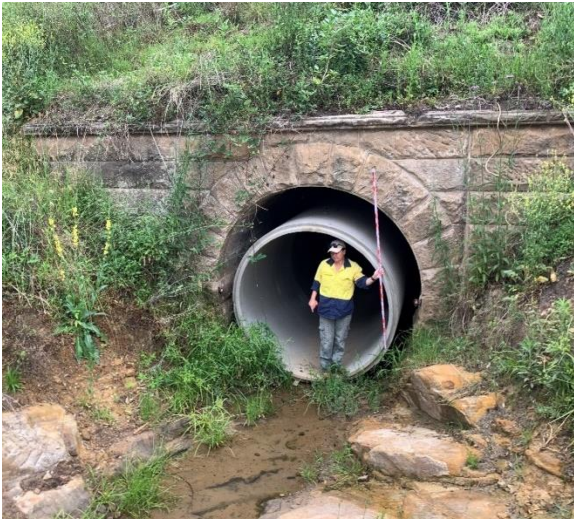
| Heritage List | Heritage Item | Address | Description of Item | Distance from Longwalls | Significance |
|---|---|---|---|---|---|
| (none) | Loop Line sandstone culvert 88.400 | Picton-Mittagong Loop Line | Integrity of structure and condition of the sandstone is good. | 400 m west of LW W3 | Local |

**Plate 3.5** Sandstone culvert 88.400 with RCP sleeve  
(The RCP is a mitigation measure for subsidence, refer to Table 6.1).

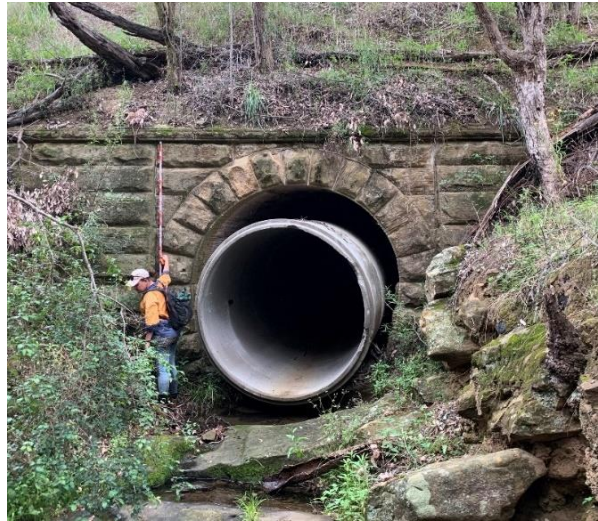
**Plate 3.6** Sandstone culvert 88.980 with RCP sleeve.

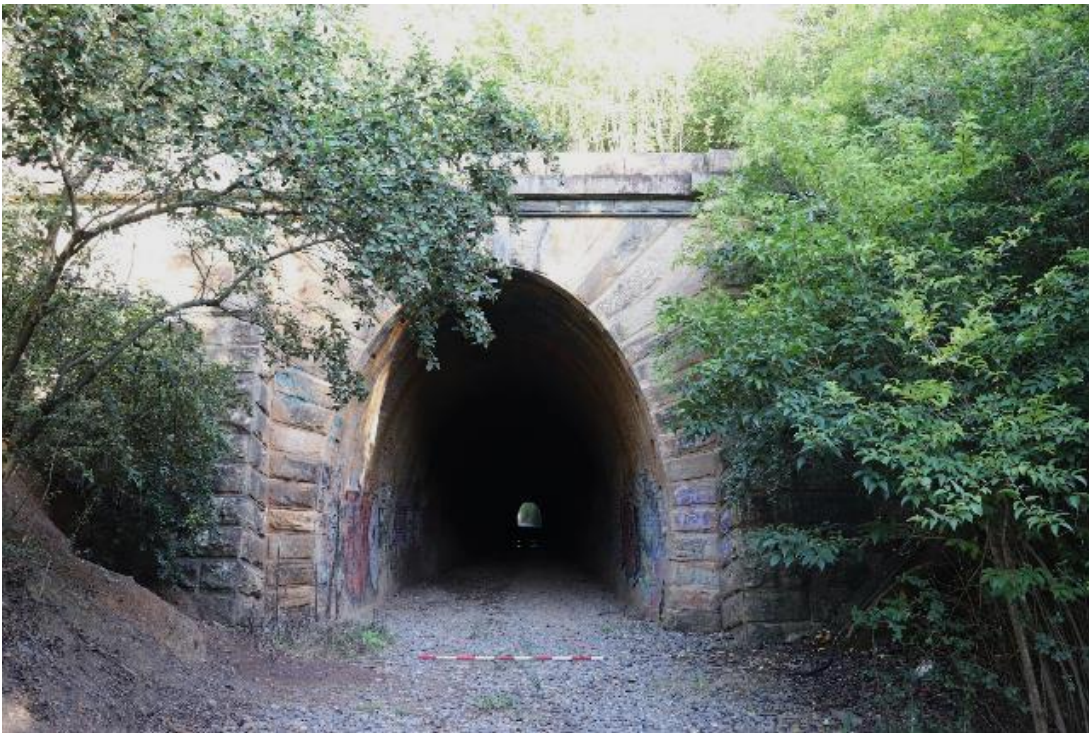
**Plate D.6** Mushroom Tunnel, southern entrance. Dressed sandstone blocks radiate from the portal. View north-west.

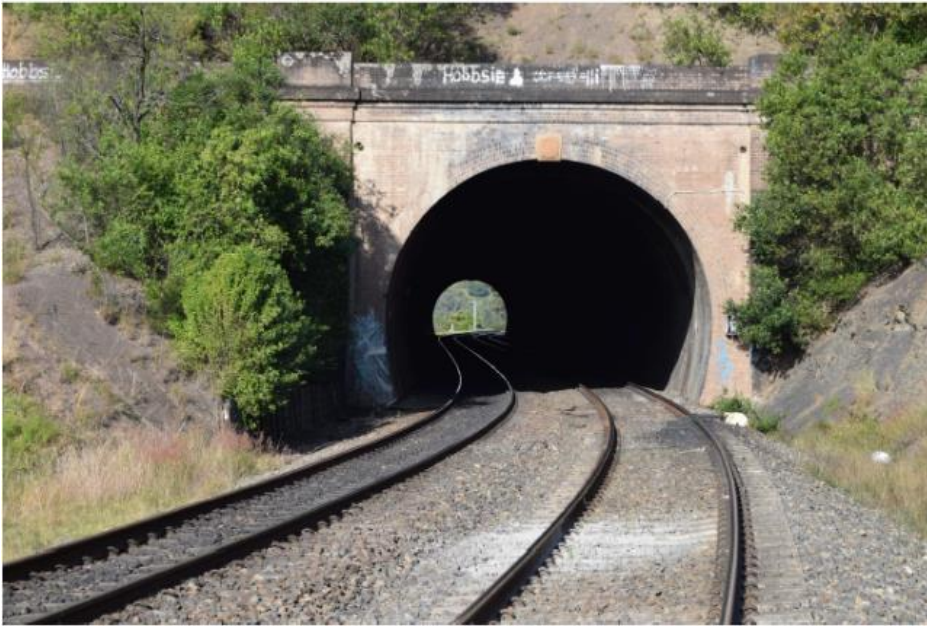
#### Plate D.7      Picton Tunnel, northern portal

Picton Tunnel is situated on the 1919 double track deviation of the Main Southern Line. The horseshoe arch tunnel has five heading courses surrounding the arch and a sandstone keystone (Plate D.7). The opening is approximately 6.3m high and 8.3m long (MSEC 2020, p.32). Brick wing walls on either side of the entrance provide support. The brick work is English bond with a string course and cornice towards the top. The tunnel is an operational rail asset and well maintained.

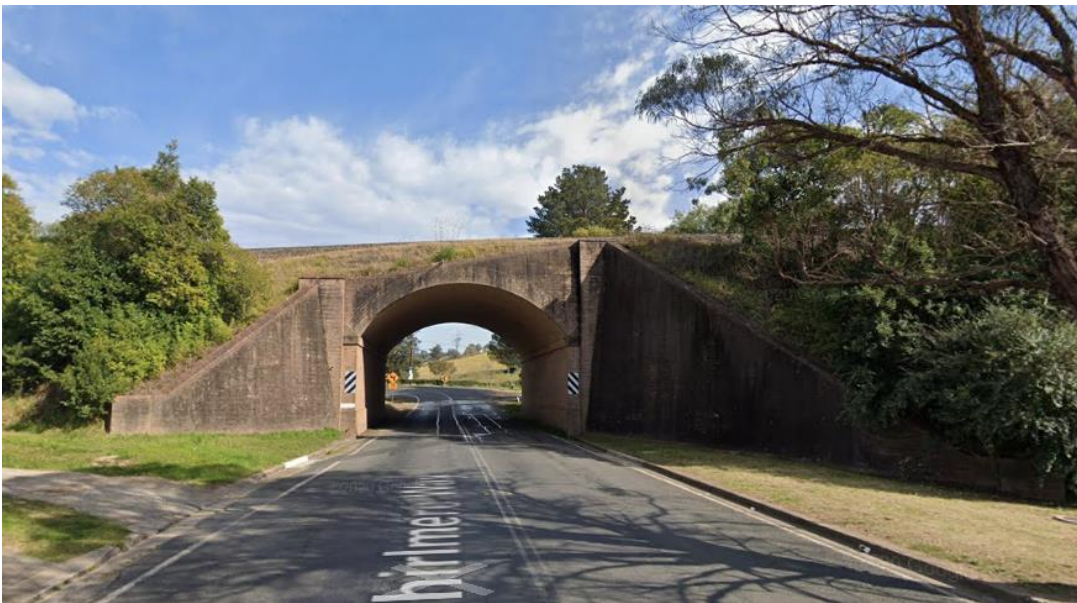
#### Plate D.9 Antill Street Underbridge

The Antill Street Underbridge is listed on the ARTC S170 Register. The listing incorrectly gives its location as 88.133 km. The Antill Street Underbridge is located at 89.326 on Thirlmere Way (Antill Street becomes Thirlmere Way, west of the roundabout intersection with Argyle St/Old Hume Highway). The single span arch bridge is formed with six, rowlock brick courses supported by brick abutments and angled wingwalls. The underbridge serves as a road bridge for cars passing below the Main Southern Railway. It was possibly constructed in the early twentieth century as part of the railway deviation works. Antill Street Underbridge is a single span brick road underbridge on Thirlmere Way.

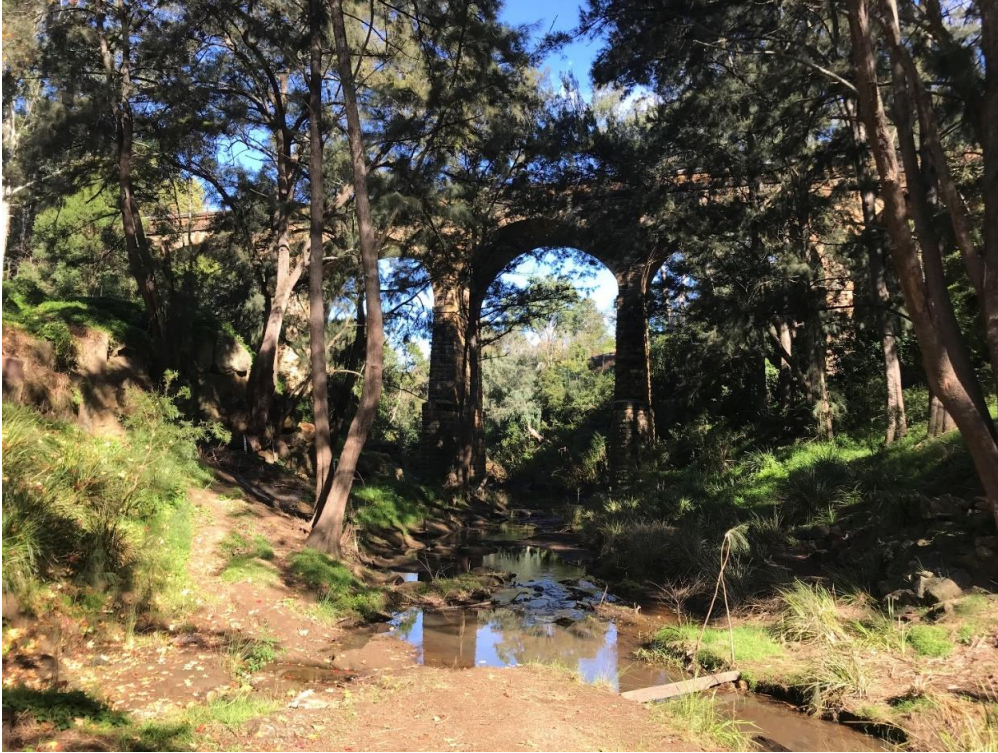
**Plate D.10**      Looking south-west towards Picton Viaduct from Stonequarry Creek.

The piers are solid stone, founded at shallow depth into rock. The internal 'V' formed above each pier is filled with stone rubble (to about 5 m) and dished to form a drain. A drainpipe down the middle of the 'V' discharges at the springing level (the level at which the arch starts). This prevents the tracks from becoming waterlogged. There is a low stone parapet wall on each side of the viaduct. Abutments are U-shaped in plan with three internal buttresses.

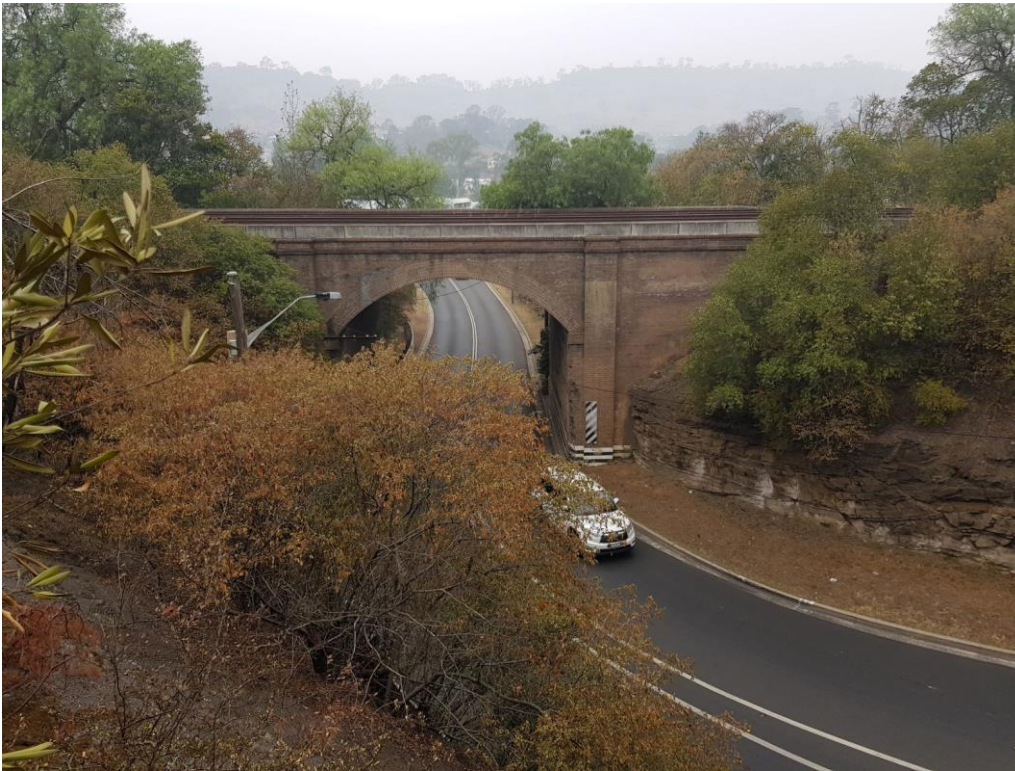
The “Hole in the Wall” is a high brick arch railway bridge over the old Great South Road/Argyle Street (now the Hume Highway) to the south of Picton Village. It is also referred to as the Argyle Street Underbridge (ARTC S170 register). The railway bridge was constructed in 1918-19 as part of the railway development to replace the Picton Mittagong line. A photograph of the Dunlop cycle race taken in 1930 (Plate D.13) looks up the hill away from Picton Village towards the bridge.

**Plate D.12**      **Railway bridge (Hole in the Wall) on Argyle Street with Picton Village behind. View east.**

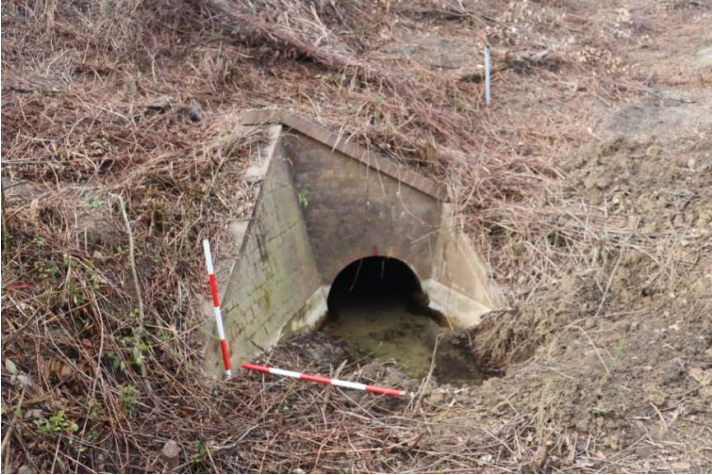
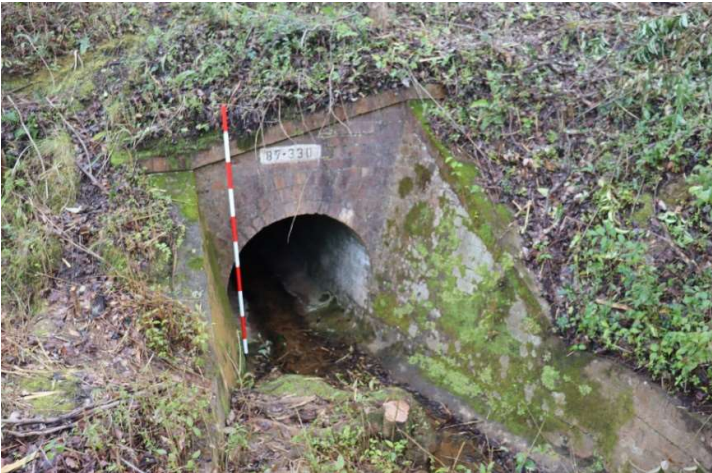
| <b>Site condition</b> | The brick and concrete culvert is in good condition. There is a minor amount of vegetation growth, however, this does not appear to have impacted the feature. |
| <b>Photographs</b> | <div><p>Northern view of the brick and concrete culvert, showing northern outlet.</p><p>Southern view of brick and concrete culvert, showing southern outlet.</p></div> |

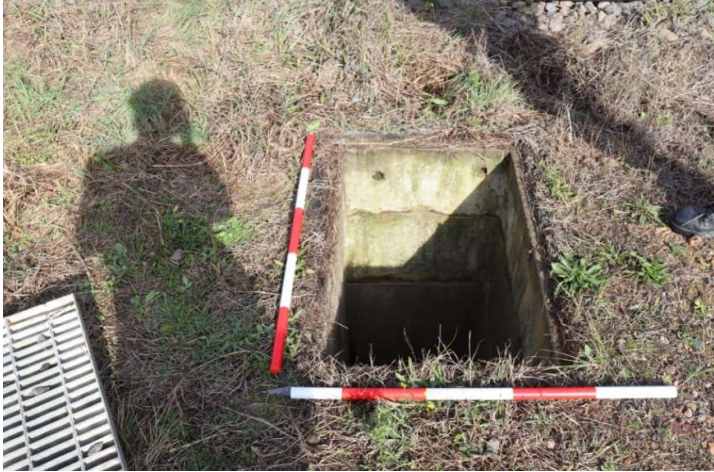
| Photographs | <p>Southwestern view of concrete drain at chainage 87.918 km.</p> |

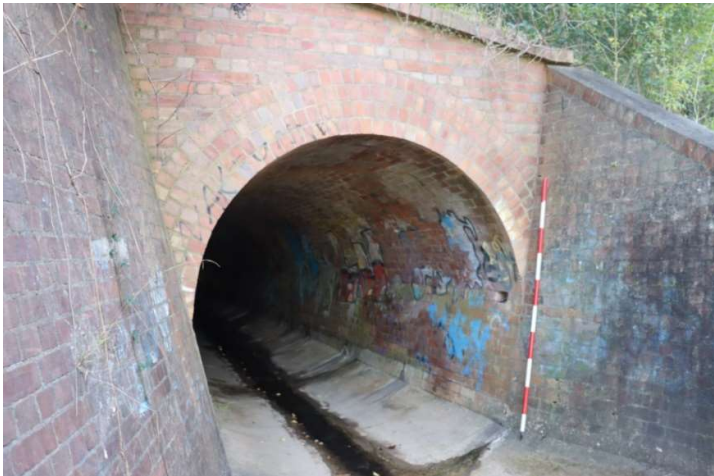
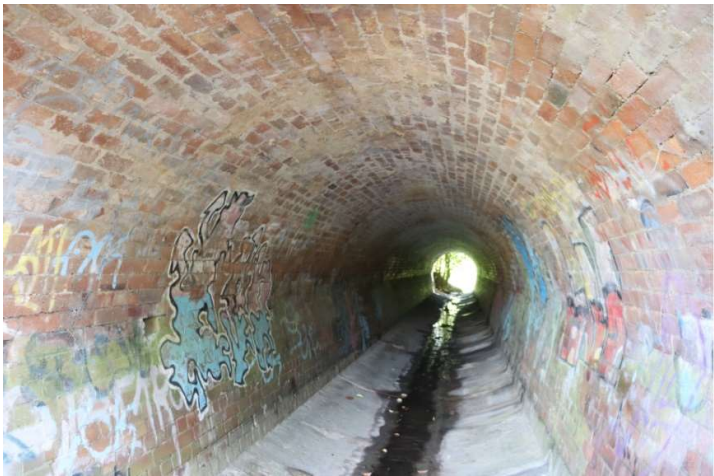
| Site condition | The brick culvert is in good condition despite a moderate amount of graffiti. |
| Photographs | <p>Western view of brick culvert at 89.216 km chainage.</p> <p>Western view within the brick culvert at 89.216 km chainage.</p> |

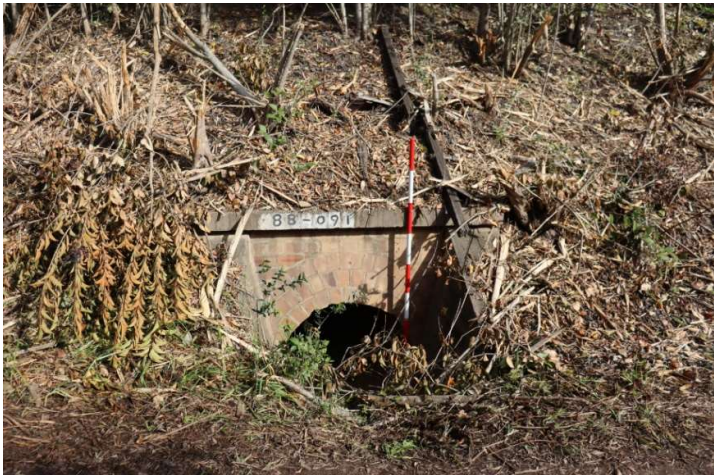
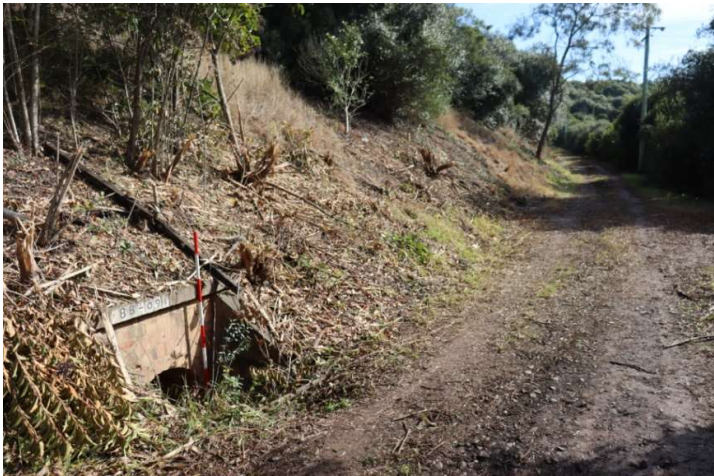
| Location | 88.091 km, Main Southern Railway, Picton |
|---|---|
| Site condition | The brick culvert is in good condition, despite a moderate amount of vegetation overgrowth. |
| Photographs | <p>Southwestern view of brick culvert at chainage 88.091 km.</p> <p>Southwestern view of brick culvert at chainage 88.091 km.</p> |

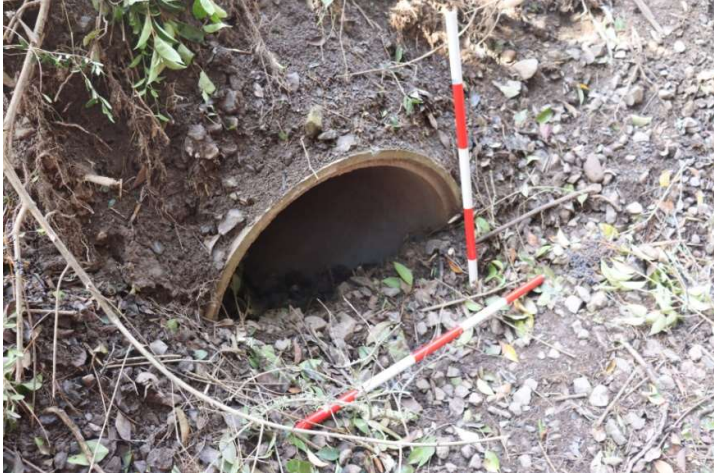
| Location | 88.496 km, Main Southern Railway, Picton |
|---|---|
| Site condition | The outlet pipe was in good condition. |
| Photographs | <p>View of terracotta culvert located at chainage 88.496 km.</p> |

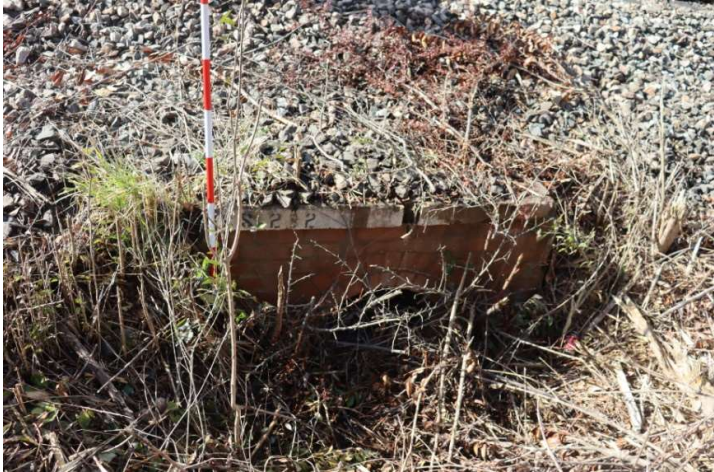
| Location | 88.232 km, Main Southern Railway, Picton |
|---|---|
| Site condition | The brick culvert is in good condition, despite a moderate amount of vegetation overgrowth. |

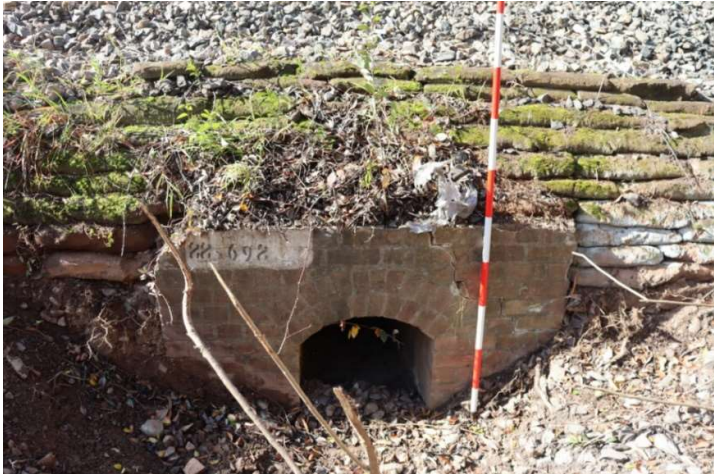
| Location | 88.698 km, Main Southern Railway, Picton |
|---|---|
| Site condition | The brick culvert is in good condition. The cement sandbag shoring may indicate previous conservation works. |
| Photographs | <p>View of brick culvert at chainage 88.698 km. Note the cement sandbag shoring.</p> |

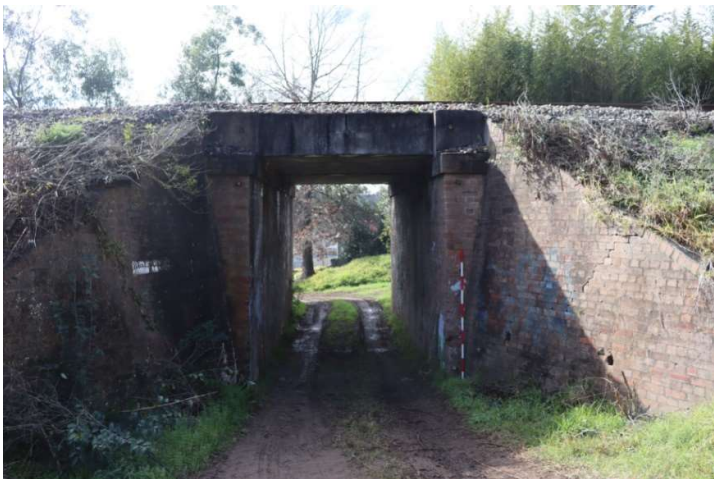
| Site condition | The pedestrian subway is in good condition, despite a number of superficial cracks and minimal graffiti. |

View of pedestrian subway at chainage 88.133 km along the Main Southern Railway, Picton.

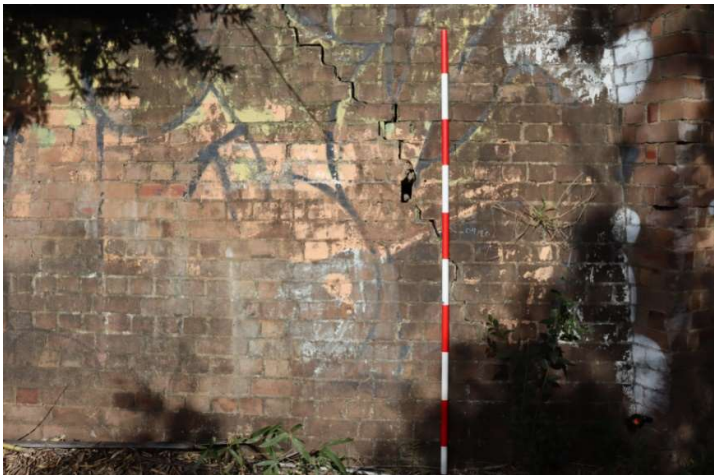
| Detail view of pedestrian subway, showing cracks and graffiti. | |

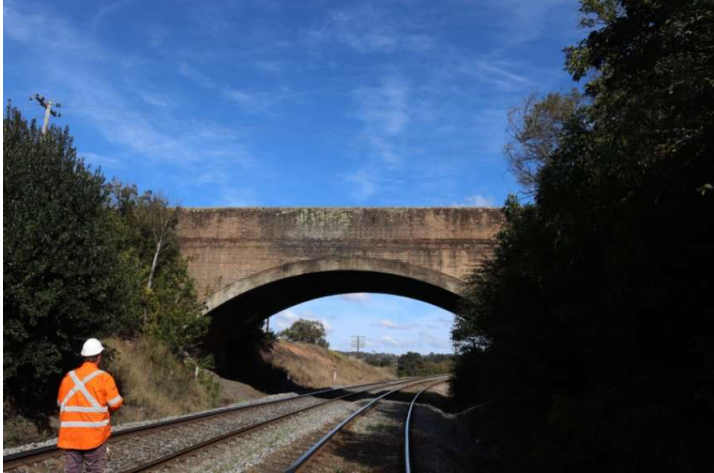
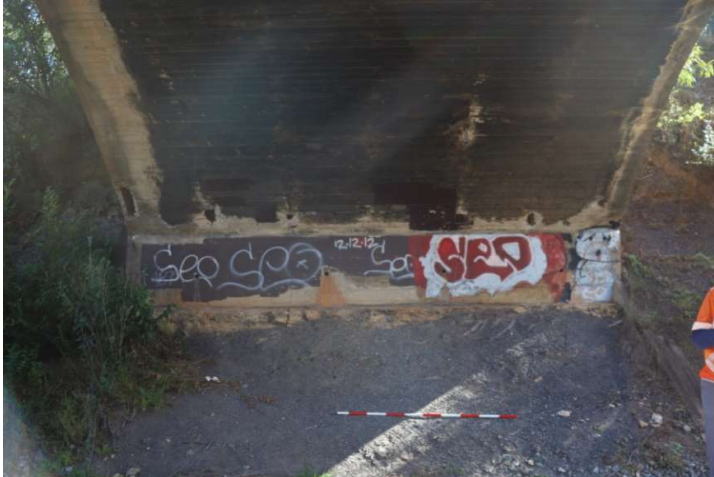
| Site condition | The Connellan Crescent Overbridge is in good overall condition, despite a moderate amount of graffiti. |
| Photographs | <p>Southwest facing view of the Connellan Crescent Overbridge from within the Main Southern Railway corridor.</p> <p>Southwest facing view of the Connellan Crescent Overbridge from within the Main Southern Railway corridor showing graffiti. Note the evidence of timber formwork on the concrete arch.</p> |

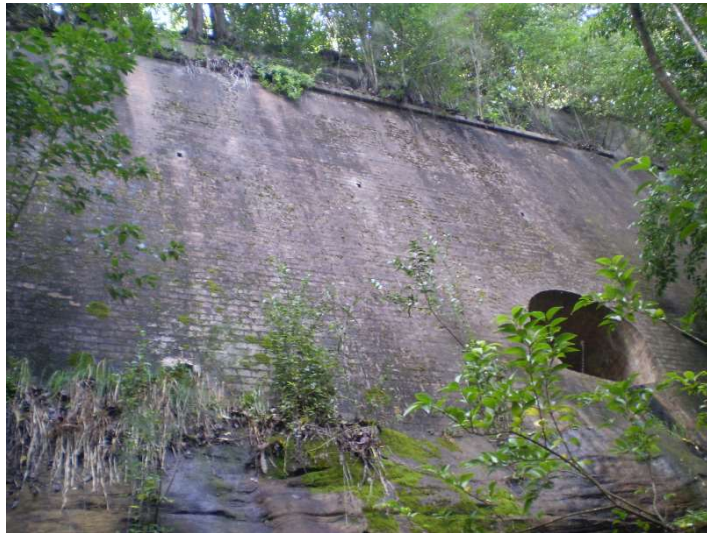
East facing view of high retaining wall from Stonequarry Creek.

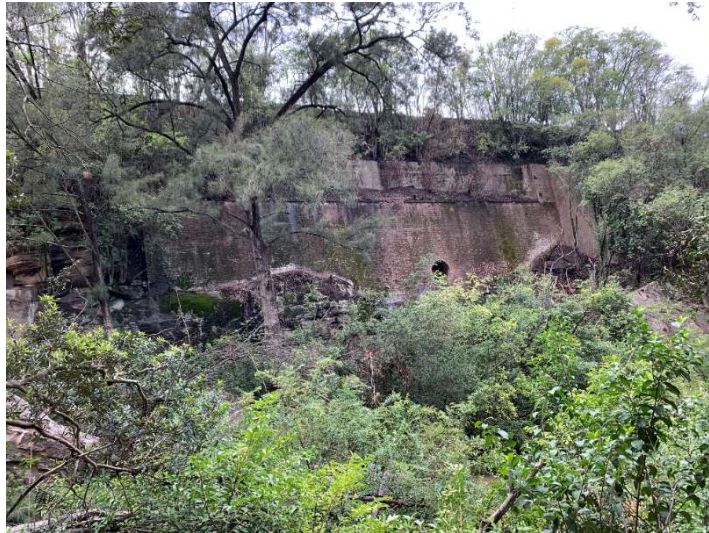
| Heritage List | Heritage Item | Address | Description of Item | Distance from Longwalls | Significance |
|---|---|---|---|---|---|
| (none) | High retaining wall 84.687 | Main Southern Railway | Retaining wall adjacent to the Main Southern Railway that is not within a valley or stream channel, in good condition. | 1 km east of LW W4 | Local |

East facing view of high retaining wall from Stonequarry Creek.

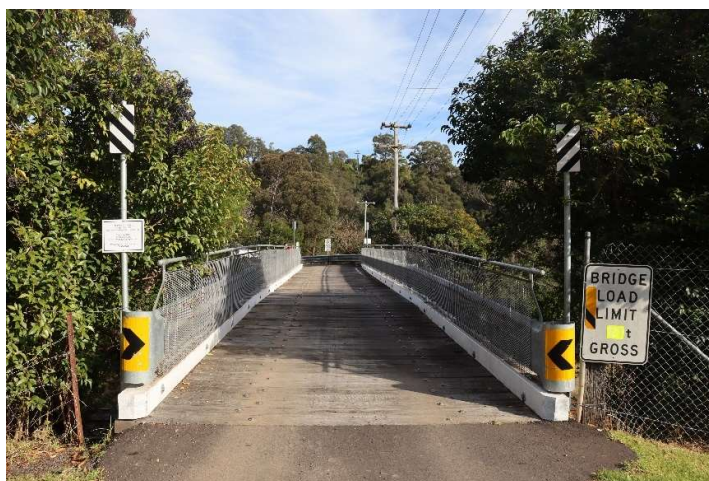
East facing view of Bridge on Mathews Lane showing timber decking, metal guard rails and modern signage.

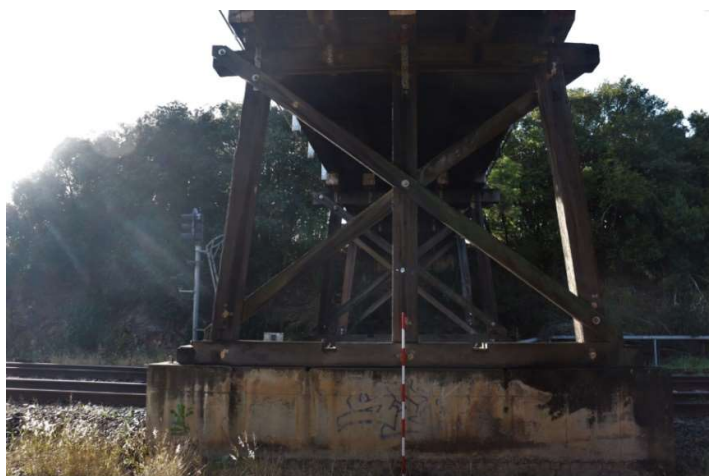
East facing view of underside of Bridge on Mathews Lane showing timber cross bracing and concrete foundations.

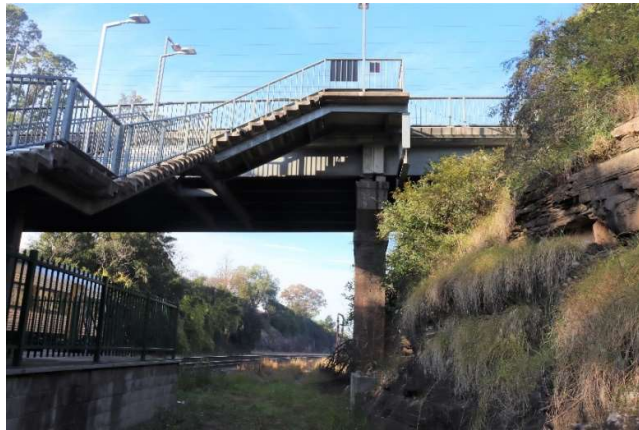
Southeast facing view of the Prince Street Overbridge from within the Main Southern Railway corridor showing brick piers and pedestrian access staircase.

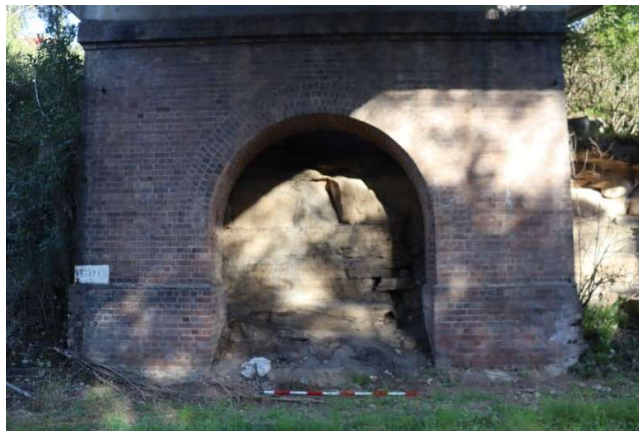
| Heritage List | Heritage Item | Address | Description of Item | Distance from Longwalls | Significance |
|---|---|---|---|---|---|
| (none) | Prince Street Overbridge 85.171 | Prince Street | Steel framed bridge with steel guard rails supported by concrete headstocks over brick arched piers that cross over the Main Southern Railway at Picton Station, in good condition, despite a moderate amount of graffiti. | 960 m east of LW W4 | Local |

WSW facing view of Prince Street Overbridge showing brick arched piers and railway cutting (into sandstone bedrock).

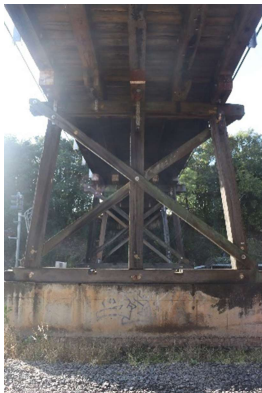
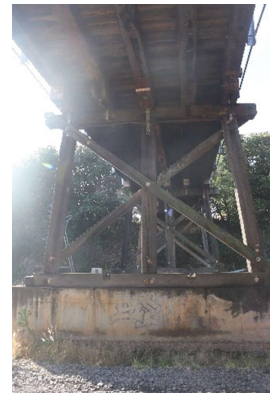
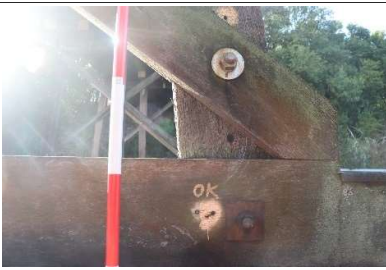
| Location | 84.551 km, Main Southern Railway, Picton |
|---|---|
| Site condition | The Bridge on Mathews Lane is in good condition. |

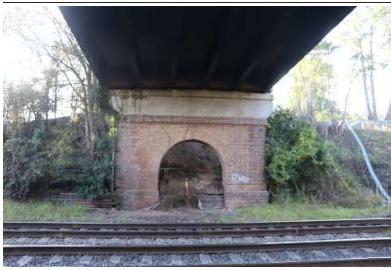
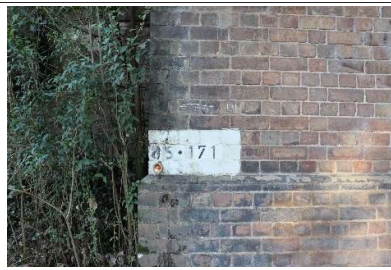
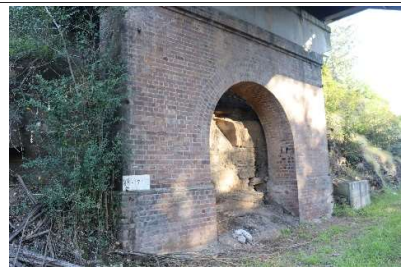
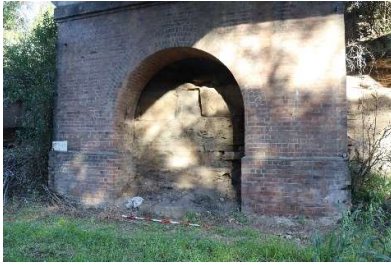
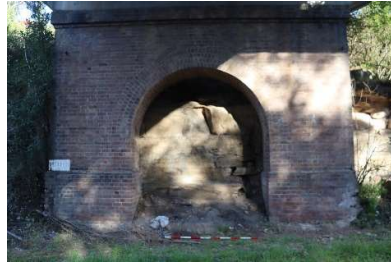
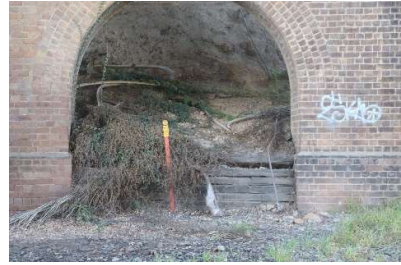
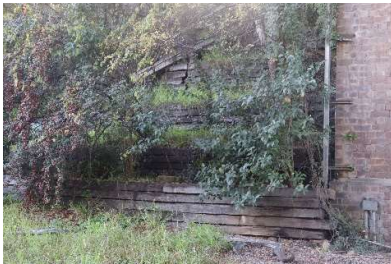
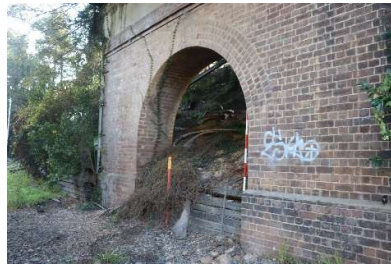
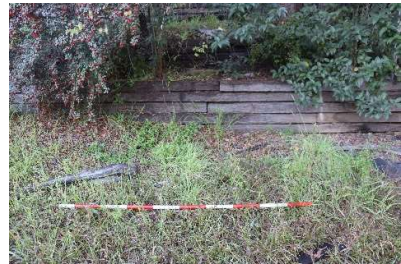
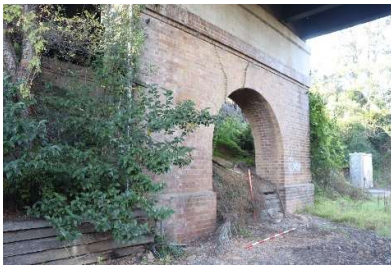
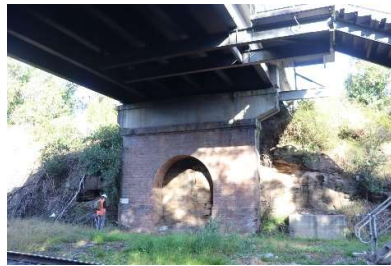
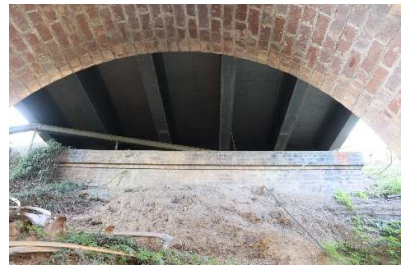
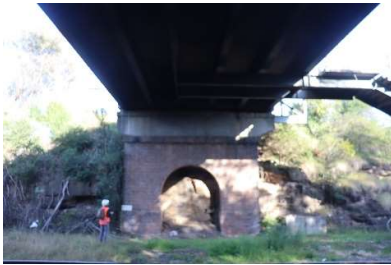
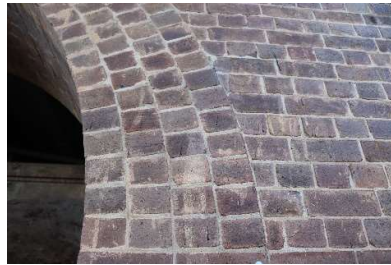
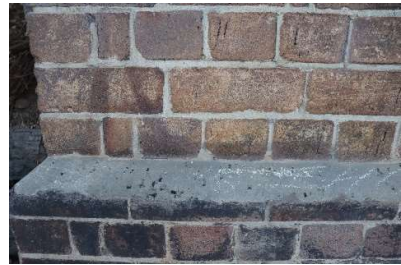
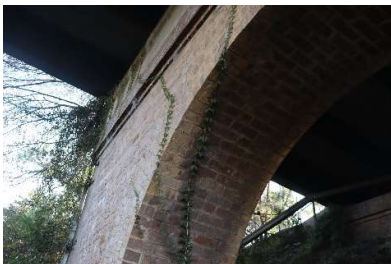
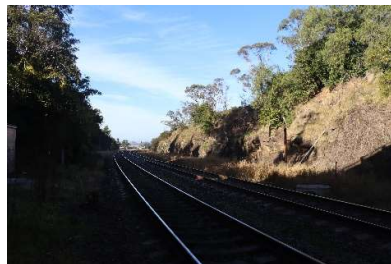
**Site condition** The Prince Street Overbridge is in good condition, despite a moderate amount of graffiti.
