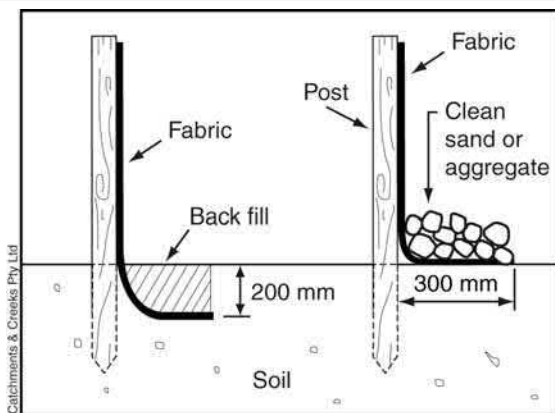
Figure 8 – Anchoring the fabric

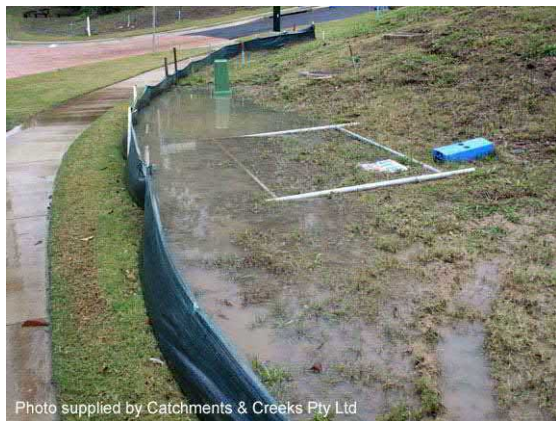
Photo 9 – Sediment fence placed along the contour

Ideally, the sediment fence should be installed along the contour, thus maintaining sheet flow conditions across fence. If located across the contour, the fence should be installed with regular 'returns' to avoid water concentrating along the fence.

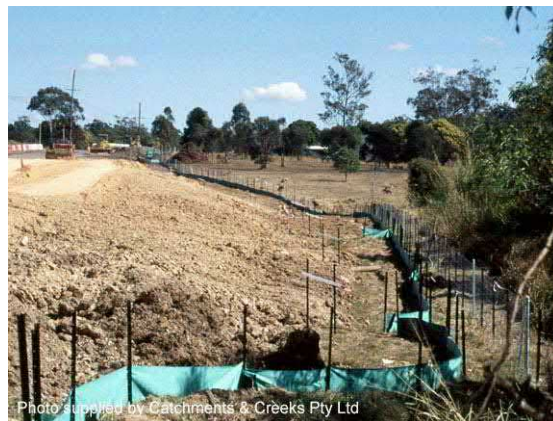
Photo 10 – Use of fence 'returns'

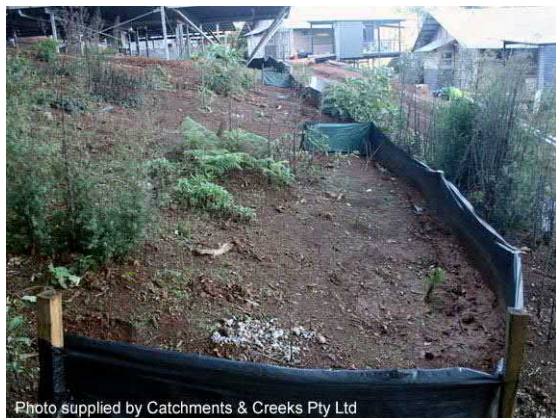
Photo 11 – Placement of fence off the contour with regular fence 'returns'

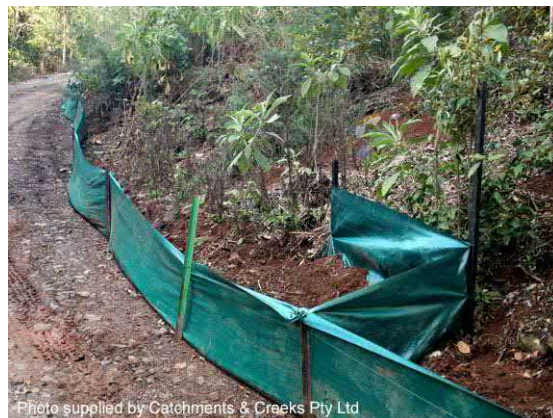
Photo 12 – Alternative design of a fence 'return'

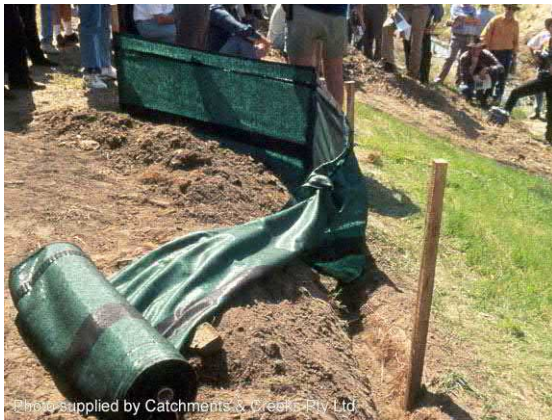
Photo 13 – Trenching the fabric

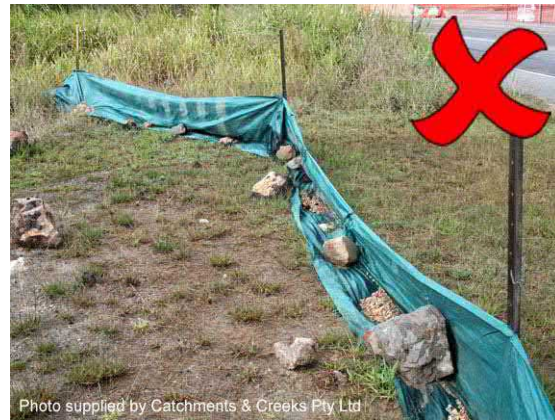
Photo 14 – Inappropriate installation

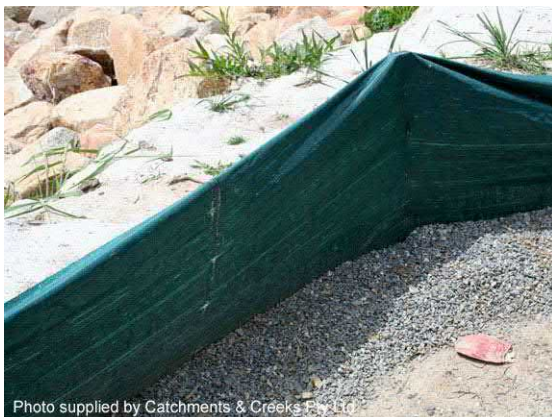
Photo 15 – Bottom of fabric buried under aggregate

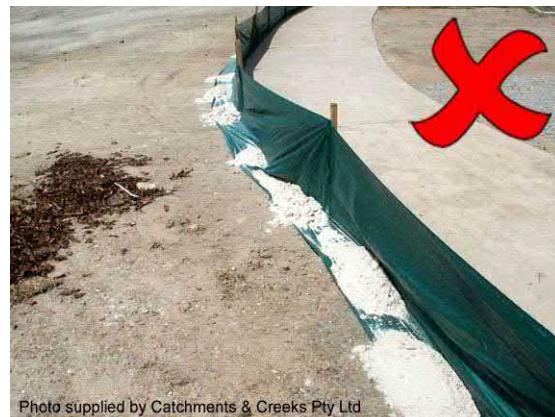
Photo 16 – Inappropriate use of sand to bury the fabric

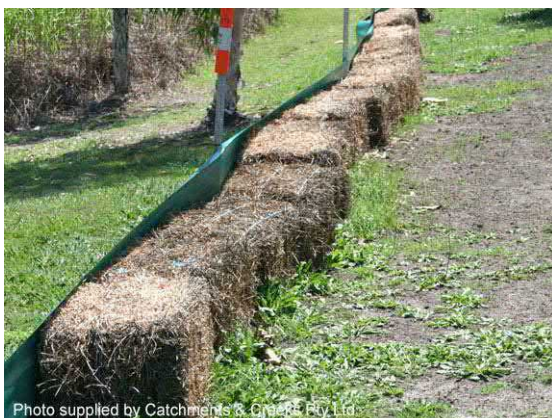
Photo 17 – Straw bales placed up-slope of fence to separate sediment and fabric

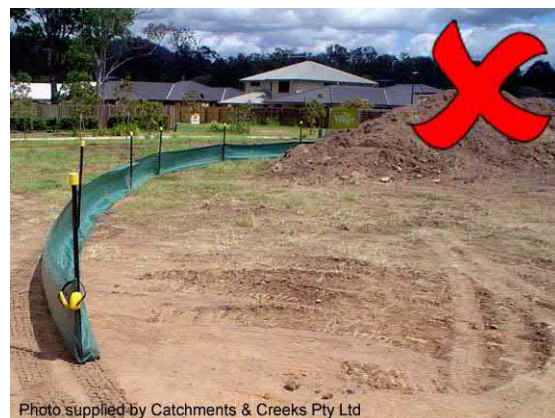
Photo 18 – Inappropriate installation of the posts up-slope of the fabric

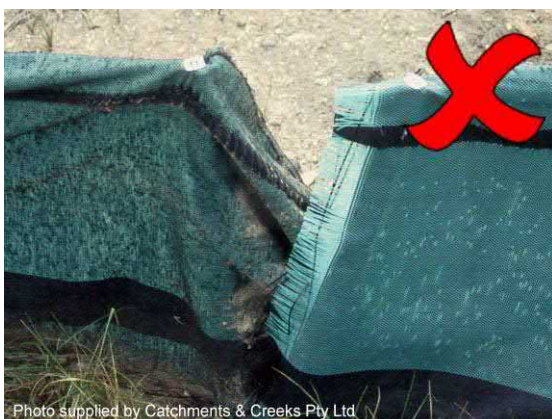
Photo 19 – Inappropriate junction

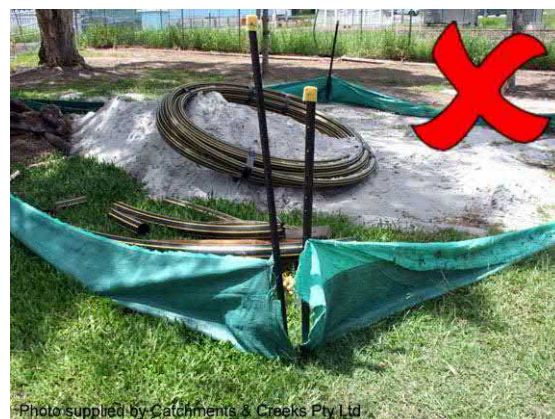
Photo 20 – Gaps in fence are not allowed

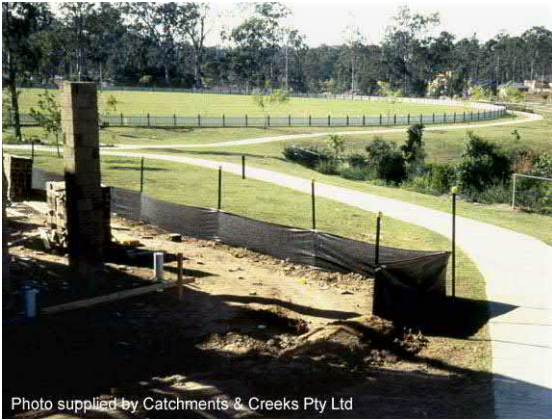
Photo 21 – Installation without backing weir/mesh

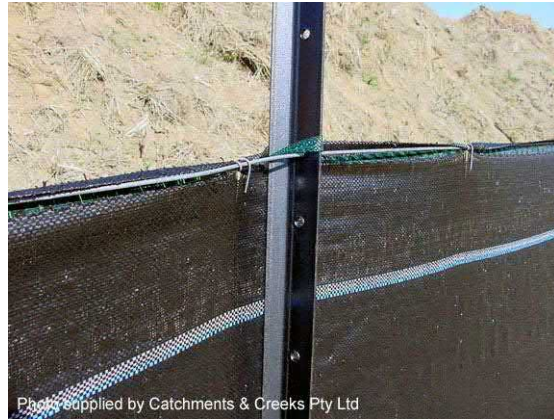
Photo 22 – Installation with top wire support

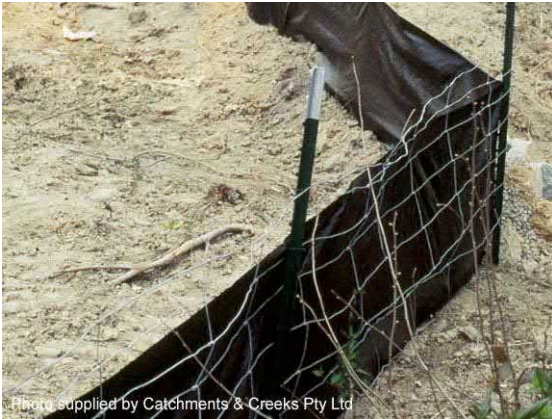
Photo 23 – Installation with weir mesh

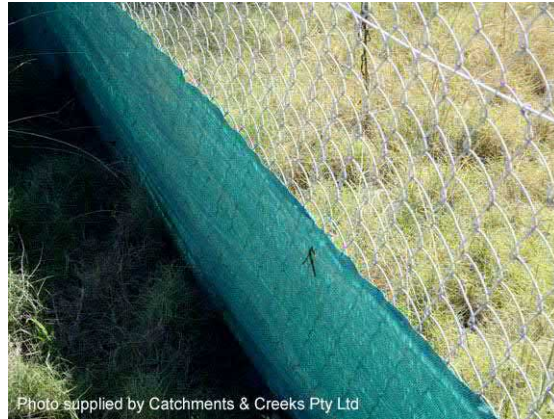
Photo 24 – Installation using fence support

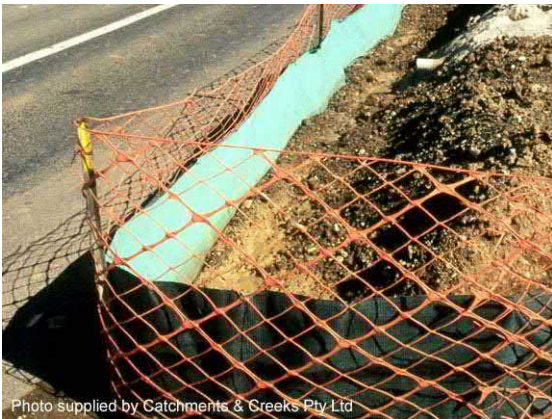
Photo 25 – Installation with safety fencing used as support

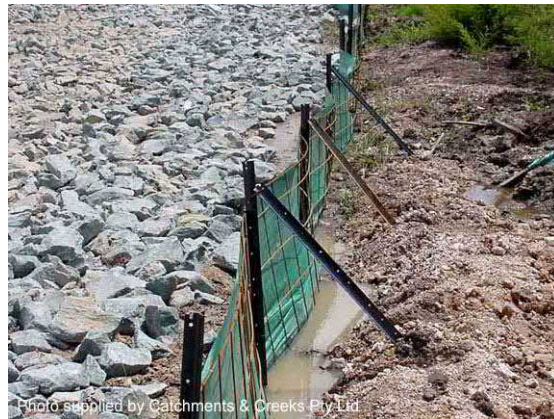
Photo 26 – A sediment fence braced for possible high flows

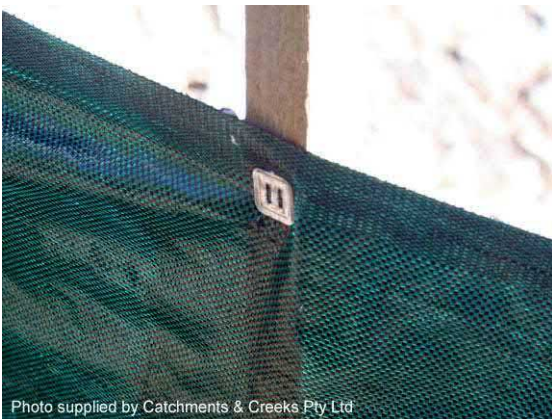
Photo 27 – Example of tacking

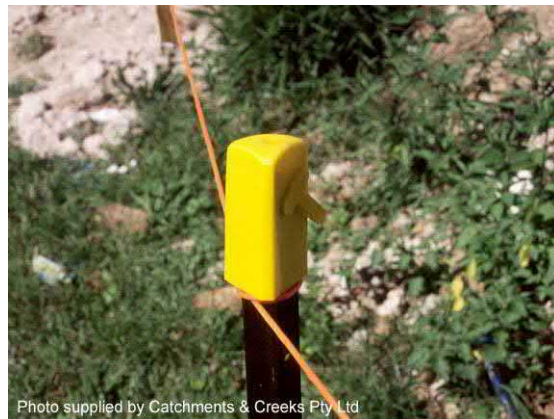
Photo 28 – Safety cap on a steel stake

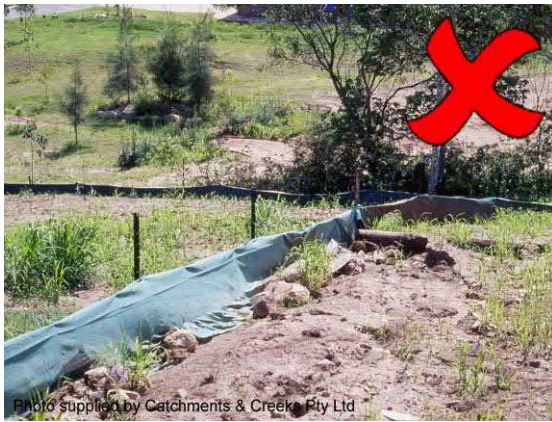
Photo 29 – Flow diversion by fence

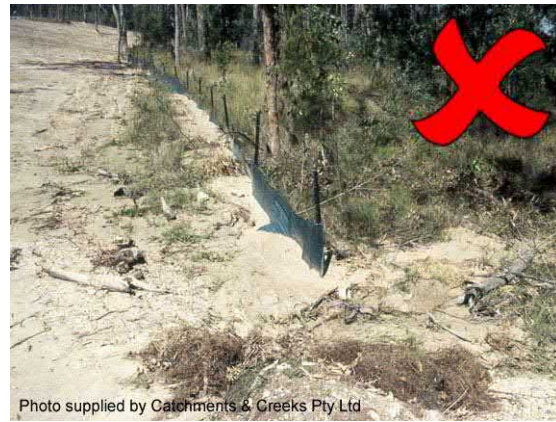
Photo 30 – No end return

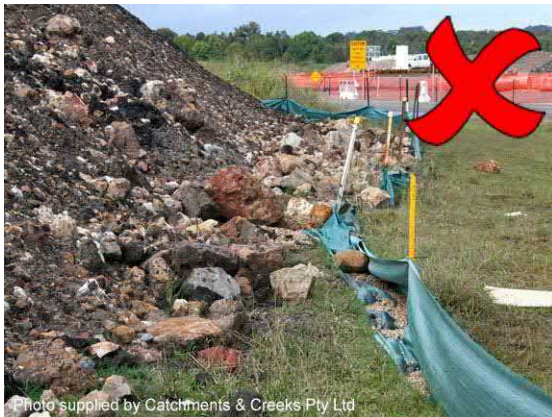
Photo 31 – Damage by shifting fill

Easily damaged by construction equipment and shifting earth (Photos 31 & 32).

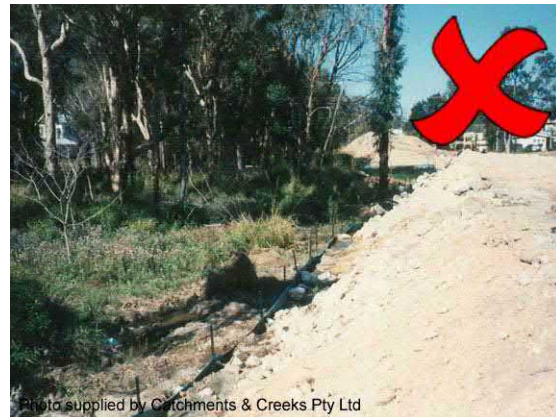
Photo 32 – Fence placed too close to fill

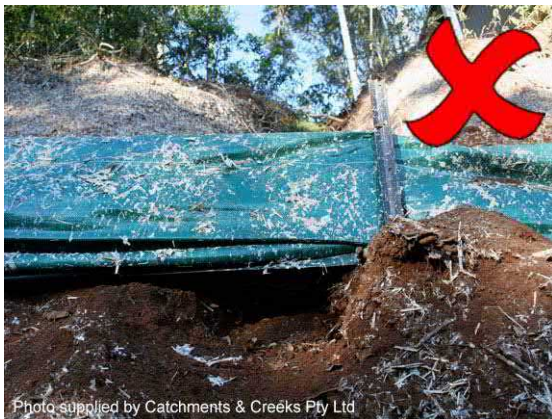
Photo 33 – Evidence of hydraulic wash-out under fence caused by poor trenching

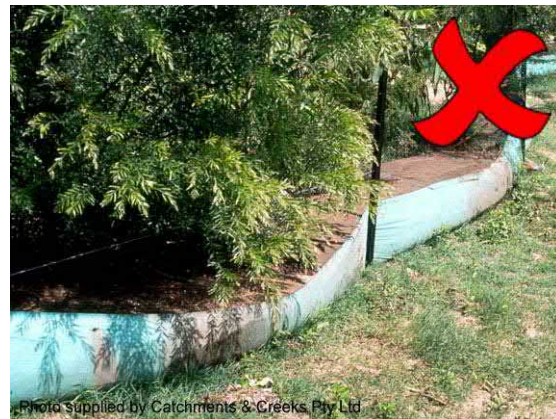
Photo 34 – Sediment not removed after storm

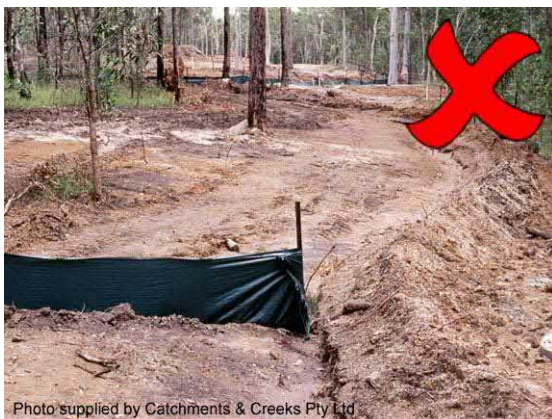
Photo 35 – Flow allowed to bypass the fence

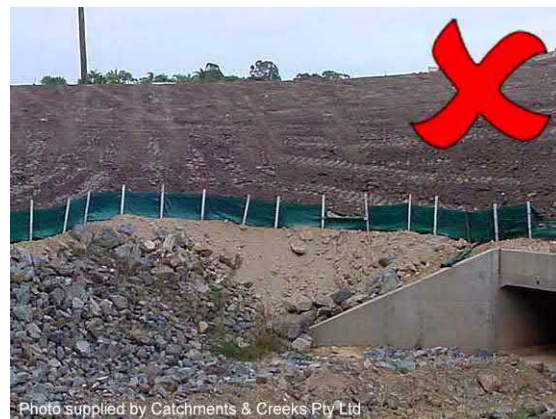
Photo 36 – Spill-through weirs must not discharge onto unstable land

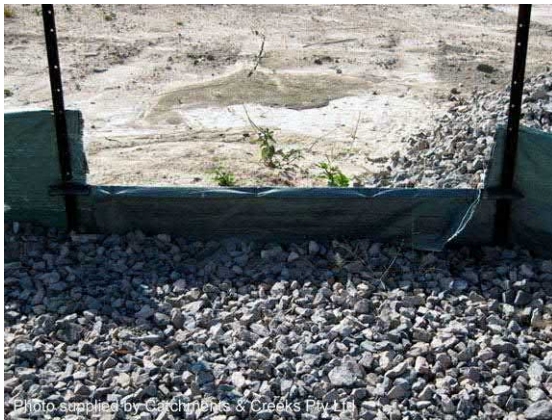
Photo 37 – Spill-through weir (down-slope side) with rock splash pad

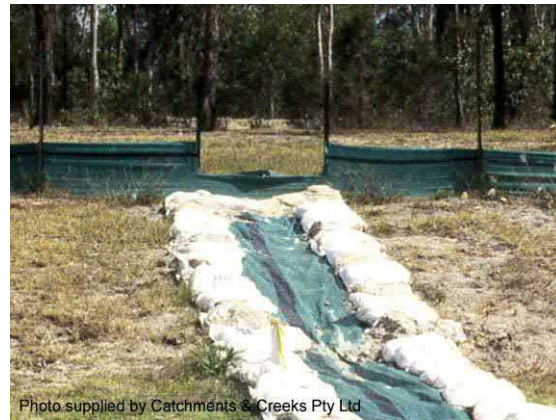
Photo 38 – Spill-through weir with outlet chute

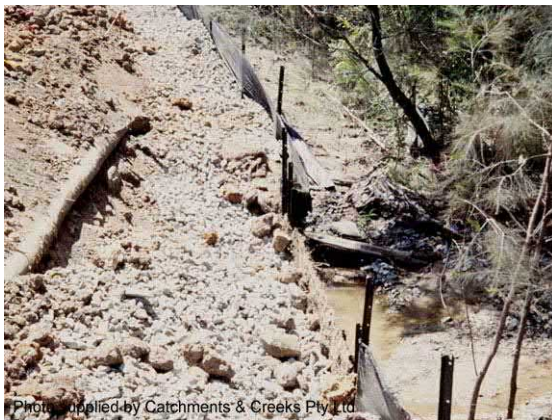
Photo 39 – Spill-through weir with up-slope aggregate filter

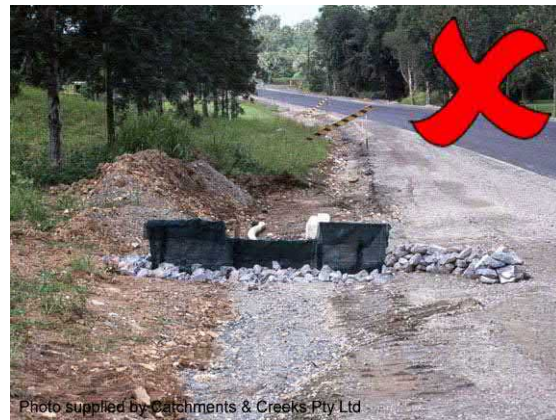
Photo 40 – Inappropriate placement of fence and installation of spill-through weir

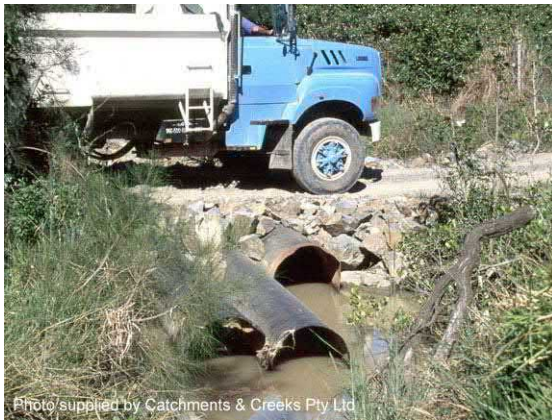
Photo 1 – Temporary culvert formed from recycled steel pipes

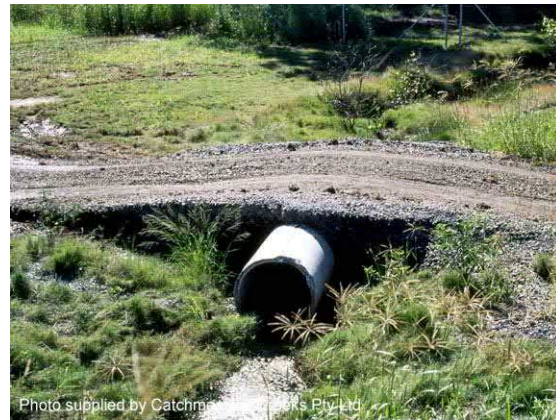
Photo 2 – Temporary crossing of minor drainage channel

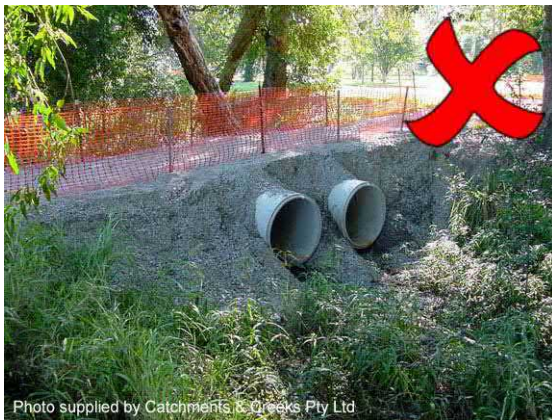
Photo 3 – Using only fine aggregate to form the fill embankment can result in severe wash-outs if overtopped

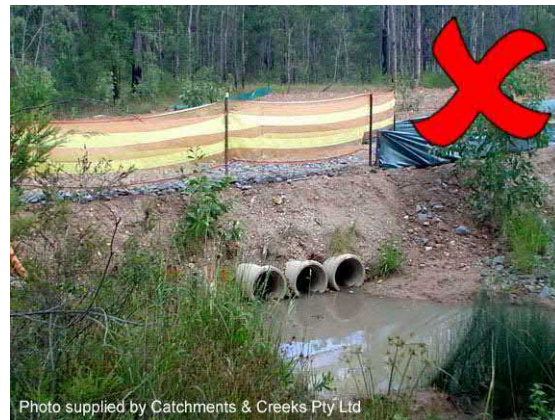
Photo 4 – If the culvert has insufficient hydraulic capacity, then overtopping flows are likely to cause severe bank erosion

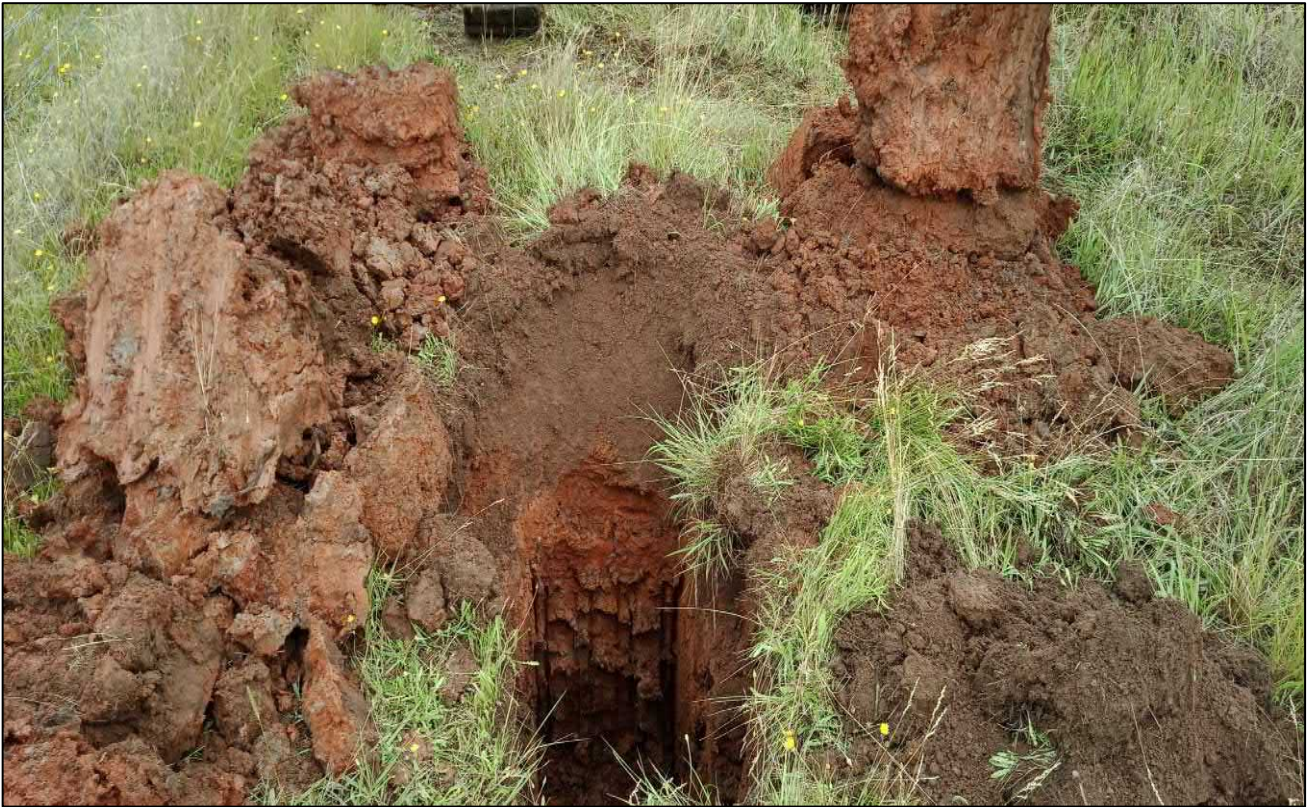
Photograph 1. Soil matrix throughout TP79. Date: 16.12.2021.

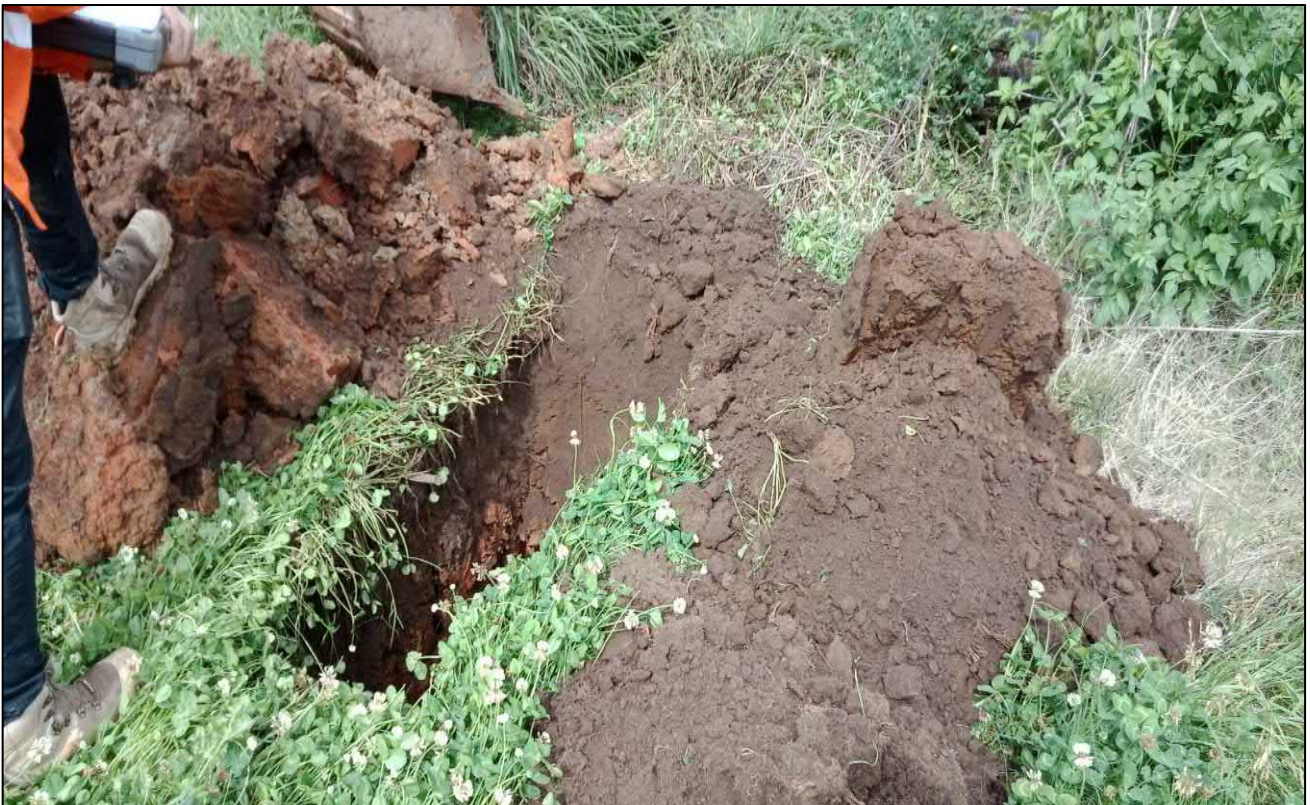
Photograph 2. Soil matrix throughout TP87. Date: 16.12.2021.

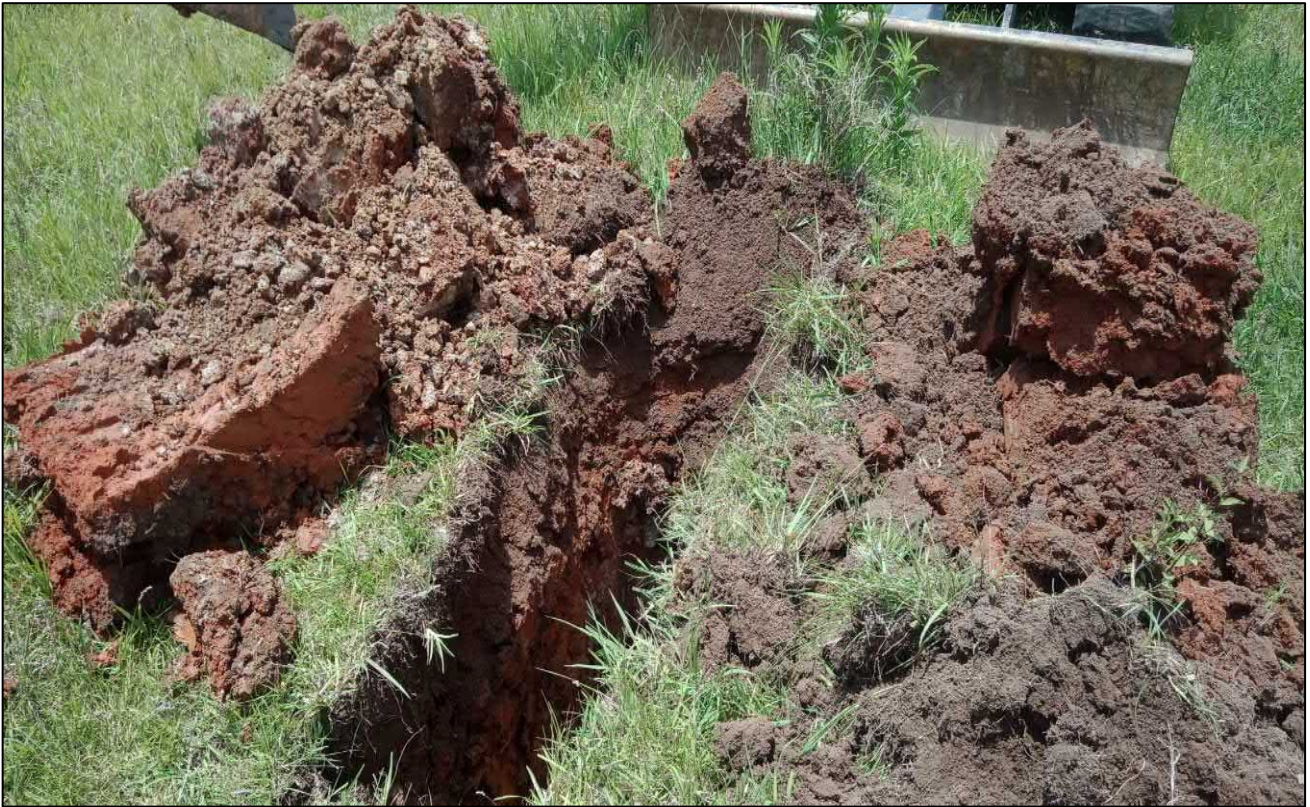
Photograph 3. Soil matrix throughout TP37. Date: 16.12.2021.

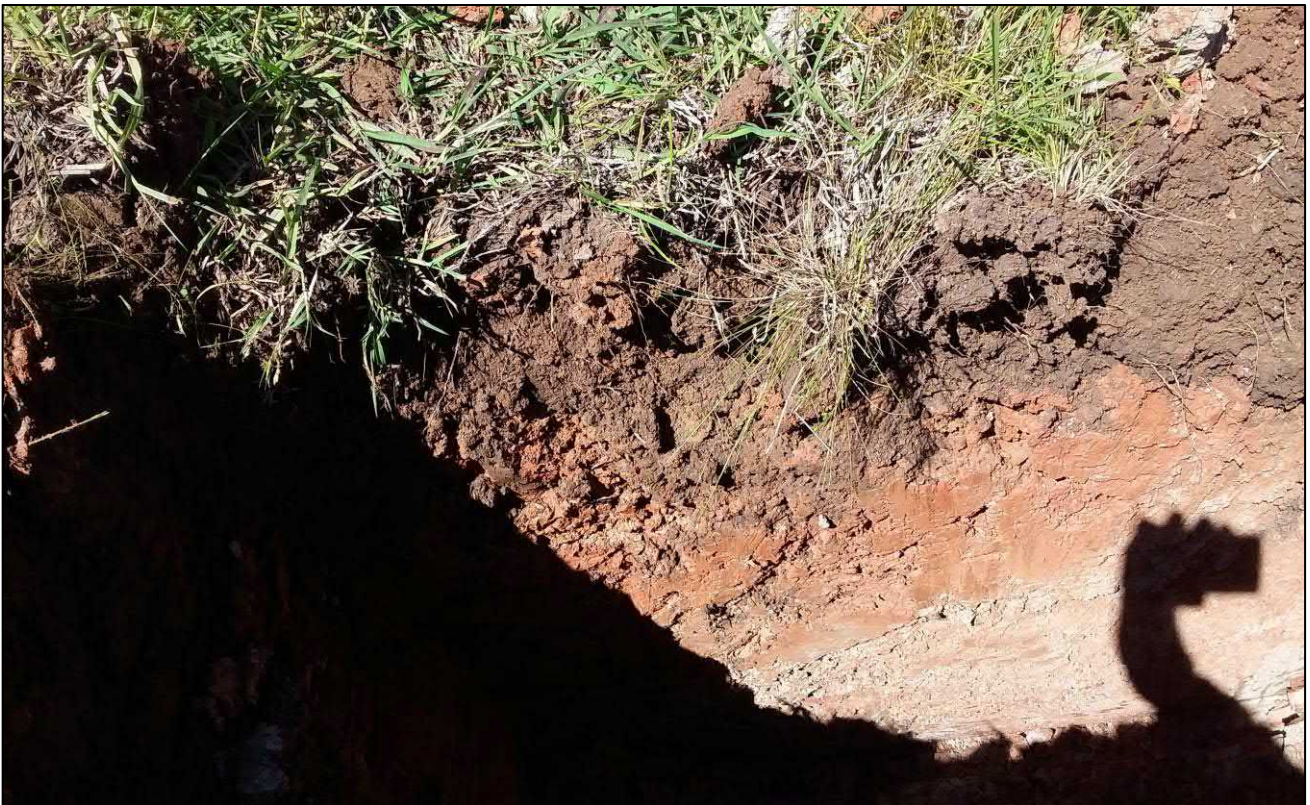
Photograph 4. Soil profile throughout TP62. Date: 15.12.2021.

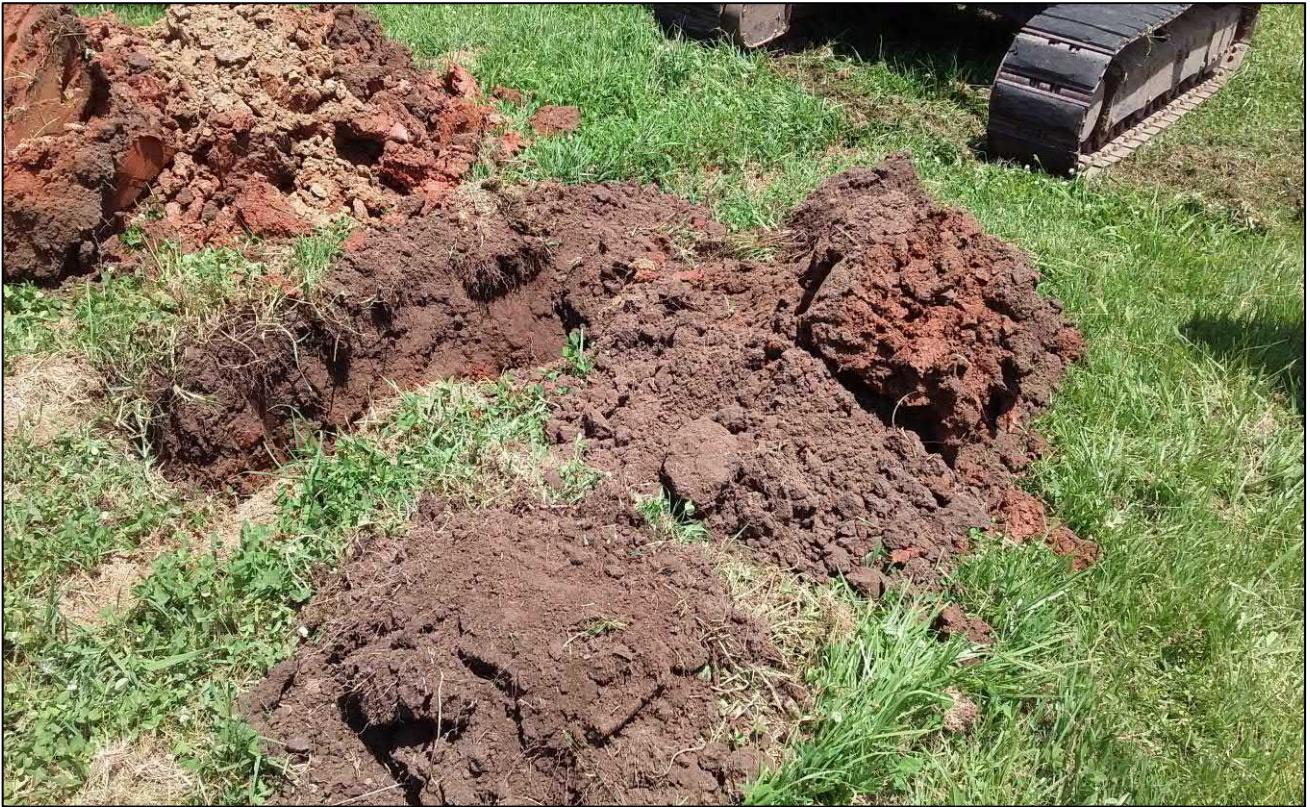
Photograph 5. Soil matrix throughout TP27. Date: 20.12.2021.

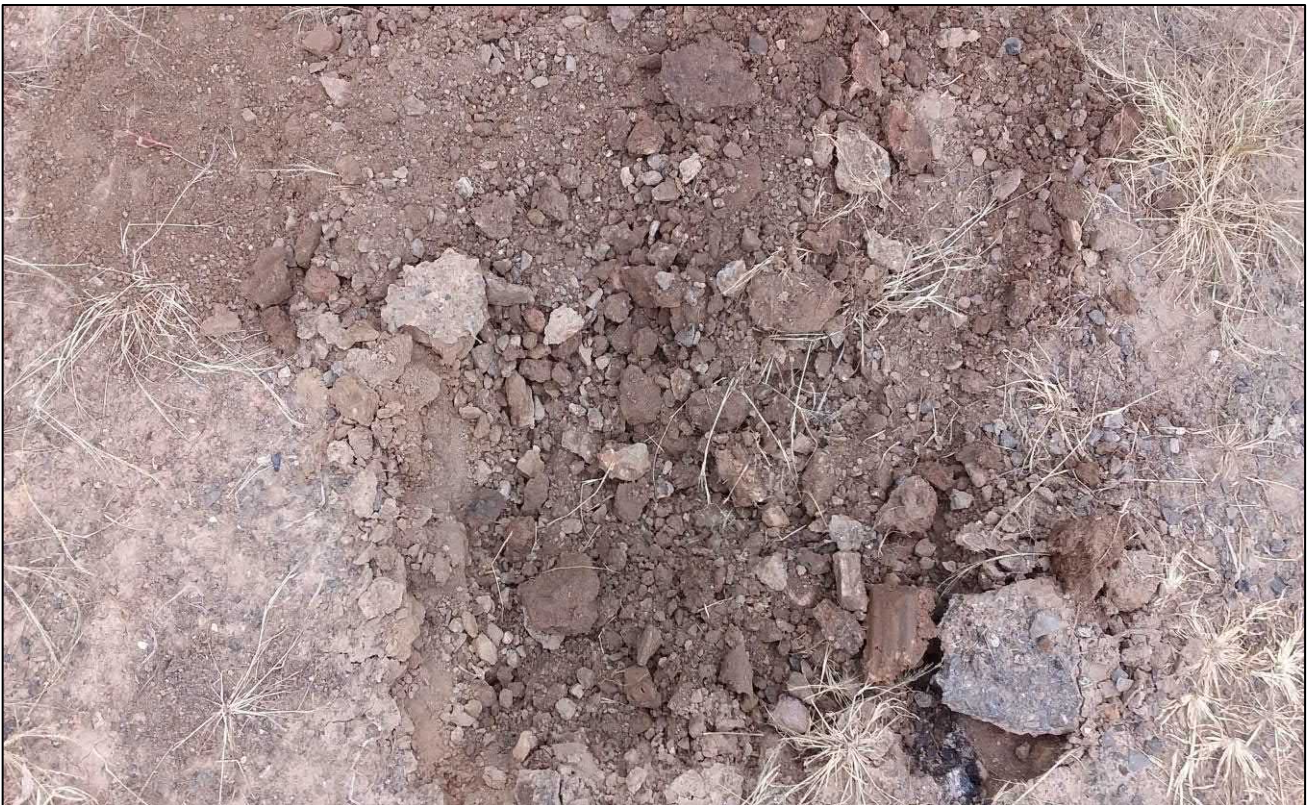
Photograph 6. Fill materials throughout TP49. Date: 20.12.2021.

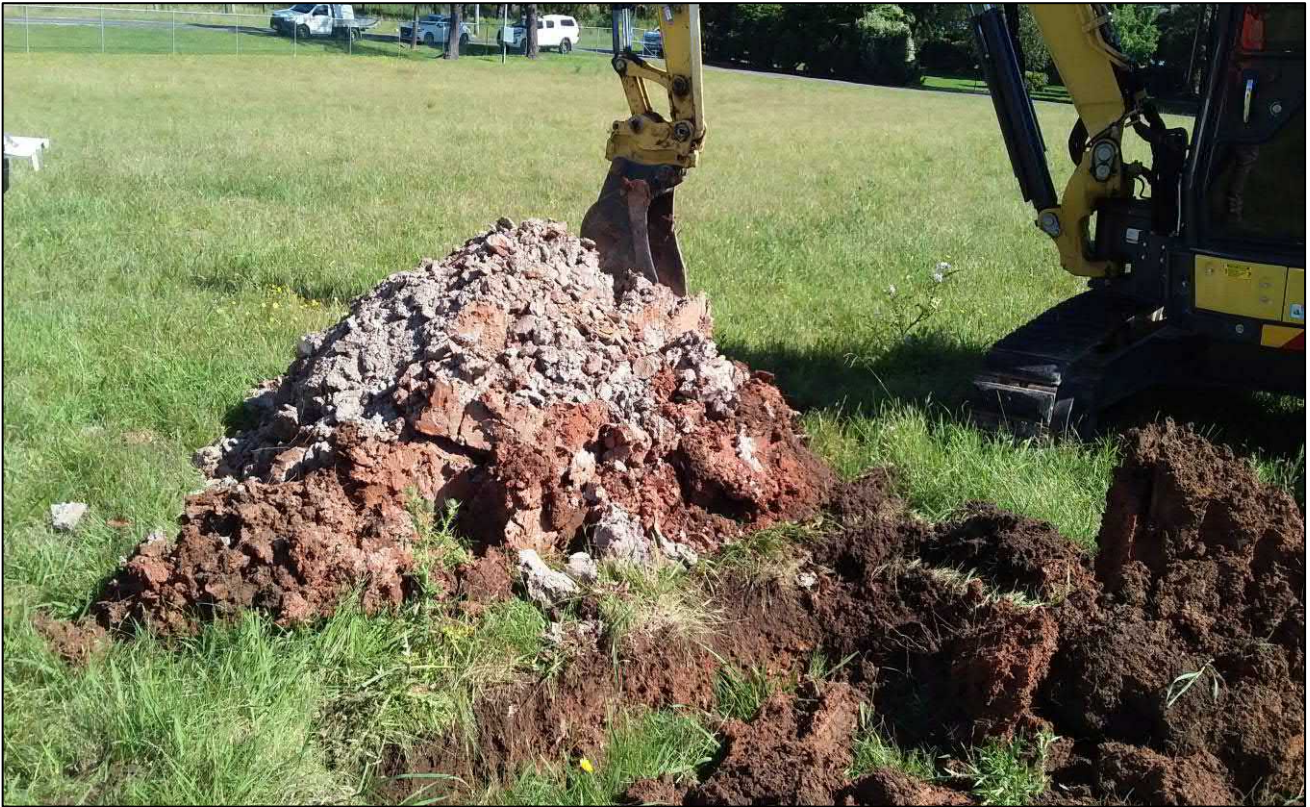
Photograph 7. Soil matrix throughout TP29. Date: 15.12.2021.

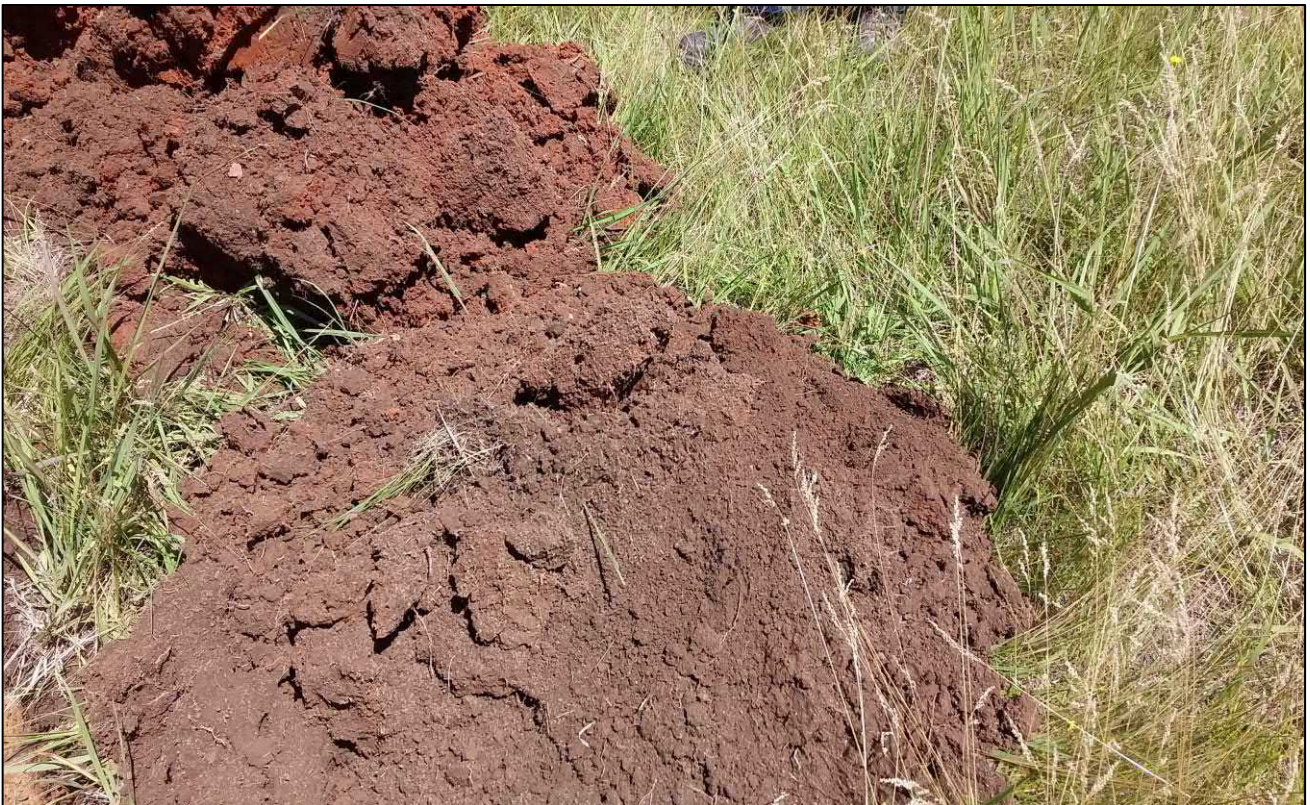
Photograph 8. Fill materials observed at TP65. Date: 15.12.2021.
