Report on  
Preliminary Geotechnical Investigation and  
Preliminary Salinity Assessment

Proposed Commercial/Industrial Subdivision  
144 - 228 Aldington Road, Kemps Creek

Prepared for  
Stockland Commercial Property Pty Ltd

Project 92364.01  
September 2019

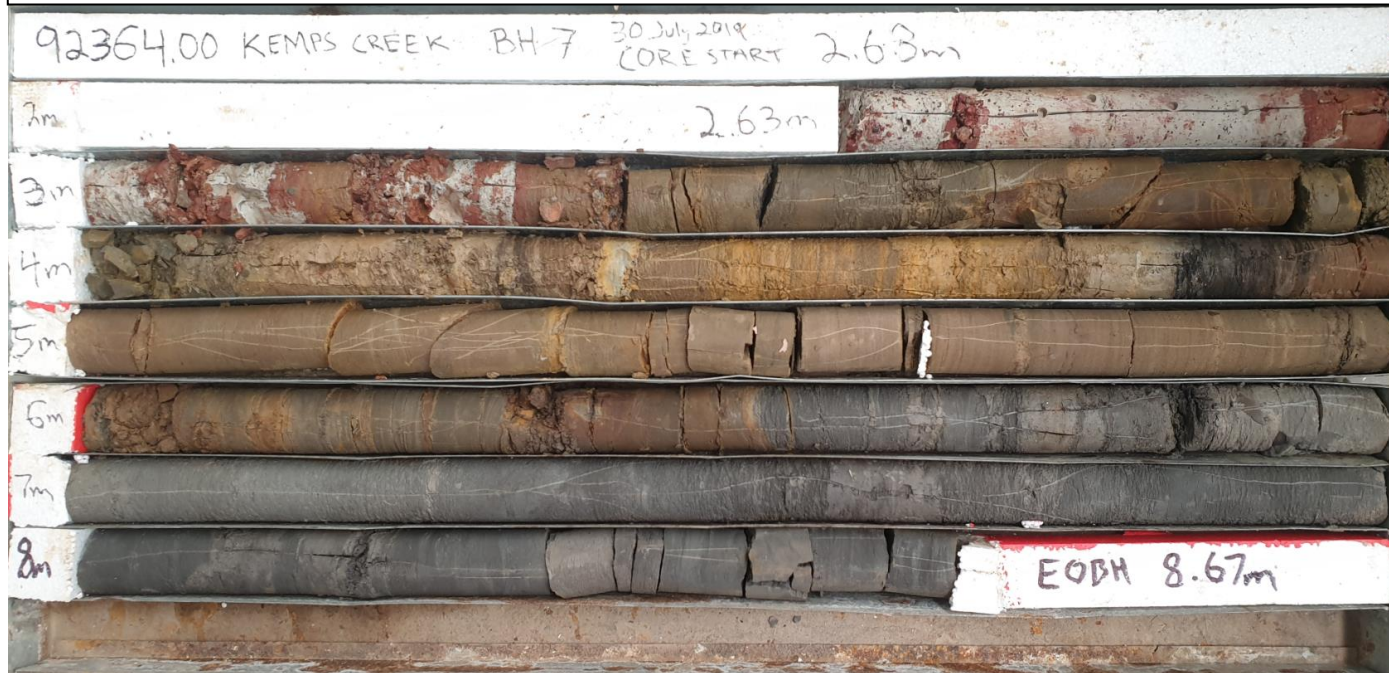
BORE: 7    DEPTH: 2.63 – 8.67 m    PROJECT: 92364.00    JULY 2019

End of Bore at 8.67 m

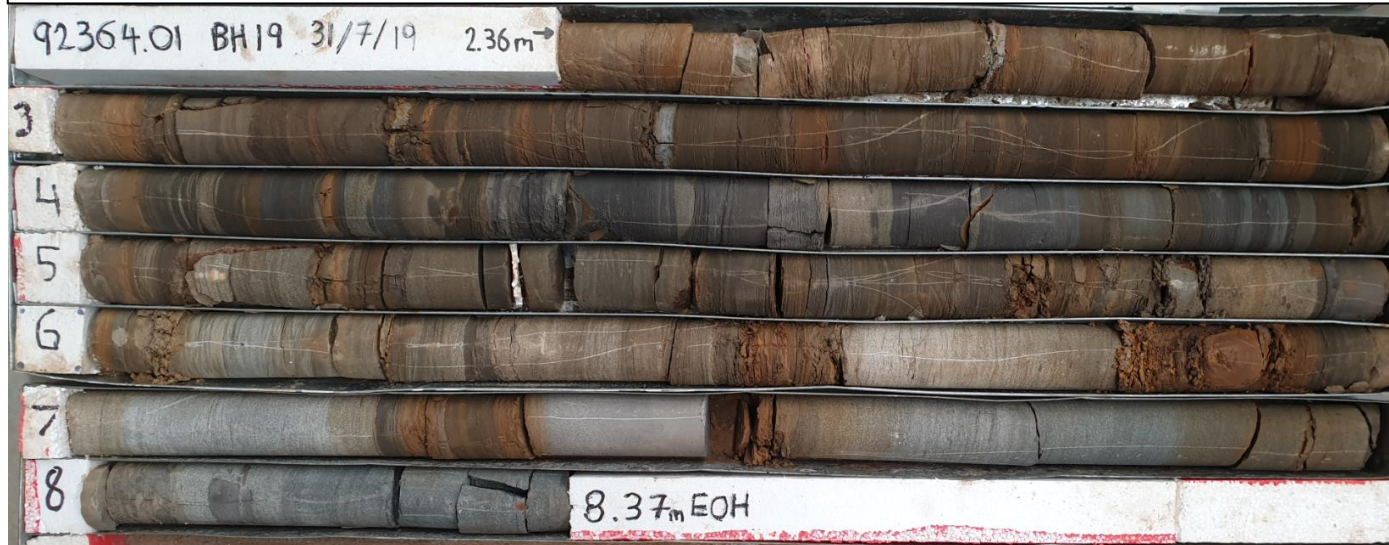
BORE: 19    DEPTH: 2.36 – 8.37 m    PROJECT: 92364.00    JULY 2019

End of Bore at 8.37 m

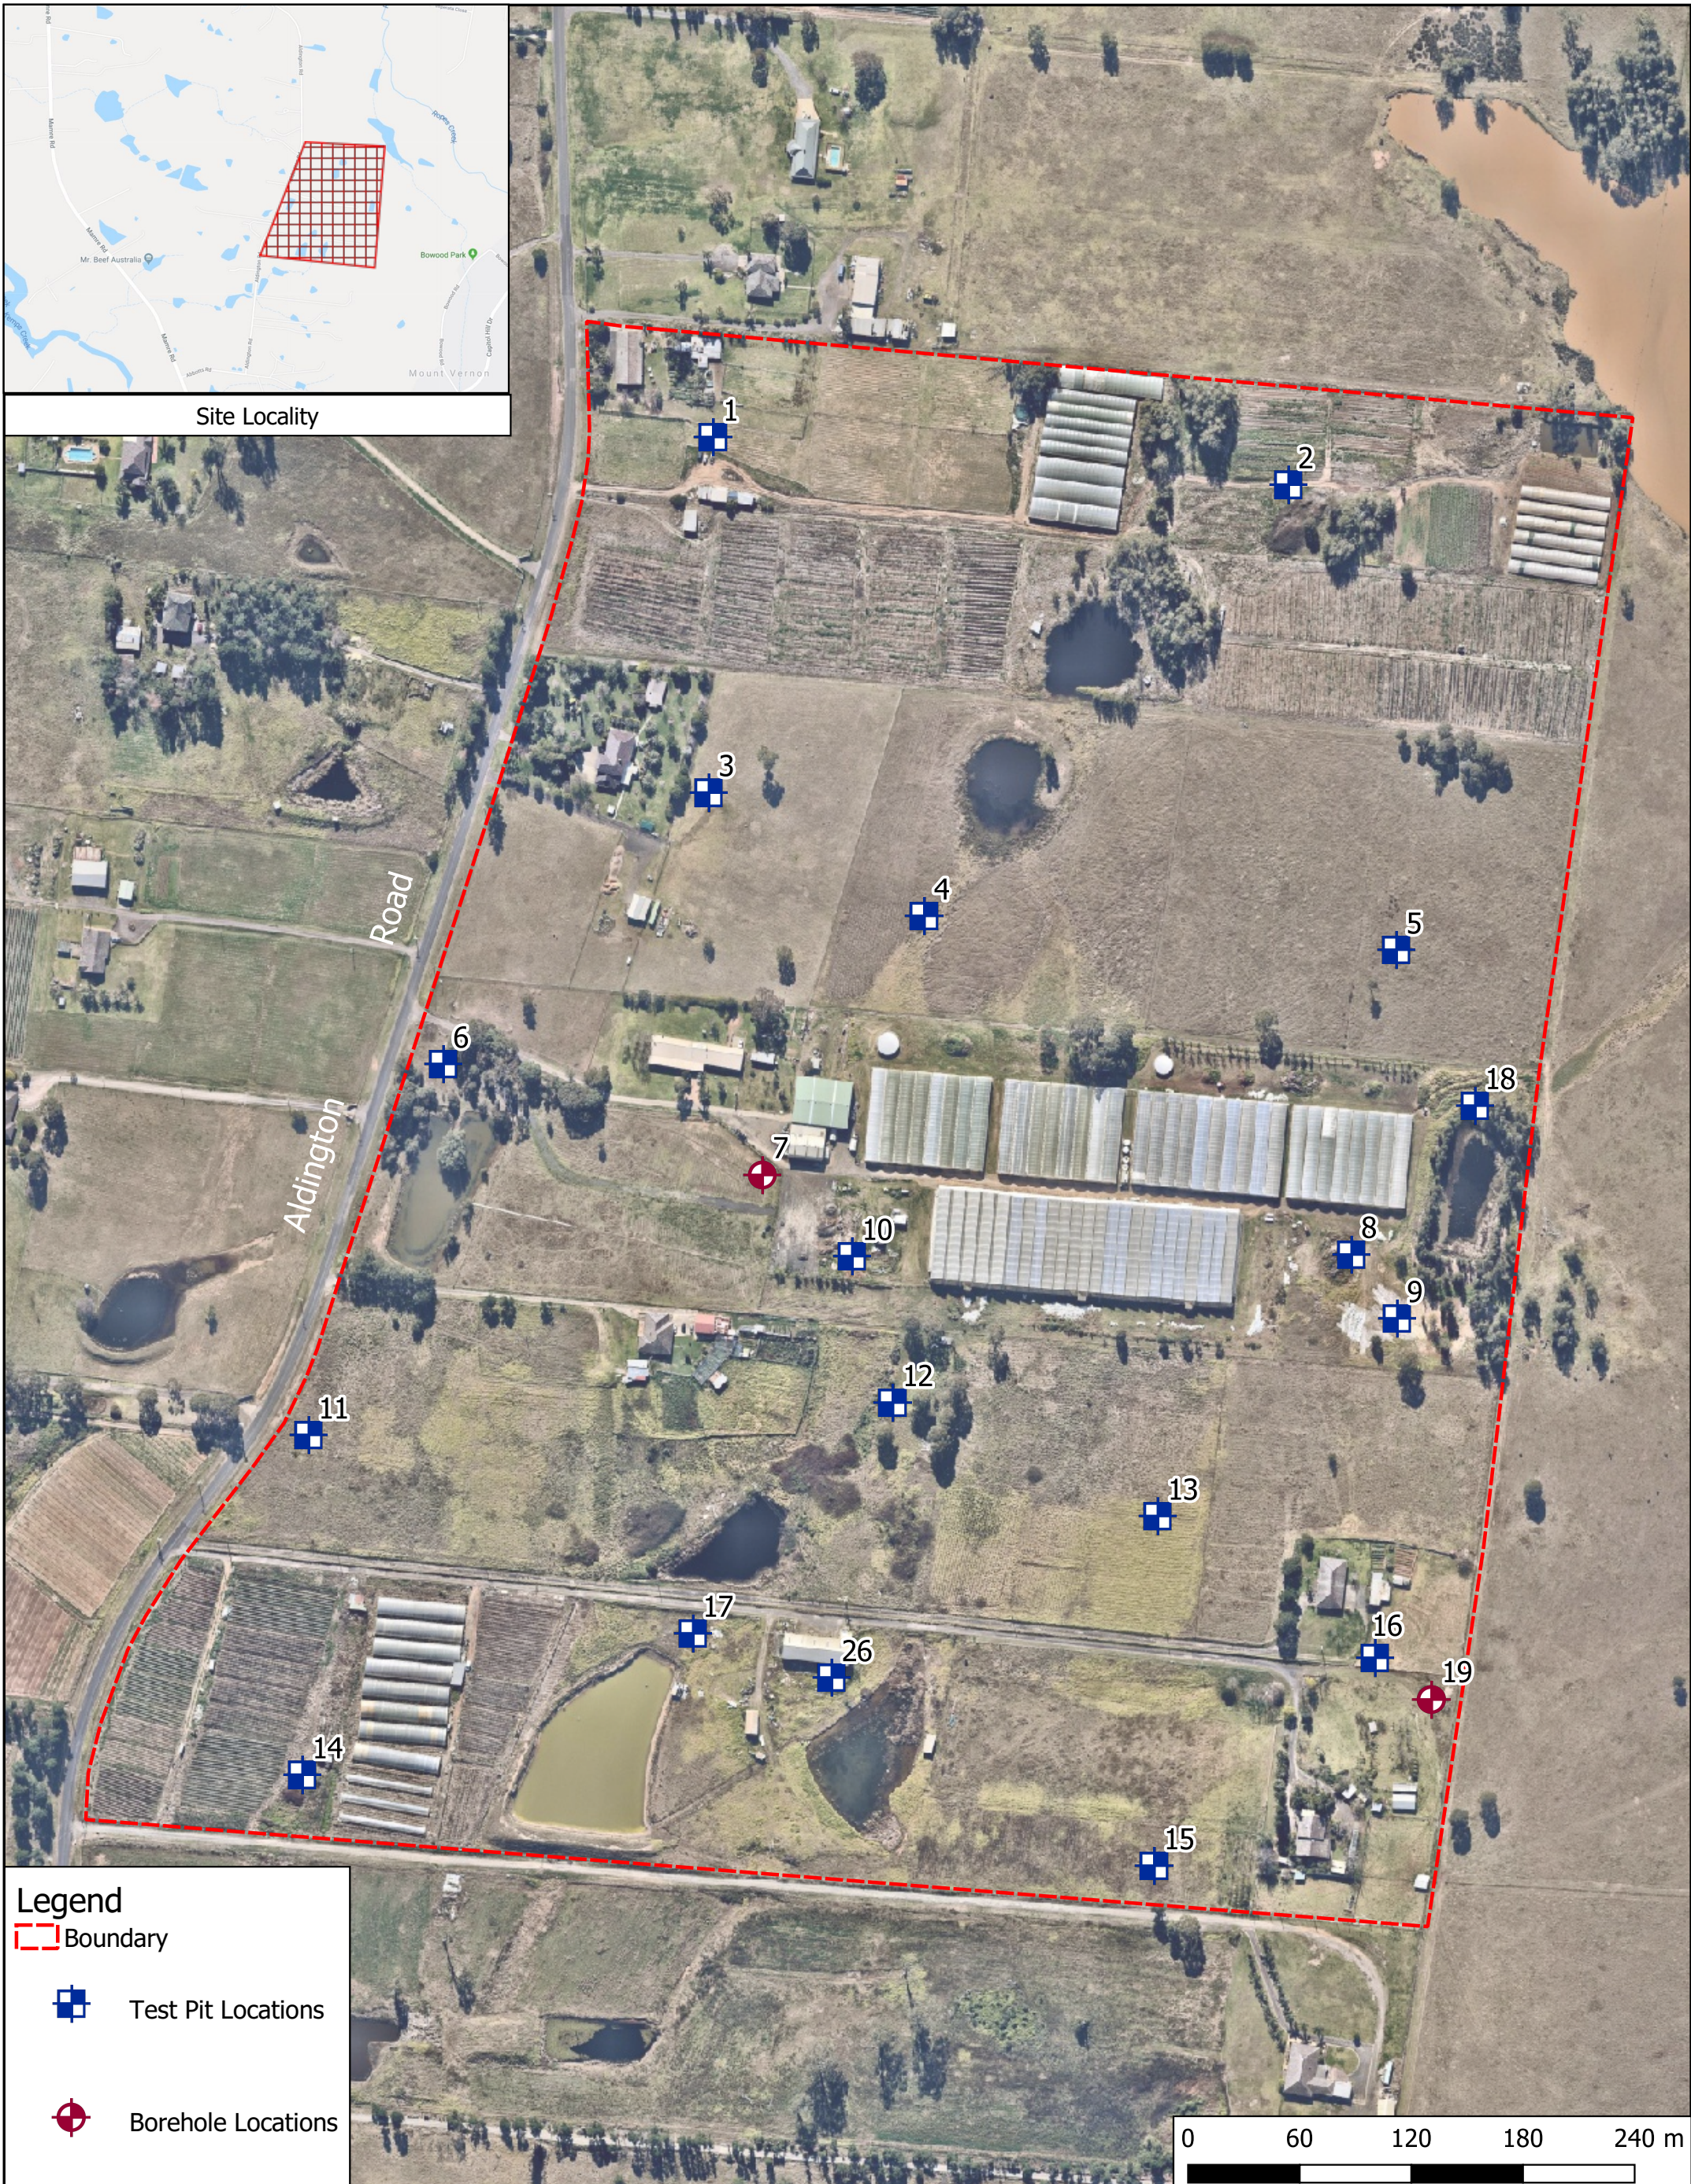
- Boundary
- Test Pit Locations
- Borehole Locations

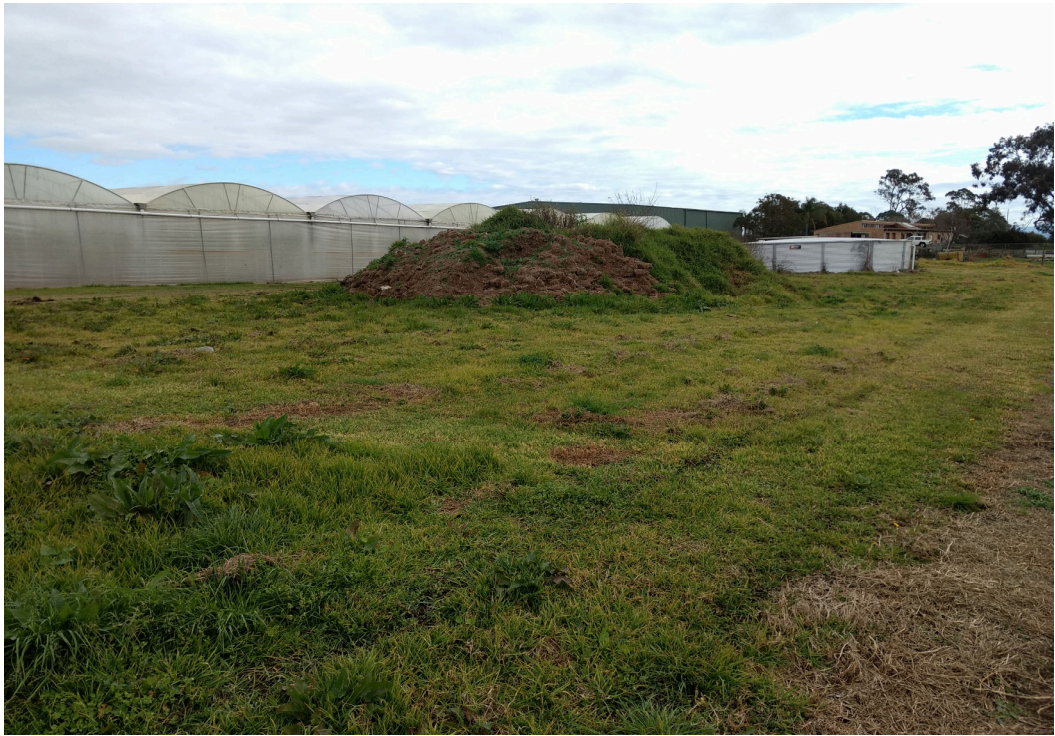
Photograph 3 - Typical topsoil and vegetation stockpile (farm spoil)

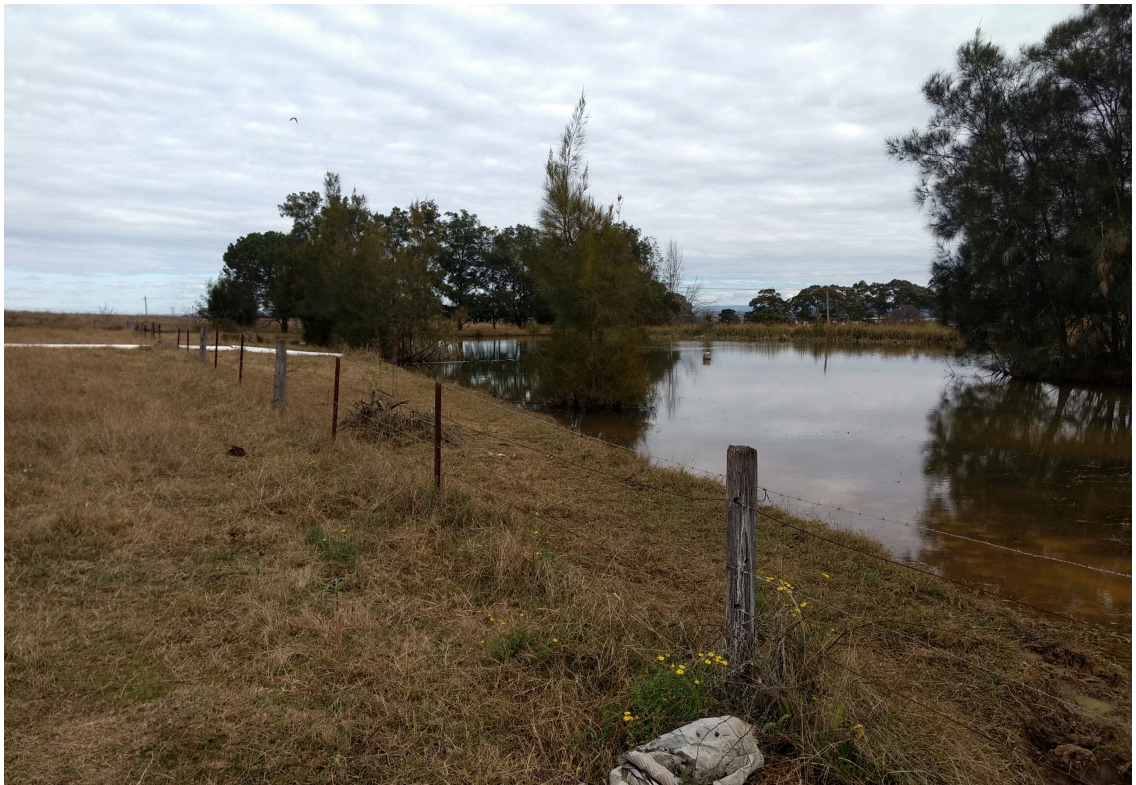
Photograph 4 - Typical farm dam

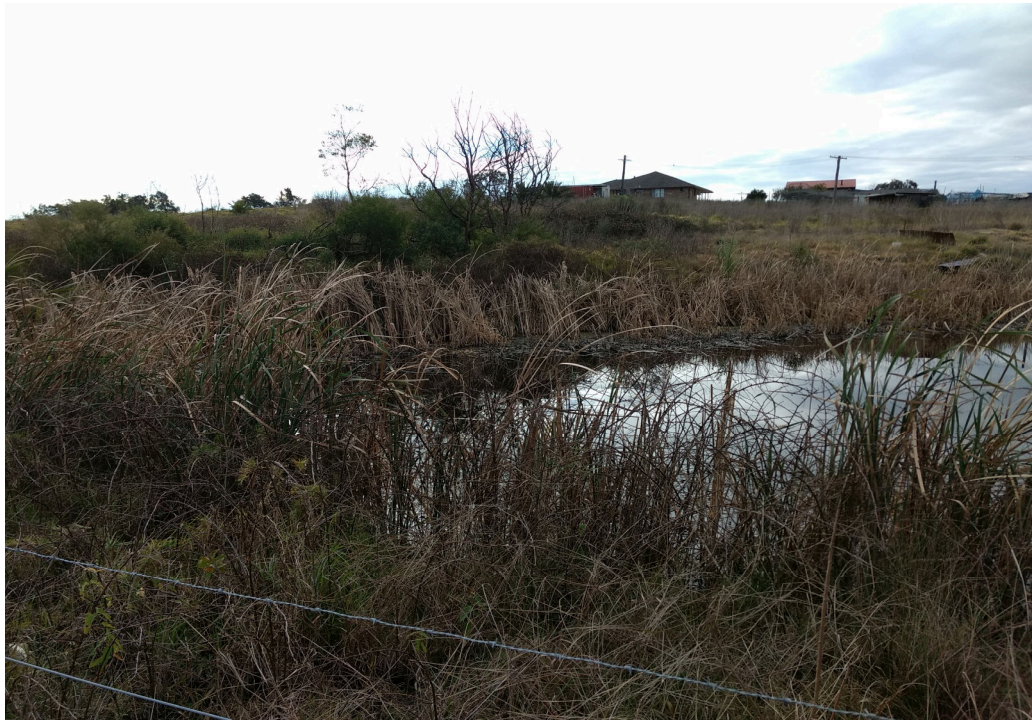
- Two relatively small portions of the site were observed to be affected by water logging (MRPs 6 and 12 and Photo 9). The water logging and heavy vegetation at MRP 12 appeared to be due to a low lying area while the isolated water logging at MRP 6 appeared to be due to runoff from the above greenhouse irrigation.

Photograph 9 - View of heavily vegetated dam in southern portion of site

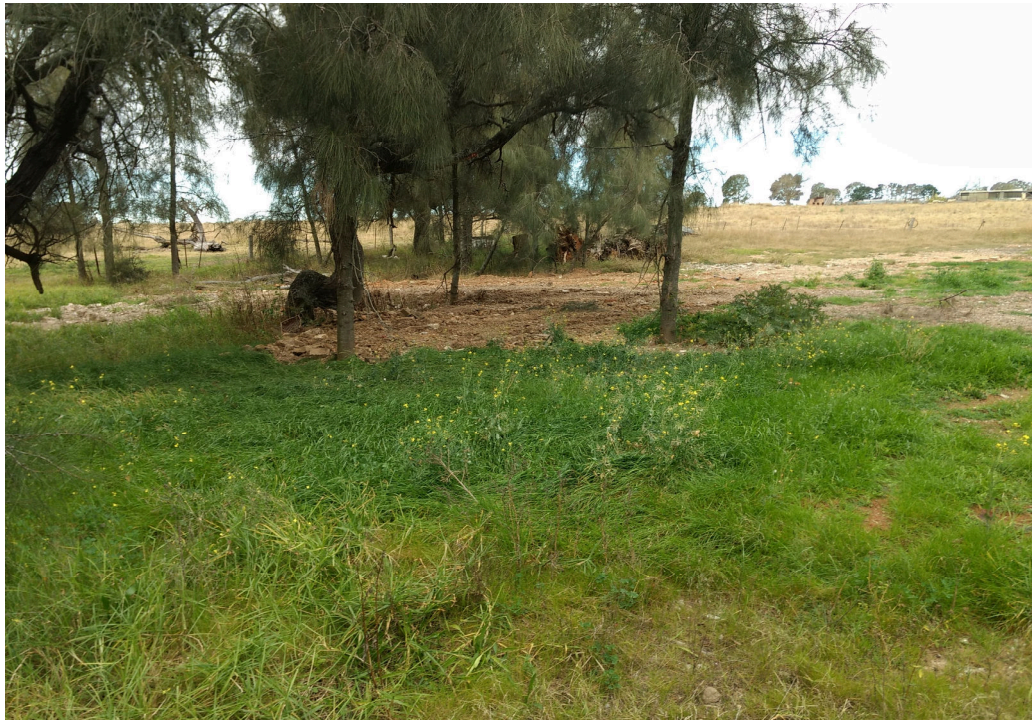
Photograph 11 - Clay, sandstone and shale fill spread across site

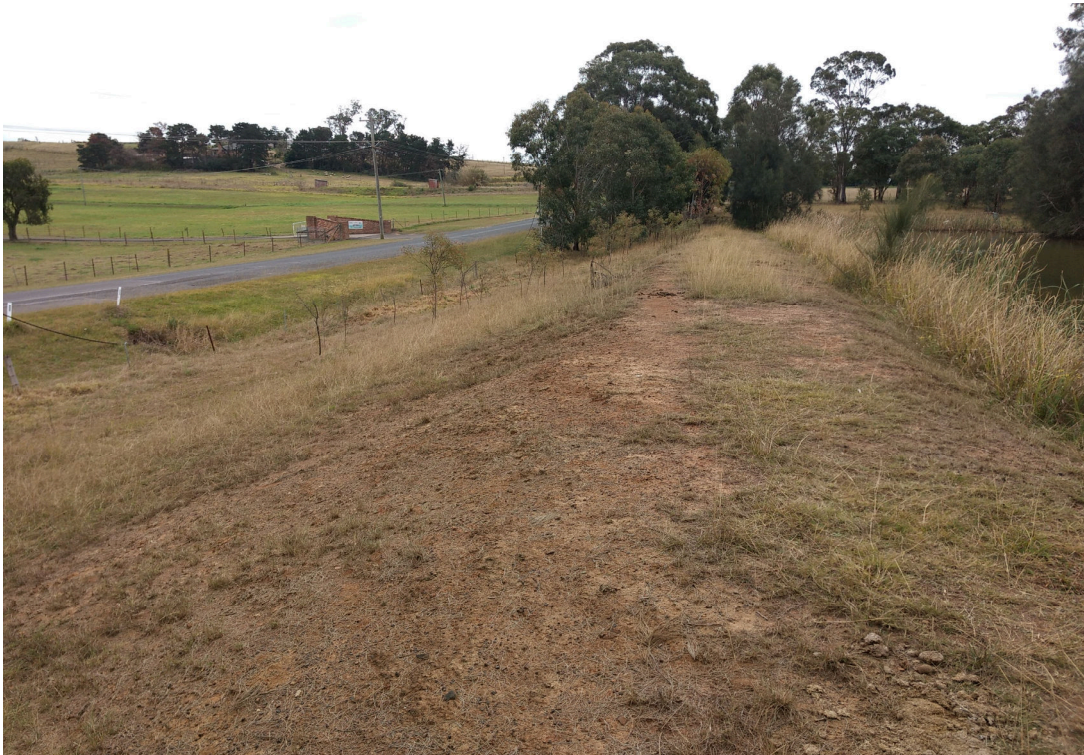
Photograph 12 - Dam embankment along Aldington Road
