## 200 Aldington Road Industrial Estate - Riparian Assessment

**Fife Kemps Creek Trust**

<b>Project Name</b>	200 Aldington Road Kemps Creek Riparian Assessment
<b>Project Number</b>	20SYD-16452
<b>Project Manager</b>	David Bonjer
<b>Prepared by</b>	Claire Wheeler and David Bonjer
<b>Reviewed by</b>	Peter Hancock
<b>Approved by</b>	David Bonjer
<b>Status</b>	Final
<b>Version Number</b>	6
<b>Last saved on</b>	22 June 2022

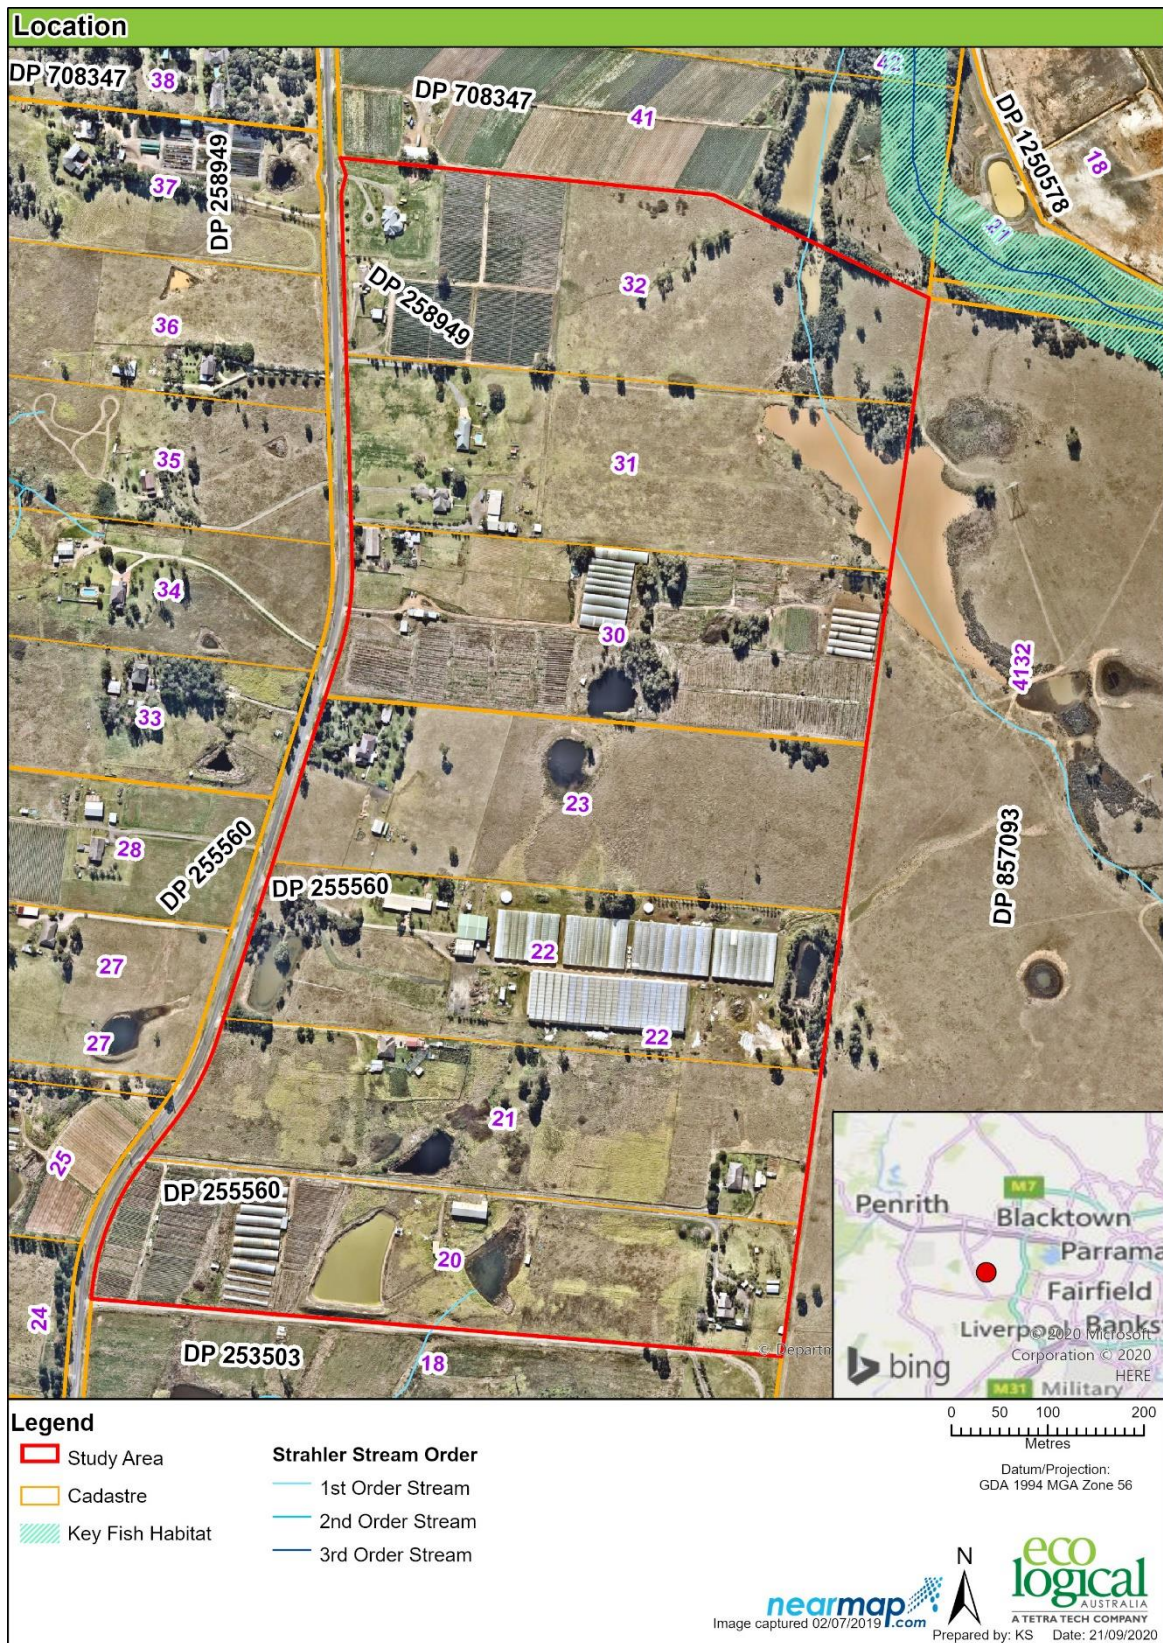
Figure 1: Location map with hydroline and Strahler stream order

DPI mapping showed two unnamed watercourses within the study area (Figure 1); a 1<sup>st</sup> order tributary of Kemps Creek in the south of the site and a 1<sup>st</sup> order tributary of Ropes Creek in the north east of the site.

The Strahler stream order classification was extracted from the DPI Hydroline Spatial Data. A field survey was conducted by ELA Aquatic Ecologist Claire Wheeler on 20 July 2020 to determine if the watercourses on site met the definition of a 'river' under the WM Act and determine the current condition and extent of riparian and aquatic habitat:

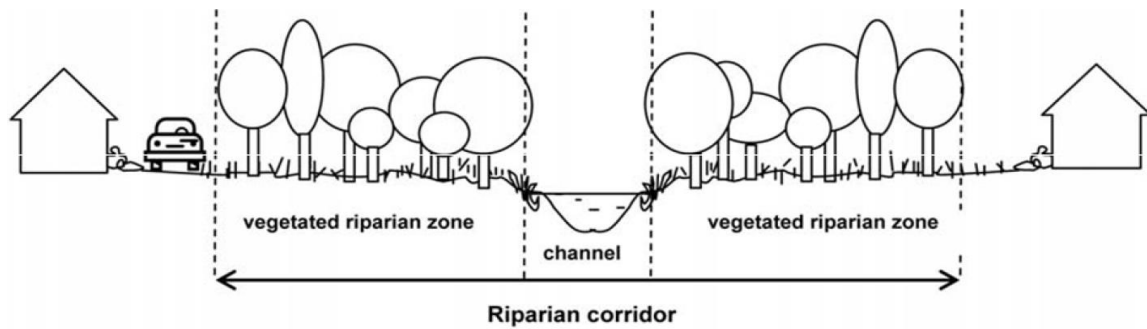
NRAR's *Guidelines for Controlled Activities on waterfront land—Riparian corridors* (NRAR, 2018) outline the need for a Vegetated Riparian Zone (VRZ) adjacent to the channel to provide a transition zone between the terrestrial environment and watercourse. This vegetated zone helps maintain and improve the ecological functions of a watercourse whilst providing habitat for terrestrial flora and fauna. The VRZ plus the channel (bed and banks of the watercourse to the highest bank) constitute the 'riparian corridor' (Figure 2). NRAR recommends a VRZ width based on watercourse order as classified under the Strahler System of ordering watercourses and using Hydroline Spatial Data which is published on the department's website (Table 4).

Figure 2: Vegetated Riparian Zone and watercourse channel comprising the riparian corridor (NRAR, 2018).

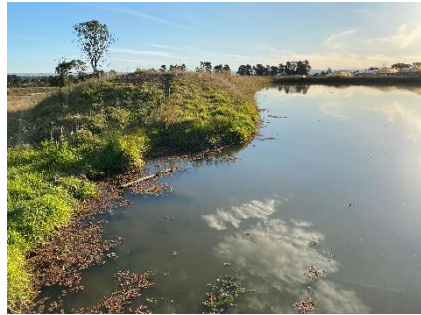
Dam number	Description	Aquatic fauna observed	Aquatic flora observed	Representative photo
1	Dam 1 covered an area of approximately 5,600 m <sup>2</sup> and was surrounded by pasture grasses. There was no fringing vegetation surrounding the dam and the banks of the dam was relatively steep.	No aquatic fauna observed.	Floating macrophytes ( <i>Azolla pinnata</i> ).

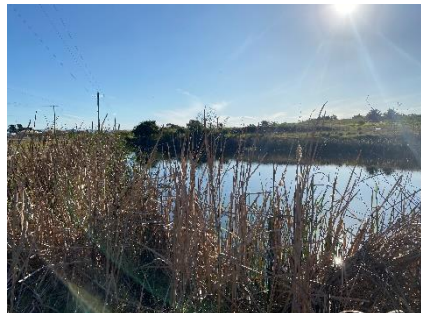
2	Dam 2 covered an area of approximately 2,300 m <sup>2</sup> . No grease, oil or sheen was observed on the water's surface. On the northern and southern sides of the dam, it was fringed with dense <i>Typha orientalis</i> (Cumbungi).	No aquatic fauna observed.	Emergent <i>Typha orientalis</i> plus submerged macrophytes.	 
3	Dam 3 covered an area of approximately 1,700 m <sup>2</sup> . Two thirds of the edge of the dam were covered in dense <i>Typha orientalis</i> with exotic species such as <i>Rubus fruticosus</i> (Blackberry), <i>Cestrum parqui</i> (Green Cestrum) and pasture grasses growing alongside the remaining edge of the dam	No aquatic fauna observed.	<i>Typha orientalis</i> .

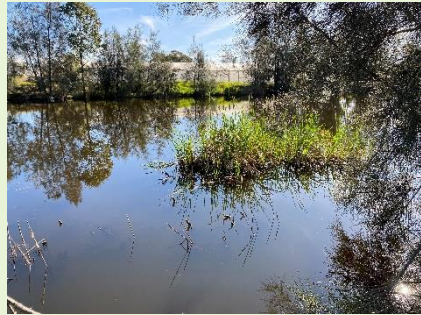
Dam number	Description	Aquatic fauna observed	Aquatic flora observed	Representative photo
4	Dam 4 covered an area of approximately 1,800 m <sup>2</sup> and was actively used for irrigation of nearby vegetable crops. The dam was surrounded on all sides by <i>Casuarina</i> sp. and had some areas of dense <i>Typha orientalis</i> on the southern side of the dam.	No fauna observed.	Emergent macrophytes including <i>Ludwigia peploides</i> (Water Primrose) and <i>Persicaria decipiens</i> (Knotweed) and floating <i>Azolla pinnata</i> .

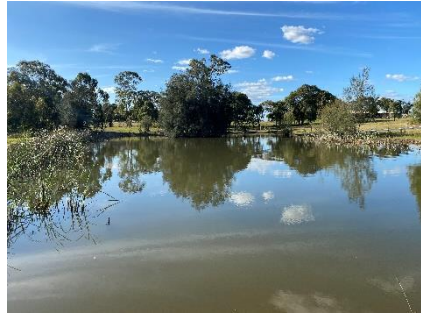
5	Dam 5 covered an area of approximately 1,700 m <sup>2</sup> and was partially surrounded by <i>Casuarina</i> sp. Evidence of soil pugging by stock was seen on the northern side of the dam.	No fauna observed.	Submerged macrophytes in the form of <i>Vallisneria australis</i> (Ribbonweed).

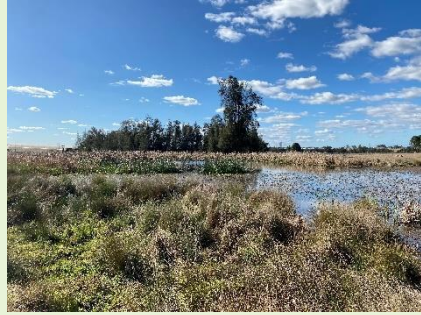
6	Dam 6 covered an area of approximately 875 m <sup>2</sup> and on the southern side of the dam there was a large area of <i>Juncus</i> sp. where it appeared that the area was constantly damp and supported the growth of these species.	Eurasian Coots and frogs could be heard calling.	<i>Ludwigia peploides</i> and <i>Eleocharis sphacelata</i> within the dam.

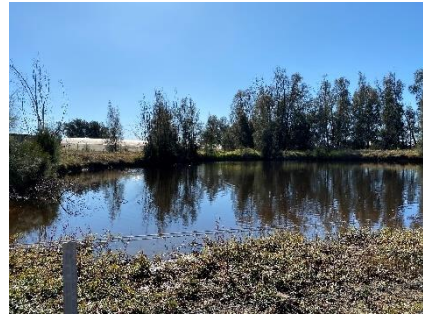
Dam number	Description	Aquatic fauna observed	Aquatic flora observed	Representative photo
7	Dam 7 covered an area of approximately 1,700 m <sup>2</sup> . The dam was located approximately 100 m downstream of dam 6, however there was no defined channel observed between these two dams.	Frogs heard calling.	<i>Persicaria decipiens</i> .

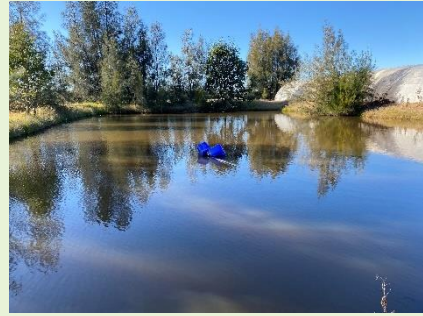
8	Dam 8 covered an area of approximately 650 m <sup>2</sup> . There were a few <i>Eucalyptus</i> sp. on the edge of the dam however it was predominantly surrounded by exotic vegetation including <i>Rubus fruticosus</i> , <i>Senecio madagascariensis</i> and pasture grasses.	Pied cormorant.	No aquatic flora observed.

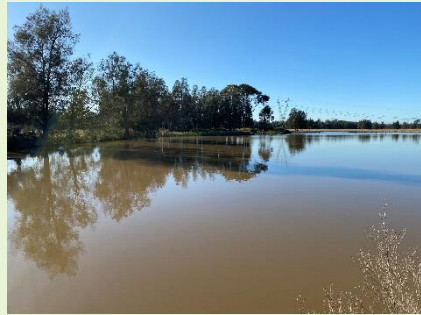
Dam number	Description	Aquatic fauna observed	Aquatic flora observed	Representative photo
10	Dam 10 covered an area of approximately 7,800 m <sup>2</sup> . Erosion was observed on some parts of the bank of the north western side of the dam and there was little shrub or canopy vegetation surrounding the dam that would provide bank stability.	No aquatic fauna observed	<i>Typha orientalis</i> , <i>Lemna</i> sp. and <i>Ludwigia peploides</i> on the edges of the dam.

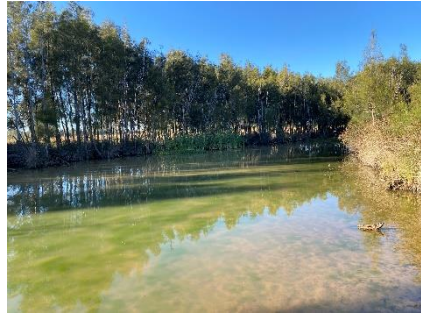
11	Dam 11 covered an area of approximately 3,750 m <sup>2</sup> . The dam was surrounded by a narrow-vegetated buffer of <i>Casuarina</i> sp., with <i>Juncus acutus</i> and <i>Typha orientalis</i> . Woody debris within the waterbody was present and some of the <i>Casuarina</i> sp. on the edge of the waterbody had roots exposed above the water level and undercut in some areas, which would provide good refuge for aquatic fauna.	Long finned eel.	<i>Typha orientalis</i> in the middle of the dam

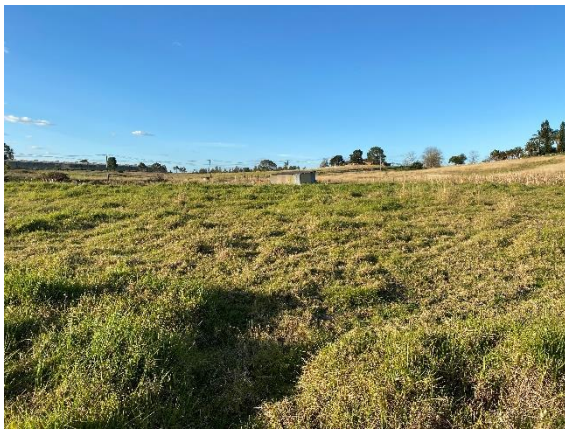
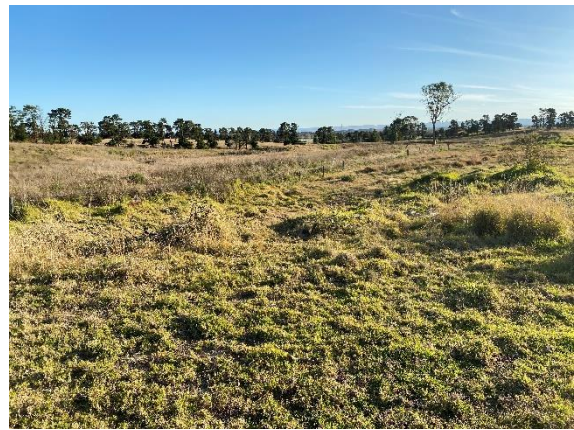
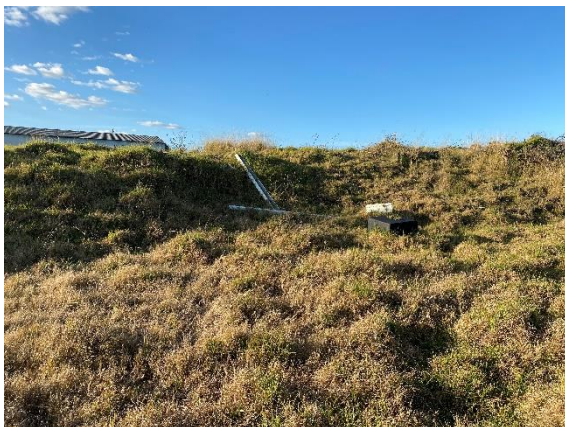
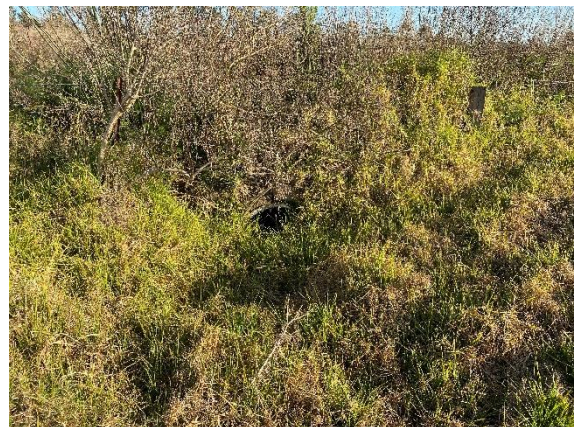
The site inspection identified that there was no defined channel downstream of Dam 2 in the location where a watercourse was mapped on the hydroline dataset. There was an overland flow path that had been channelled towards Dam 1 through a section of concrete pipe. Downstream of the dam there was dense pasture grasses but no defined bed or bank or evidence of geomorphic processes such as erosion and deposition (Figure 5 to Figure 8). A pipe was observed at the southern boundary of the SSD area (Figure 8) to channel the flow into the property to the south. The mapped watercourse within the south of the site does not meet the definition of a 'river' under the WM Act.

**Figure 5: Upstream extent of mapped Kemps Creek tributary, looking north east**

**Figure 6: Upstream extent of mapped Kemps Creek tributary, looking south west**

**Figure 7: Downstream extent of mapped Kemps Creek tributary, looking north east**

**Figure 8: Downstream extent of mapped Kemps Creek tributary, looking south west.**

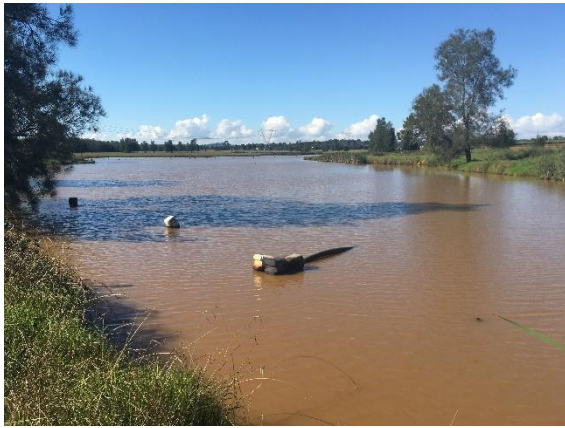
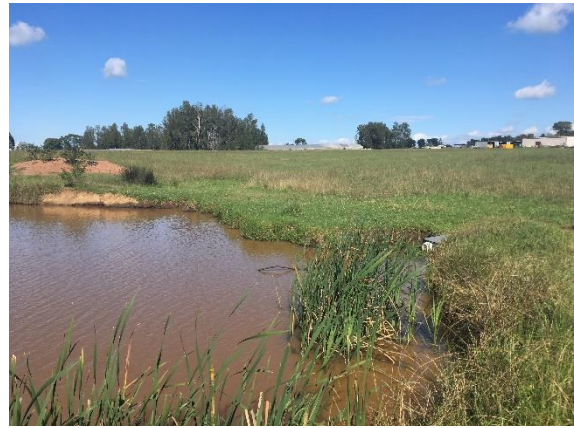
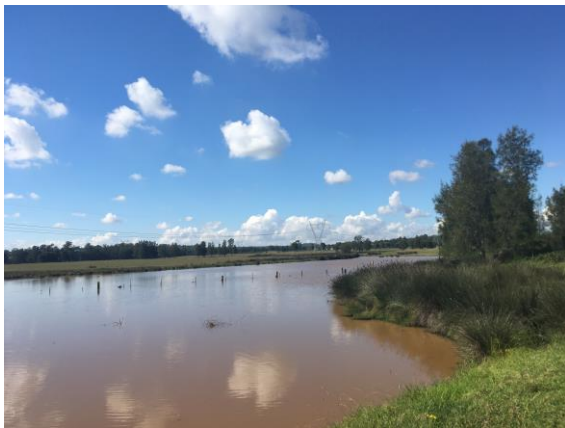
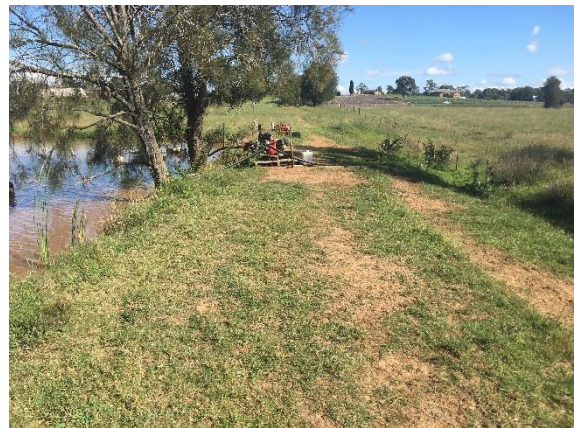
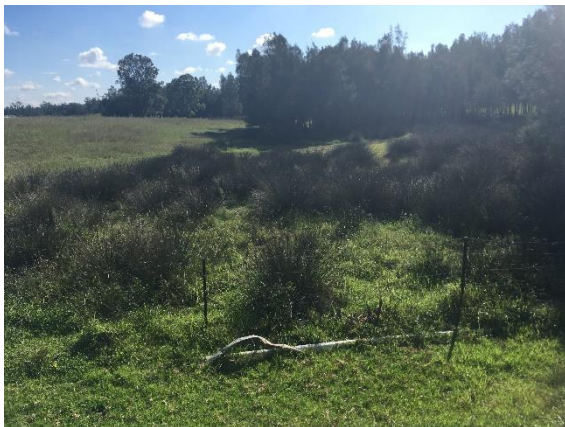
The mapped watercourse within the north east area of the site is located through Dams 10 and 11. Although this is a highly modified system, water flowing out of Dam 10 would flow to Dam 11. This area is shown in Figure 9 to Figure 15.

**Figure 9: Dam 10, looking south east**

**Figure 10: Dam 10, looking south**

**Figure 11: Boundary fence in between Dams 9 and 10, looking south east**

**Figure 12: Top of dam wall on northern side of Dam 10, looking west.**

**Figure 13: No defined channel between Dam 9 and 10, looking north.**

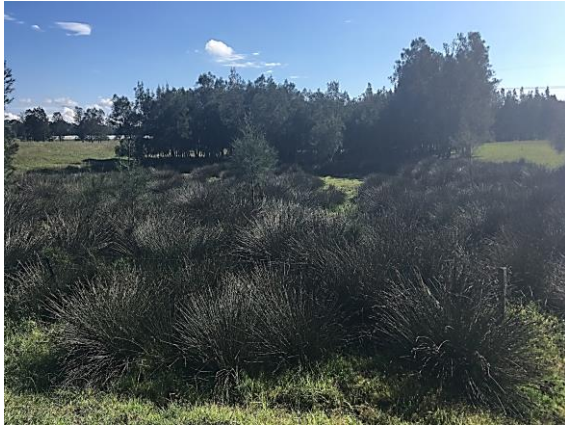
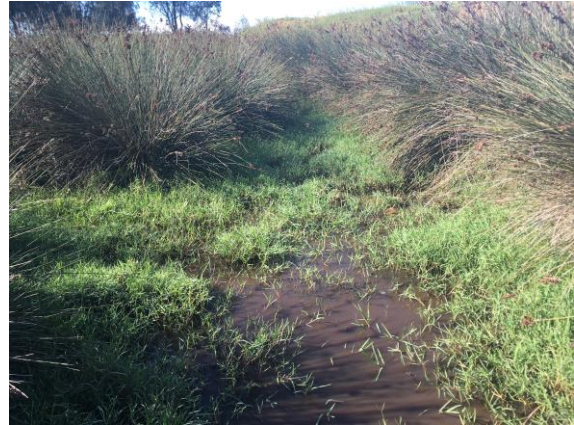
On the downstream side of Dam 11, it was evident that a channel had been blocked at some point to create a dam, however the dam now resembled a wetland environment. There is unlikely to be any low flows moving through this section of watercourse other than in high flow events. Immediately upstream of Dam 11 was a damp area that would be inundated following heavy rain. There were small isolated

pools of water within this area in amongst the dense *Juncus acutus* (Figure 14 and Figure 15) and evidence of pugging from cattle.

**Figure 14:** Area between upstream of Dam 11 and northern side of Dam 10, looking north

**Figure 15:** Isolated pools of water between Dams 10 and Dam 11, looking south
