Salinity, Aggressivity, and Sodicity Assessment

200 Aldington Road, Kemps Creek NSW

Prepared for: Fife Kemps Creek Limited

21.1994 | SASA1.v2f | Date: 23 March 2022

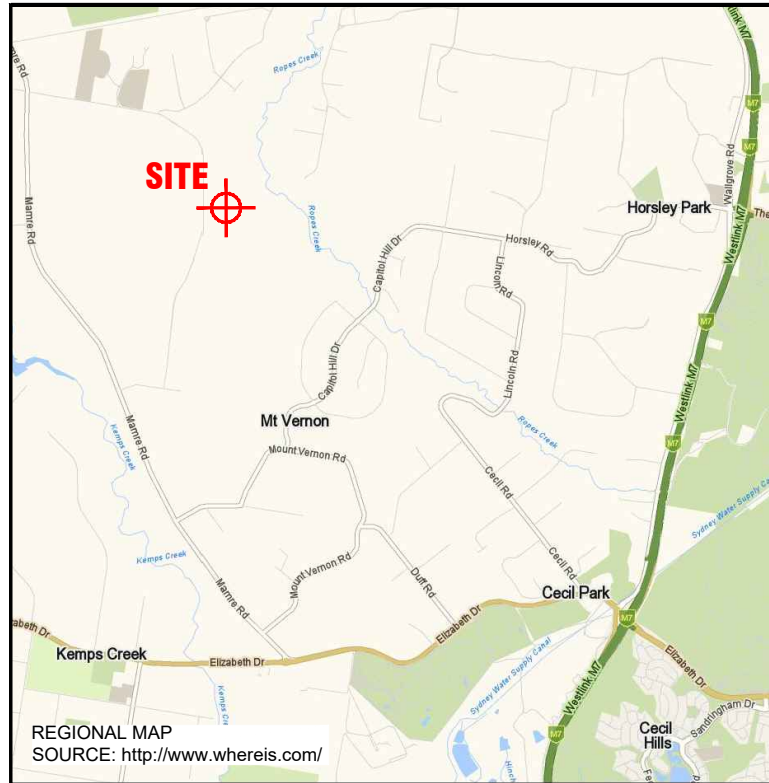
drawn	MC	client: FIFE CAPITAL	
approved	HN	project: DETAILED SITE INVESTIGATION LOT 20-32 ALDINGTON ROAD KEMPS CREEK, NSW	
date	19/01/2022	title: SAMPLE LOCATION AND SITE LOCATION PLAN	
scale	AS SHOWN	project no: 21.1994_DSI	figure no: FIGURE 3
original size	A3	rev: A

- SUBJECT AREA
- TP TEST PIT LOCATION

Soil samples collected by ADE between the 15th of December and 20th of December 2021 for analysis of pH, EC, Sulfates, Chlorides, Sodium, CEC and Clay were submitted to Eurofins Environment Testing in Lane Cove West. A summary of the samples collected by ADE and Douglas Partners (2019) are presented in **Table 3** on the following page (Refer to *Appendix A – Figures* for sample locations).
