ABORIGINAL CULTURAL HERITAGE ASSESSMENT REPORT

BOWMANS CREEK WINDFARM

BOWMANS CREEK, NSW

FEBRUARY 2022

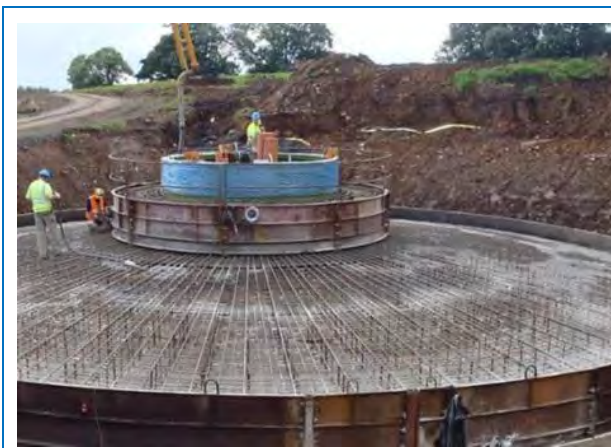
Figure 1-7: View of wind turbine transport and construction (various sources).

1. A view of impacts associated with the construction of turbine foundations (Photo source: Engineers Australia: *Design and Construction. Aspects of Foundations for Onshore Wind Turbines*).

The turbine maximum height (blade tip height) will be 220 m. Turbine foundation construction causes high, localised impacts. To assist with the visualisation of the degree of impact associated with transporting turbines to their location and the construction of the turbines themselves, a number of indicative photos are included on **Figure 1-7**. These photos indicate that most of the Survey Boundary surrounding turbine locations could be impacted to some degree, either from the excavation of turbine foundations, or from impacts associated with soil stockpiles, material laydown and construction vehicle use.

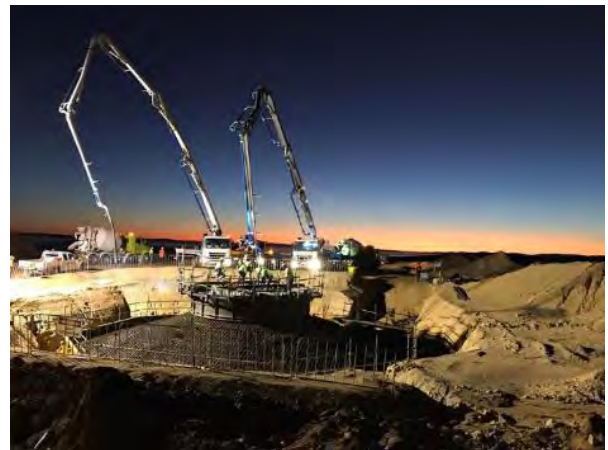
2. Construction of the turbine foundations involves a localised impact including the area of foundations, as well as soil stockpiles and construction vehicle parking areas (photo source: Vestas, Collector Wind Farm, NSW).

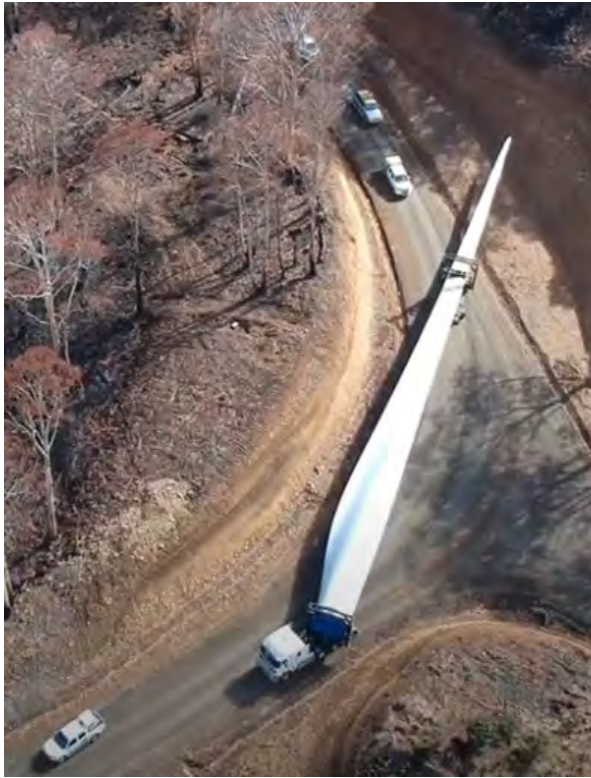
3. Transporting the turbine elements requires substantial access tracks given the length of the components being transported (photo source: Goldwind. Cattle Hill Wind Farm, Tasmania).

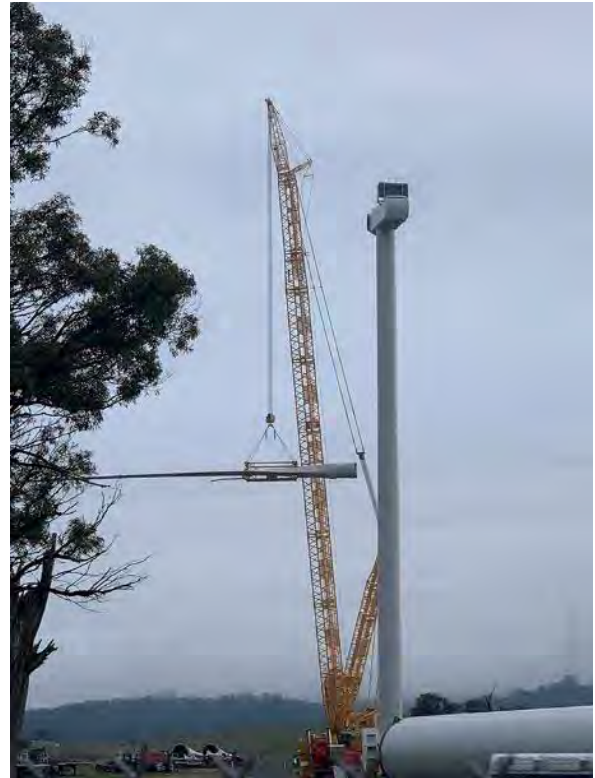
4. A view of the blades being attached to the turbine hub. Note the area needed for material laydown and construction vehicle, such as the crane, and parking (photo source: Vestas, Collector Wind Farm, NSW).

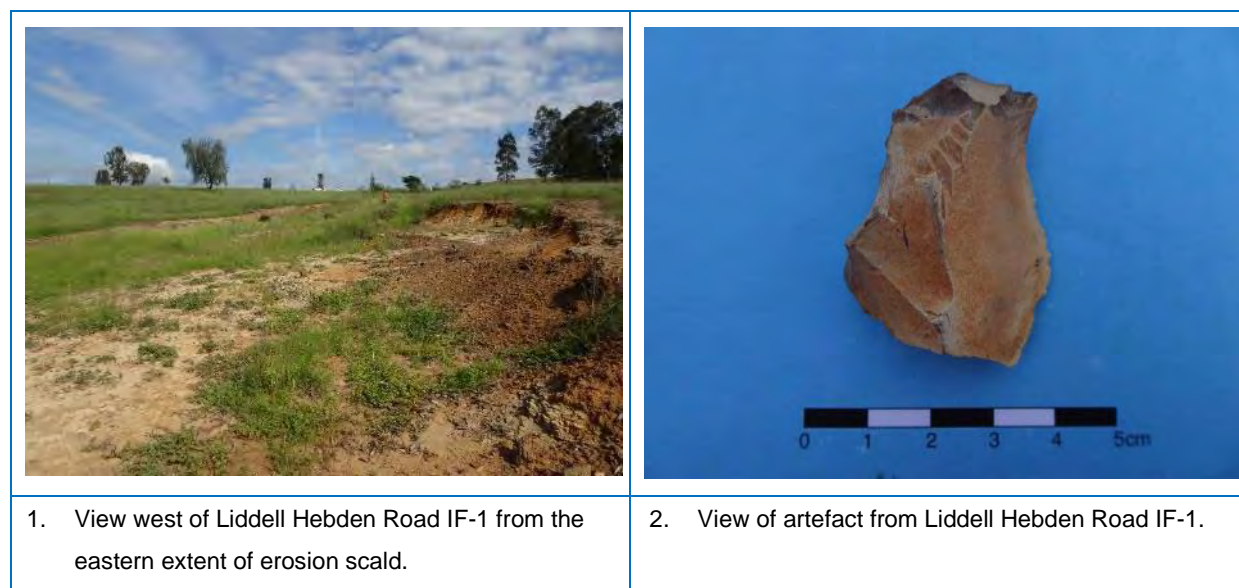
Figure 6-6: Liddell Hebden Road IF-1. View of site and selection of recorded artefacts.

Artefact ID	Art. Type	Material	Integrity	Reduction	Length x width x thickness (mm) or size class
1	Flake	Tuff	Proximal Fragment	Secondary	40x30x15

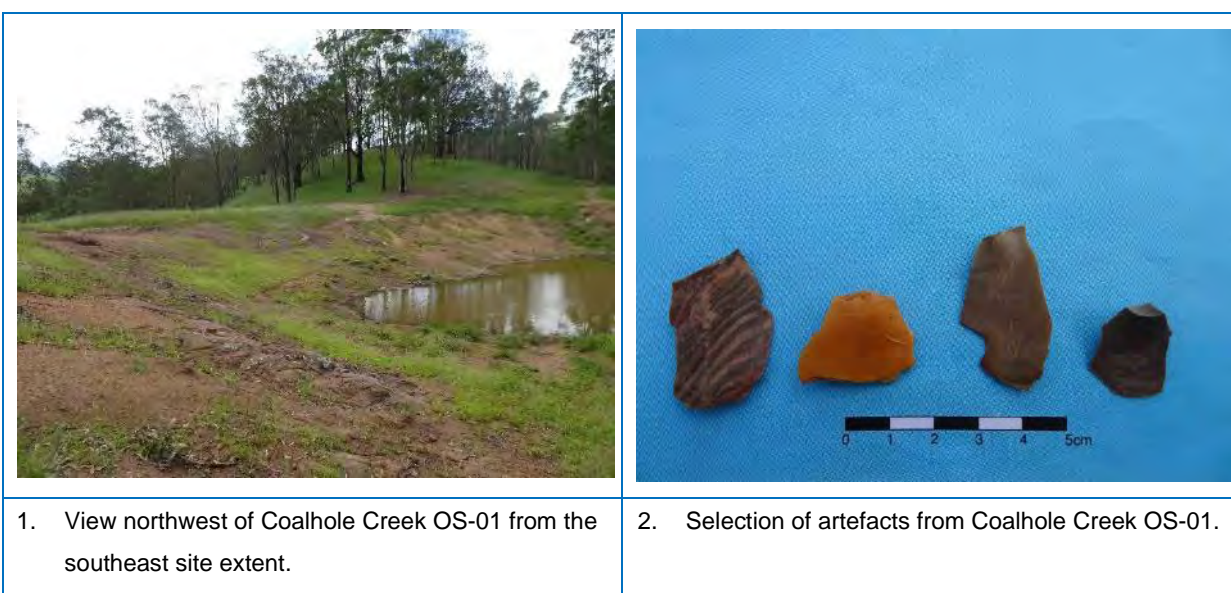
Figure 6-7: Coalhole Creek OS-01. View of site and selection of recorded artefacts.

1. View northwest of Coalhole Creek OS-01 from the southeast site extent.

2. Selection of artefacts from Coalhole Creek OS-01.

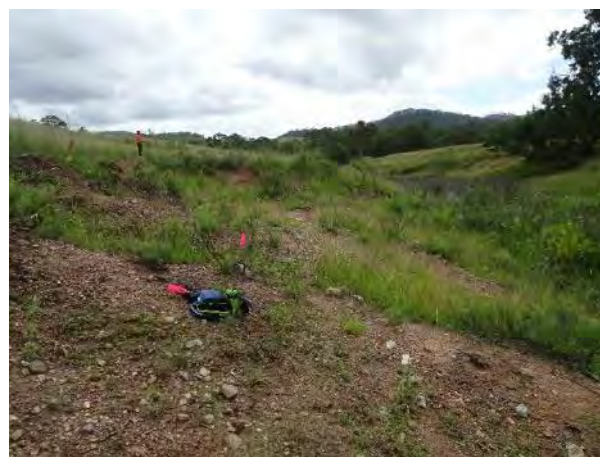
1. View north of Bowmans Tributary IF-01. Note drainage line on the right and slope on the left.

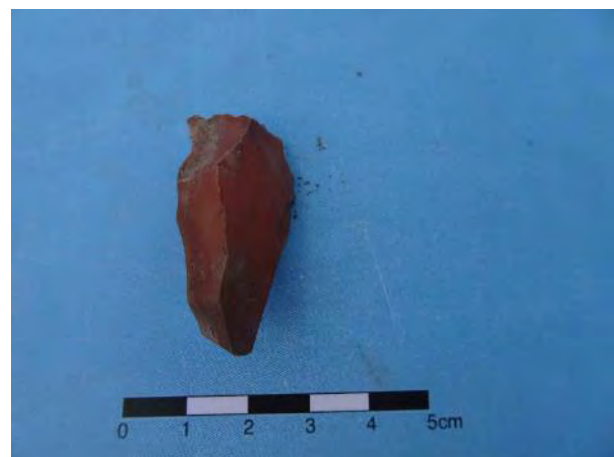
2. View of artefact from Bowmans Tributary IF-01.

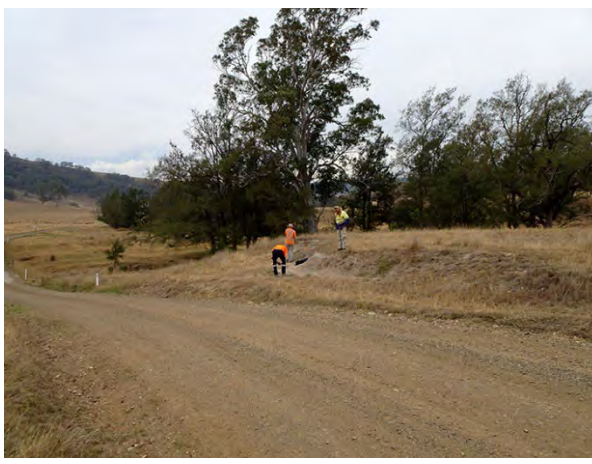
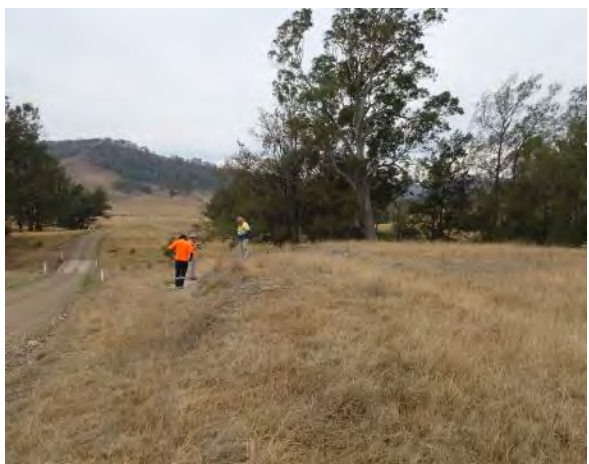
Figure 6-18: Albano Road OS-02. View of site and selection of recorded artefacts.

<p>1. View northeast across Albano Road to the terrace where Albano Road OS-02 is located (at the figures).</p>	<p>2. View north towards Albano Road OS-02 and Bowmans Creek (tree line).</p>

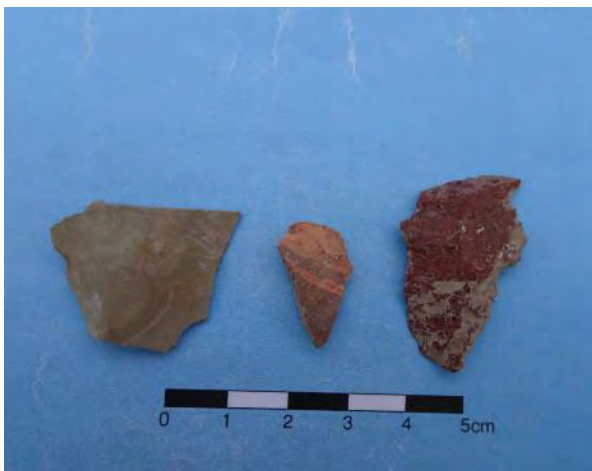
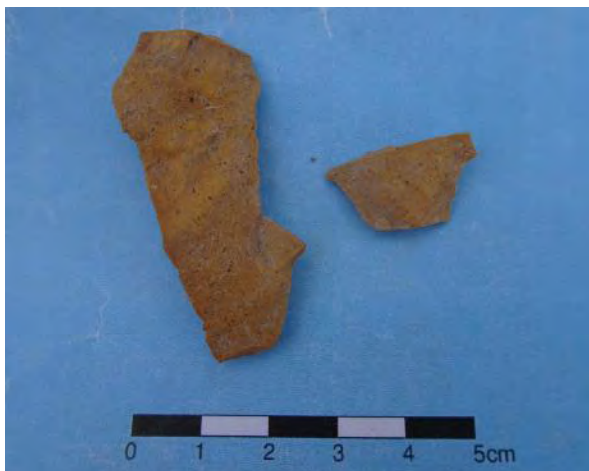
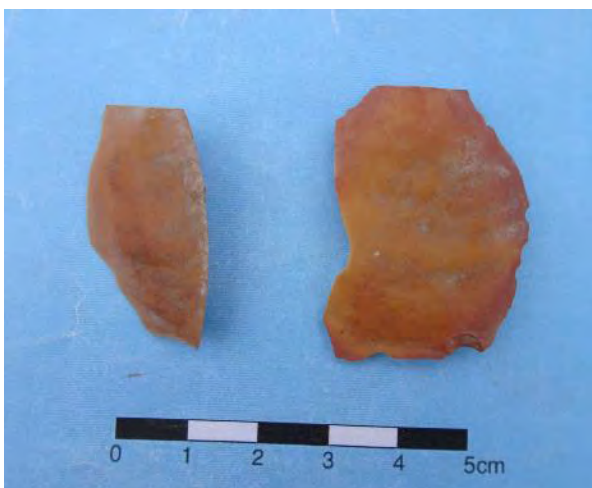
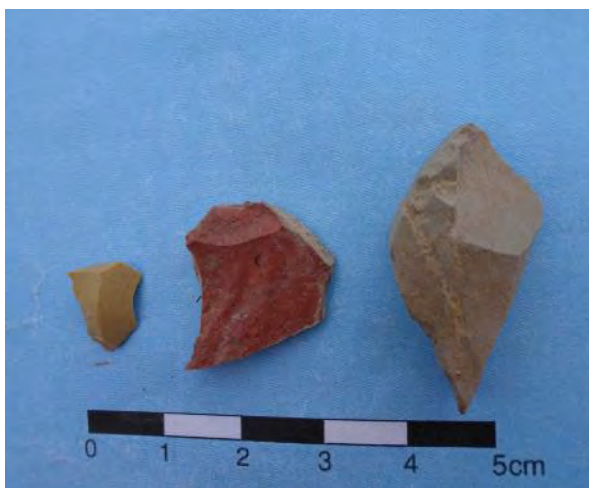
<p>3. Selection of mudstone and silcrete flakes.</p>	<p>4. Silcrete flakes.</p>

<p>5. Mudstone flakes.</p>	<p>6. Selection of silcrete and mudstone flakes.</p>

Artefact ID	Art. Type	Material	Integrity	Reduction	Length x width x thickness (mm) or size class
1	Flake	Silcrete	Complete	Tertiary	15x20x5
2	Flake	Mudstone	Complete	Tertiary	15x10x5
3	Flake	Mudstone	Complete	Tertiary	35x25x5
4	Blade	Mudstone	Distal fragment	Tertiary	25x10x5
5	Flake	Mudstone	Complete	Tertiary	40x30x5
6	Flake	Silcrete	Proximal fragment	Tertiary	15x20x5
7	Blade	Silcrete	Complete	Tertiary	45x2x5
8	Flake	Silcrete	Complete	Tertiary	25x15x10
9	Flake	Mudstone	Complete	Tertiary	30x30x5
10	Shatter	Silcrete		Tertiary	20x10x5
11	Flake	Silcrete	Distal Fragment	Tertiary	15x5x5
12	Blade	Silcrete	Complete	Tertiary	50x30x5
13	Flake	Silcrete	Complete	Tertiary	40x20x5

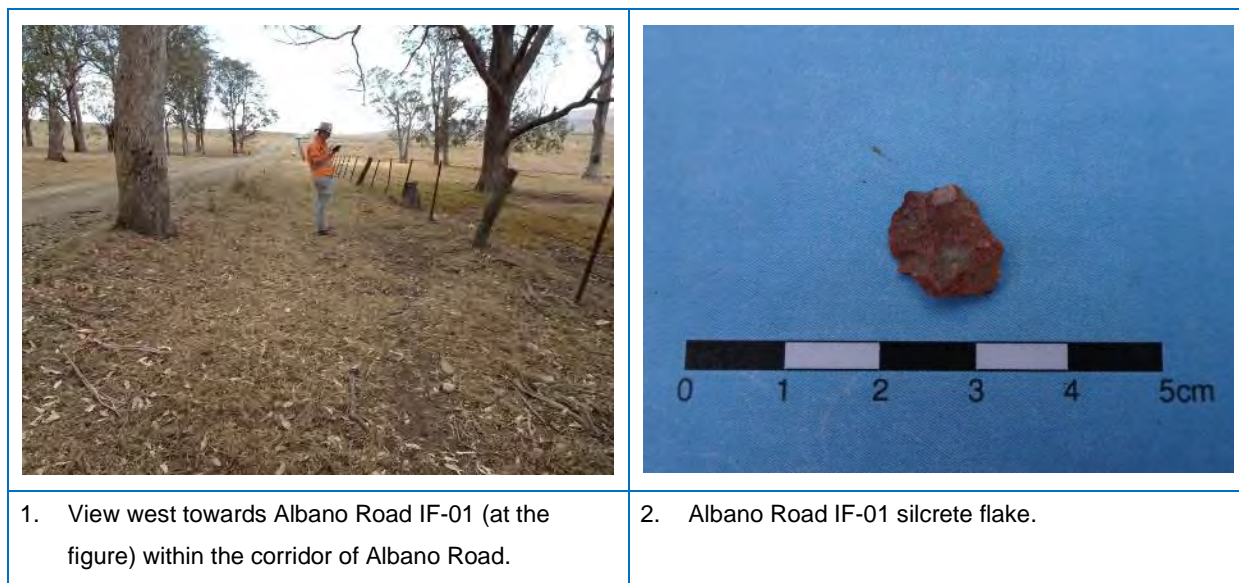
Figure 6-22: Albano Road IF-01. View of site and recorded artefact.

Artefact ID	Art. Type	Material	Integrity	Reduction	Length x width x thickness (mm) or size class
1	Flake	Silcrete	Complete	Tertiary	10x10x5

**Albano Road IF-01 (37-3-1590)****Site Type:** Isolated find**GPS Coordinates:** 324175E / 6427570N (centroid, GDA94 Zone 56)**Location of Site:** The site is within the northern corridor of Albano Road, approximately 105 m south of Bowmans Creek; 30 m west of a tributary of Bowmans Creek and 315 m west of a shearing shed (**Figure 6-3, Figure 6-23**).**Description of Site:** The site is located on a flat landform surrounded by regrowth and mature trees (**Figure 6-22**). One silcrete flake was identified within a small area of exposure within the table drain of Albano Road (**Table 6-14**). Soils at the location consists of brown-grey silt. There is low potential for *in situ* subsurface deposits at the site.**Table 6-14: Artefact attributes: Albano Road IF-01.**

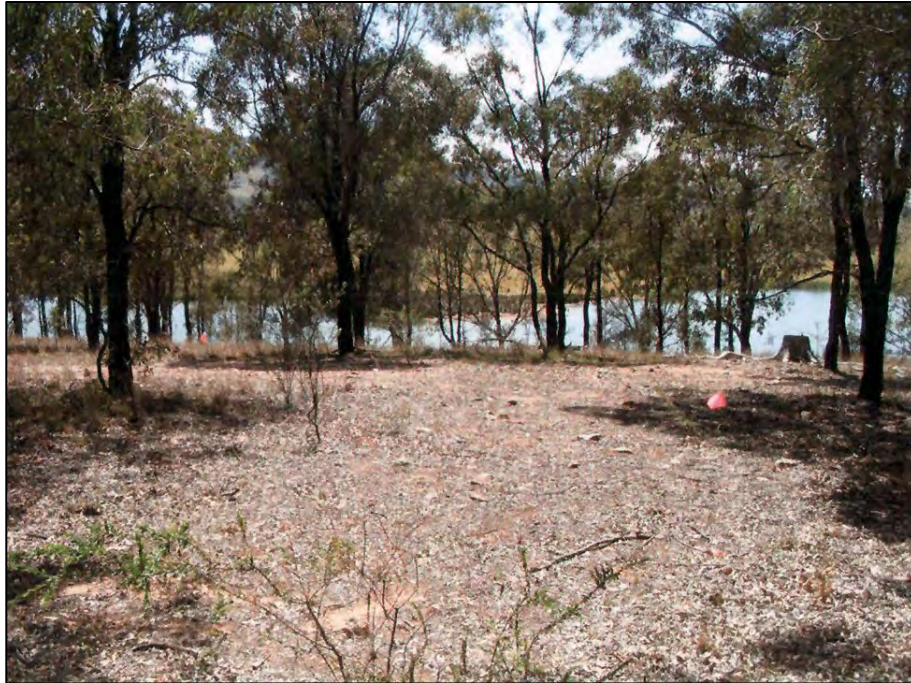
Figure 6-36: A view of 37-2-2072 from HLA-Envirosciences (2005b: Plate 24).

This site was recorded by HLA-Envirosciences (2005b) and is described as a ‘mythological place’ consisting of ‘*multiple artefacts identified around a cleared area thought to be a Boora (sic) ring*’. The artefacts included an anvil (a volcanic cobble with pitting), a quartz bipolar flake and a hammerstone. The site location is described as being ‘*on the crest of a promontory to the north of Lake Liddell*’.

In conclusion, it is difficult to verify whether this site once had ceremonial functions. However, there is little evidence to support the registration and it is not known who in the 'community' interpreted the site as a Bora Ring.

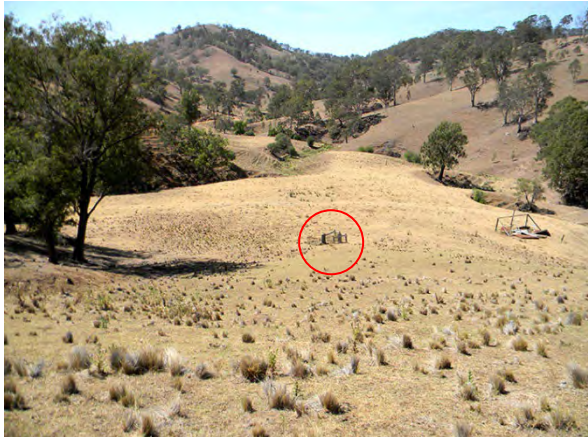
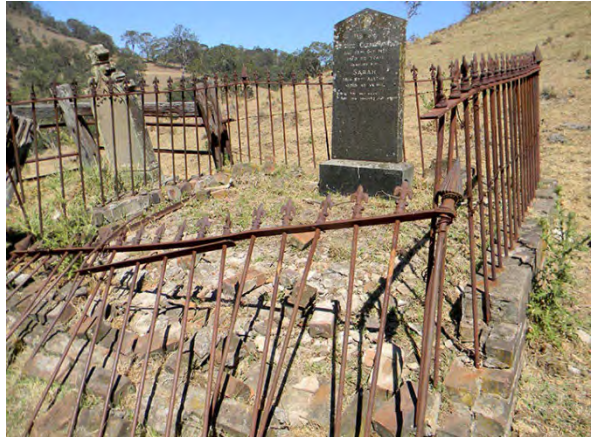
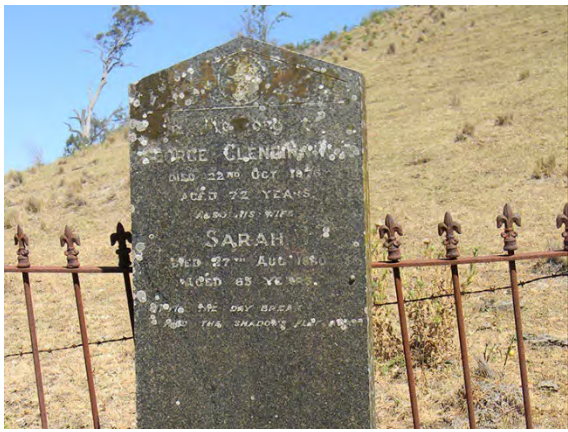
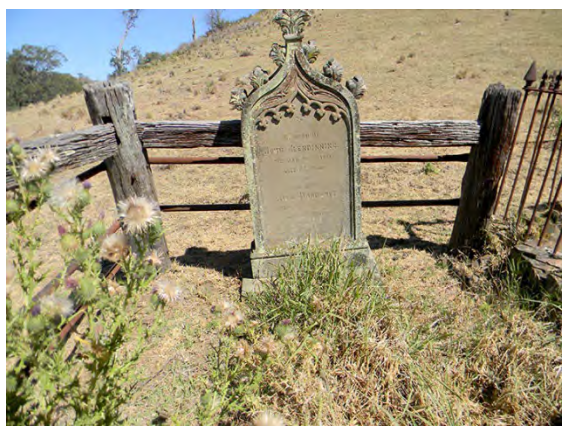
Figure 5-10: Rock Lily Gully-HS01.

<p>1. View southeast of Rock Lily Gully-HS01 (circled) with the ruined shed to the west.</p>	<p>2. View of the grave compound.</p>

<p>3. View of the headstone of George and Sarah Clendinning.</p>	<p>4. View of the headstone of John and Eliza Clendinning.</p>

The graves are fenced in a wrought iron fence with a brick base that is in poor repair. John and Eliza's headstone appears to be original while George and Sarah's headstone seems to have been replaced at some time.

Figure 5-10 shows views of the recorded historic place.

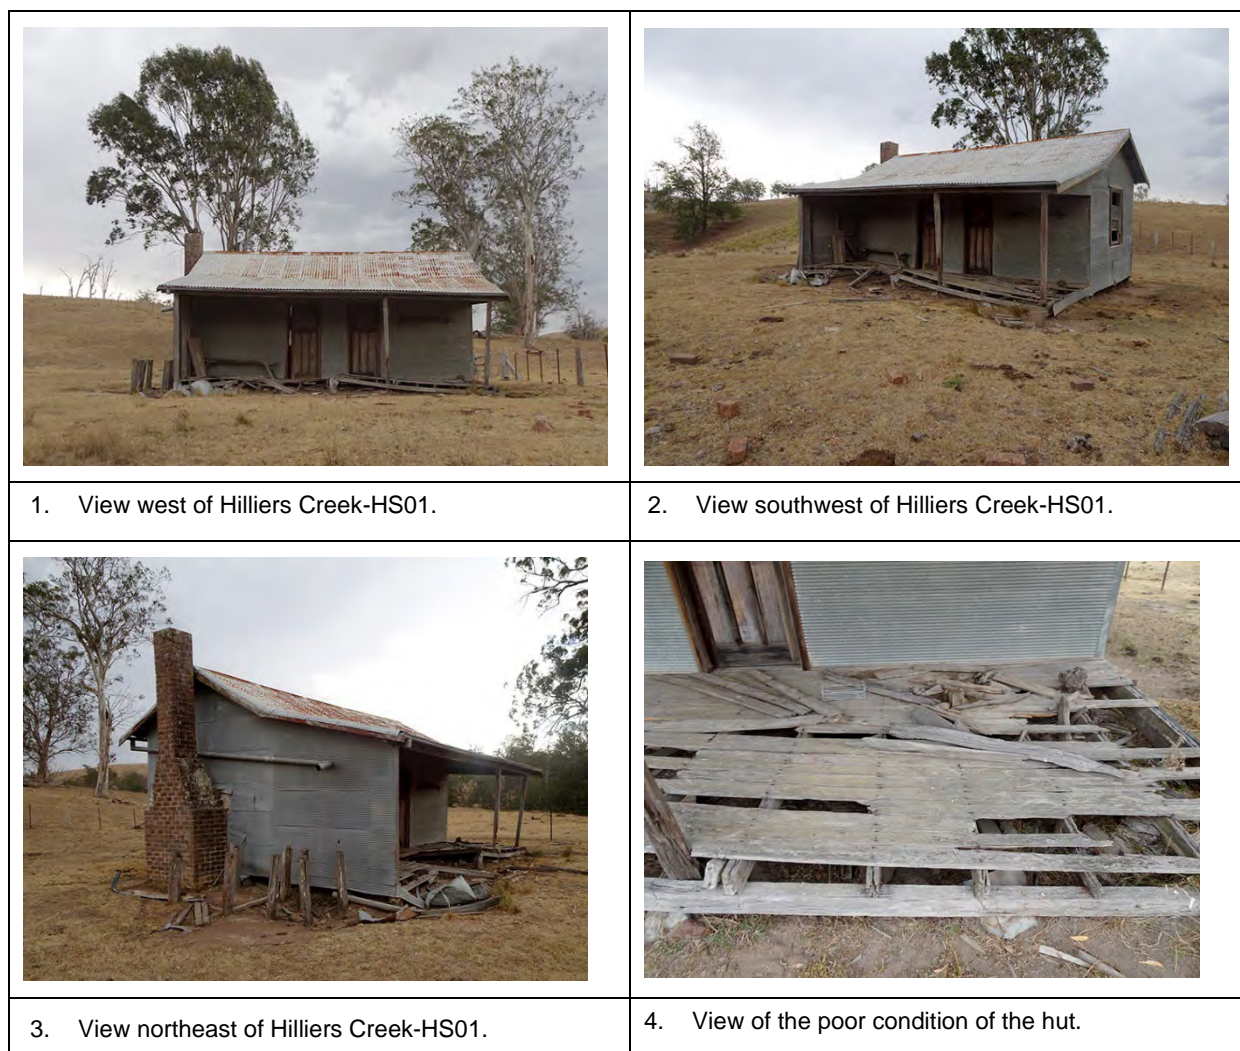
Figure 5-11: Hilliers Creek-HS01.

Description of Site: Site consists of a corrugated iron structure with a wooden verandah and a brick fireplace and chimney (Figure 5-11). There are the remains of the wooden supports for a water tank on the southern side of the building. The structure is standing but in poor condition. There are no obvious attributes to allow the construction date of the structure to be determined but it is assumed to be the early twentieth century given the narrow pitch of the corrugated iron used for the walls. However, during the 2022 survey

the property owner was unsure of the construction date but suggested the 1960s. However, unless old materials were used in the 1960s, it is likely to be older. The hut is well-made with sash-windows, guttering and flashings. Therefore, it would seem that it was constructed as a permanent residence rather than a 'shepherd's hut'.
