Brickworks Plant 2 Upgrade Soil and Water Management Plan & Civil Engineering Design Report

CLIENT/ BRICKWORKS LTD

DATE/ MARCH 2020

CODE/ R001-03-18-577

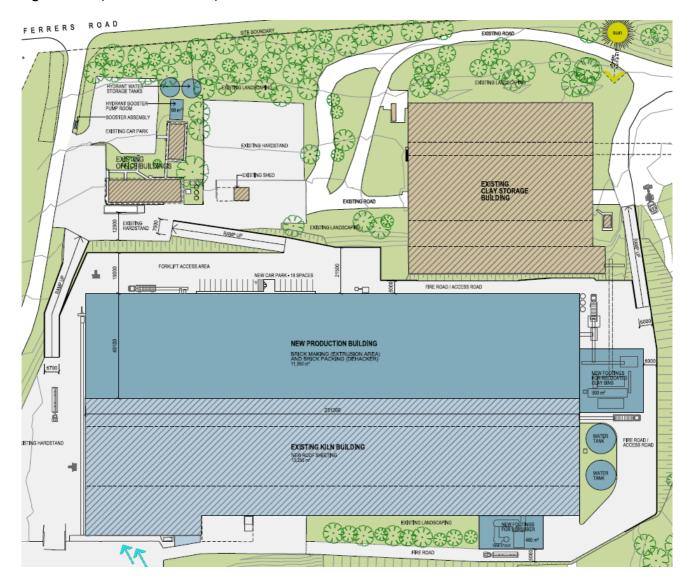
Figure 2 – Proposed Plant 2 Development

The proposed development is an extension to the existing brick manufacturing facility known as Plant 2. New state-of-the-art industrial plant and machinery will be installed to modernise the facility, including kilns, crushers and conveyors. Associated works will include the construction of access ramps, storage hardstands and loading areas. As well as the building extension, the existing roof sheeting and guttering will be removed and replaced with new materials. Refer to Figure 2 below and also the SBA architectural drawings.
