# Appendix B2

## Flora and Fauna CEMP Sub-plan

M6 Motorway Stage 1

Document Number: M6S1-CGU-NWW-ENPE-PLN-000404

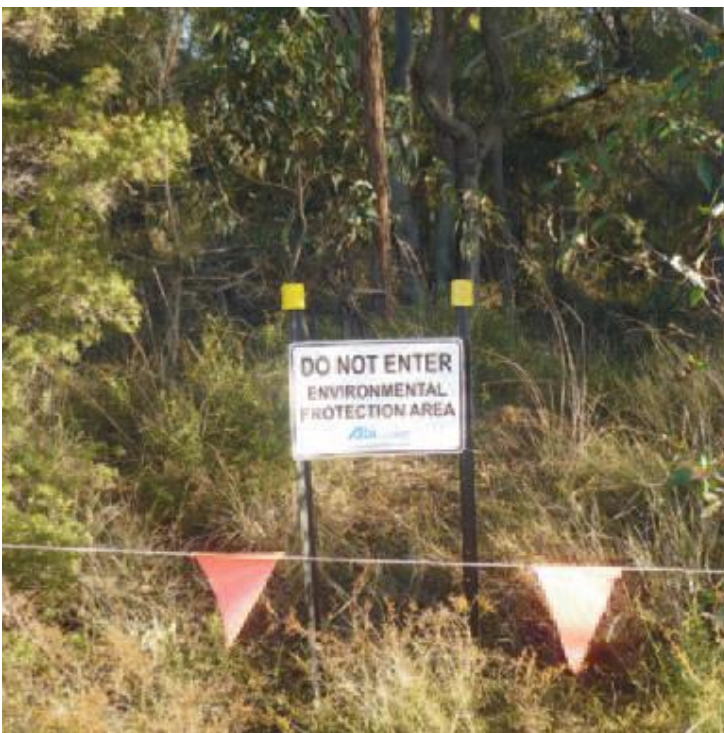
Prior to the planned vegetation clearing or wetland dewatering and pre-clearing surveys, the Project area boundaries and Environmentally Sensitive Areas must be identified and marked. All Project Boundaries and Exclusion Zones will be marked with an appropriate fence or series of boundary markers to limit clearing of native vegetation to the greatest extent practicable. In addition, all environmentally sensitive areas will have indicative signage installed every 50 metres around the boundary (or at the feature for particularly sensitive areas) (Plate 1).

Plate 1: Example of Environmentally Sensitive Area exclusion fencing and signage (Source: TR&T 2010)

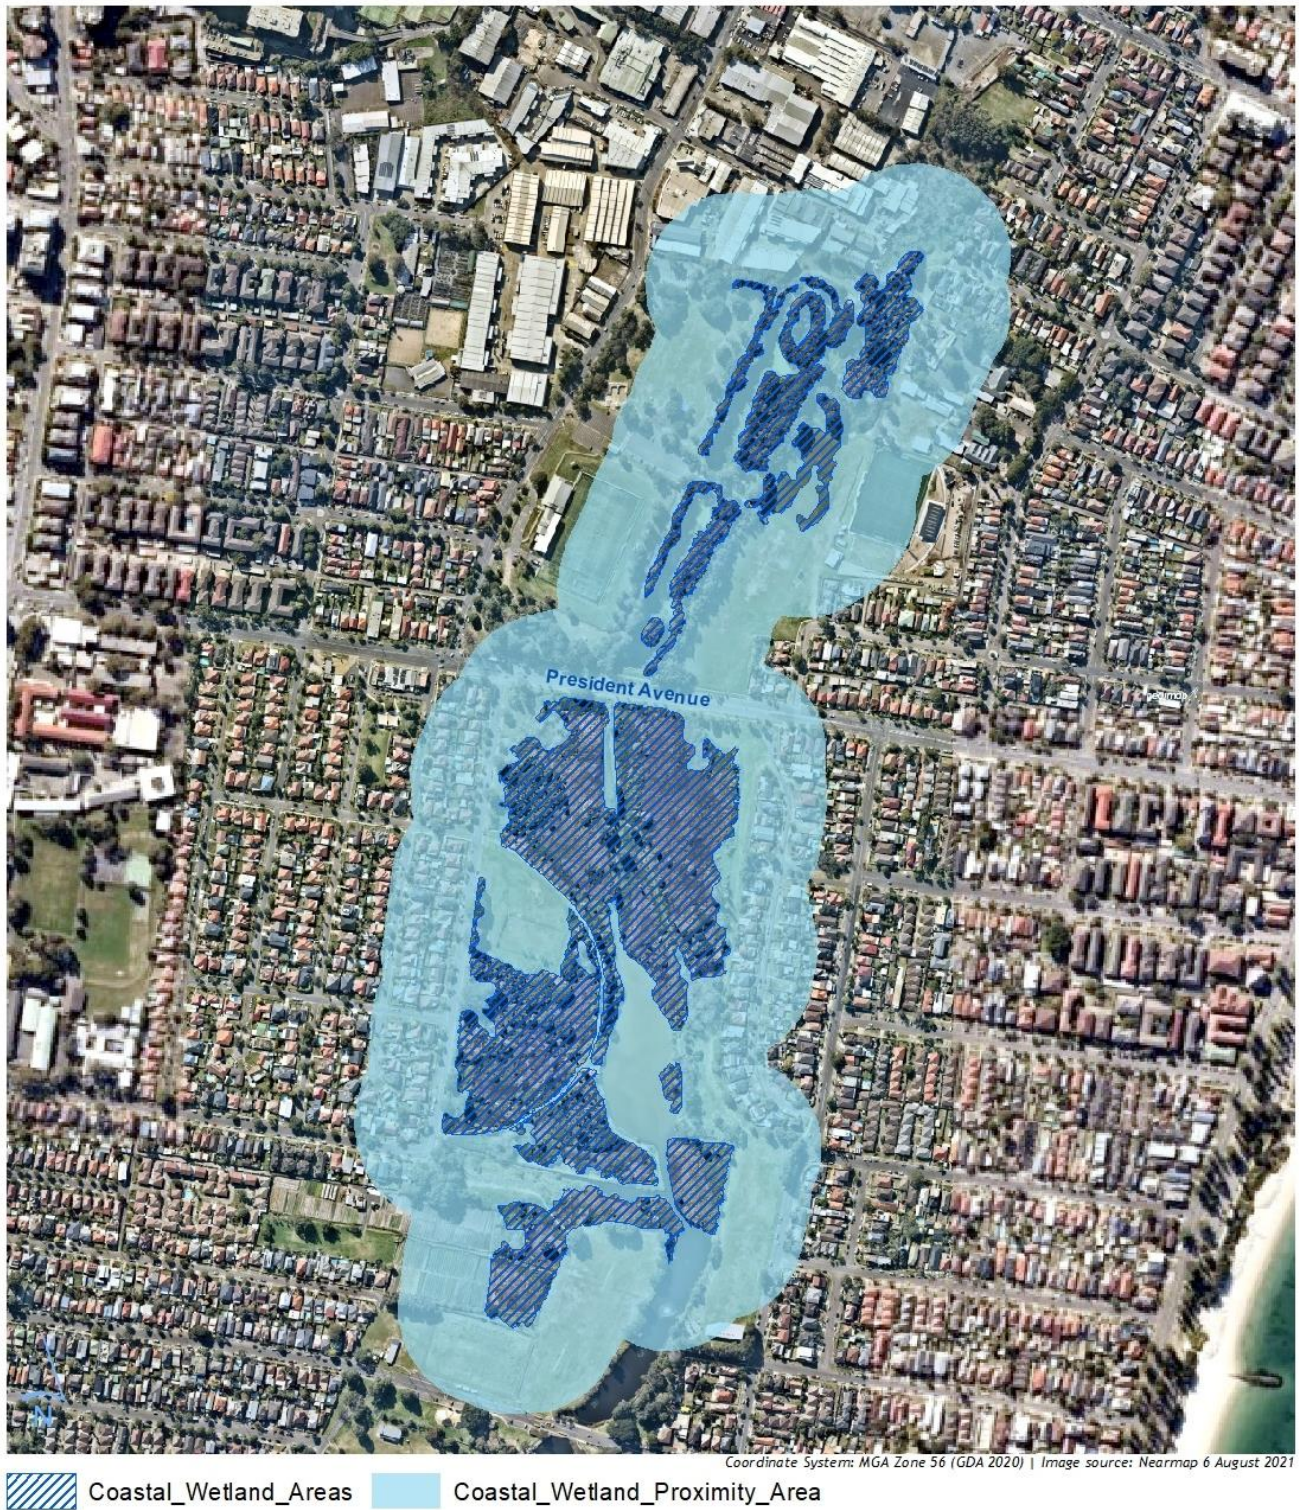
Figure 2 Coastal Management SEPP areas

As shown in Figure 2, the study area is mapped as Coastal Wetland proximity areas and partially mapped as Coastal Wetland areas under the Coastal Management SEPP. The study area generally encompasses mapped Coastal Wetland areas except where mapping includes non-wetland open spaces areas.
