CONSTRUCTION MANAGEMENT PLAN (ADDENDUM)

New Sydney Fish Market
Stage 2 Site Accommodation
Sydney Secondary College Carpark

Multiplex Constructions Pty Limited

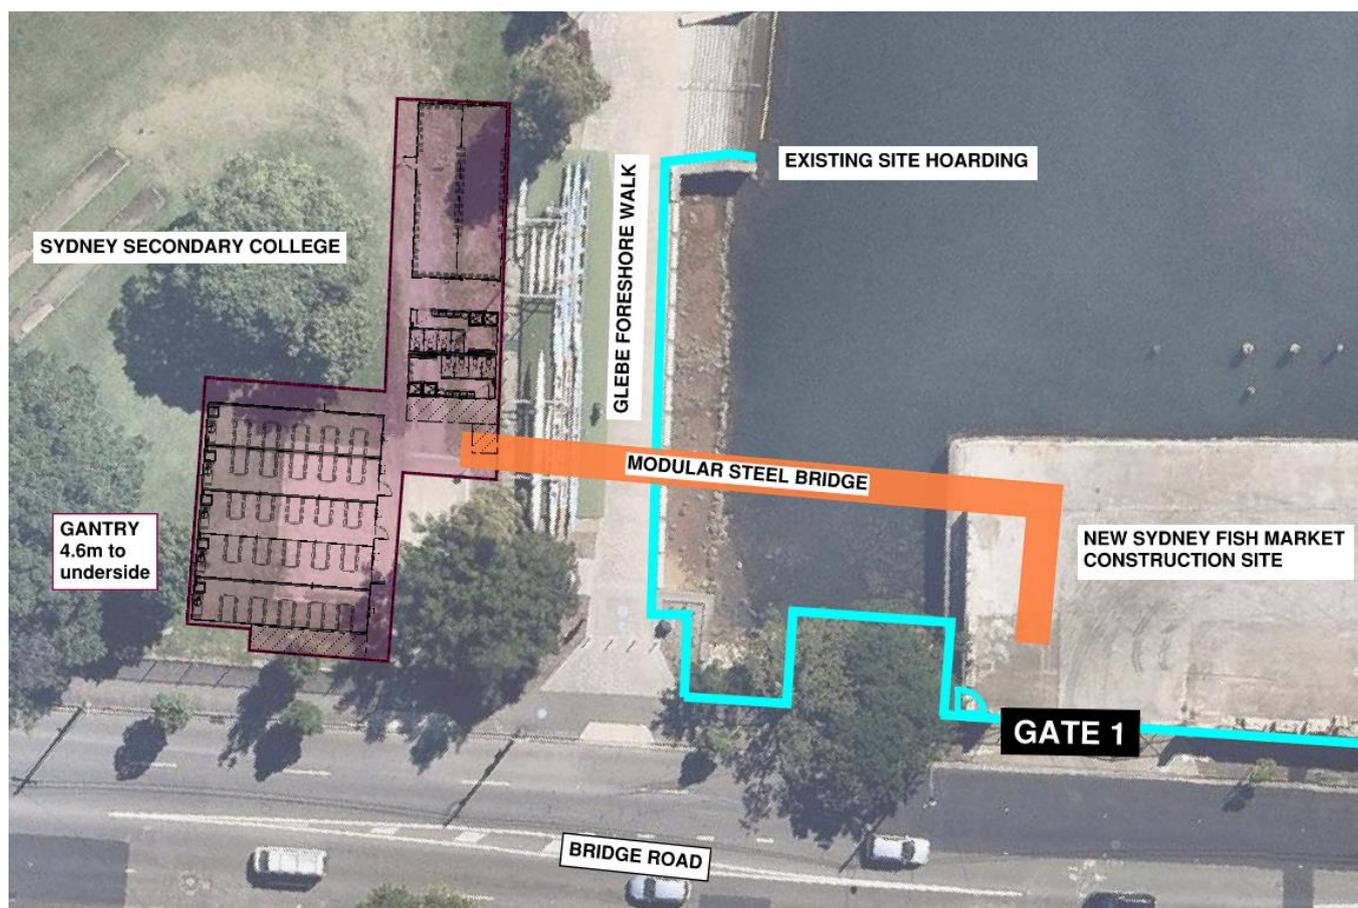
Figure 1 Overall plan for temporary site accommodation complex

Multiplex have been contracted to construct the New Sydney Fish Market project. One of the challenges on the project is the limited land available on site to accommodate worker amenities, particularly during the earlier stages of construction. The project team have developed a proposal to locate worker amenities within the Sydney Secondary College boundary illustrated below.

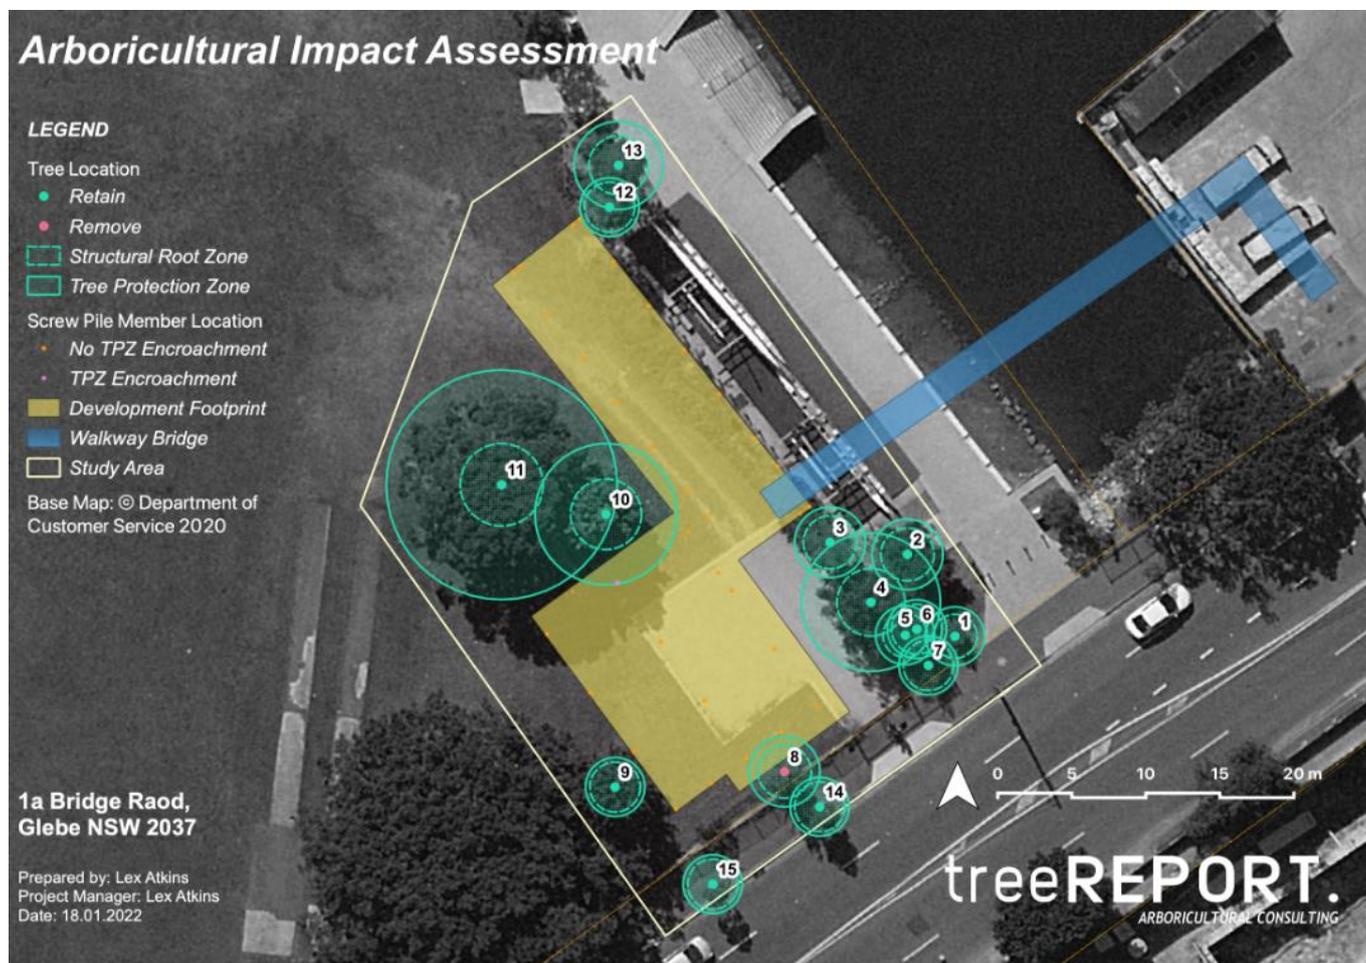
Figure 3 Arboricultural Impact Assessment

One tree (T8) will require removal, while four trees (T3, T4, T9, T10) require pruning as per the arborist advice to allow for the gantry structure. T8 will need to be removed to undertake excavation works to connect to an existing sewer junction point, where excavation work will undermine T8 which poses a safety risk for workers and the public.

The remaining trees will be protected/treated as per the AIA. Multiplex note that Tree 4 is a *Melia azedarach*, which is an exempt species in City of Sydney Council and thus does not require Council permission to prune or remove.

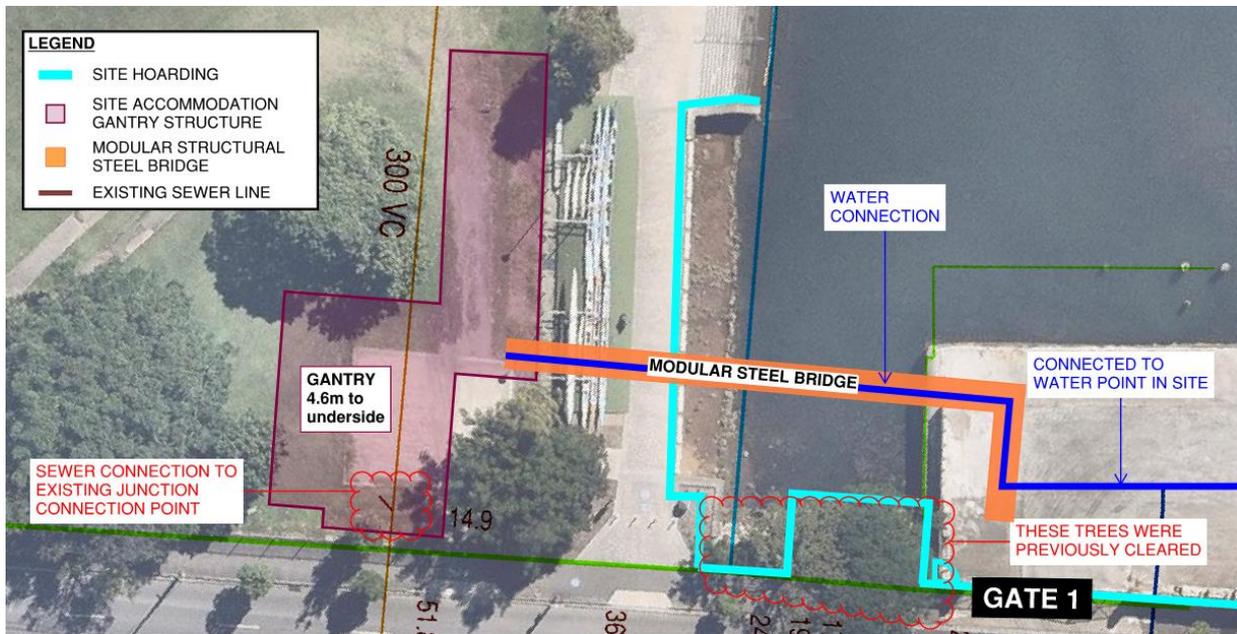
Figure 4 Proposed temporary water services connection

Temporary water will be connected from an existing water point within the site boundary, with the water pipe to run along the underside of a modular structural steel bridge spanning between the gantry over the school carpark and the western hardstand within the site boundary. The bridge will be elevated approximately 4.6m from the Glebe Foreshore Walk footpath surface to maintain all vehicle access currently in place.

Temporary sewer will be connected to an existing sewer junction connection point within the school grounds, adjacent to the existing carpark entry. This was identified in Water Dial Before You Dig plans. Excavation is required to make the connection to the junction connection point.

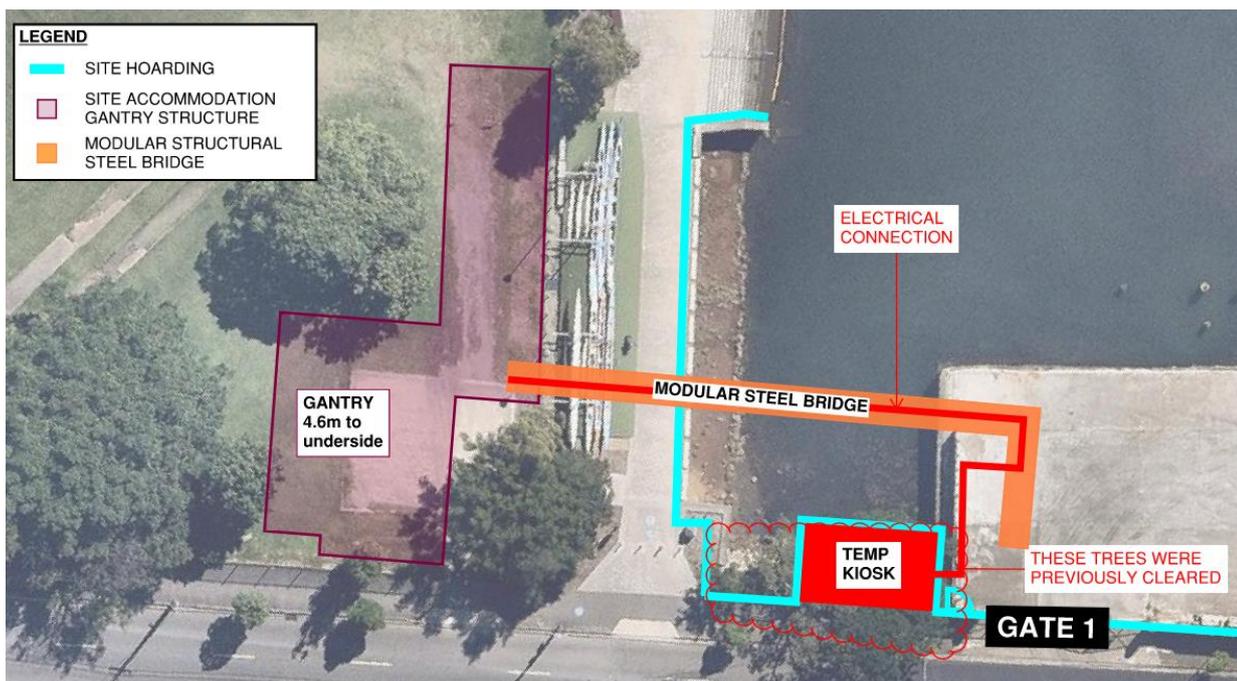
Figure 5 Proposed temporary electrical services connection

Power will be sourced from the temporary substation kiosk that will be installed for construction power for the main project site (within the site boundary between Glebe Foreshore Walk and Gate 1 of the construction site). All cables and conduits will be run underneath the proposed modular structural steel bridge spanning between the gantry over the school carpark and the western hardstand within the site boundary. The bridge will be elevated approximately 4.6m from the Glebe Foreshore Walk footpath surface to maintain all vehicle access currently in place.

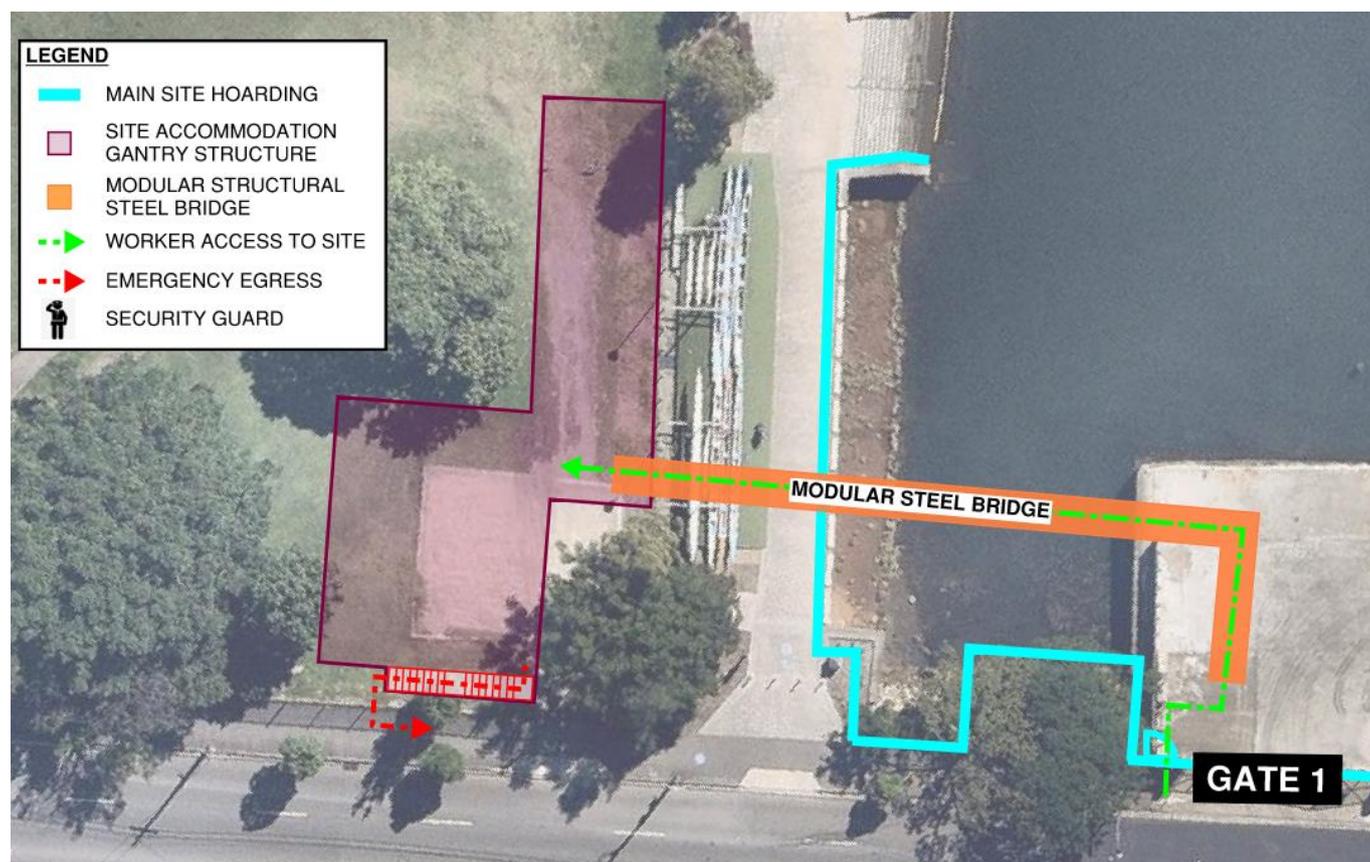
Figure 6 Worker access to site accommodation complex

Workers will access the site accommodation complex from within the construction site via a modular structural steel bridge. Workers will enter the bridge from ground floor within the site boundary then walk along the bridge into the gantry deck level of the site accommodation complex. The bridge will span over Glebe Foreshore Walk from the site accommodation complex to the existing hardstand within the site boundary for direct worker access, preventing congestion along the public footpath on Bridge Road and Glebe Foreshore Walk.

There will be a set of stairs along the southern face of the site accommodation gantry from the gantry deck level (4.6m above ground) to ground floor (along the existing palisade fence on Bridge Road) as emergency egress. This stair will be fenced off from public access, kept clear at all times and will only be used as an escape route during emergencies.

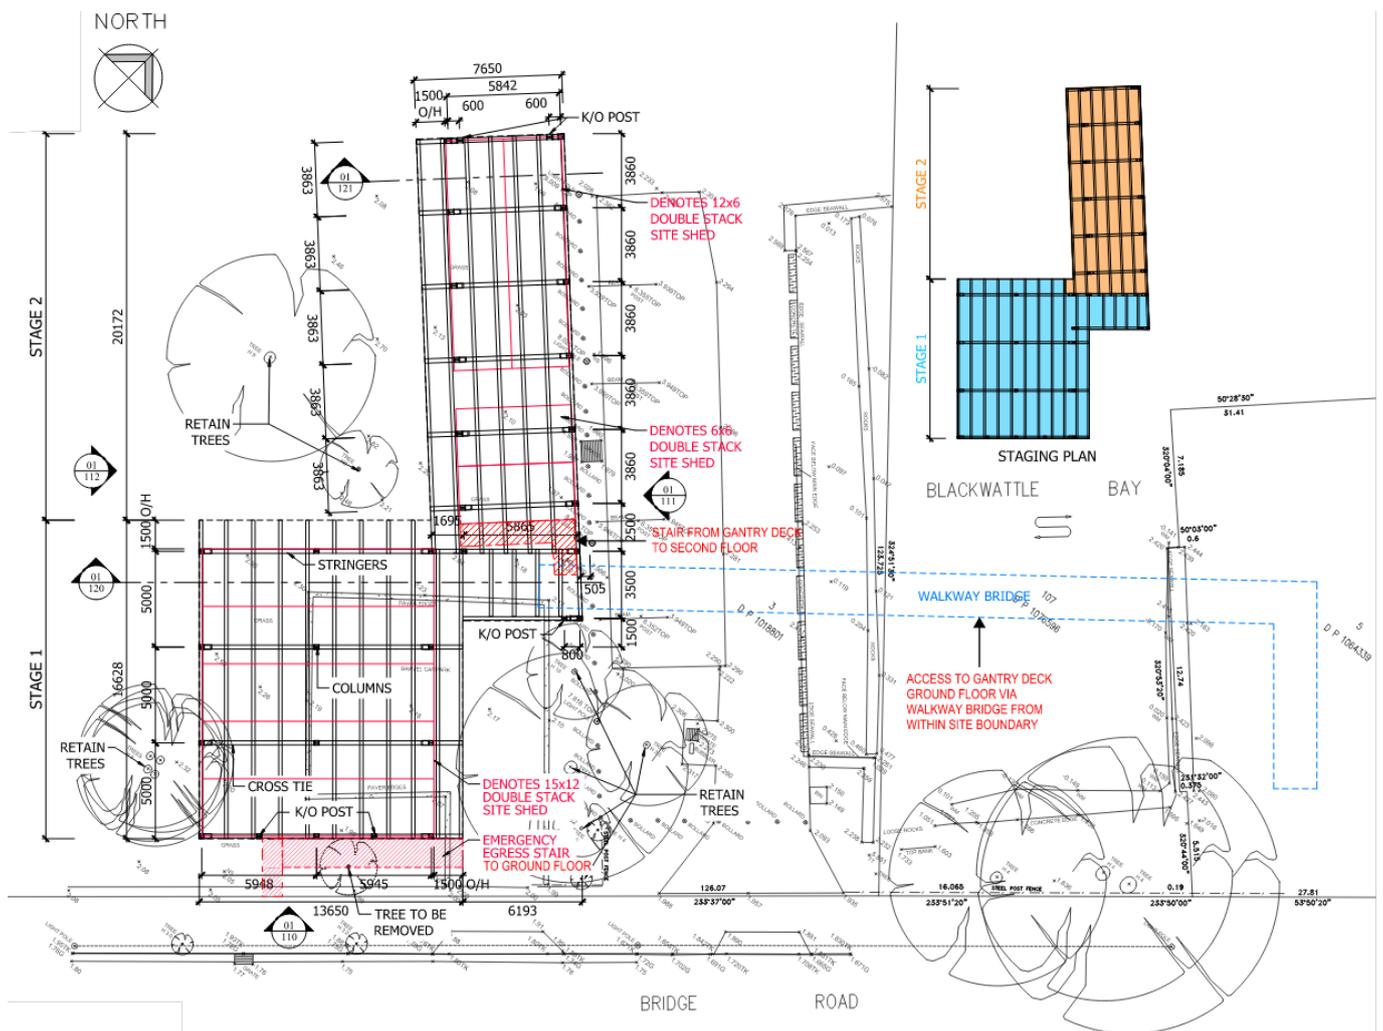
Figure 7 Gantry layout with staged installation

- Temporary water and electrical connection from within the main site
 - Run water pipe and electrical conduit underneath the modular bridge from the site accommodation complex into their respective connection points inside the site boundary
- Roofing and walkway installation for access to site sheds
 - Engineer to inspect walkways and roofing and provide certification
- Demobilisation of plant and equipment
- Handover area back to Sydney Secondary College

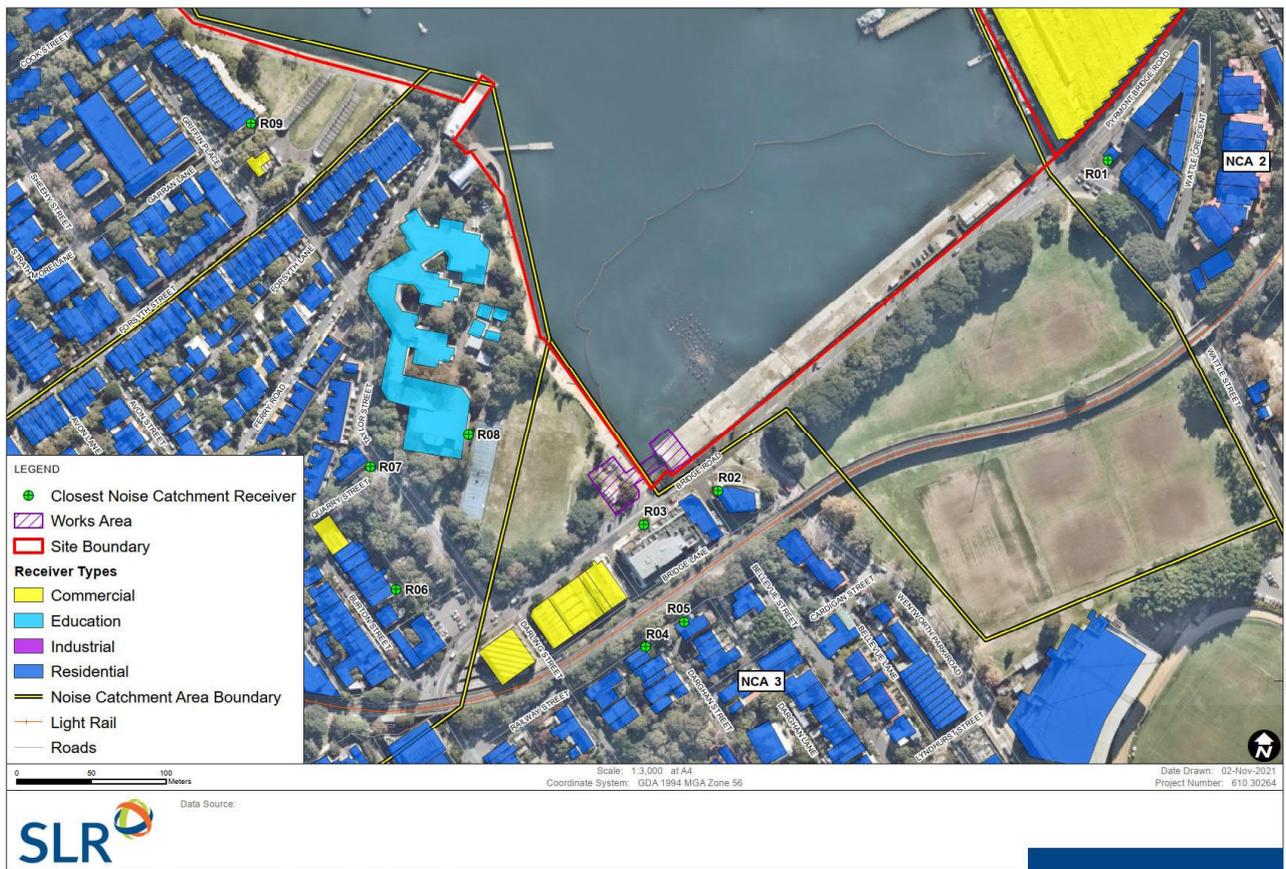
Figure 2 Site Location and Noise Sensitive Receivers

Figure 2 shows the proposed work zone and nearest sensitive receivers that may be affected by the works. The NVIA report has defined all potentially noise sensitive receivers near the proposed construction zone which are summarised in **Figure 2**.

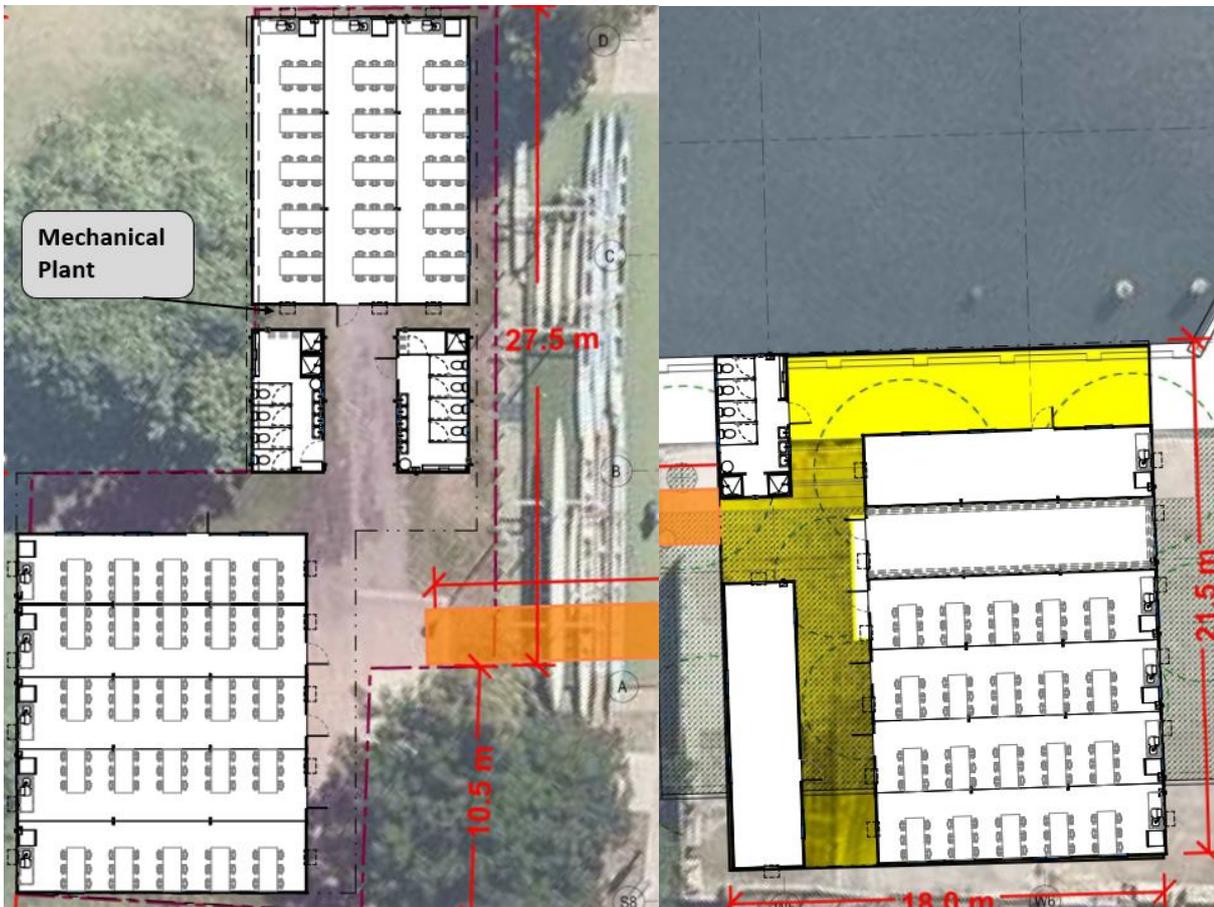
Figure 3 Mechanical Plant Locations

Noise emissions from mechanical plant have been calculated based on indicative locations around the site accommodation sheds and are shown by the dotted boxes below in **Figure 3**. A total of 49 units have been proposed as part of the project design. Sound power level limits for the units have been provided in **Table 14**. As it is not known whether mechanical plant is required to run 24 hours a day, limits have been provided for day, evening and night-time periods. In order for mechanical plant to operate 24 hours a day, the night-time PNTL will need to be met at the nearest sensitive receiver (R03).

Once plant selections are made, noise emission levels should be checked to ensure the criteria will be achieved. Should any changes be made to the layout, or number of units, these limits should be reviewed to ensure the criteria will be achieved.

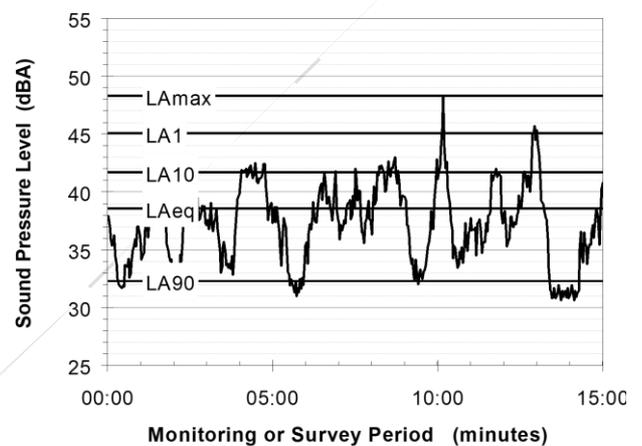
The following figure presents a hypothetical 15 minute noise survey, illustrating various common statistical indices of interest.

- LA1 The noise level exceeded for 1% of the 15 minute interval.
- LA10 The noise level exceeded for 10% of the 15 minute interval. This is commonly referred to as the average maximum noise level.
- LA90 The noise level exceeded for 90% of the sample period. This noise level is described as the average minimum background sound level (in the absence of the source under consideration), or simply the background level.
- LAeq The A-weighted equivalent noise level (basically, the average noise level). It is defined as the steady sound level that contains the same amount of acoustical energy as the corresponding time-varying sound.

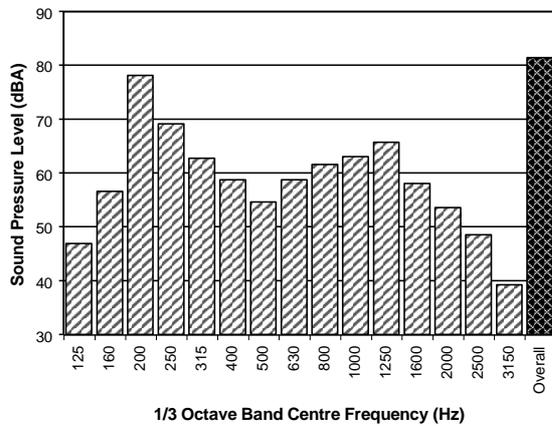
The following figure shows a 1/3 octave band frequency analysis where the noise is dominated by the 200 Hz band. Note that the indicated level of each individual band is less than the overall level, which is the logarithmic sum of the bands.

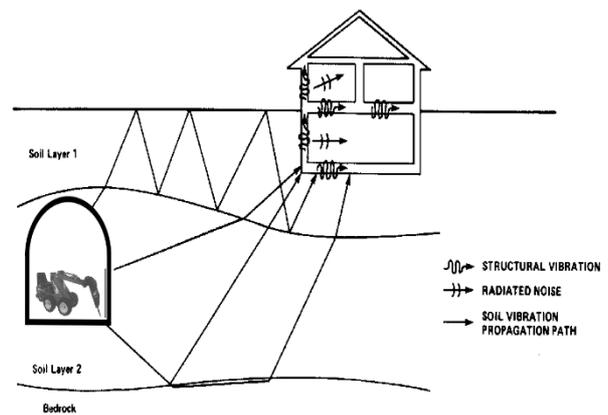
The following figure presents an example of the various paths by which vibration and ground-borne noise may be transmitted between a source and receiver for construction activities occurring within a tunnel.

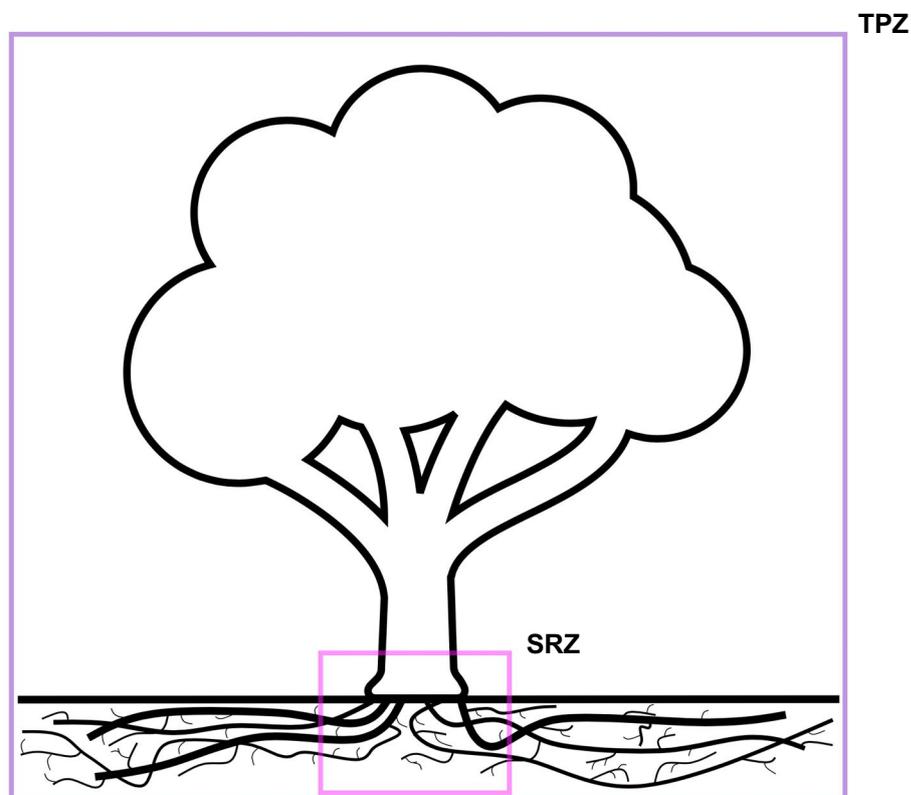
Figure 2: Indicative TPZ and SRZ

- **Structural root zone (SRZ):** The SRZ is the area of the root system (as defined by AS 4970-2009) used for stability, mechanical support and anchorage of the tree. Severance of structural roots (>50 mm in diameter) within the SRZ is not recommended as it may lead to the destabilisation and/or decline of the tree.

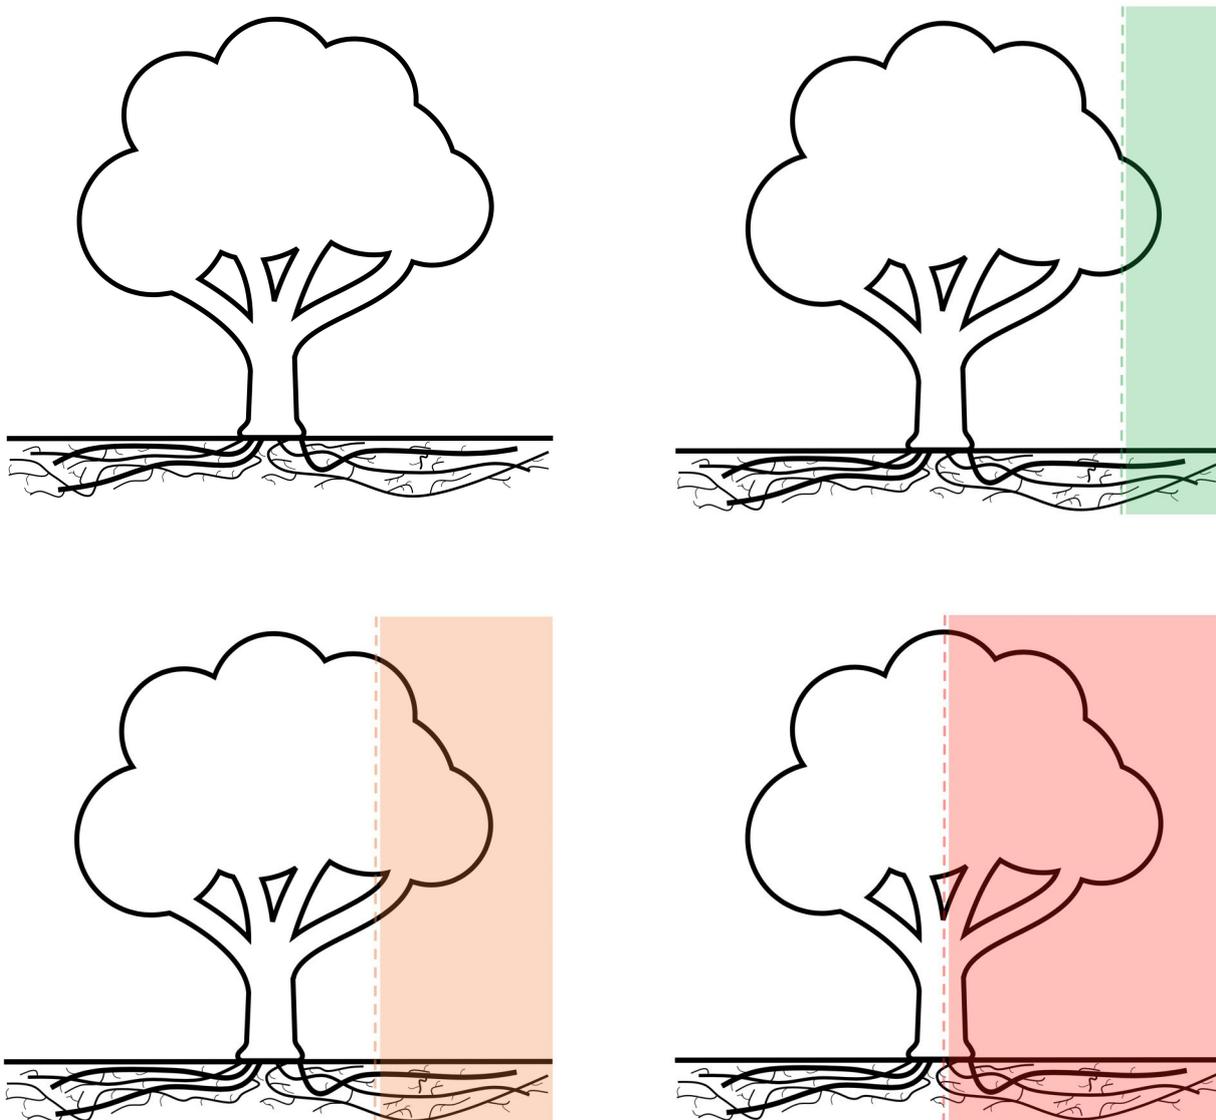
Figure 3: Indicative levels of encroachment

- **No encroachment (0%):** There are no likely or foreseeable encroachment within the TPZ as a result of the proposed development.
- **Minor encroachment (<10%):** The proposed encroachment is less than 10% (total area) of the TPZ, and outside of the SRZ.
- **Major encroachment (>10%):** The proposed encroachment is greater than 10% (total area) of the TPZ.
- **Total encroachment:** The Subject Tree(s) located wholly within the proposed development footprint.

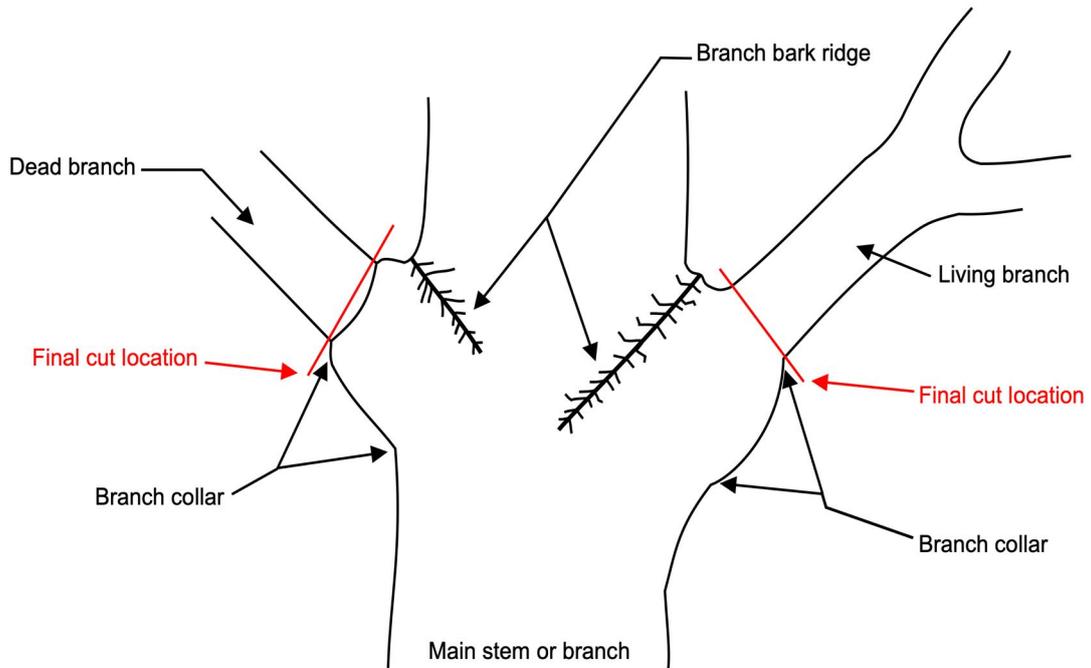
Figure 2.3

Natural Target Pruning is the removal of branches, stems, and stubs such that final cuts are achieved as close as possible to the branch collar without cutting into the branch collar or leaving a protruding stub. The branch collar is an area of overlapping trunk and branch tissue forming a swelling around the base of many branches. It contains defensive chemicals that can prevent infection from bacterial and/or fungal pathogens. **Figure 2.3** shows final cut locations when undertaking pruning works.

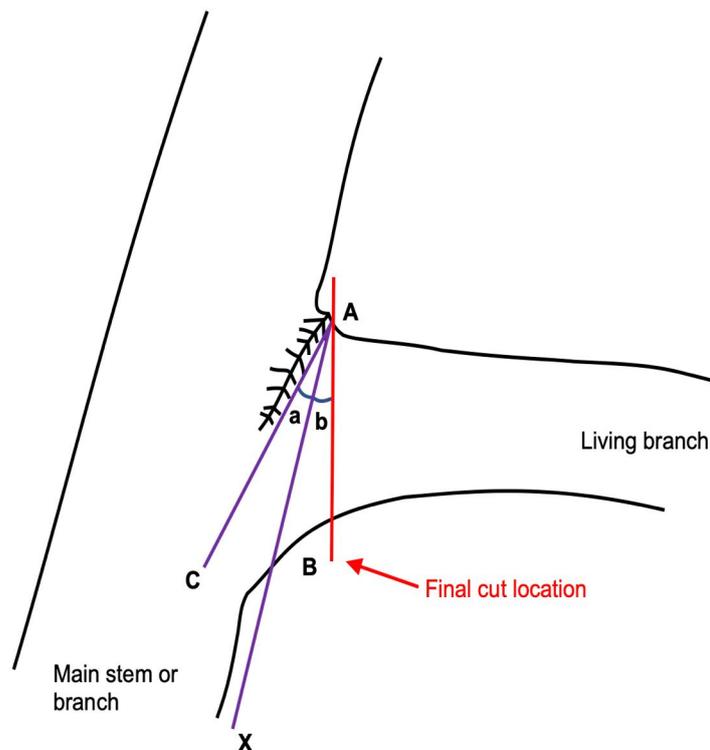
Figure 2.4

On branches where the branch bark collar cannot be found, the branch bark ridge is to be used as a pruning guide. **Figure 2.4** shows final cut location where – Line A to X is a line parallel to the trunk occurring just outside the branch bark ridge. Line A to C indicates the angle of the branch bark ridge and Line A to B represents the angle and location of the final cut. Angle 'a' should equal angle 'b'.

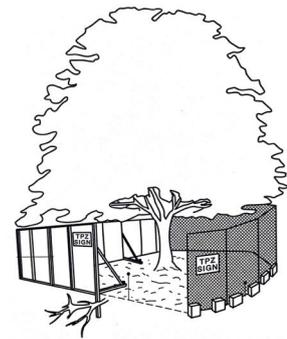
- Enclosed to the full extent of the TPZ (or as specified in the Recommendations and Tree Protection Plan).
- Temporary mesh panel fencing (minimum height 1.8m).
- Certified and inspected by the project arborist.
- Installed prior to the commencement of works.
- Prominently signposted with 300mm x 450mm boards stating, "NO ACCESS - TREE PROTECTION ZONE".

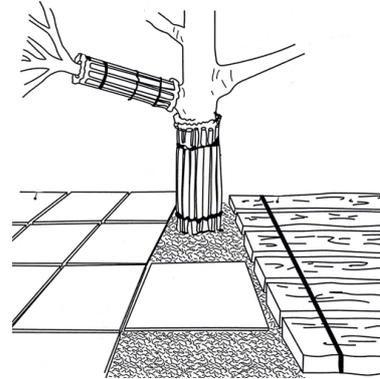
- Permeable membrane such as geotextile fabric.
- Layer of lightly compacted road base (at minimum depth of 200mm)
- Geotextile fabric shall extend a minimum 300mm beyond the edge of the road base.

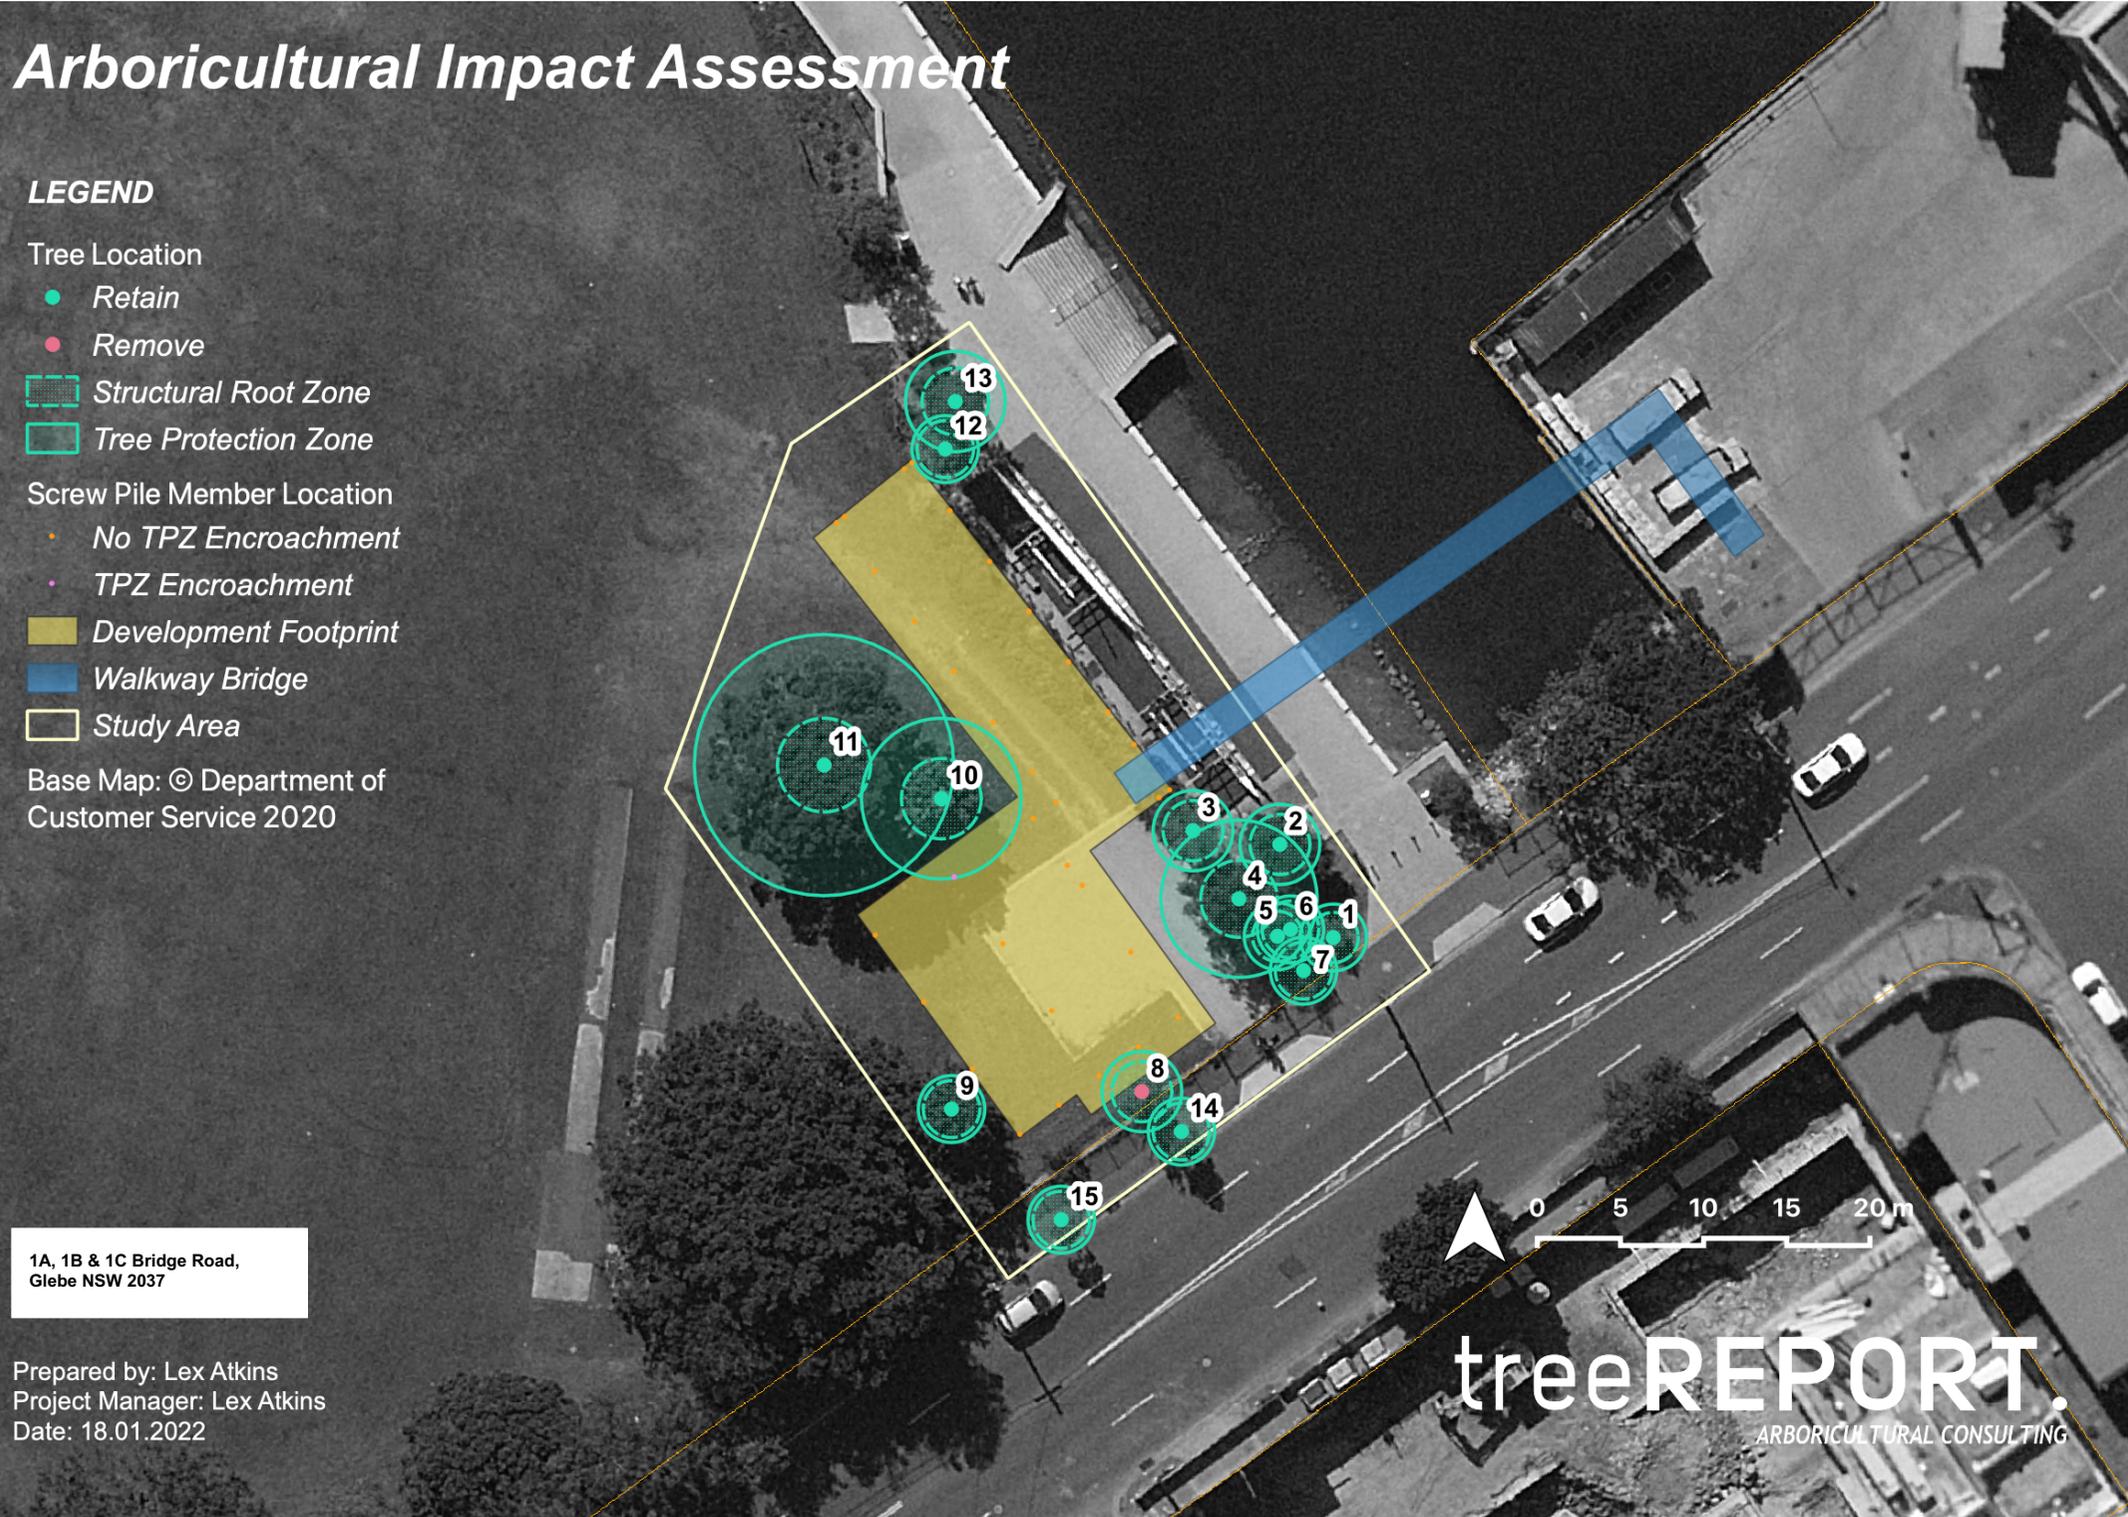
Arboricultural Impact Assessment

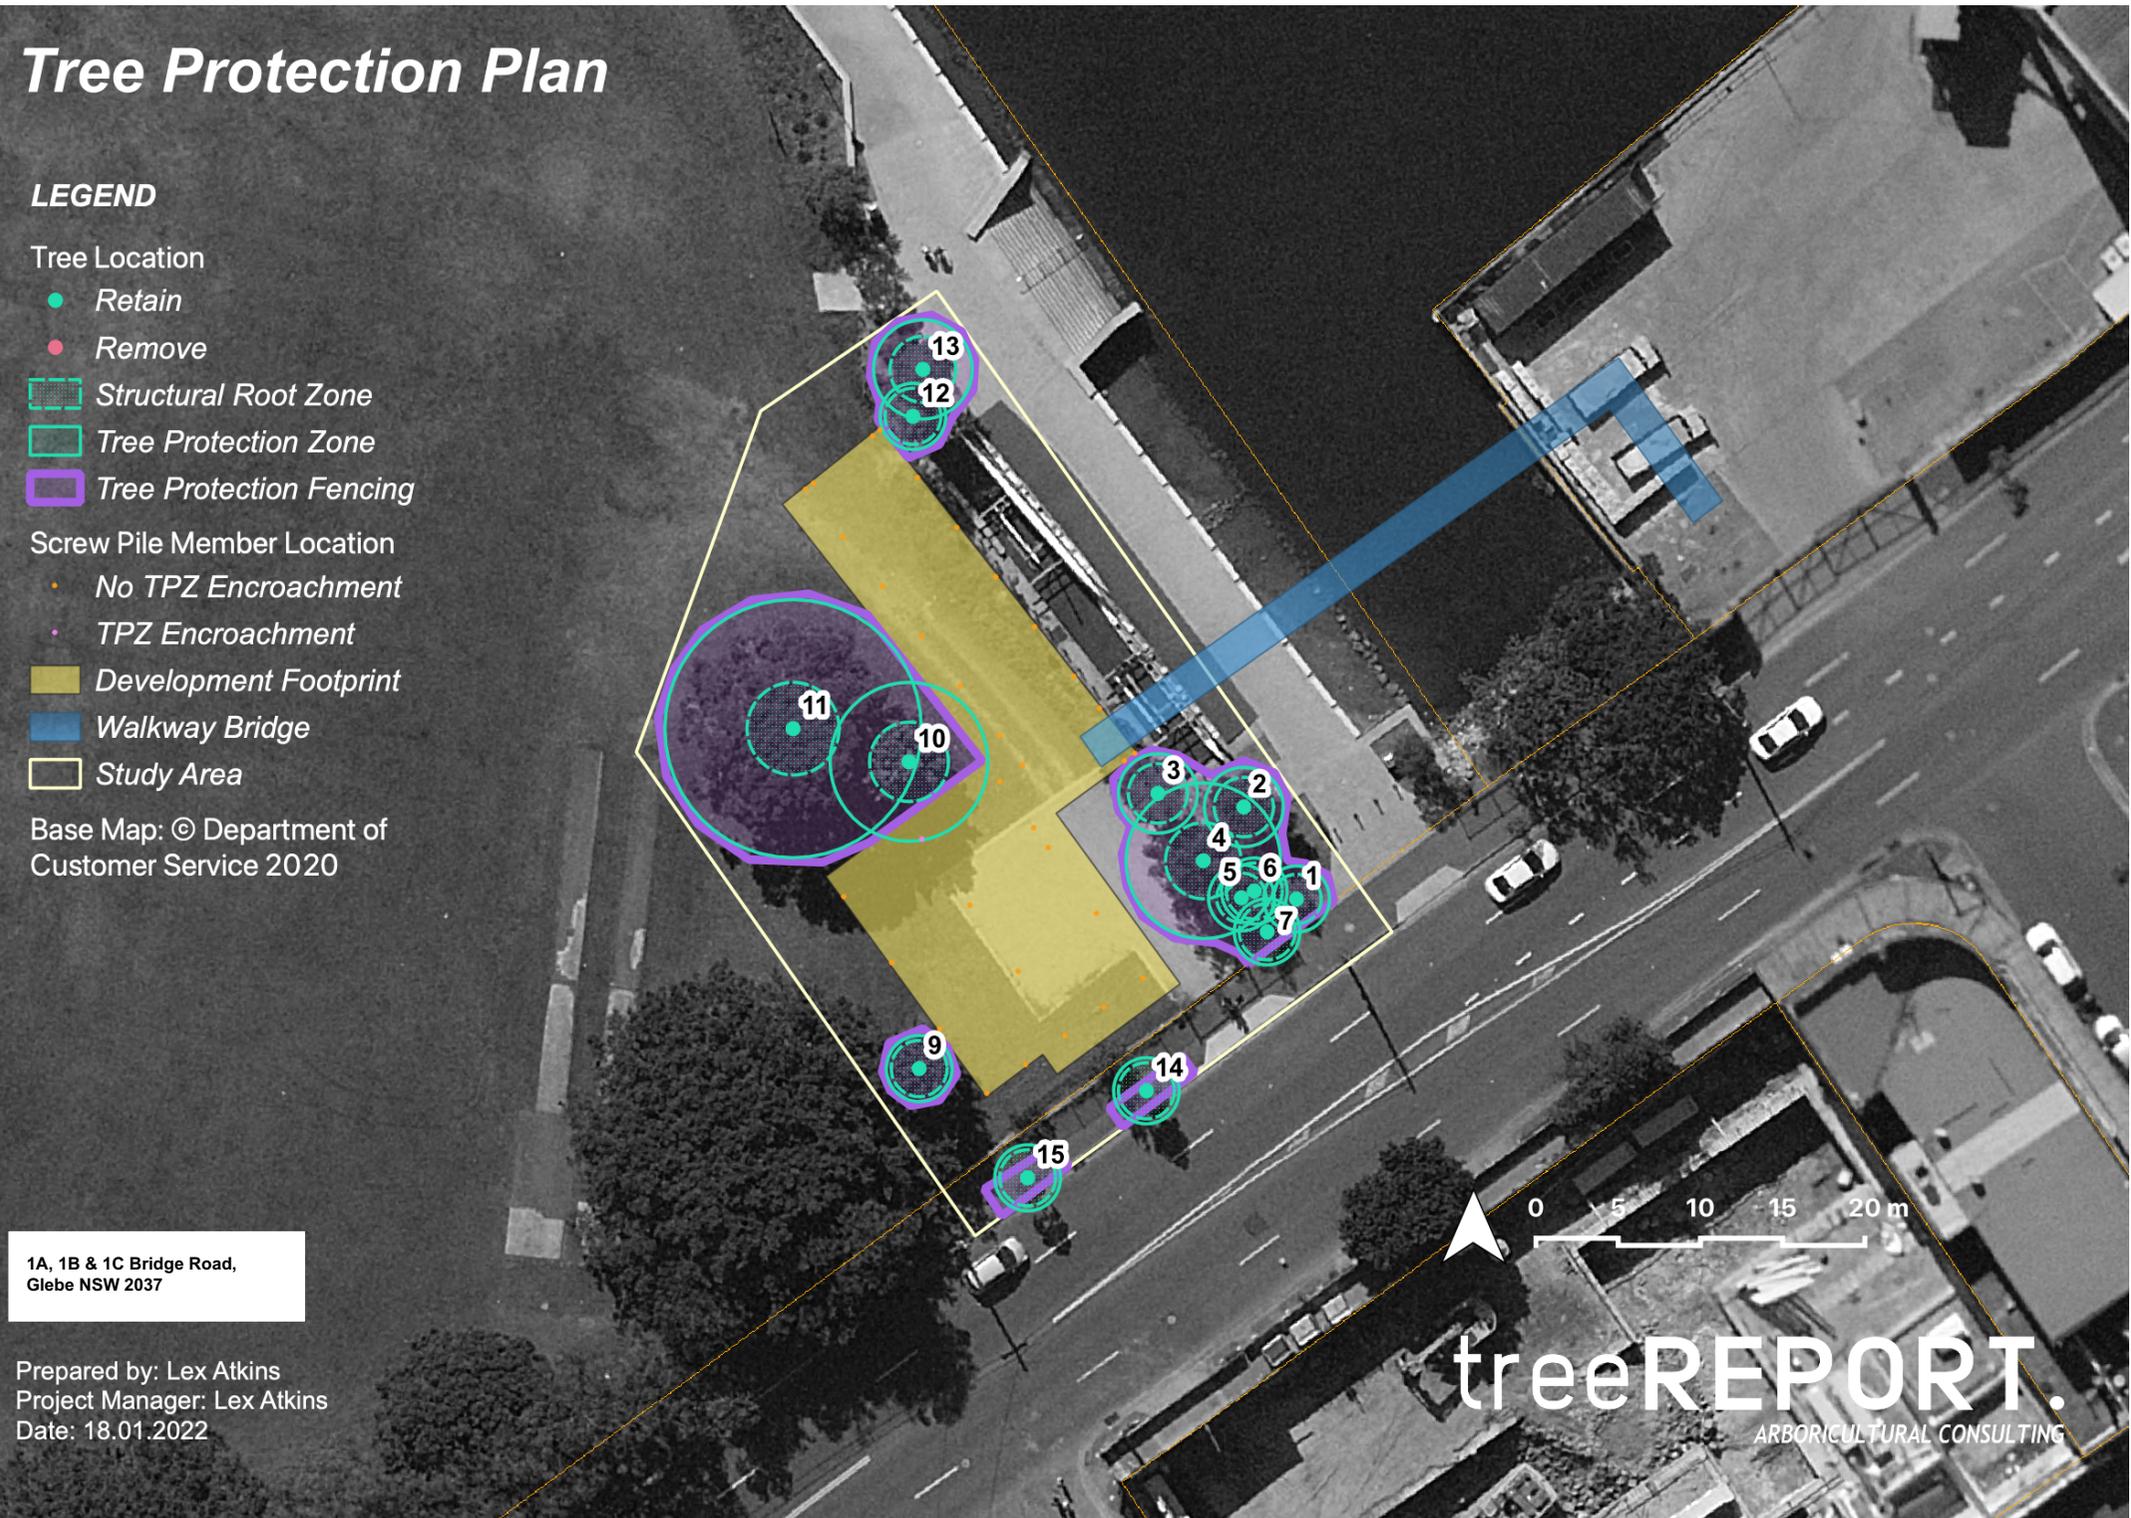
Tree Protection Plan

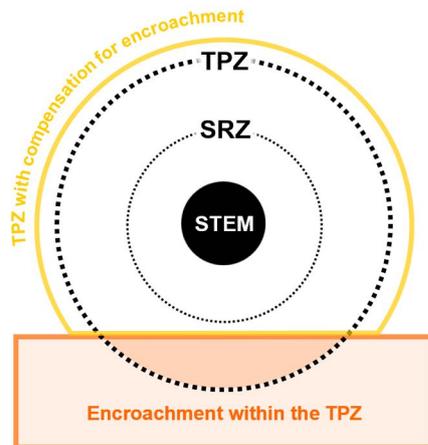
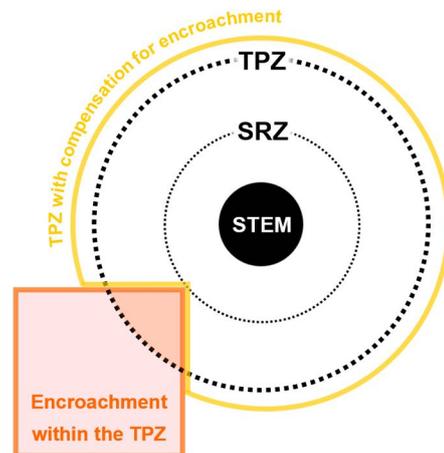
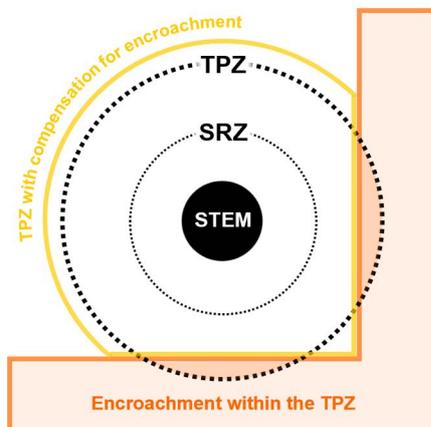
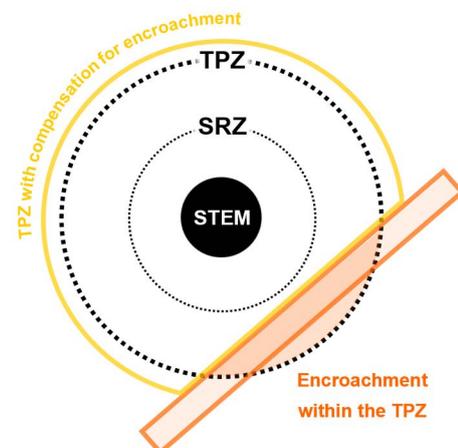
The images below show how encroachment within the tree protection zone can be compensated for elsewhere.
