CONSTRUCTION MANAGEMENT PLAN (ADDENDUM)

New Sydney Fish Market
Stage 2 Site Accommodation
Sydney Secondary College Carpark

Multiplex Constructions Pty Limited

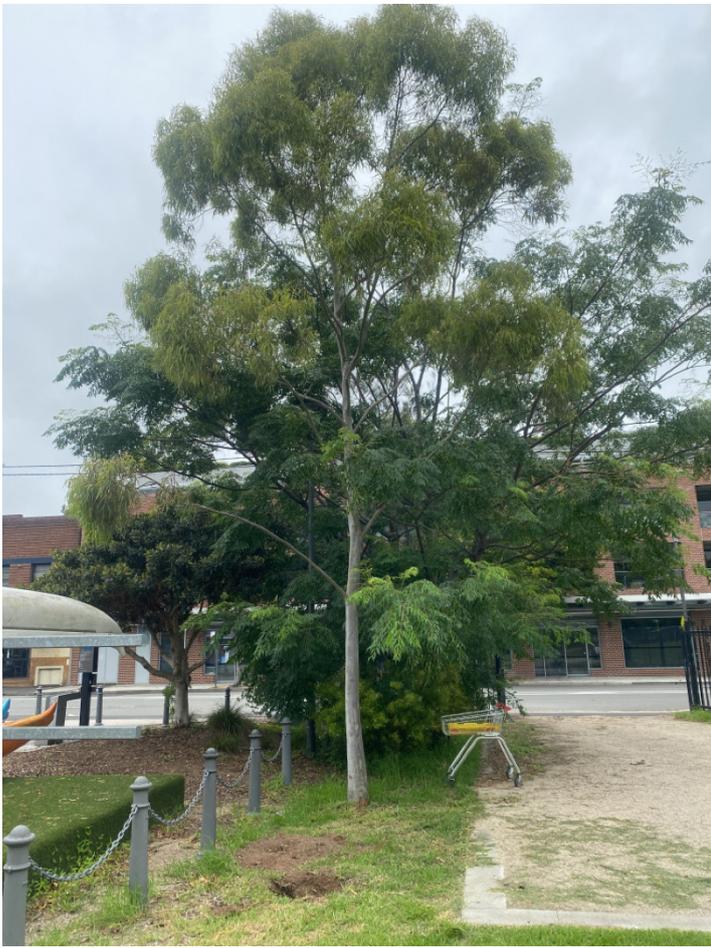
Image I: Subject Tree id. 3

A total of **two** Subject Trees (**id. 3 & 10**) will require excavation activities <20% of total TPZ area and in order to facilitate site establishment and/or construction of the site accommodation structure. These works are unlikely to have a significant impact on the Subject Tree's ability to store carbohydrates, use stored carbohydrates in times of stress and are unlikely to have a significant impact on the health, condition and/or stability of the subject trees long term.

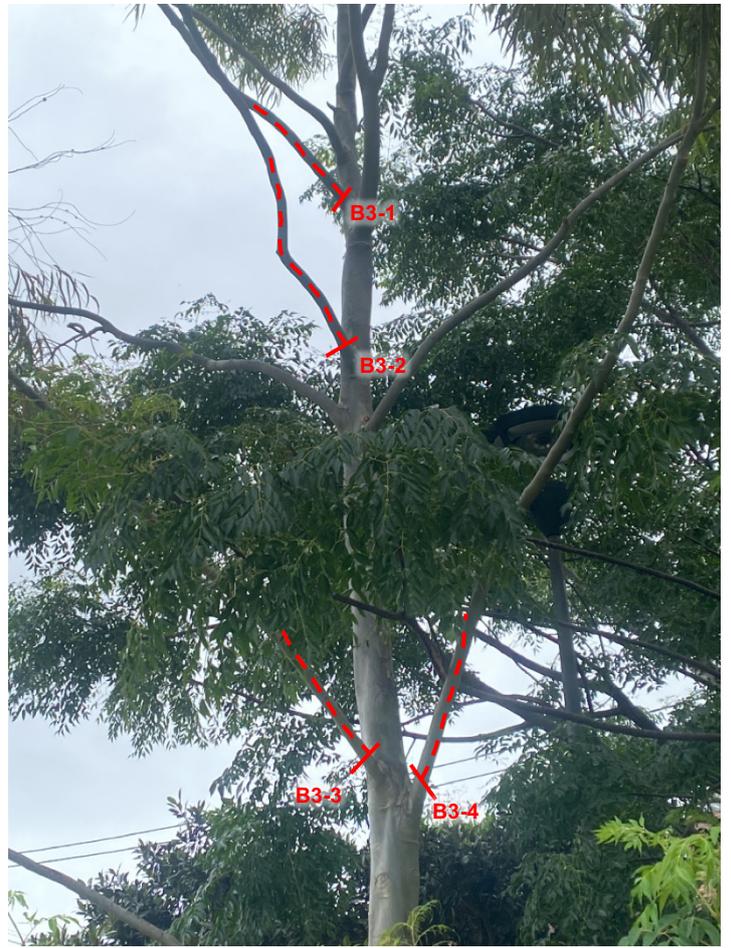
Image II: Subject Tree id. 3 indicative pruning locations

One tree (T8) will require removal, while four trees (T3, T4, T9, T10) require pruning as per the arborist advice to allow for the gantry structure. T8 will need to be removed to undertake excavation works to connect to an existing sewer junction point, where excavation work will undermine T8 which poses a safety risk for workers and the public.

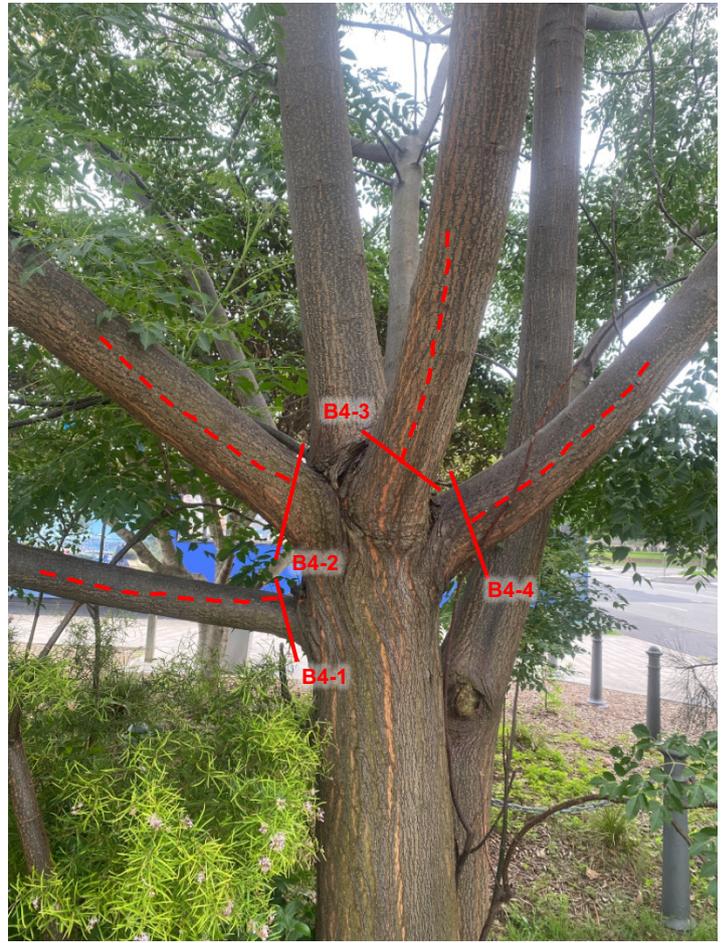
Image IV: Subject Tree id. 4 indicative pruning locations

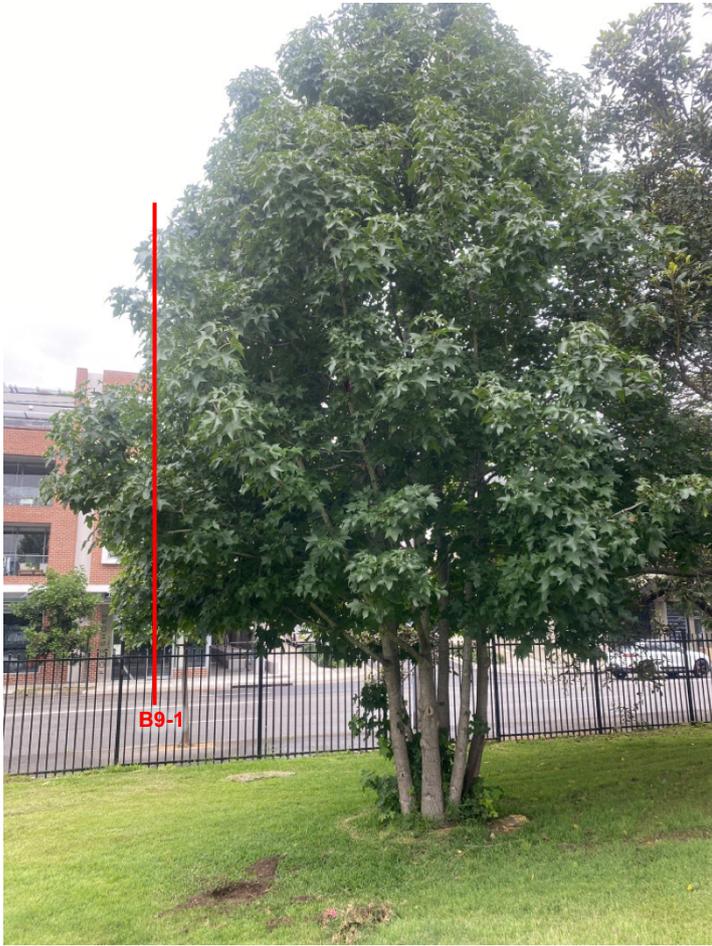
Image V: Subject Tree **id. 9** indicative terminal foliage pruning locations

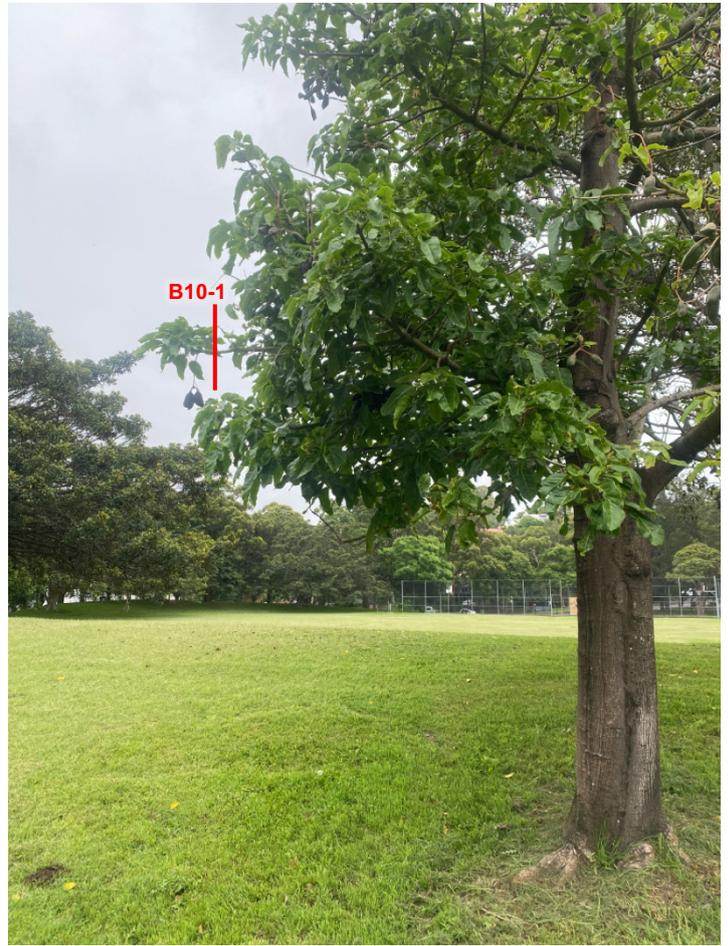
Image VI: Subject Tree **id. 10** indicative terminal foliage pruning location

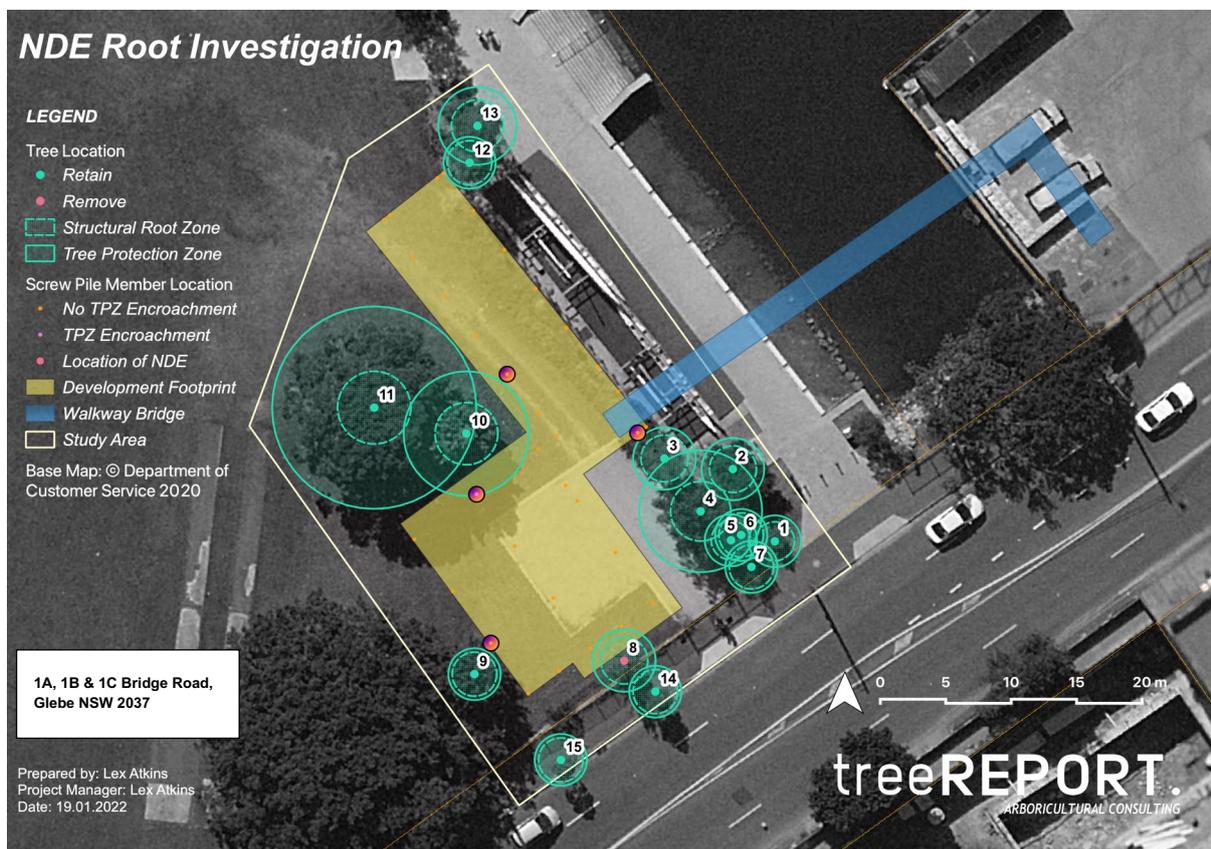
Figure 1: NDE locations

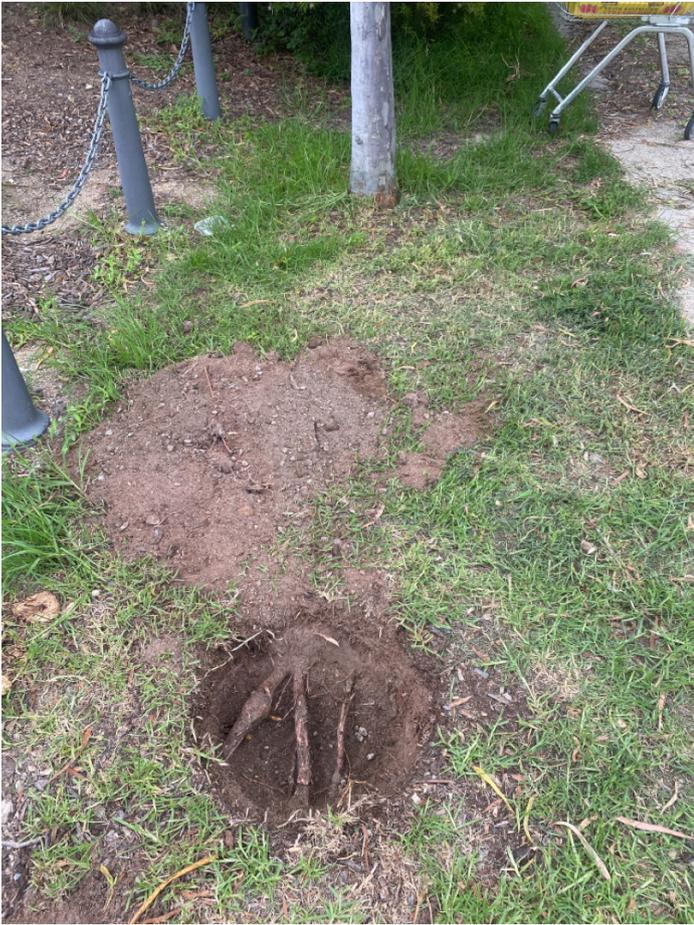
Image I: Subject Tree id. 3 in relation to NDE

*Further information following excavations via non-destructive methods adjacent to Subject Trees **id. 3, 9 & 10** can be found in **Appendix VI**.*
