# TREE ROOT MAPPING AT SIRIUS BUILDING, GLOUCESTER WALK, THE ROCKS NSW

Date: 15 April 2021 Job Number: GBGA2437

Project Number	GBGA2437	
Document Title	Tree Root Mapping at Sirius Building, Gloucester Walk, The Rocks NSW	
Site Address	Gloucester Walk, The Rocks, New South Wales	
Client Details	Ben Wilderink Senior Project Engineer Richard Crookes Constructions	
Client Address	Level 3, 4 Broadcast Way, Artarmon NSW 2064	
Contact Information	Contact Information Tel: 02 9902 4700   0419 672 839 Email: WilderinkB@richardcrookes.com.au

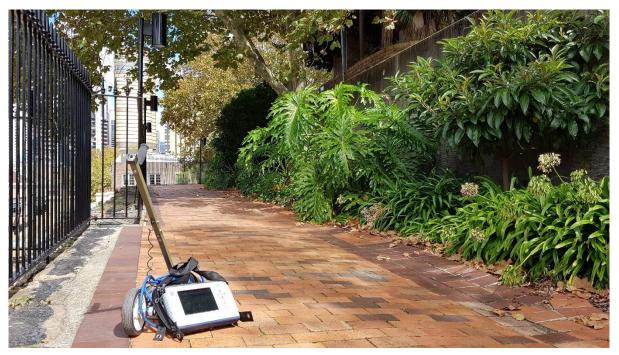
Figure 1: Ground Penetrating Radar equipment at Tree 2, looking south.

The investigation was undertaken over two 20 m long stretches of the walkway on the eastern edge of the SIRIUS building basement carpark (see Figure 1 overleaf). The purpose of the survey was to assist an arborist in determining the location and depth of the tree roots larger than 50mm diameter associated with trees 50 and 51.

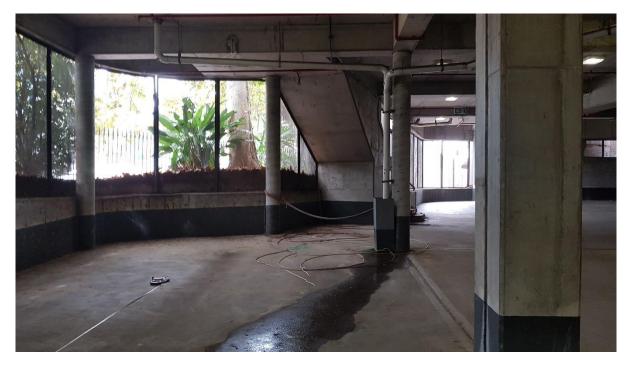
Figure 2. Tree 1 visible next to the basement. The trial was conducted on the concrete ground slab and retaining wall.

The survey data trialled in the basement (see Figure 2 overleaf) was unsuccessful. Data showed significant reinforcement that obscured the tree roots below (see **Figure 3** overleaf) therefore the trial was abandoned.

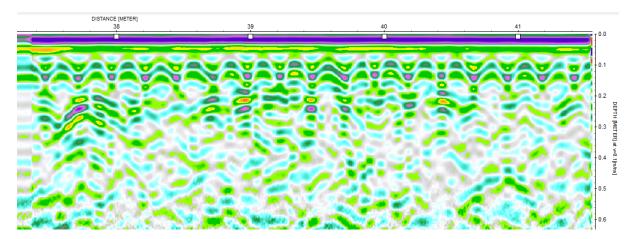
Figure 3: Reinforcement detail in the concrete obscuring tree root detail below.

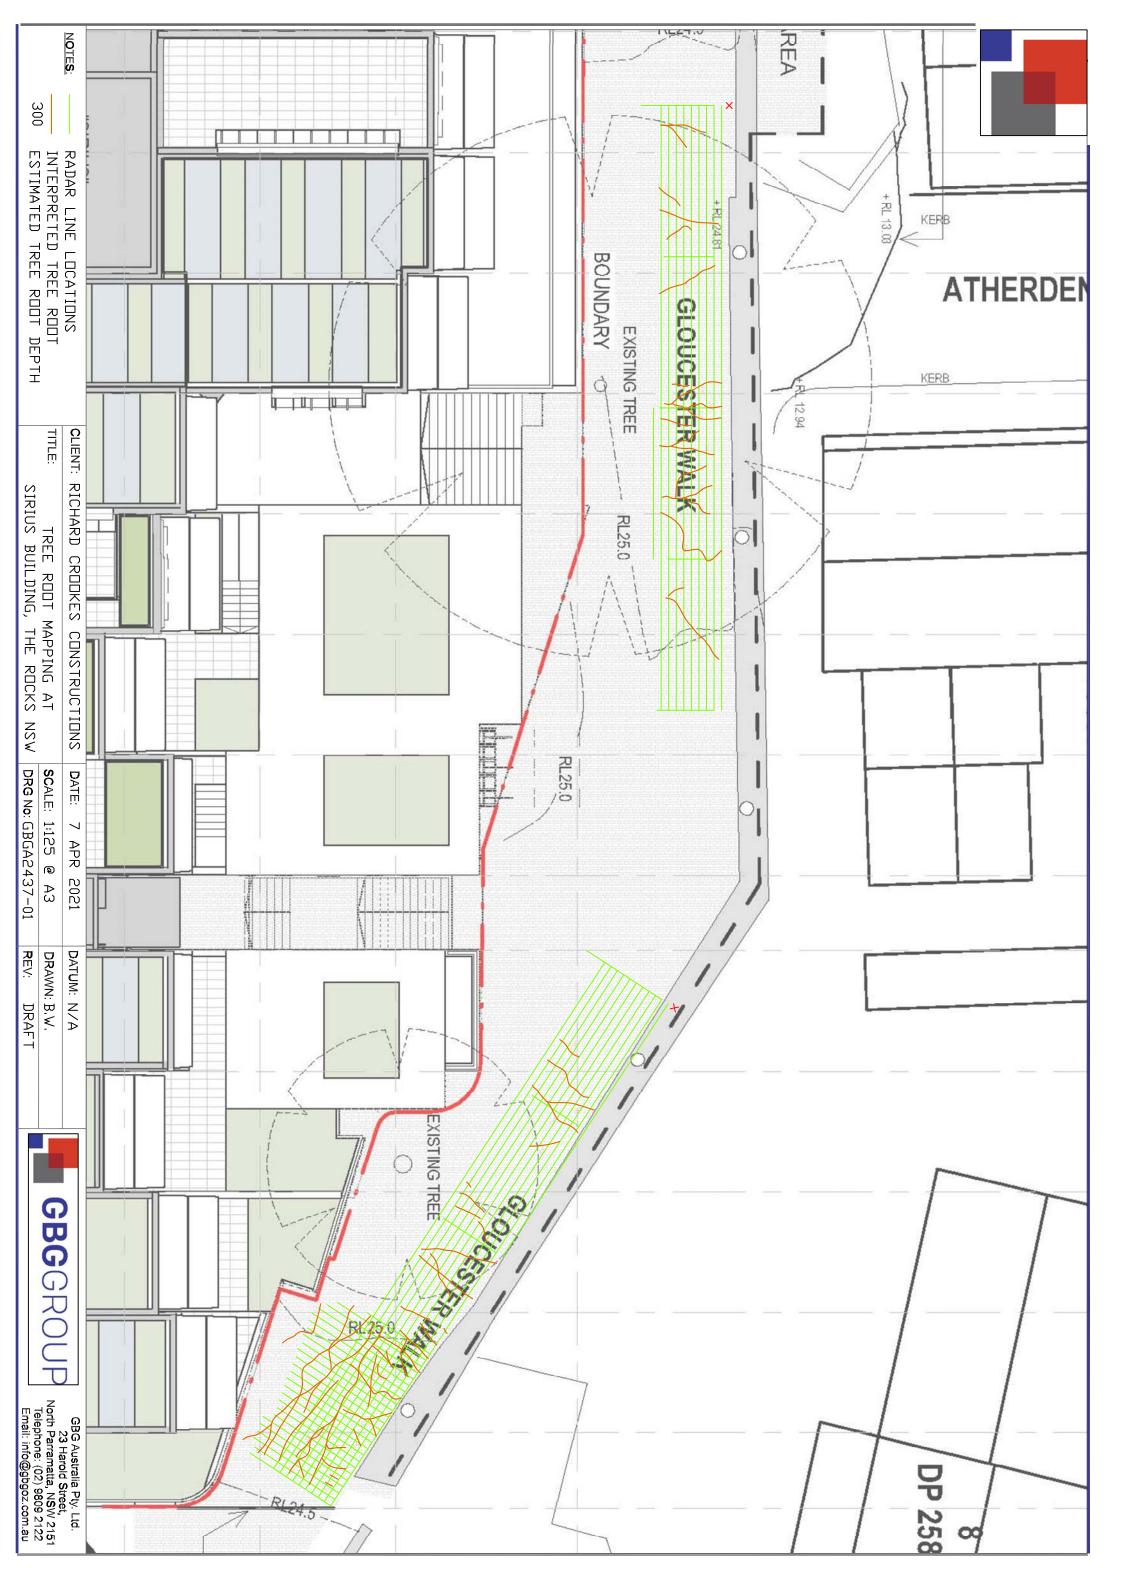
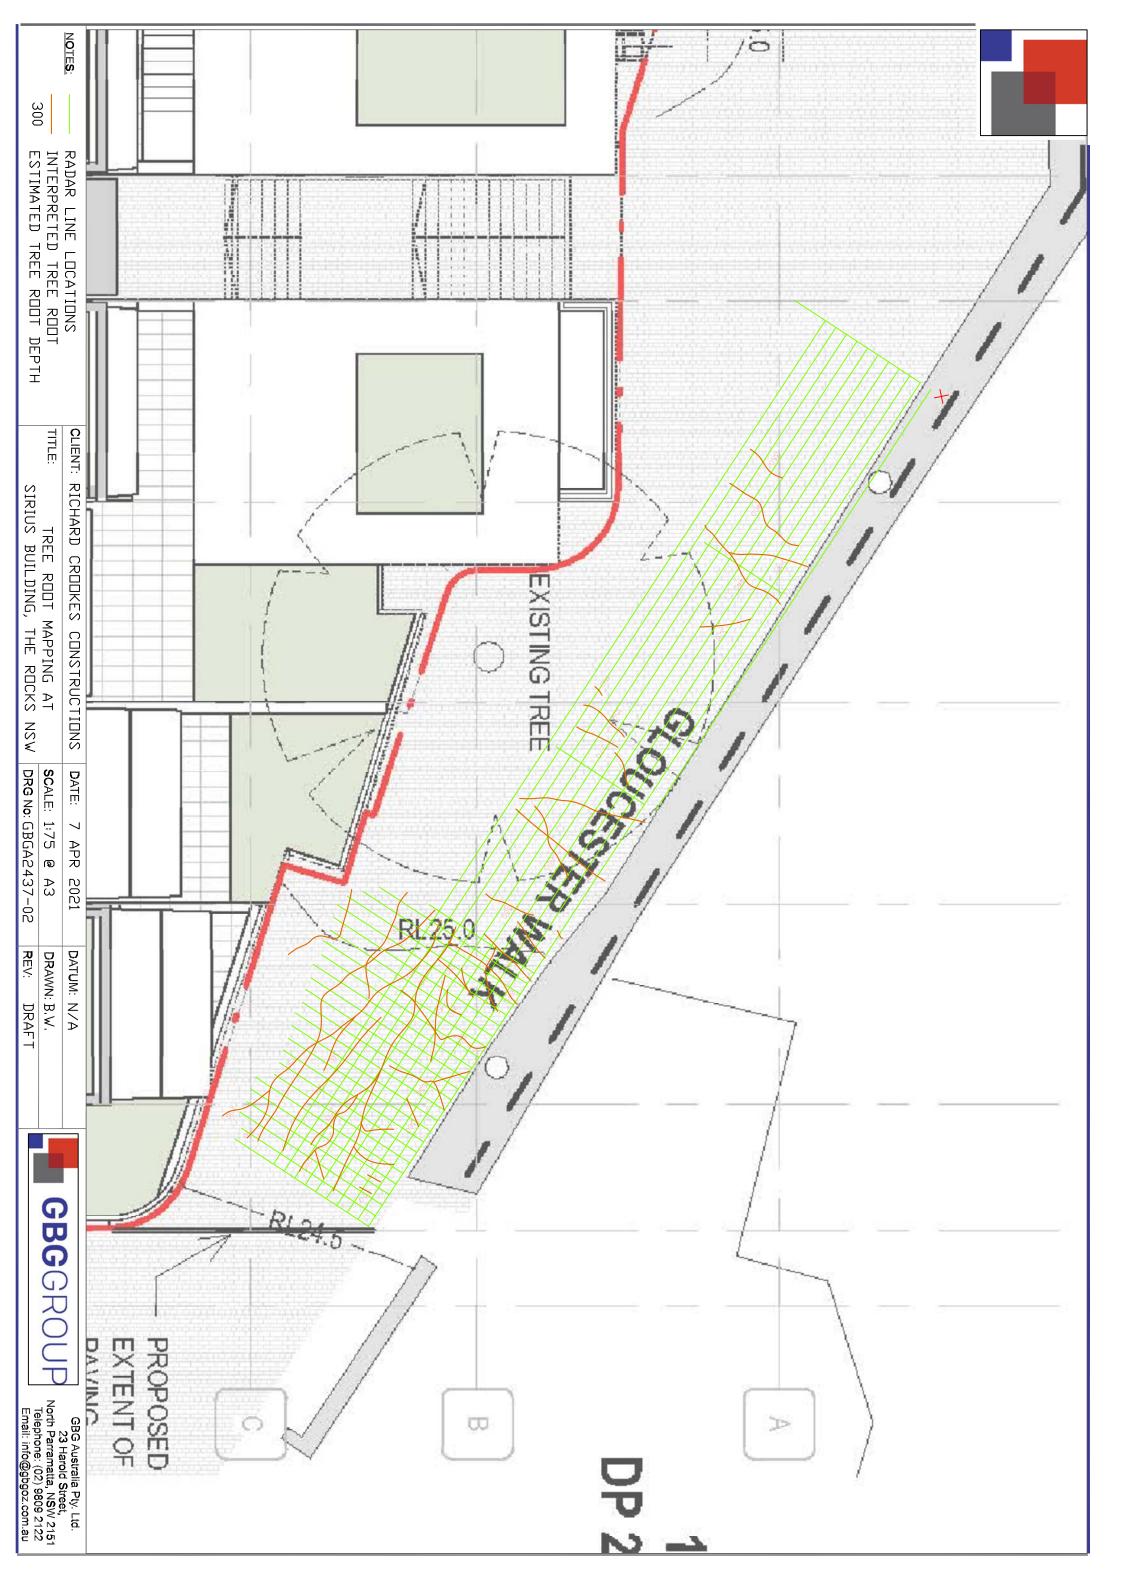
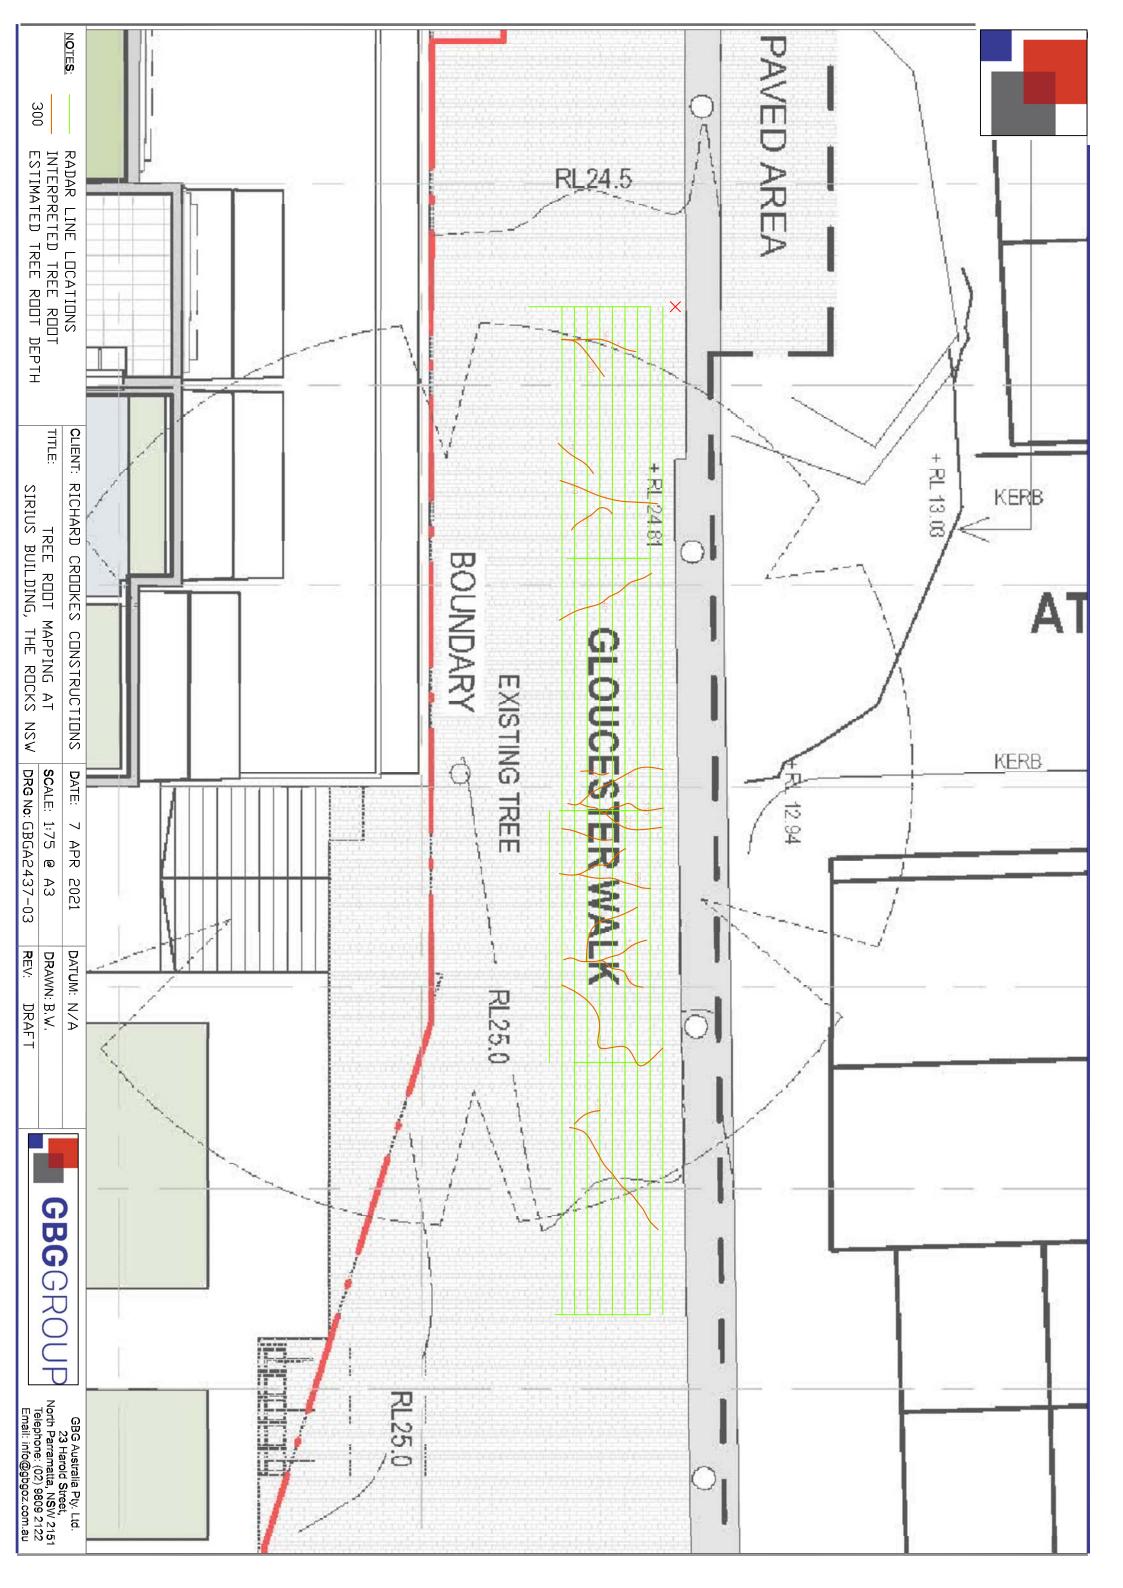
- GBGA2437-01 Tree Root Mapping
- GBGA2437-02 Tree Root Mapping Tree 1
- GBGA2437-03 Tree Root Mapping Tree 2

Survey lines are shown in green, and the interpreted tree root locations are shown in brown. Estimated depth to the top of the tree roots is shown next to the tree roots.

Interpreted roots have been mapped to the target Tree. These roots may emanate from the target tree, or possibly be roots from other trees near the survey area. Despite the analyst's best efforts in determining which root belongs to each tree, it must be noted that due to the nature of tree roots, it is not always possible to do so. It is not possible to gain information on the sizes (Diameters) of different tree roots. However, we know that the highest resolution system, 900MHz frequency, will not image targets less than 50 mm in diameter. As a result, only interpreted larger roots have been plotted. Depths to the identified tree roots in millimetres are shown alongside the plotted root in brown. Depths quoted in this investigation have been calculated using an un-calibrated radar wave velocity. The typical radar wave speed through the subsurface can vary considerably depending on the soil type, moisture content and various surface materials. As such without calibration, we would expect an accuracy of  $\pm 20\%$  of quoted depths.

A number of tree roots have been mapped. These appear to emanate from the respective target trees.
