**INDEPENDENT TRAFFIC AUDIT REPORT OF  
ORICA ANE PRODUCTION FACILITY  
AT 1151 GEORGE BOOTH DRIVE, KURRI KURRI**

**Development Type:** Orica ANE Production Facility

**Site Address:** 1151 George Booth Drive, Kurri Kurri

**Document reference:** 210030.01FB

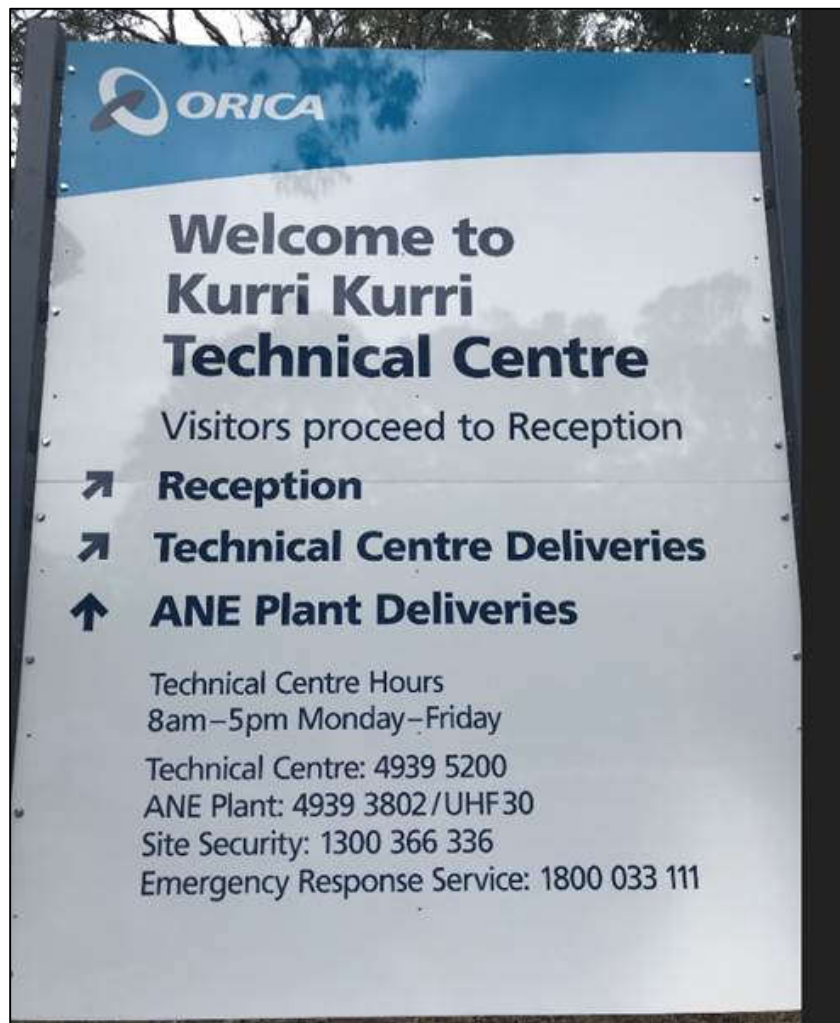
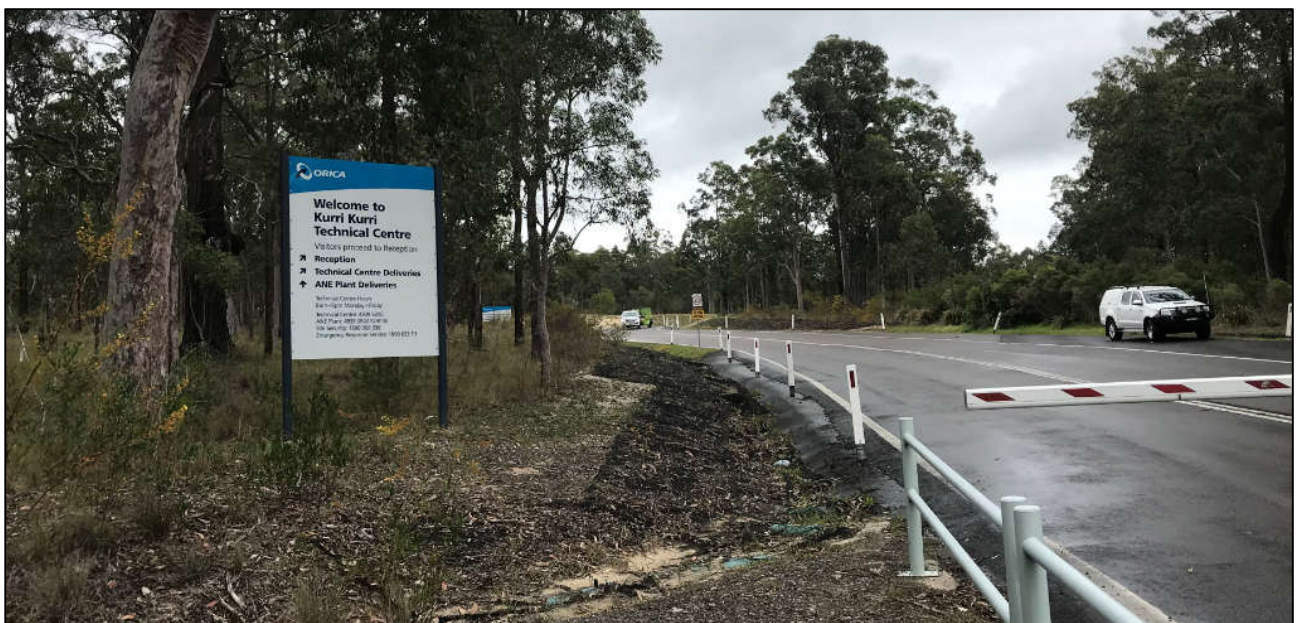
It is observed that the Orica Emergency Response Service phone number is advertised via signage at ORICA's site entrance on George Booth Drive, see photos below.

Further, it is noted that the ORICA's Emergency Response Service contact phone number and *Heavy Vehicle Road Transport Protocol* is available on ORICA's website.

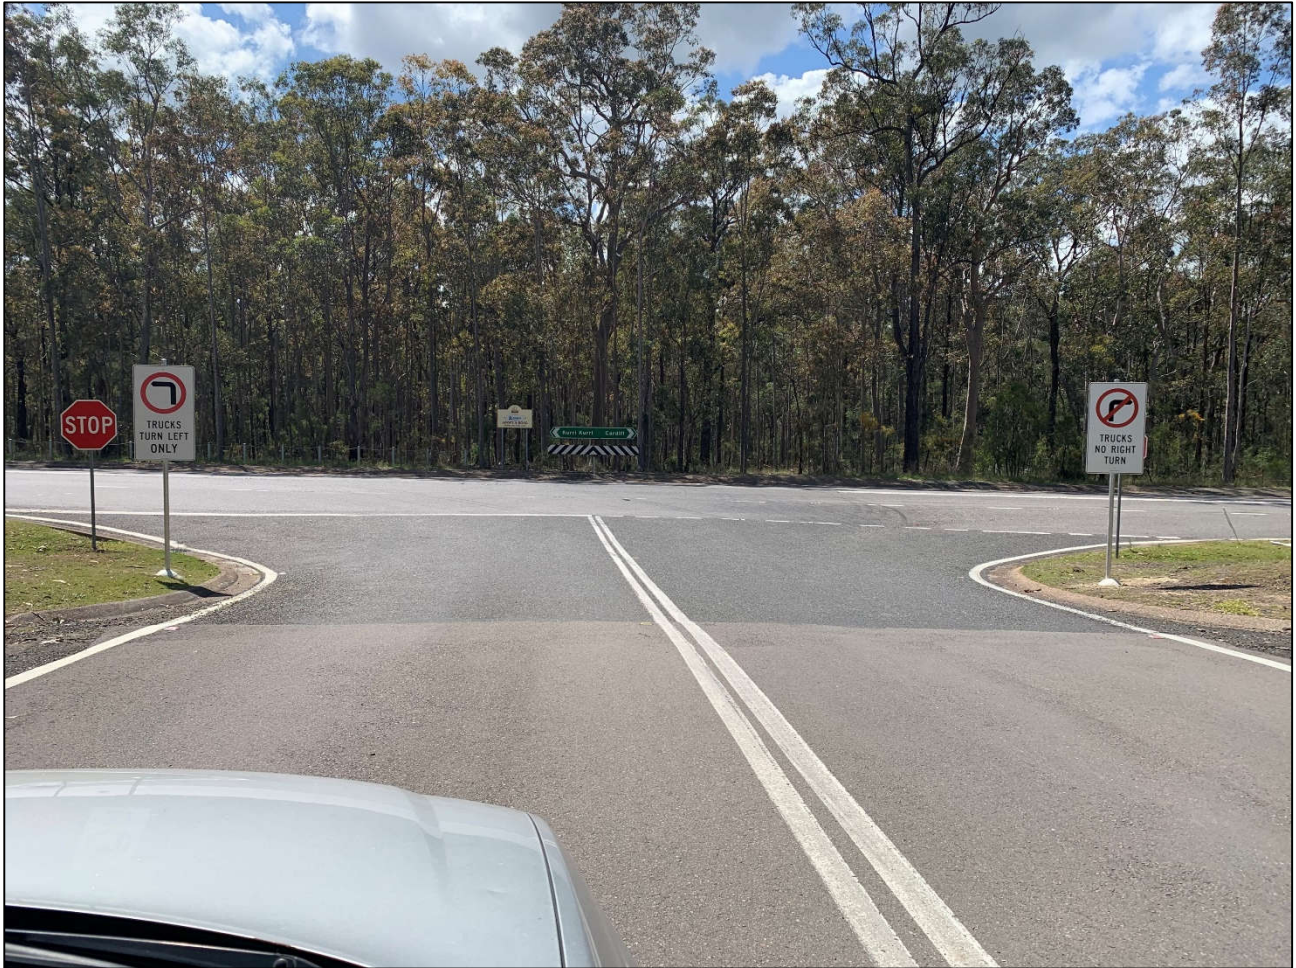
Recent signage, since last traffic audit, has been installed at the site entrance from George Booth Drive, Richmond Vale that prohibits trucks from turning right onto the public road when departing the site, as shown in the image below. This is supported to further emphasis the appropriate and controlled departure route consistent with the DCC.

- No adverse impact on the surrounding road network or intersections from the development was noted from incidence records. Trucks are prohibited, via recently installed signage, from turning right into George Booth Drive when departing the site.

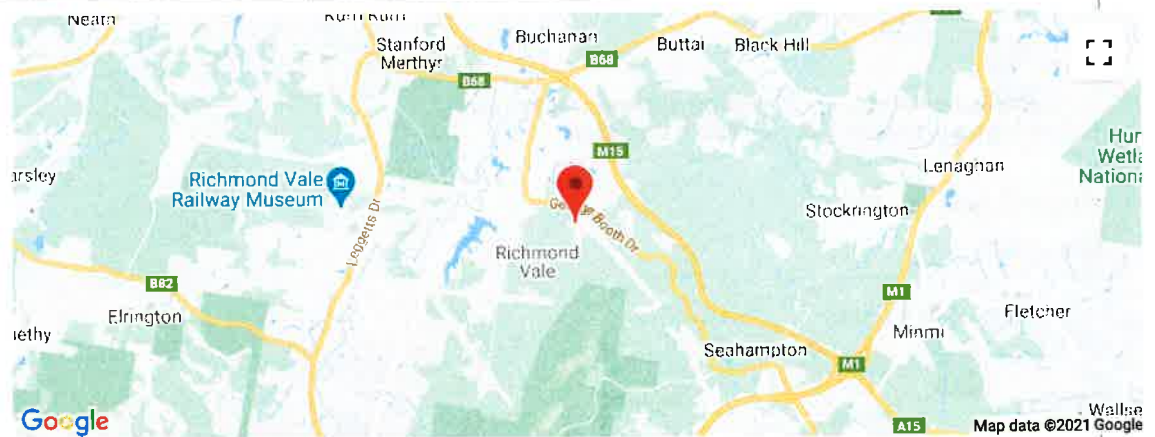
Report (Site language) Orica Supervisor seen McColls truck carrying ISO of E25 parked on George Booth drive when travelling to site at approximately 03:00 hrs. Truck was parked off the road opposite Orica site. Supervisor returned soon after & attempted to wake Driver but received no response. Driver awoke & attended site at approximately 06:00 hrs. When questioned why he was parked on GBD & if he was aware that he was not allowed to park on GBD the Driver replied yes to both questions. He stated that he had parked there so he could be onsite at the assigned delivery time of 06:00 hrs.

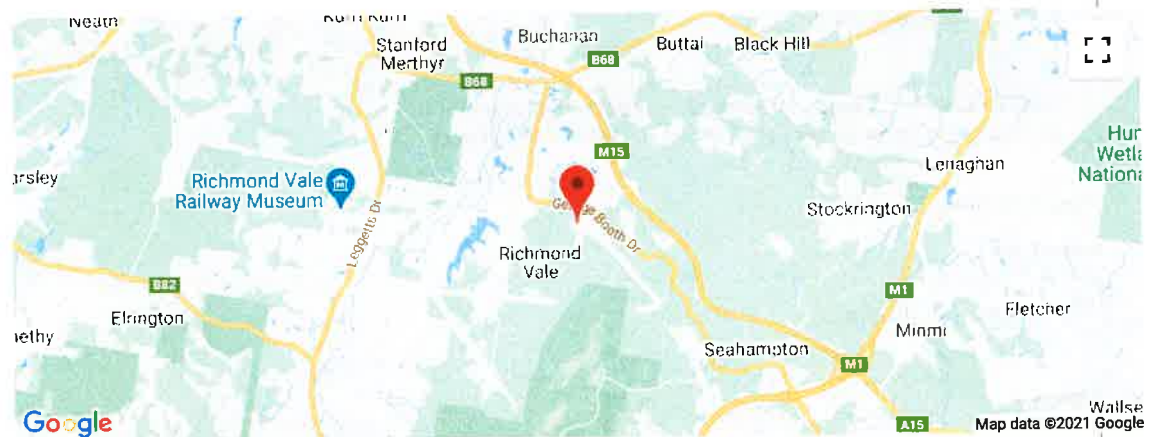
Report (Site language) Orica Operator witnessed a McColls vehicle towing an ISO on George Booth drive heading towards Sea Hampton while on his way to work & reported to Supervisor.  
McColls vehicle had delivered load of Emulsifier & left site just prior to report.  
Travel via this route is a breach of our Road Transport Protocol & our Licence to Operate.

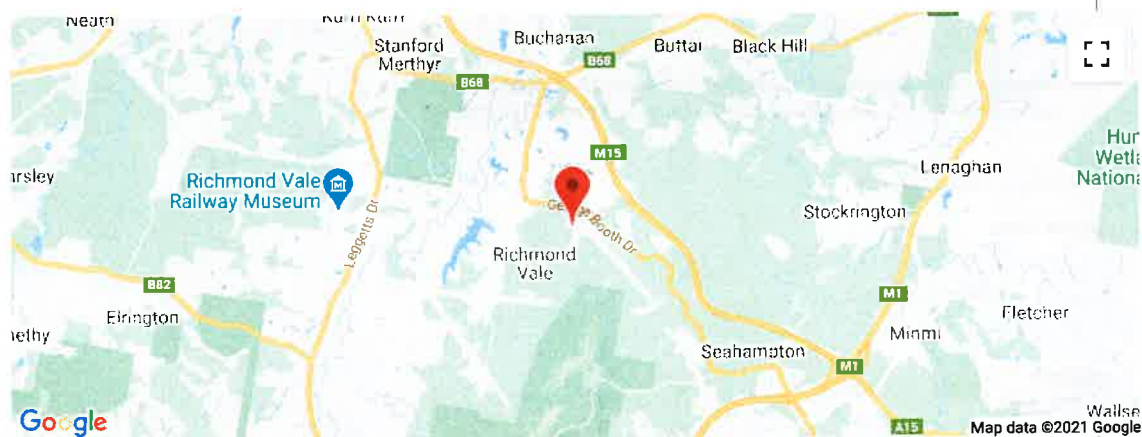
Report (Site language) Orica employee observed McColl's truck parked on GBD across road from Orica site at 05:00 am. Truck remained there until approximately 08:00 when he contacted control room to gain entry to site.

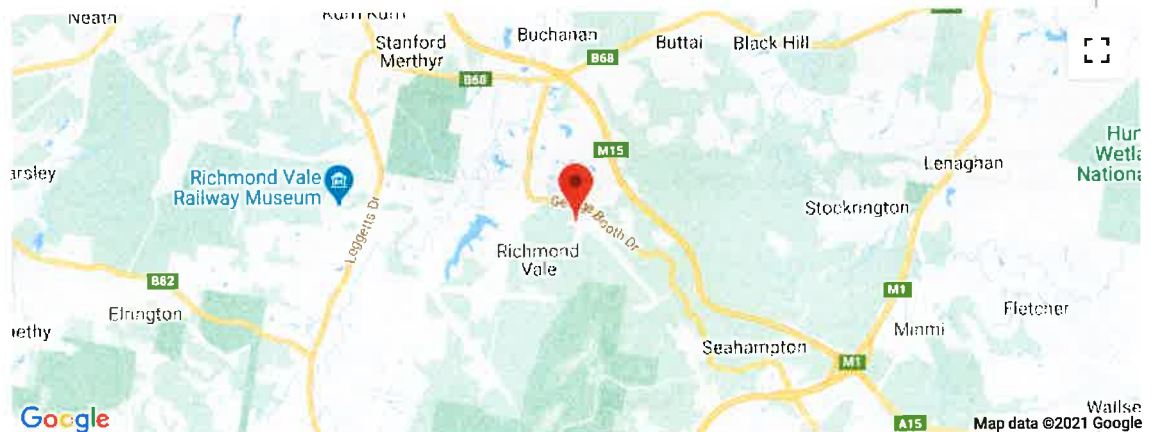
Report (Site language) Rocky's Own truck loaded at ANE Plant. After departing plant at 12 noon, while traveling along George Booth Drive the vehicle has malfunctioned. The Driver was able to get the vehicle off the road into a position where no safety hazard was caused to traffic & could be worked on safely. No public complaints received. Information only.

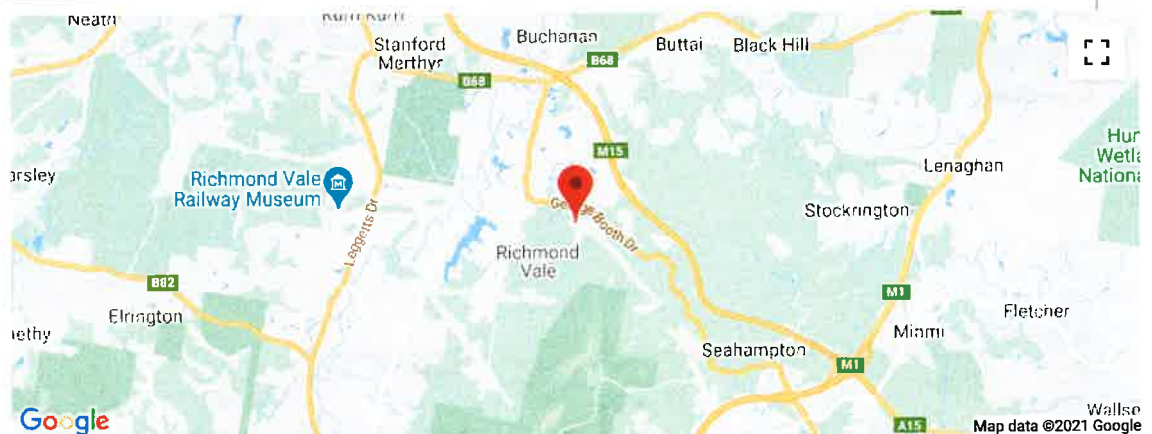
Report (Site language) Driver parked on George booth driver to have his allotted break before entering site to unload.
