Construction Monitoring Report - Landfill Leachate Gas and Odour

December 2021

Project: Sydney Gateway Road Project

Document No: SGWPW-JHSW-NWW-EN-RPT-059163

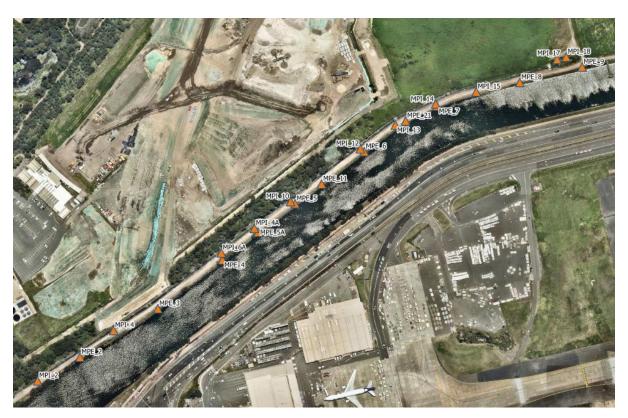
Figure 1, Leachate monitoring well sampling locations.

The leachate monitoring wells were sampled in accordance with the leachate analyte criteria detailed in Appendix A of the LLGOMP. The Location of monitoring wells are shown in Figure 1. The adopted analyte suite is listed in Table 1. Data captured during monitoring was assessed against the baseline groundwater quality maxima as detailed in Table 2.

Wells GW7 and GW8 were not sampled during the reporting period as they were either lost or destroyed as part on earthworks within Tempe tip, both wells are located within the new road alignment. JHSW is currently working through any necessary action regarding the sampling of alternative wells or the installation of new wells.

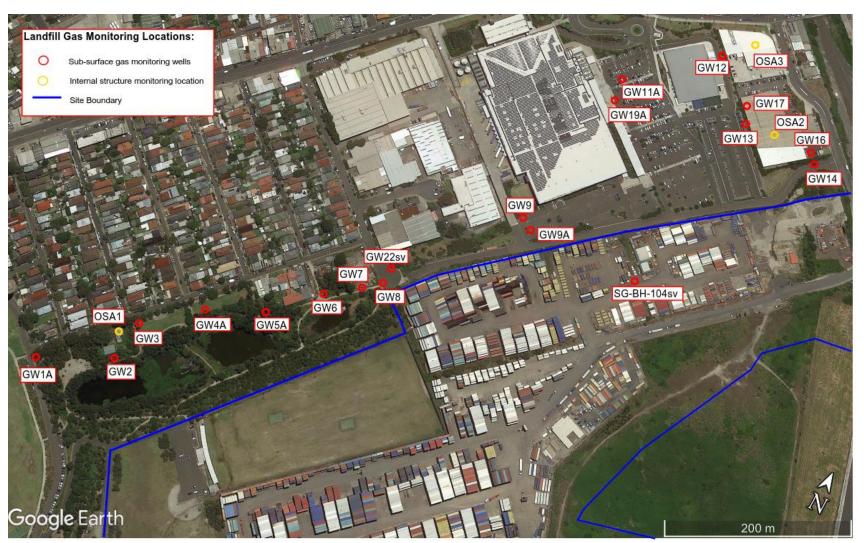
Figure 2: Monthly offsite landfill gas monitoring locations

Monthly gas monitoring of the sub-surface wells including gas accumulation monitoring in offsite buildings was undertaken at locations shown in Figure 2. Results of monitoring are detailed in Table 4.

Gas accumulation monitoring was also undertaken within onsite buildings and the three nominated offsite assessment locations shown in Figure 2 during the reporting period. All readings were compliant with the adopted assessment criteria.

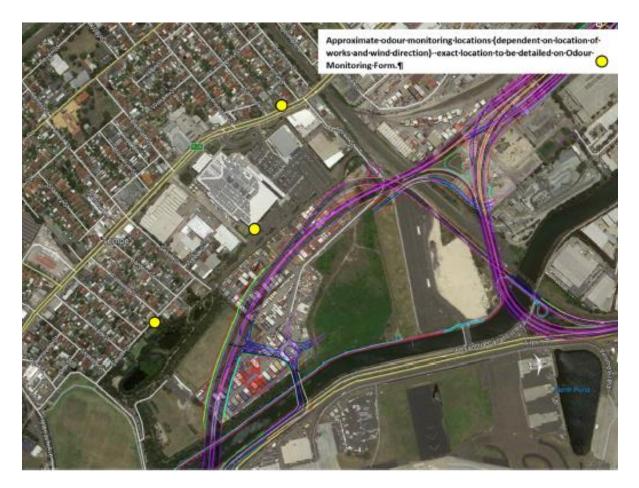
Figure 4, Indicative offsite odour monitoring locations

Odour monitoring was undertaken during the reporting period. All active work areas and stockpiles onsite were inspected twice daily, as well as the site boundary. Where odour was recorded at >2OU at the site boundary, offsite monitoring was undertaken downwind at the most effected receiver depicted in Figure 4. Odour monitoring results are detailed within Table 7.
