Arboricultural Impact Assessment

M6 Motorway Stage 1
197-201 Coward Street
MASCOT NSW 2020

CDS reference: M6S1-CGU-NWW-CMPR-PLN-024001

Revision 4

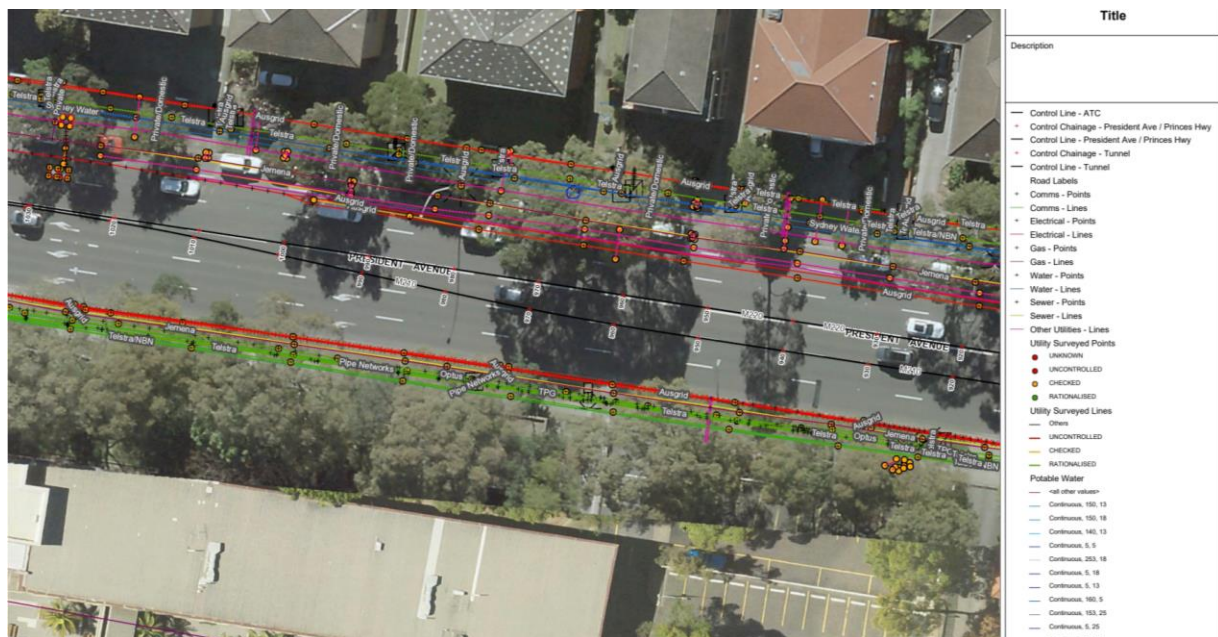
Figure 2 – Existing services on President Avenue (between Cross Lane and Cross Street)

The project utility services were considered to be placed in the roadway in order to retain existing street trees on the south side of President Avenue. However due to the existing gas asset, (Jemena pipeline), and other utilities, the project services must be installed outside the roadway on the southern side, between the TAFE, private residential property and the road verge. Refer to Figure 2 for locations of existing services on President Avenue.

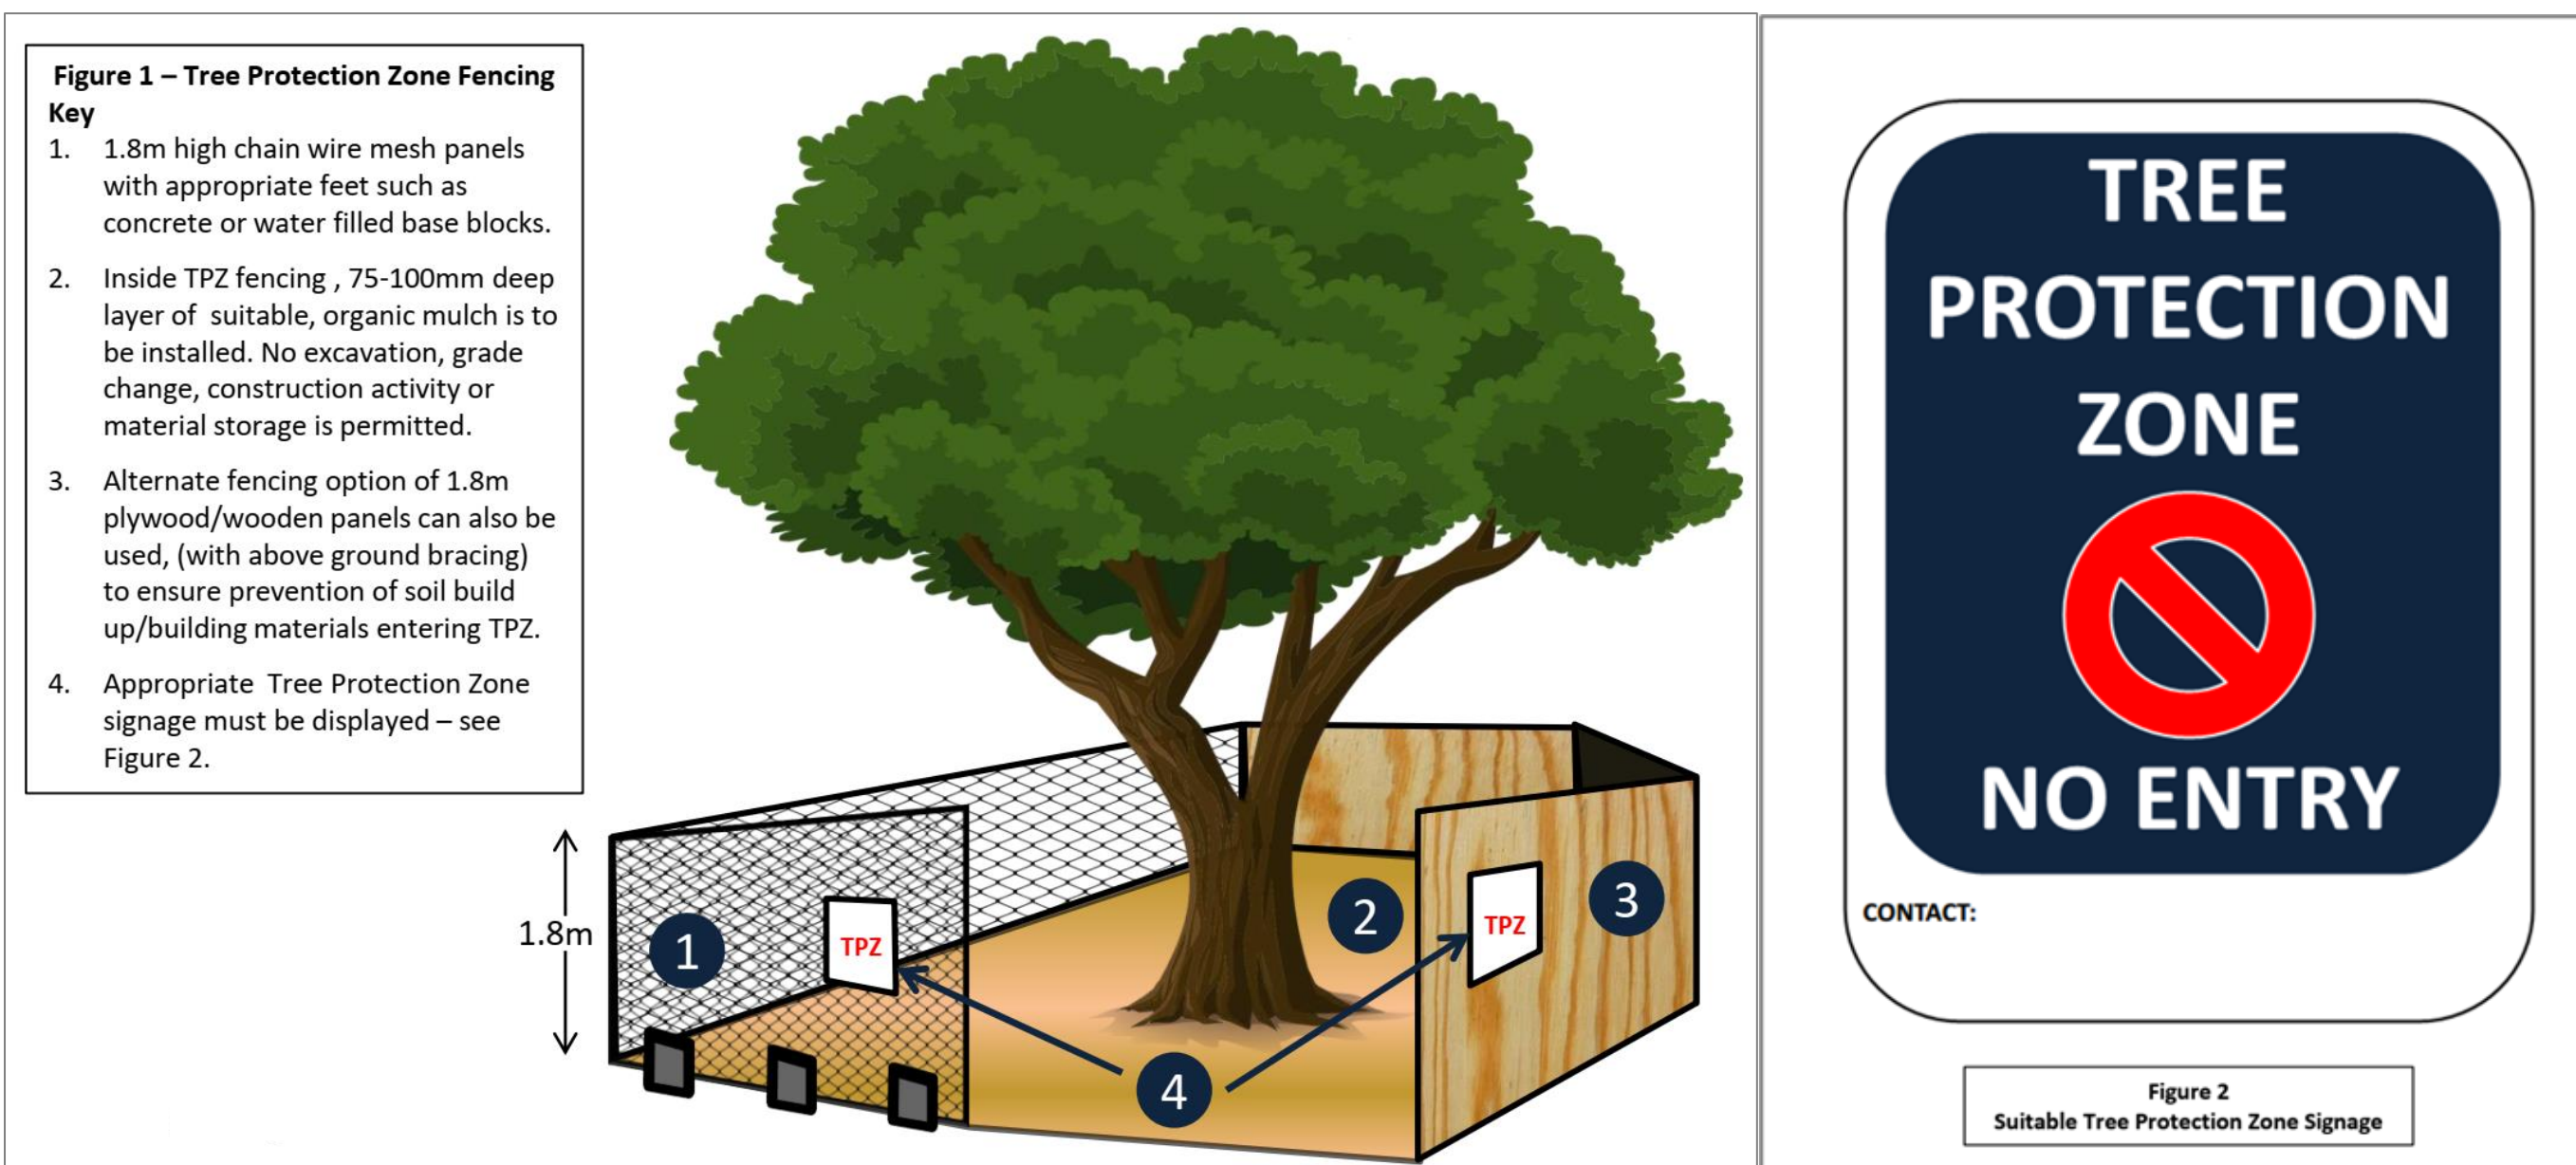
Figures 1 & 2 – Tree Protection Fencing and appropriate signage.

Figure 3 - Stem, Branch & Ground protection measures

Key

1. Padding (such as geotextile membrane, natural hessian, rubber, or carpet to protect bark).
2. Battens/boards for branch/stem protection, strapped together NOT nailed into bark/tree. Minimum 2m in height on stem where feasible.
3. Ground protection base 75-100mm of fit for purpose mulch.
4. If machinery is required to move within the TPZ then steel rumble boards (4a) or wide, timber sheeting/boards thrashed together (4b) is to be placed over mulch layer (preferably with geotextile base layer), this to spread the weight and minimise soil compaction
