AAJV Ref: SYD16081

**RE: Windsor Bridge Replacement Project; Archaeological Management Strategy for Barrel Drain Relating to Construction of Water Pipelines**

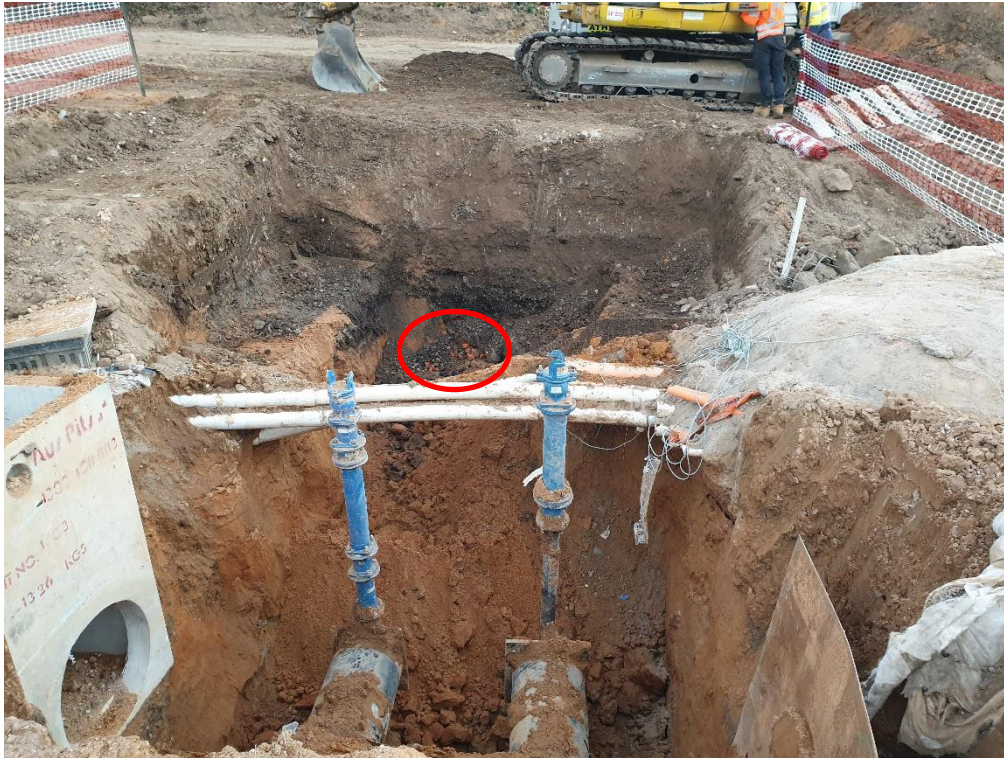
**Figure 1** West facing view showing condition of trench upon arrival at site. Note brick fragments circled in red.

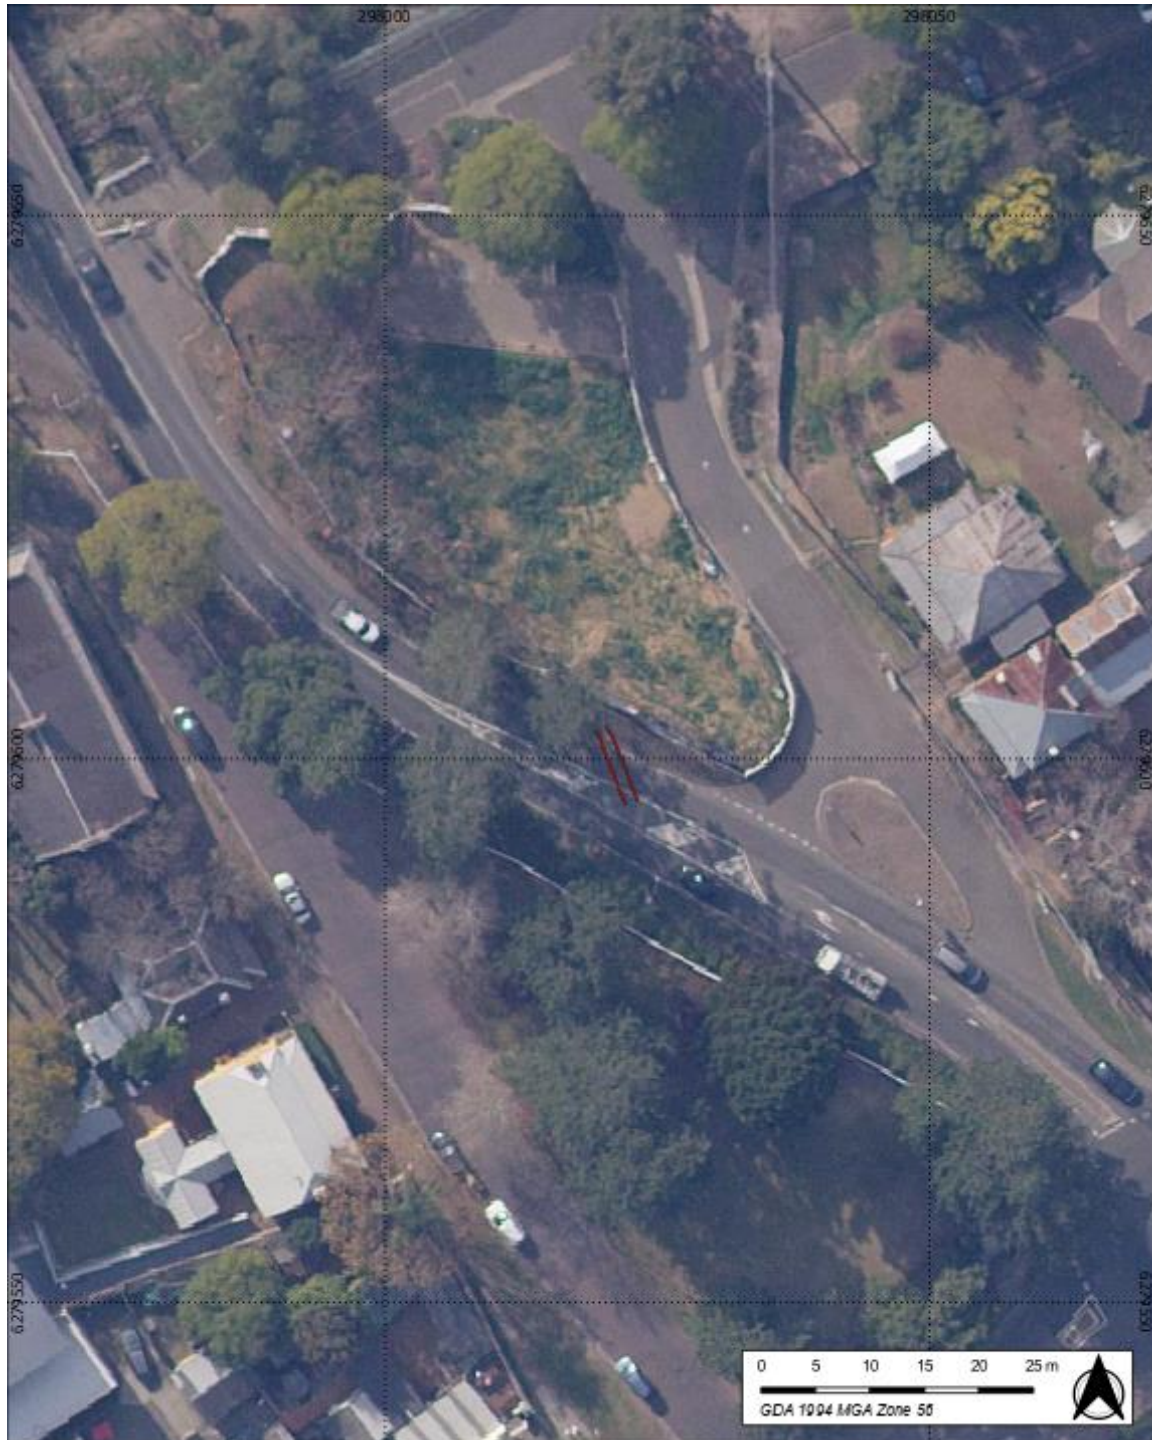
By the completion of the archaeological investigations, a length of 7.42 metres of drain had been exposed, which is the length that will be affected by the installation of the two watermain plus an adjacent council recycled water main (Figure 2 and Figure 3). The barrel drain had been heavily impacted by construction of the Bridge Street cutting in the 1930s, which had truncated the upper courses of the drain with the exception of one section at the northern end where part of the upper curve remained (Figure 4).

**Figure 2** Preliminary plan showing location of barrel drain marked in red.

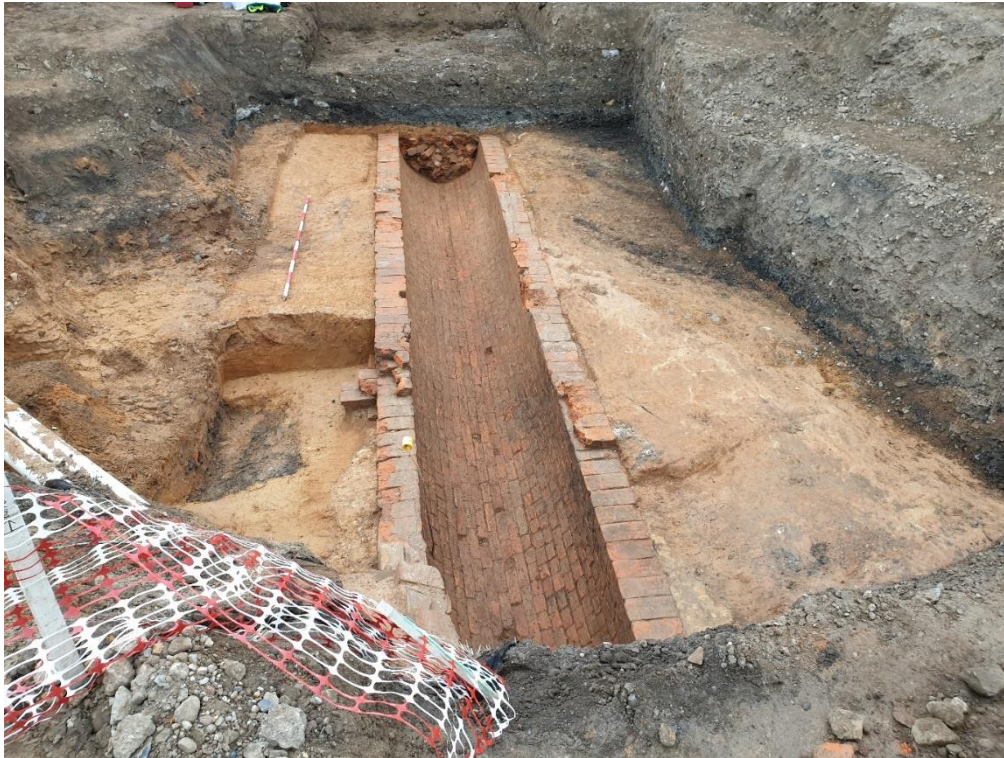
**Figure 3** South-west facing view looking along the length of exposed drain.

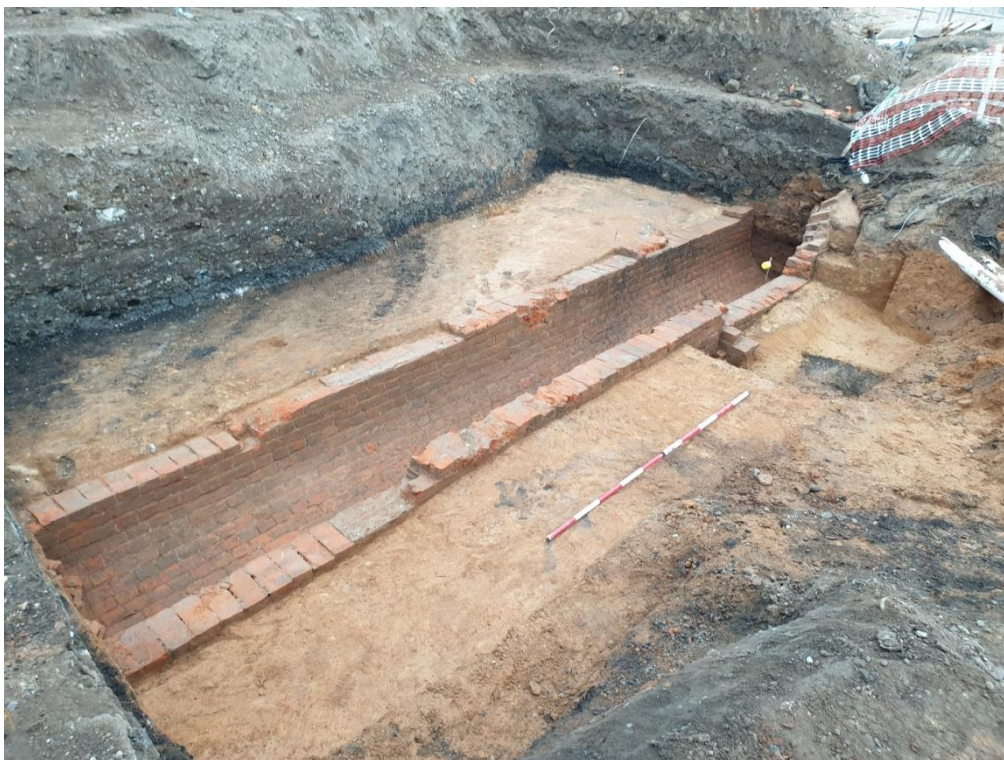
**Figure 4** East facing view showing the length of exposed drain. Note the remnant of the curve of the upper part of the eastern wall.

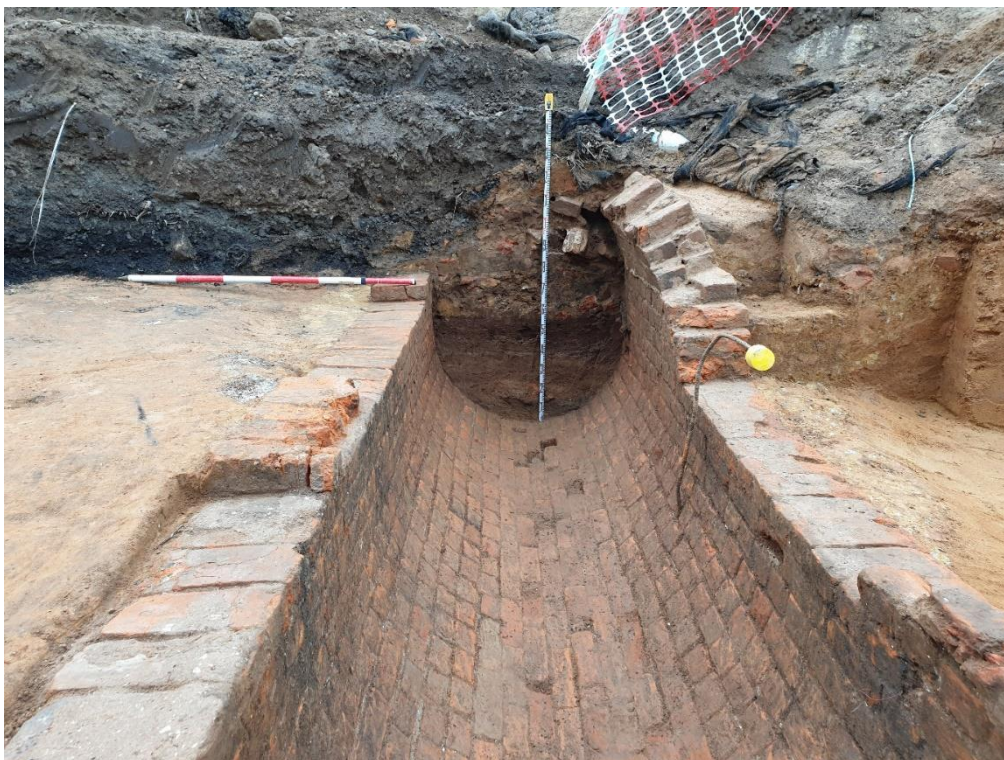
**Figure 5** North-east facing view showing the south-facing section with curve of drain truncated by Bridge Street cutting.

The length of drain which forms the unexpected find has been heavily impacted by the construction of the Bridge Street cutting, which has removed at least half the circumference of the drain. While the recently identified section of drain meets the criteria for State significance, there are better preserved sections that illustrate the significance of the barrel drain to a higher degree. The condition of the portion within the study area has reduced significance due to its lack of intactness, which impacts its aesthetic, representative, and rarity values.

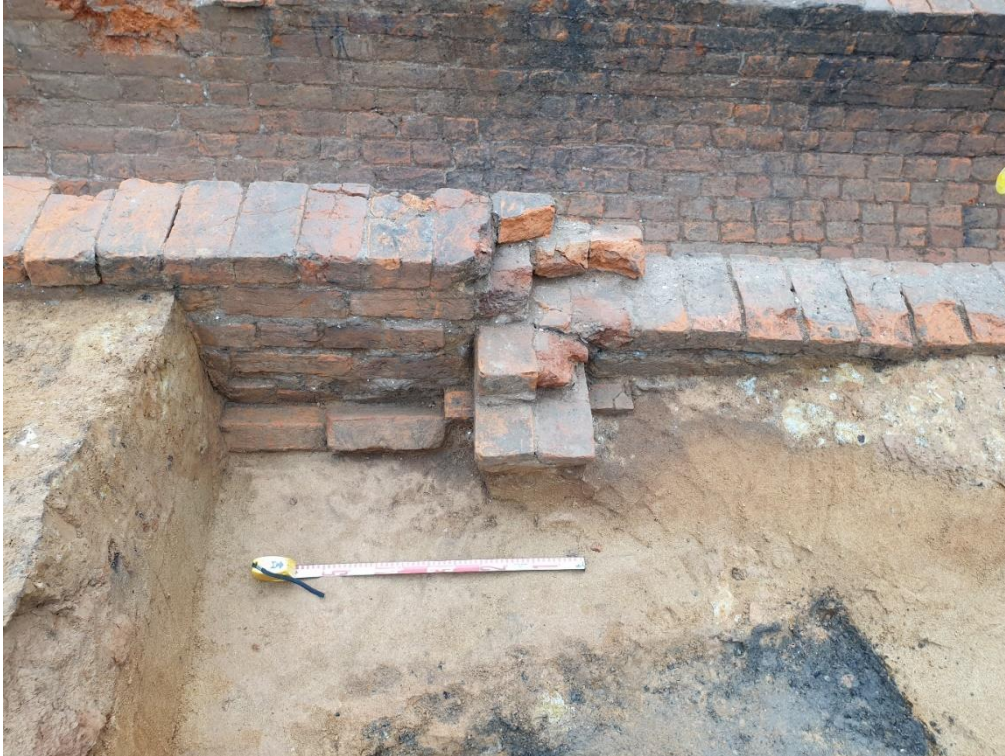
As with the previous section, the drain structure consisted of a shallow inverted segmental arch forming the base (the invert). It was not possible to view the invert to determine whether it was a single skin of bricks, but as with the previous section, the invert was laid in stretcher bond. The walls were laid as two skins constructed using English bond; however, the stretcher courses present in the complete section of drain were missing from all except the northernmost part of the eastern wall (Figure 5). Whereas the walls on the originally identified section were straight battered with a receding slope (AAJV 2018, p.28), the side walls of the newly identified section of drain were almost vertical (Figure 6 and Figure 7). One structural element was noted which had not been seen elsewhere along the drain, and this related to several bricks which were keyed into the main drain at a right angle (Figure 6 and Figure 7). The feature consisted of two courses of bricks bonded with shell mortar laid directly on to the sand which was used to fill the cut of the drain. The purpose of these bricks is unknown, but it is assumed that it was potentially conceived of functioning as an engaged pier to provide structural support to the wall during the construction process or subsequent to it

**Figure 6** North-west facing view showing vertical section of wall and keyed-in brick feature.

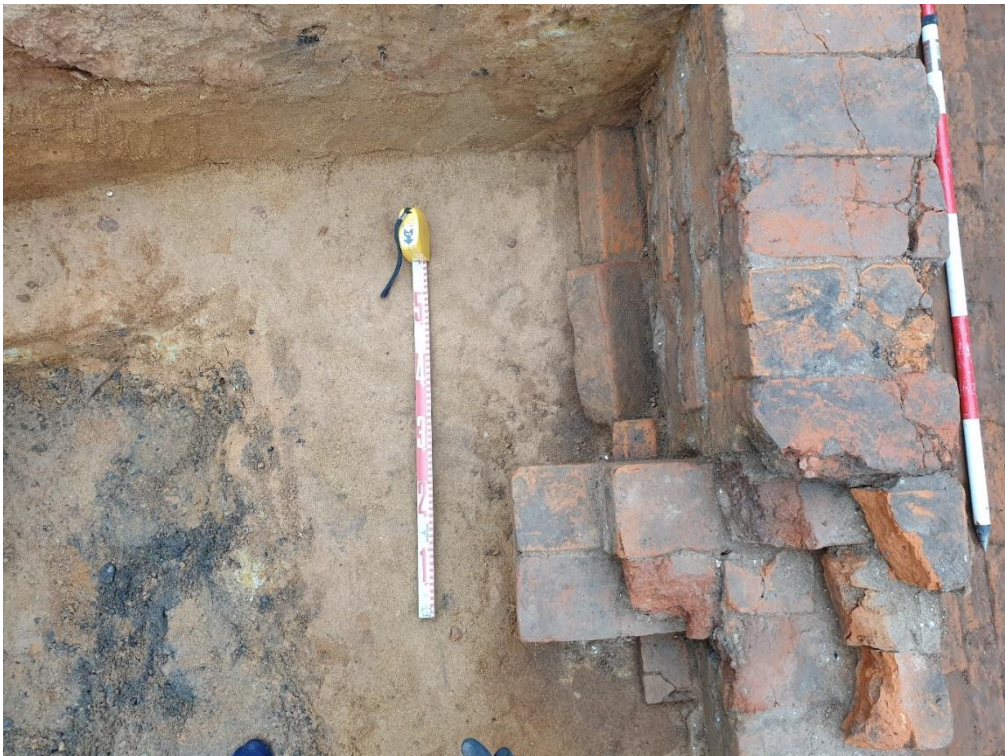
**Figure 7** Roughly vertical view showing brick wall and keyed-in brick feature.

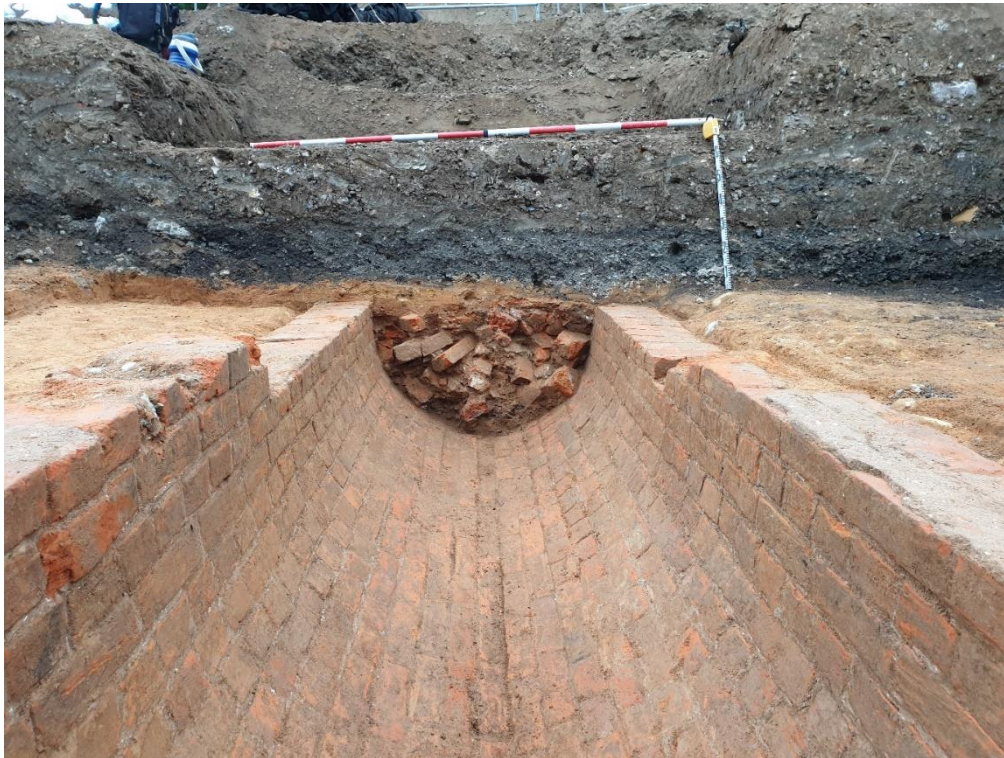
The interior of the drain was predominantly filled with a demolition deposit containing the bricks from the upper arch of the drain held in a clay matrix. This deposit would have formed following demolition of the drain in the 1930s, and it was capped in the section by various blue metal and bitumen deposits associated with construction of the Bridge Street road surface (Figure 8). However, at the northerly (downhill) end of the drain, a noticeable accumulation of silt was present in its base which measured 580 millimetres thick at the northern section (c.f. Figure 5). It is presumed that this related to the where the drain had previously been breached as part of the construction of the 1874 road alignment and where it had been filled up with large rocks, blocking the drain and causing the silt to back up.

**Figure 8** South-west facing view showing north-eastern section. Note rubble blocking the drain below layers associated with construction of the Bridge Street road.

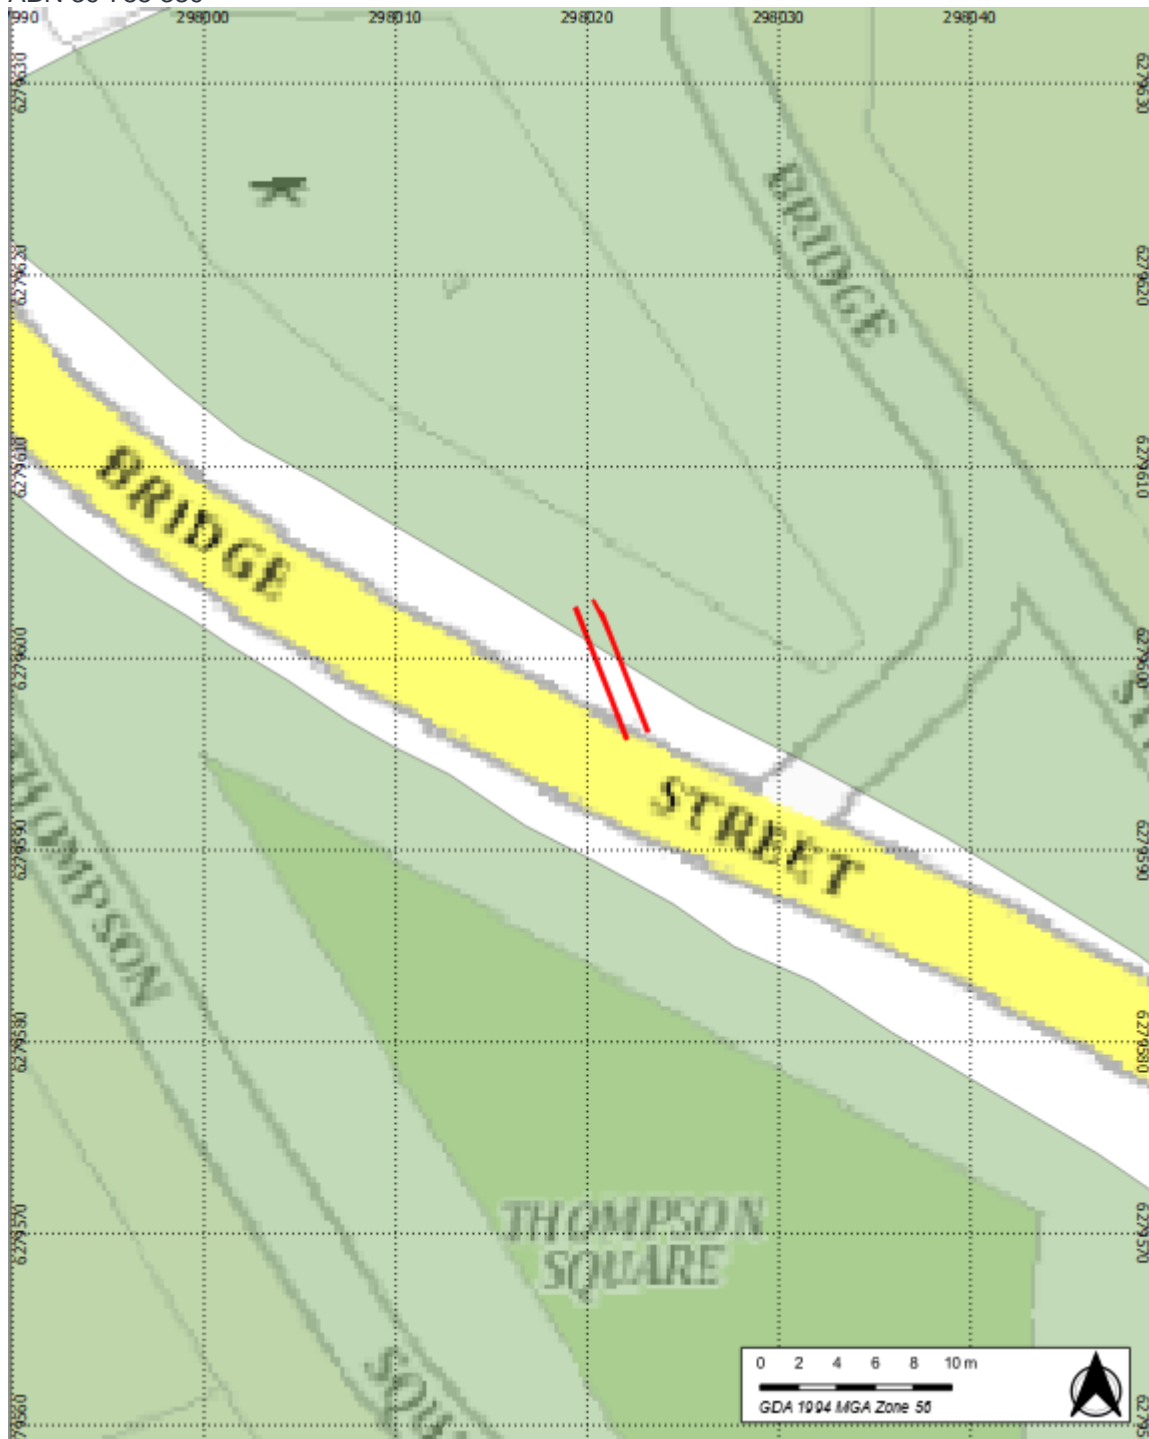
It is noted that the identified section of barrel drain is located within the Bridge Street cutting, and this is therefore predominantly outside of the State Heritage Register curtilage for Thompson Square Conservation Area (SHR #00126) (Figure 9).

**Figure 9** Preliminary plan showing SHR curtilage (green) in relation to brick barrel drain (red)

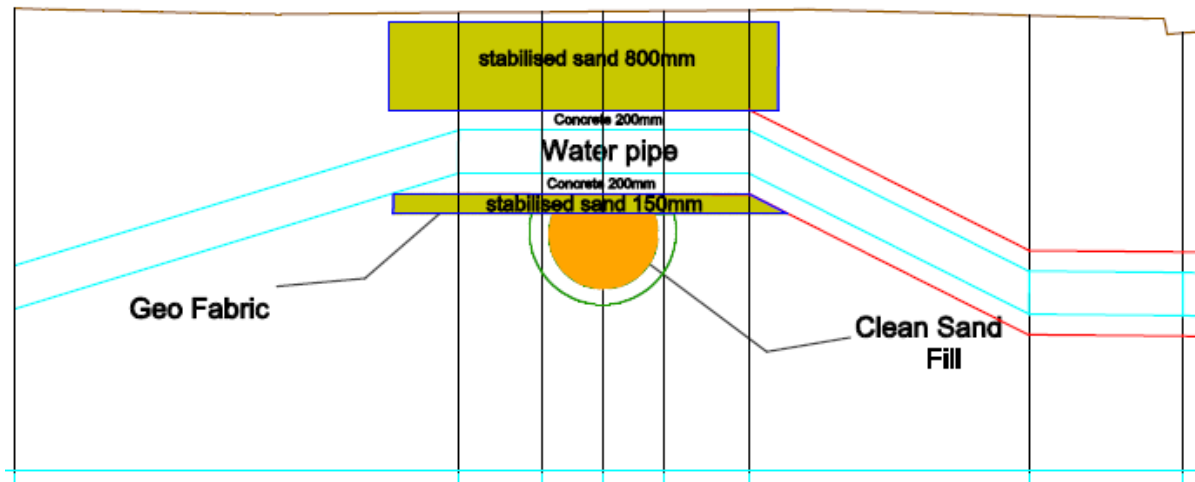
Option 1 results in the water mains being redesigned to pass above the barrel drain. This requires the installation of additional bends and the concrete encasement of the mains as shown in the Figure 11 below.

**Figure 11** Detail from provided survey plan showing required clearances to allow for recommended depth of service.

- As detailed in Figure 11, the minimum gap between the base of the concrete encased watermain and the top of the remnant barrel drain would only be 150 millimetres. With only this gap, it is possible that the concrete encased watermain would place loading on the barrel drain and that some loads may be transferred during construction; and
- This redesign would have to be approved by Sydney Water before work could continue.

1. Filling of the barrel drain structure with clean sand to the level of the top of the structure;
2. Covering the filled structure with geotextile;
3. Placing a 150 millimetre layer of cement stabilised sand above the drain; and
4. Filling the water main trench with stabilised sand to eliminate the need for compaction above the barrel drain remains.

On the basis that the redesign of the pipes over the barrel drain is feasible from an engineering standpoint, and will allow for the greater retention of historic fabric *in situ*, it is recommended that Option 1 be selected.
