Dewatering Management Plan

Stage 2 - Midtown
Herring Road, Macquarie Park

Prepared for
Frasers Property Ivanhoe Pty Ltd

Project 86043.06
May 2022

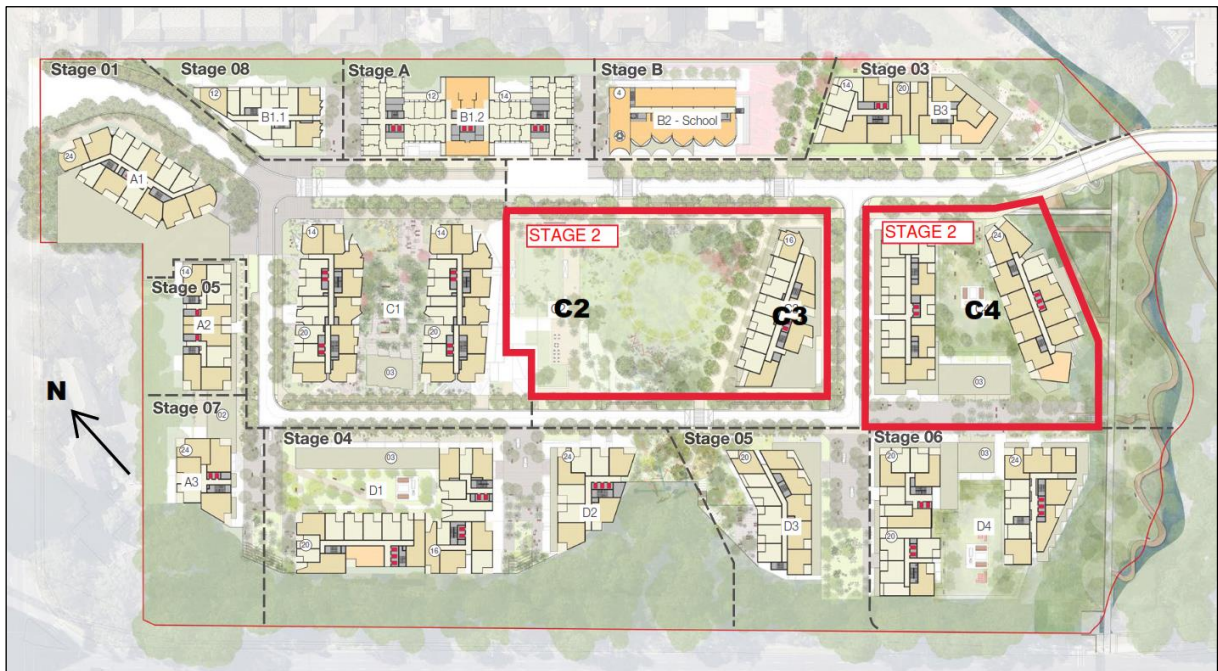
Figure 1: Location of the Stage 2 development areas (red), relative to the greater Midtown site (provided by Client).

The greater Midtown site is in Macquarie Park near the corner of Epping Road and Herring Road, within the Ryde Local Government Area. The site occupies an area of approximately 8.2 hectares. The approximate location of the Stage 2 site relative to the greater Midtown area, is shown in Figure 1, and in Drawing 801, in Appendix B.

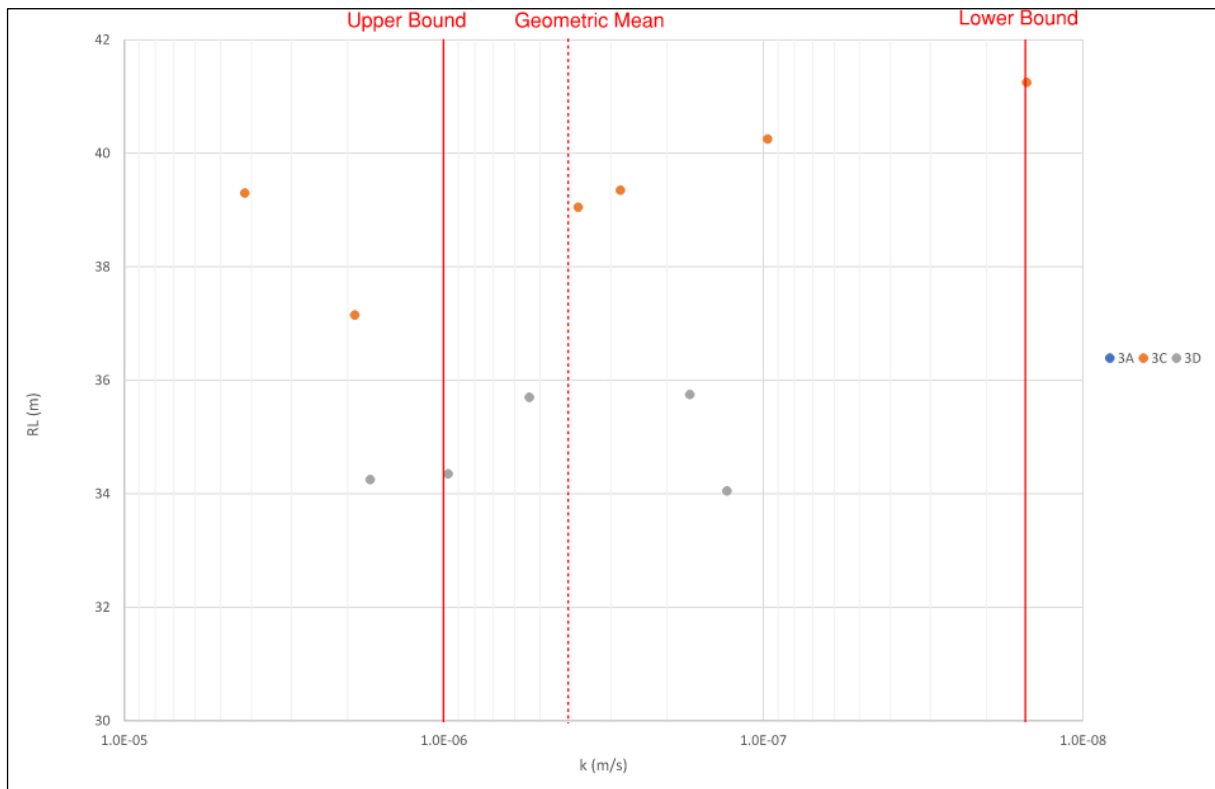
Figure 2: Hydraulic Conductivity vs RL using Midtown data (x axis log scale)

The hydraulic conductivity values in Table 4 were then plotted against RL to interpret appropriate parameters for the inflow assessment for each unit, as shown in Figure 3.

It is noted in Figure 3 that there is no noticeable variation when comparing the permeability of the in-situ testing for the 3c and 3d units, which are the primary units which will contribute to seepage and groundwater inflows. Testing on the 3a unit was in a similar order to the other sandstone units, while inconclusive testing occurred in the 3b unit. Given this, it was deemed suitable to adopt a bulk rock horizontal hydraulic conductivity (k_h) for the inflow and drawdown assessment. This was calculated by taking the geometric mean of all hydraulic conductivities for borehole screens located below the long-term water table, and represents an average permeability on a large rock mass scale. Table 5 summarises the adopted (hydraulic) conductivity values, with 'lines of best fit' indicated in Figure 3. Note that the x axis on Figure 2 is a log scale.

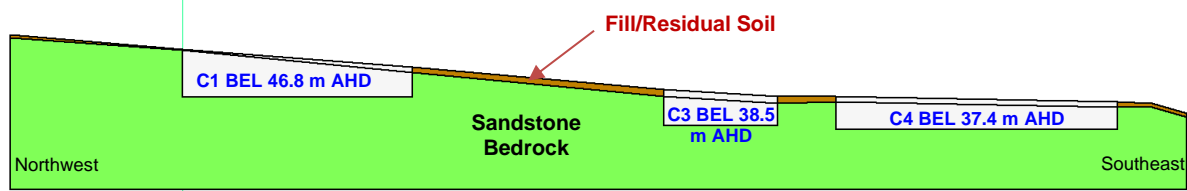
Figure 3: Model Geometry

For the purpose of the analysis, DP selected one cross-section in the west to east direction, intersecting the C1, C3, and C4 basements footprint through the centre. The ground surrounding the proposed development was simulated as being a multi-layered numerical model to represent the subsurface conditions surrounding the site. The C2 basement was excluded from the inflow assessment, as there is very limited interception of the groundwater table (<0.5 m) in a corner of the basement, and the inflows are expected to be orders of magnitude less than the inflows to C3 and C4 (ie effectively negligible for the consolidated basement inflows).

The geological units were subdivided into layers corresponding to the main soil and rock units for the numerical model, as outlined and characterised in Section 6.2. The boundaries of the model were extended approximately 50 m from the western end of C1 basement and 20 m from the eastern end of C4 excavation. This is slightly less than the actual distance to Shrimpton's Creek from the C4 basement area (approximately 25 m), but is considered reasonable for the purpose of this assessment.

The geological units were simulated by assigning multiple materials with different hydraulic conductivities (permeabilities) to the model layers. Details of the layering are provided in Figure 3. All layers were assigned as SEEP/W saturated/unsaturated materials.

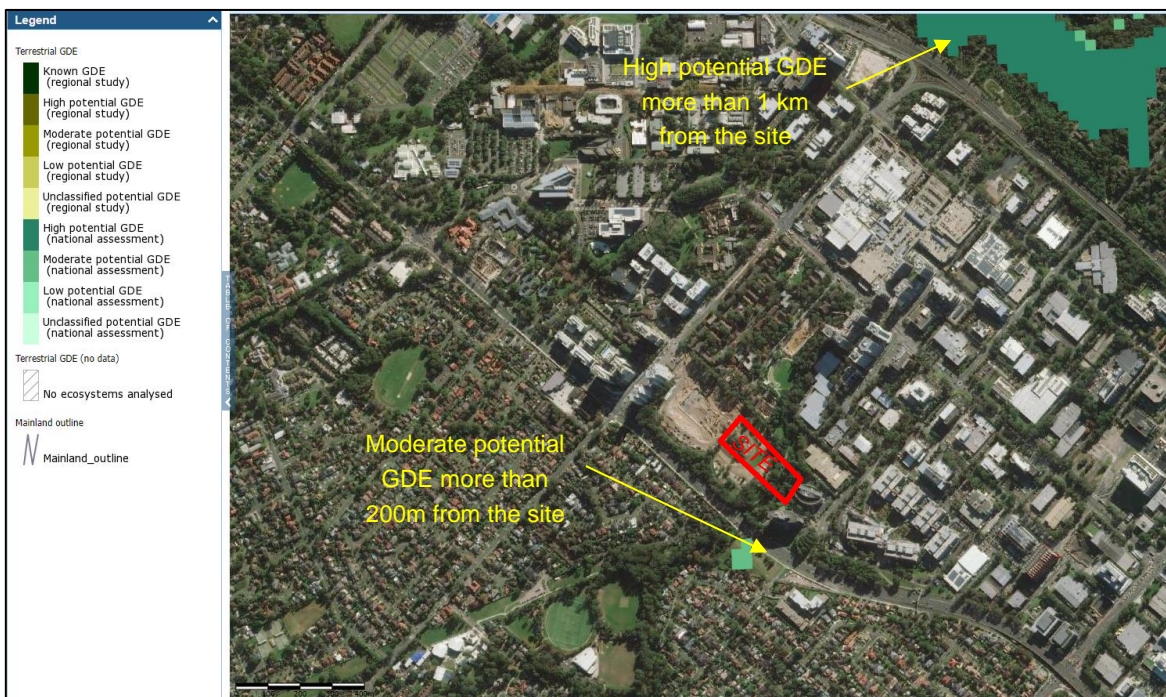
Figure 5: Map of Groundwater Dependent Ecosystems (GDEs) Near the Site (Bureau of Meteorology (BoM): GDE Atlas online, viewed 28 April 2022.)

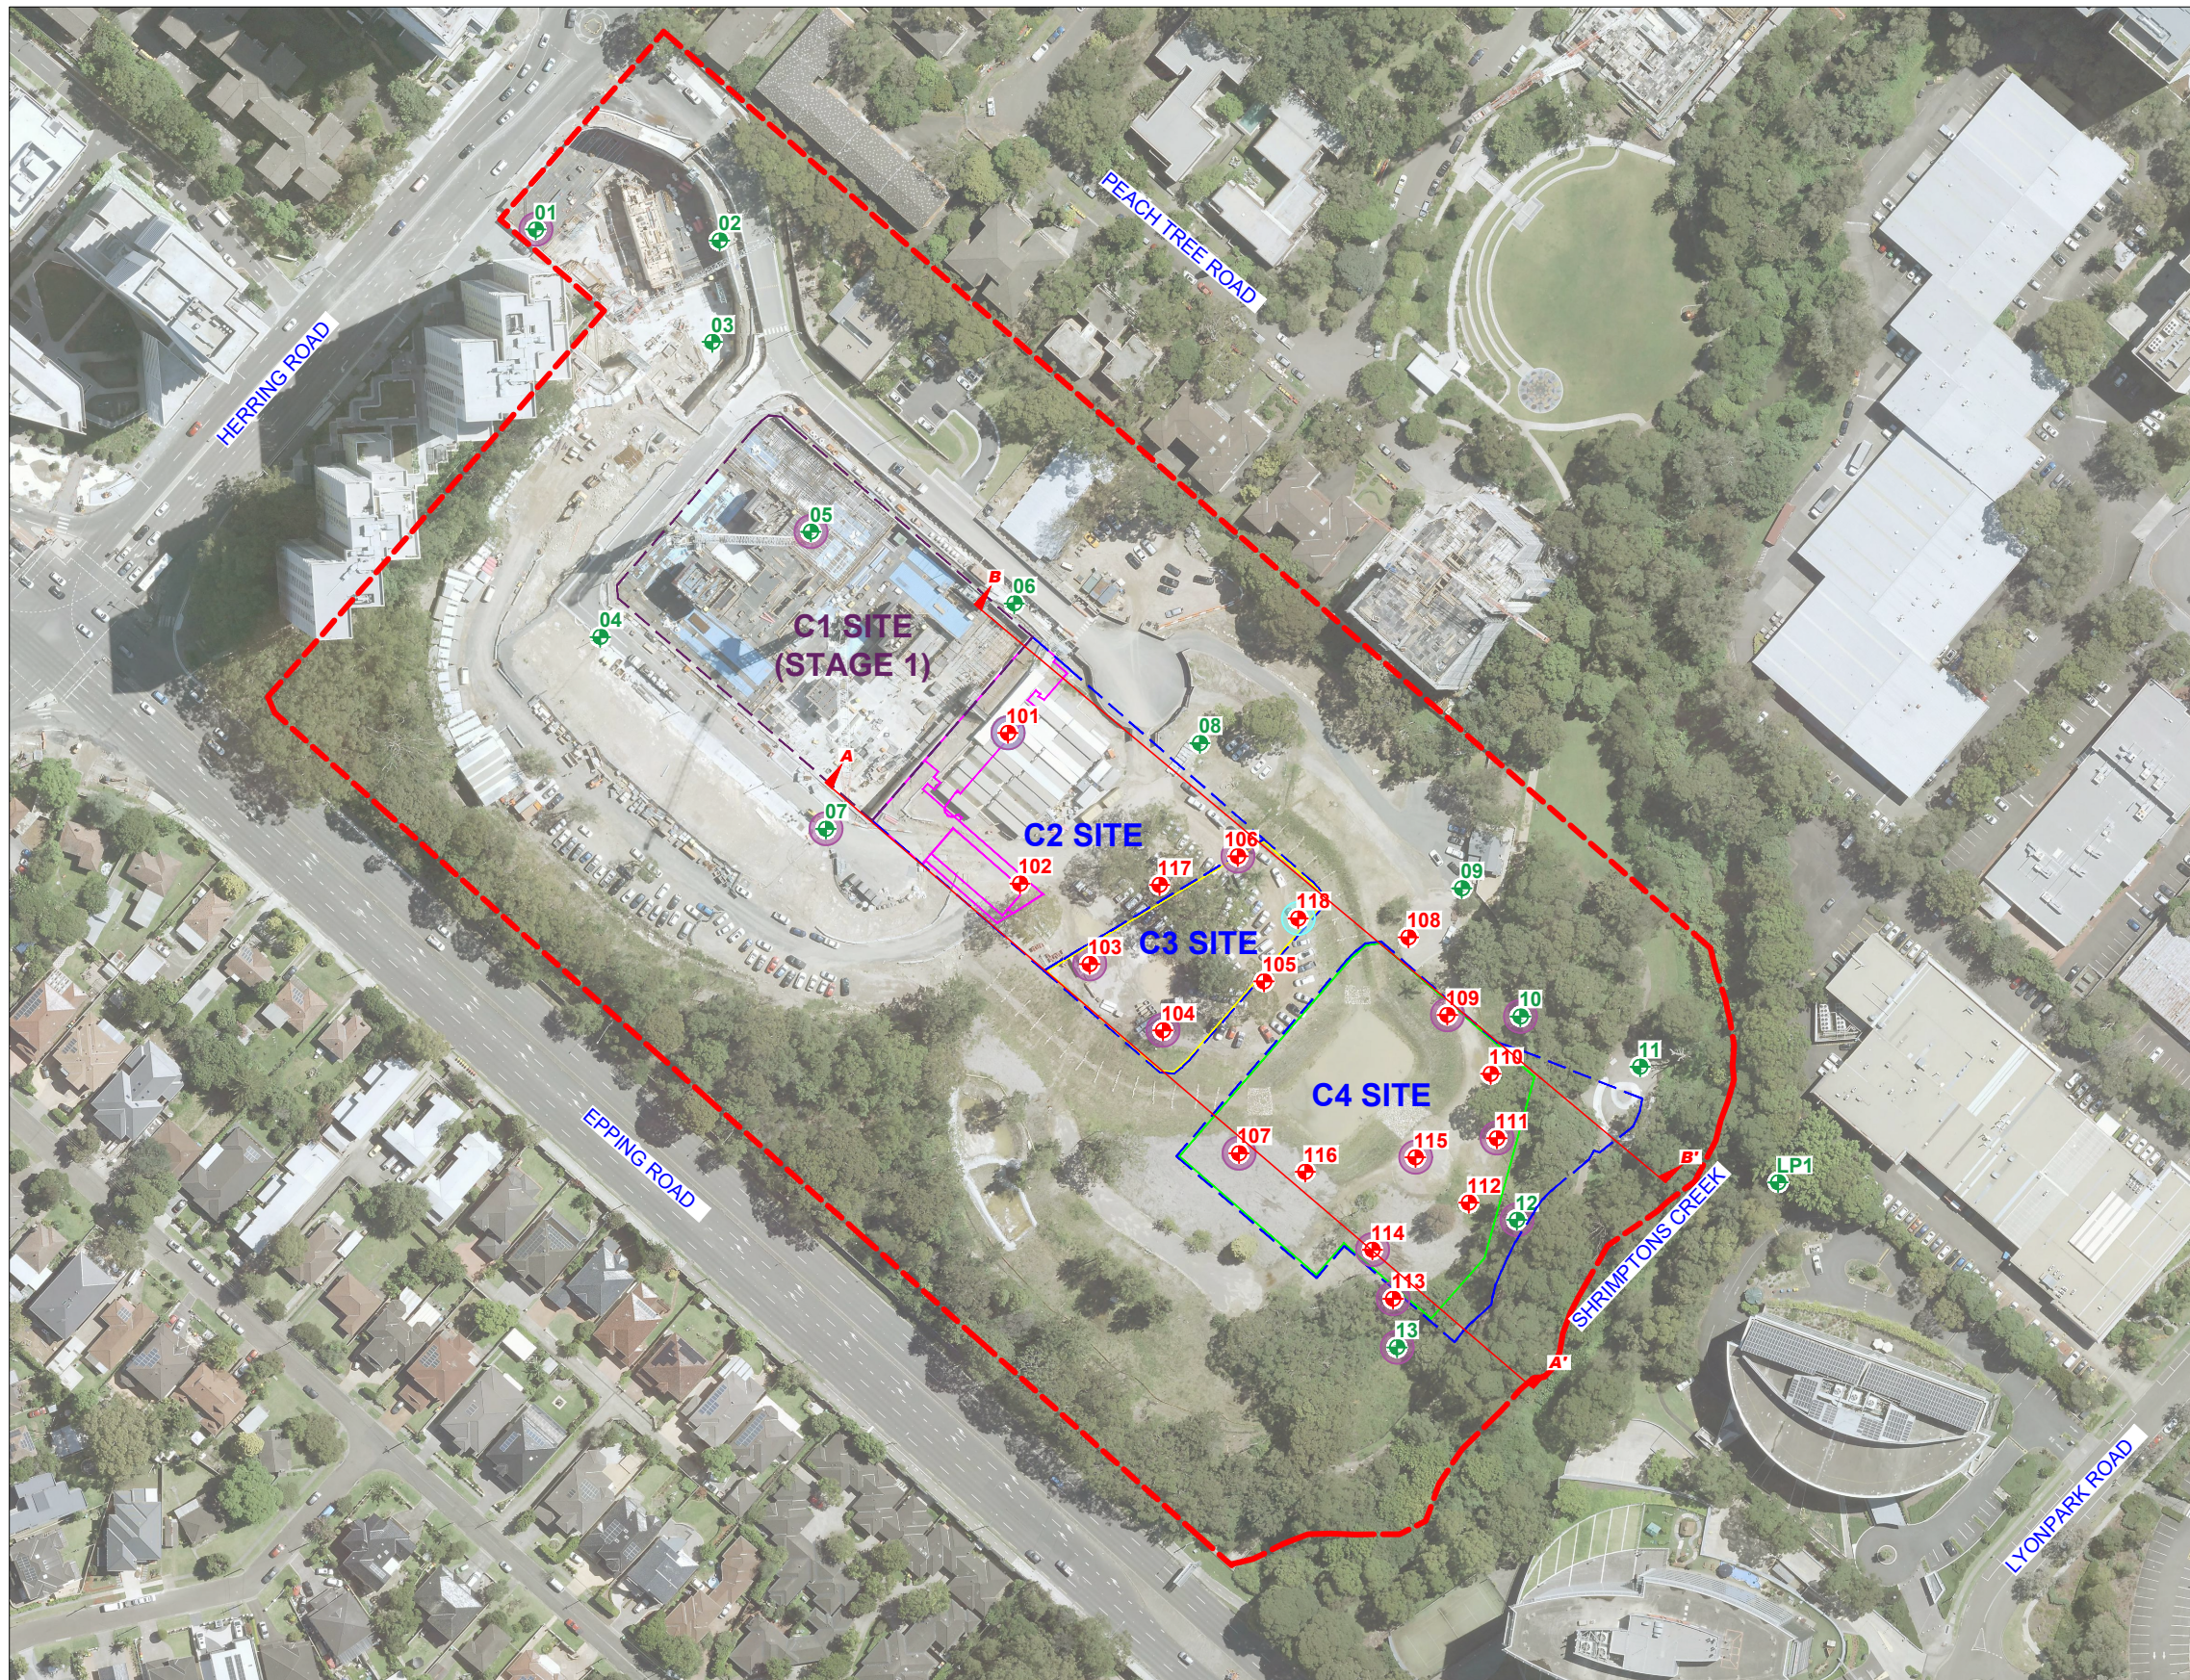
CLIENT: Frasers Property Ivanhoe		TITLE: Test Location Plan Proposed Residential Development Ivanhoe Estate, Macquarie Park		PROJECT No: 86043.06
	OFFICE: Sydney	DRAWN BY: MG			DRAWING No: 801
	SCALE: 1:2000 @ A3	DATE: 13.04.2022			REVISION: 0

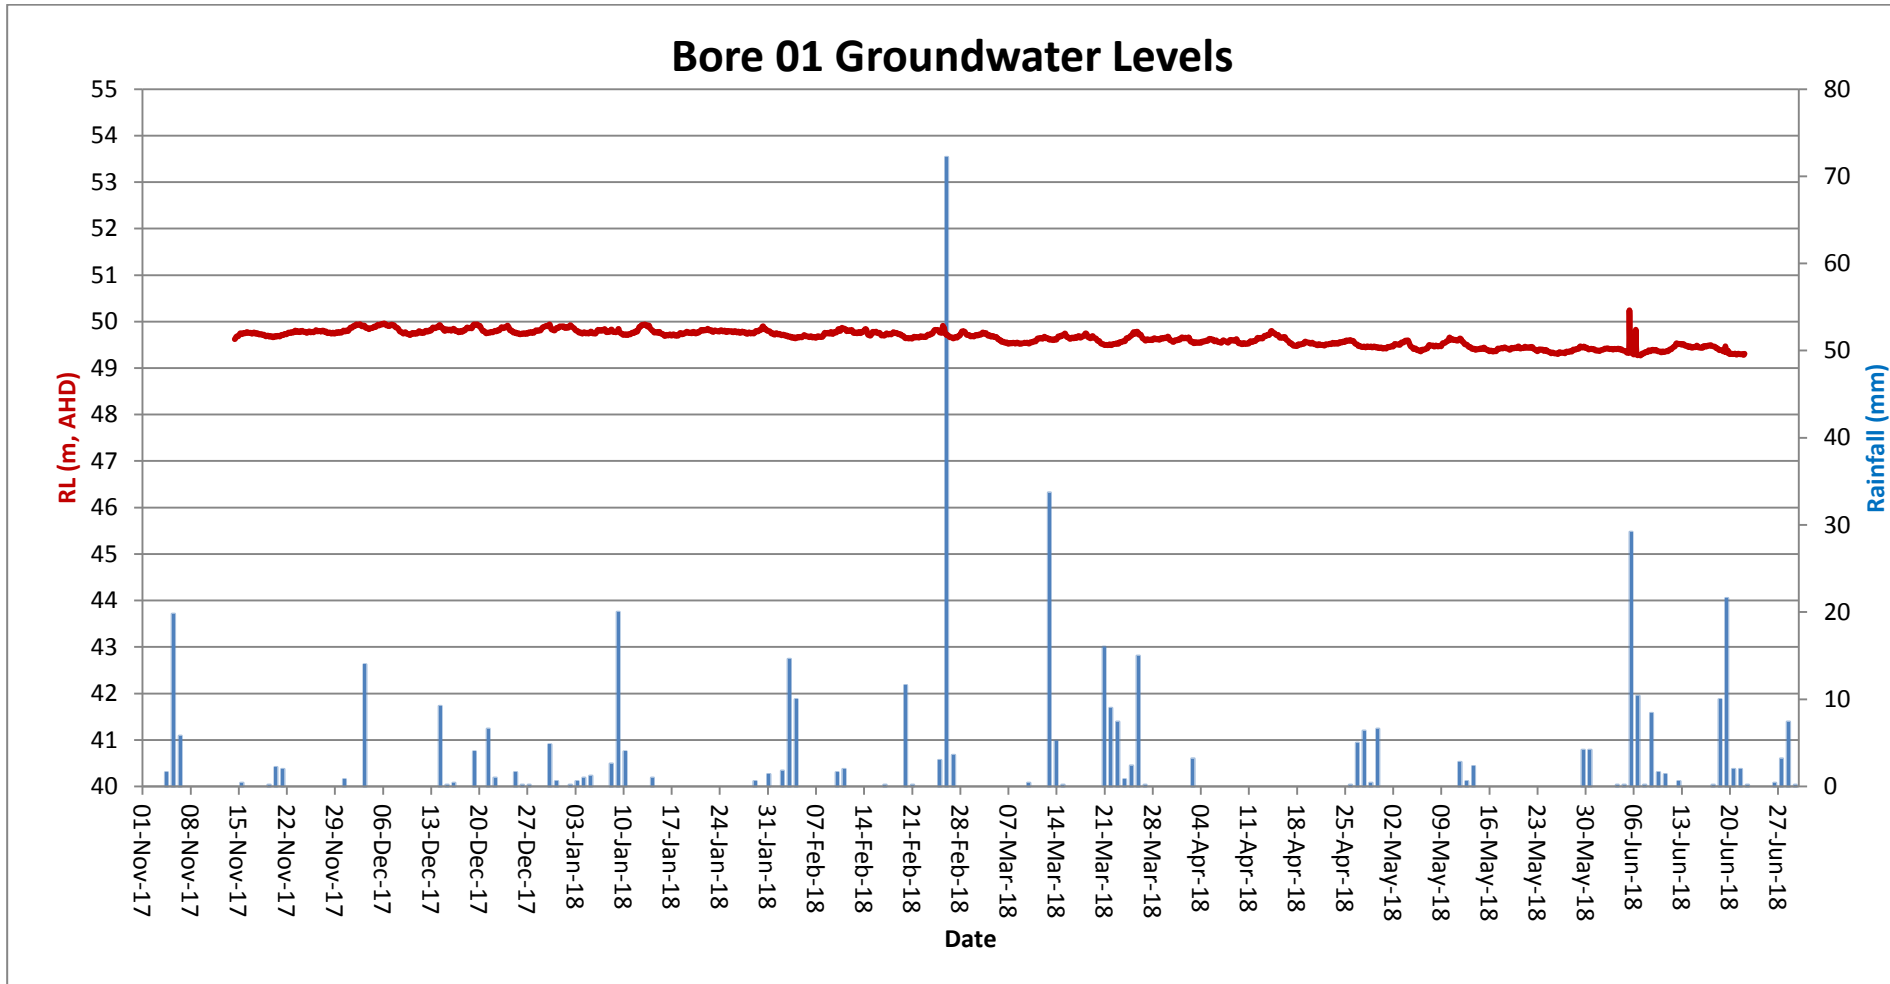
Figure 1: Groundwater Monitoring Results at Bore 01

- At Bore 01, unusual readings were obtained in June 2018 following rainfall. It is considered likely that this is due to the surficial damage observed at the standpipe, with dislodgement of the standpipe cover possibly resulting in surface water inflow to the standpipe.

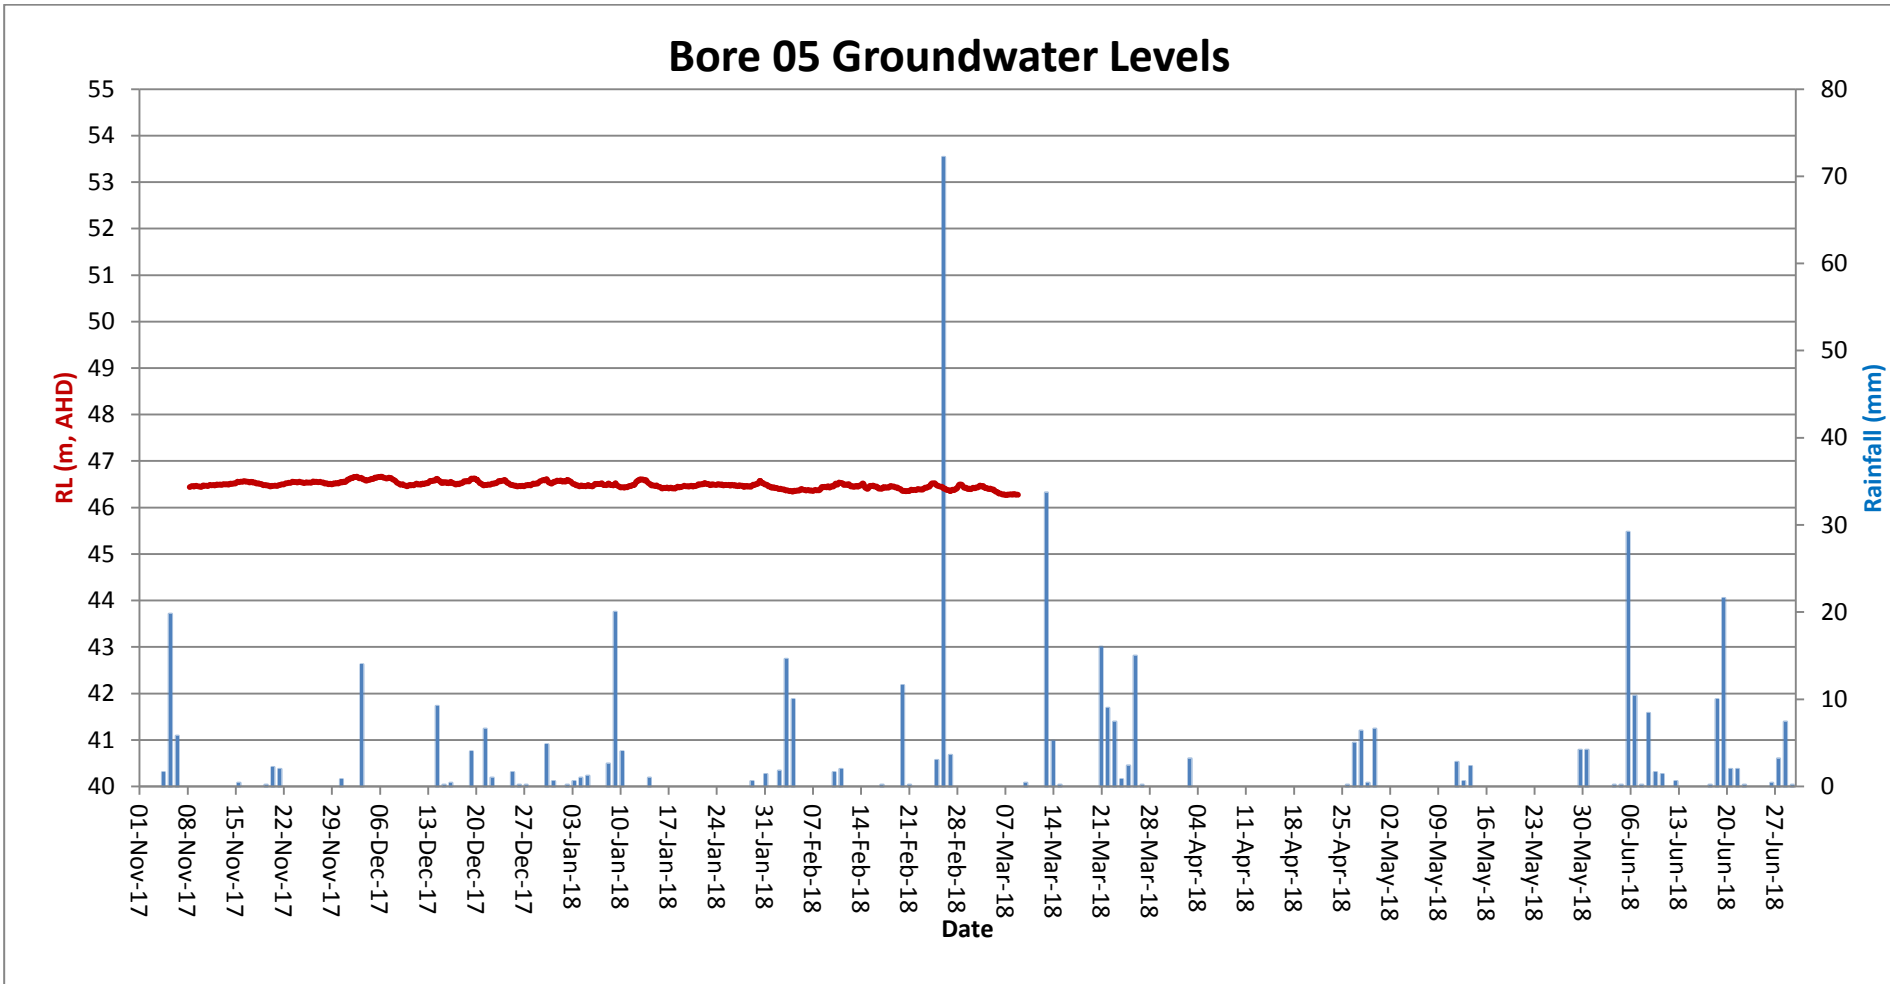
Figure 2: Groundwater Monitoring Results at Bore 05

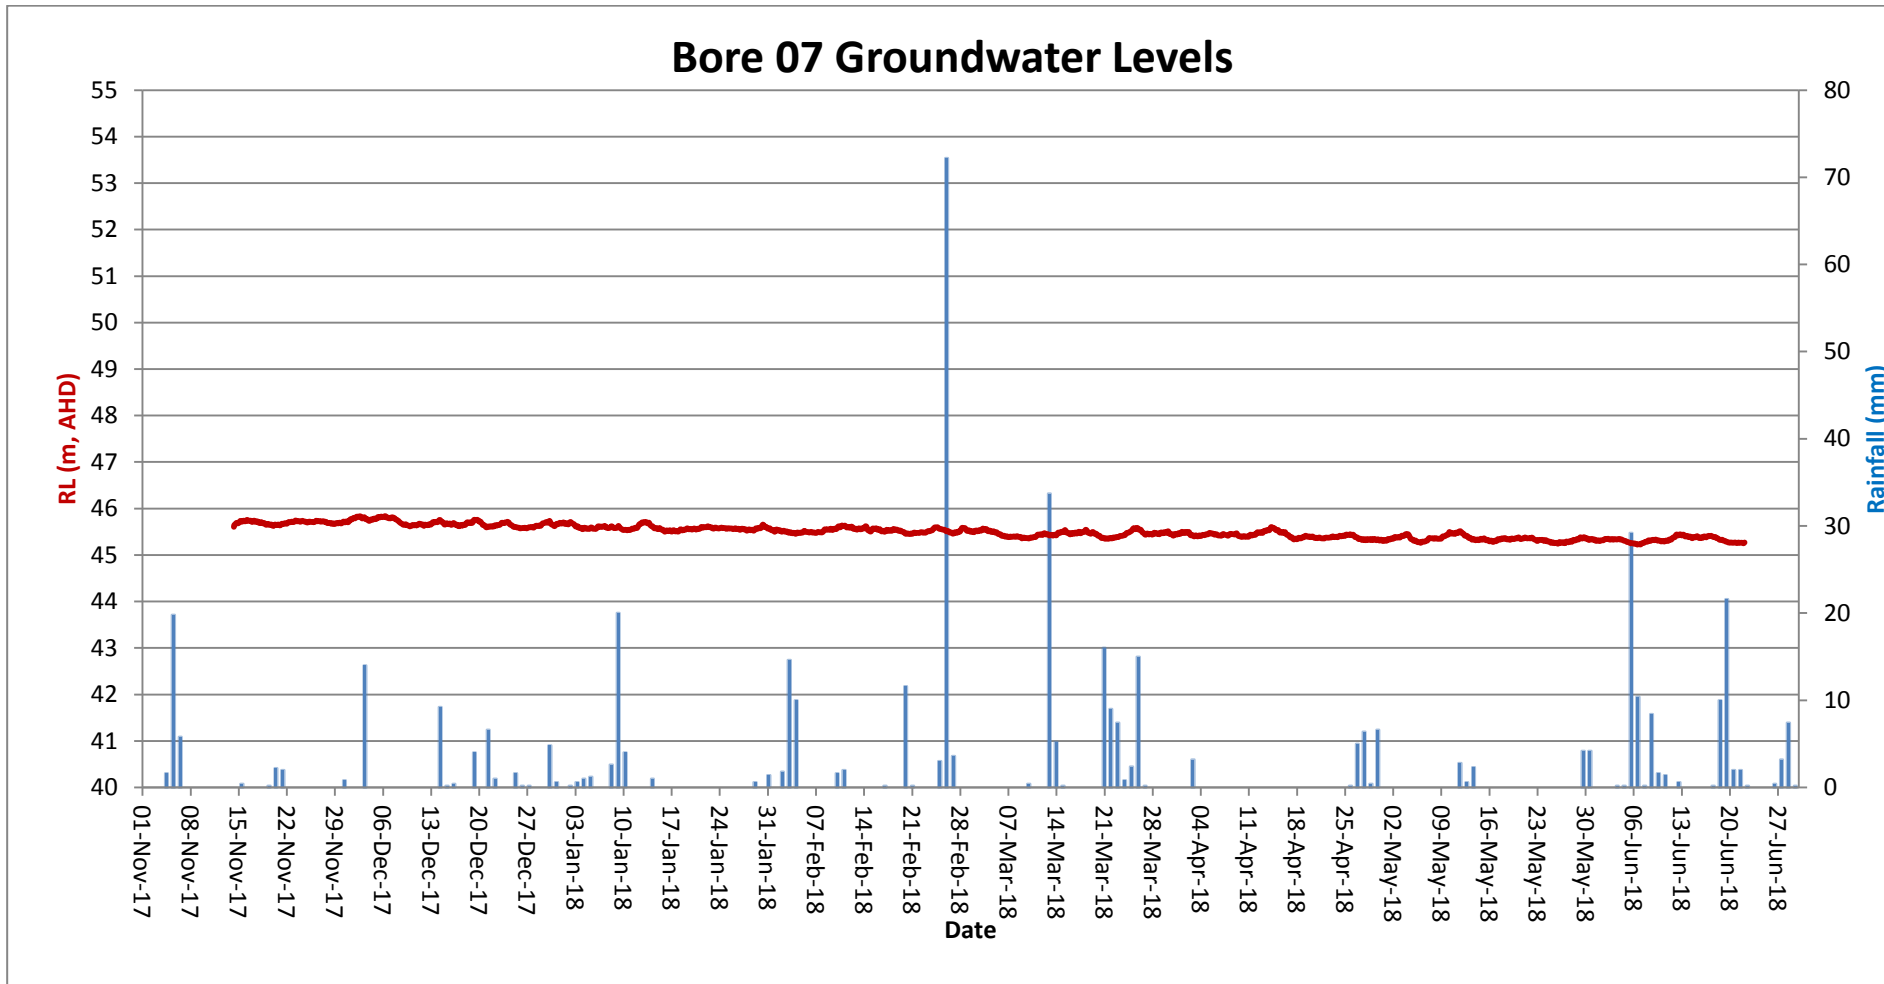
Figure 3: Groundwater Monitoring Results at Bore 07

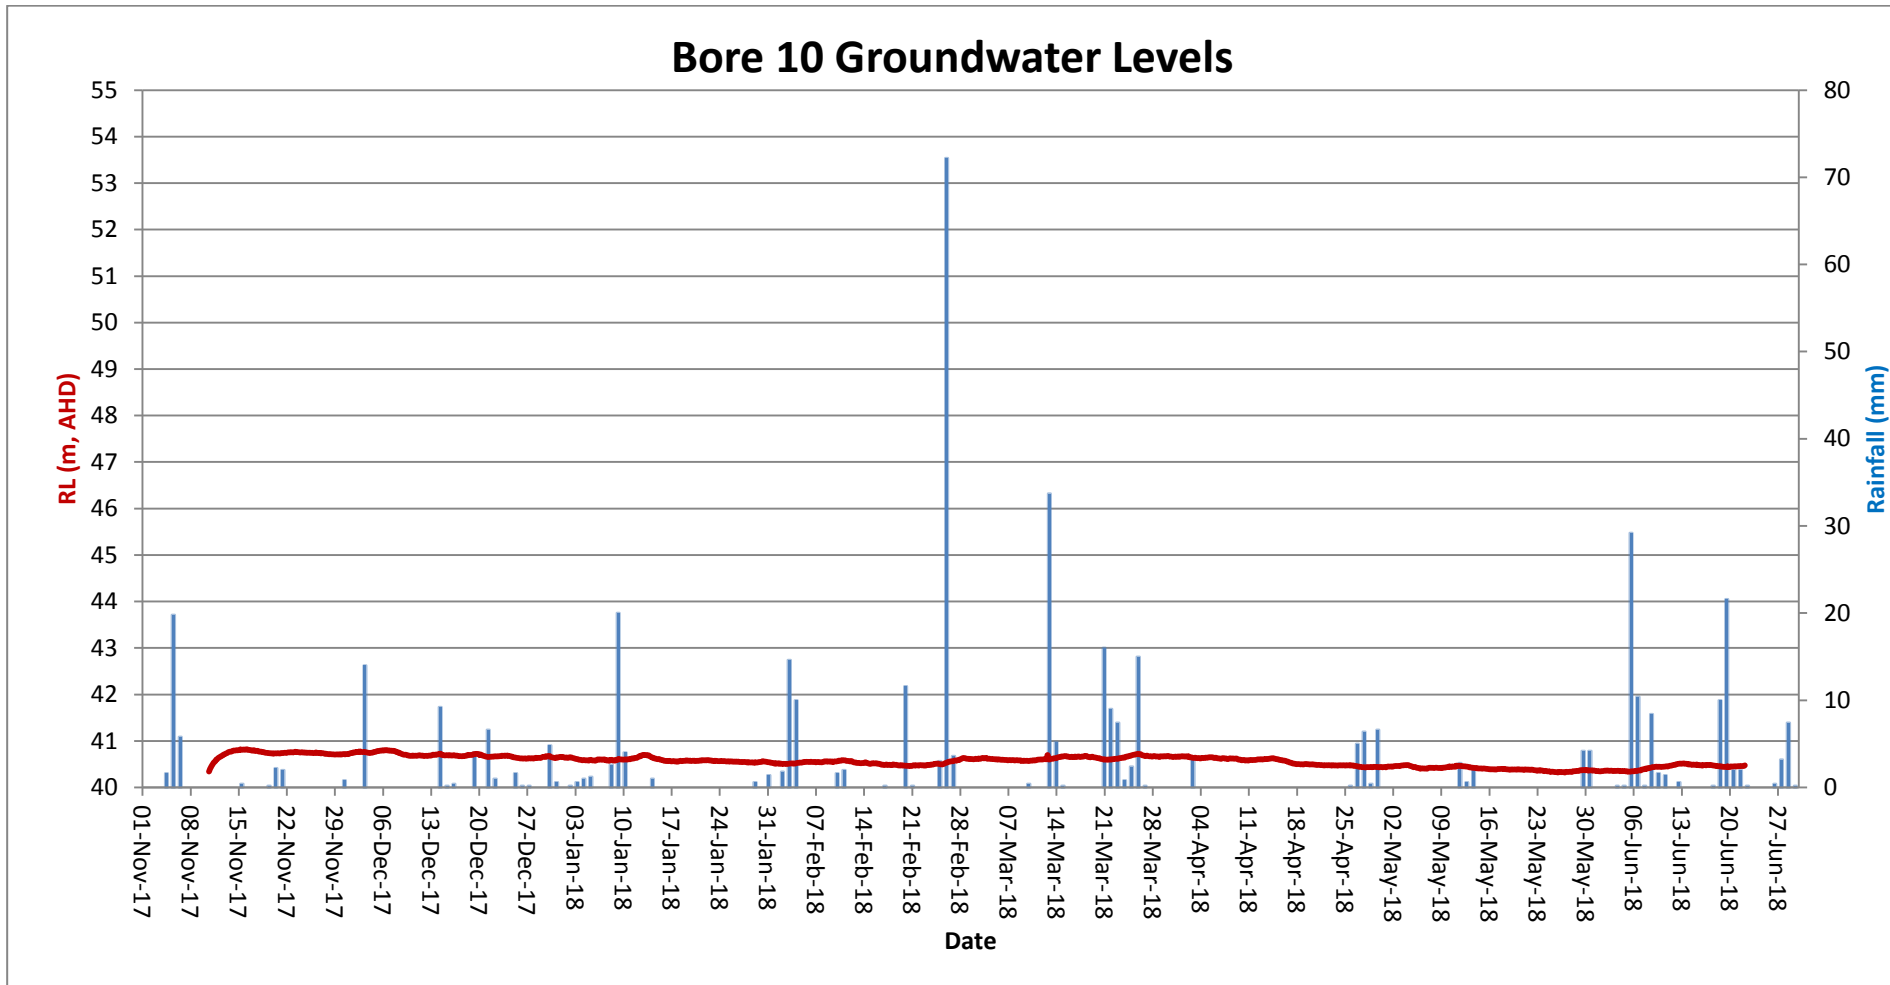
Figure 4: Groundwater Monitoring Results at Bore 10

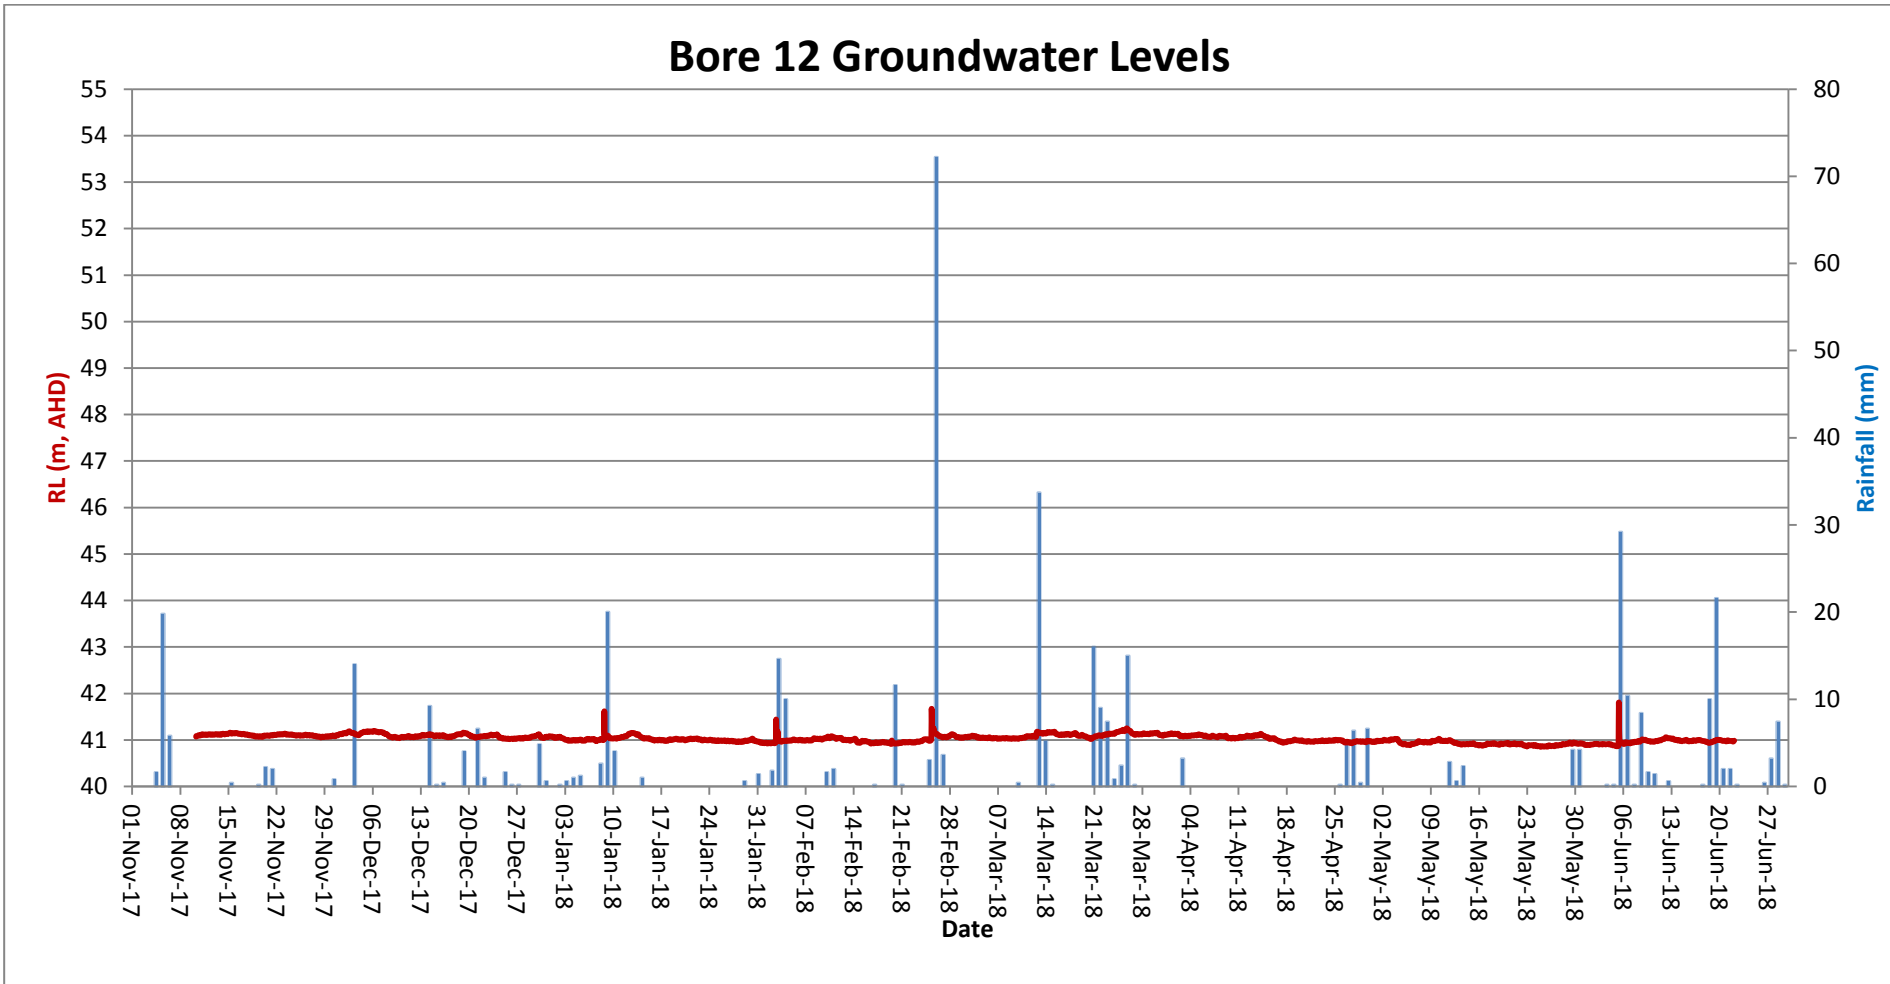
Figure 5: Groundwater Monitoring Results at Bore 12

- At Bore 12, elevated groundwater readings followed some rainfall events, with water levels rising by up to 0.6 m, then rapidly dissipating to more typical groundwater levels. The standpipe construction at this location includes a bentonite seal down to sandstone. Presuming that the seal has performed adequately, the cause of the elevated water levels may be due to local ground conditions (eg groundwater infiltration through joints or bedding planes in the sandstone) and its proximity to the creek and/or the adjacent stormwater drains.

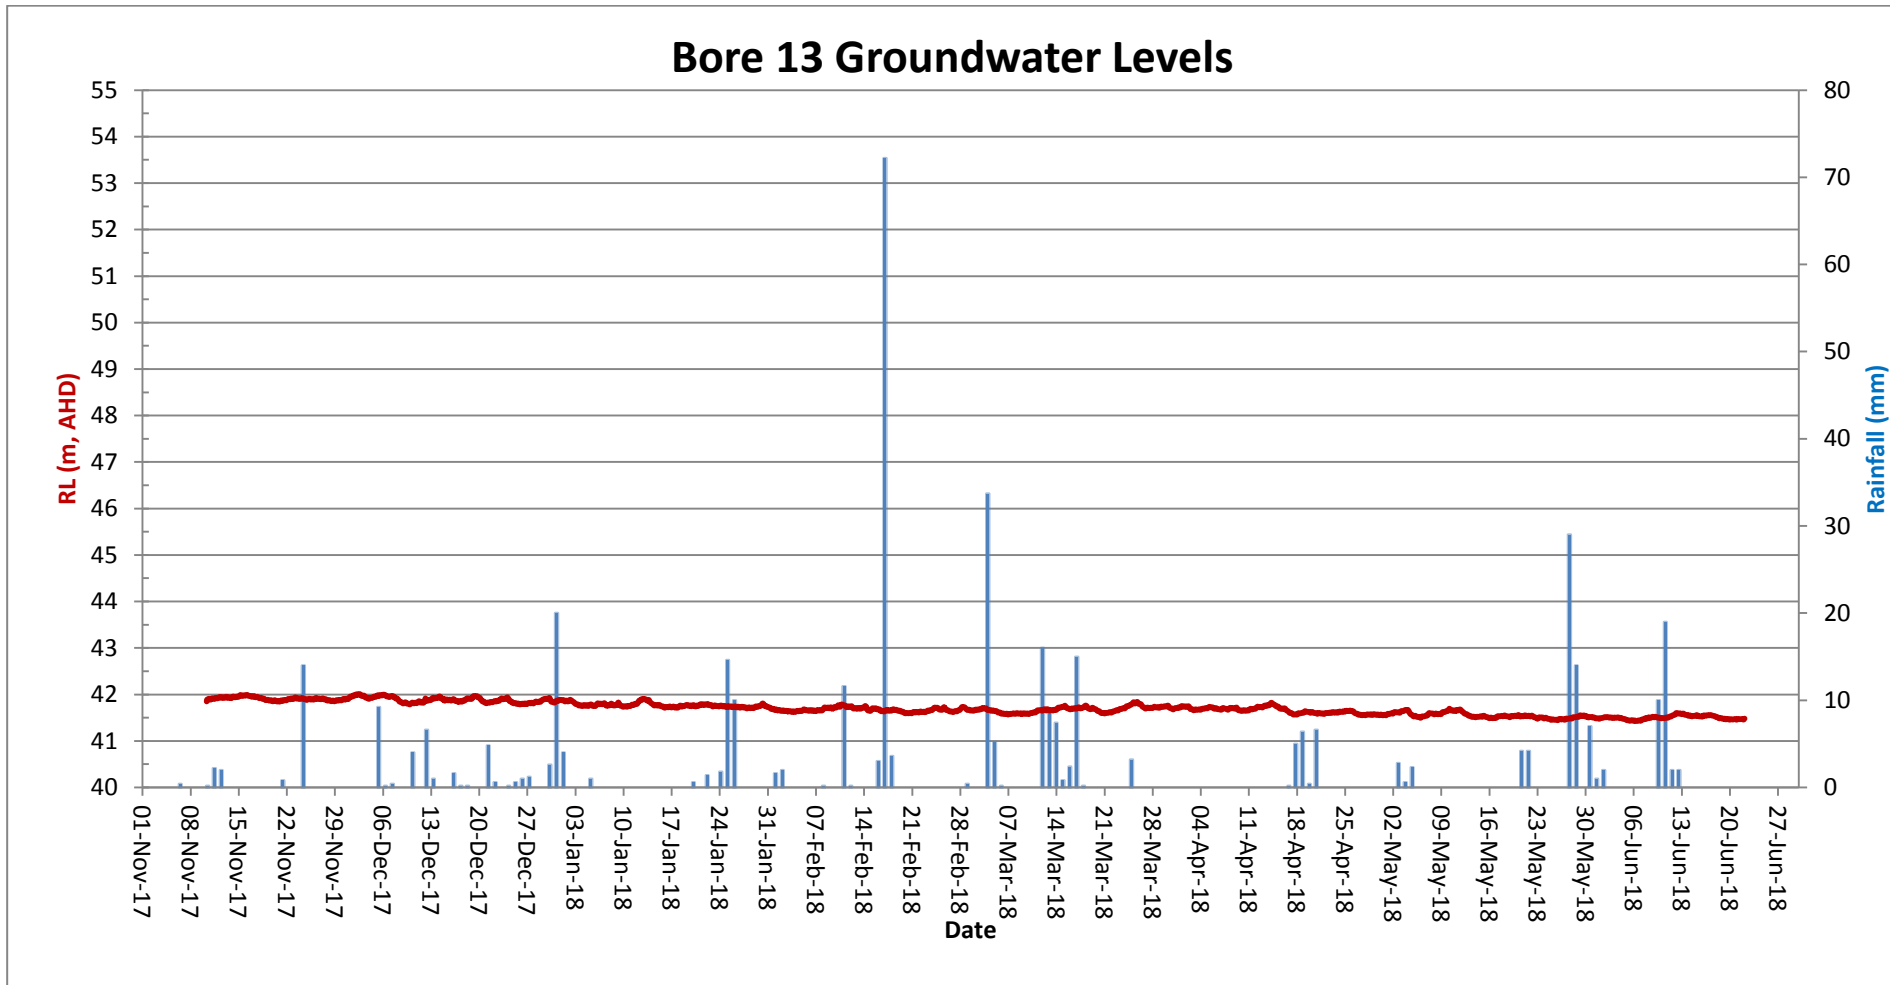
Figure 6: Groundwater Monitoring Results at Bore 13

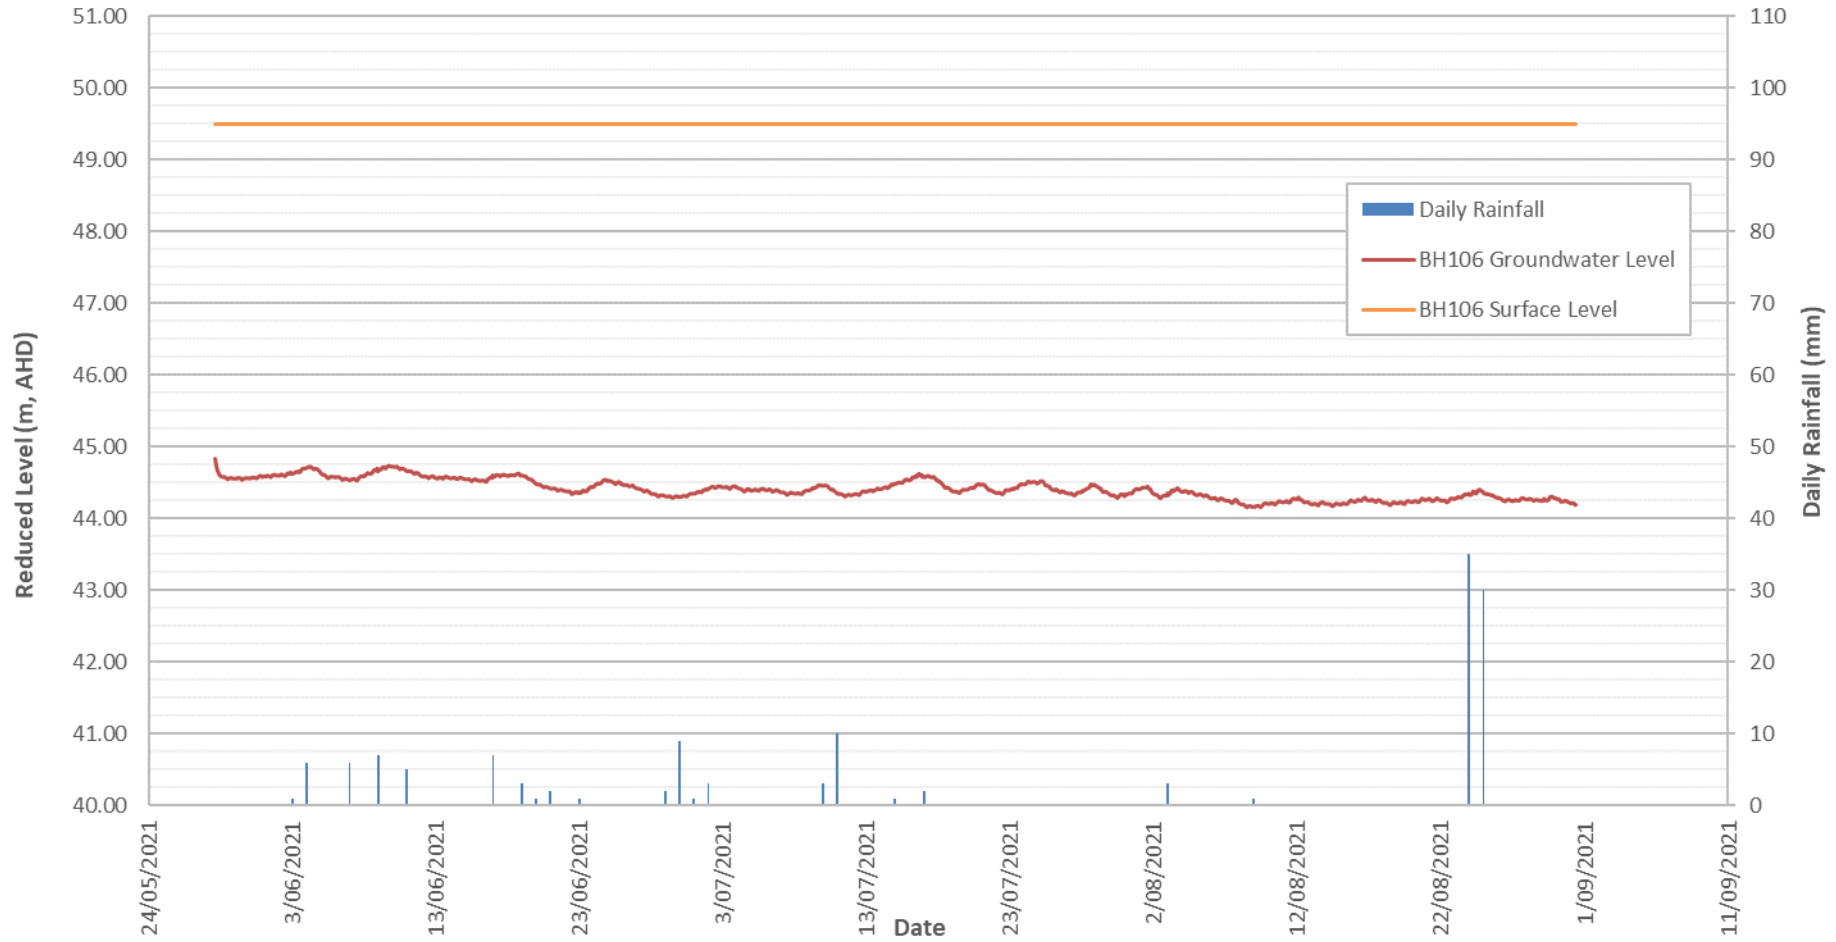
Groundwater Monitoring BH106

Figure 1: Groundwater Monitoring Results at Bore 106

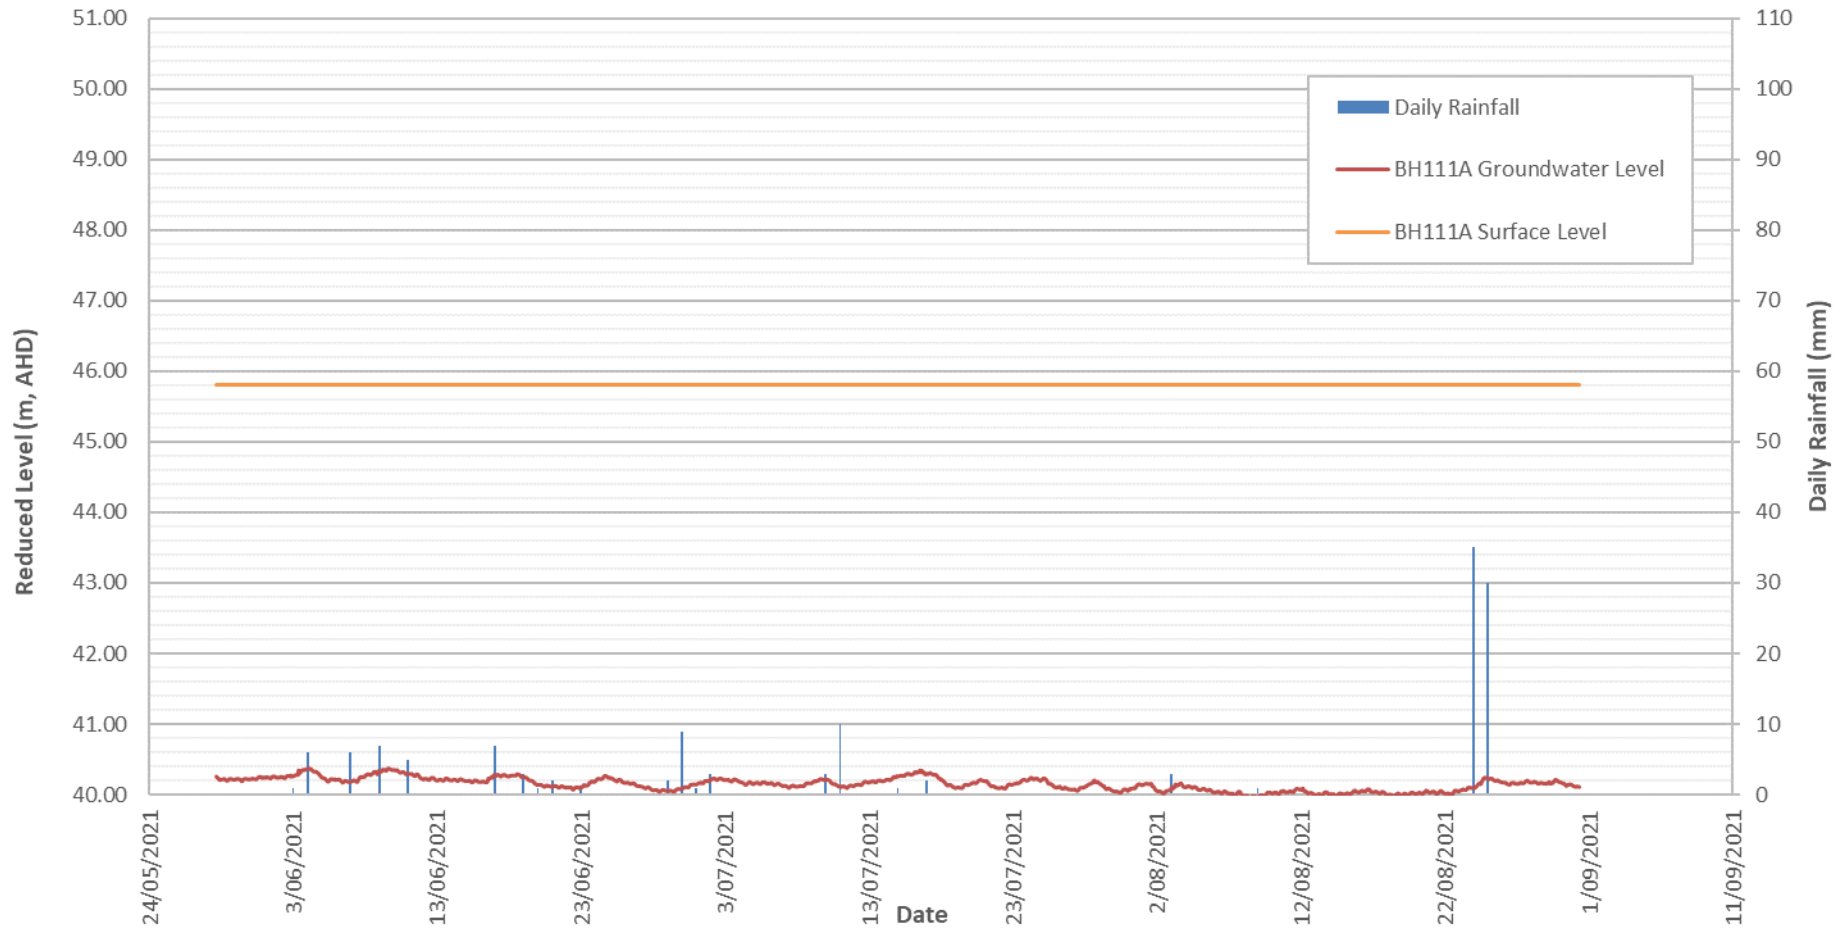
Groundwater Monitoring BH111A

Figure 2: Groundwater Monitoring Results at Bore 111A
