Dewatering Management Plan

Stage 2 - Midtown
Herring Road, Macquarie Park

Prepared for
Frasers Property Ivanhoe Pty Ltd

Project 86043.06
May 2022

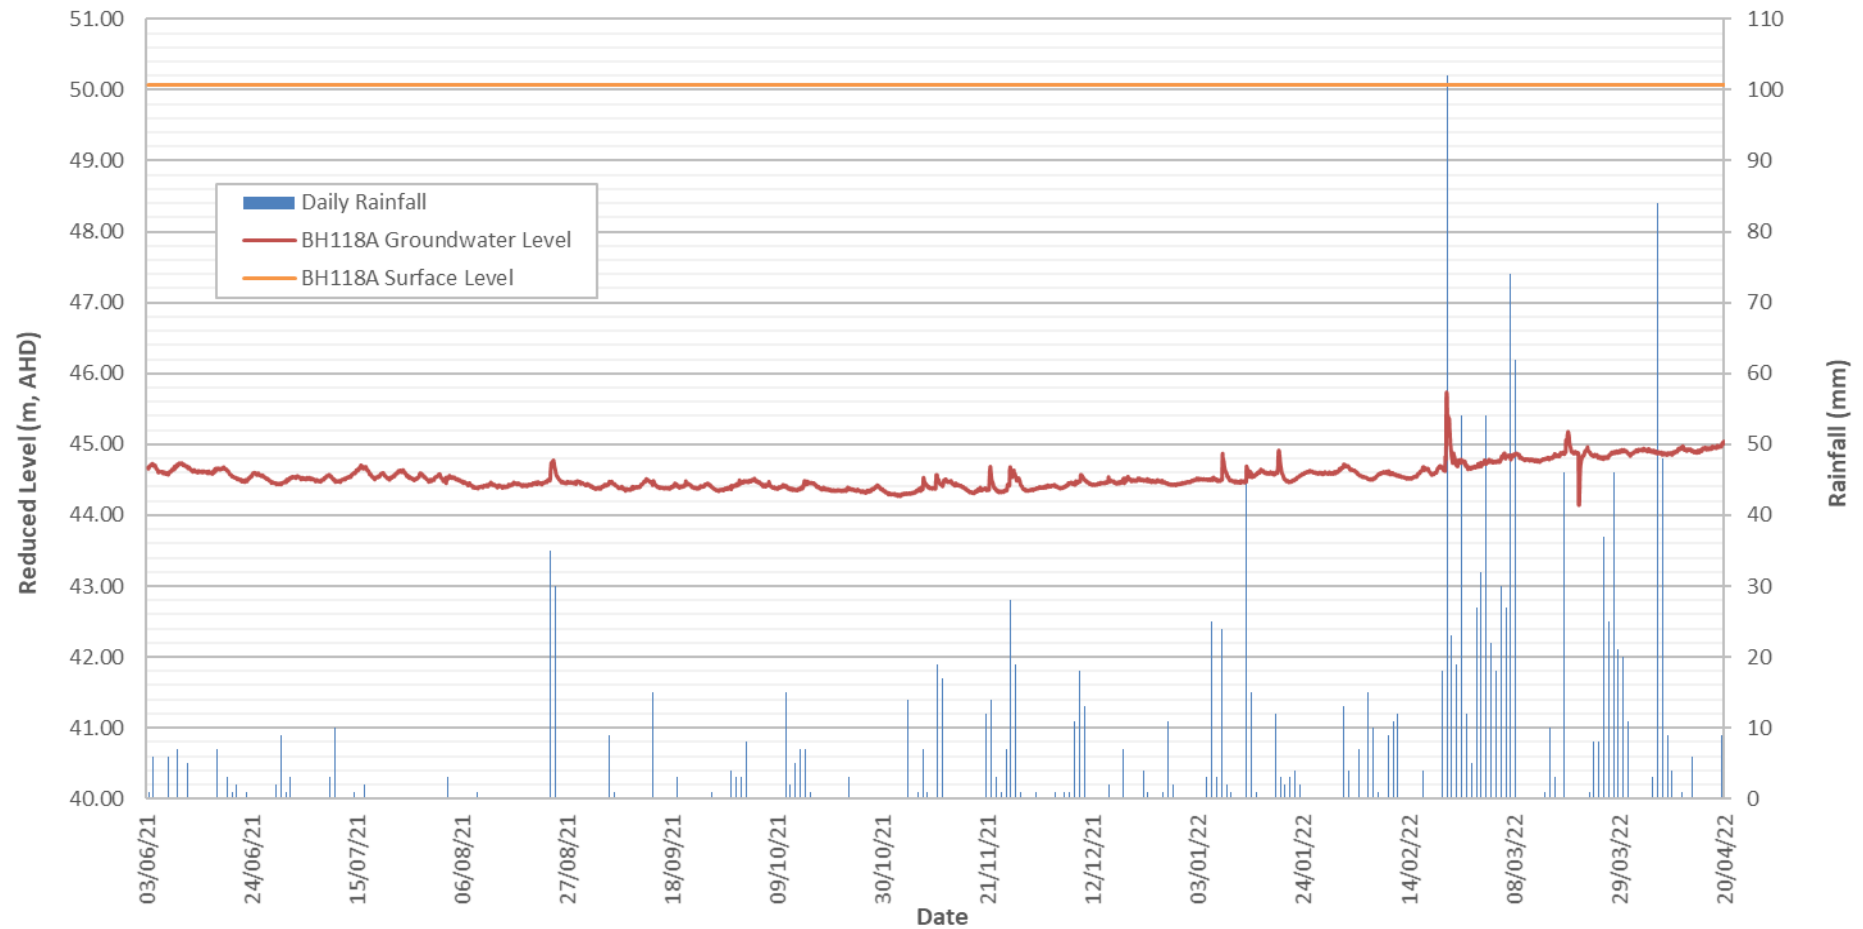
Groundwater Monitoring BH118A

Figure 3: Groundwater Monitoring Results at Bore 118A
