# GROUNDWATER MANAGEMENT PLAN – REV 4

Aspect Industrial Estate, Mamre Road, Kemps Creek, NSW

Prepared for Mirvac Projects Pty Ltd

02 MAY 2022

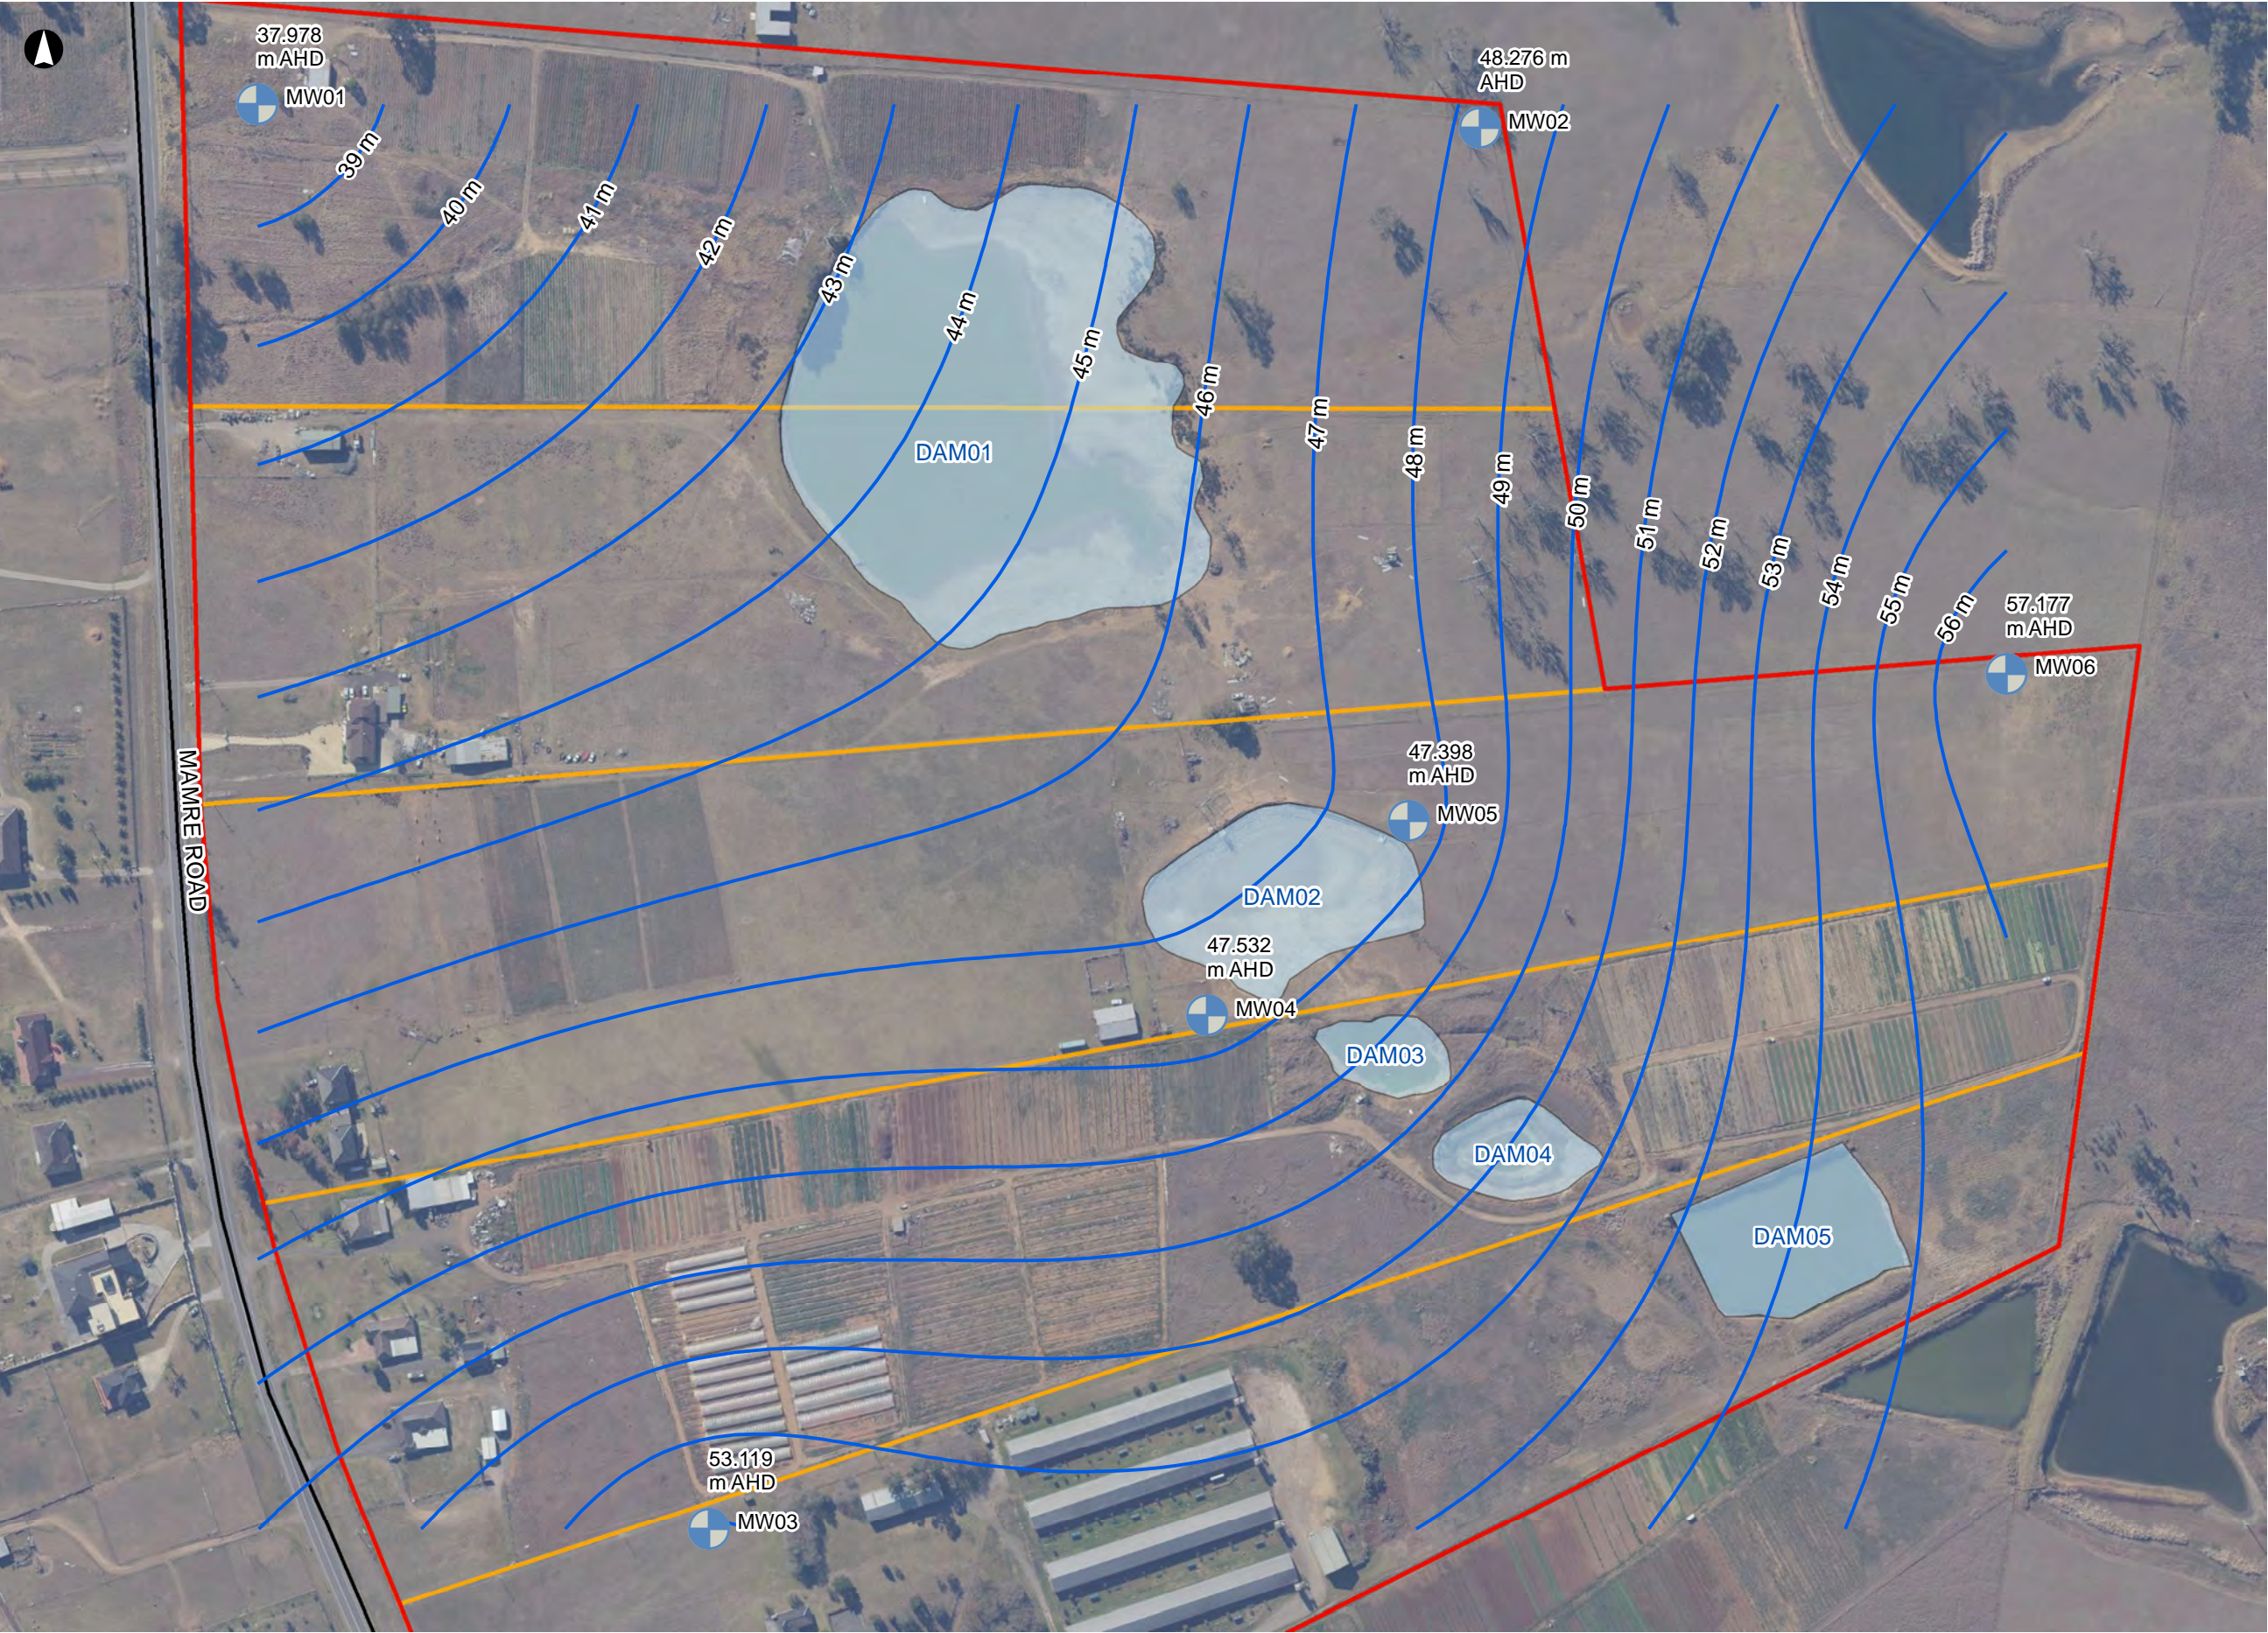
- Groundwater Wells
- Groundwater Contours (m AHD)
- Dams
- Site Boundary
- Lot Boundaries
