# DAM DECOMMISSIONING STRATEGY – REV 2

Aspect Industrial Estate, Mamre Road, Kemps Creek, NSW

Prepared for Mirvac Office and Industrial Pty Ltd

04 MAY 2022

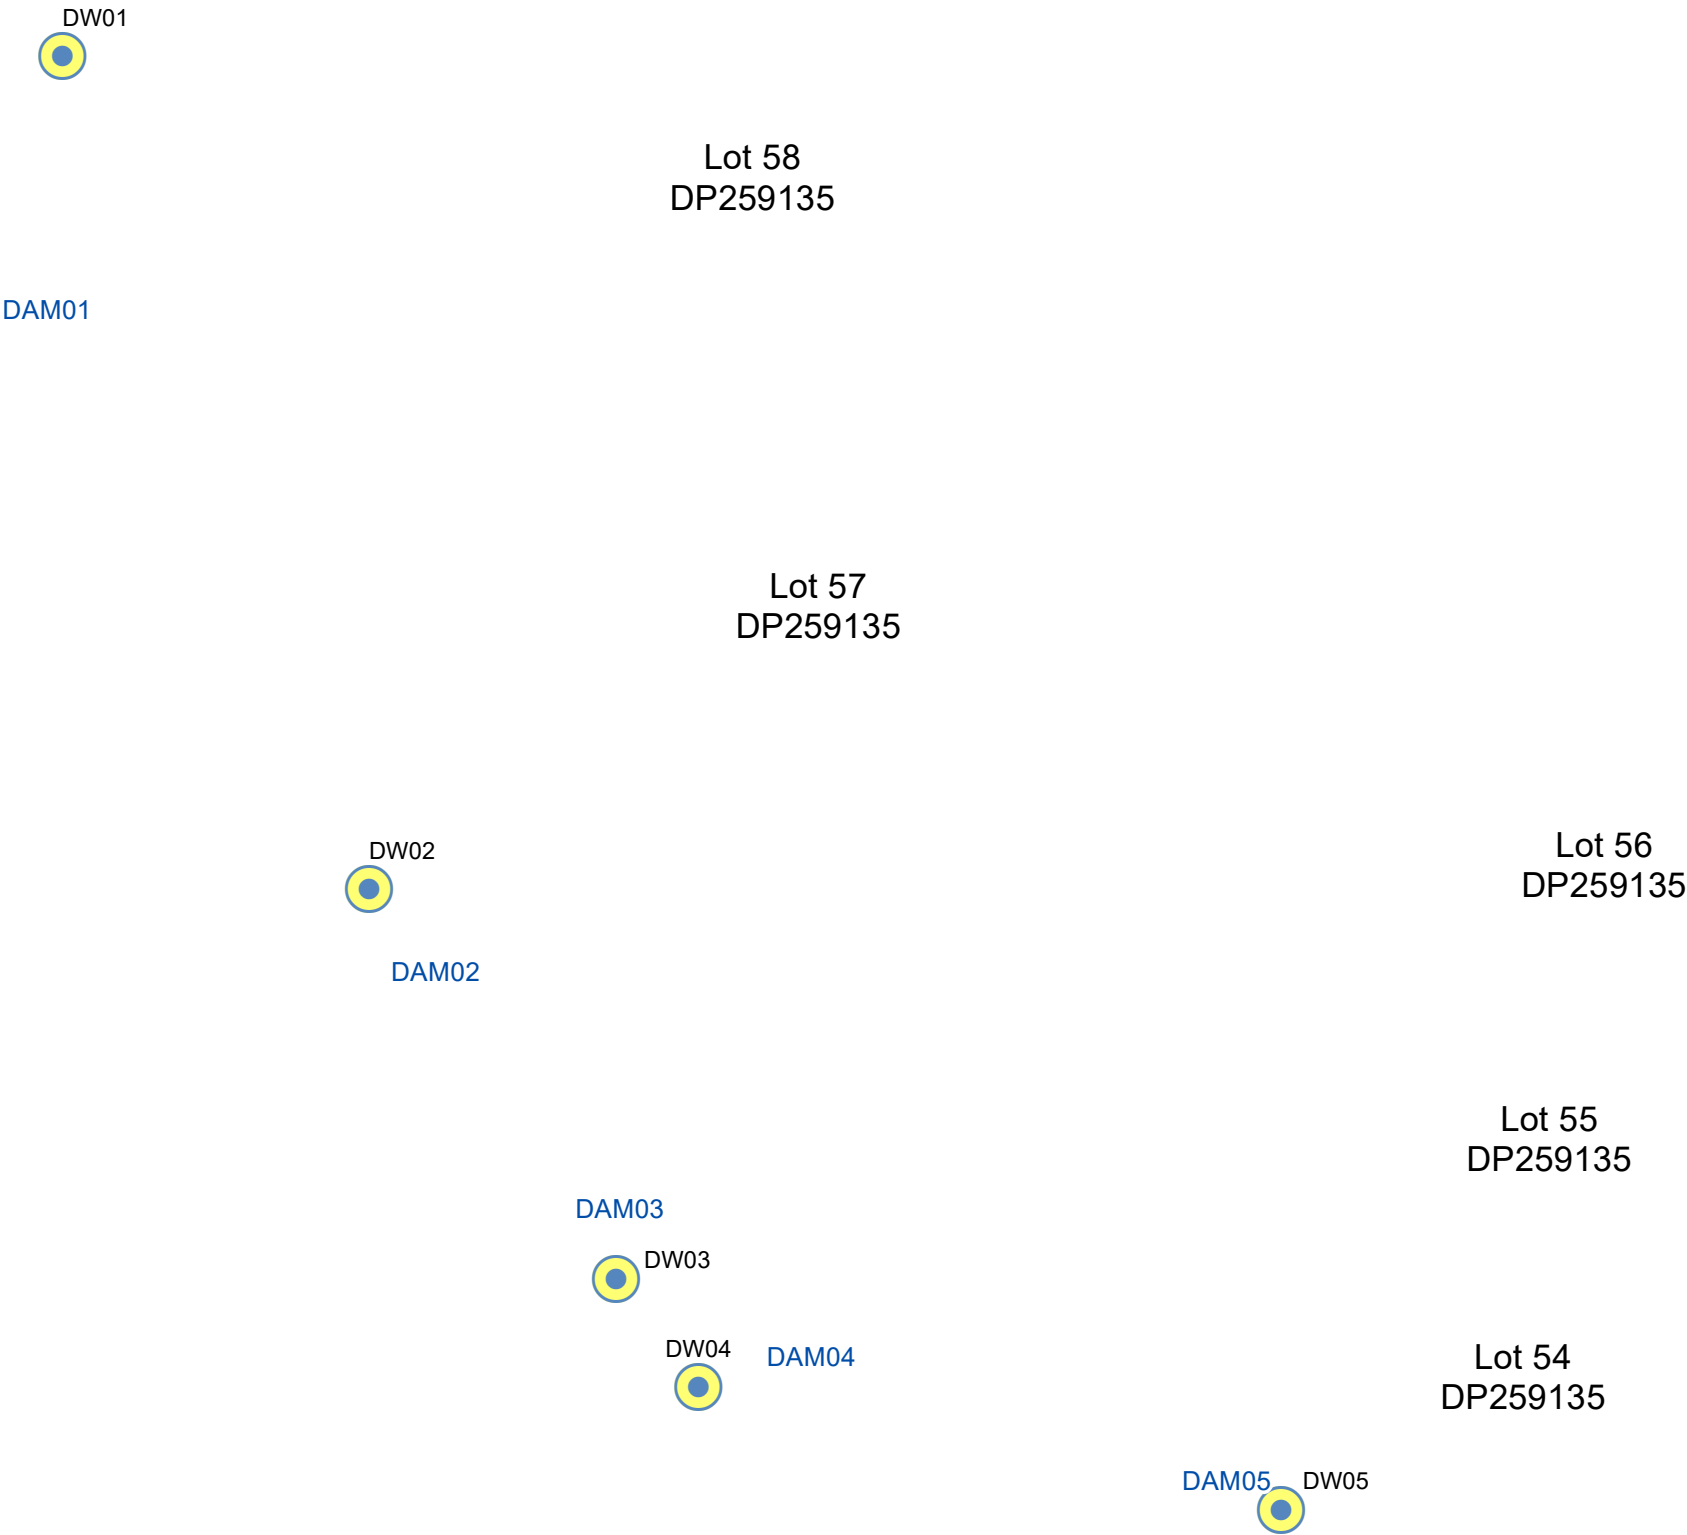
- Surface Water Samples
- Dams
- Site Boundary
- Lot Boundaries

The site location and five on-site dams are shown in Figures 1 and 2, **Appendix A**. The site details are summarised in Table 2-1 and described in the following sections.

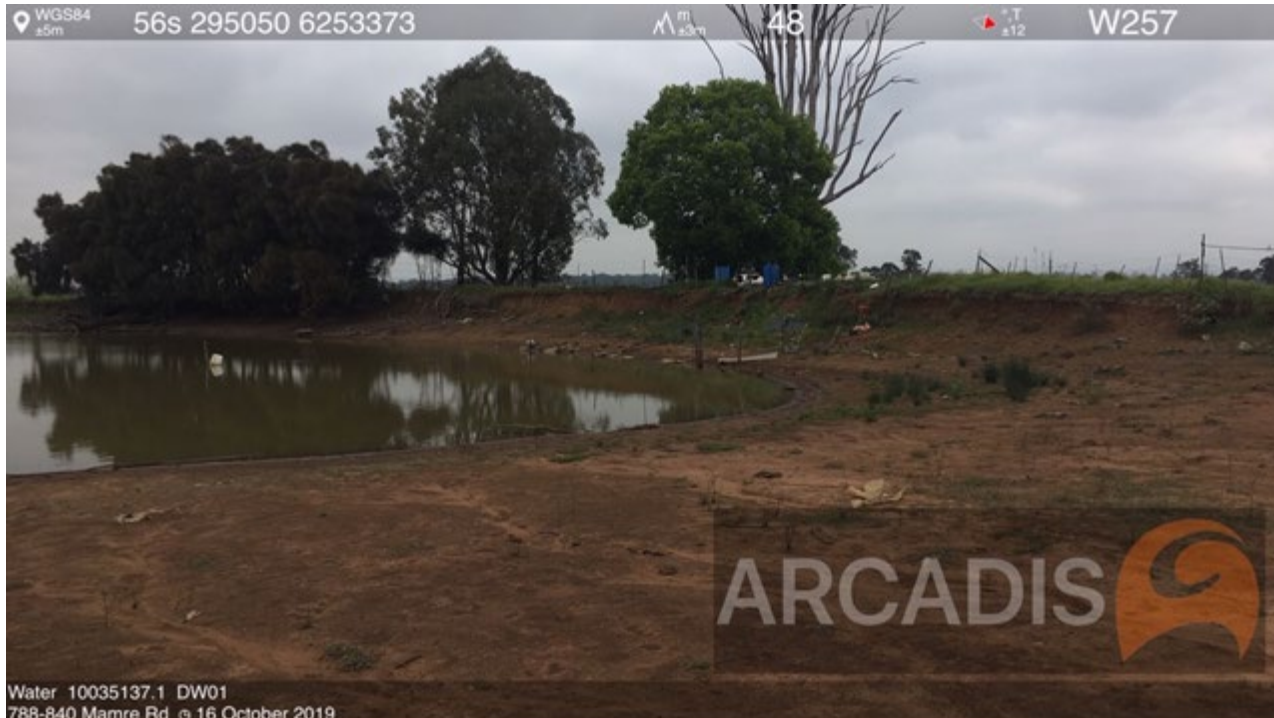
**Photo 1**

Dam01

Dam	Description
Dam01	<p>Dam01 is the largest dam on the site and spans across the central to southern portion of the two northern-most properties (Lots 58 and 57 DP259135). The dam appeared to be at less than half capacity.</p> <p>The construction material of the dam embankment appeared to comprise of local natural reworked soils. The western embankment of Dam01 was observed to be raised approximately 3m above the ground surface.</p> <p>A dry watercourse connecting Dam01 to the other dams on-site appears on its south-eastern most point. Another watercourse connecting the dam to Kemps Creek (located to the west of</p>

Dam	Description
	the site) was also apparent on the north-western point of Dam01. The dam appears to be infilled by rainfall runoff from the east.
Dam02	<p>Dam02 is situated at the central to southern portion of Lot 56 DP259135. At the time of inspection, the water level in the dam was noted to be very low. It was also noted that at full capacity, Dam02 and Dam03 (to the south) would join together to become a single larger dam. This is also evident in the historical photographs provided in JBS&amp;G's report (2019).</p> <p>The construction material of the dam embankment appeared to comprise of local natural reworked soils. The northern embankment was observed to be raised approximately 3m above the ground surface.</p> <p>A dry watercourse connecting Dam02 to Dam01 appears on its northern most point. The dam appears to be infilled from rainfall runoff from the east and south-east.</p>
Dam03	<p>Dam03 is located at a central to northern portion of Lot 55 DP259135. At full capacity, Dam03 and Dam02 (to the north) join together to become a single larger dam.</p> <p>The construction material of the dam embankment appeared to comprise of local natural reworked soils with the embankments raised approximately 3m above the ground surface.</p> <p>A dry watercourse connecting Dam03 to Dam04 appears to exist on its southern most point. The dam appears to be infilled from rainfall runoff from the south-west.</p>

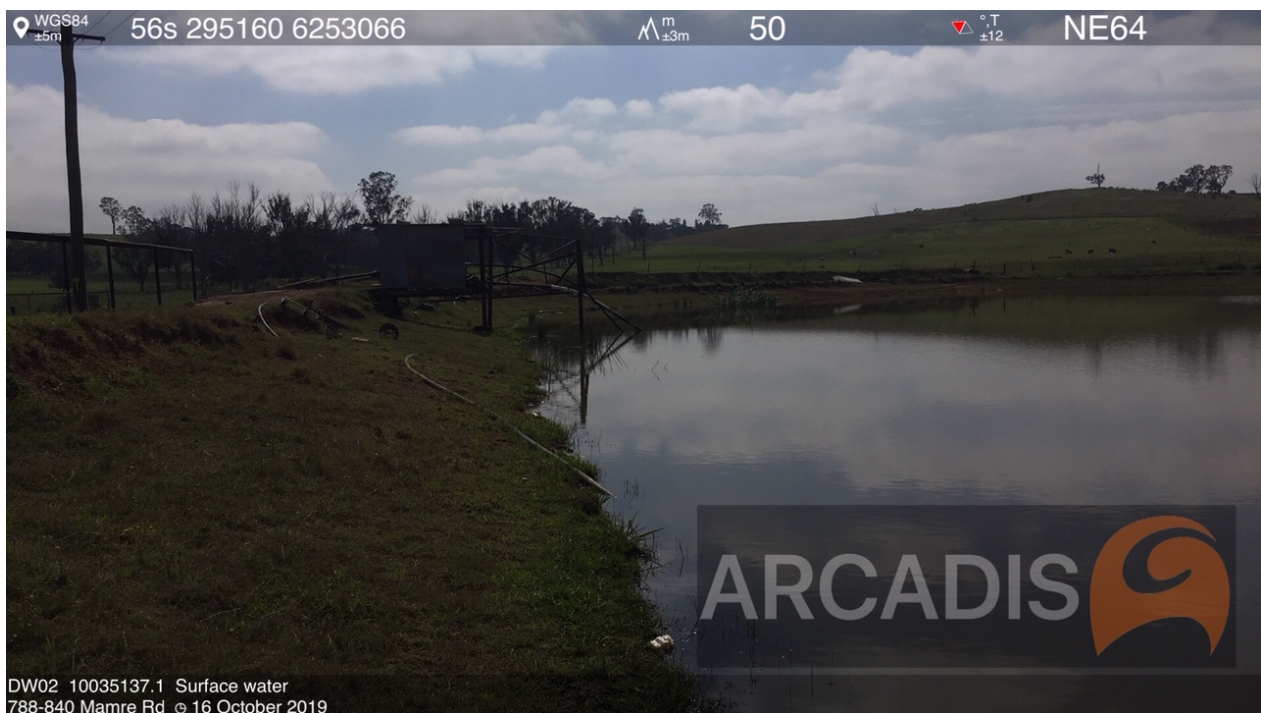
**Photo 2**

Dam02

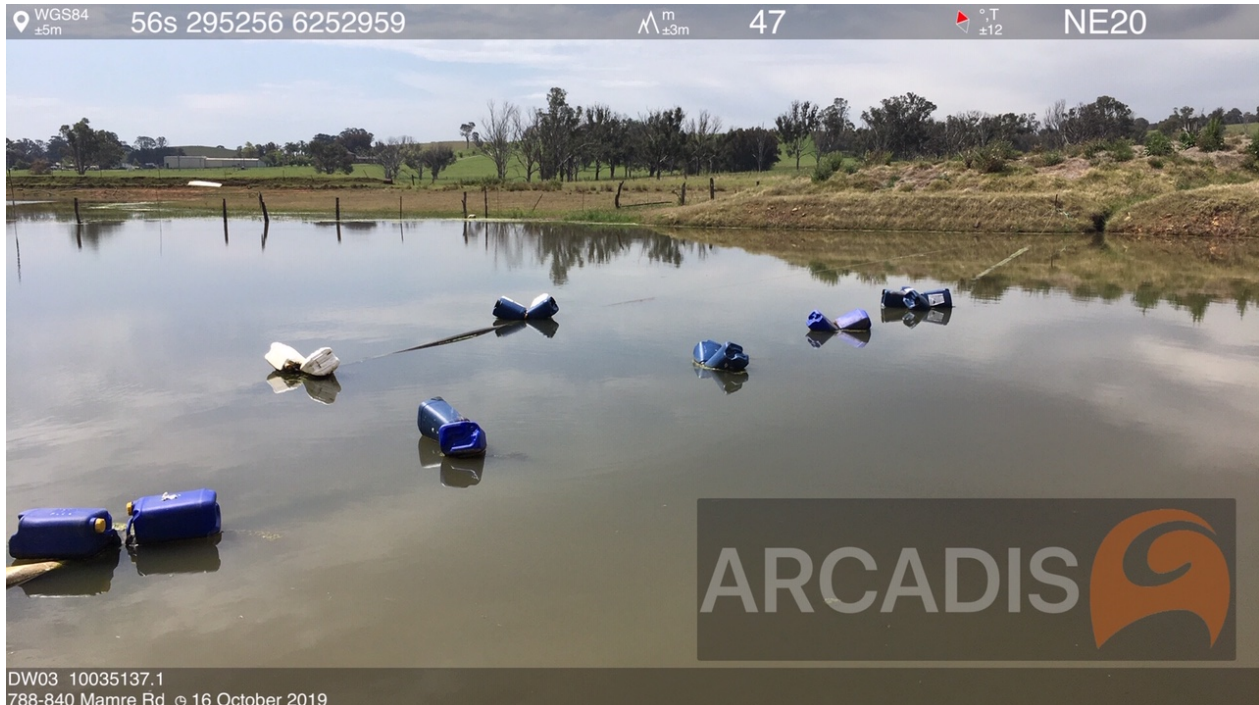
**Photo 3**

Dam03

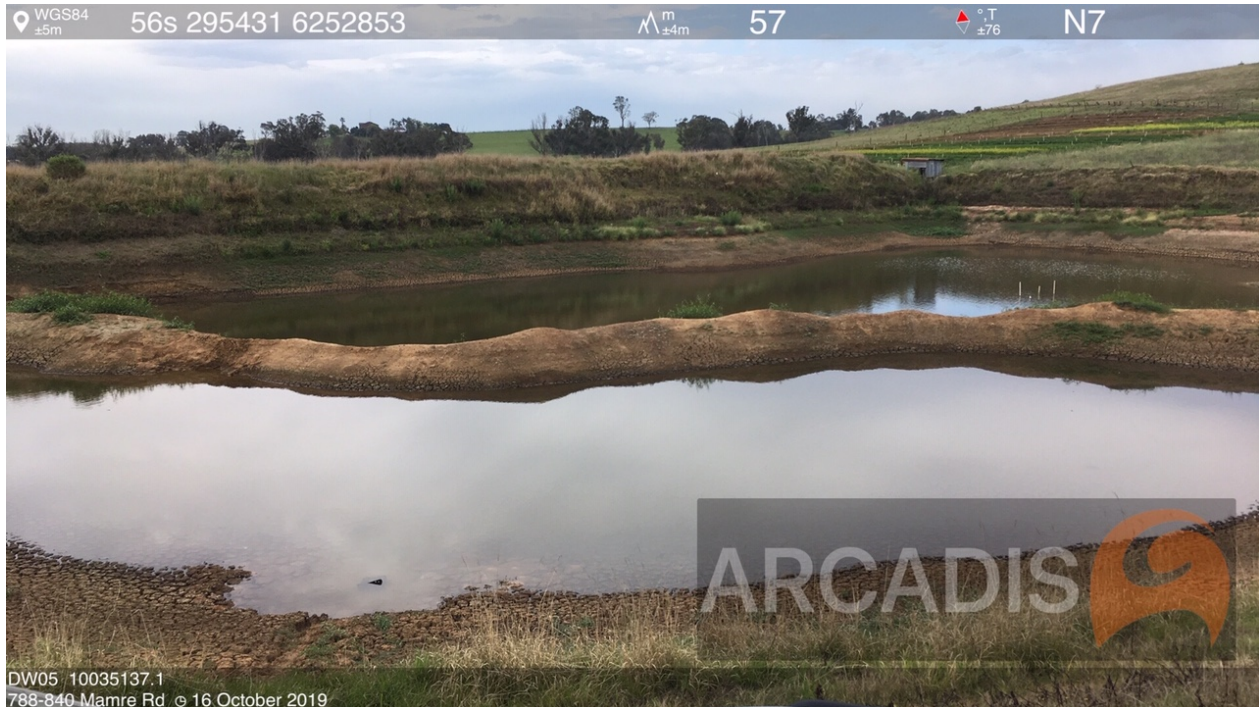
**Photo 5**

Dam05
