# EnergyConnect (NSW – Eastern Section)

## Response to Department of Planning and Environment Request for Information

30 August 2022

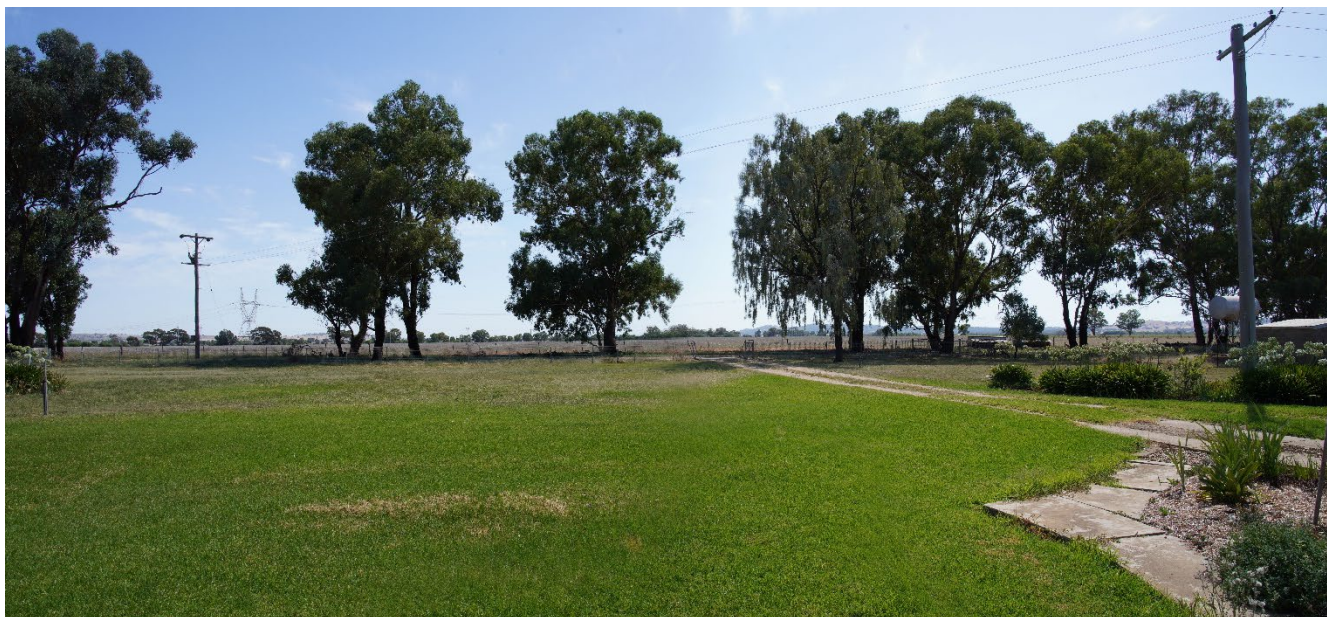
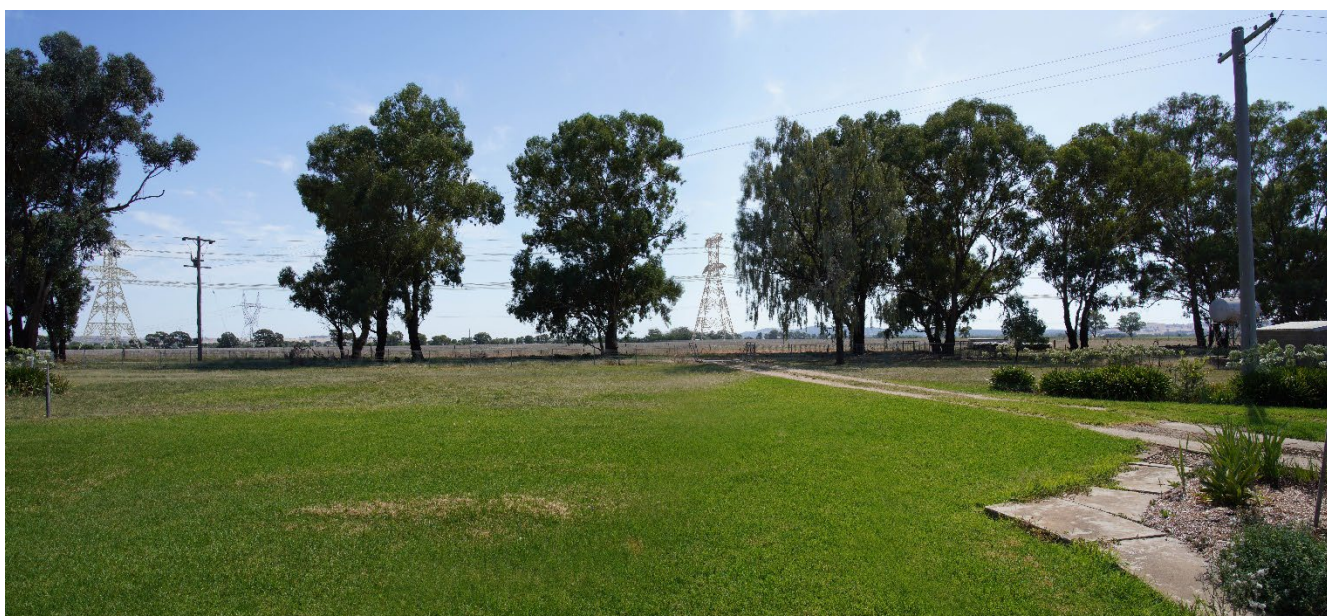
**Figure 1-1 Photomontage of R186 – Elswick, 5746 Olympic Highway, Uranquinty**

*(Top – before, bottom, with project)*

*Photomontages are indicative and the tower design, location and associated infrastructure is subject to finalisation of the project design*

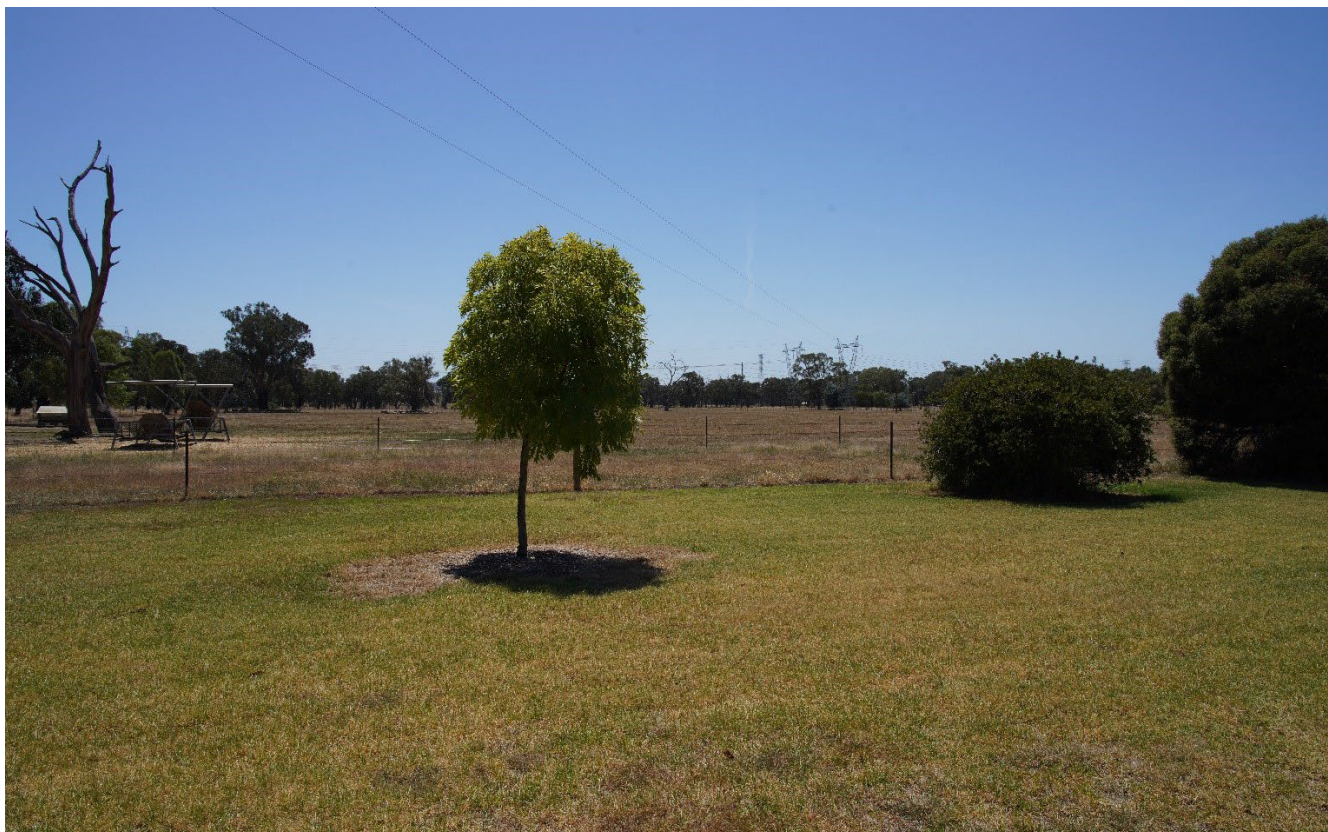
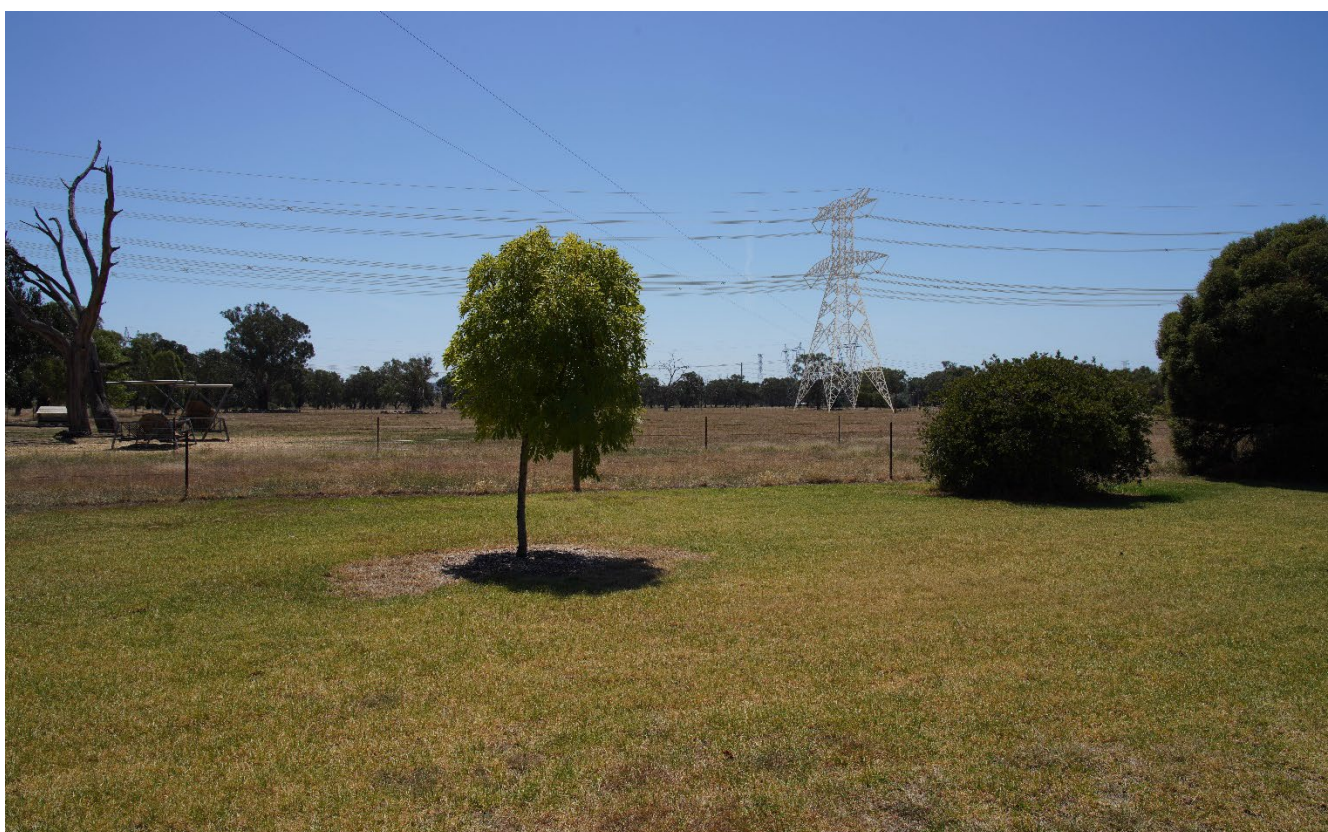
**Figure 1-2 Photomontage of R233 – Berkley, 99 Rowan Road, Rowan**

*(Top – before, bottom, with project)*

*Photomontages are indicative and the tower design, location and associated infrastructure is subject to finalisation of the project design*

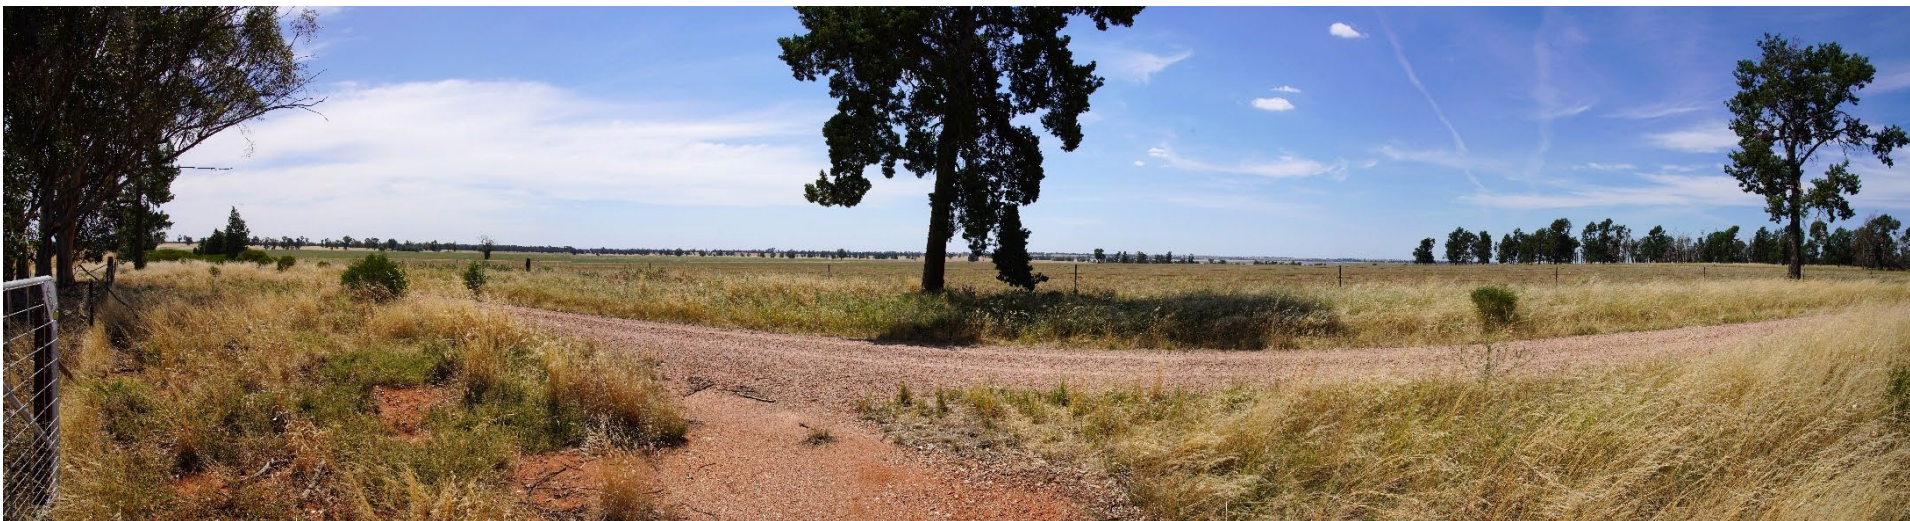
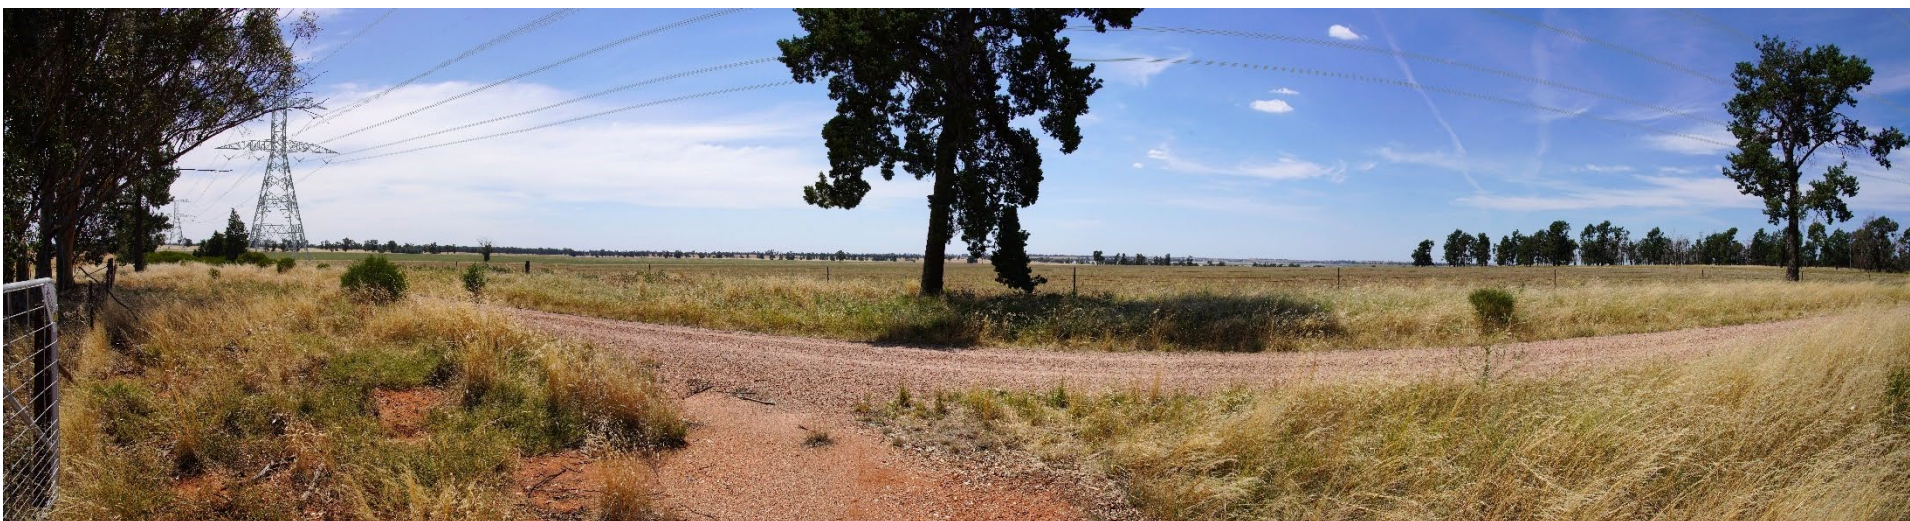
**Figure 1-3 Photomontage of R385 – Andriskes Lane, Cullivel (noting the location for this photomontage is taken from the land adjacent to the property due to land owner restriction to access the property)**

*(Top – before, bottom, with project)*

*Photomontages are indicative and the tower design, location and associated infrastructure is subject to finalisation of the project design*

| No. | Building ID | Holding No. | Location / address | Property visit undertaken | Preliminary potential visual impact level from EIS | Verified potential visual impact level (pre-mitigation), post field validation | Key factors supporting the verified visual impact level | Potential mitigation measures | Potential residual visual impact level with mitigation (subject to agreement with land holder) |
|---|---|---|---|---|---|---|---|---|---|
| 9 | 385 | H134 | Andriskies Lane, Cullivel | Observed from the Lane | Very high | High | <ul style="list-style-type: none"> <li>View would be under and between the towers</li> <li>Panoramic rural view with view to Lake Cullivel (water visible at time of visit)</li> <li>Vegetation surrounding the house directs view towards and beyond the alignment.</li> </ul> | <ul style="list-style-type: none"> <li>Additional trees provided to the northwest and northeast of the residence on adjacent fields or on the perimeter of the garden to provide additional screening and fill gaps between existing trees.</li> </ul> | Moderate |

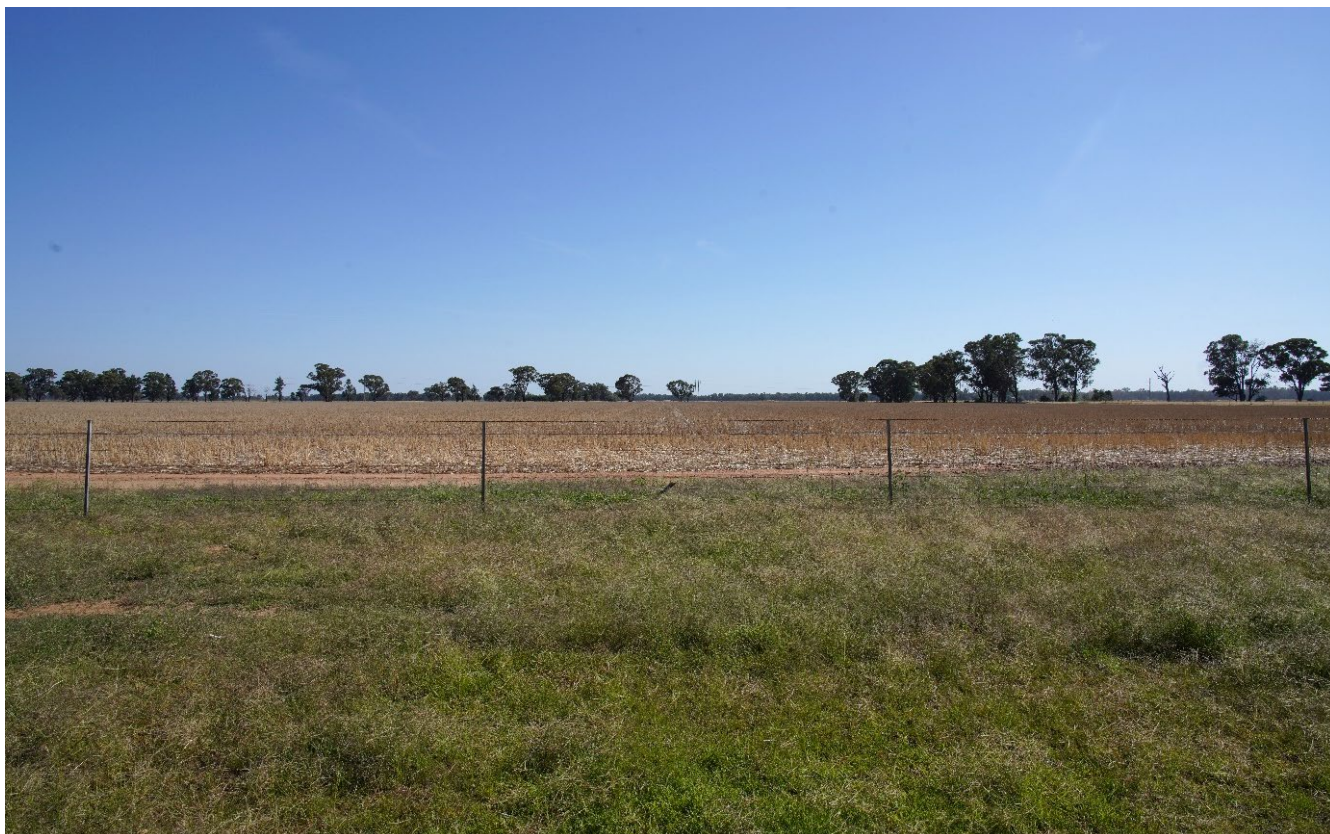
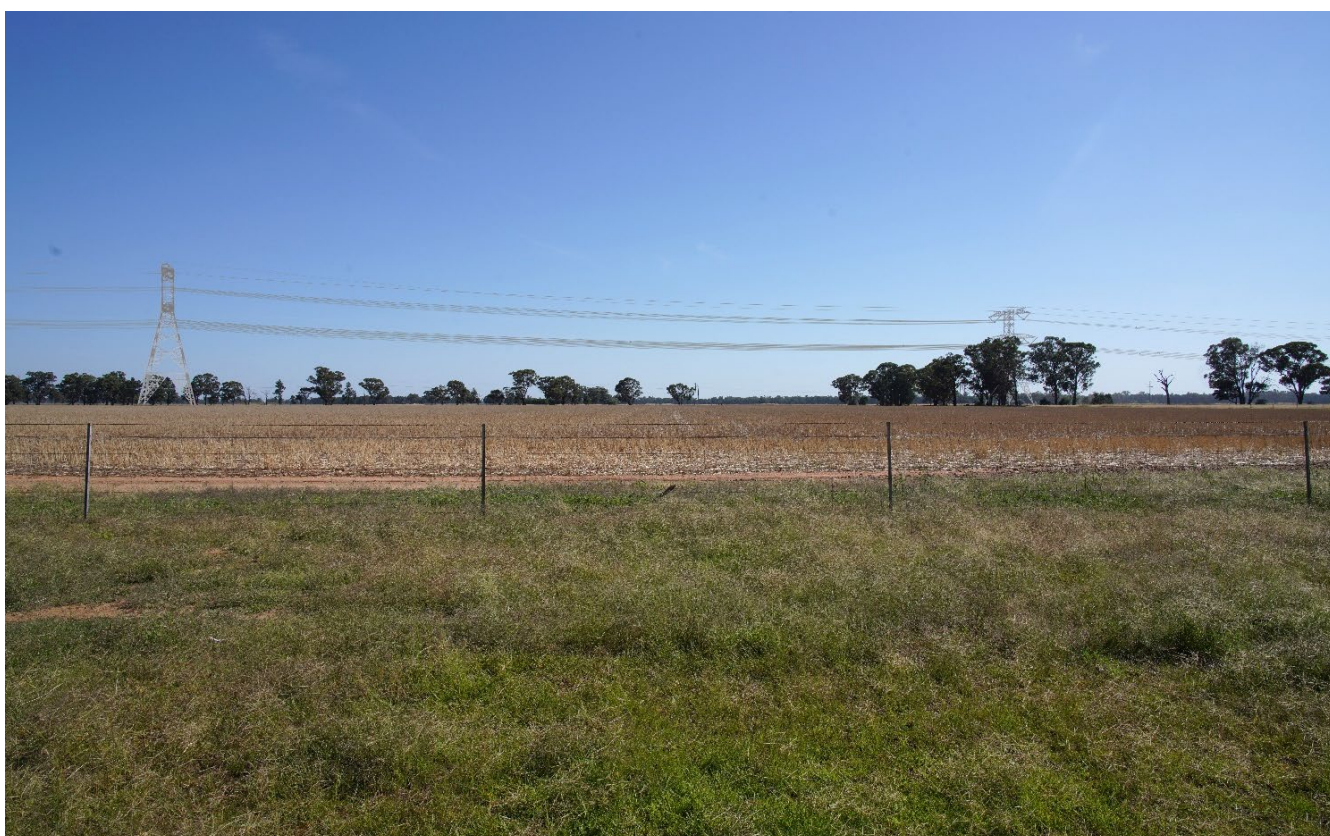
**Figure 1-5 Photomontage of R432 – ‘Rosebank’ 535 Tuttys Lane, Tootool**

*(Top – before, bottom, with project)*

*Photomontages are indicative and the tower design, location and associated infrastructure is subject to finalisation of the project design*

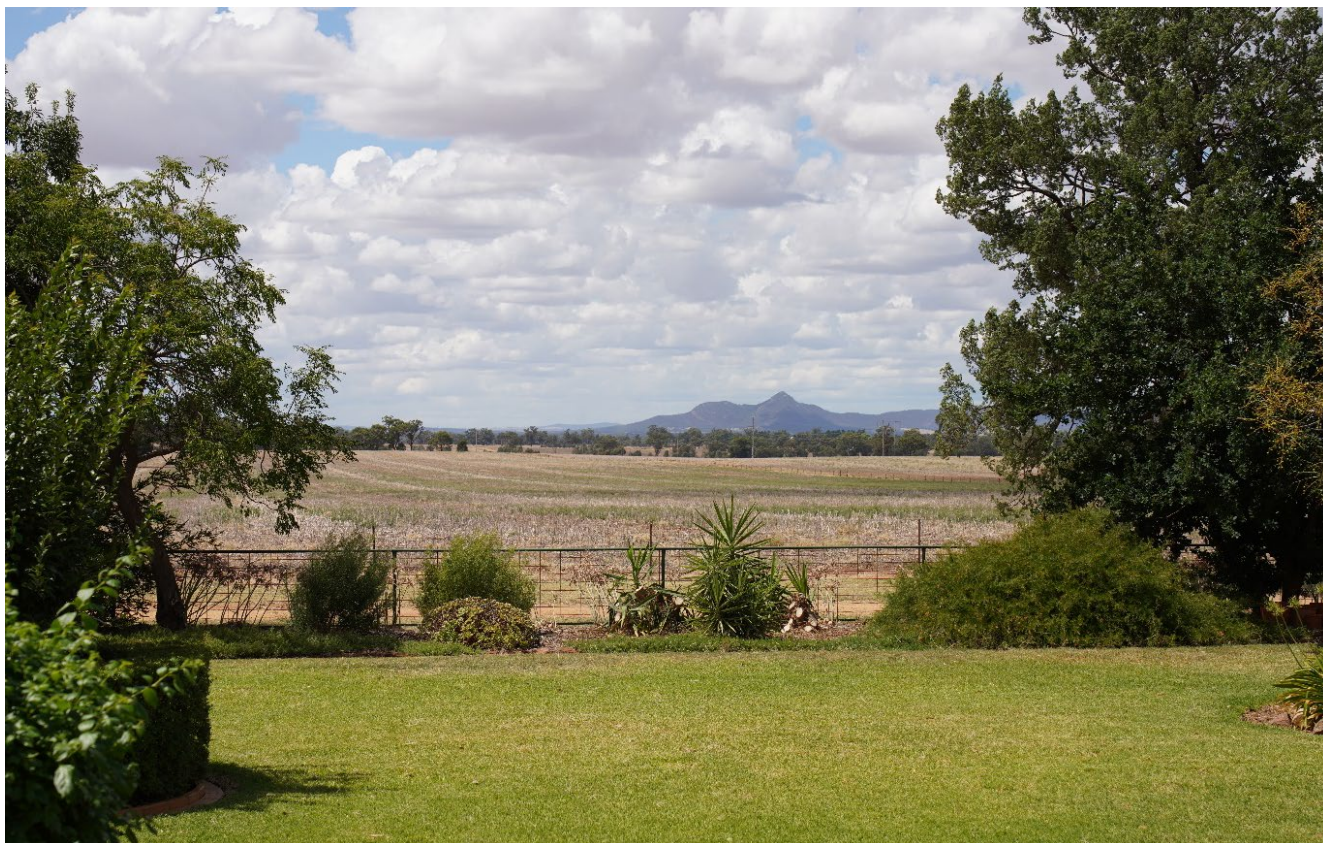
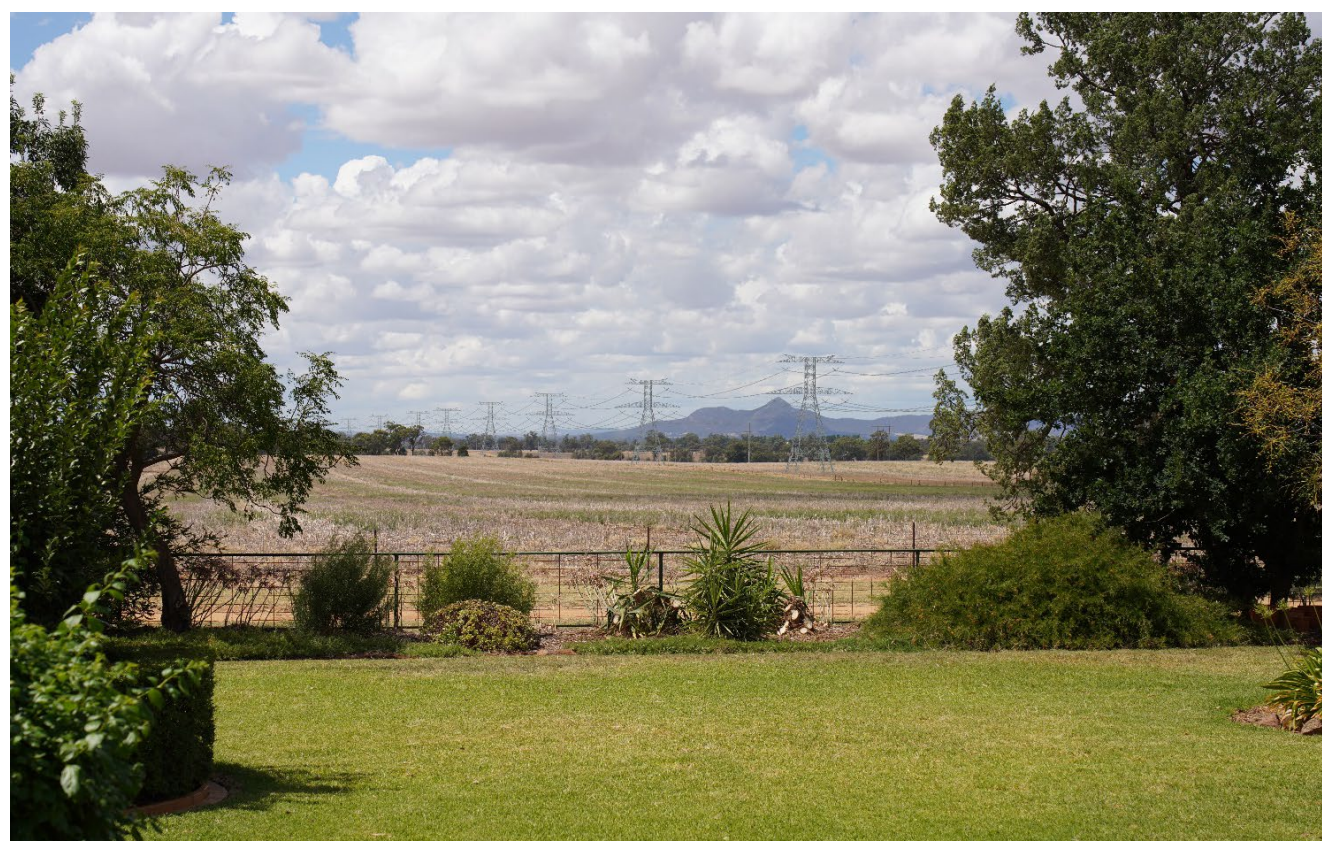
**Figure 1-6 Photomontage of R450 – 128 Slys Lane, Milbrulong (top – before, bottom, with project)**

*(Top – before, bottom, with project)*

*Photomontages are indicative and the tower design, location and associated infrastructure is subject to finalisation of the project design*

| No. | Building ID | Holding No. | Location / address | Property visit undertaken | Preliminary potential visual impact level from EIS | Verified potential visual impact level (pre-mitigation), post field validation | Key factors supporting the verified visual impact level | Potential mitigation measures | Potential residual visual impact level with mitigation (subject to agreement with land holder) |
|---|---|---|---|---|---|---|---|---|---|
| 11 | 450 | H172 | 128 Slys Lane, Milbrulong | Yes | High | High | <ul style="list-style-type: none"> <li>Tower located on a rise in the landscape</li> <li>Dwelling and living areas oriented towards a view to The Rock</li> <li>This is a whole view to The Rock which is a regional icon in the landscape</li> <li>Multiple towers would be seen crossing the view</li> <li>Towers would rise above the skyline, partly obstructing and detracting from the visual prominence of The Rock in this view.</li> </ul> | <ul style="list-style-type: none"> <li>Additional vegetation along the boundary of the garden and / or on adjacent fields would provide some screening of the closer towers to the south, and not crossing the main viewline.</li> <li>Adjust tower locations (if feasible and reasonable) to avoid a tower being directly in line with / obstructing the view to The Rock</li> </ul> | High-moderate |

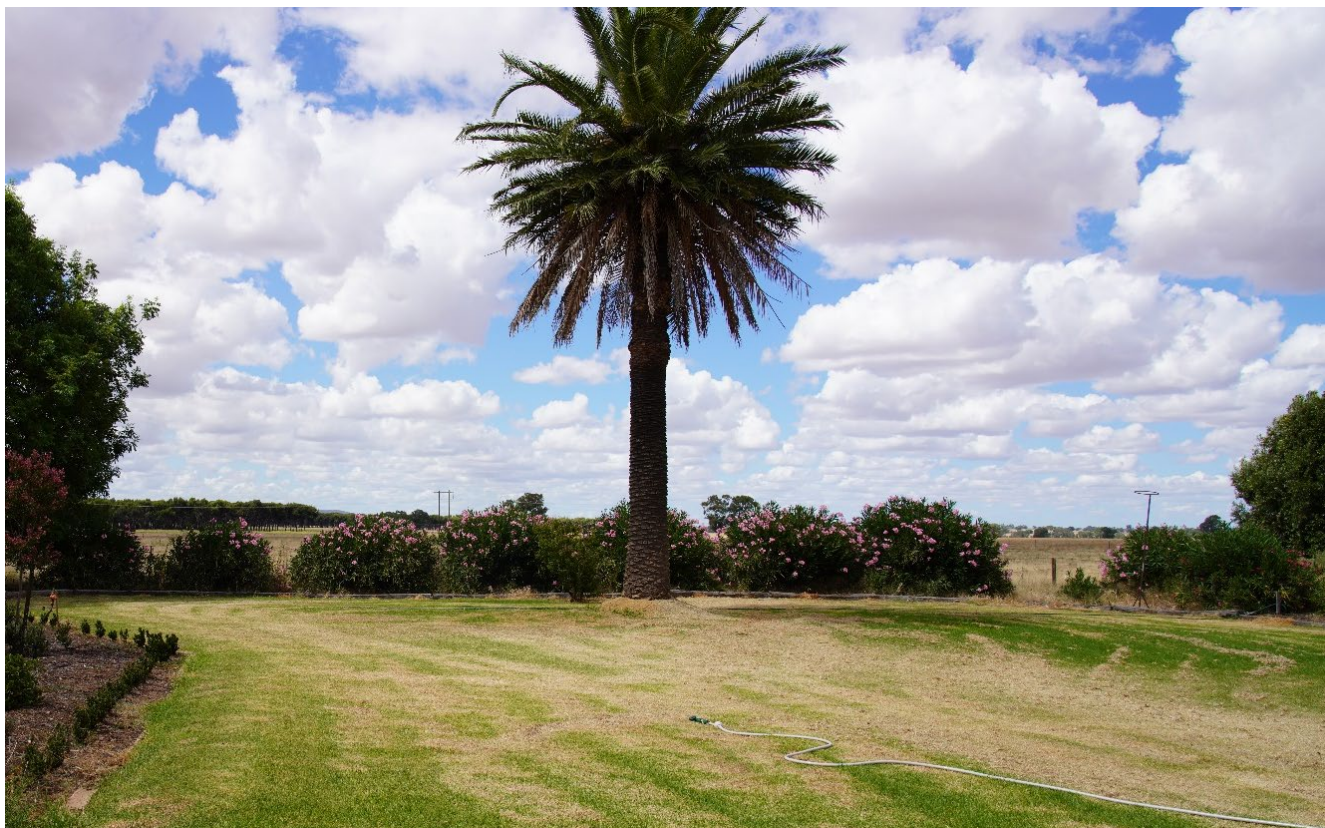
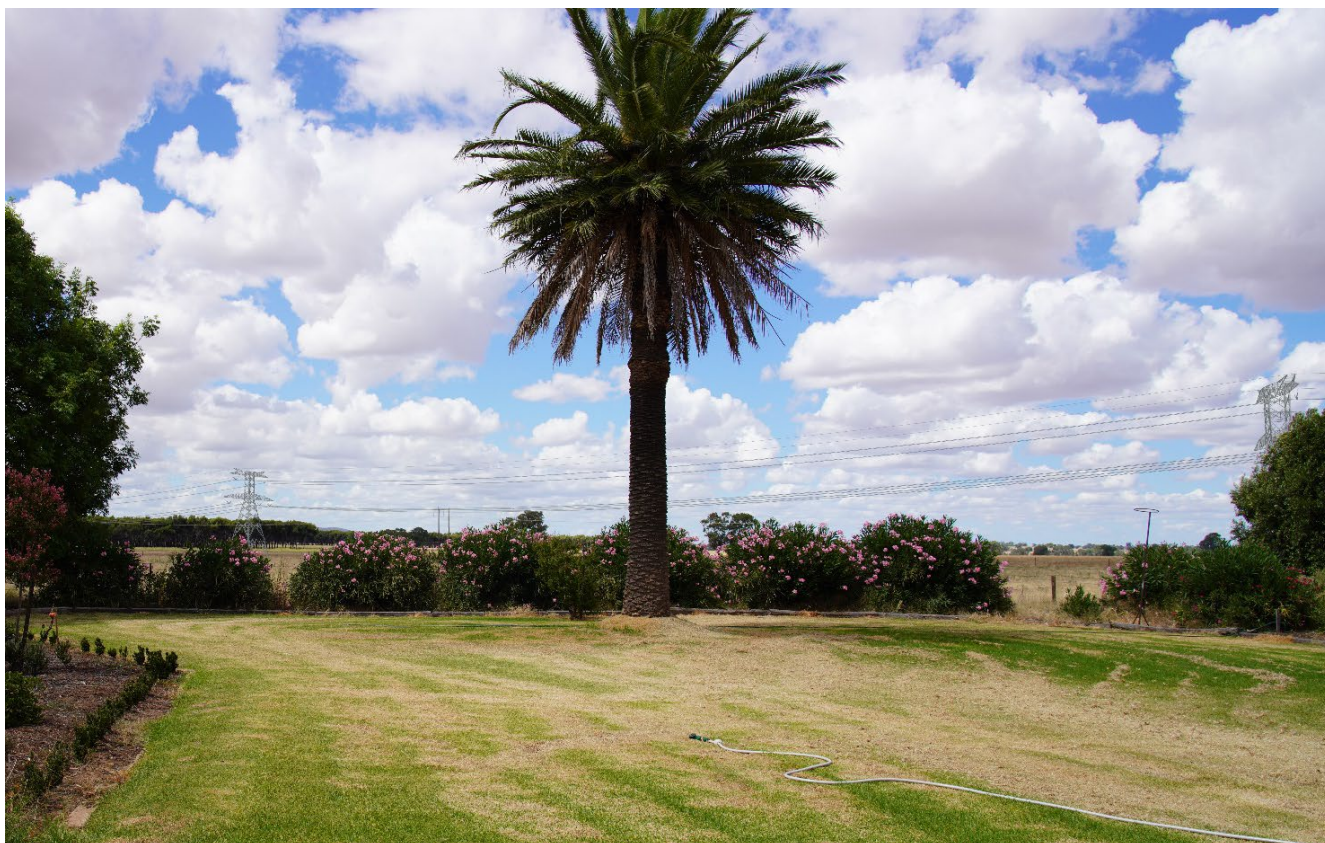
**Figure 1-7 Photomontage of R461 – 731 Hendersons Road, Tootool**

*(Top – before, bottom, with project)*

*Photomontages are indicative and the tower design, location and associated infrastructure is subject to finalisation of the project design*

| No. | Building ID | Holding No. | Location / address | Property visit undertaken | Preliminary potential visual impact level from EIS | Verified potential visual impact level (pre-mitigation), post field validation | Key factors supporting the verified visual impact level | Potential mitigation measures | Potential residual visual impact level with mitigation (subject to agreement with land holder) |
|---|---|---|---|---|---|---|---|---|---|
| 12 | 461 | H176 | 'Yarrow' 731 Hendersons Road, Tootool | Yes | High | High-moderate | <ul style="list-style-type: none"> <li>Dwelling, pool and partly constructed tennis court oriented towards the alignment</li> <li>Some trees and shrubs in the garden would screen the view from the dwelling</li> <li>There is more visibility of the alignment from outdoor areas associated with the house, including a view to The Rock from tennis court area.</li> </ul> | <ul style="list-style-type: none"> <li>Additional trees and shrubs to the south of the dwelling to screen views to the nearest towers and fill gaps in the trees</li> <li>Trees along the driveway to reduce the visibility of the towers on the approach to the dwelling.</li> </ul> | Moderate |

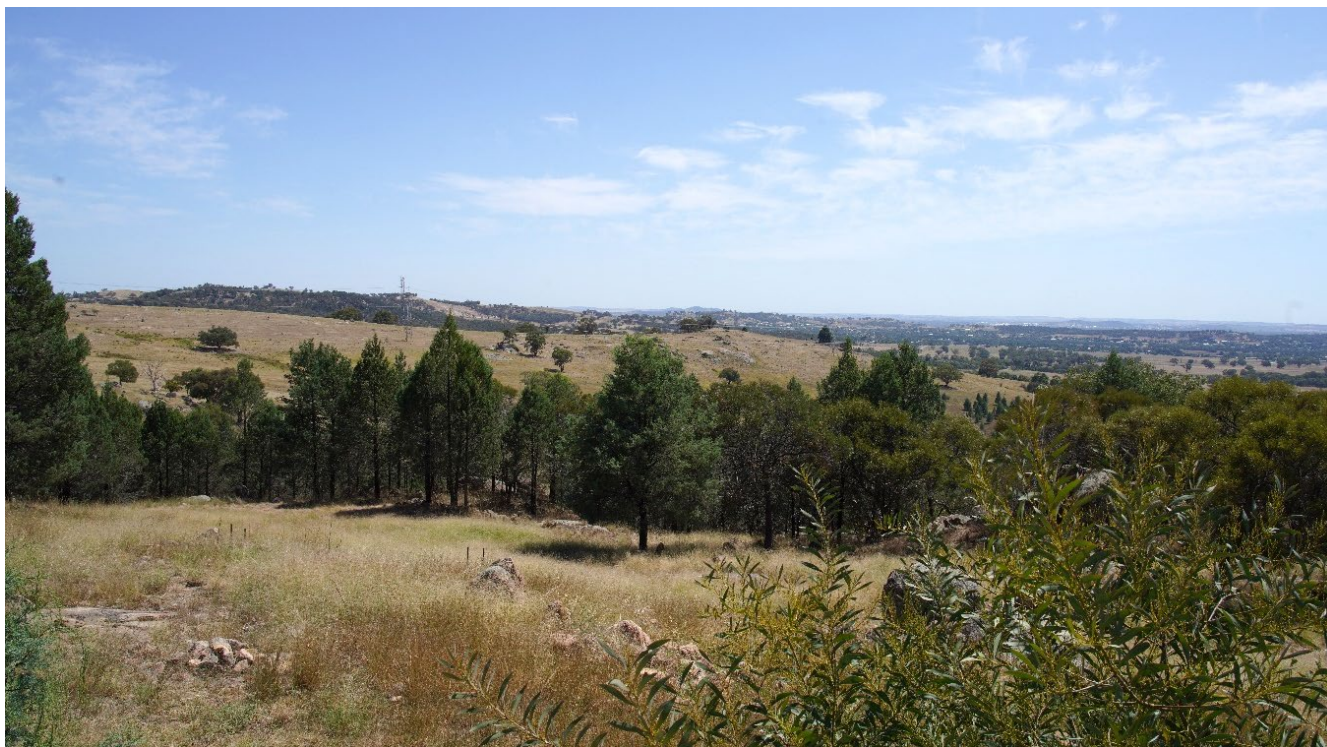
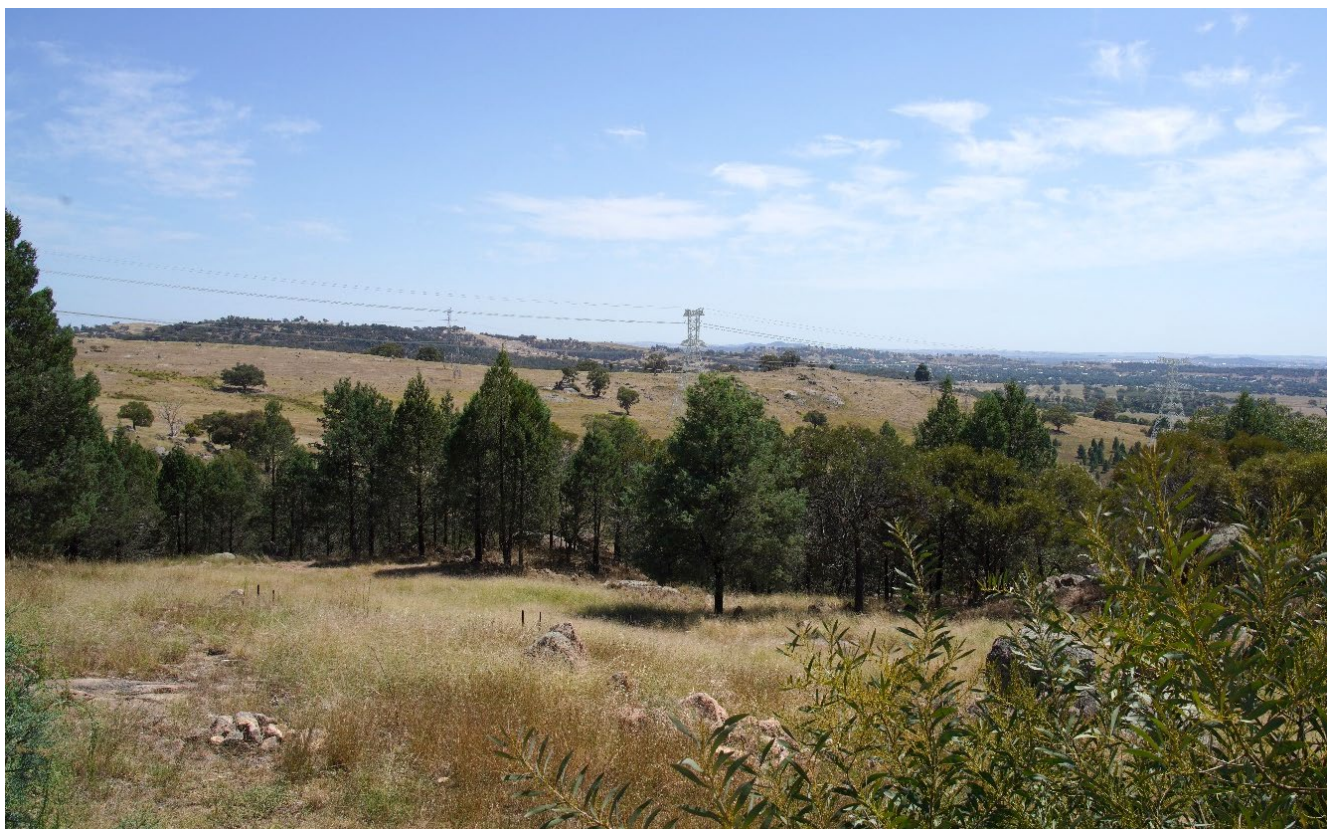
**Figure 1-8 Photomontage of R501 – 6645 Holbrook Road, Gelston Park**

*(Top – before, bottom, with project)*

*Photomontages are indicative and the tower design, location and associated infrastructure is subject to finalisation of the project design*

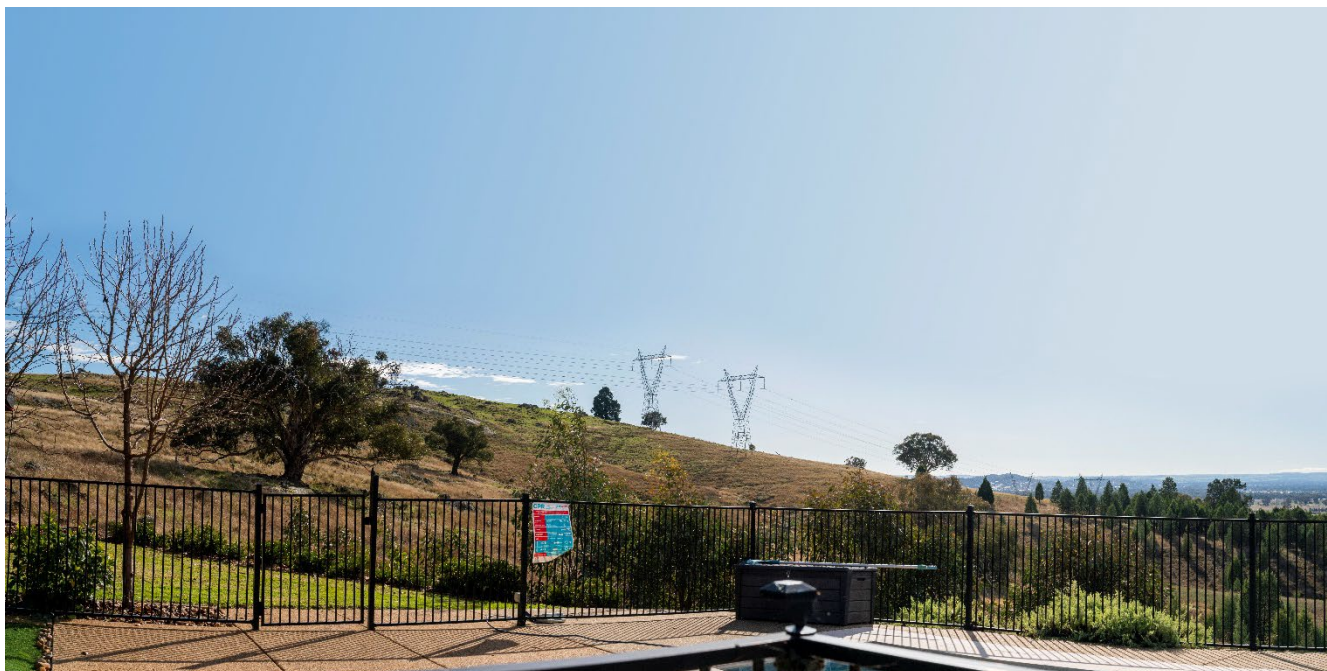
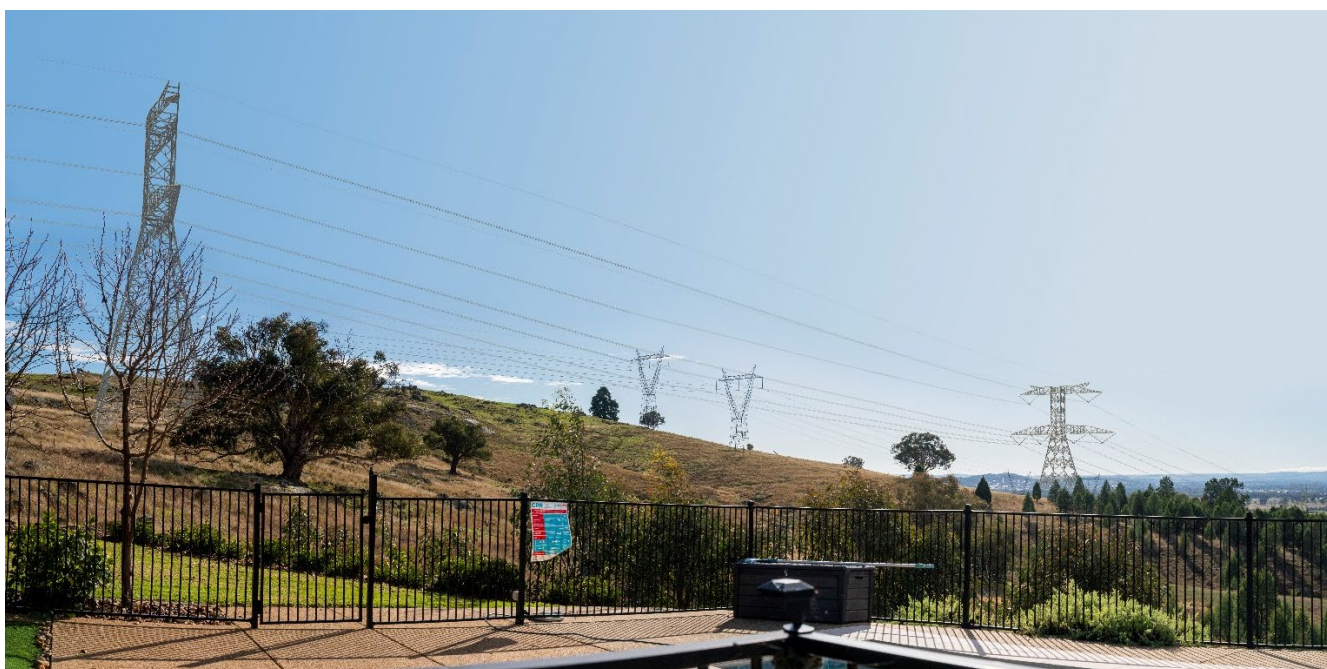
**Figure 1-9 Photomontage of R26749 – 6707 Holbrook Road, Gelston Park**

*(Top – before, bottom, with project)*

*Photomontages are indicative and the tower design, location and associated infrastructure is subject to finalisation of the project design*

As indicated in Table 2 below, the potential residual visual impact level with mitigation for receiver R26749 remains at 'High'. For this location, Transgrid would examine a range of at-site treatments, together with examining the feasibility of micro-siting towers immediately adjacent to the property in order to reduce visual impacts. This would occur in consultation with the landholder.

| No. | Building ID | Holding No. | Location / address | Property visit undertaken | Preliminary potential visual impact level from EIS | Verified potential visual impact level (pre-mitigation), post field validation | Key factors supporting the verified visual impact level | Potential mitigation measures | Potential residual visual impact level with mitigation (subject to agreement with land holder) |
|---|---|---|---|---|---|---|---|---|---|
| 27 | 26749 | H200 | 6707 Holbrook Road, Gelston Park, Rowan | Observed from Holbrook Road | High | High | <ul style="list-style-type: none"> <li>Dwelling oriented parallel to the alignment</li> <li>A tower would be located to the northwest of and in close proximity to the pool area</li> <li>A tower would be located prominently on the ridgeline to the northeast and in the middle ground of this view</li> <li>Towers of a large scale and would be prominently located on higher ground.</li> </ul> | Vegetation could be provided to the northwest of the pool area to provide some screening of the nearest tower. Otherwise, there is limited opportunity on this property to screen the view to the most visible tower that would be located to the northeast of the dwelling. | High |

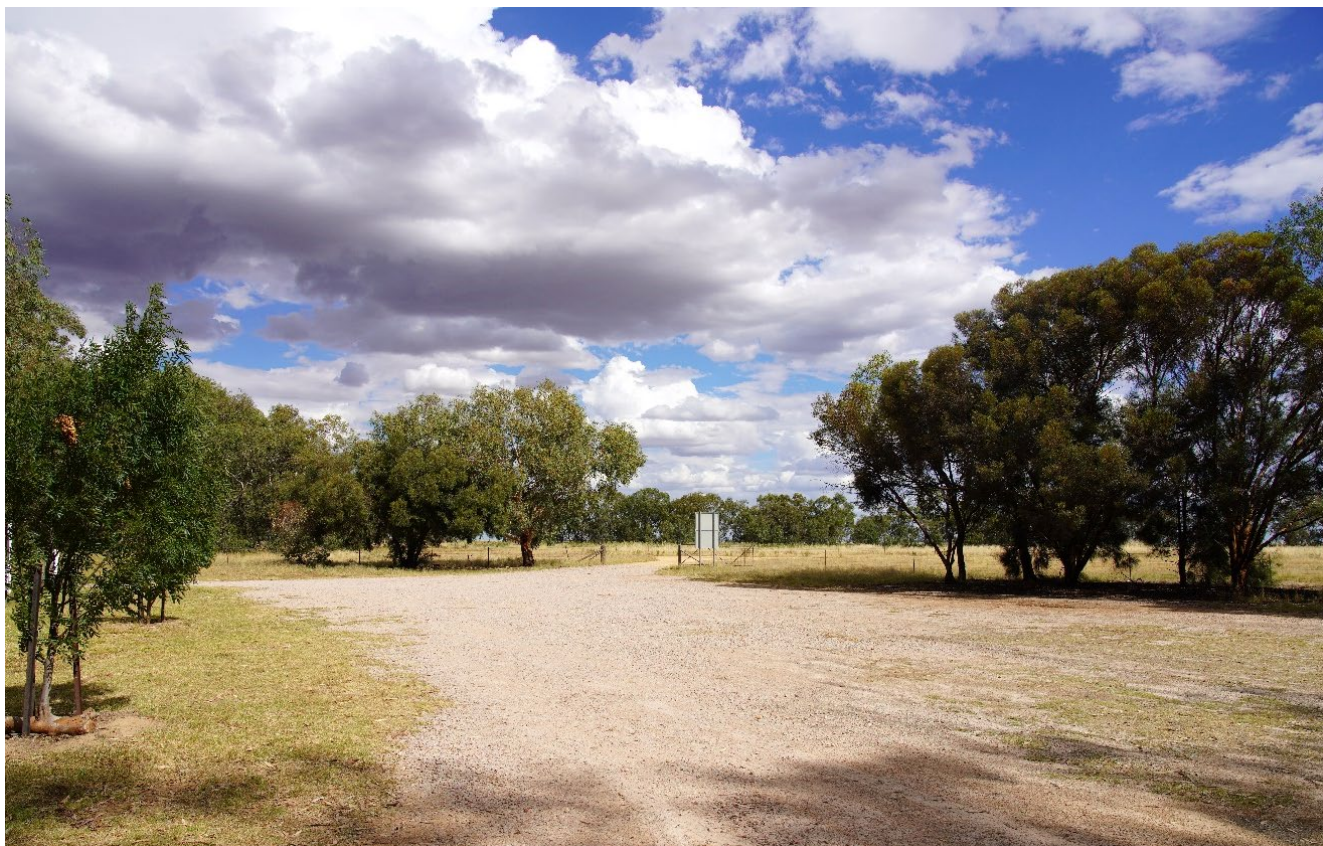
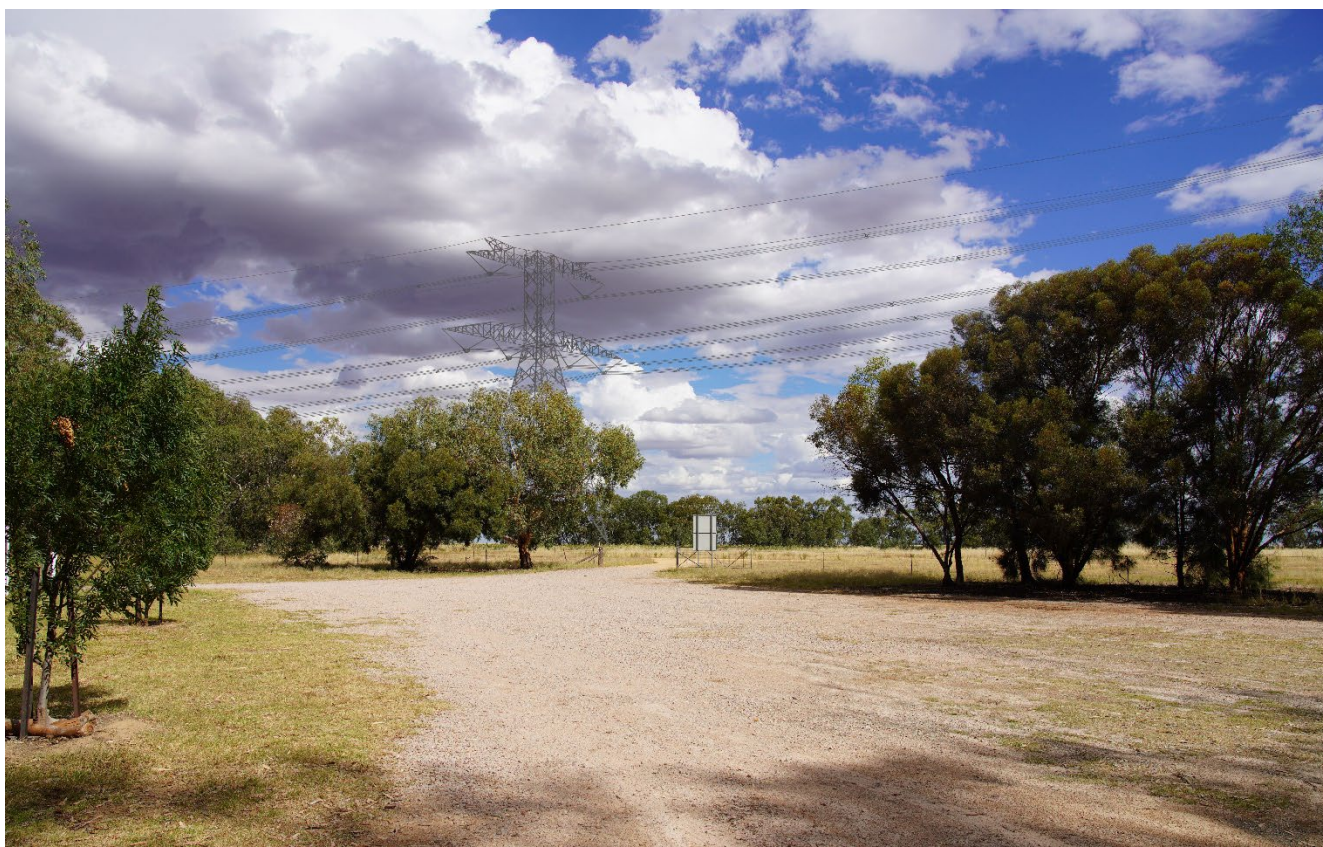
**Figure 1-10 Photomontage of R534 – Colombo Creek water ski club and camp ground**

*(Top – before, bottom, with project)*

*Photomontages are indicative and the tower design, location and associated infrastructure is subject to finalisation of the project design*

To the best of Transgrid's knowledge, all key public viewpoints with the potential for a visual impact (including within 500 metres of the alignment) have been considered in the assessment. R534, the Colombo Water Ski Club was identified in EIS as a potential high visual impact. As part of the response to the public submissions following exhibition of the EIS, this site was not included in the refined table which only assessed private dwellings impacts. With respect to the request for a photomontage from R534 (Colombo Water Ski Club and Campground with amenities), this has been included as Figure 1-10 in the previous section.

Existing conditions: This view is from the carpark of the Colombo Creek Ski Club, in the vicinity of the picnic area where there is a playground and amenities building (refer to Figure 1-10). This view is oriented away from the creek and the main focus of activity and views from this area. This view is enclosed by vegetation along Coonong Road and includes glimpses to the surrounding rural landscape. This view includes the access road and would often include vehicles manoeuvring and parked.

Visual impact during operation: A new large-scale transmission line tower would be seen in the middle ground of this view, rising above the intervening vegetation. This tower would be viewed against the sky, in a view that is otherwise leafy. The transmission line easement, would introduce an infrastructure character to views from the Colombo Creek Ski Club, detracting from the amenity of this view. Overall, the tower would be prominent and contrast with the character of this view, resulting in a high magnitude of change and a **moderate visual impact**.
