# EnergyConnect (NSW – Eastern Section)

## Response to Department of Planning and Environment Request for Information

30 August 2022

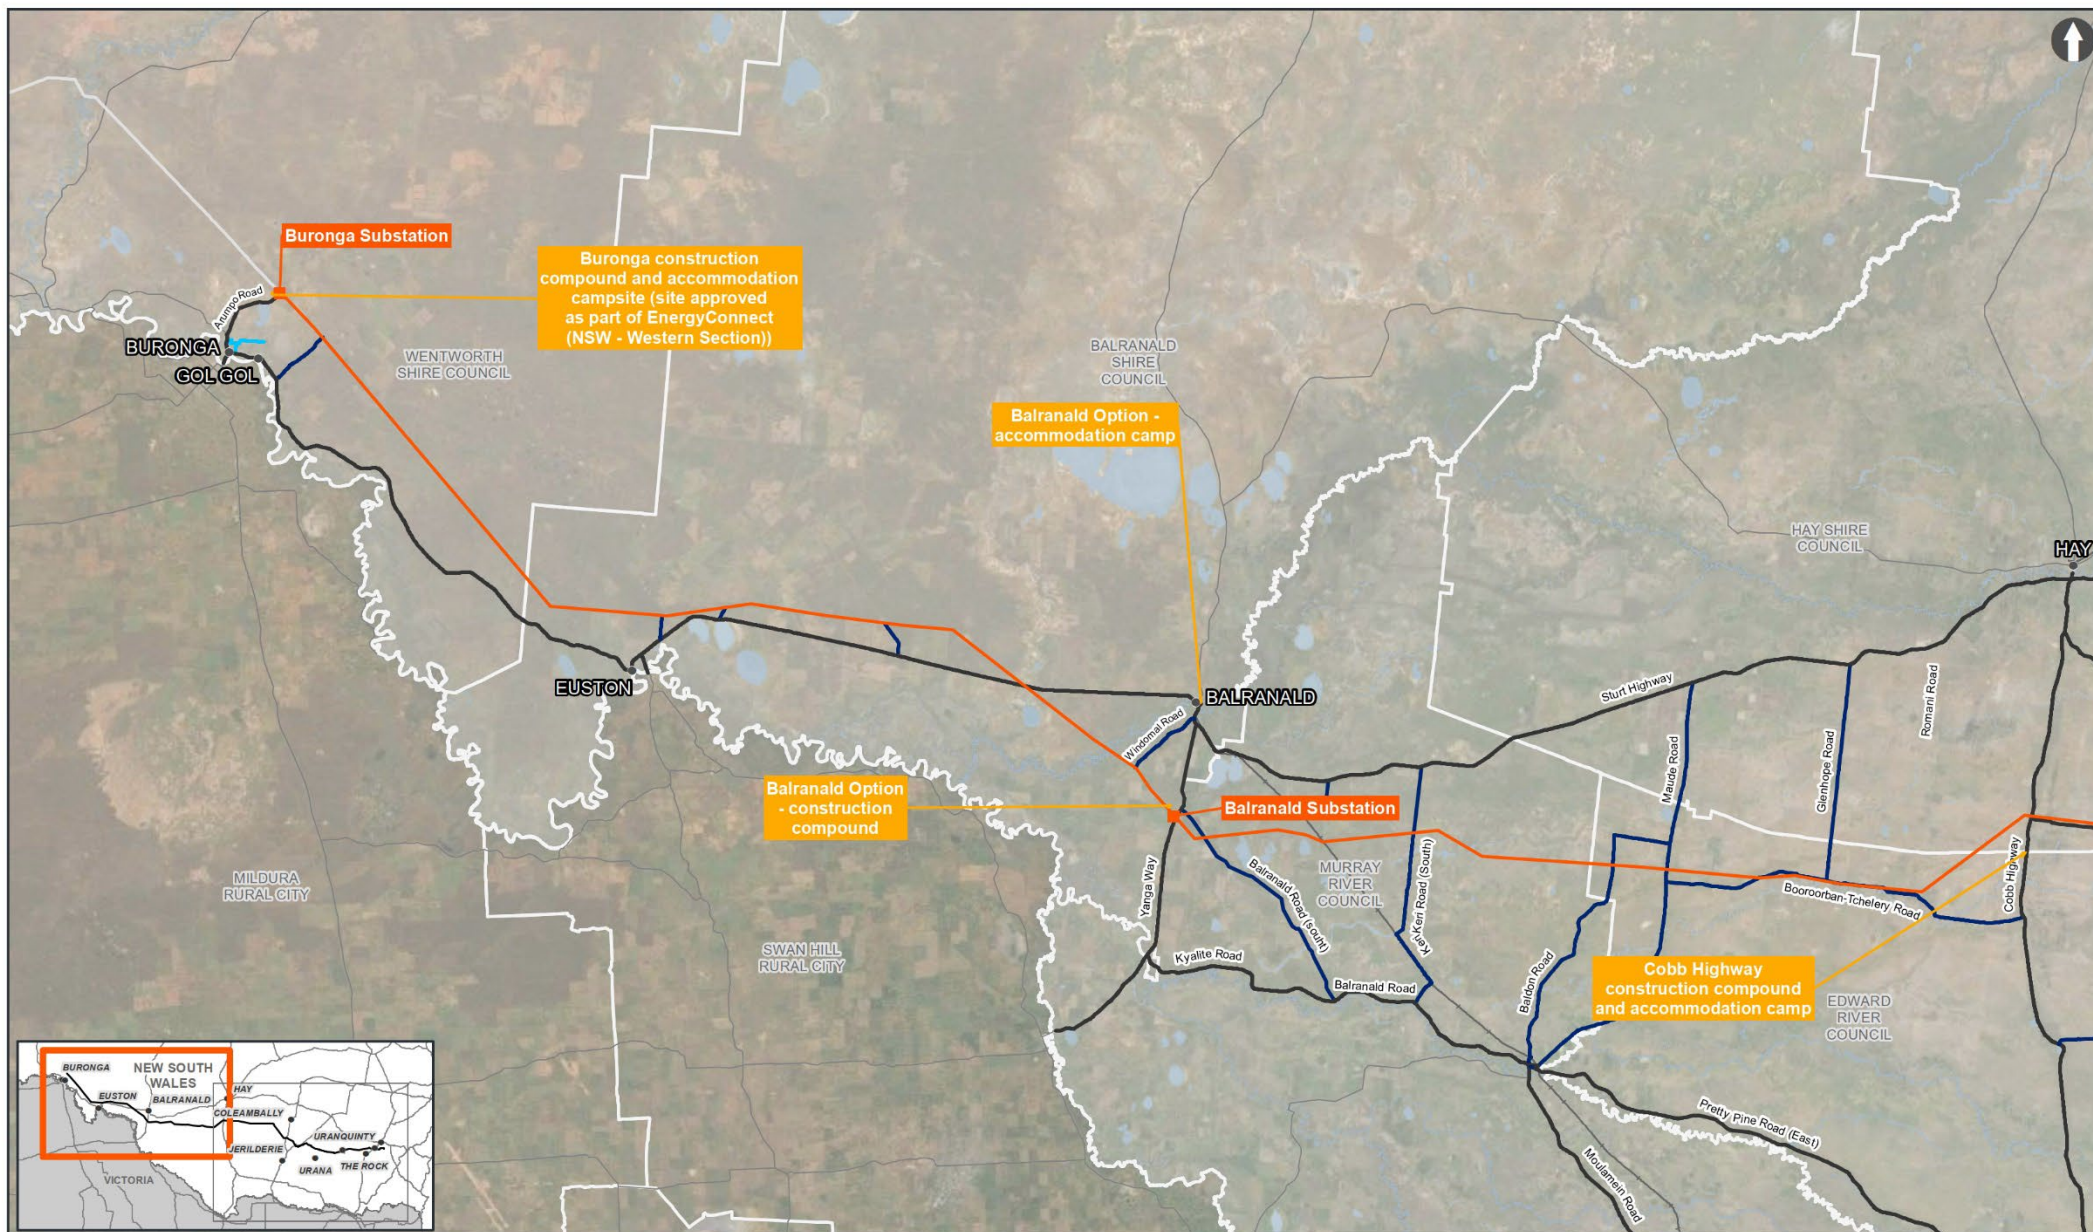
Figure 6-12

Prospective traffic access routes within the traffic and transport study area

Transgrid has renamed 'haulage routes' as 'access routes' to reflect that these routes will be used by all project-related traffic accessing construction locations, not just heavy vehicles hauling plant and equipment. To account for this change, revised figures for inclusion in Appendix 4 of the project Infrastructure Approval have been provided below.
